## APPENDIX M    UPDATED PRELIMINARY HAZARD ASSESSMENT

## Preliminary Hazard Analysis

Bendemeer Solar Farm

**Riskcon Engineering Pty Ltd**

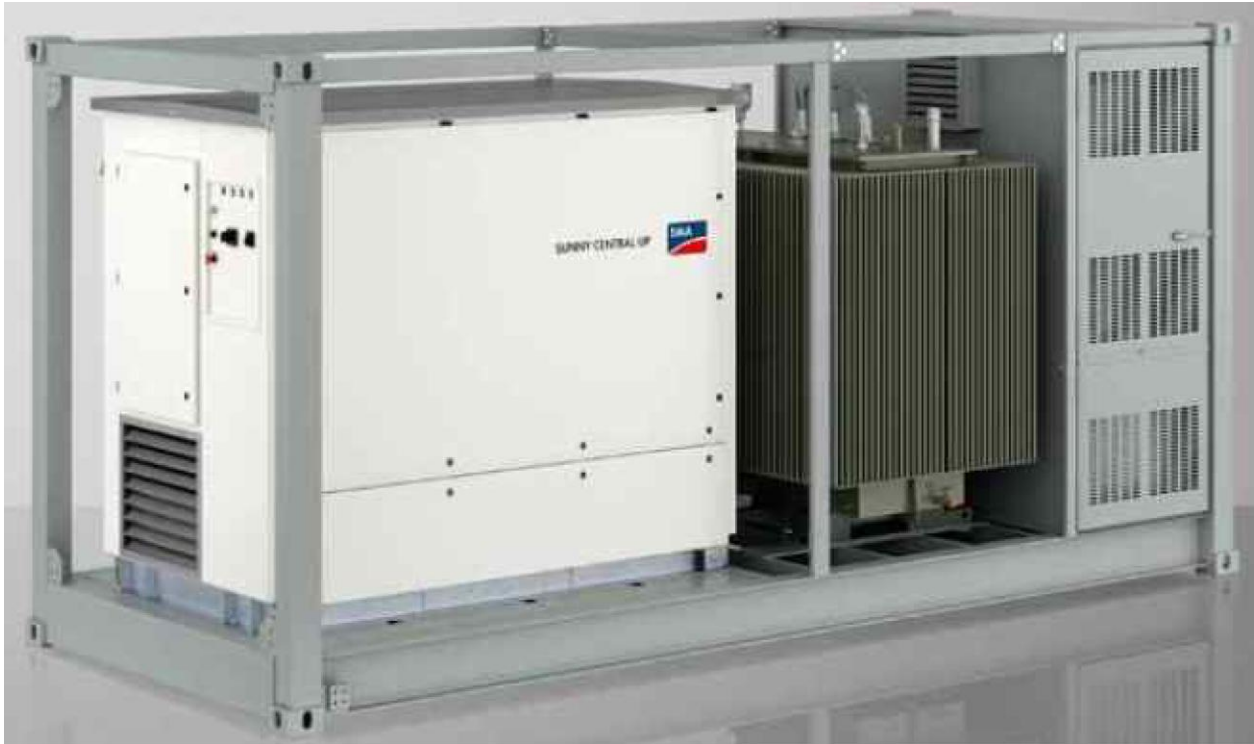
**Figure 3-3: Typical PCU**

The inverters convert the Direct Current (DC) to Alternating Current (AC), while the transformers increase the voltage from Low Voltage to a Medium or High Voltage, as required for the electricity grid connection. PCU's are a compact, containerised product, with each unit measuring approximately 2.5 metres wide by 3 metres high, with a depth of 6 metres. **Figure 3-3** provides an example of a typical PCU.

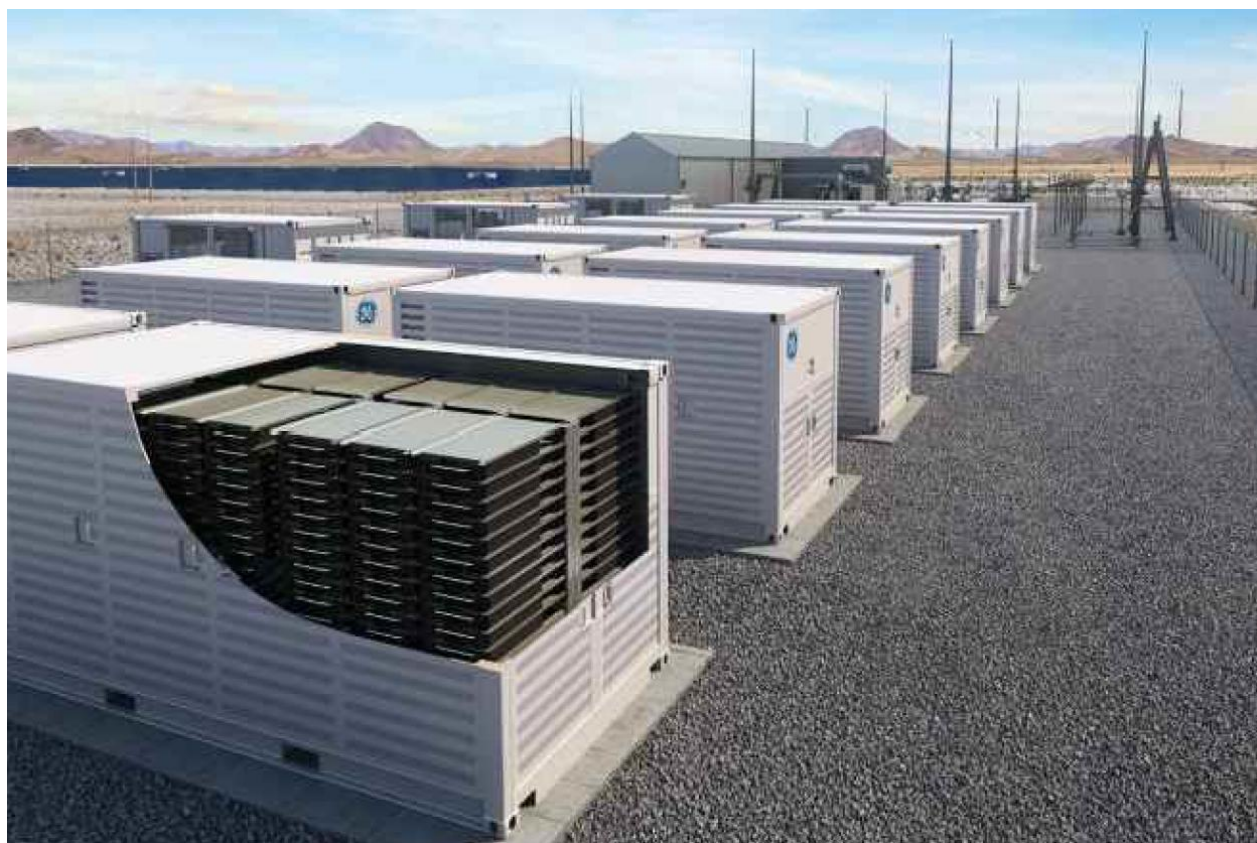
**Figure 3-4: Typical BESS Arrangement**

The BESS will be located within the site compound, laydown and substation footprint area, adjacent to the substation (southwest). The BESS converts electrical energy into chemical energy and stores the energy internally. It may also provide additional network support such as Frequency Control Ancillary Services (FCAS) assisting with transmission network grid stability. A typical BESS is shown in **Figure 3-4**.
