Our Ref: PSM3828-008L REV1

**RE: RYDE HOSPITAL REDEVELOPMENT  
RESULTS OF GEOTECHNICAL INVESTIGATION**

This letter presents the results of the geotechnical investigation and slope stability analysis undertaken by Pells Sullivan Meynink (PSM) for the proposed re-development of Ryde Hospital, Eastwood. The investigation was undertaken in accordance with our proposal PSM3828-007L, dated 10 May 2022. Approval to proceed was provided in an email from Mitchell Hodgins dated 14 June 2022.

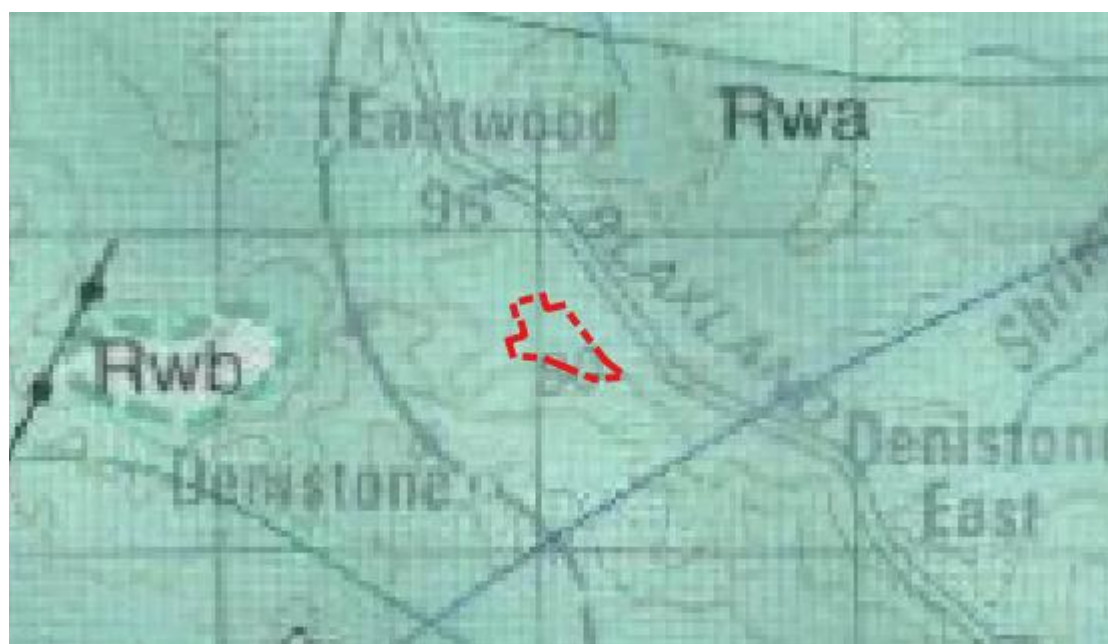
**Inset 1: Sydney geological map indicating approximate site location**

The 1:100,000 Sydney Geological Map indicates the site is underlain by Ashfield Shale of the Wianamatta group (Rwa) which consists of black to dark-grey shale and laminite. Inset 1 presents an indicative site locality on the geological map.

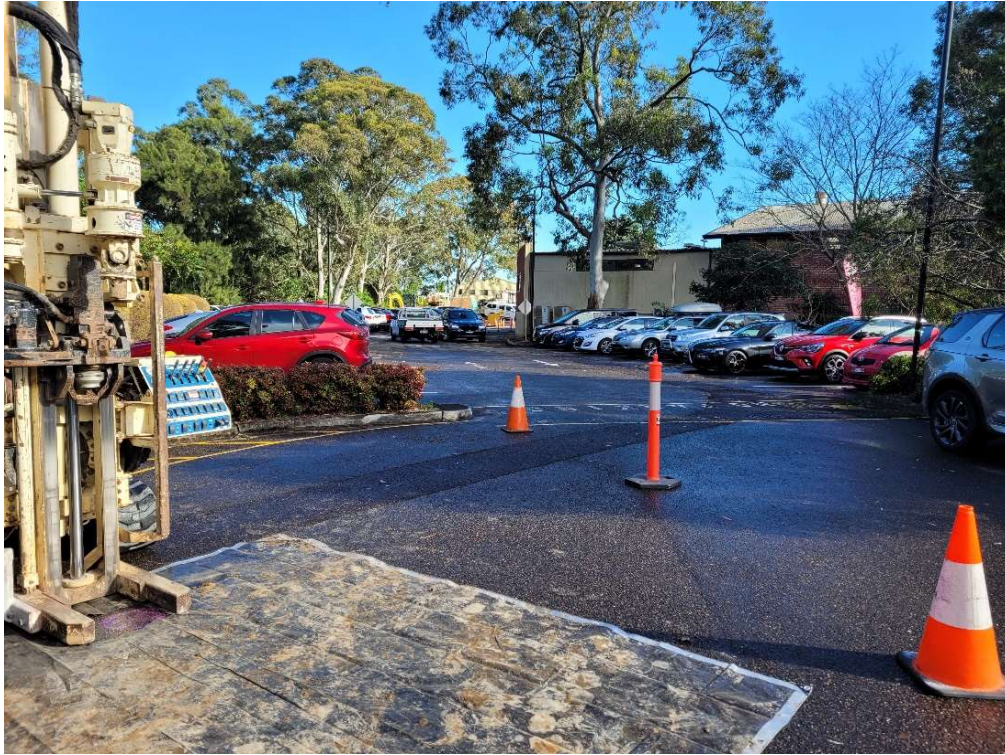
Photo 1: General site photo looking north west from BH02A

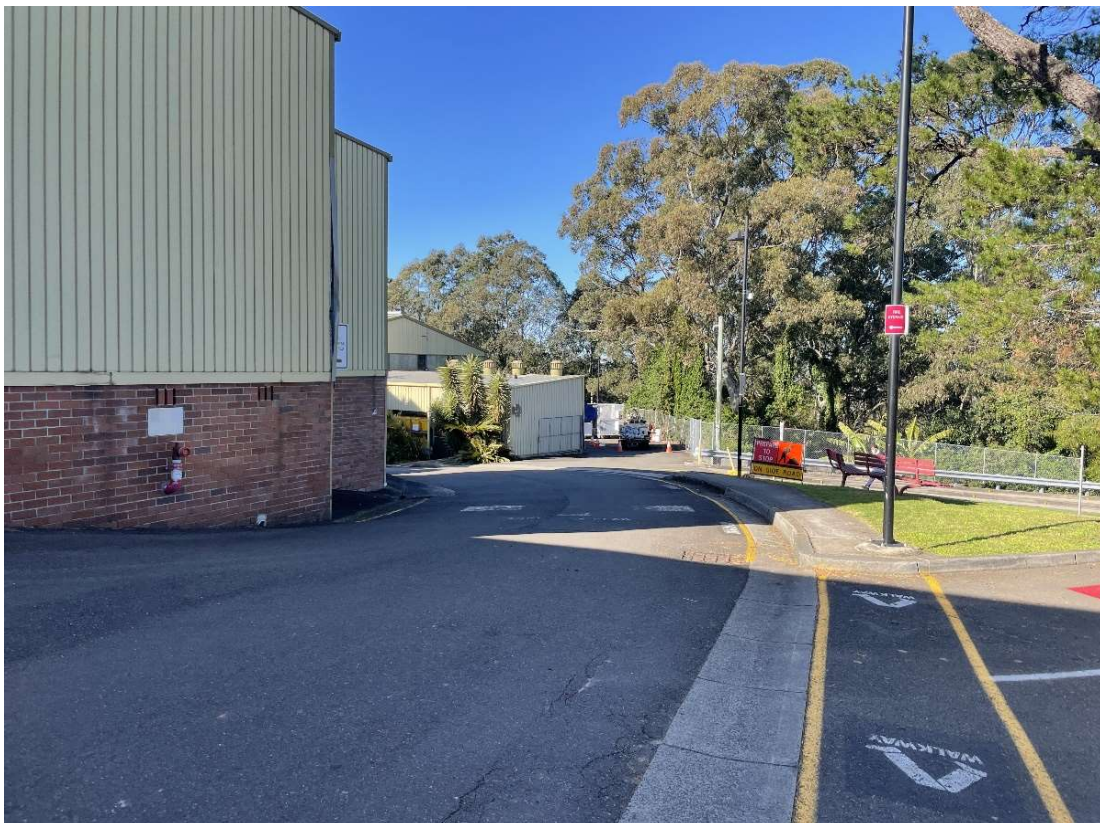
Photo 2: General site photo looking south around BH07A

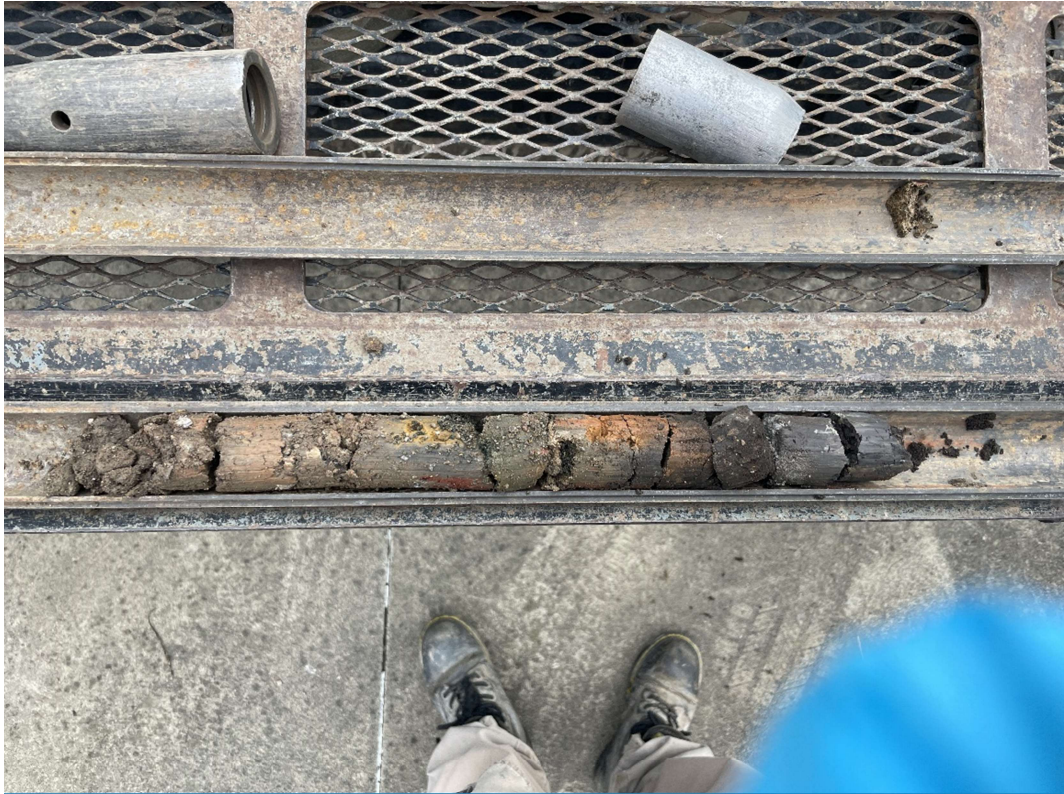
Photo 3: Typical FILL material encountered

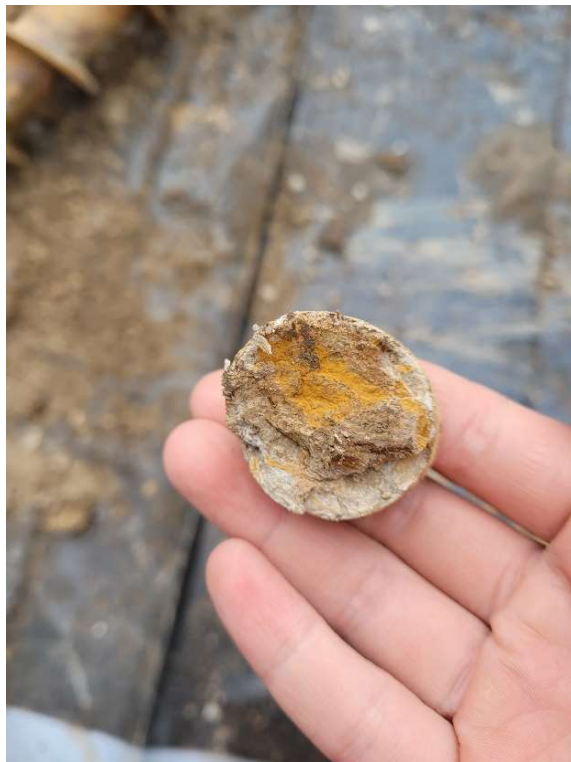
Photo 4: Typical NATURAL material encountered

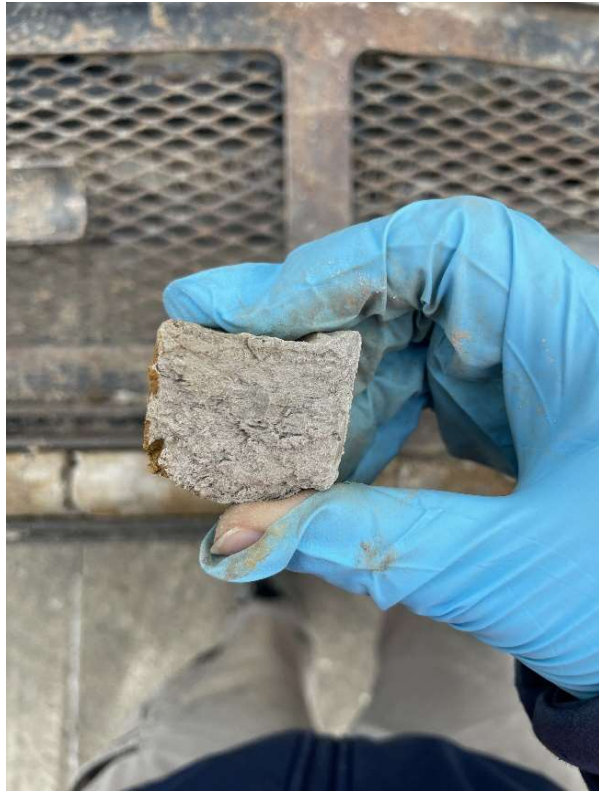
Photo 5: Typical BEDROCK unit encountered

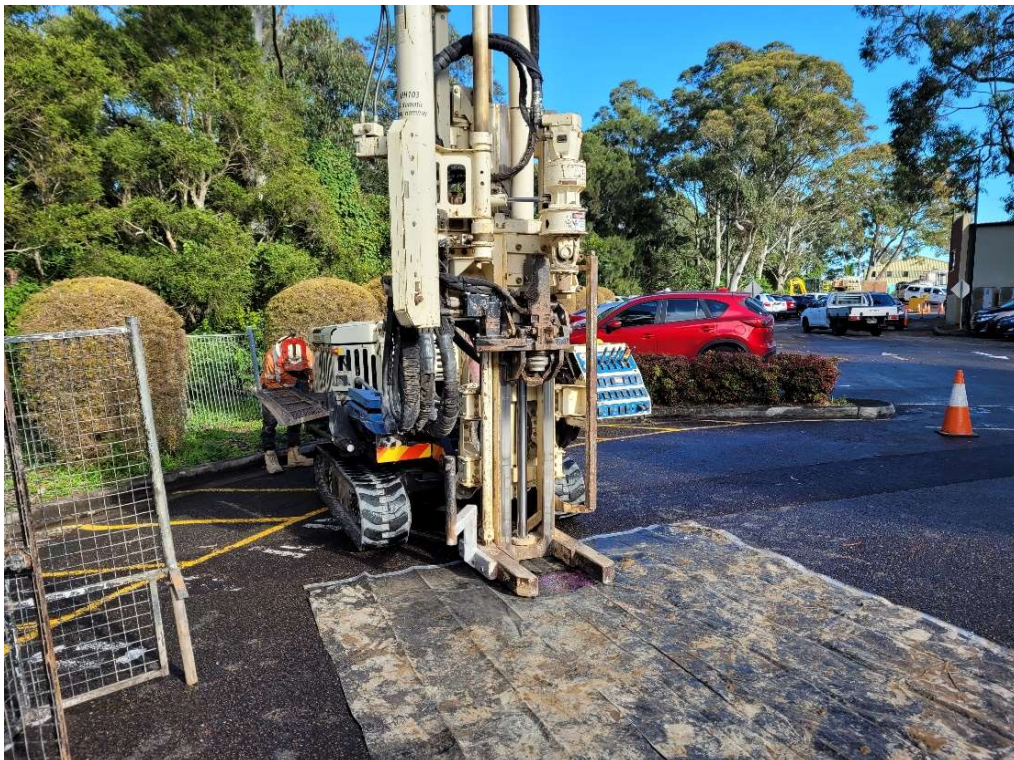
Photo 6: Rig used for drilling

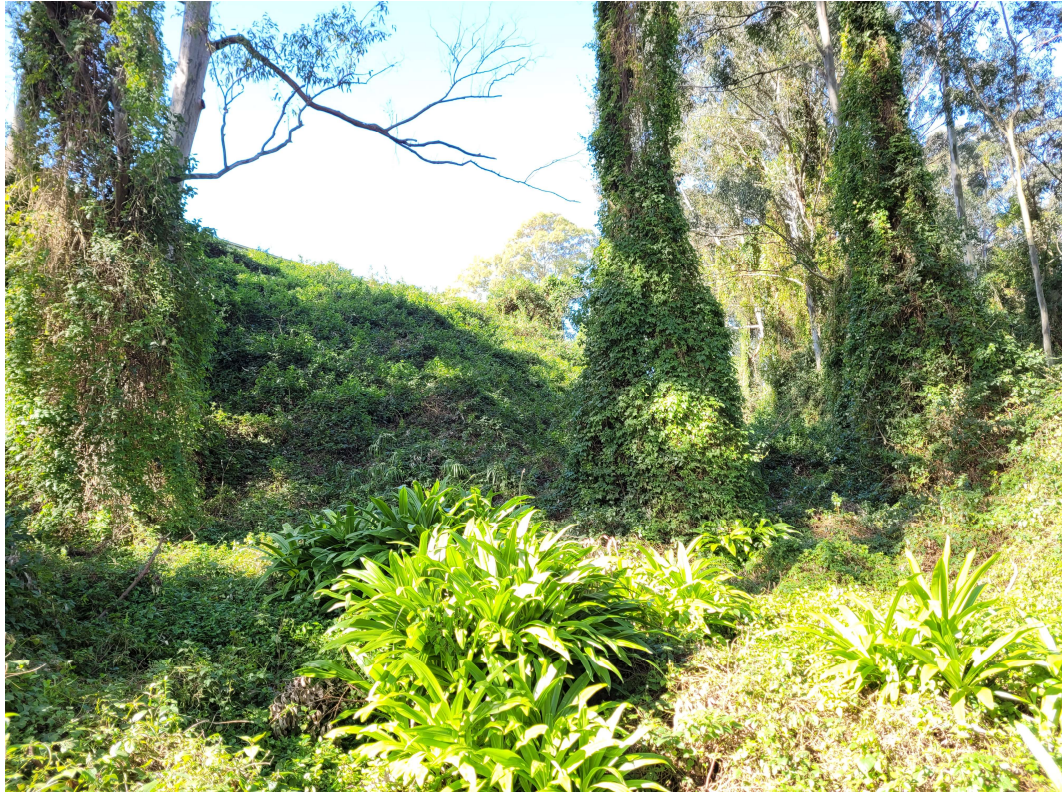
- The batter immediately south of the Site was heavily vegetated and was thus not able to be inspected
- At some locations the batter was estimated to be sloping between 1H:1V and 1.5H:1V
- The ground is generally uneven with some significant erosion gullies observed at location of preferential surface flows
- Significant amounts of debris including construction rubble was observed on the surface
- No significant land slips or instability was observed
- Evidence of surficial movement of the slope was observed.

Photo 7: Southern slope batter with dense vegetation

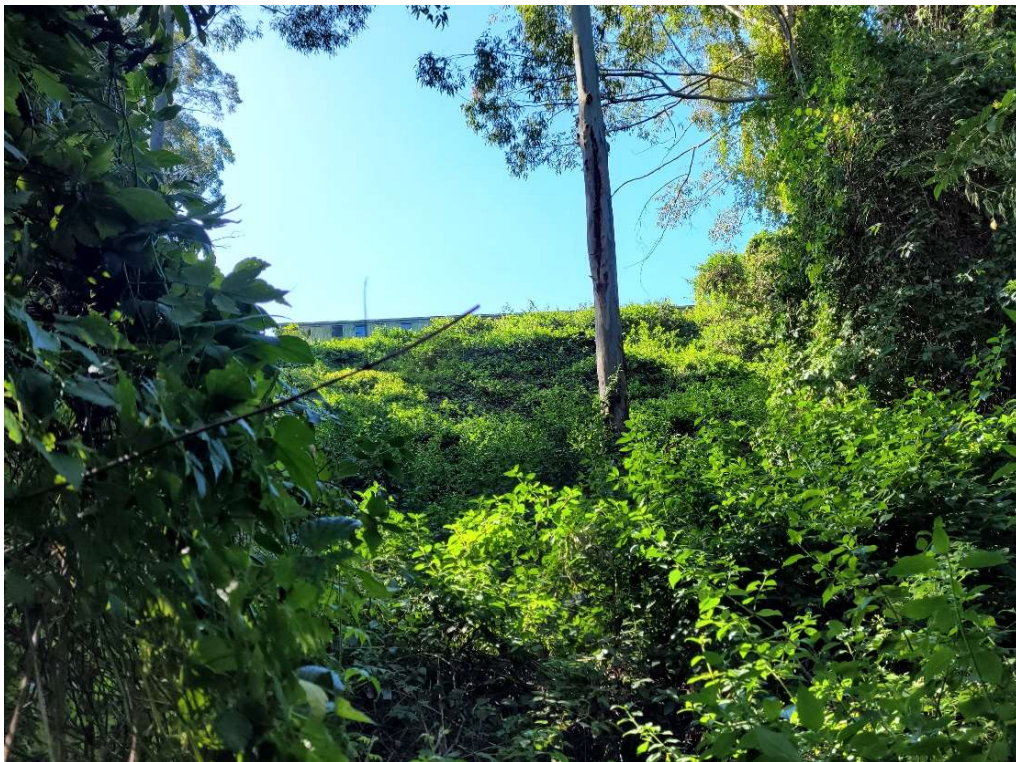
Photo 8: Southern slope looking North at Ryde Hospital

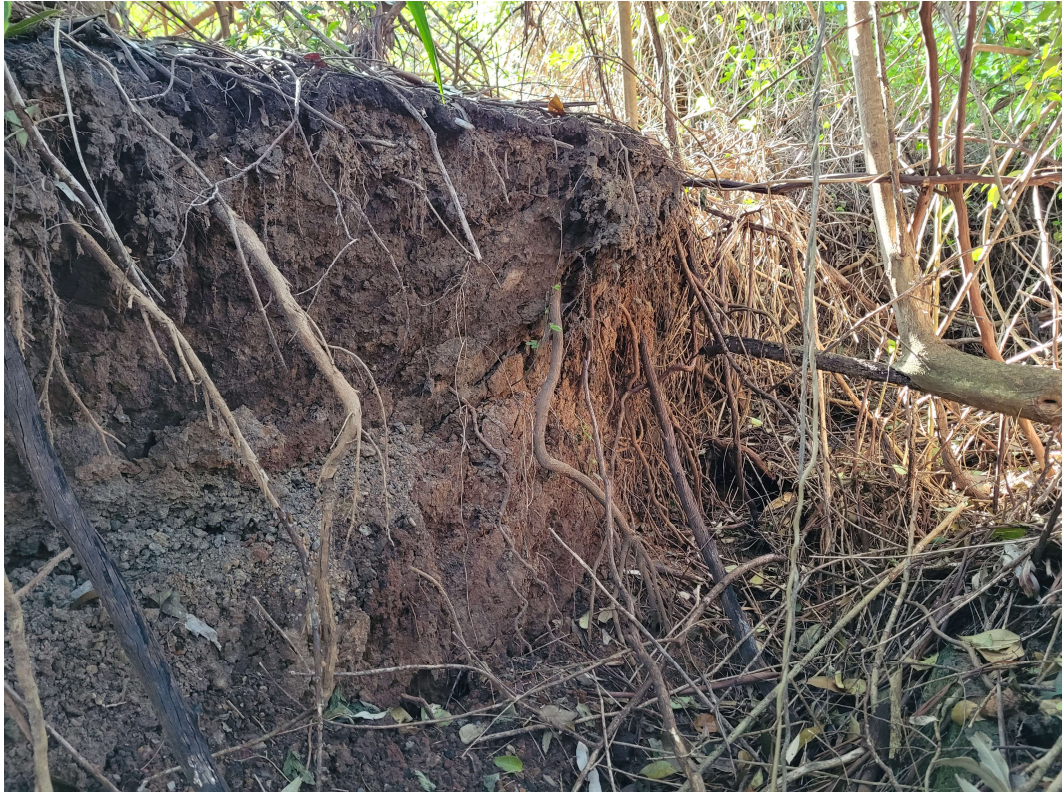
The level pads for buildings and carparks appear to have been formed by permanent cuts on the high side and fill platforms on the low side. The cuts are in residual clay and shale and were observed to be performing satisfactorily.

Photo 9: Exposed cut face at slope

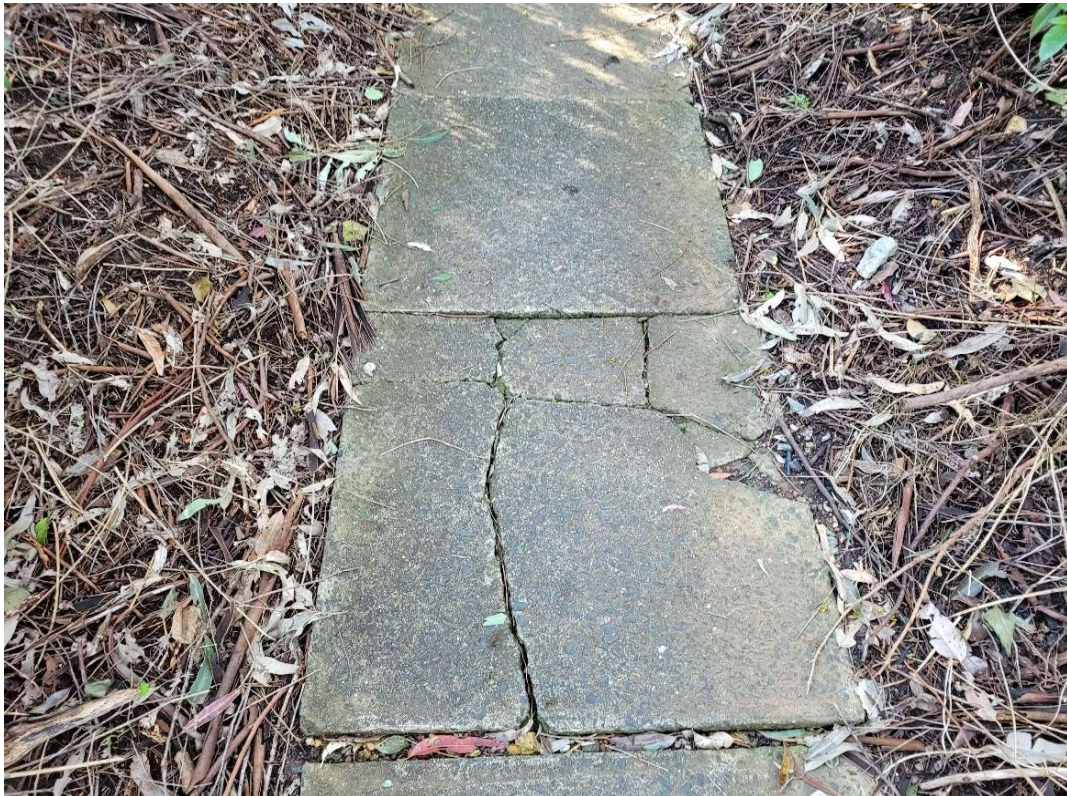
The slope in its current condition is marginally stable.

Photo 10: Cracks and Deformations present on footpath

Following the results of the investigation and analyses in order to have negligible effects on the stability of this slope, we recommend that:

Alternatively, the road could be built on a “bridge” supported on piles founded in the Bedrock unit. In this case the road could be closer to the crest. Should this option be pursued specific geotechnical advice should be sought. Preliminary sizing of the piles should be based on advice below.
