Report on  
Geotechnical Investigation

Proposed Industrial Development  
5 Skyline Crescent, Horningsea Park

Prepared for  
ESR Australia

Project 213088.00  
April 2022

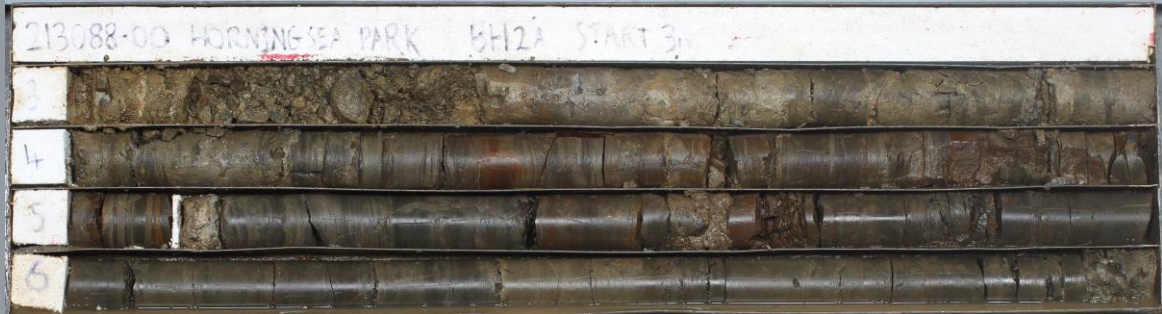
3 - 7m

Low to medium strength interlaminated siltstone and sandstone with some high strength bands, highly to moderately weathered, dark grey, slightly fractured to unbroken. Encountered in the deeper boreholes BH2A and BH3A from depths of 4.2 m and 4.6 m, respectively.

Bedding inclination was generally between 0 and 10 degrees. Defects in both rock profiles included inclined joints at 30 to 90 degrees (mostly 60 to 90 degrees), clay seams of between 3 mm and 40 mm thick, as well as decomposed seams and crushed zones of between 10 mm and 110 mm thick.

Project No: 213088-00  
BH ID: BH2A  
Depth: 3m - 7m  
Core Box No.: 1/2

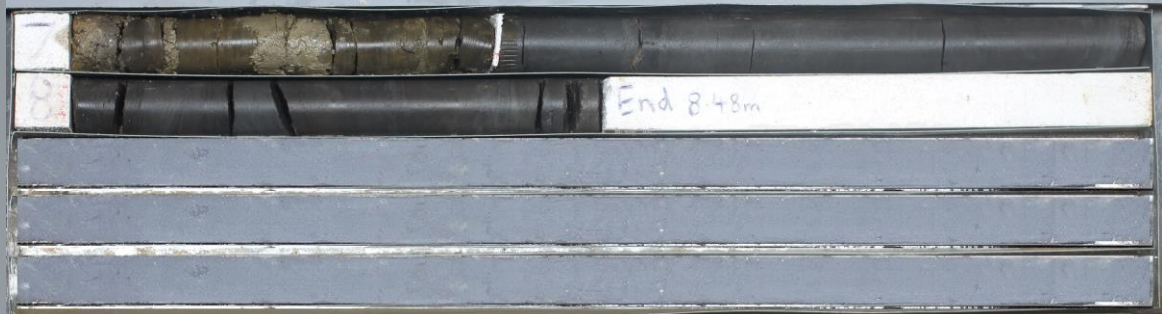
7 - 8.48m

Project No: 213088-00  
BH ID: BH2A  
Depth: 7m - 8.48m  
Core Box No.: 2/2
