Report on  
Geotechnical Investigation

Harbourside Redevelopment  
2 – 10 Darling Drive, Darling Harbour

Prepared for  
Mirvac Projects Pty Ltd

Project 200004.00  
March 2021

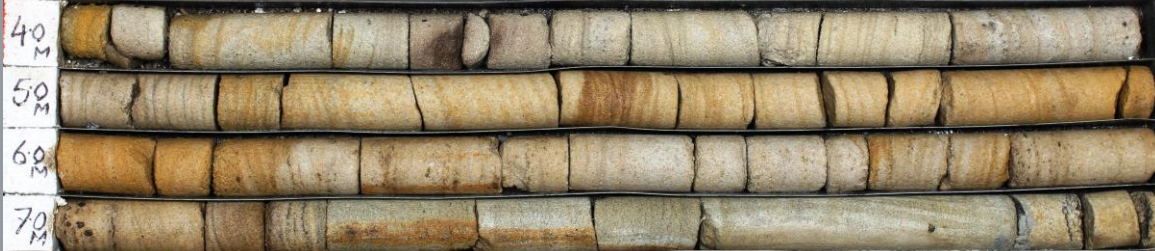
4.00 - 8.00m

DARLING HARBOUR 200004.00 BH 1

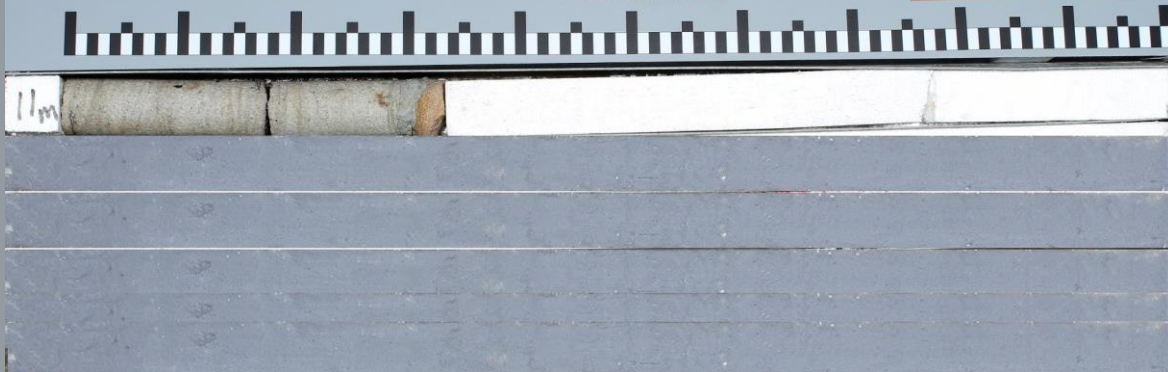
11.00 - 11.35m

Project No: 20000400  
BH ID: BH 2  
Depth: 11.00 - 11.35 m  
Core Box No.: 2

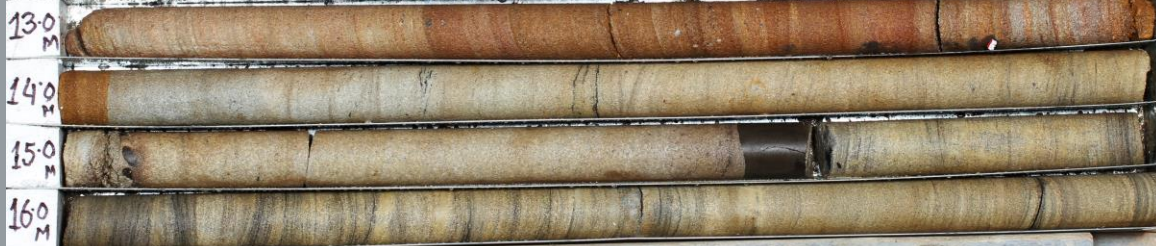
13.00 - 17.00m

DARLING HARBOUR START: 13.00 M 18/01/2021  
200004.00 BH7

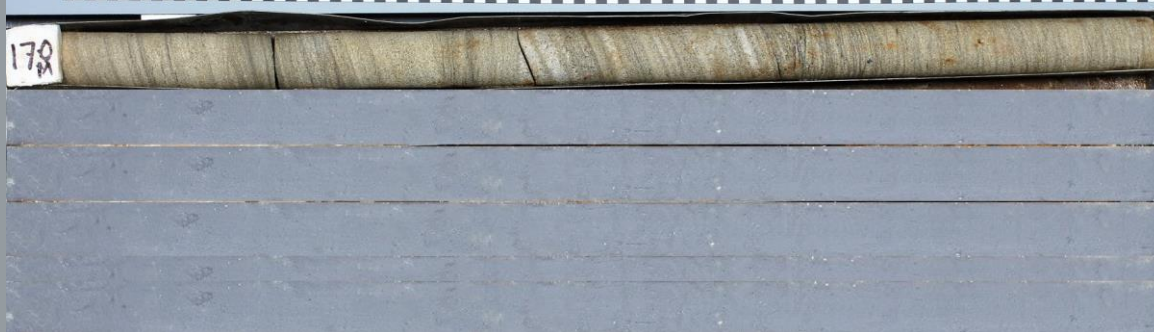
17.00 - 18.00m

Project No: 200004.00  
BH ID: BH 7  
Depth: 17.00 - 18.00 m  
Core Box No.: 2

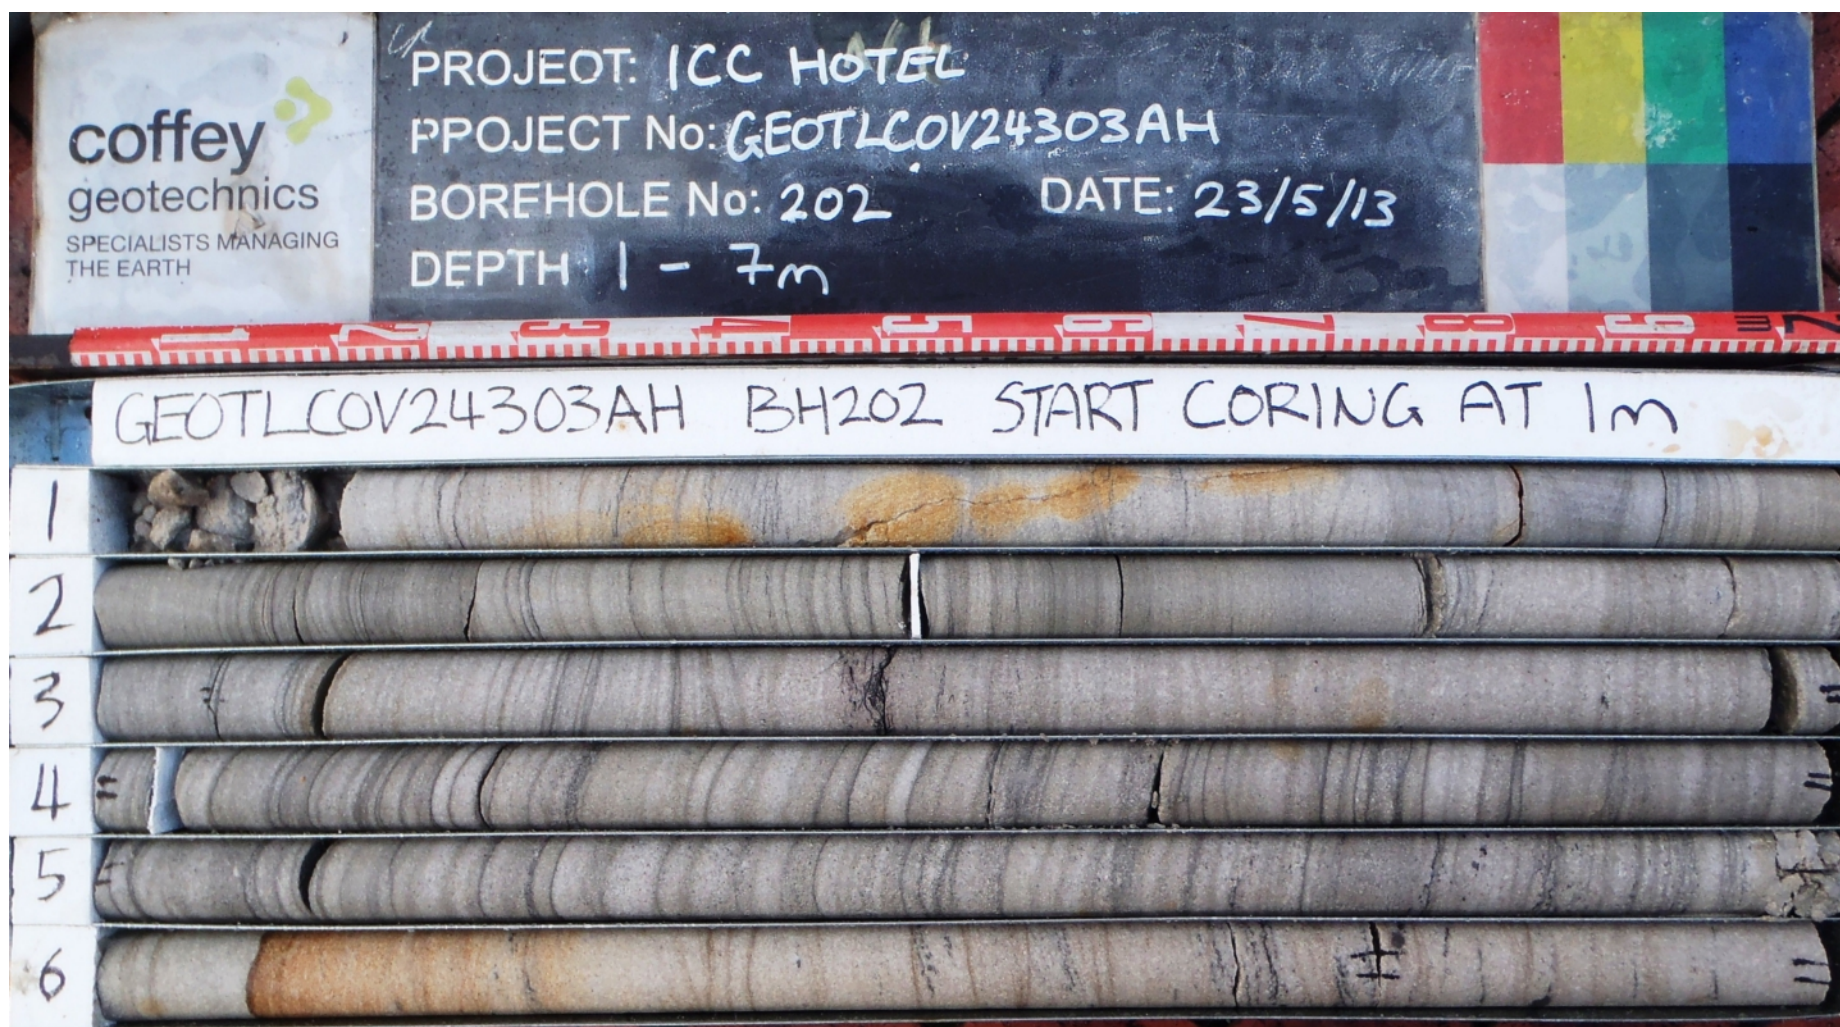
| scale | N.T.S. | | project no: | GEOTLCOV24303AH | fig no: | <b>FIGURE 3</b> |

PointID : BH202 Depth Range: 1.00 - 7.00 m

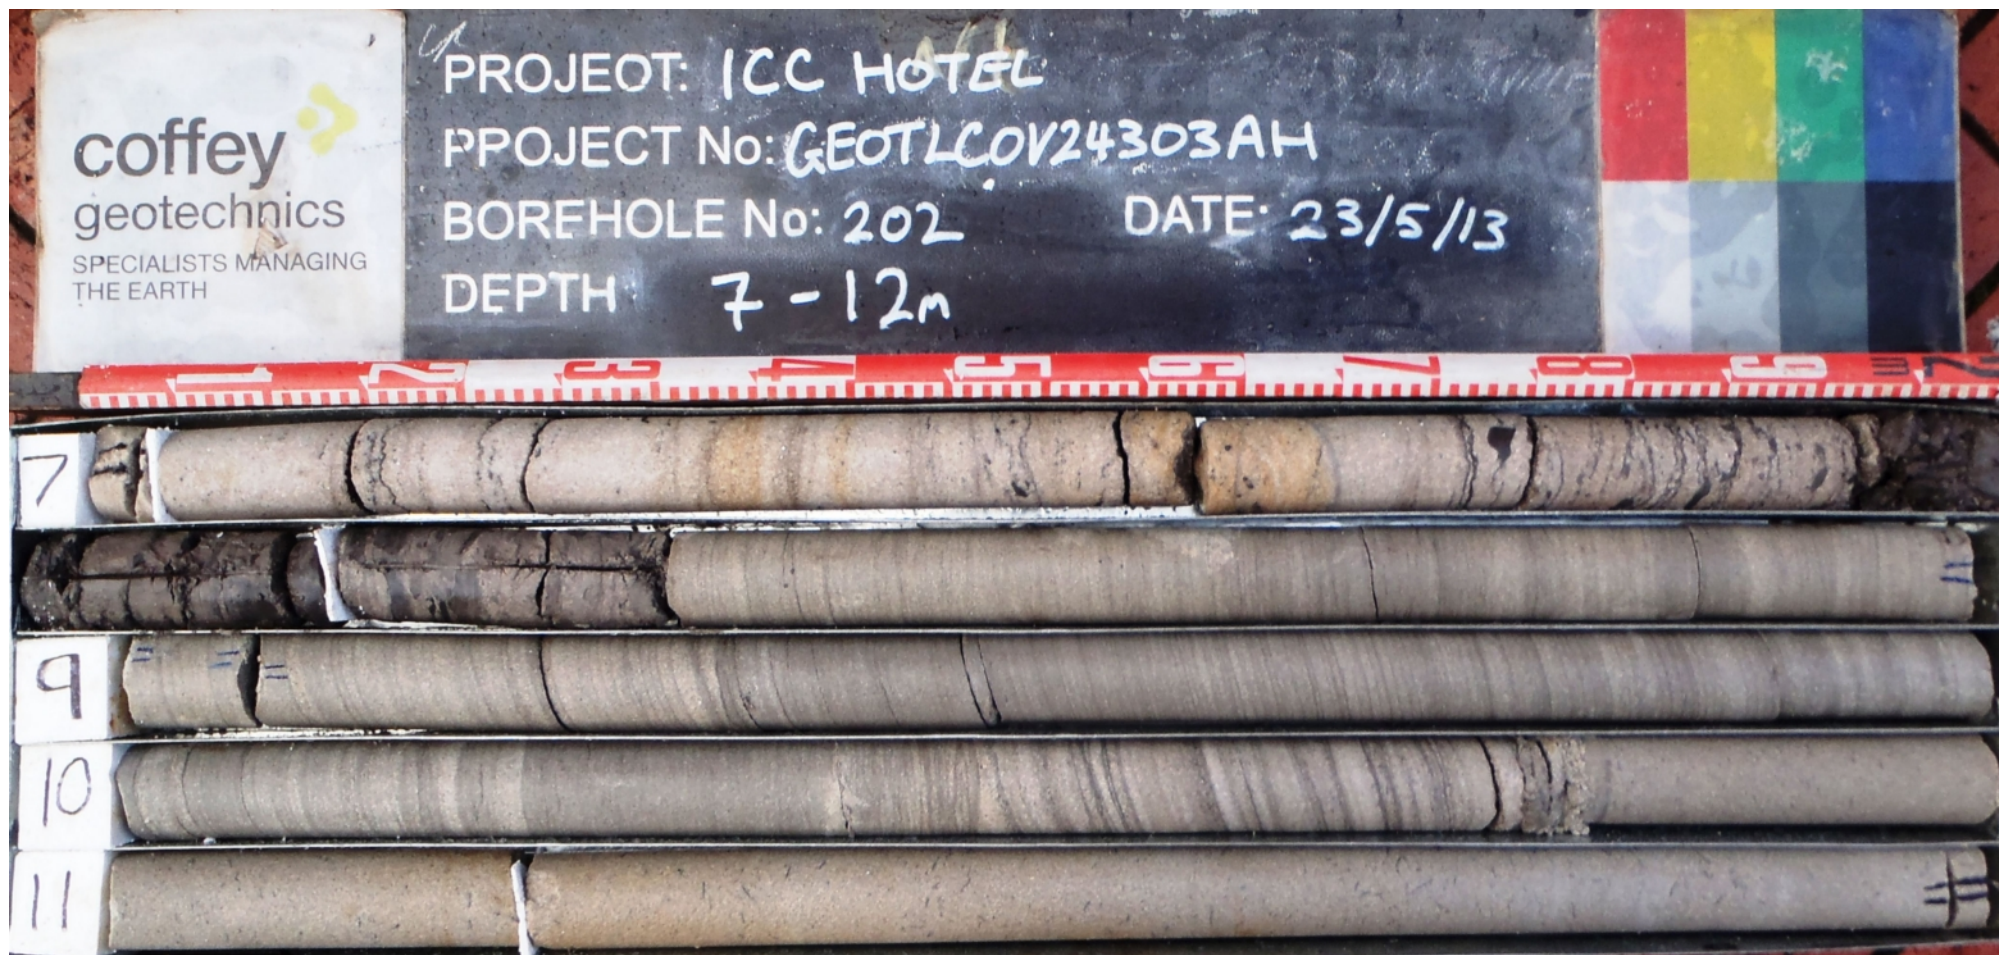
| scale | N.T.S. | | project no: | GEOTLCOV24303AH | fig no: | <b>FIGURE 4</b> |

PointID : BH202 Depth Range: 7.00 - 12.00 m

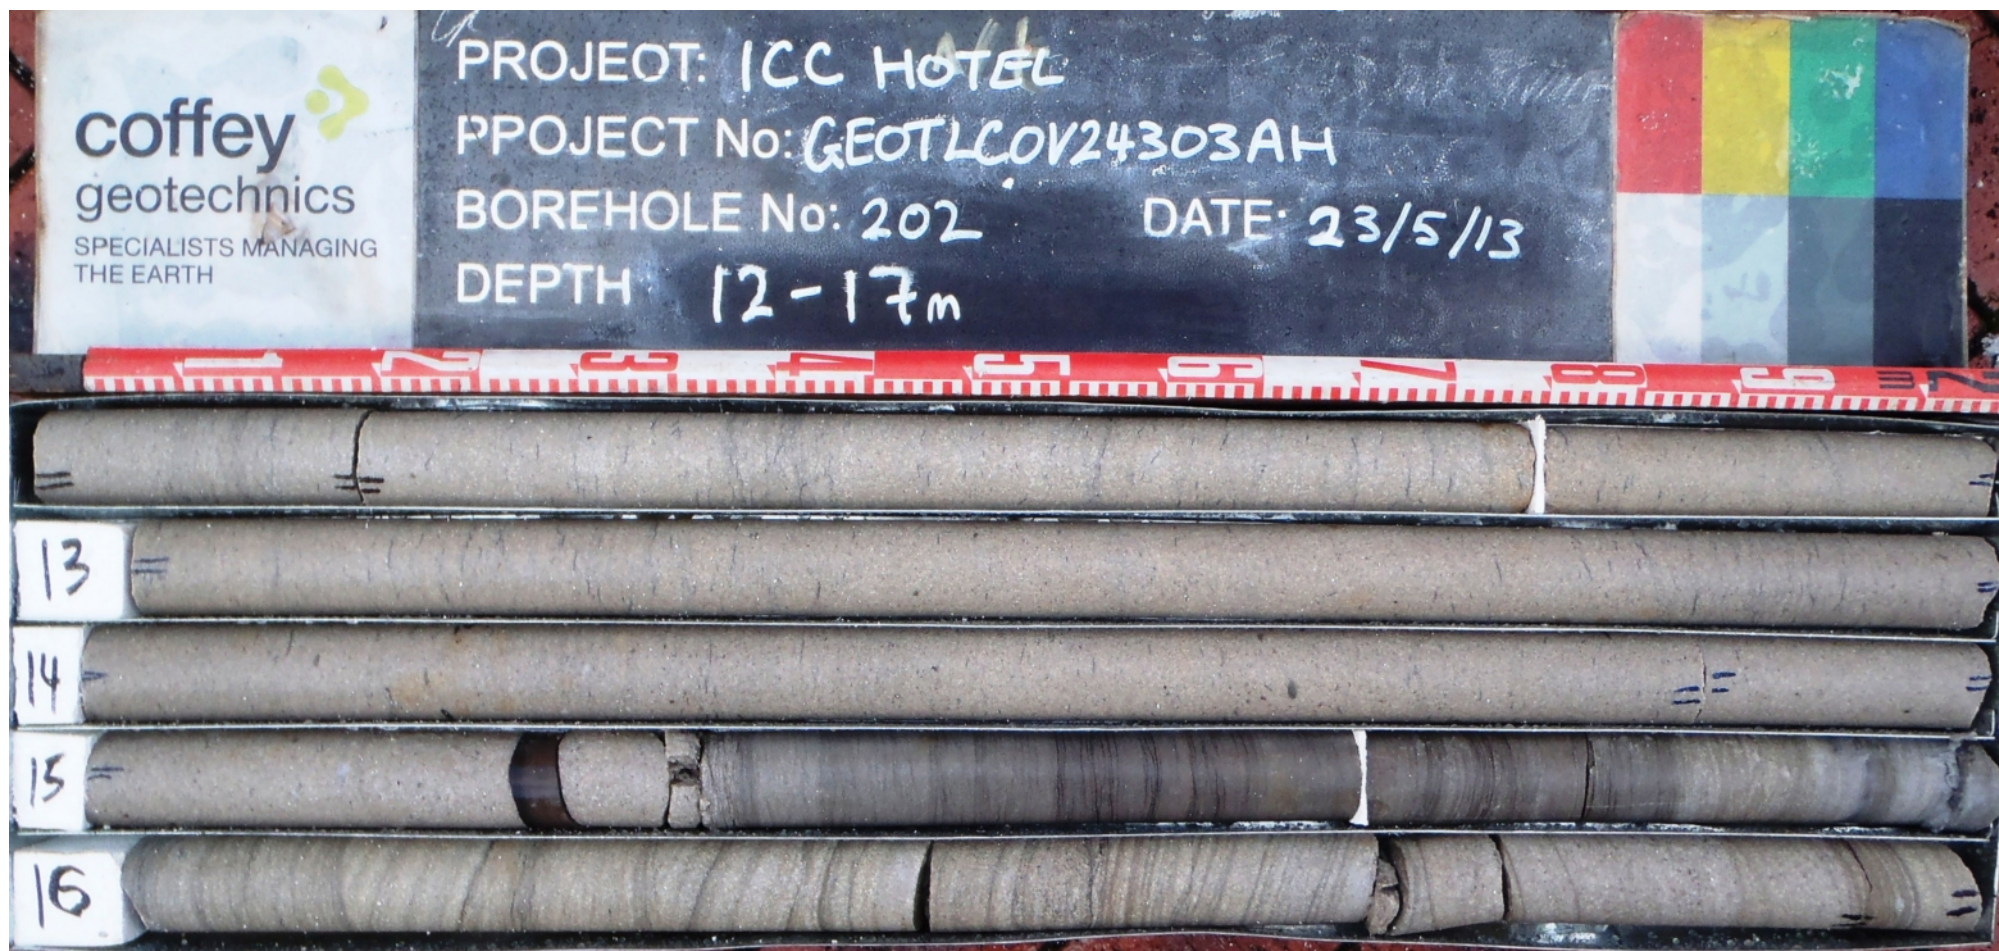
| scale | N.T.S. | | project no: | GEOTLCOV24303AH | fig no: | <b>FIGURE 5</b> |

PointID : BH202 Depth Range: 12.00 - 17.00 m

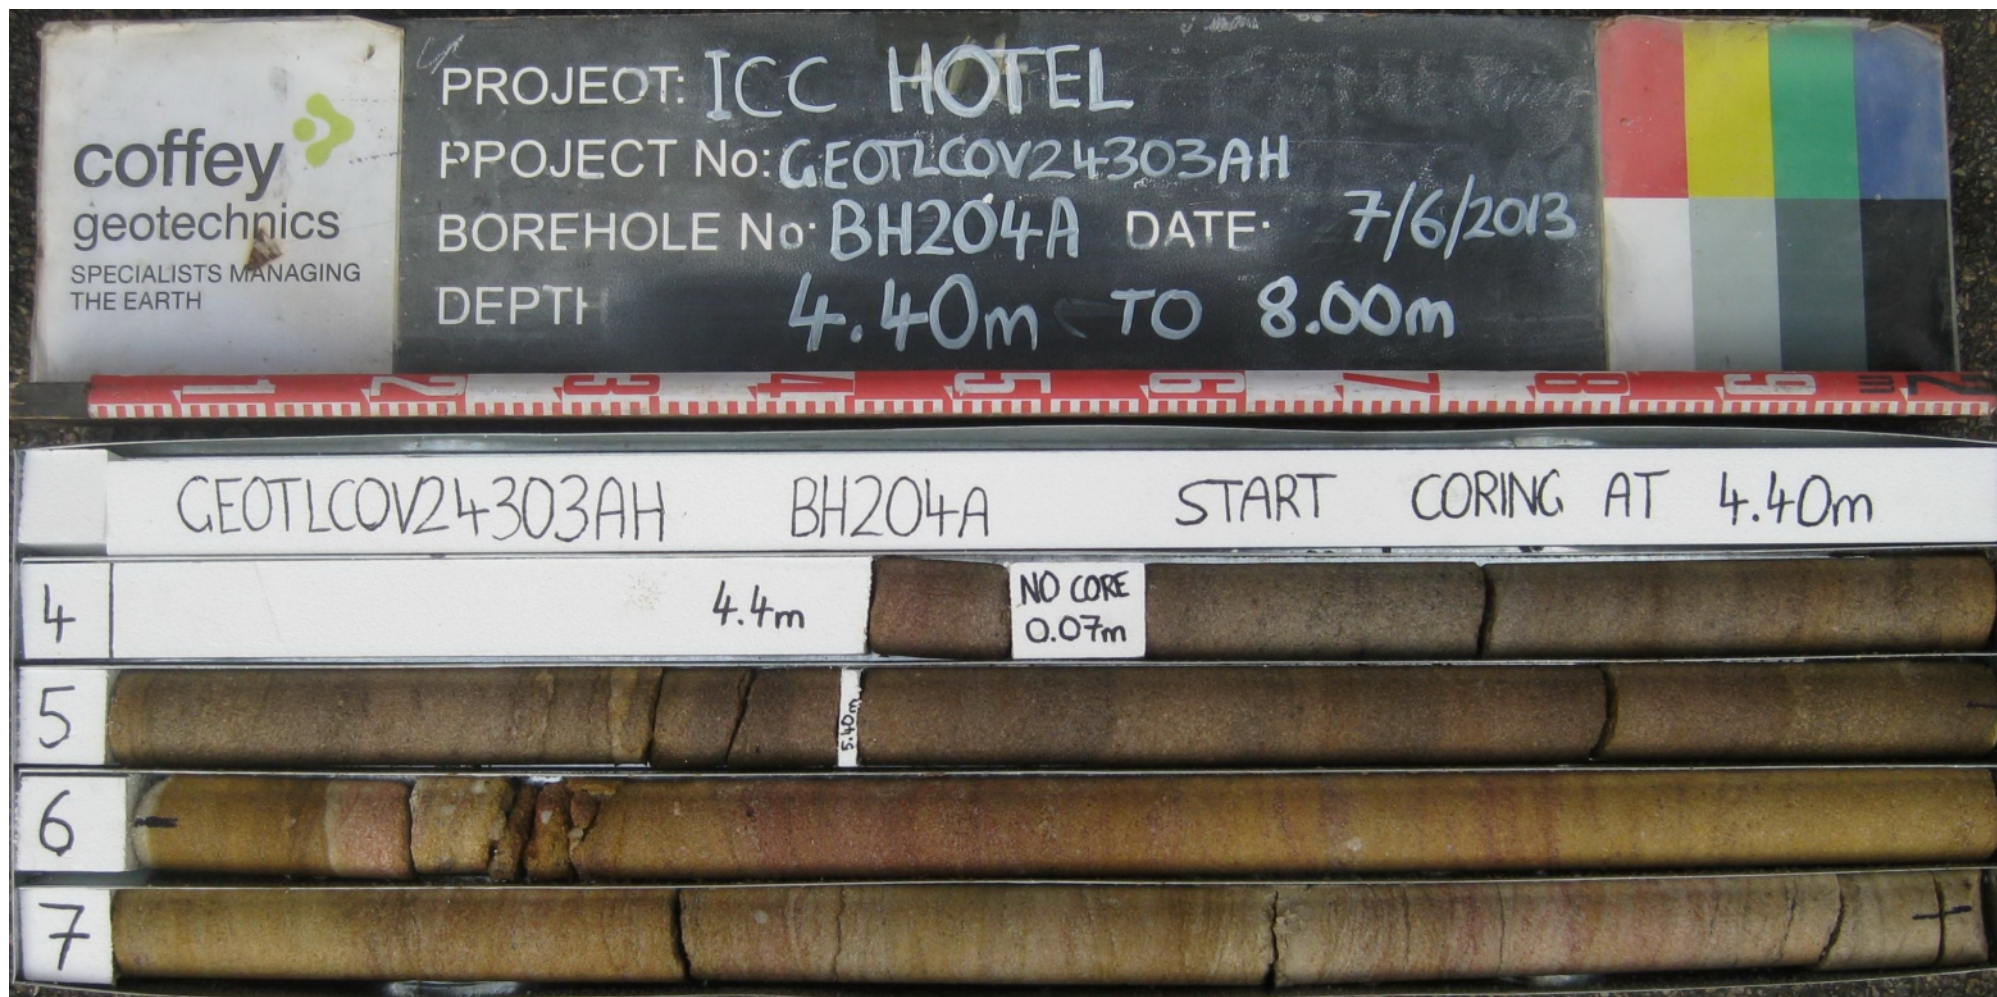
| scale | N.T.S. | | project no: | GEOTLCOV24303AH | fig no: | <b>FIGURE 11</b> |

PointID : BH204a Depth Range: 4.40 - 8.00 m

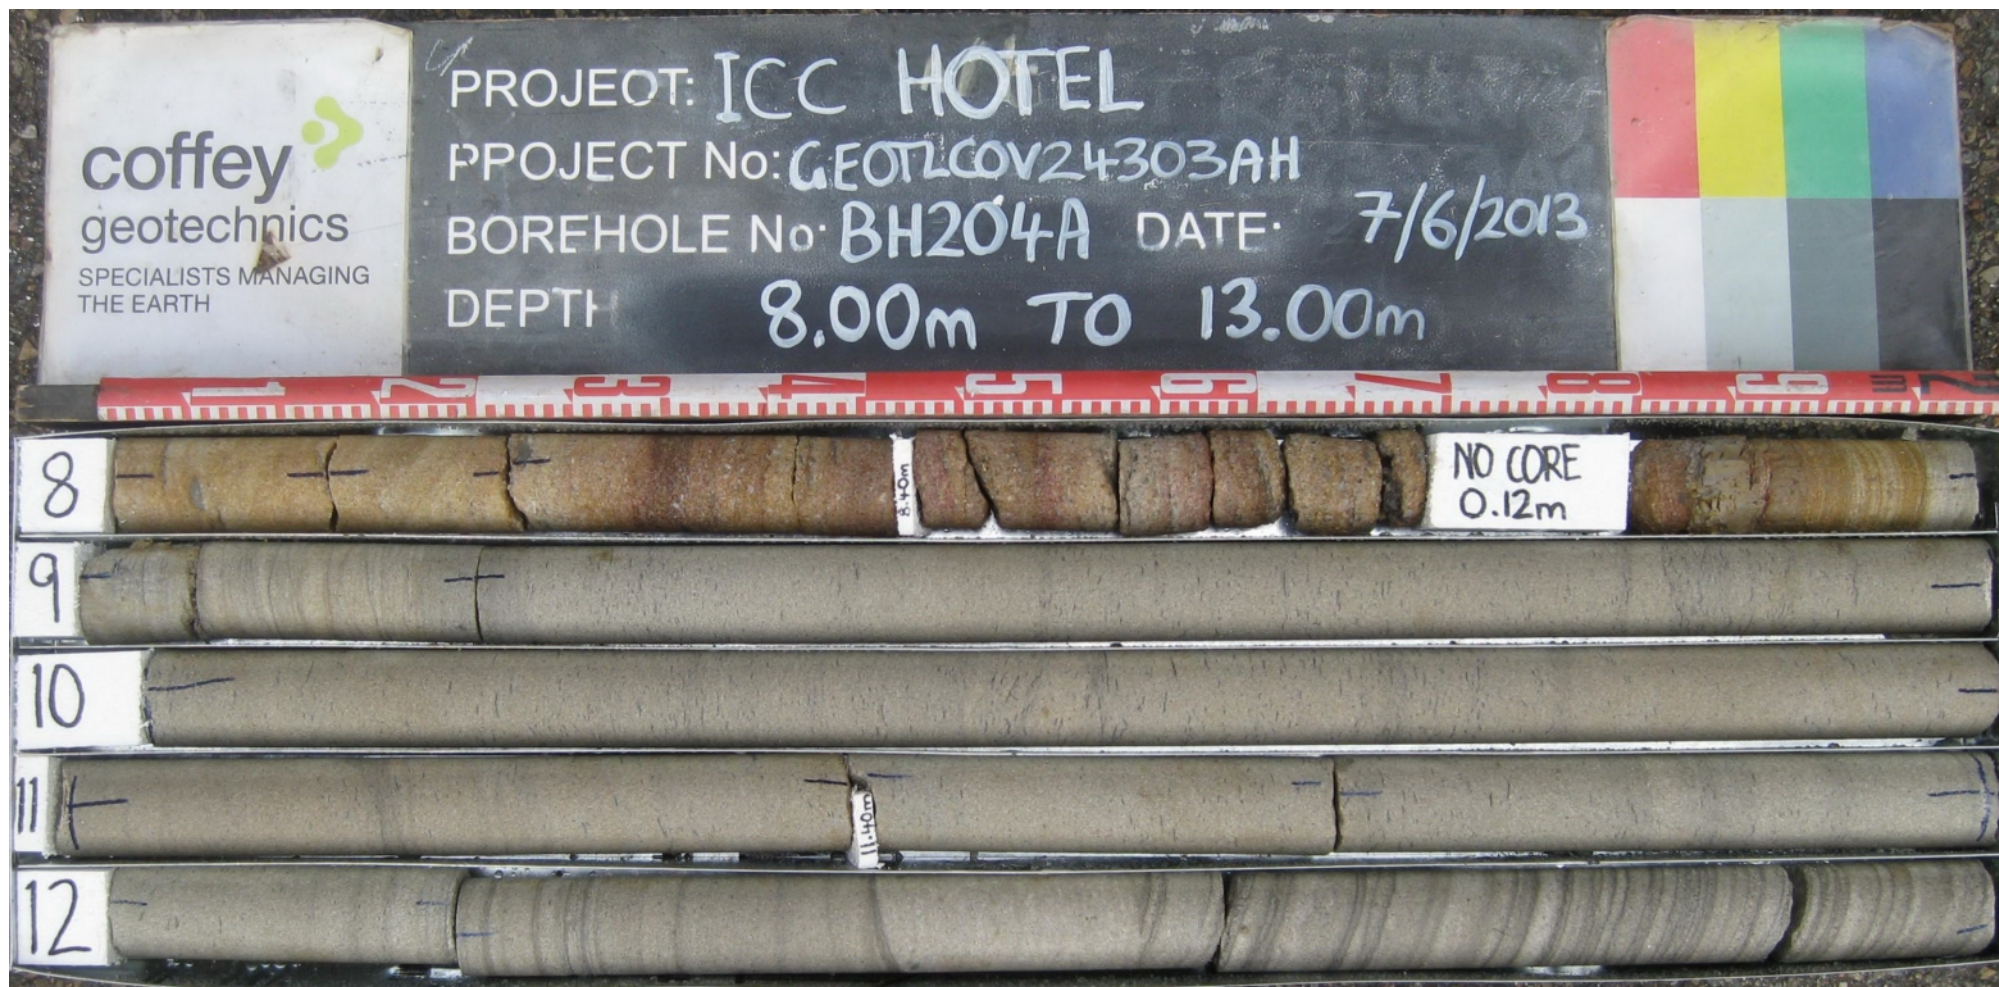
| scale | N.T.S. | | project no: | GEOTLCOV24303AH | fig no: | <b>FIGURE 12</b> |

PointID : BH204a Depth Range: 8.00 - 13.00 m

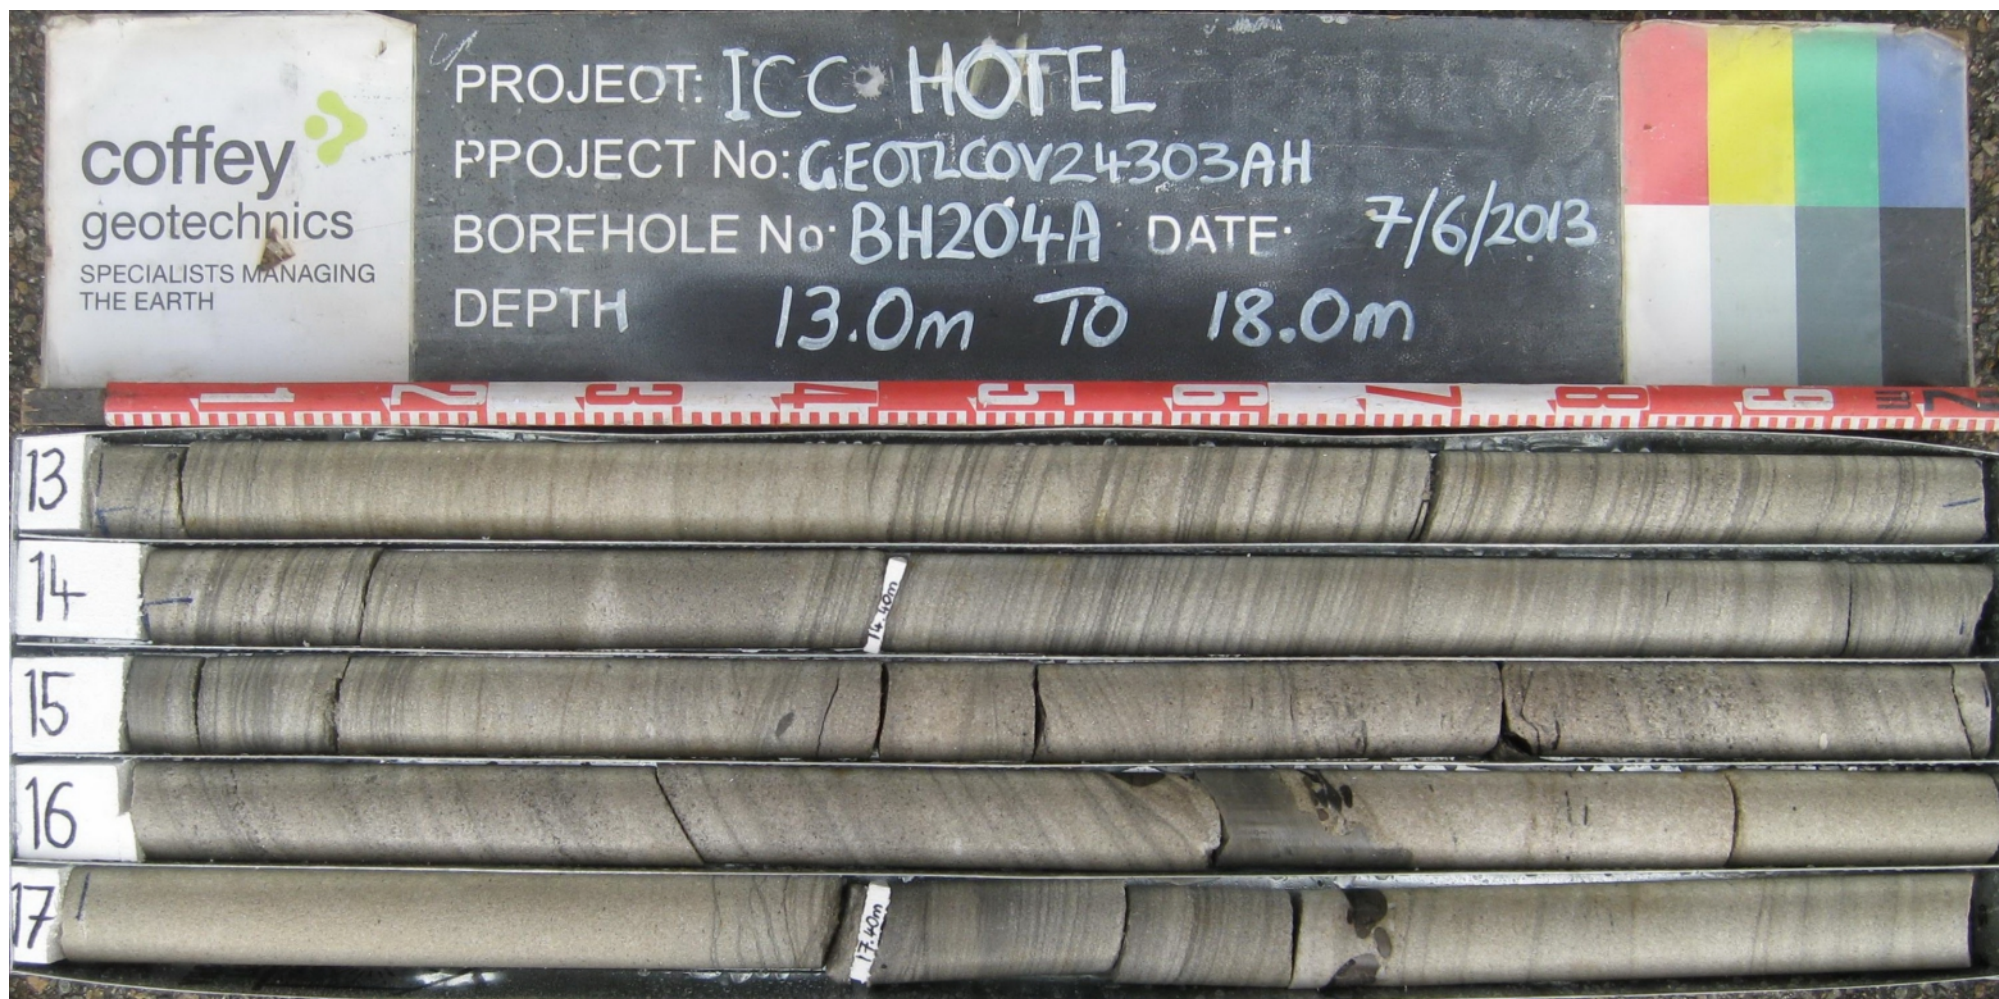
| scale | N.T.S. | | project no: | GEOTLCOV24303AH | fig no: | <b>FIGURE 13</b> |

PointID : BH204a Depth Range: 13.00 - 18.00 m
