RE: INTERIM AUDIT ADVICE LETTER NO. 1 - REVIEW OF REMEDIATION ACTION PLAN FOR PROPOSED DESIGN AND CREATIVE ARTS BUILDING AND SOCIAL SCIENCES BUILDING, MERIDEN SENIOR SCHOOL CAMPUS

Audit Number: LW-027

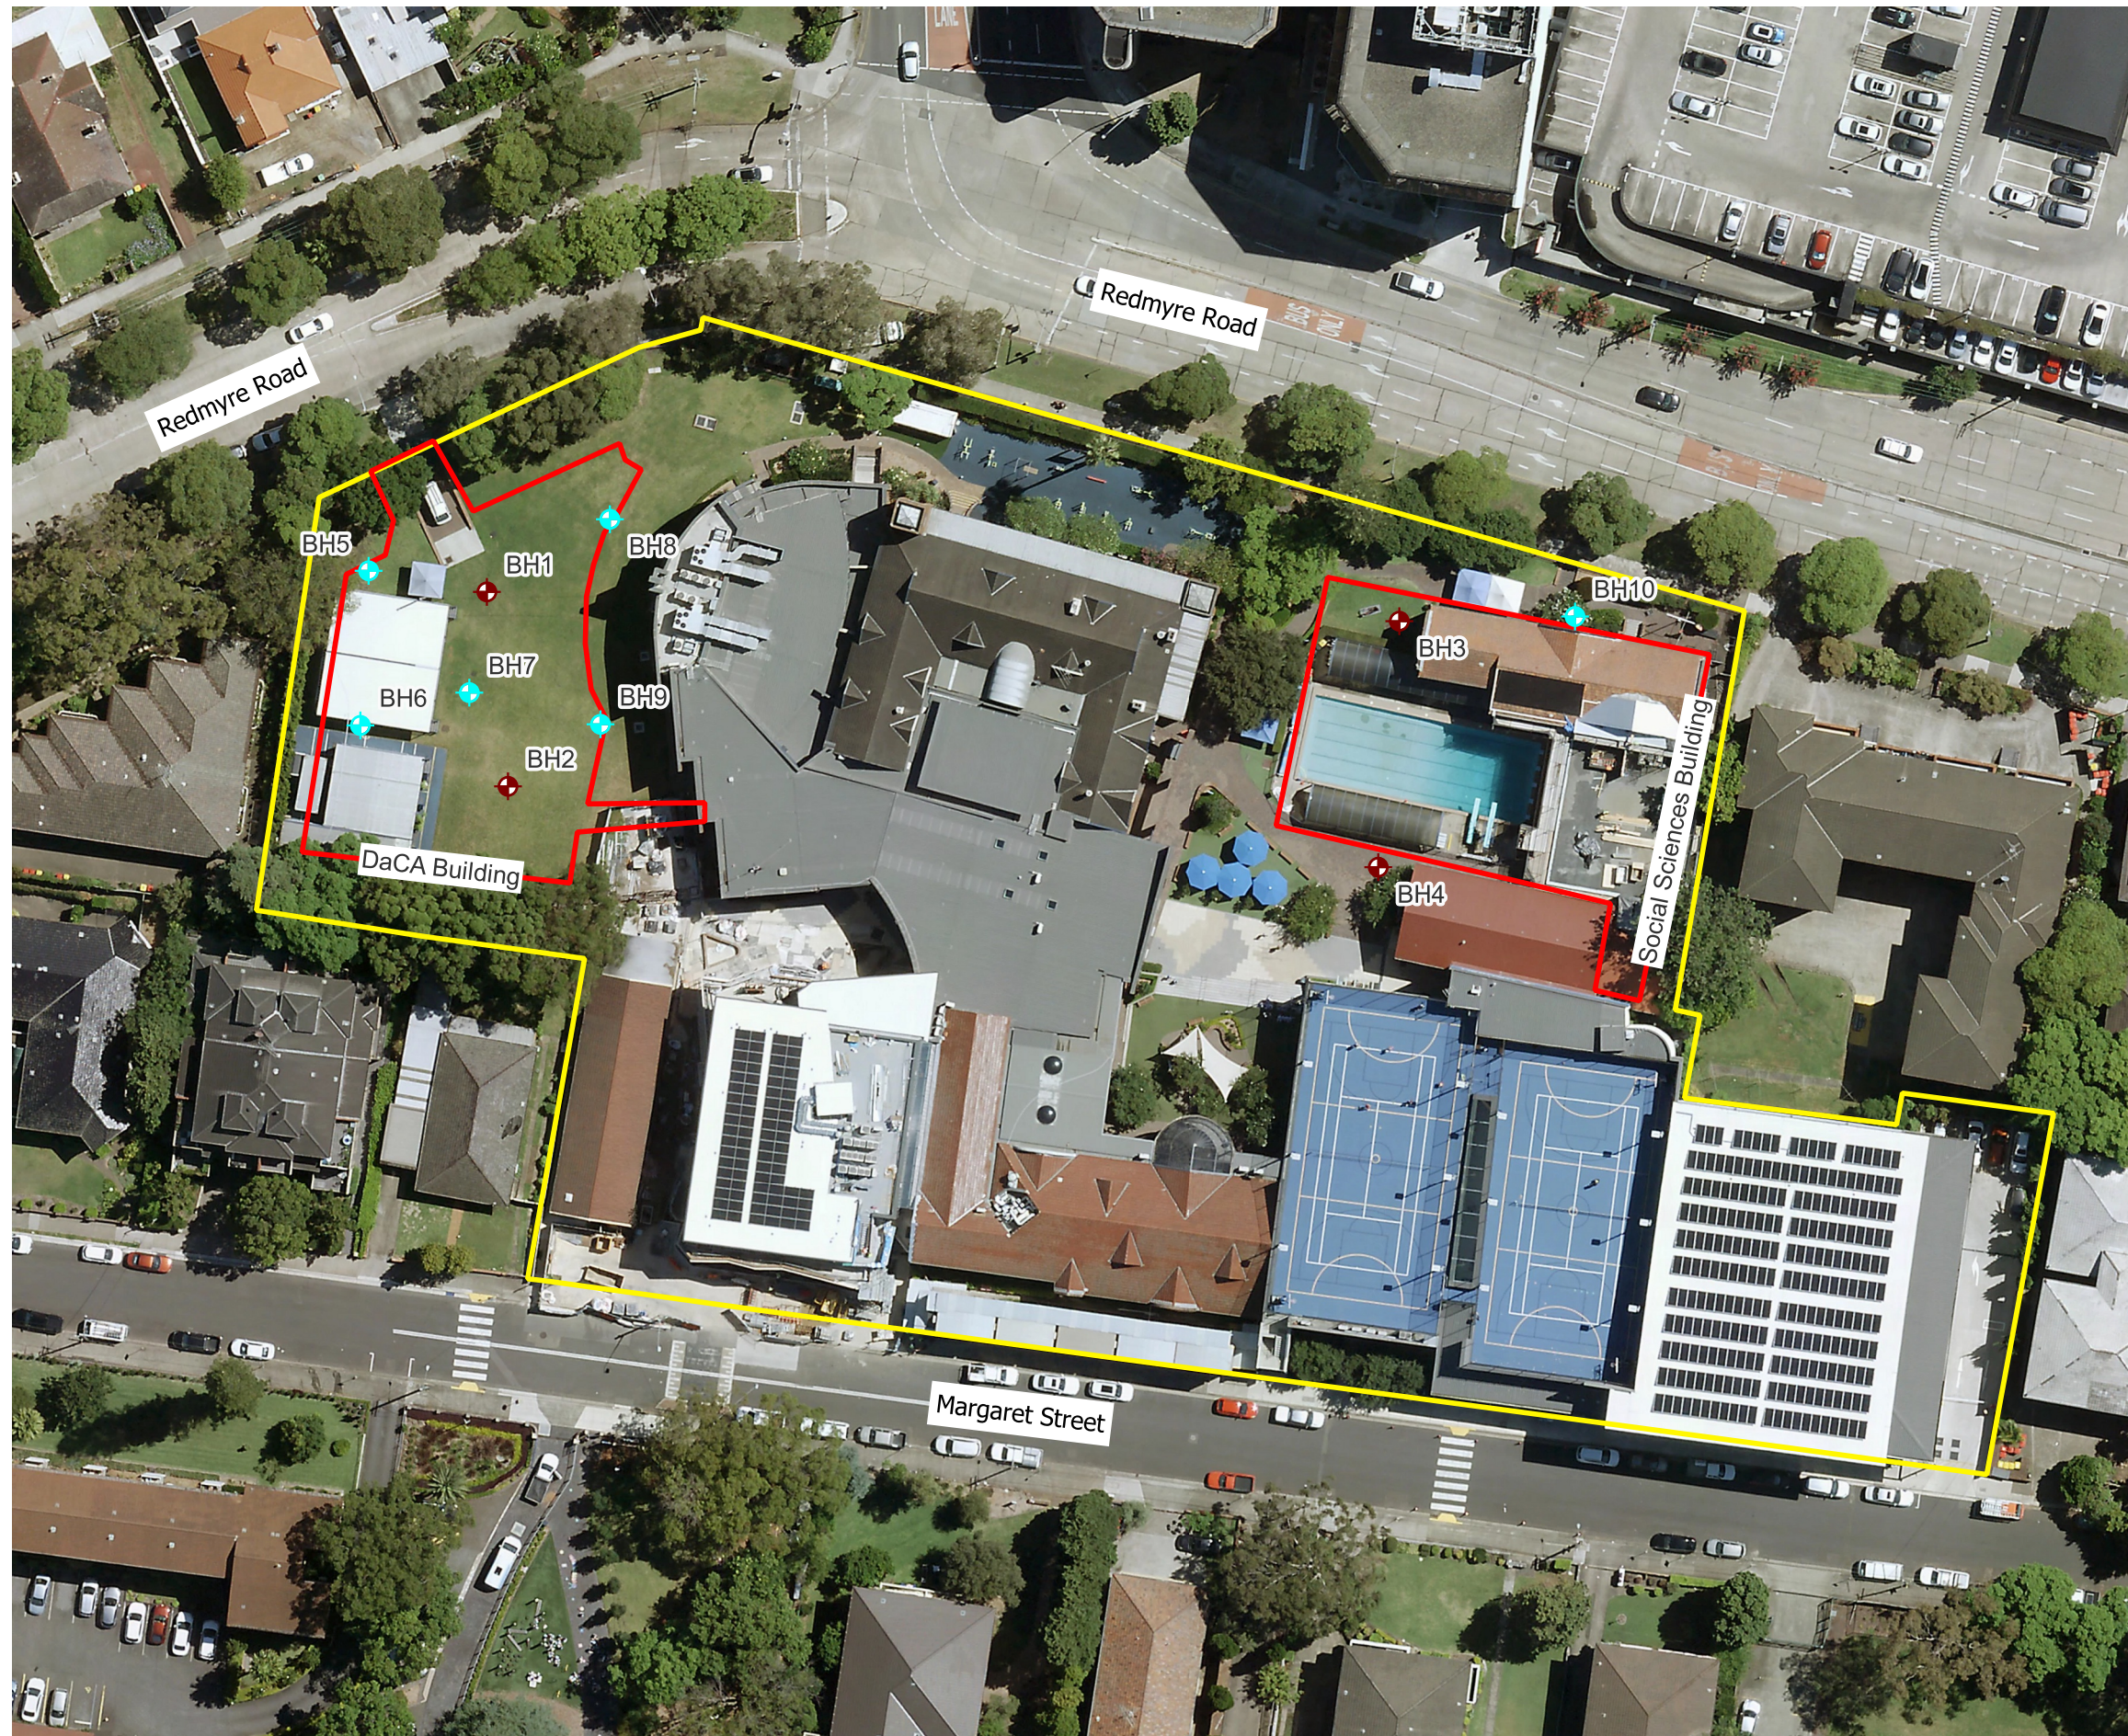
The boundaries of the school campus are well defined by streets and adjoining properties. The development site boundaries within the campus are not well defined. The school campus layout and development site boundaries are shown on Attachment 1.

DP note in the RAP that the two site areas are currently occupied by existing school infrastructure including existing site buildings, demountable classrooms and grassed open areas (Attachment 1).

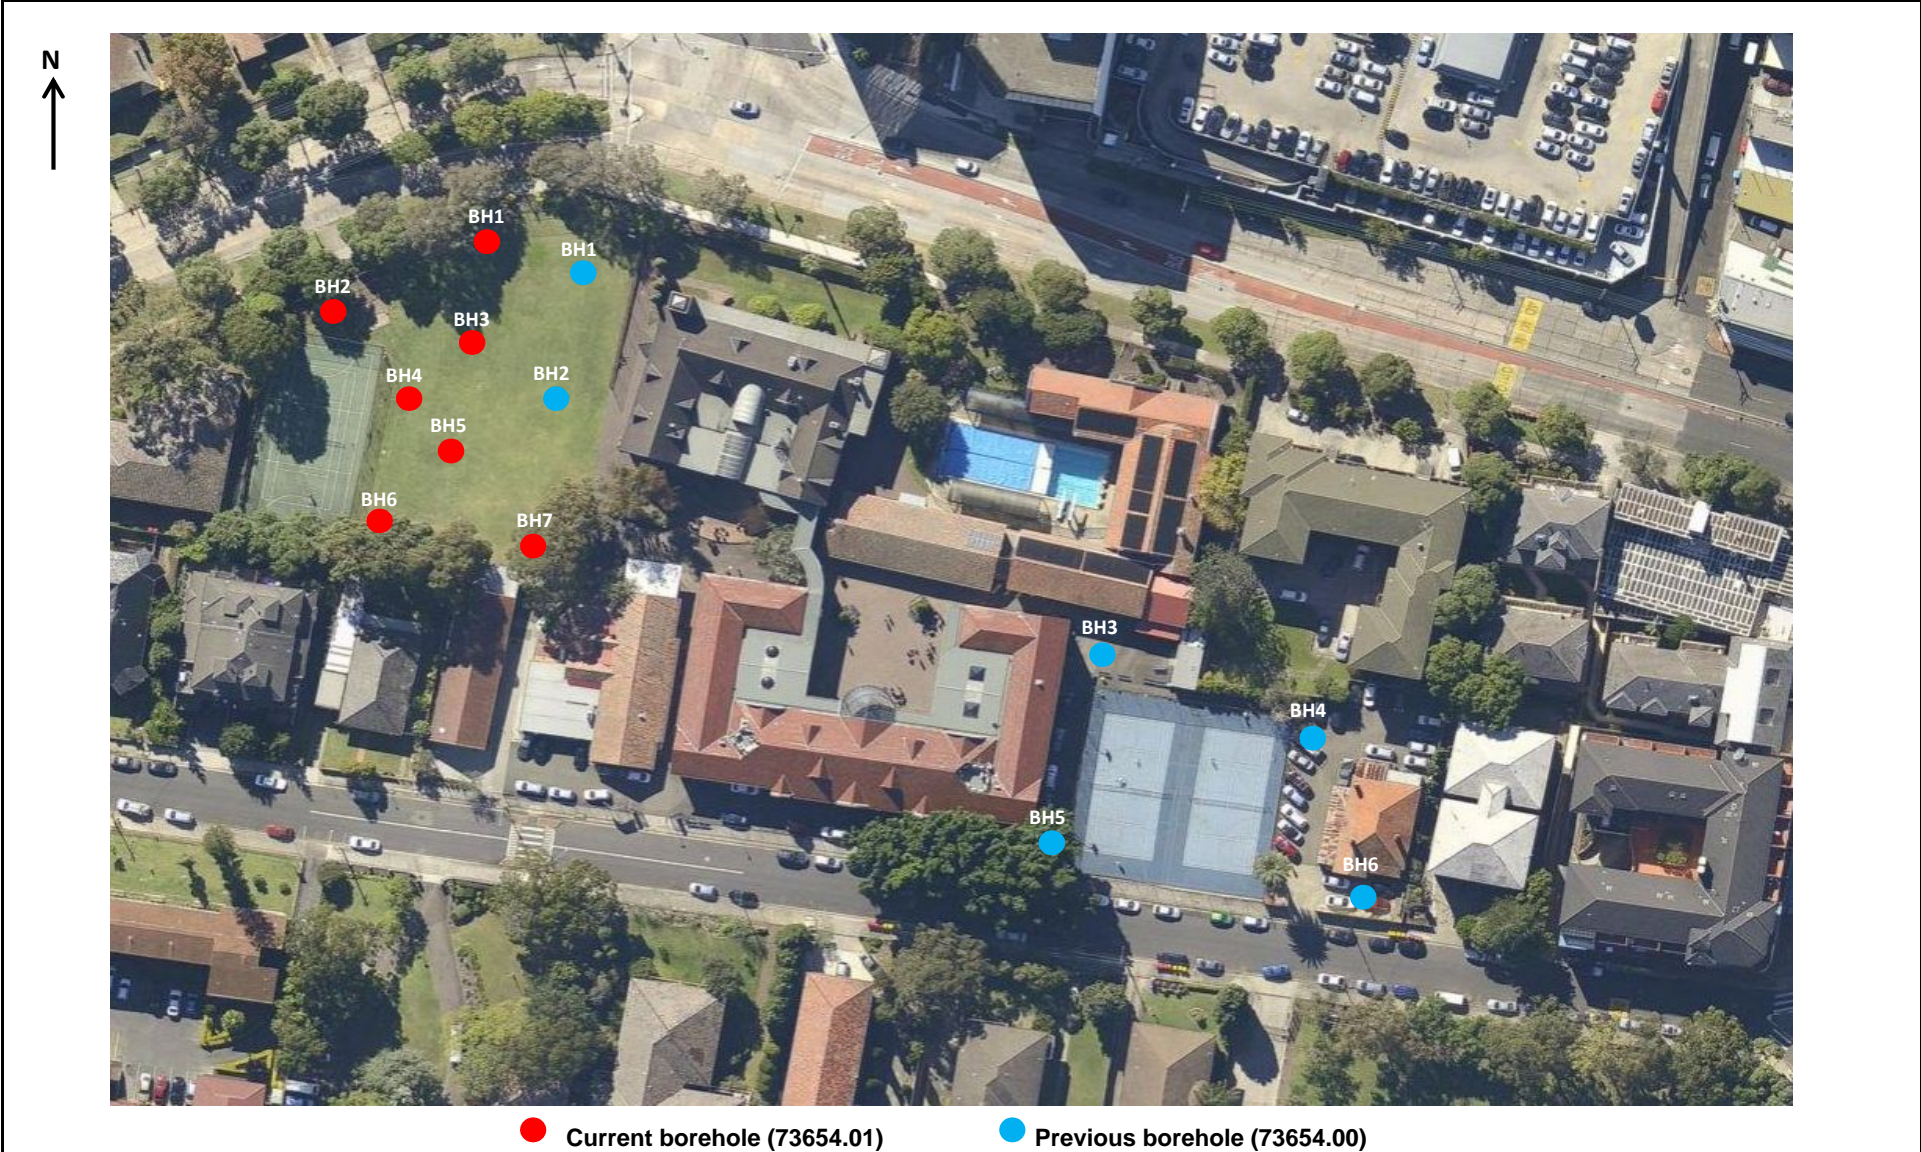
CLIENT: Meriden Anglican School	Locations of Boreholes Meriden Anglican School for Girls 10 - 28 Redmyre Road, Strathfield	PROJECT No: 73654.01
	OFFICE: Sydney		DWG No: 1
	DATE: 30 May 2014		REVISION: 0

● Current borehole (73654.01) ● Previous borehole (73654.00)
