Redfern North Eveleigh Precinct

Chief Mechanical Engineers Building

Aboriginal Due Diligence

Assessment

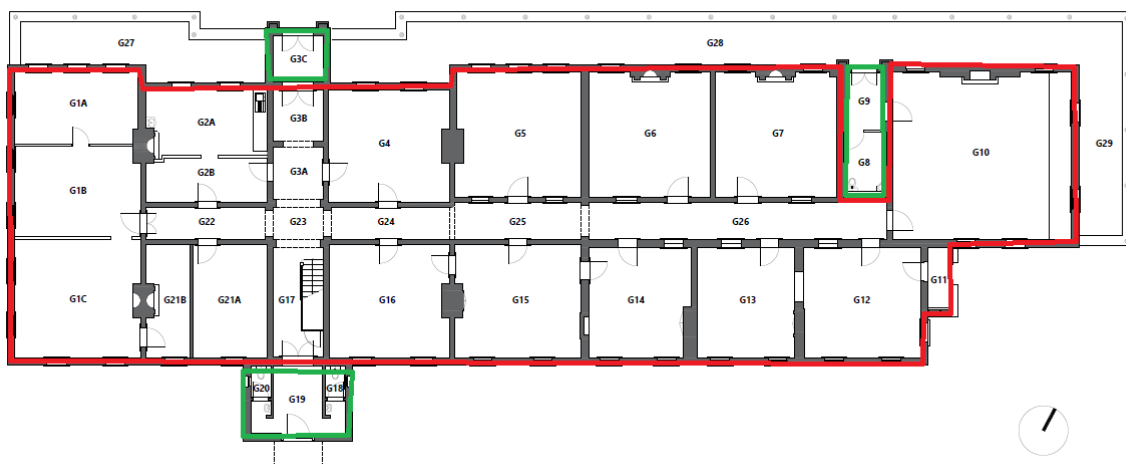
Figure 2-1: Architectural scope of works, with rooms to have subsurface reduction indicated in red and rooms with concrete floors and no impact in green. Source: Curio 2022 with markup

- Removal of existing piers below floor level
- New footings at 600m excavated depth across ground floor (excluding Rooms G3C, G8, G9, G18, G19 and G20) (Figure 2-1)
- 300mm depth excavation of ground surface below floor level for termite protection (excluding Rooms G3C, G8, G9, G18, G19 and G20)

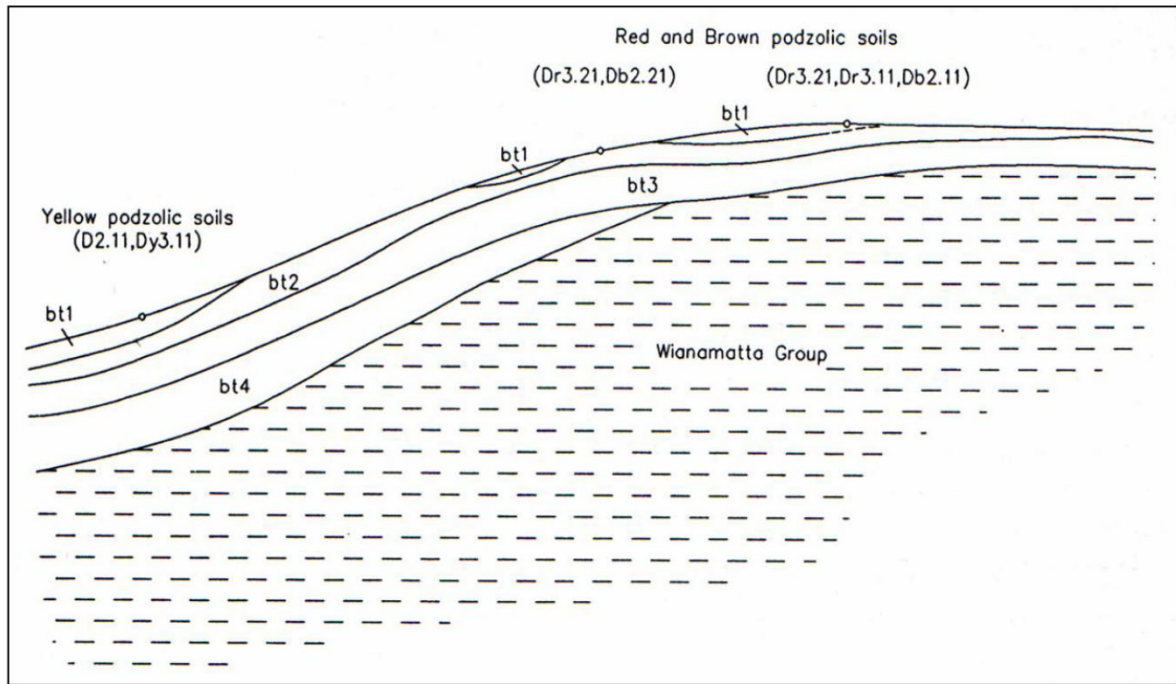
Figure 2.9: Distribution of the Blacktown soil landscape showing the occurrence and relationship of dominate soil materials
Source: eSPADE

Soils on the Blacktown landscape are generally shallow to moderately deep (>100cm) hard-setting clay loam on plastic, mottled clay¹. Soils within this landscape can be subject to moderate erodibility where they have higher fine sand and silt content. Figure 2.9 shows a cross-section of the Blacktown soil landscape, with shallower soils on the hillcrests grading to deeper soils on the slopes. They generally have poor fertility and are poorly drained. Potential archaeological material is typically located within the upper friable dark brown loamy A1 unit (bt1) of the Blacktown soil, as deeper layers are made up of denser clays and are generally sterile of archaeological material.

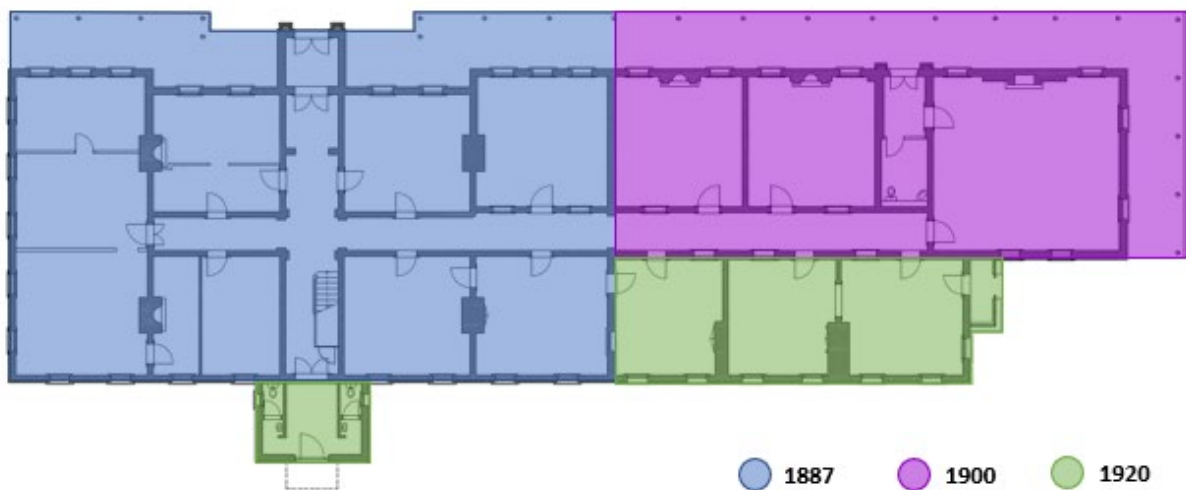
Figure 2.12: Ground floor plan of the CME Building showing the three main phases of construction.
Source: Curio 2022

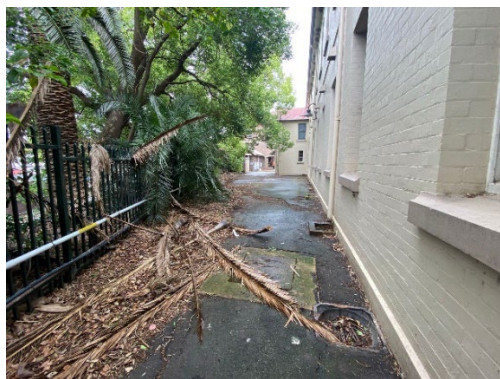
Figure 3.7: Southwestern view along southern façade, modern security fence along the CME curtilage in left of image

Modern security fencing has been constructed around the perimeter of the CME Building, dividing the original garden area from the building along its eastern elevation (Figure 3.7, Figure 3.11, Figure 3.12 and Figure 3.17).

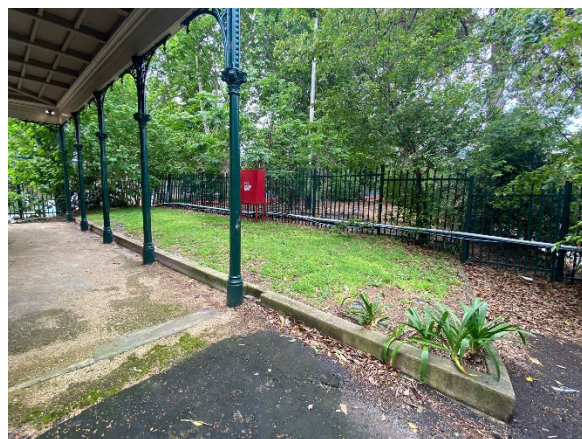
Figure 3.17: Northern view of security fence between the CME Building and gardens

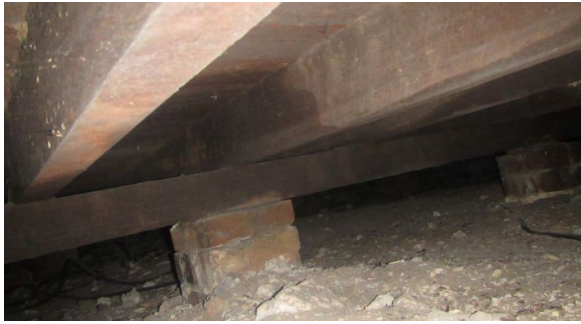
Figure 3.16: Detail of underfloor. (Source: Timber Inspection 2017)

A below-floor inspection underneath the CME building was conducted in 2017 by Timber Inspection.¹⁷ This identified that there is limited clearance below the ground-floor level and the soil surface and that the original ground level was largely unimpacted by the construction of the CME (Figure 3.16 and Figure 3.18).

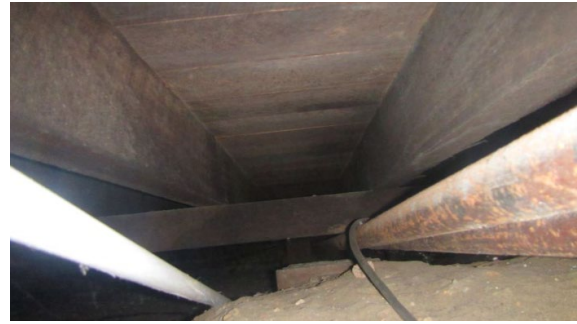
Figure 3.18: Detail of underfloor. (Source: Timber Inspection 2017)
