Chief Mechanical Engineer's Building

Conservation Management Plan (Draft)

February 2023

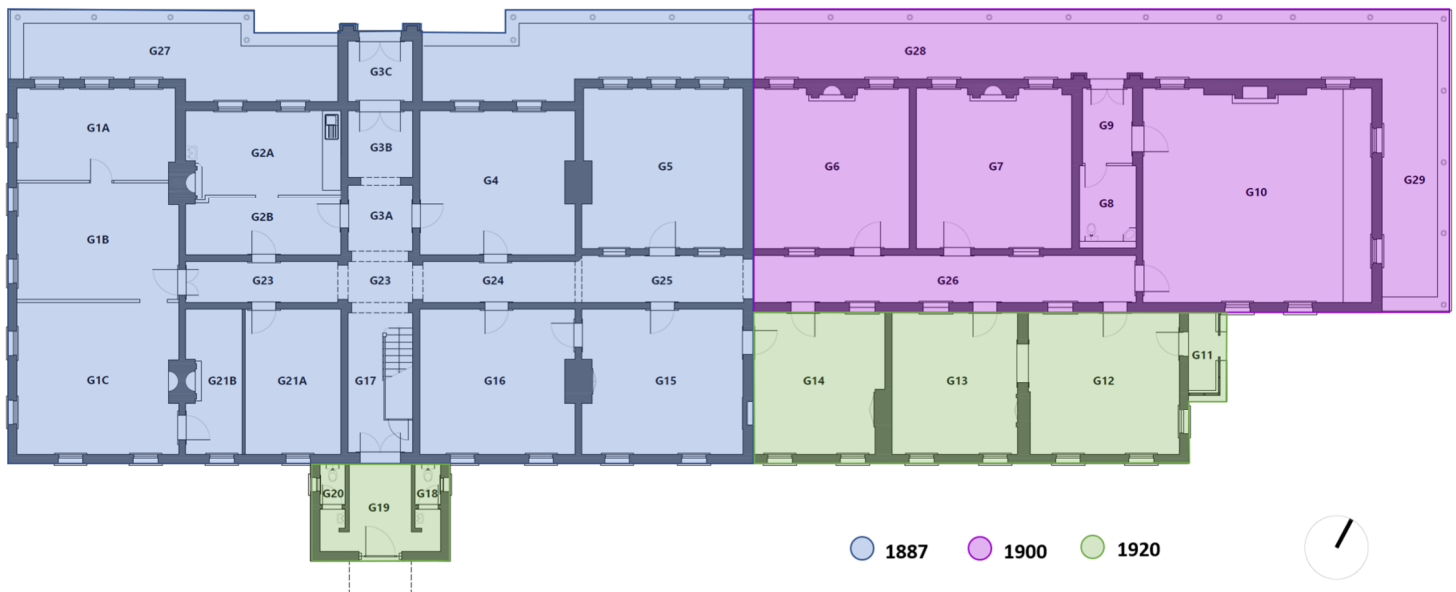
Figure 3.9: Ground floor plans of the CME building with the three main phases of construction. (Source: Rappoport & Caldis Cook Group, 1997 with Curio additions)

The CME building underwent several key phases of modifications in order to keep up with the Eveleigh Workshops rapid growth and continued expansion. The main phases of construction of the CME building are outlined in Figure 3.9 which highlight the original 1887 structure (shown in blue), the north eastern extension in 1900 (shown in purple); and the south eastern corner extension and exit addition along the southern façade of the building, in 1920 (shown in green). Figure 3.10 shows the evolution of the building in three-dimensional form.

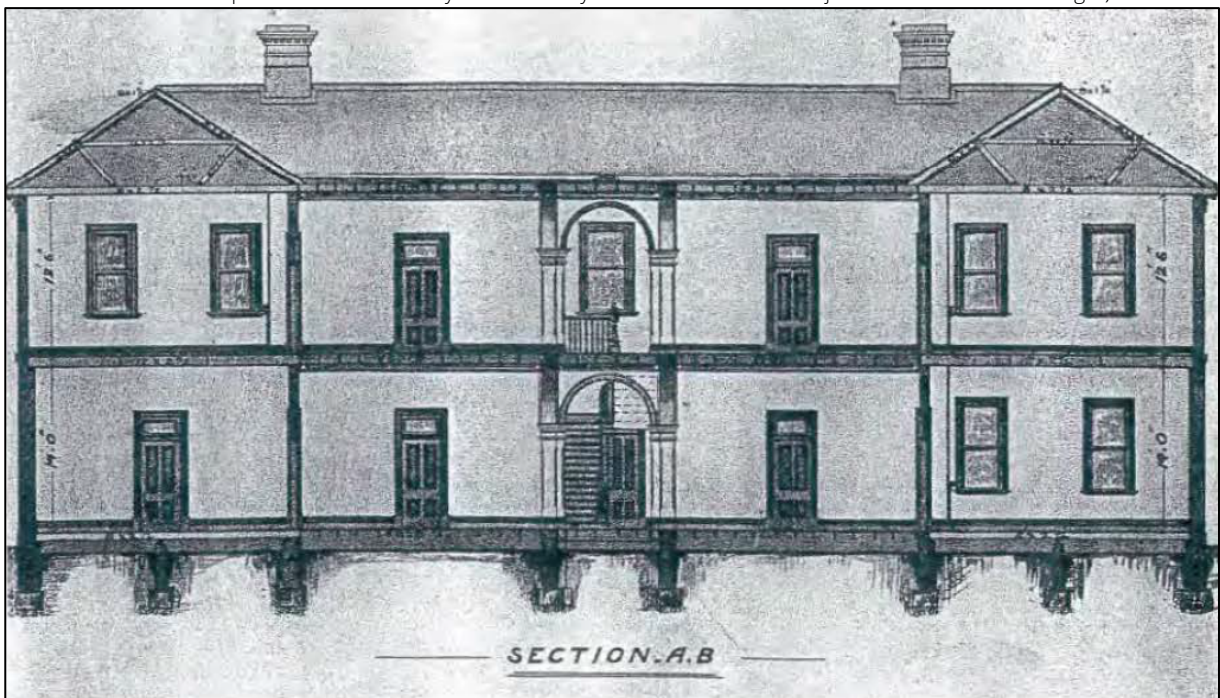
Figure 3.14: Cross sectional elevation of the original 1887 construction of the CME Building. Details of the internal staircase and offices are visible (Source: RSA Archives B2 Plan room in Transport House. Located by David Sheedy- Architect and Victor Poljanski -SRA Archives Manager)

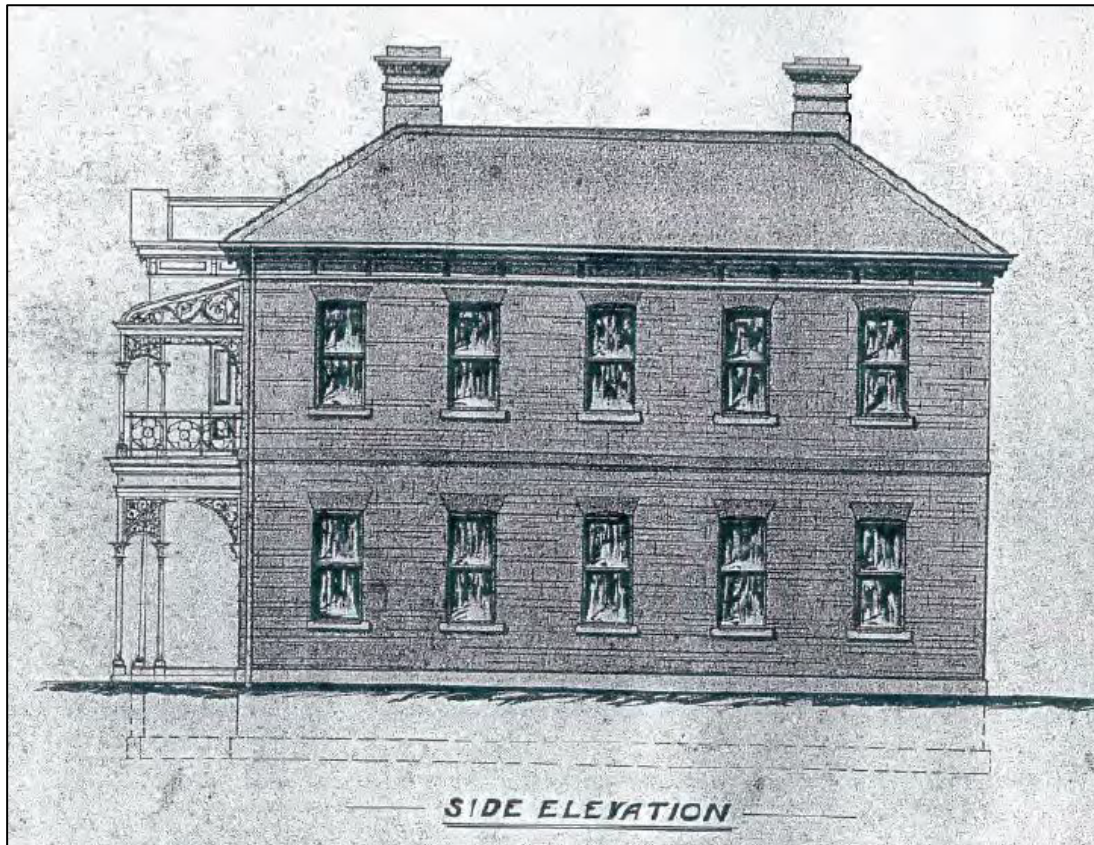
Figure 3.15: Side elevations of the original 1887 construction. Verandah and balcony on the Wilson Street side (Source: RSA Archives B2 Plan room in Transport House. Located by David Sheedy- Architect and Victor Poljanski -SRA Archives Manager)

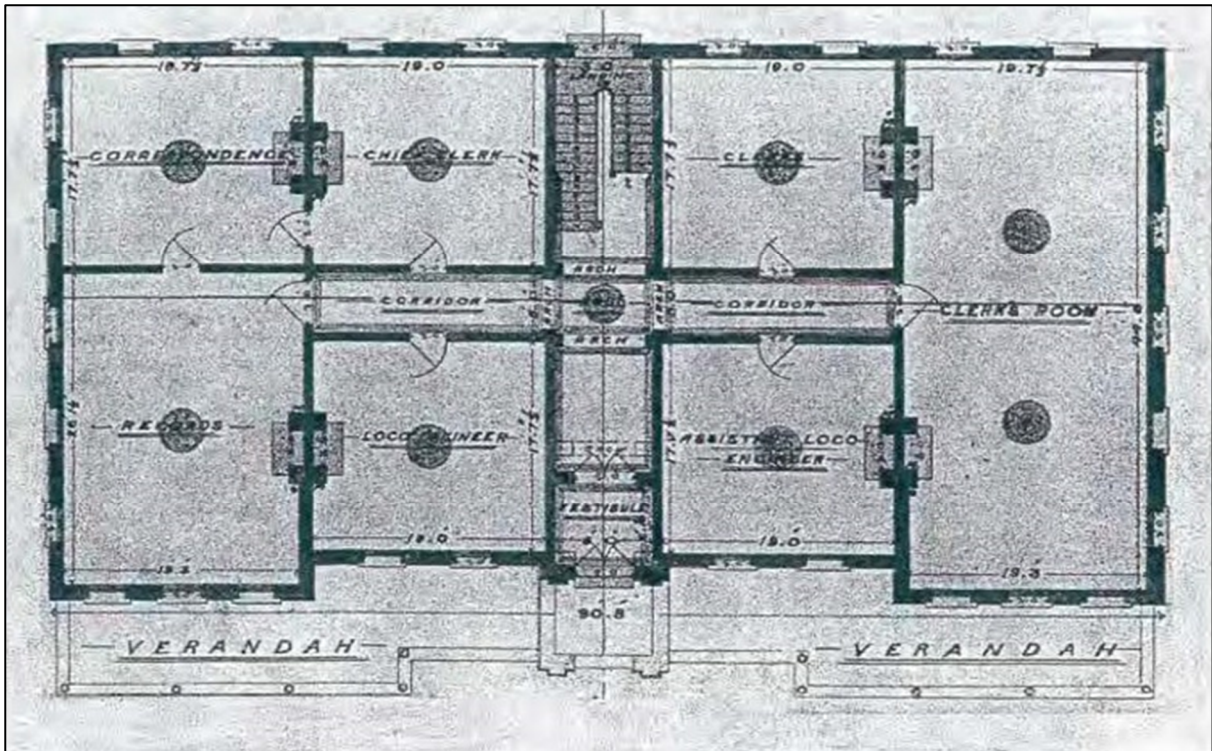
Figure 3.17: Ground Floor plan of the original 1887 construction of the CME Building (Source: RSA Archives B2 Plan room in Transport House. Located by David Sheedy- Architect and Victor Poljanski -SRA Archives Manager)

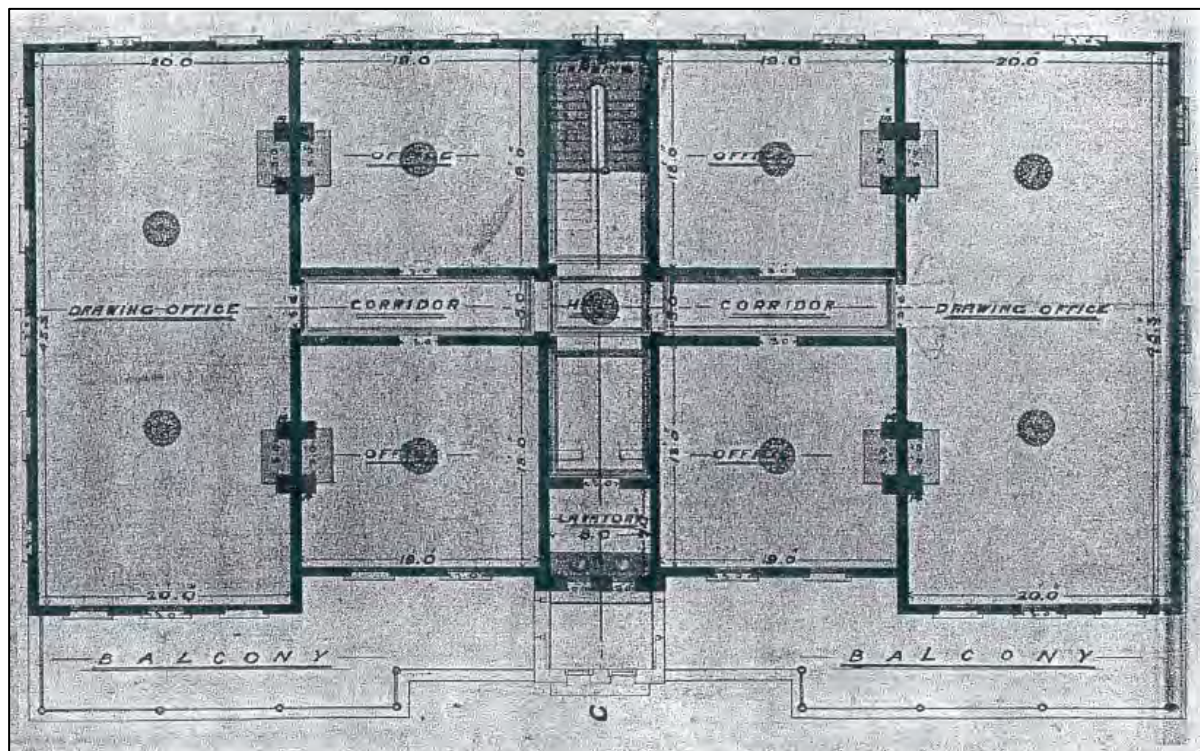
Figure 3.18: First floor plan of the original 1887 construction of the CME Building (Source: RSA Archives B2 Plan room in Transport House. Located by David Sheedy- Architect and Victor Poljanski -SRA Archives Manager)

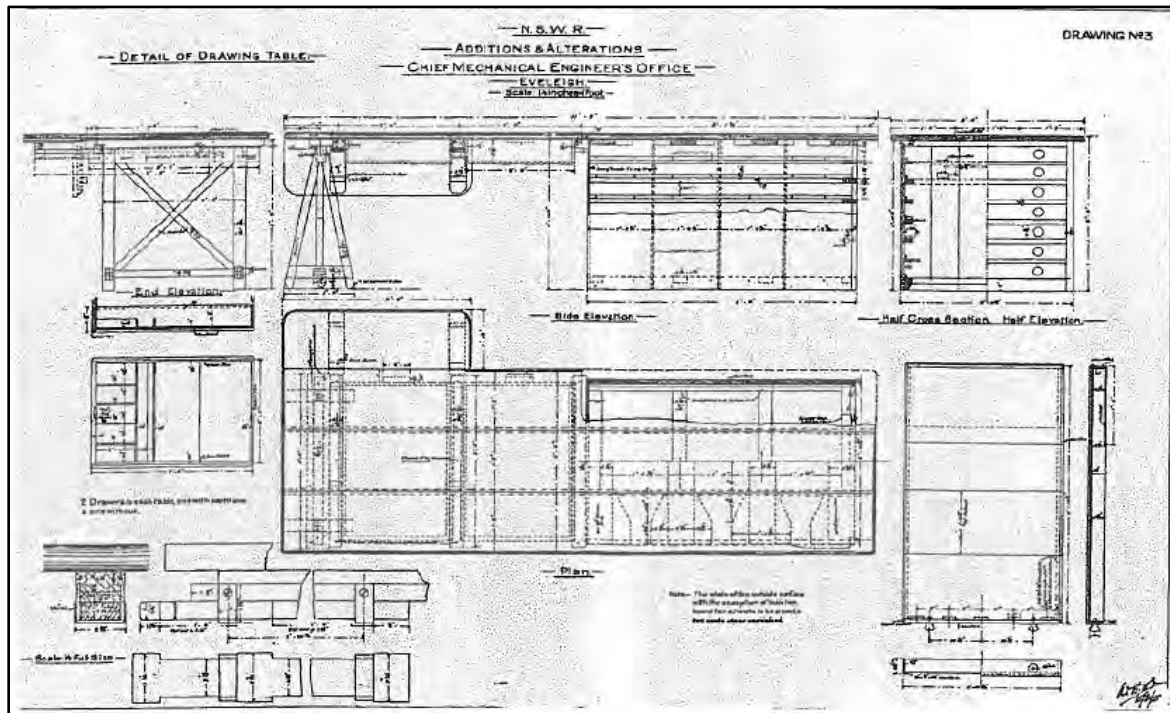
Figure 3.22: Detailed drawing of the 1900 addition drawing table design which were extensively used on the first floor of the CME building (Source: RSA Archives B2 Plan room in Transport House. Located by David Sheedy- Architect and Victor Poljanski -SRA Archives Manager)

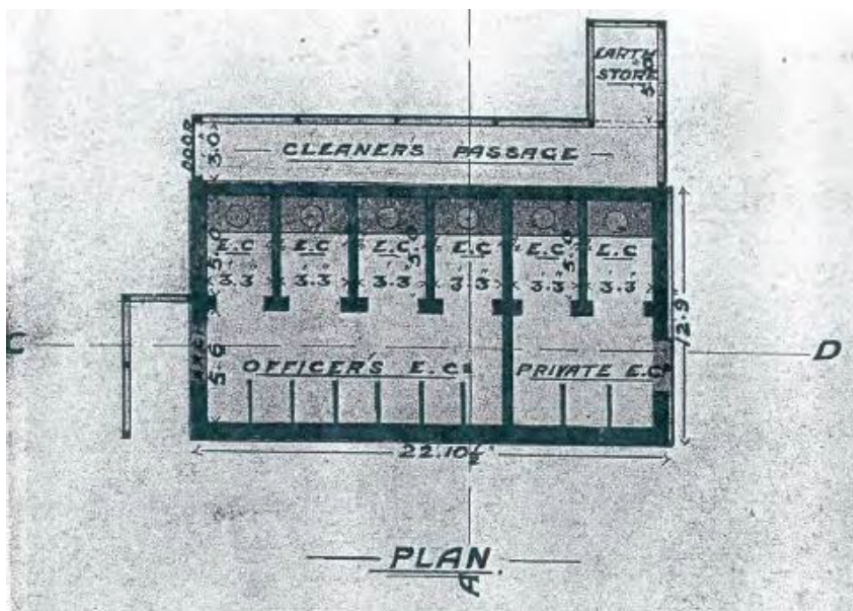
Figure 3.28: Layout of the original toilet block/ outhouse originally for the CME Building. Later adapted and altered to incorporate with the Scientific Services Building No.1 and No.2 (Source: RSA Archives B2 Plan room in Transport House. Located by David Sheedy- Architect and Victor Poljanski -SRA Archives Manager)

Located south of the CME Building was a toilet block/outhouse that was constructed during the 1887 phase of the CME Buildings establishment (Figure 3.28). The single storey brick building with a monopitch roof (measuring approximately 7 metres by 3.9 metres) provided facilities for occupants at both the CME Building and the Scientific Services Building. The cleaners passage measured to be 3 foot wide (900mm).⁸⁶ The 1887 toilets included six 'earth closets' and located behind the toilets was a cleaners passage which was used for cleaning purposes and the replacement of soiled earth with clean earth known as a 'earth store'.⁸⁷ During the 1920s the toilet block underwent modifications, and the original toilet block was potentially demolished.⁸⁸ The current toilet block includes water closets instead of earth closets and the addition of windows to the building. The construction of the current toilet block south of the CME Building is consistent with the building methods used during the 1920s.

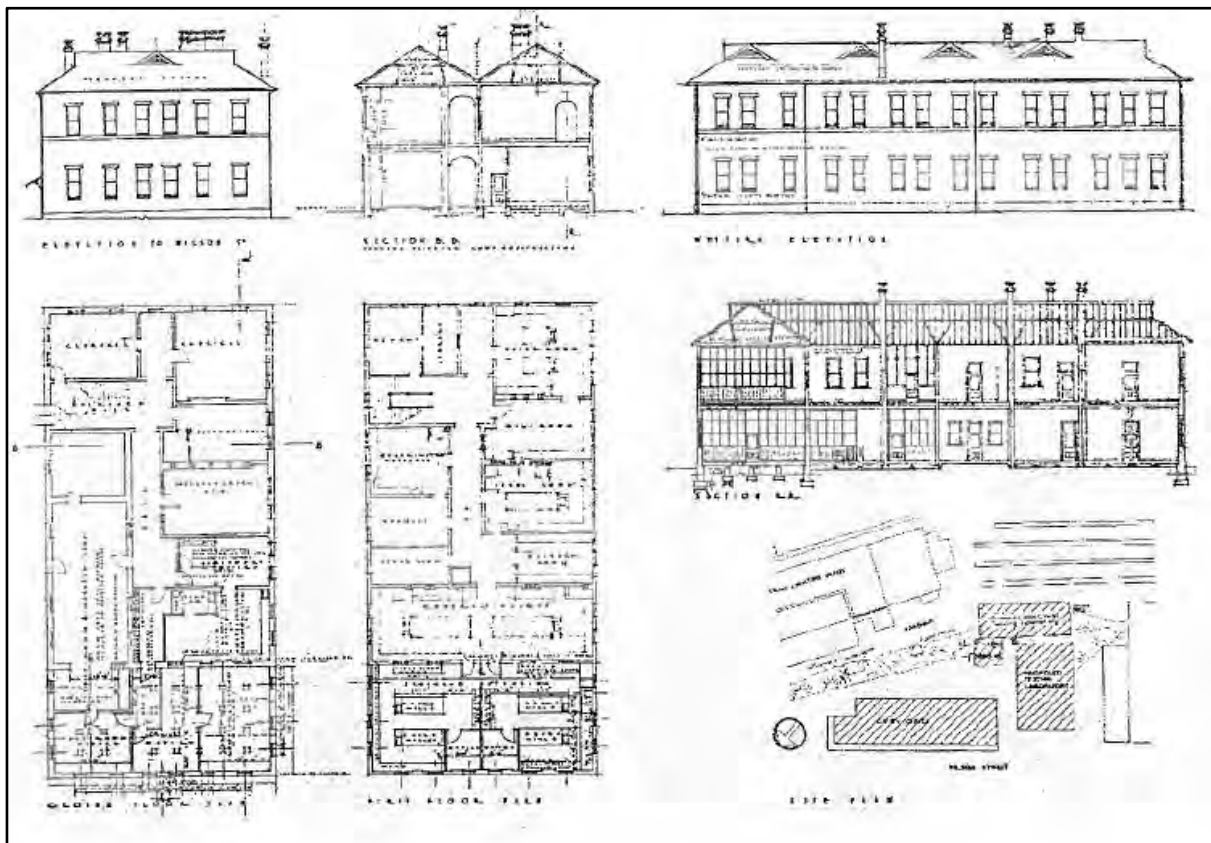
Figure 3.29: Scientific Services Building No.1 1923 plan, section and elevation of proposed designs (Source: RSA Archives B2 Plan room in Transport House. Located by David Sheedy- Architect and Victor Poljanski -SRA Archives Manager)

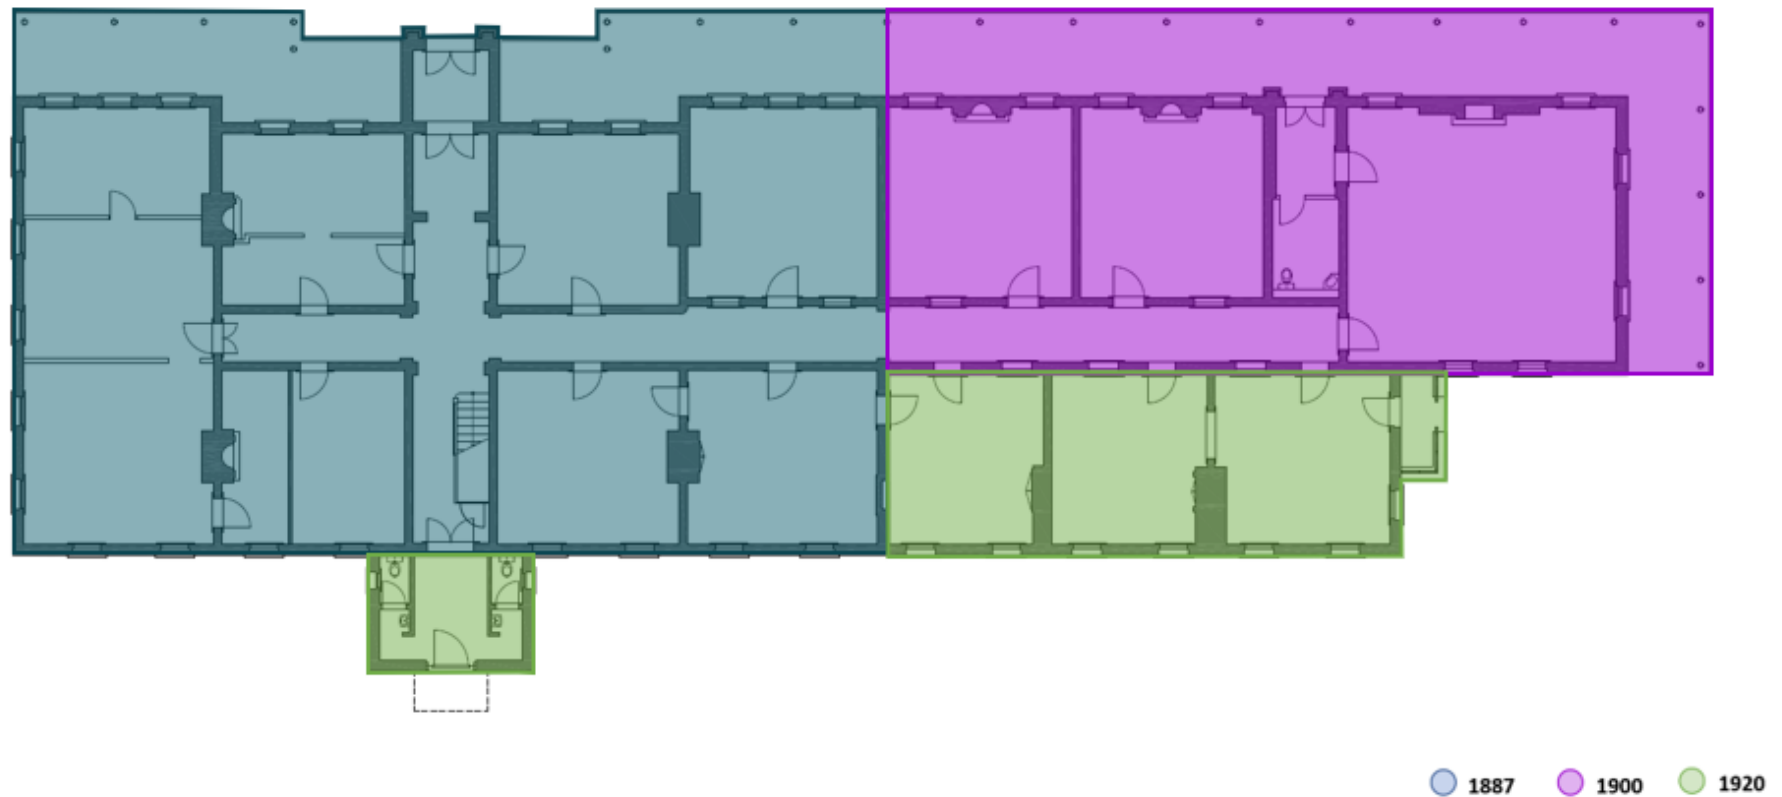
Figure 4.16: Ground floor plans of the CME building with the three main phases of construction. (Source: Rappoport & Caldis Cook Group, 1997 with Curio additions)

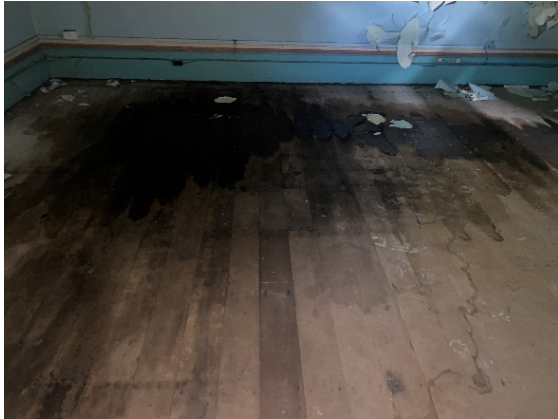
Figure 4.19: Water damage (Room F8)

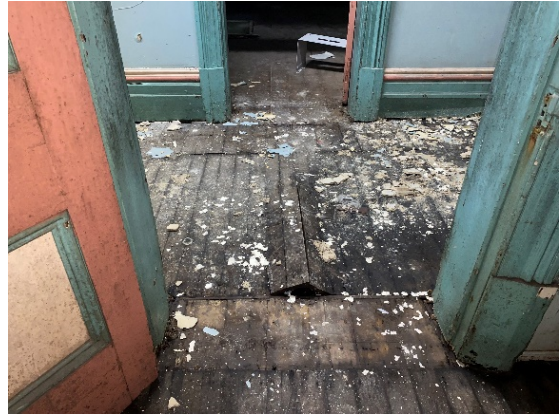
Figure 4.20: Raised floorboards due to water damage (Room G5)

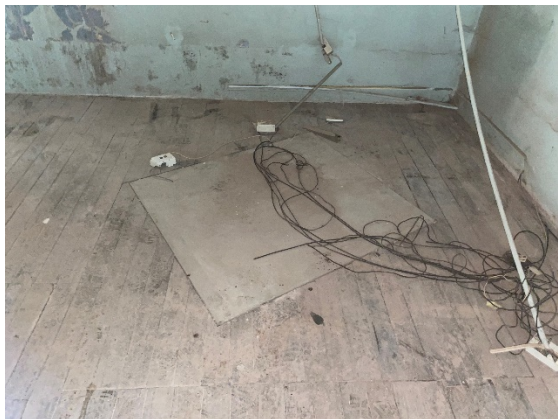
Figure 4.21: Square concrete machine footing (Room G5)

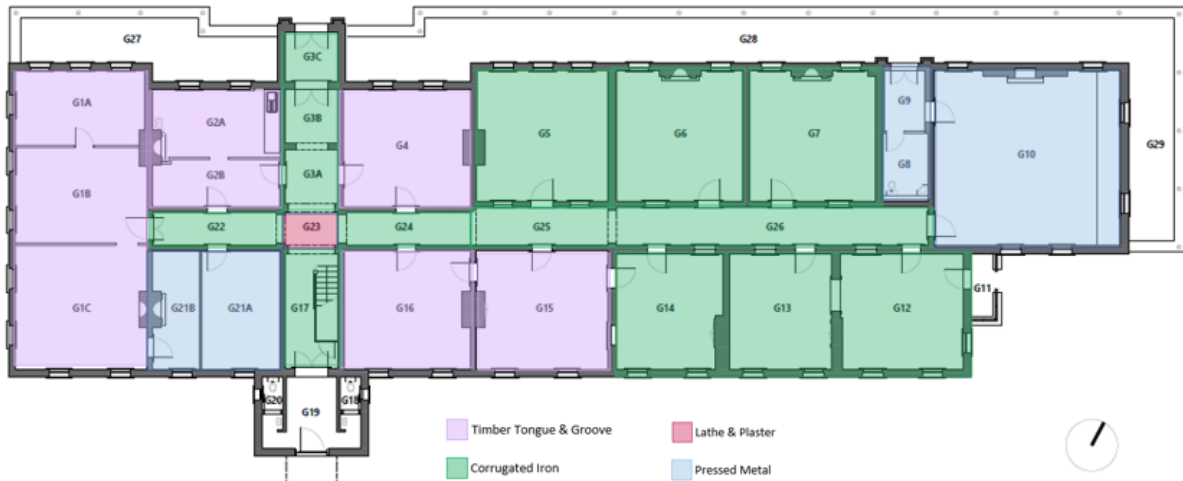
Figure 4.29: Ground Floor Ceiling Type Plan of the CME Building

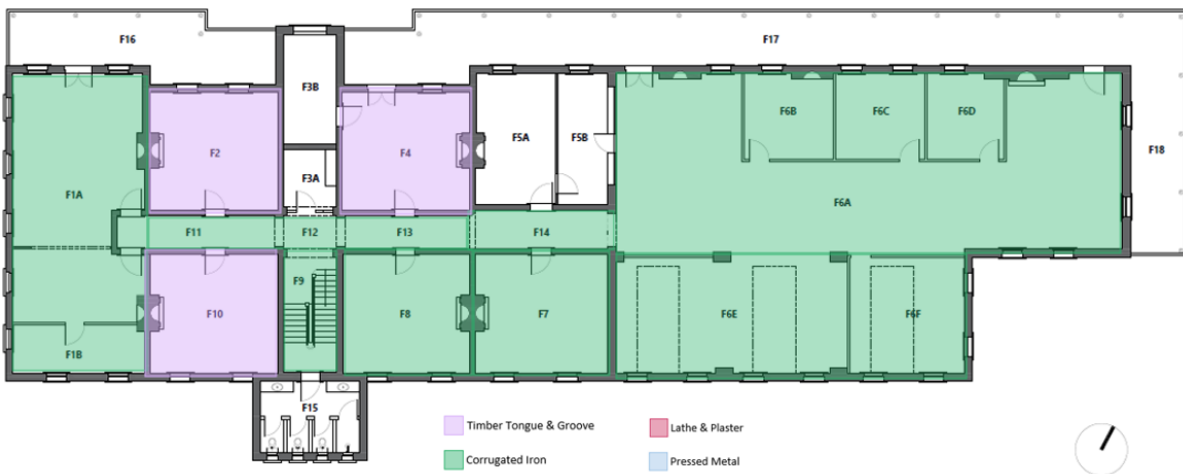
Figure 4.30: First Floor Ceiling Type Plan of the CME Building

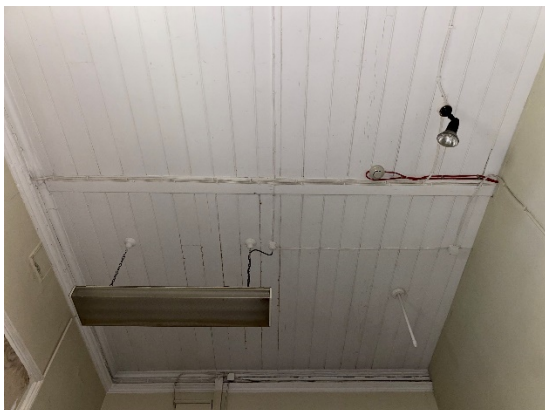
Figure 4.31: Timber tongue and groove floor ceilings (Room G2)

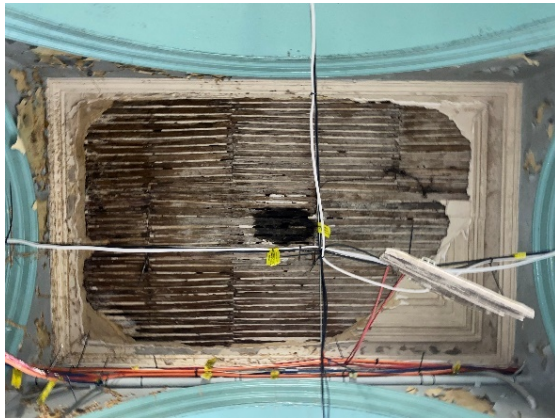
Figure 4.35: Damaged lathe & plaster ceiling which recently collapsed due to water damage (Room G23)

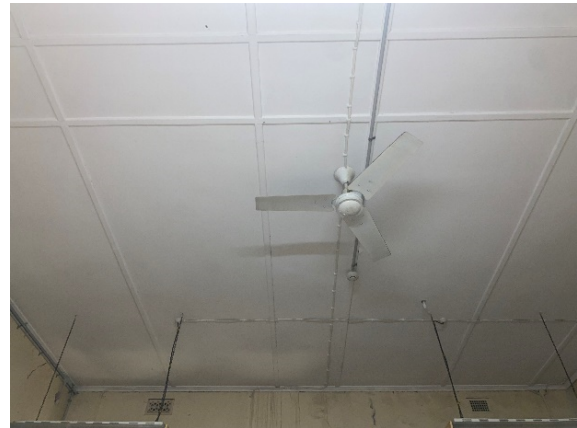
Figure 4.36: Masonite ceiling covering the timber tongue and groove ceiling (Room G1)

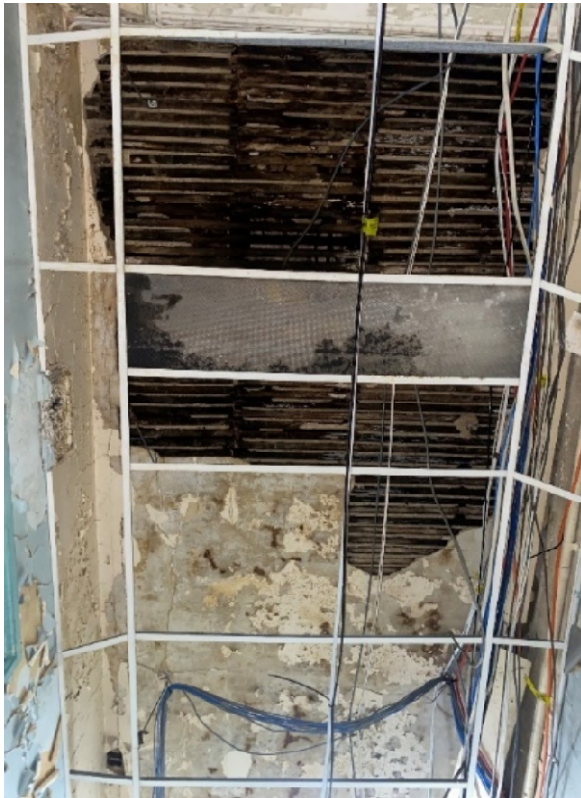
Figure 4.41: Damaged corrugated iron ceiling with suspended T-Bar system (Room G25)

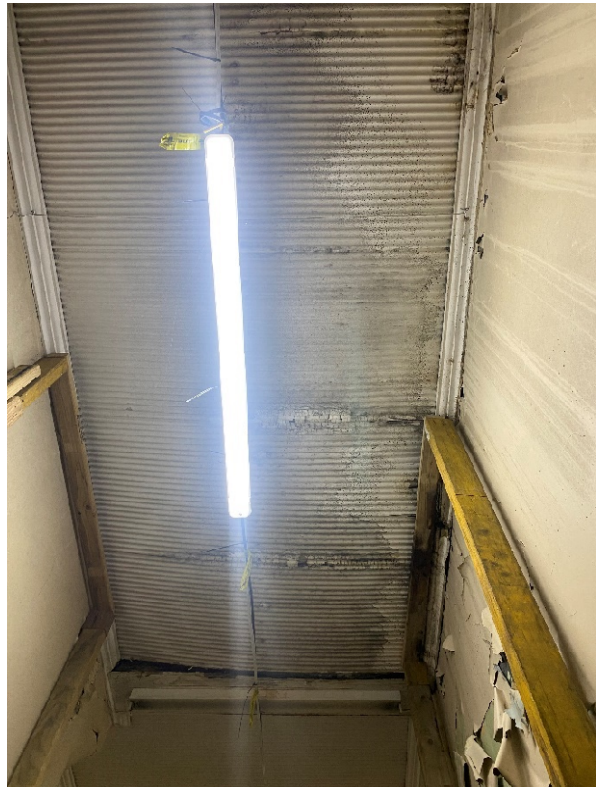
Figure 4.42: Damaged corrugated iron ceiling (Room F13)

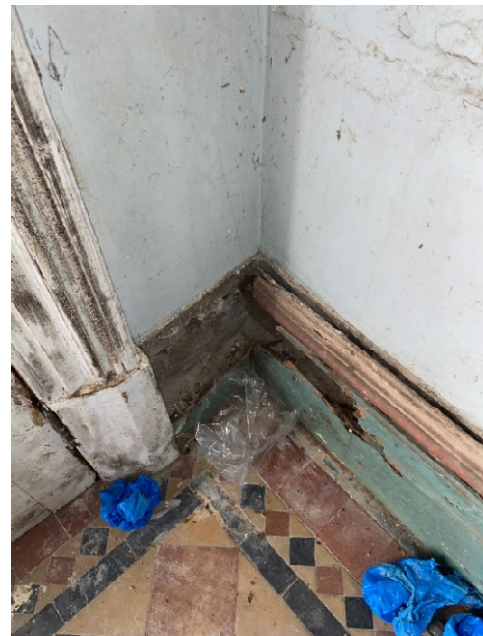
Figure 4.72: Termite Damage to skirting (Room G3A)

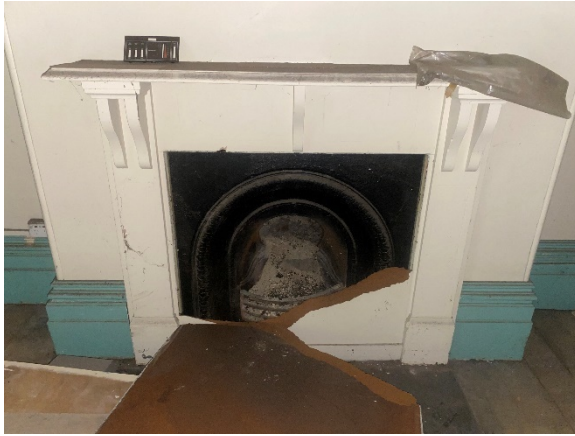
Figure 4.82: Timber mantle and surround of fireplace from the 1887 construction of CME Building (Room F2)

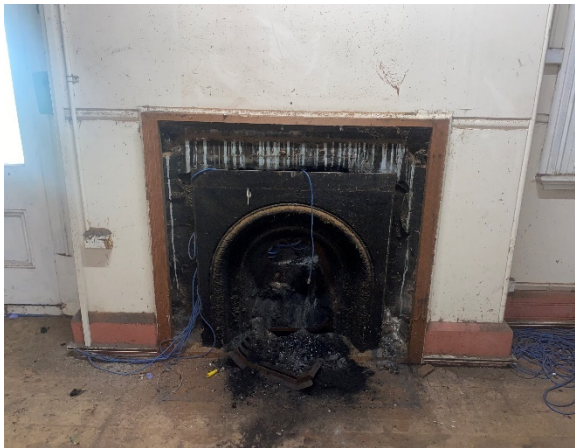
Figure 4.86: Damaged fireplace with mantle and surrounds removed (Room F6)

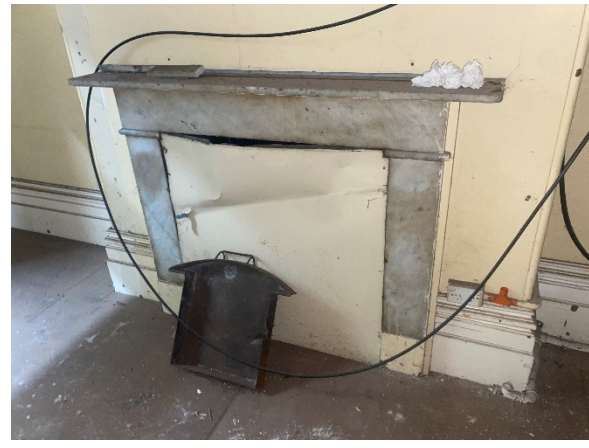
Figure 4.87 : Fireplace boarded up with marble surrounds from original 1887 phase of construction (Room F5A)

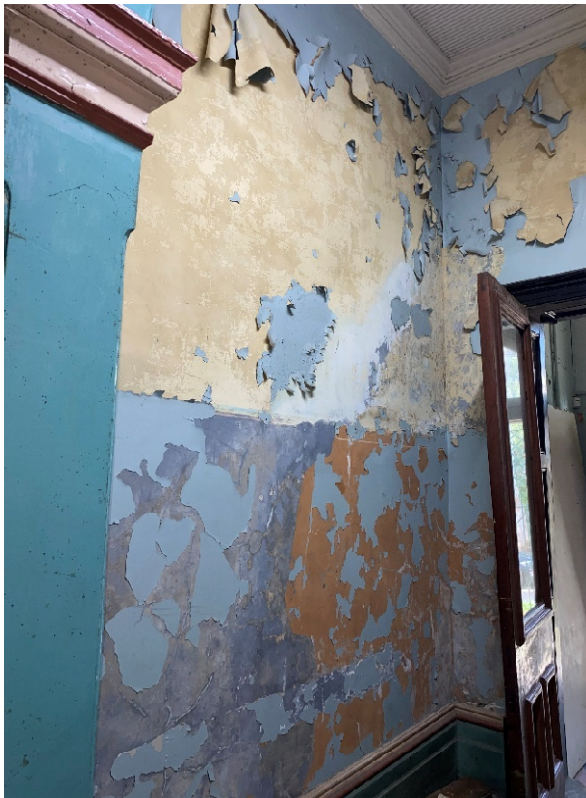
Figure 4.94: Paintwork peel and exposing previous paint colours in Room G3B

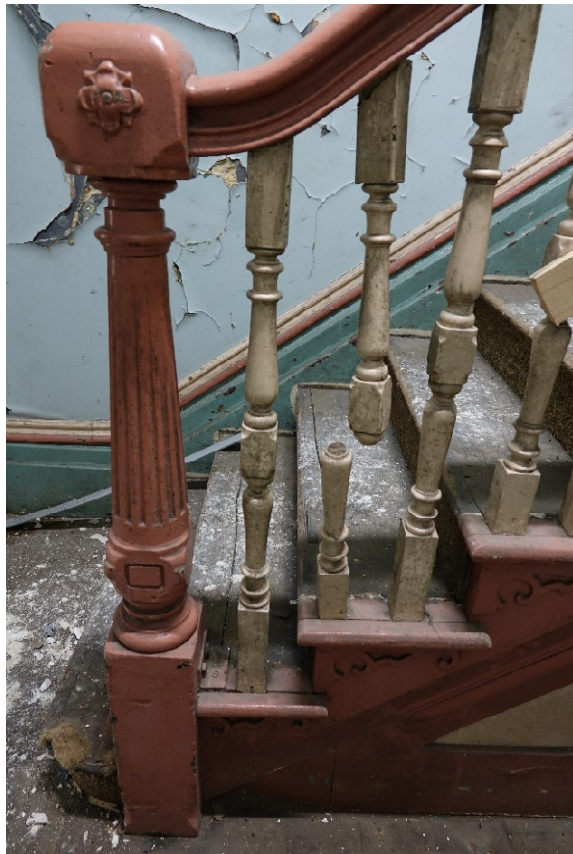
Figure 4.104: Ground floor remaining bannisters in poor condition with newel post in view.

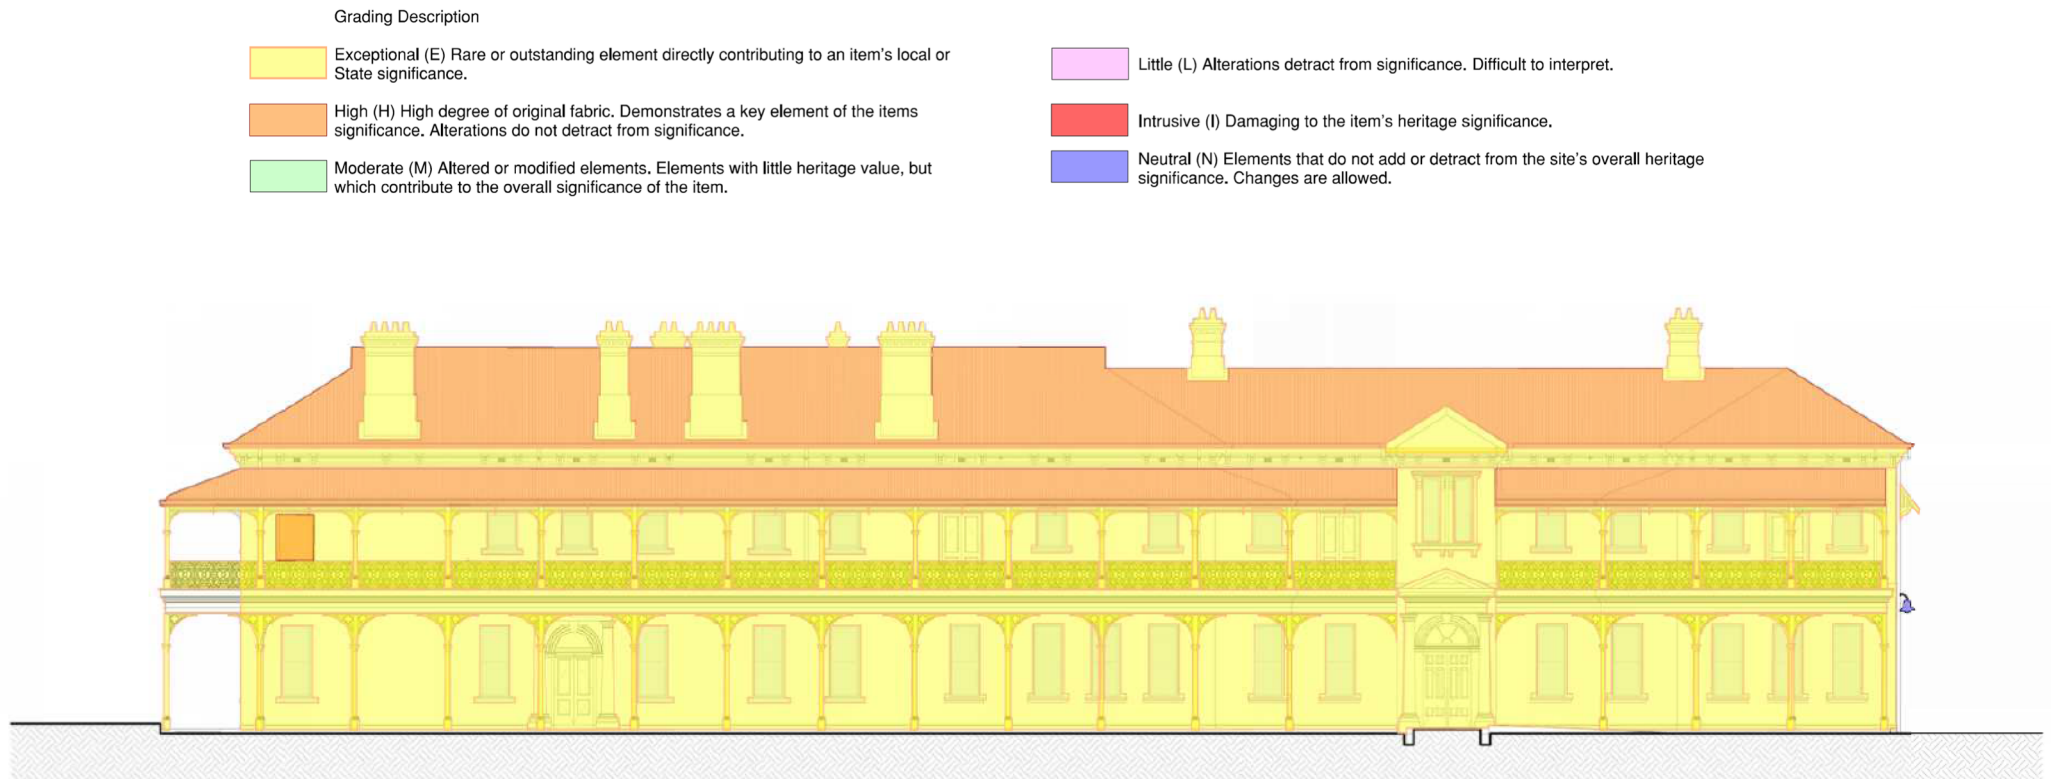
Figure 6.3: Significance - CME Building northern façade (front) (Source: CCG Architects with Curio additions)

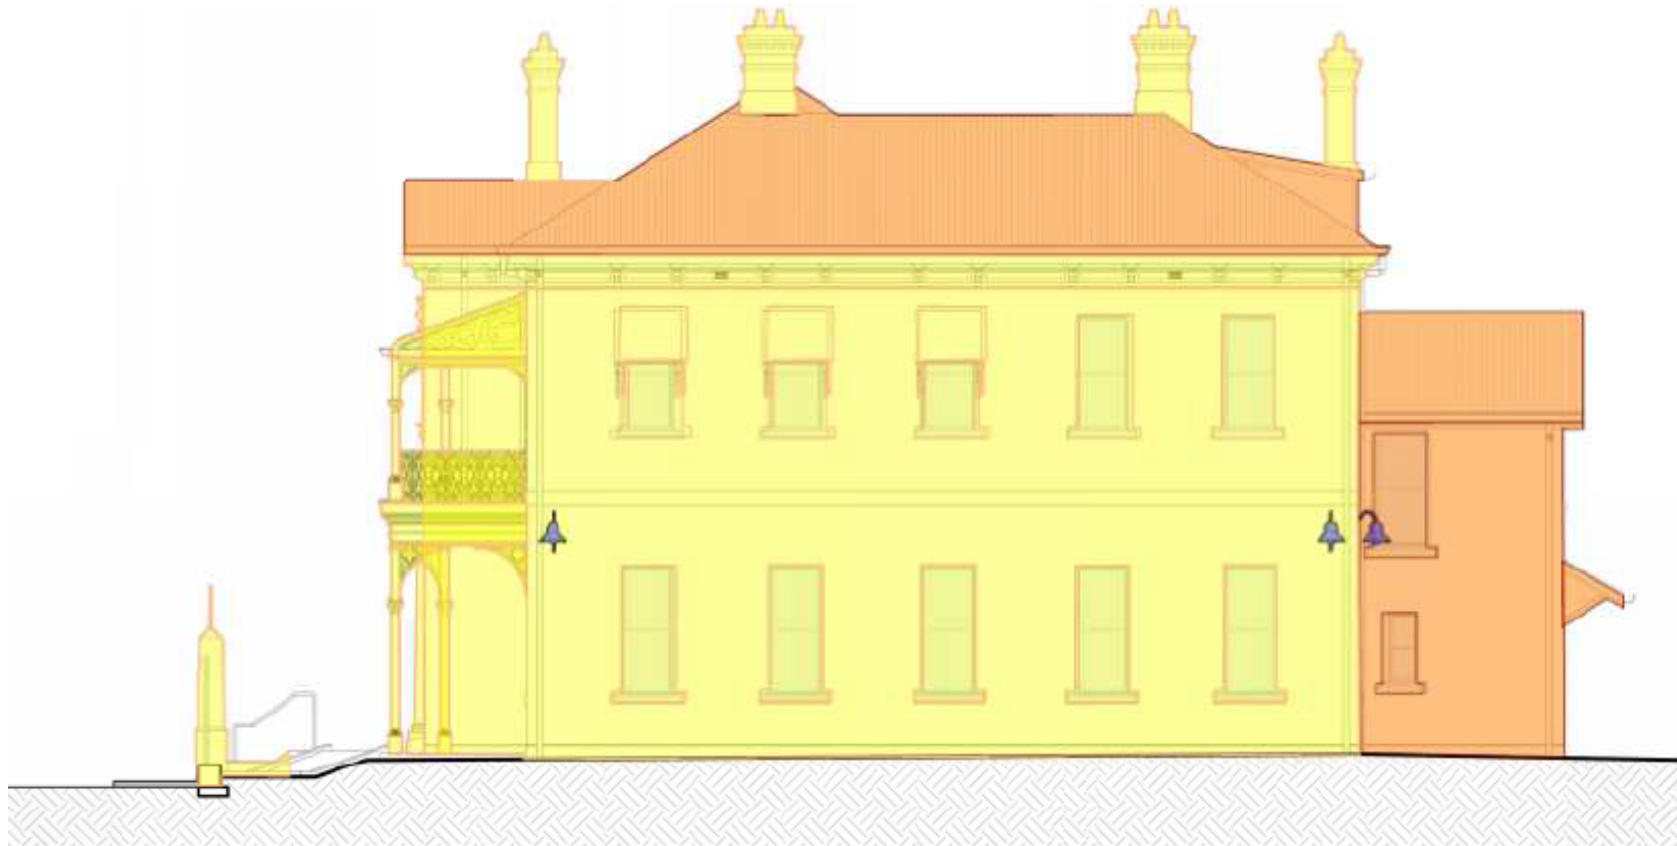
Figure 6.6: Significance - CME Building western façade (side) (Source: CCG Architects with Curio additions)

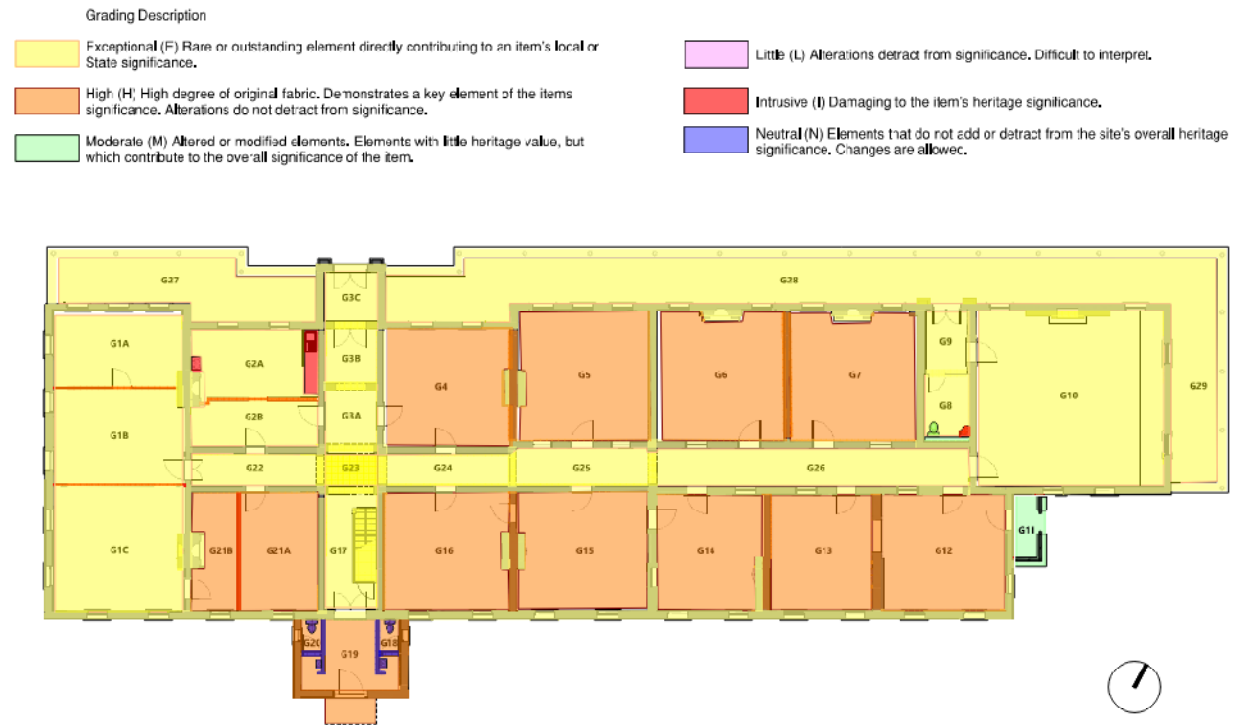
Figure 6.7: Significance Plans- CME Building Ground Floor (Source: CCG Architects with Curio additions)

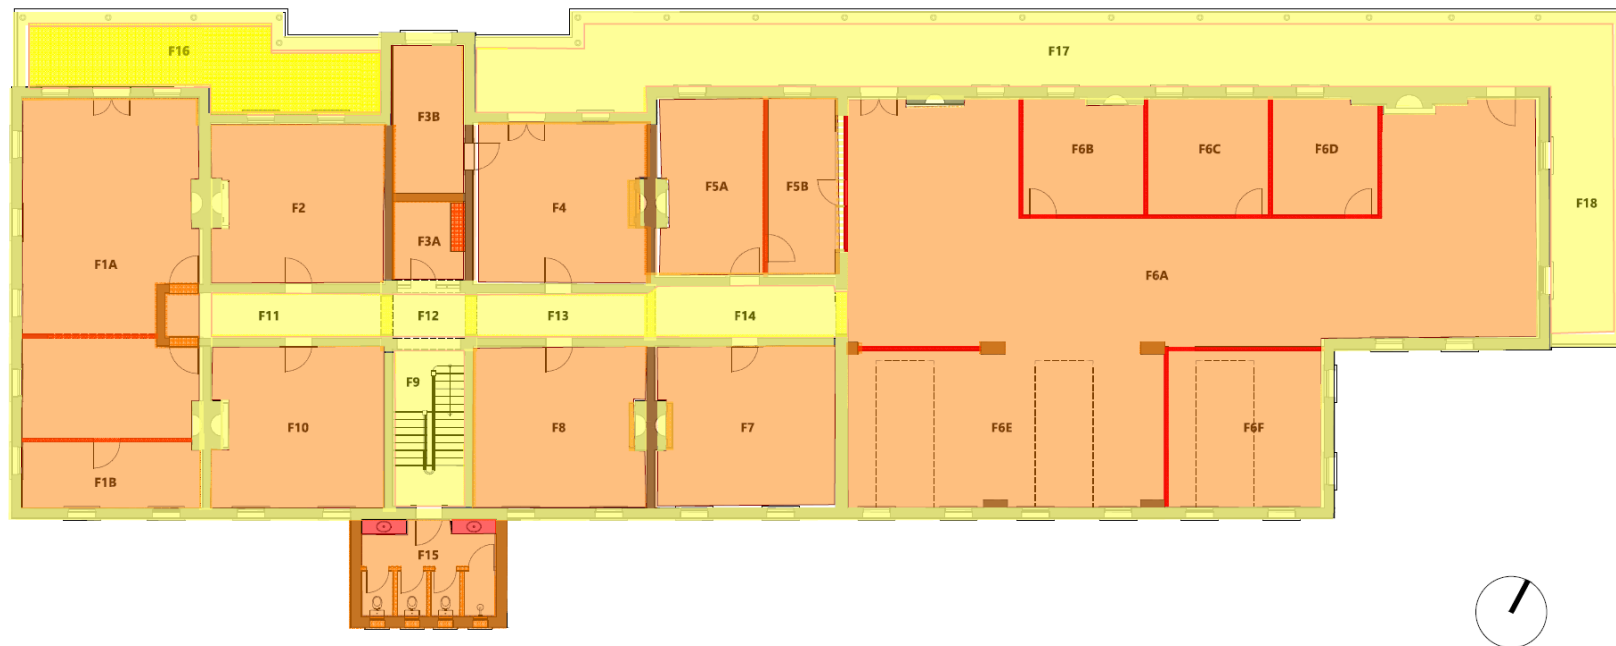
Figure 6.8: Significance Plans- CME Building First Floor (Source: CCG Architects with Curio additions)
