Detailed Site Investigation

Proposed Seniors Housing Development
87-89 Tweed Coast Road, Hastings Point NSW

Final Report

P2108580JR04V02

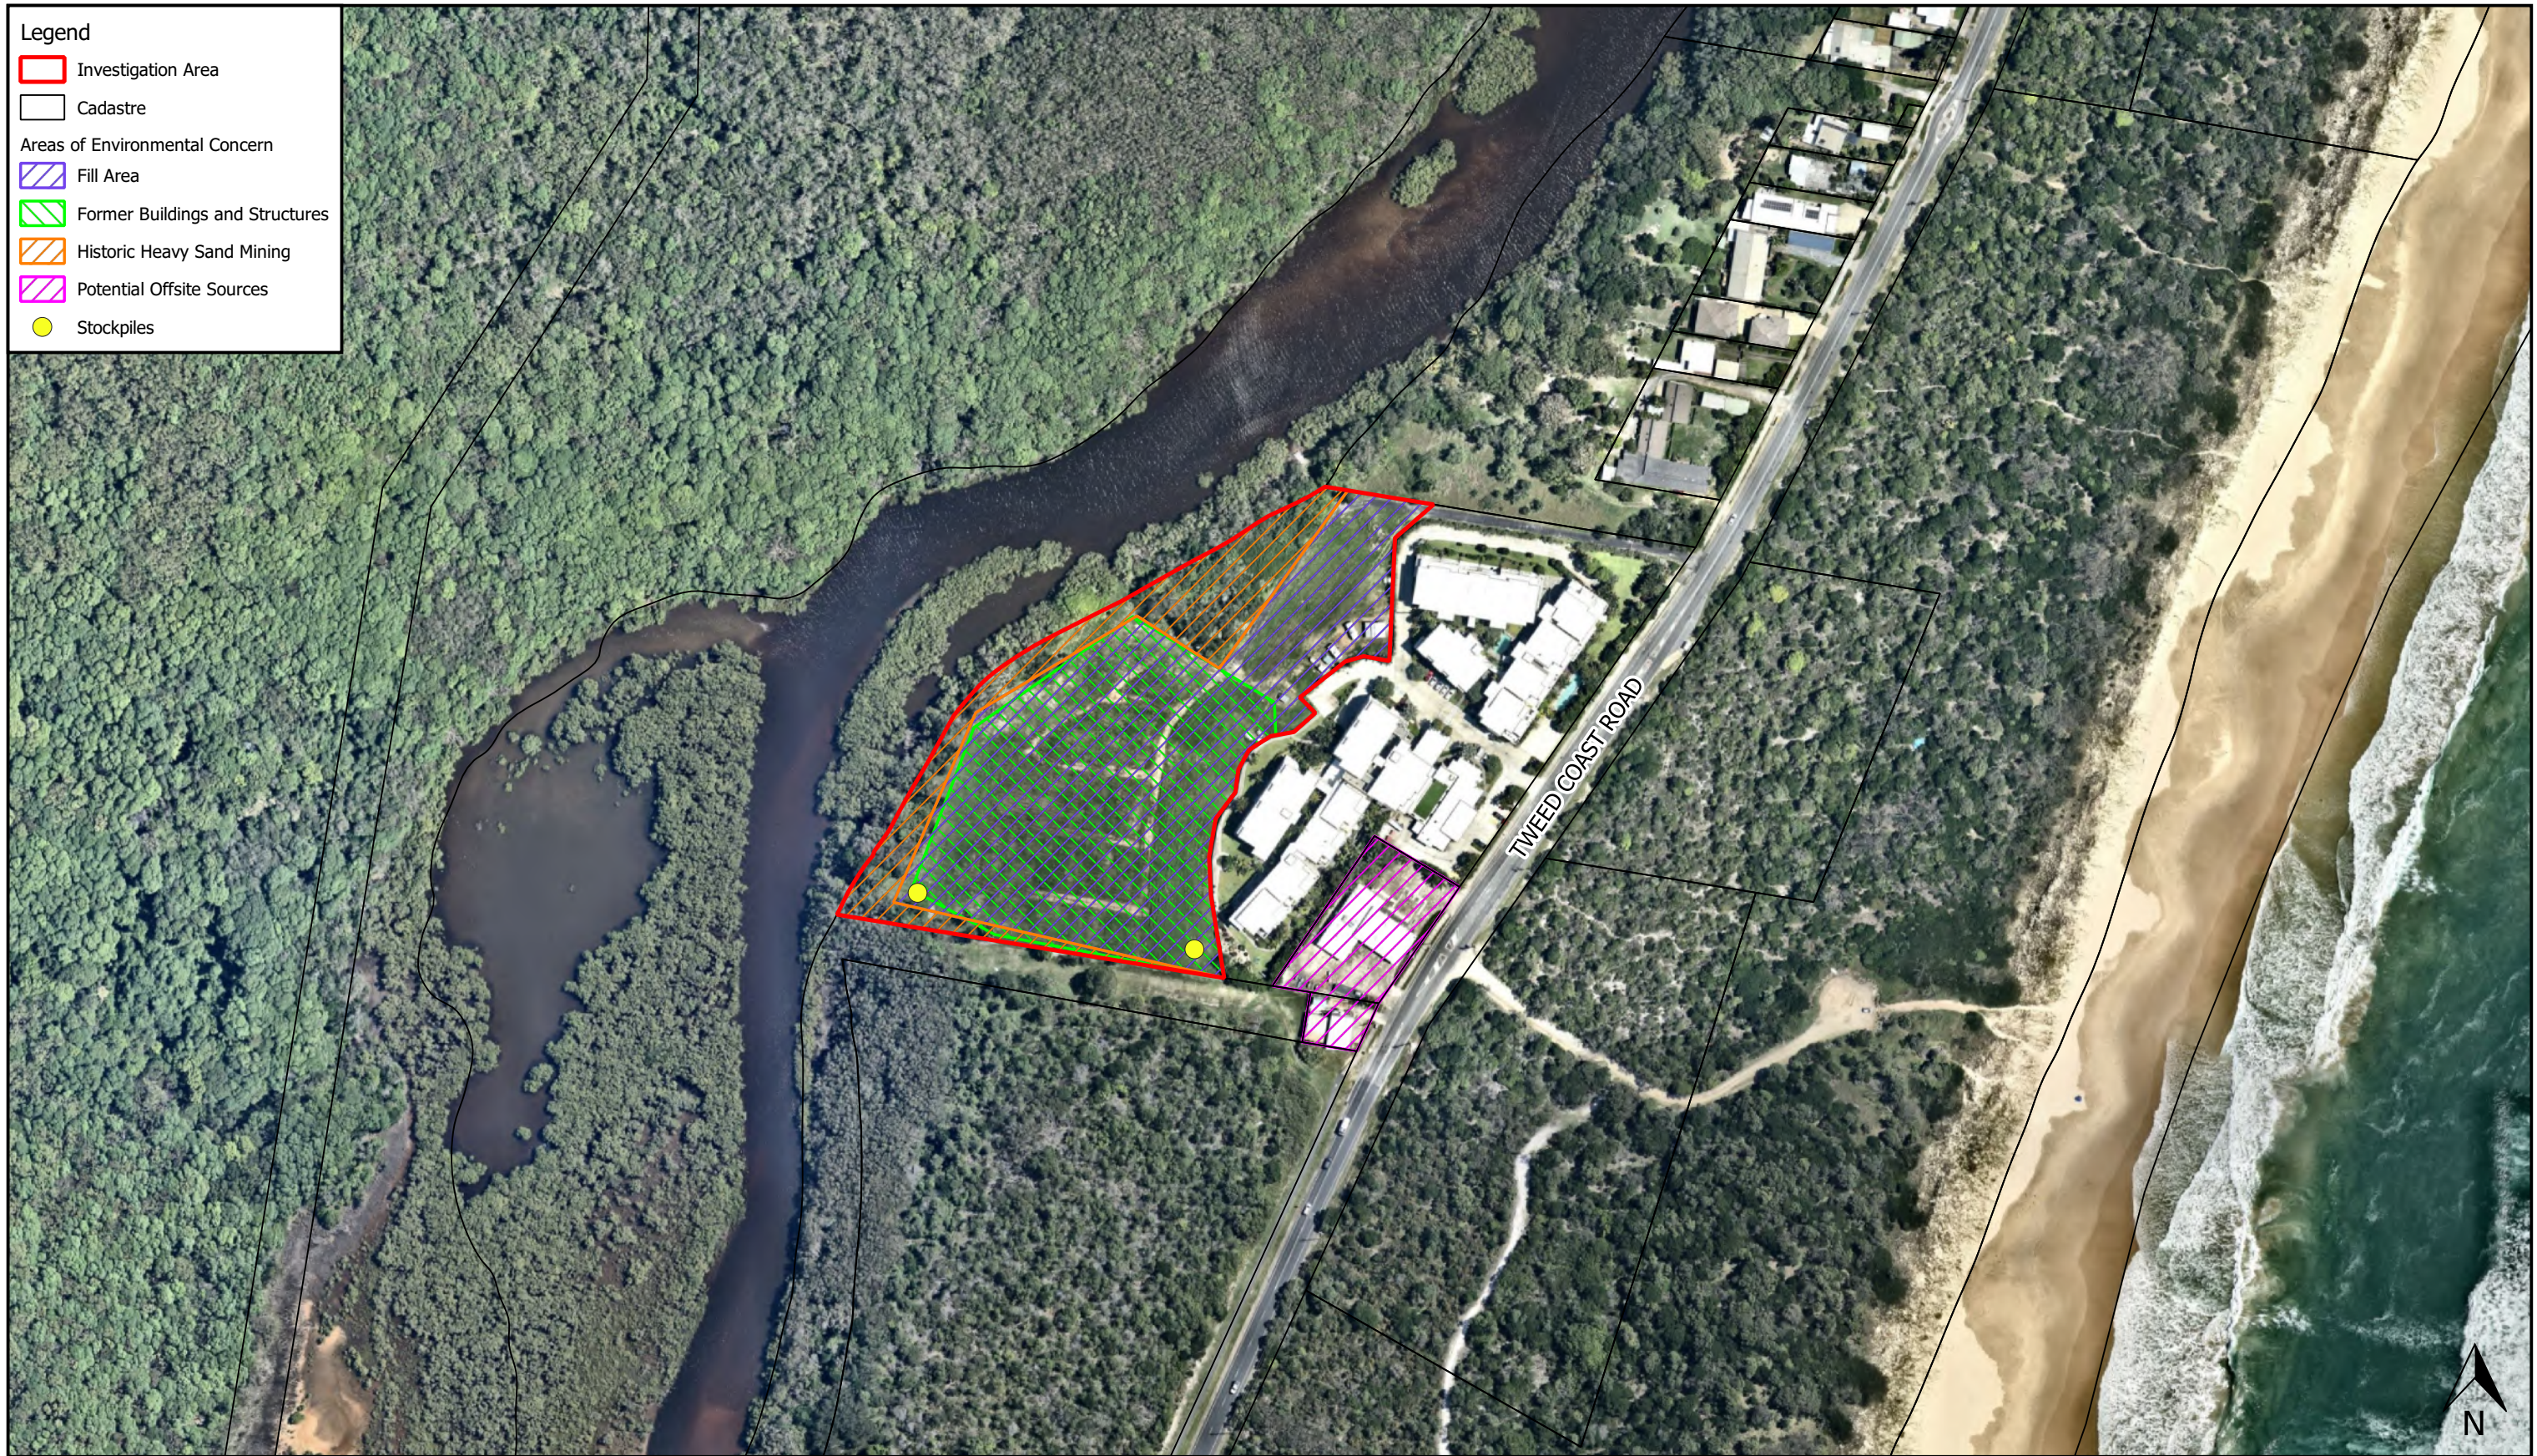
Map 04
 87-89 Tweed Coast Road, Hastings Point NSW 2489
 Proposed Seniors Housing Development
 Detailed Site Investigation
 TriCare (Hastings) Limited
 15/08/2024

- Investigation Area
- Cadastre
- Areas of Environmental Concern**
- Fill Area
- Former Buildings and Structures
- Historic Heavy Sand Mining
- Potential Offsite Sources
- Stockpiles

AEC C Vehicle parking	Due to the unsealed nature of the IA, potential localised contamination may exist within surface soils as a result of fuel / oil leaks and limited spills from long standing vehicle parking across the IA.	HM, TRH, BTEXN, PAH, phenolic compounds
AEC D Potential offsite sources – service station & telephone exchange	Offsite contamination sources identified relate to the neighbouring service station and telephone exchange facility. Due to the proximity and inferred hydraulically up-gradient location of these offsite locations, it is possible for local groundwater contamination to exist within the IA. Furthermore, should groundwater be impacted by VOCs, groundwater may be a potential vapour source.	HM, TRH, BTEXN, PAH, volatile organic compounds (VOC)

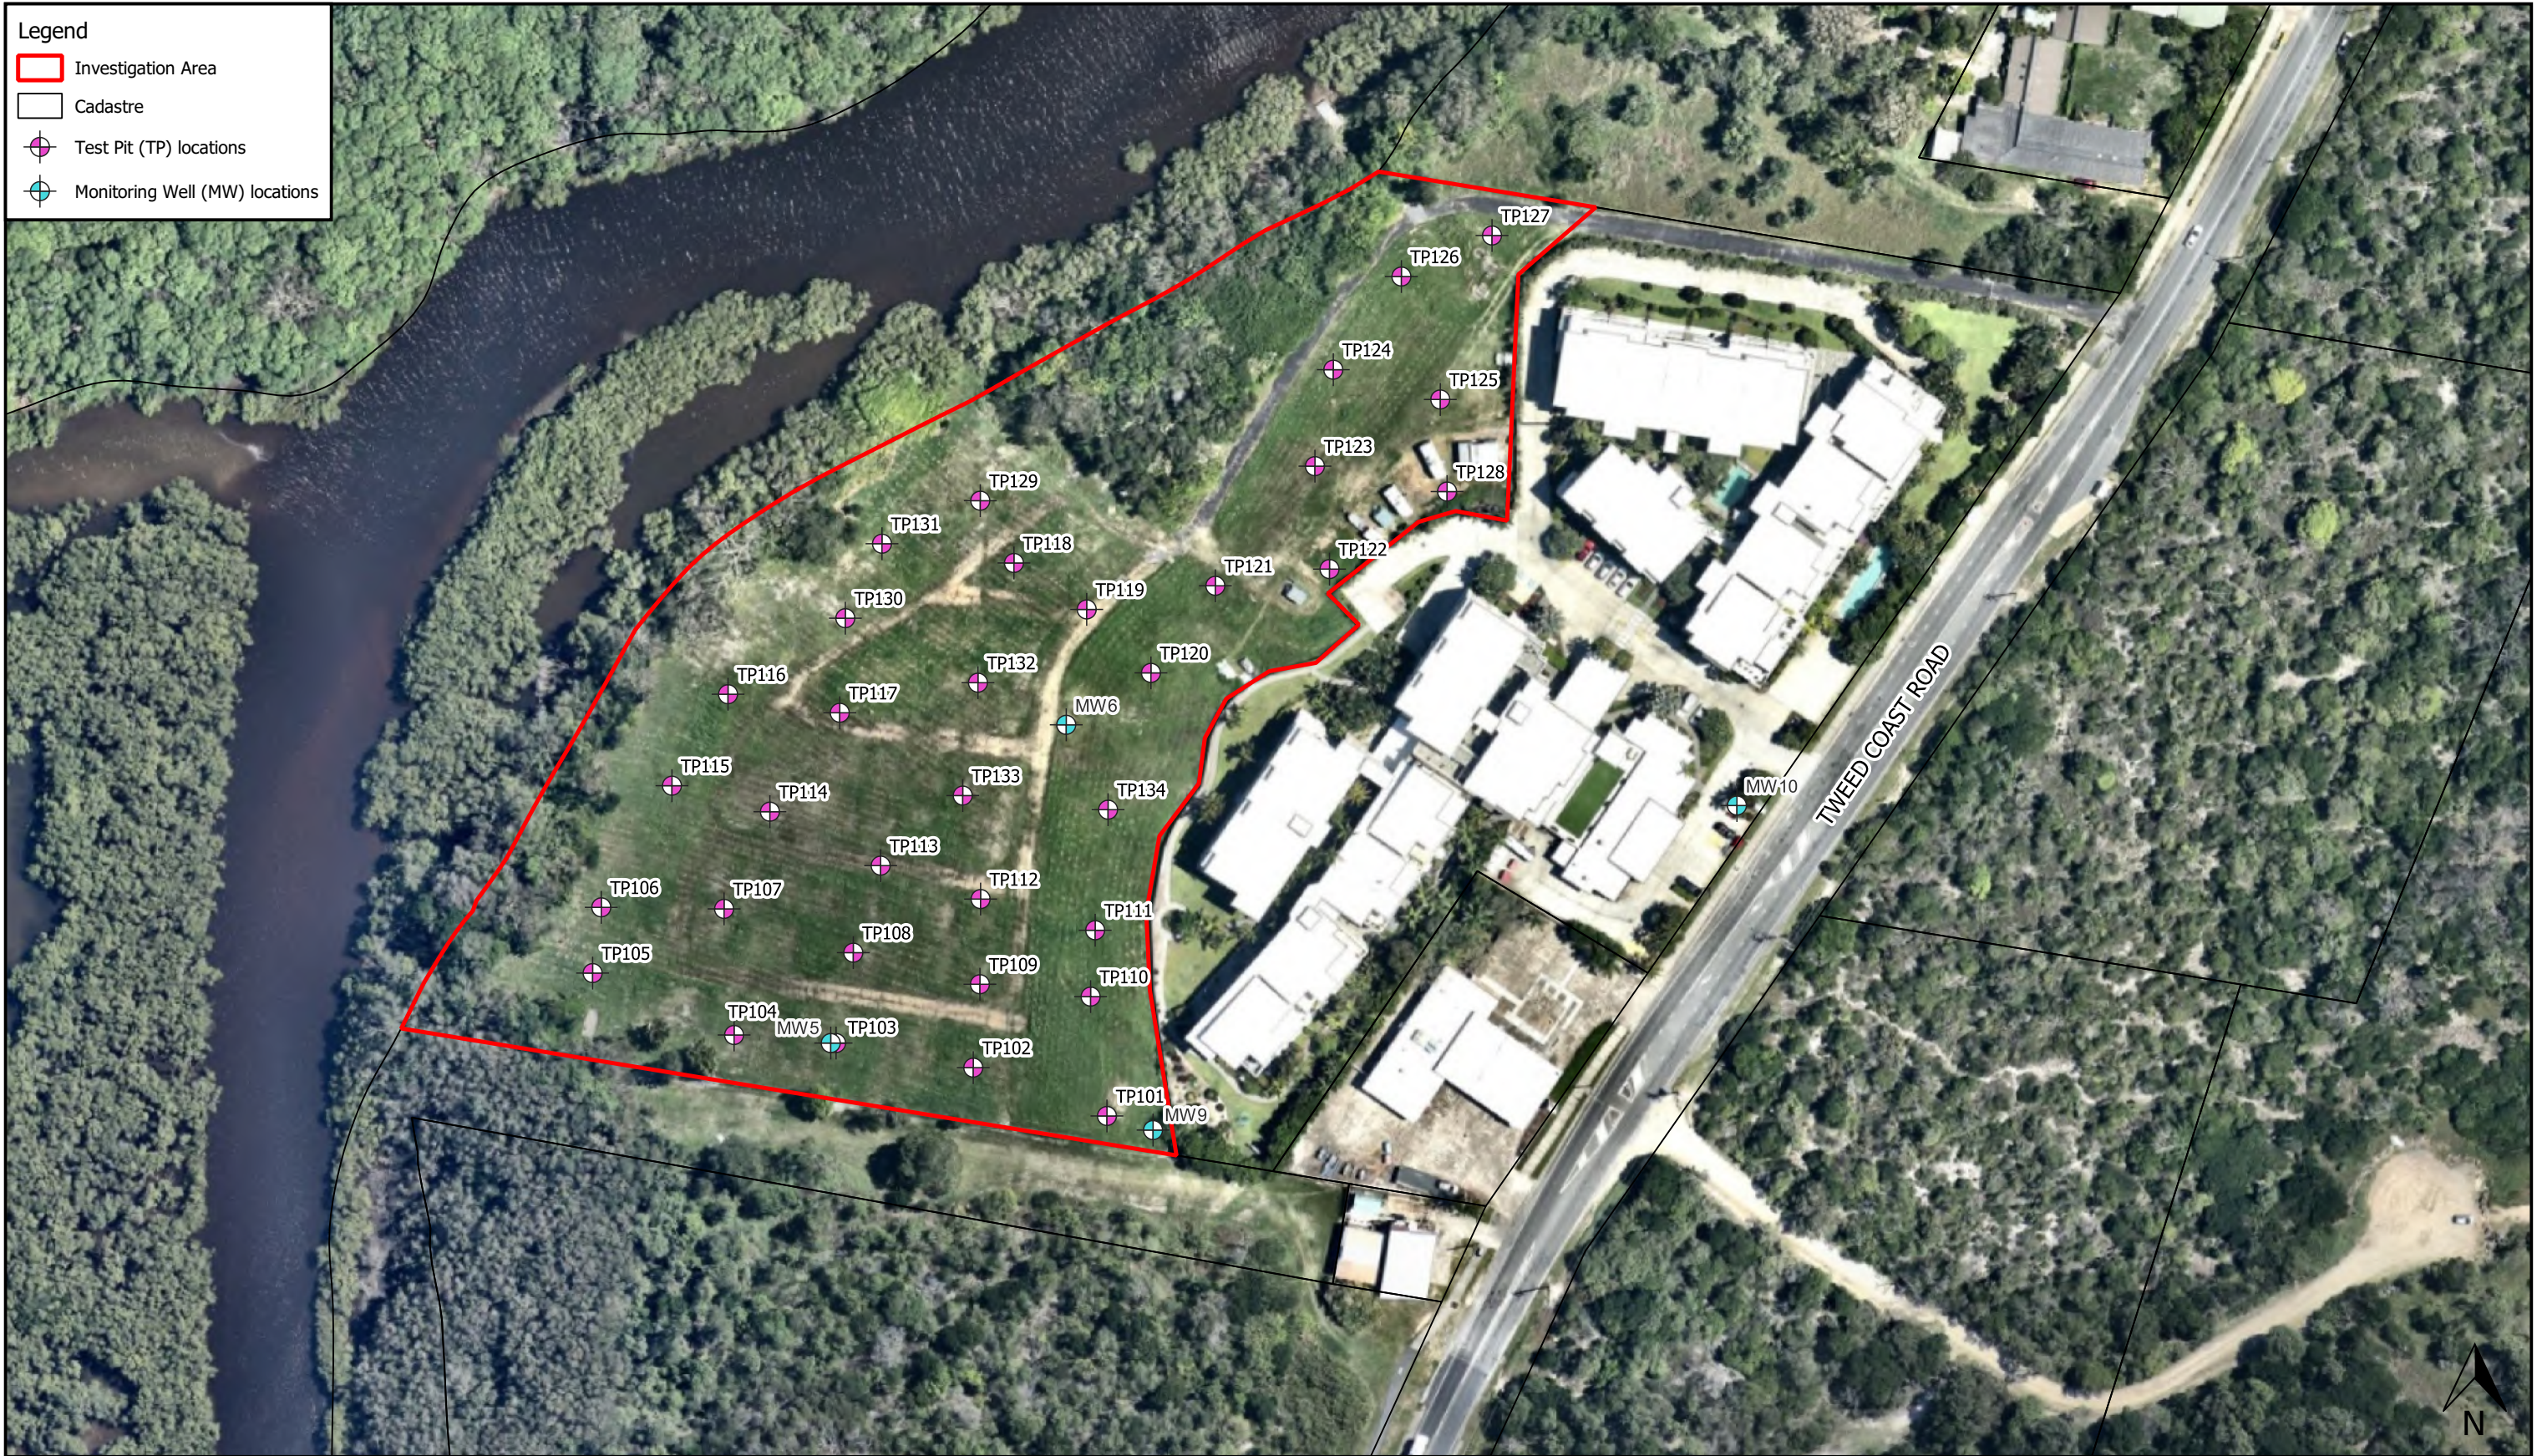
- Investigation Area
- Cadastre
- ⊕ Test Pit (TP) locations
- ⊕ Monitoring Well (MW) locations

Item	Description
Fieldworks	The soil investigation and sampling event was completed from 29 July to 1 August 2024.
Investigation methods	<p>Systematic soil investigation was proposed at thirty-four test locations on an approximate 26 m sampling grid.</p> <p>Investigation methods consisted of thirty four test pit (TP101 to TP134) excavations completed at by mechanical six tonne excavator. Test pits were advanced through fill material to a minimum depth of 0.5 m into natural soils or prior refusal.</p> <p>TP101 and TP105 were excavated adjacent to minor observed stockpiles identified in the PSI (MA, 2024).</p> <p>Sampling locations are shown in Appendix A (Map 05).</p>
Soil logging	<p>Soils were classified in the field with respect to lithological characteristics and texture. Soil classifications and descriptions were generally based on the Unified Soil Classification System (USCS) and Australian Standard (AS) AS1726:2017 - <i>Geotechnical Site Investigations</i>. Soils were also evaluated qualitatively for odour, visual evidence of contamination, and anthropogenic inclusions.</p> <p>Test pit logs for the investigation are presented in Appendix D. A summary of soil descriptions and field observations is provided in Section 6.3.</p>

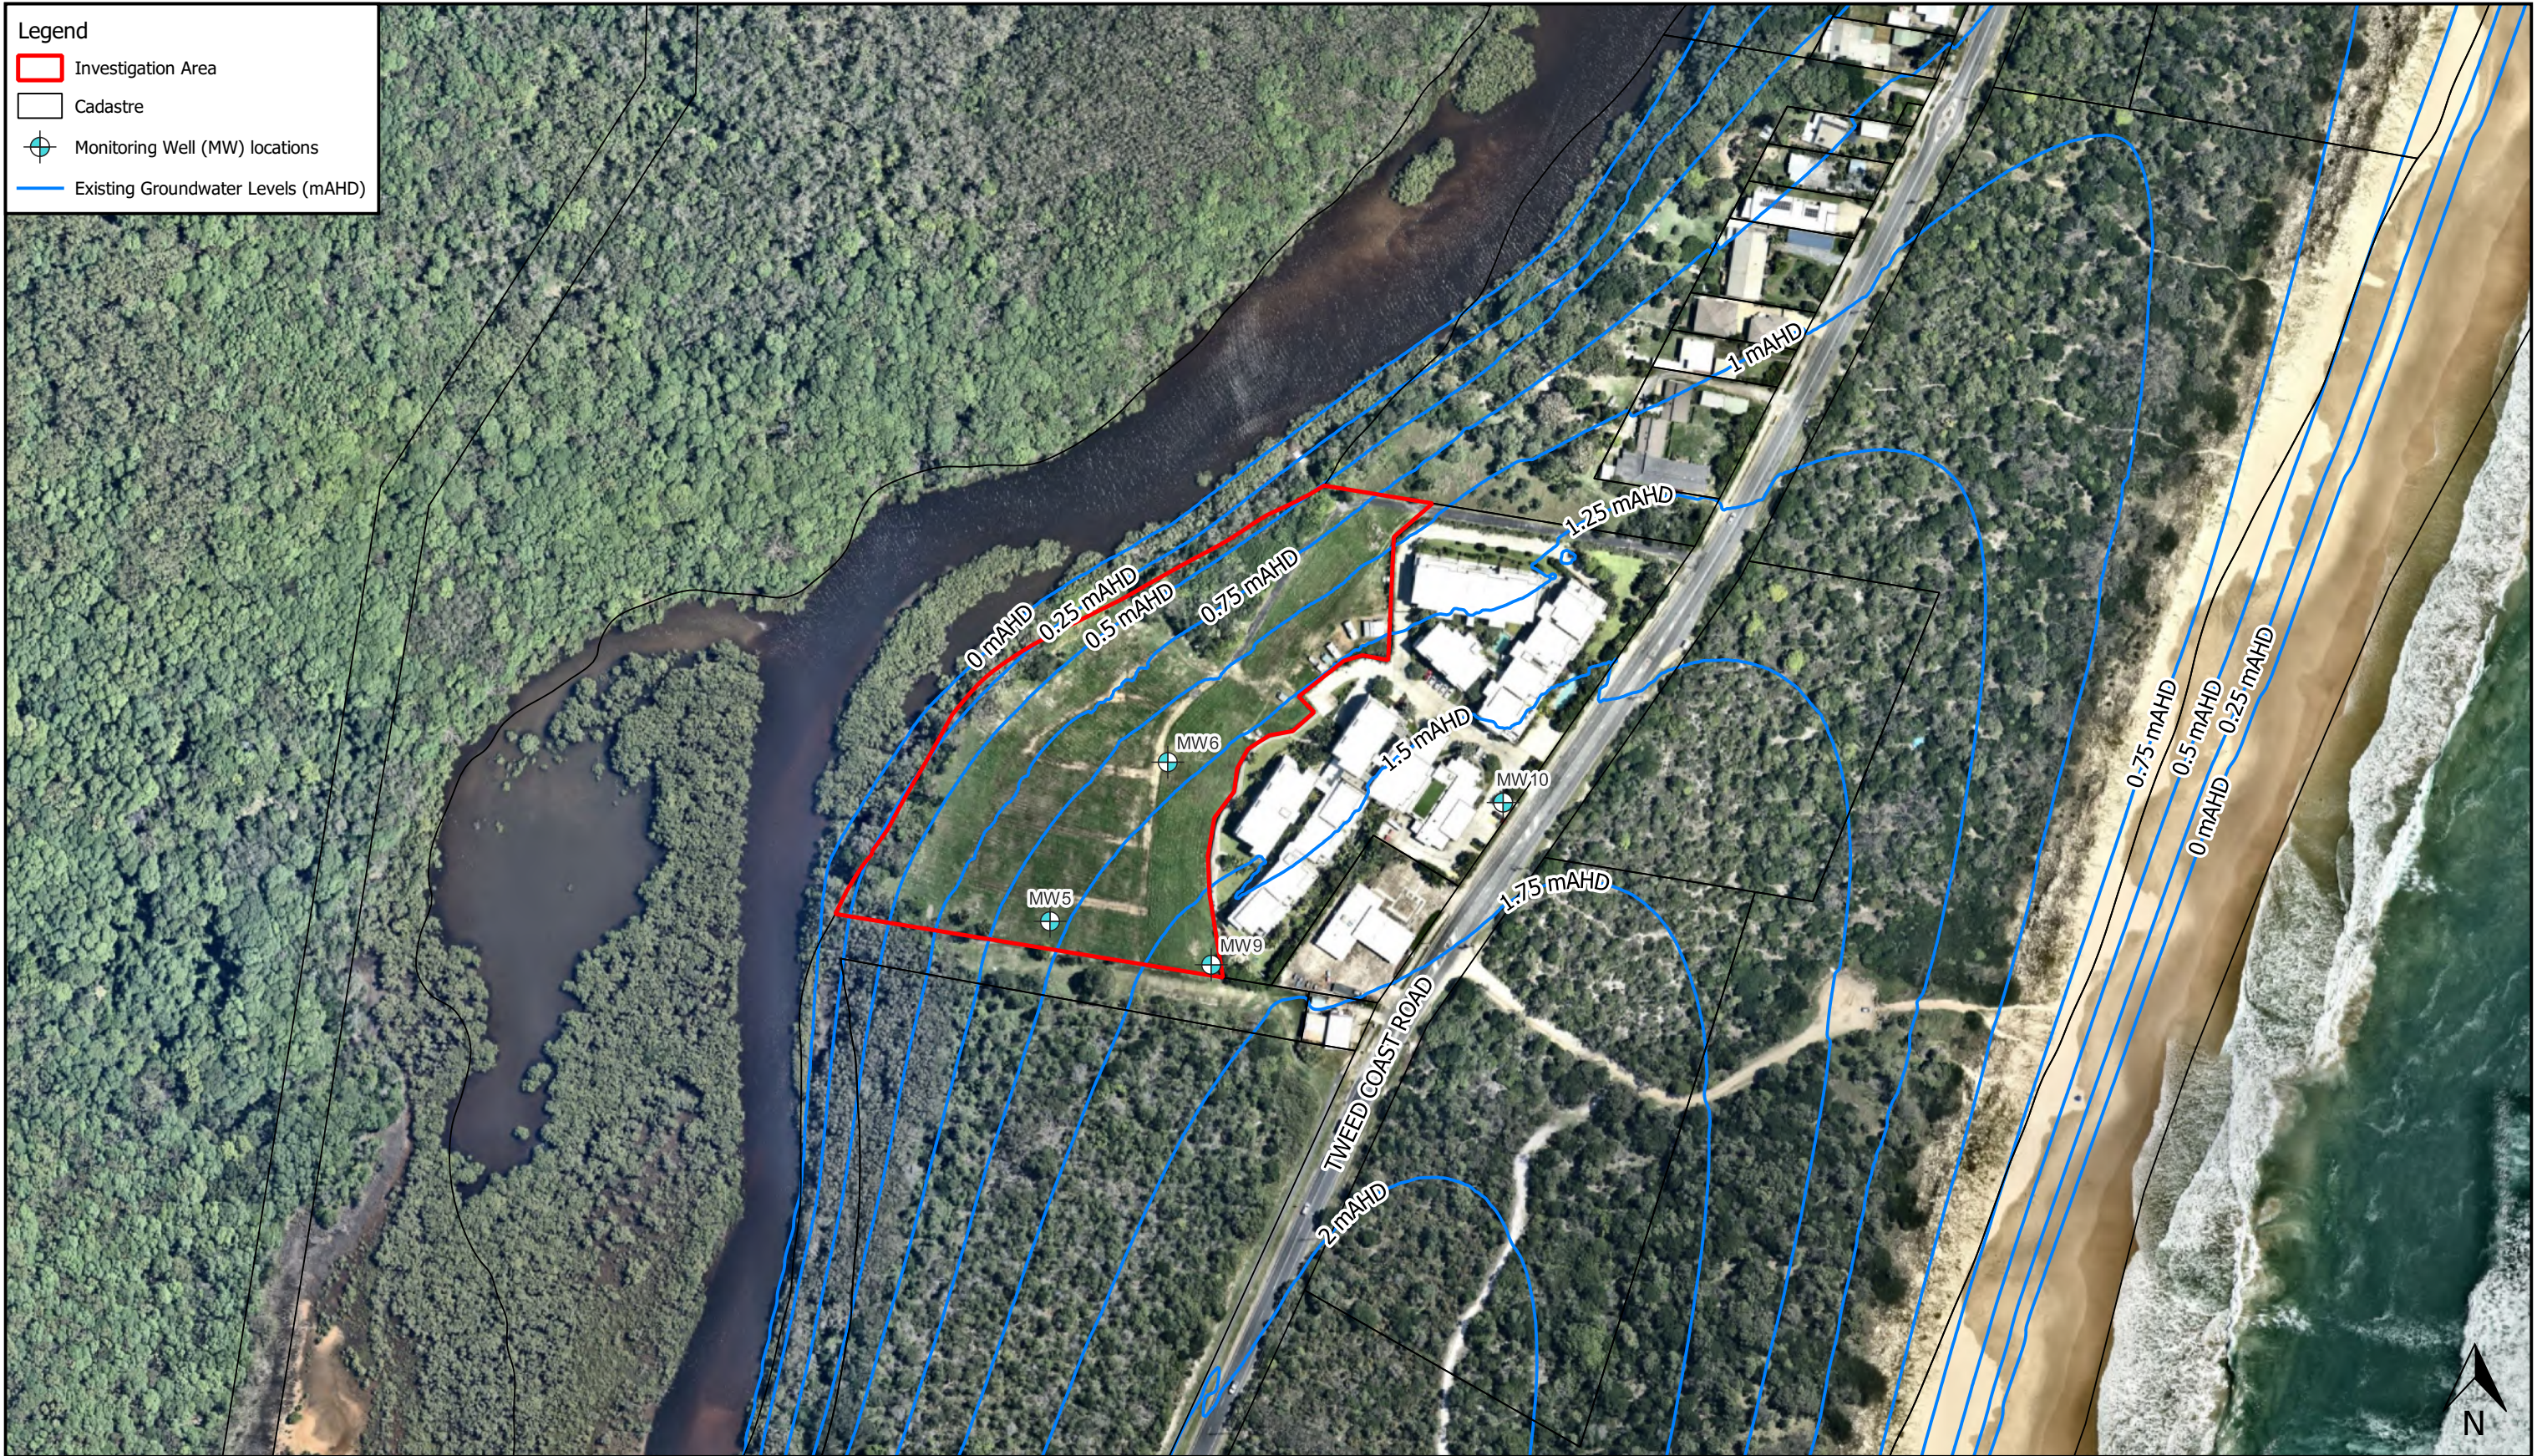
Map Title / Figure:
Groundwater Contour Plan

- Investigation Area
- Cadastre
- + Monitoring Well (MW) locations
- Existing Groundwater Levels (mAHD)

Given that beneficial groundwater use is not proposed for the development, and the basement will be fully tanked, ongoing risk to sensitive receptors or the development posed by groundwater, is expected to be low based on current data. It is noted that temporary dewatering will likely be required during excavation for the construction of the proposed basement. To address potential risks during temporary dewatering, a groundwater dewatering management plan is to be prepared, outlining requirements for dewatering during the construction phase of the development.

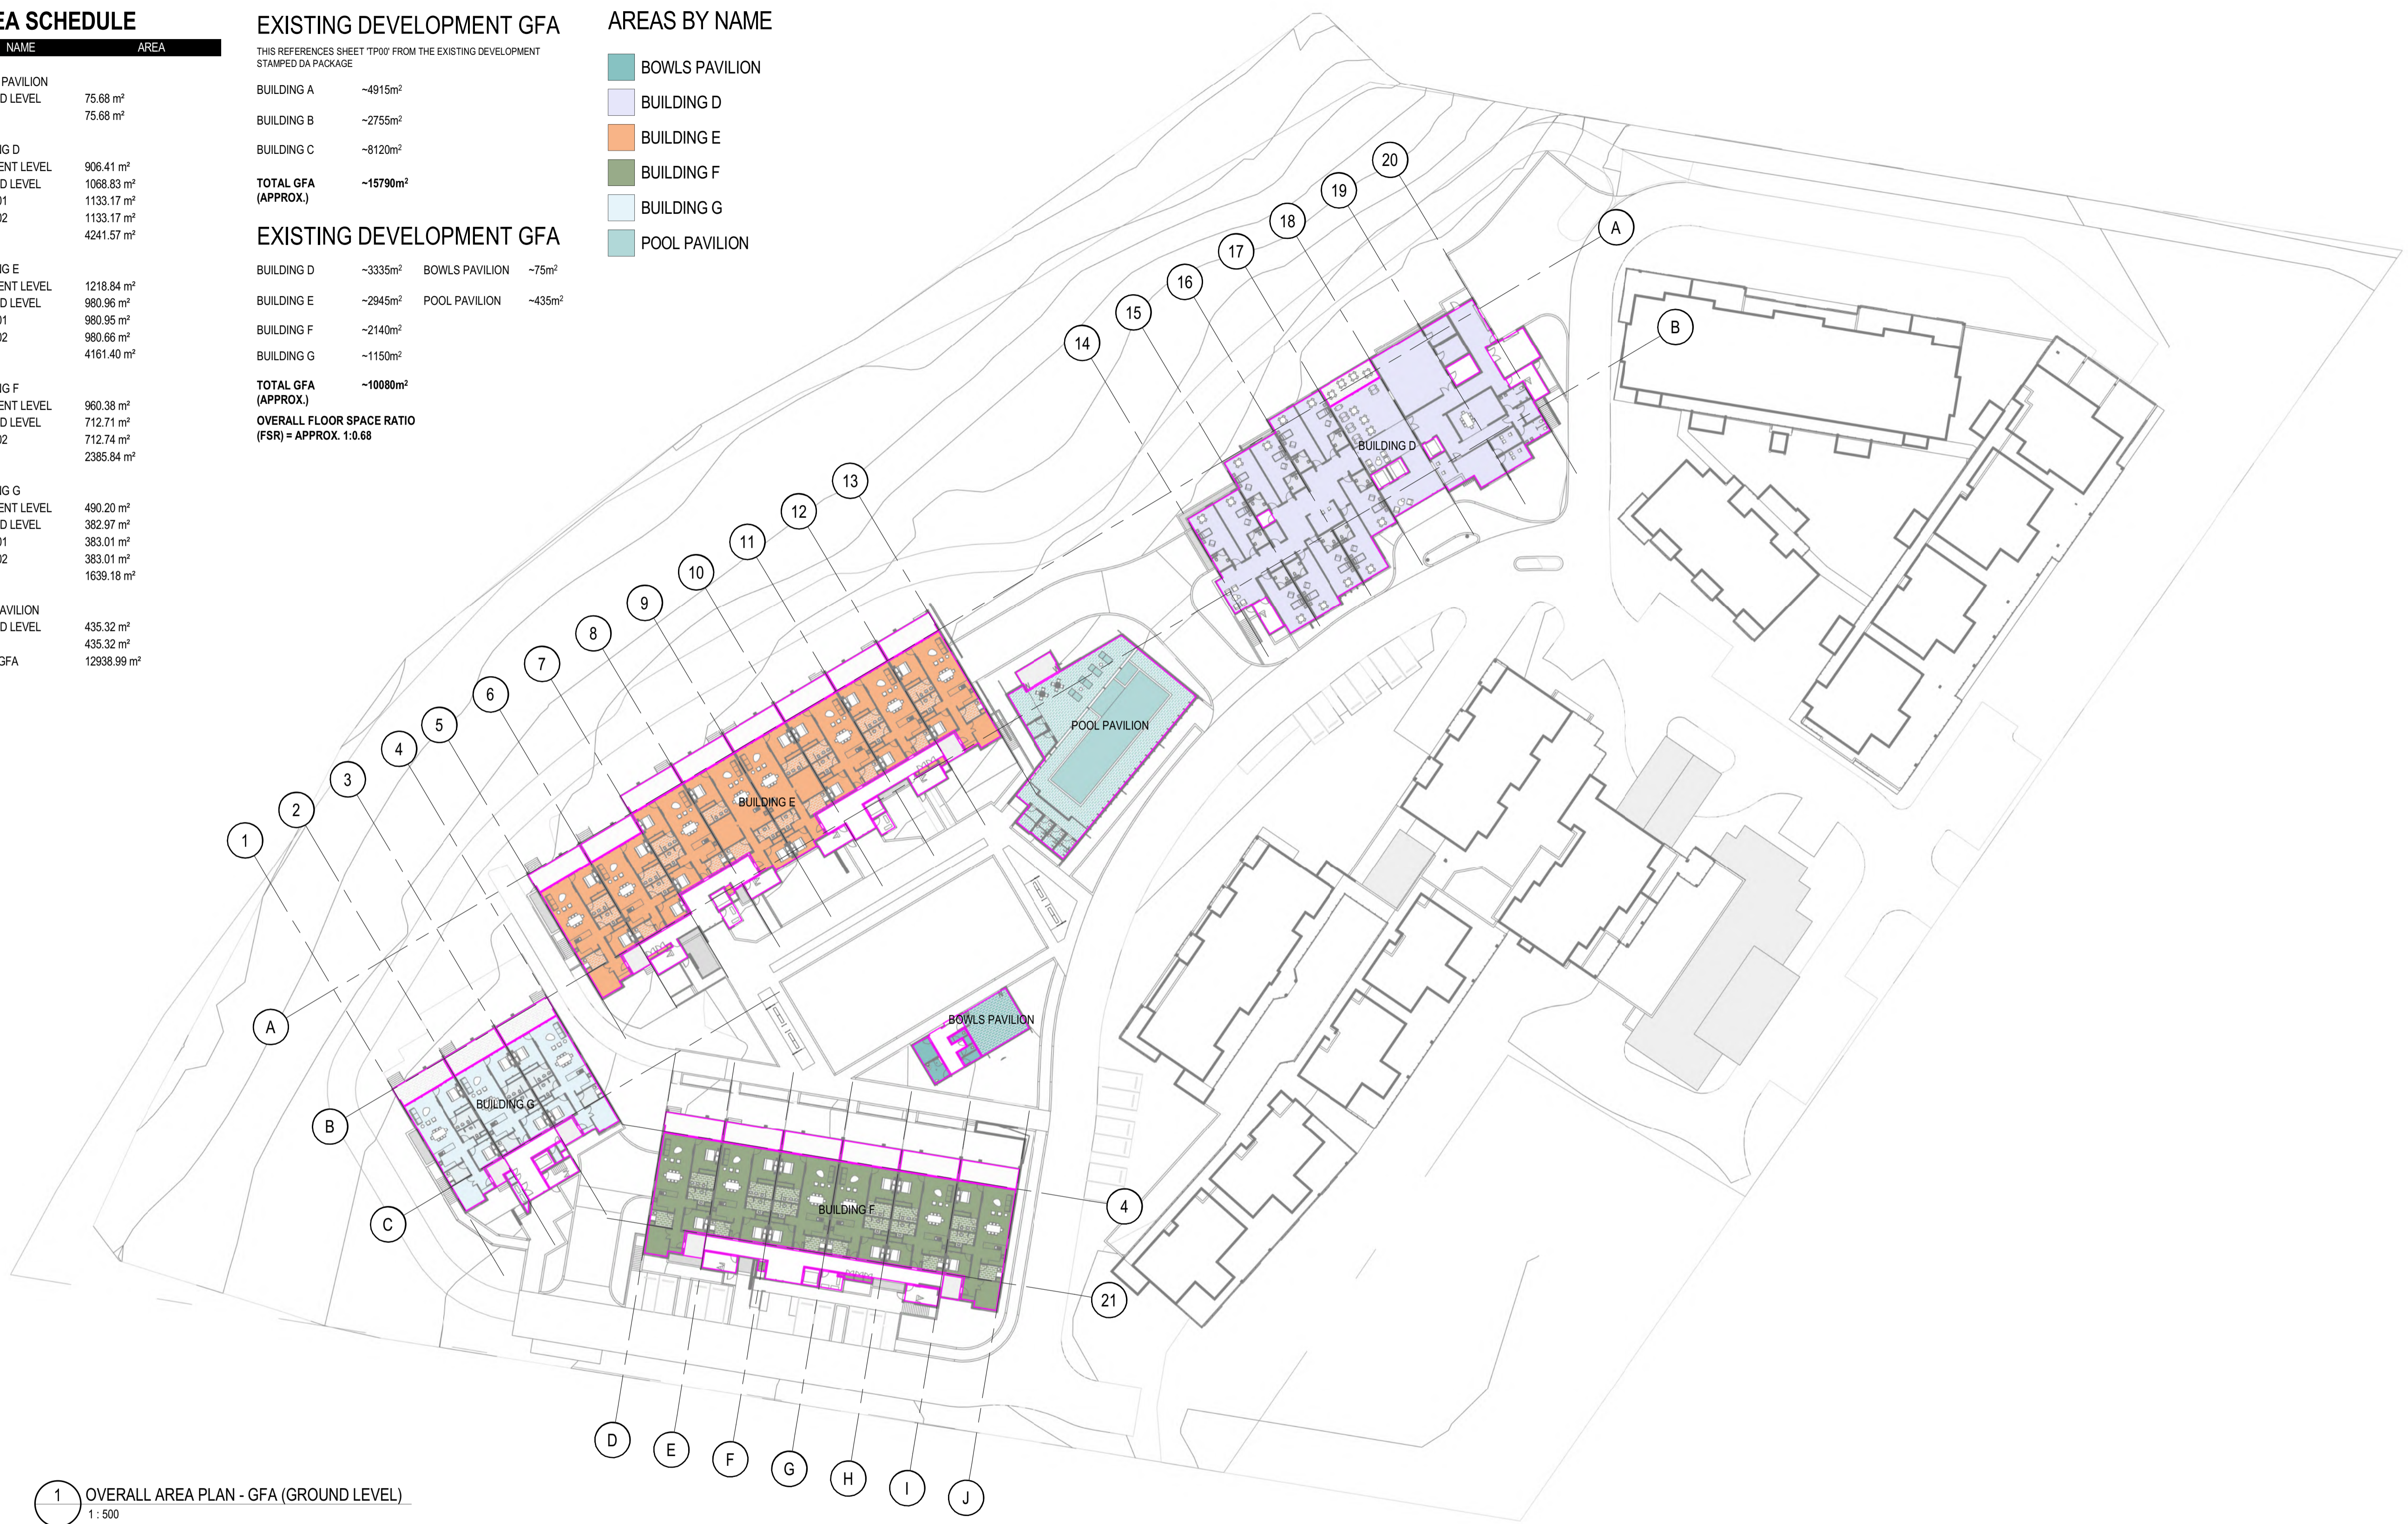
1 OVERALL AREA PLAN - GFA (GROUND LEVEL)
 1 : 500

- BOWLS PAVILION
- BUILDING D
- BUILDING E
- BUILDING F
- BUILDING G
- POOL PAVILION

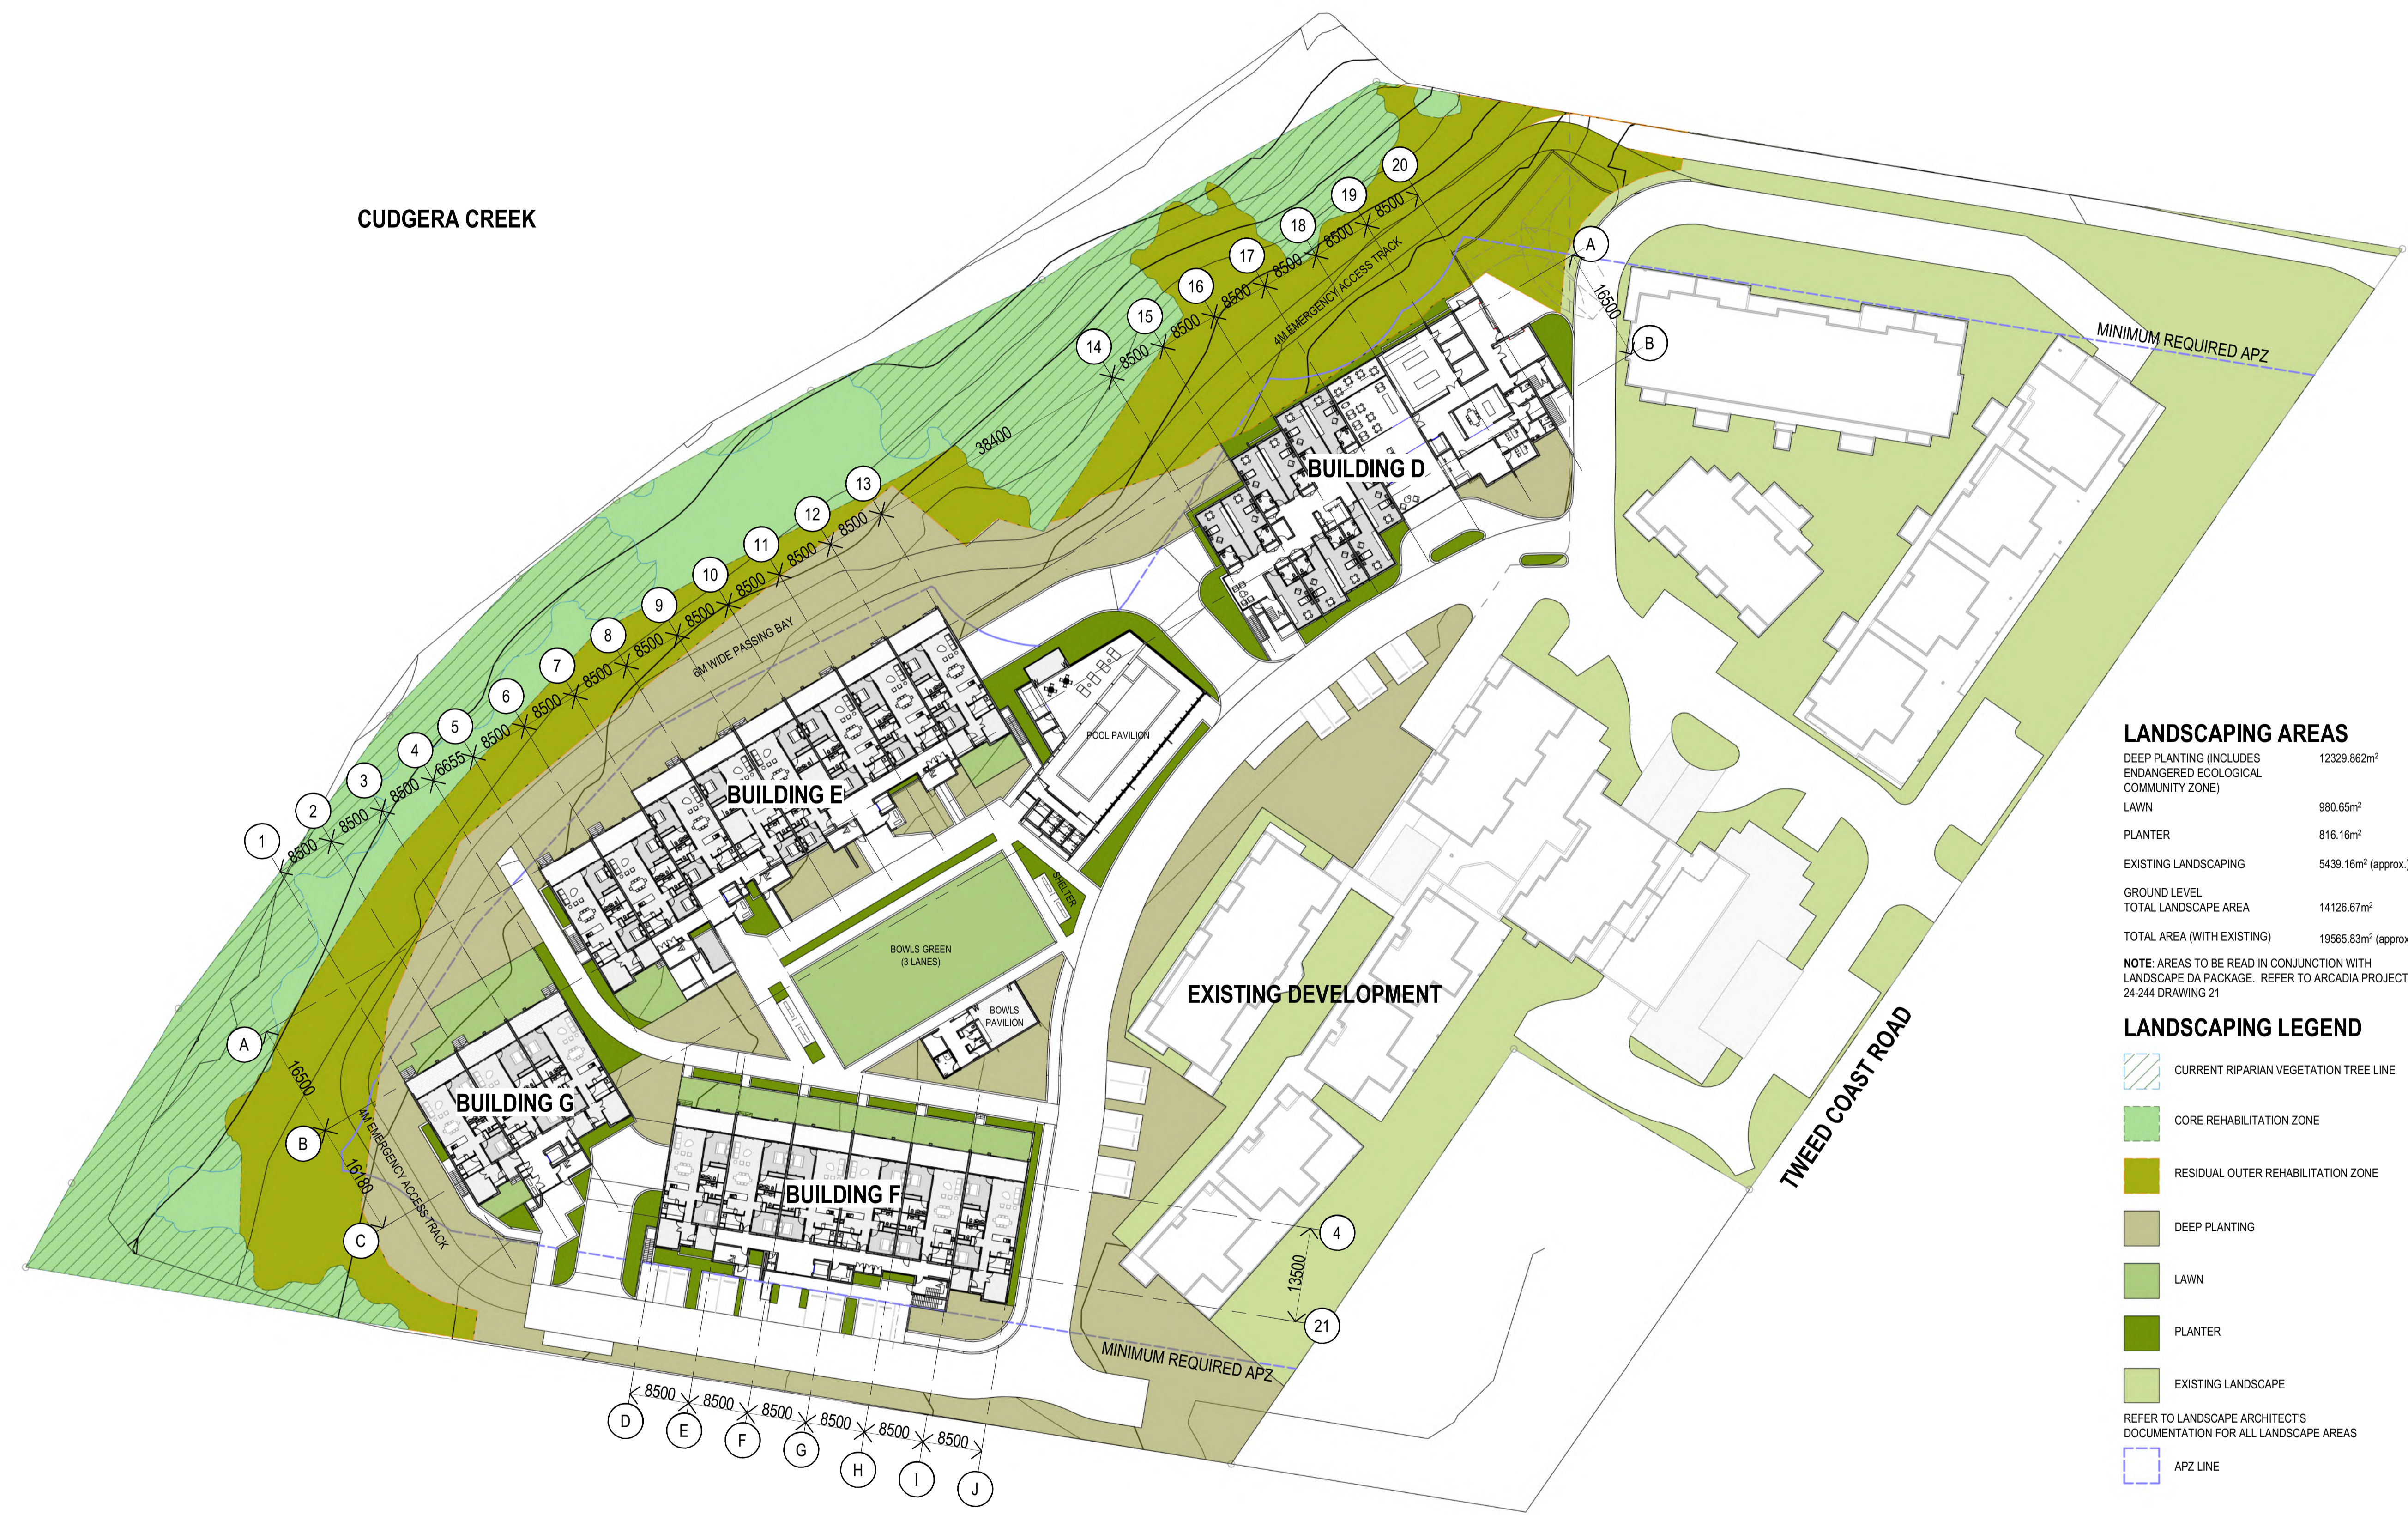
LANDSCAPING AREAS

DEEP PLANTING (INCLUDES ENDANGERED ECOLOGICAL COMMUNITY ZONE)	12329.862m ²
LAWN	980.65m ²
PLANTER	816.16m ²
EXISTING LANDSCAPING	5439.16m ² (approx.)
GROUND LEVEL TOTAL LANDSCAPE AREA	14126.67m ²
TOTAL AREA (WITH EXISTING)	19565.83m ² (approx.)

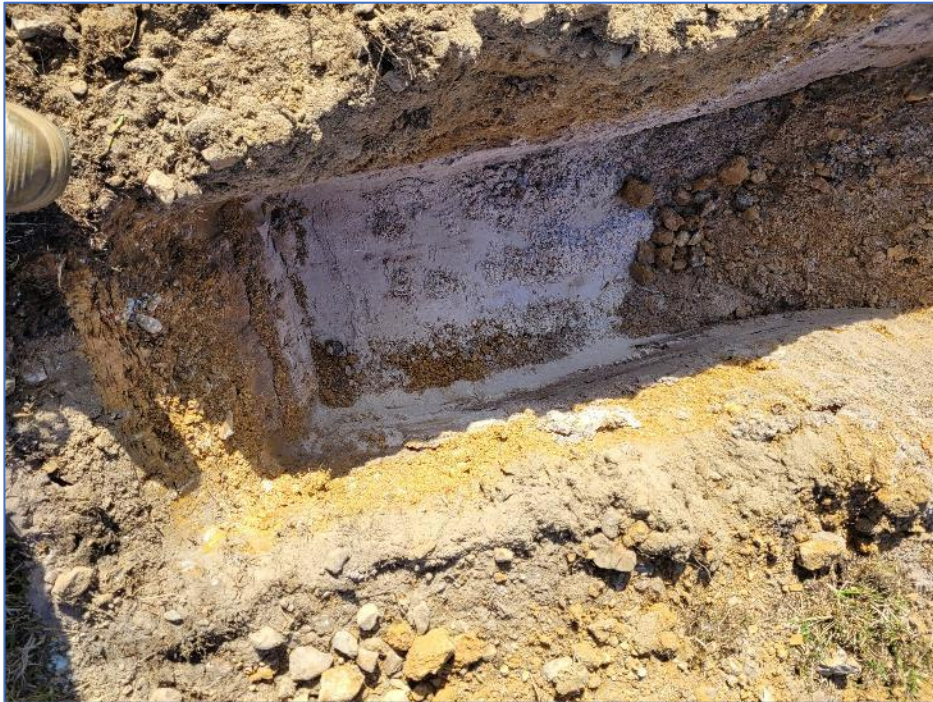
Photo 1: Typical subsurface profile.

Fill material was observed at each test pit location and generally extended to depths between 1.0 to 1.7 mBGL within the IA.

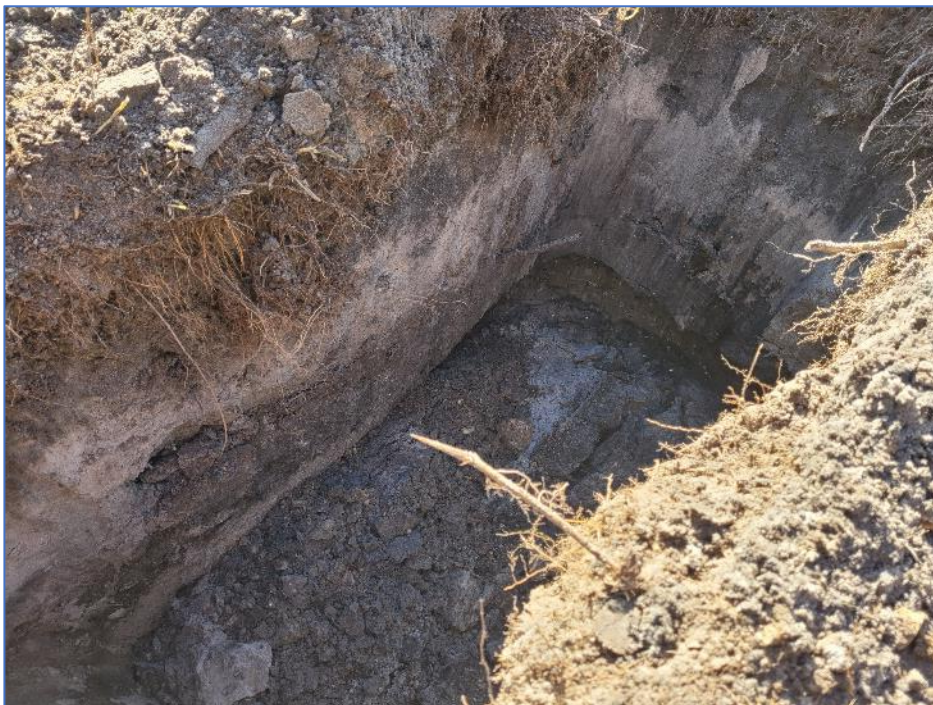
Photo 2: Typical subsurface profile
