# Hydrogeological Impact Assessment

State Significant Development: Proposed Seniors Housing Development, 87-89 Tweed Coast Road, Hastings Point, NSW

P2108580JR03V03

Prepared for TriCare (Hastings) Limited

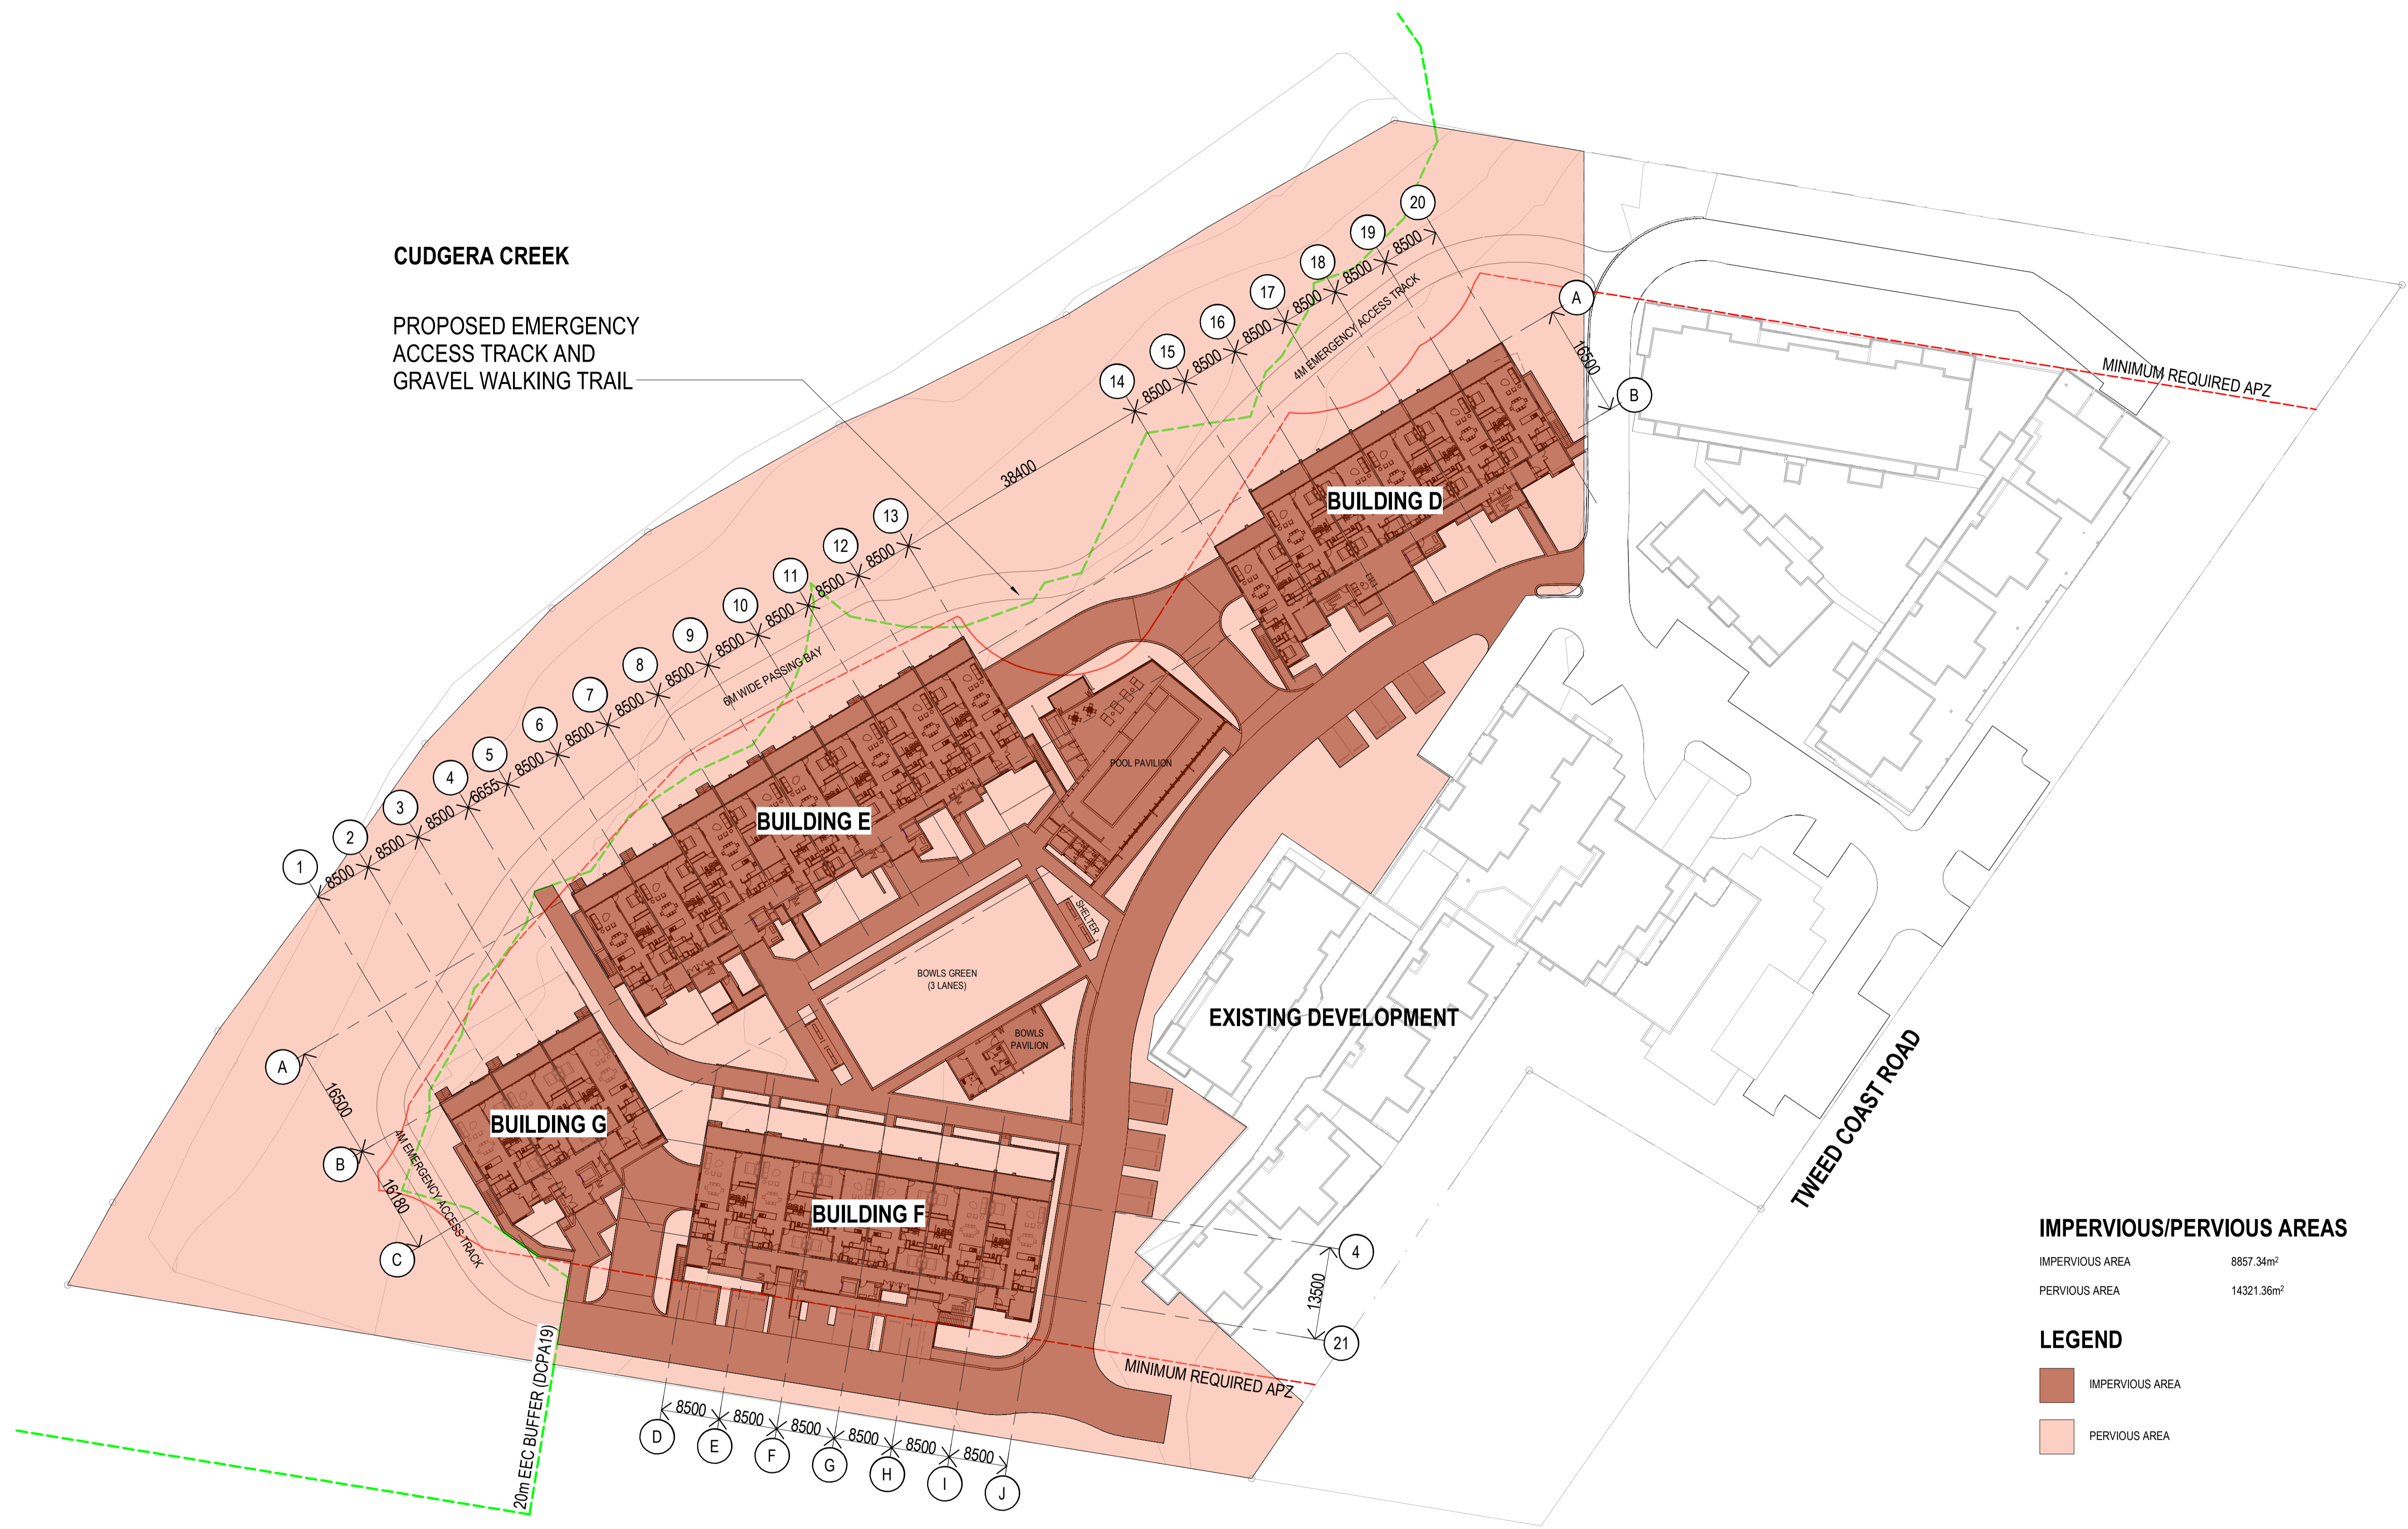
### IMPERVIOUS/PERVIOUS AREAS

IMPERVIOUS AREA	8857.34m <sup>2</sup>
PERVIOUS AREA	14321.36m <sup>2</sup>

To represent expected groundwater conditions arising from the post development scenario, recharge and evapotranspiration zones were updated to reflect the proposed development (Arqus Design, 2023), including new basements and impervious areas.

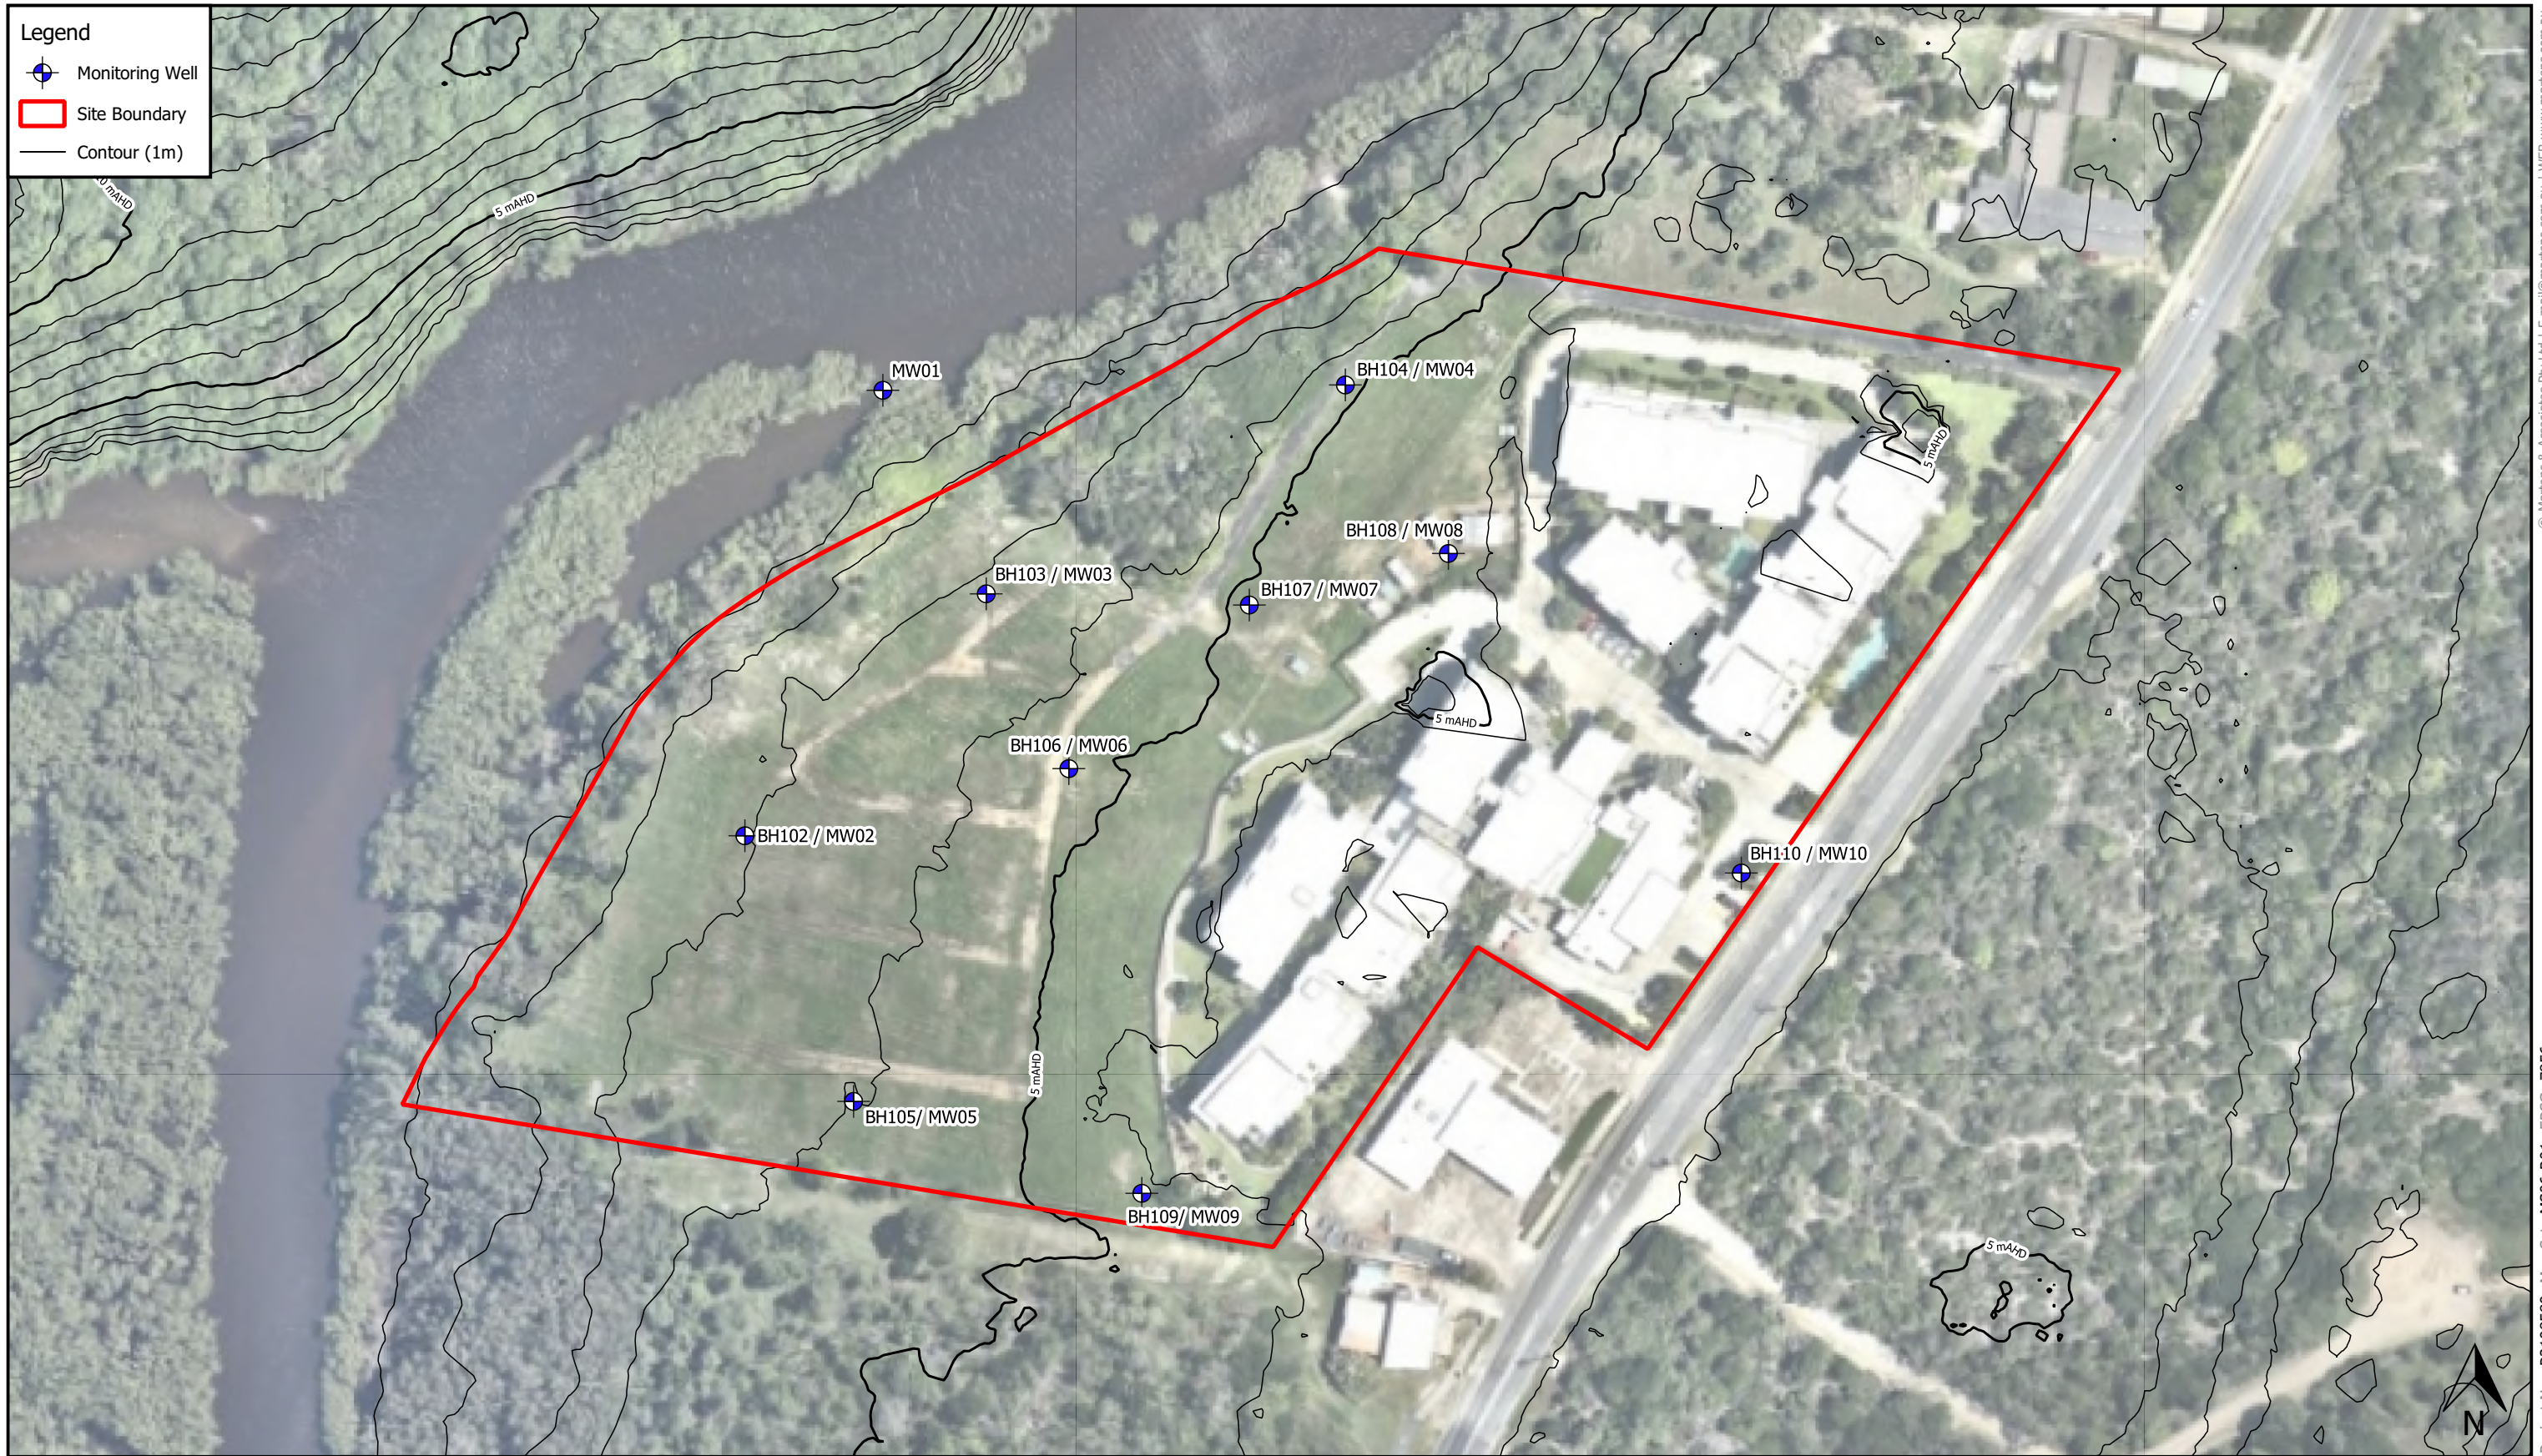
Map Title / Figure:  
**Soil Landscapes**

<b>Map 05</b>	Map
87 - 89 Tweed Coast Road, Hastings Point, NSW	Site
Proposed Seniors Housing Development	Project
Hydrogeological Impact Assessment	Sub-Project
TriCare (Hastings) Limited	Client
10/09/2024	Date

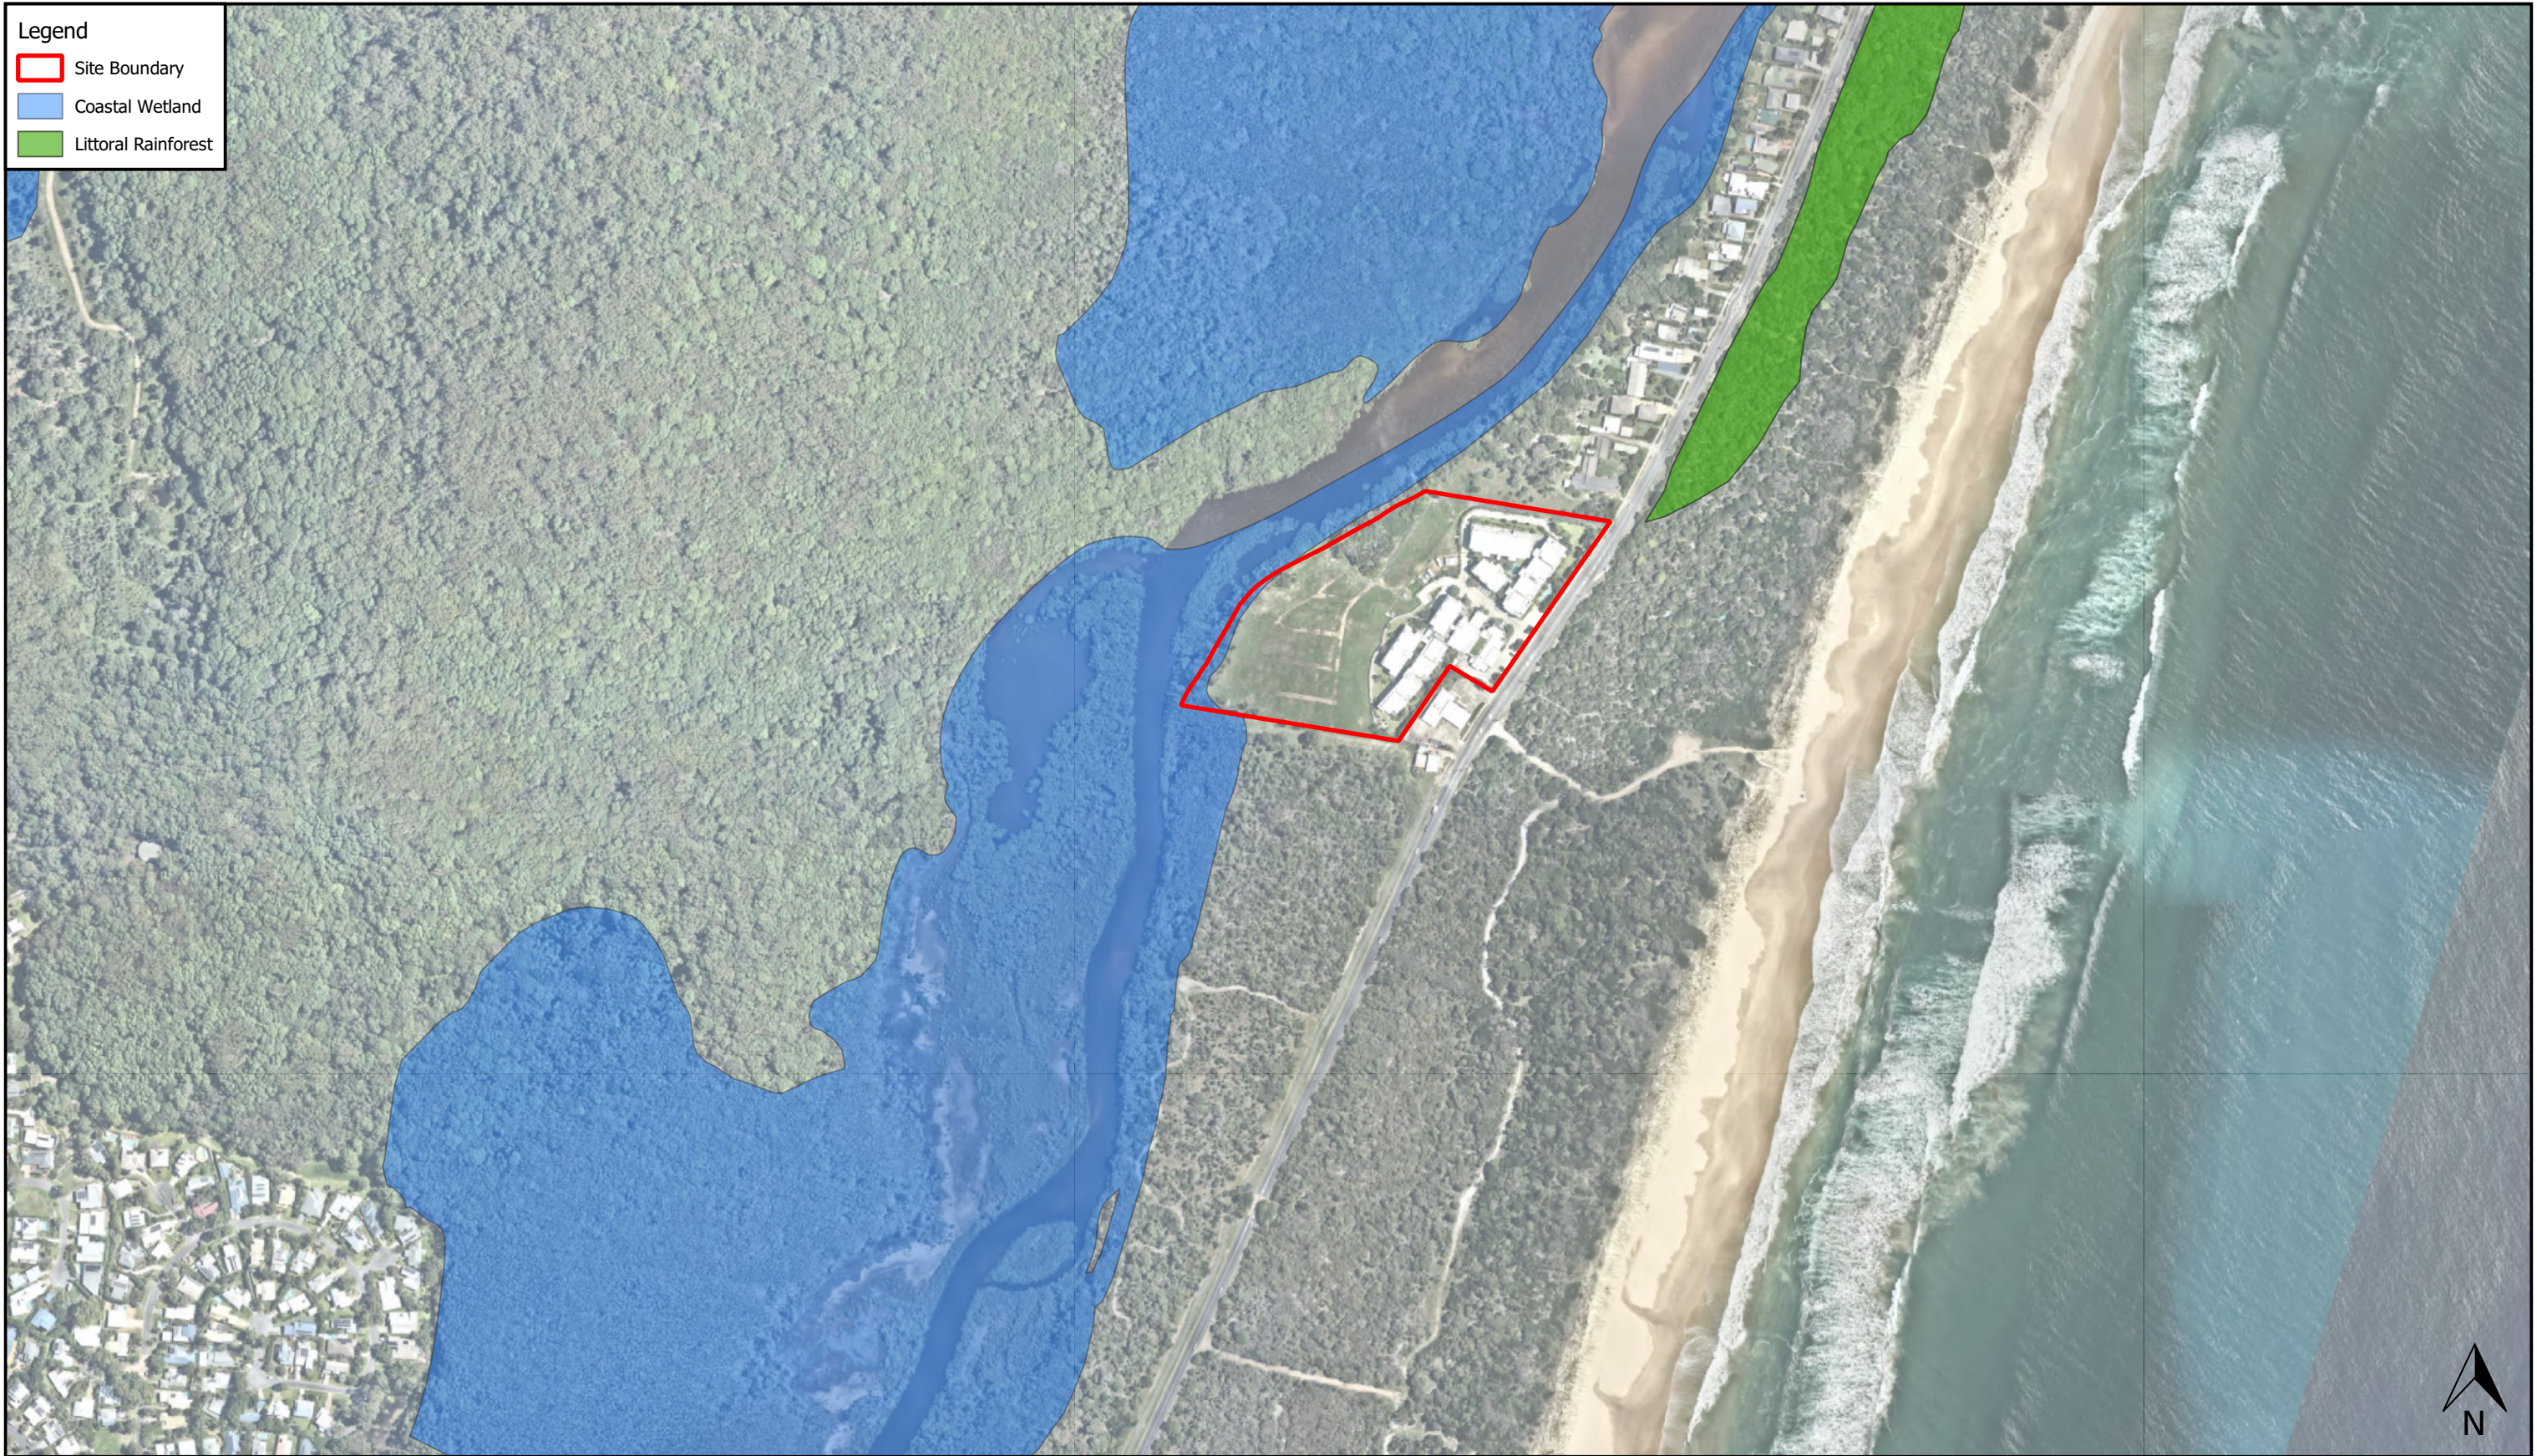
Map Title / Figure:  
**Nearby Registered Groundwater Bores**

Notes:  
 - Aerial from Nearmap (2024).  
 - Registered bore locations from Australian Government BoM's Groundwater Explorer (2024).

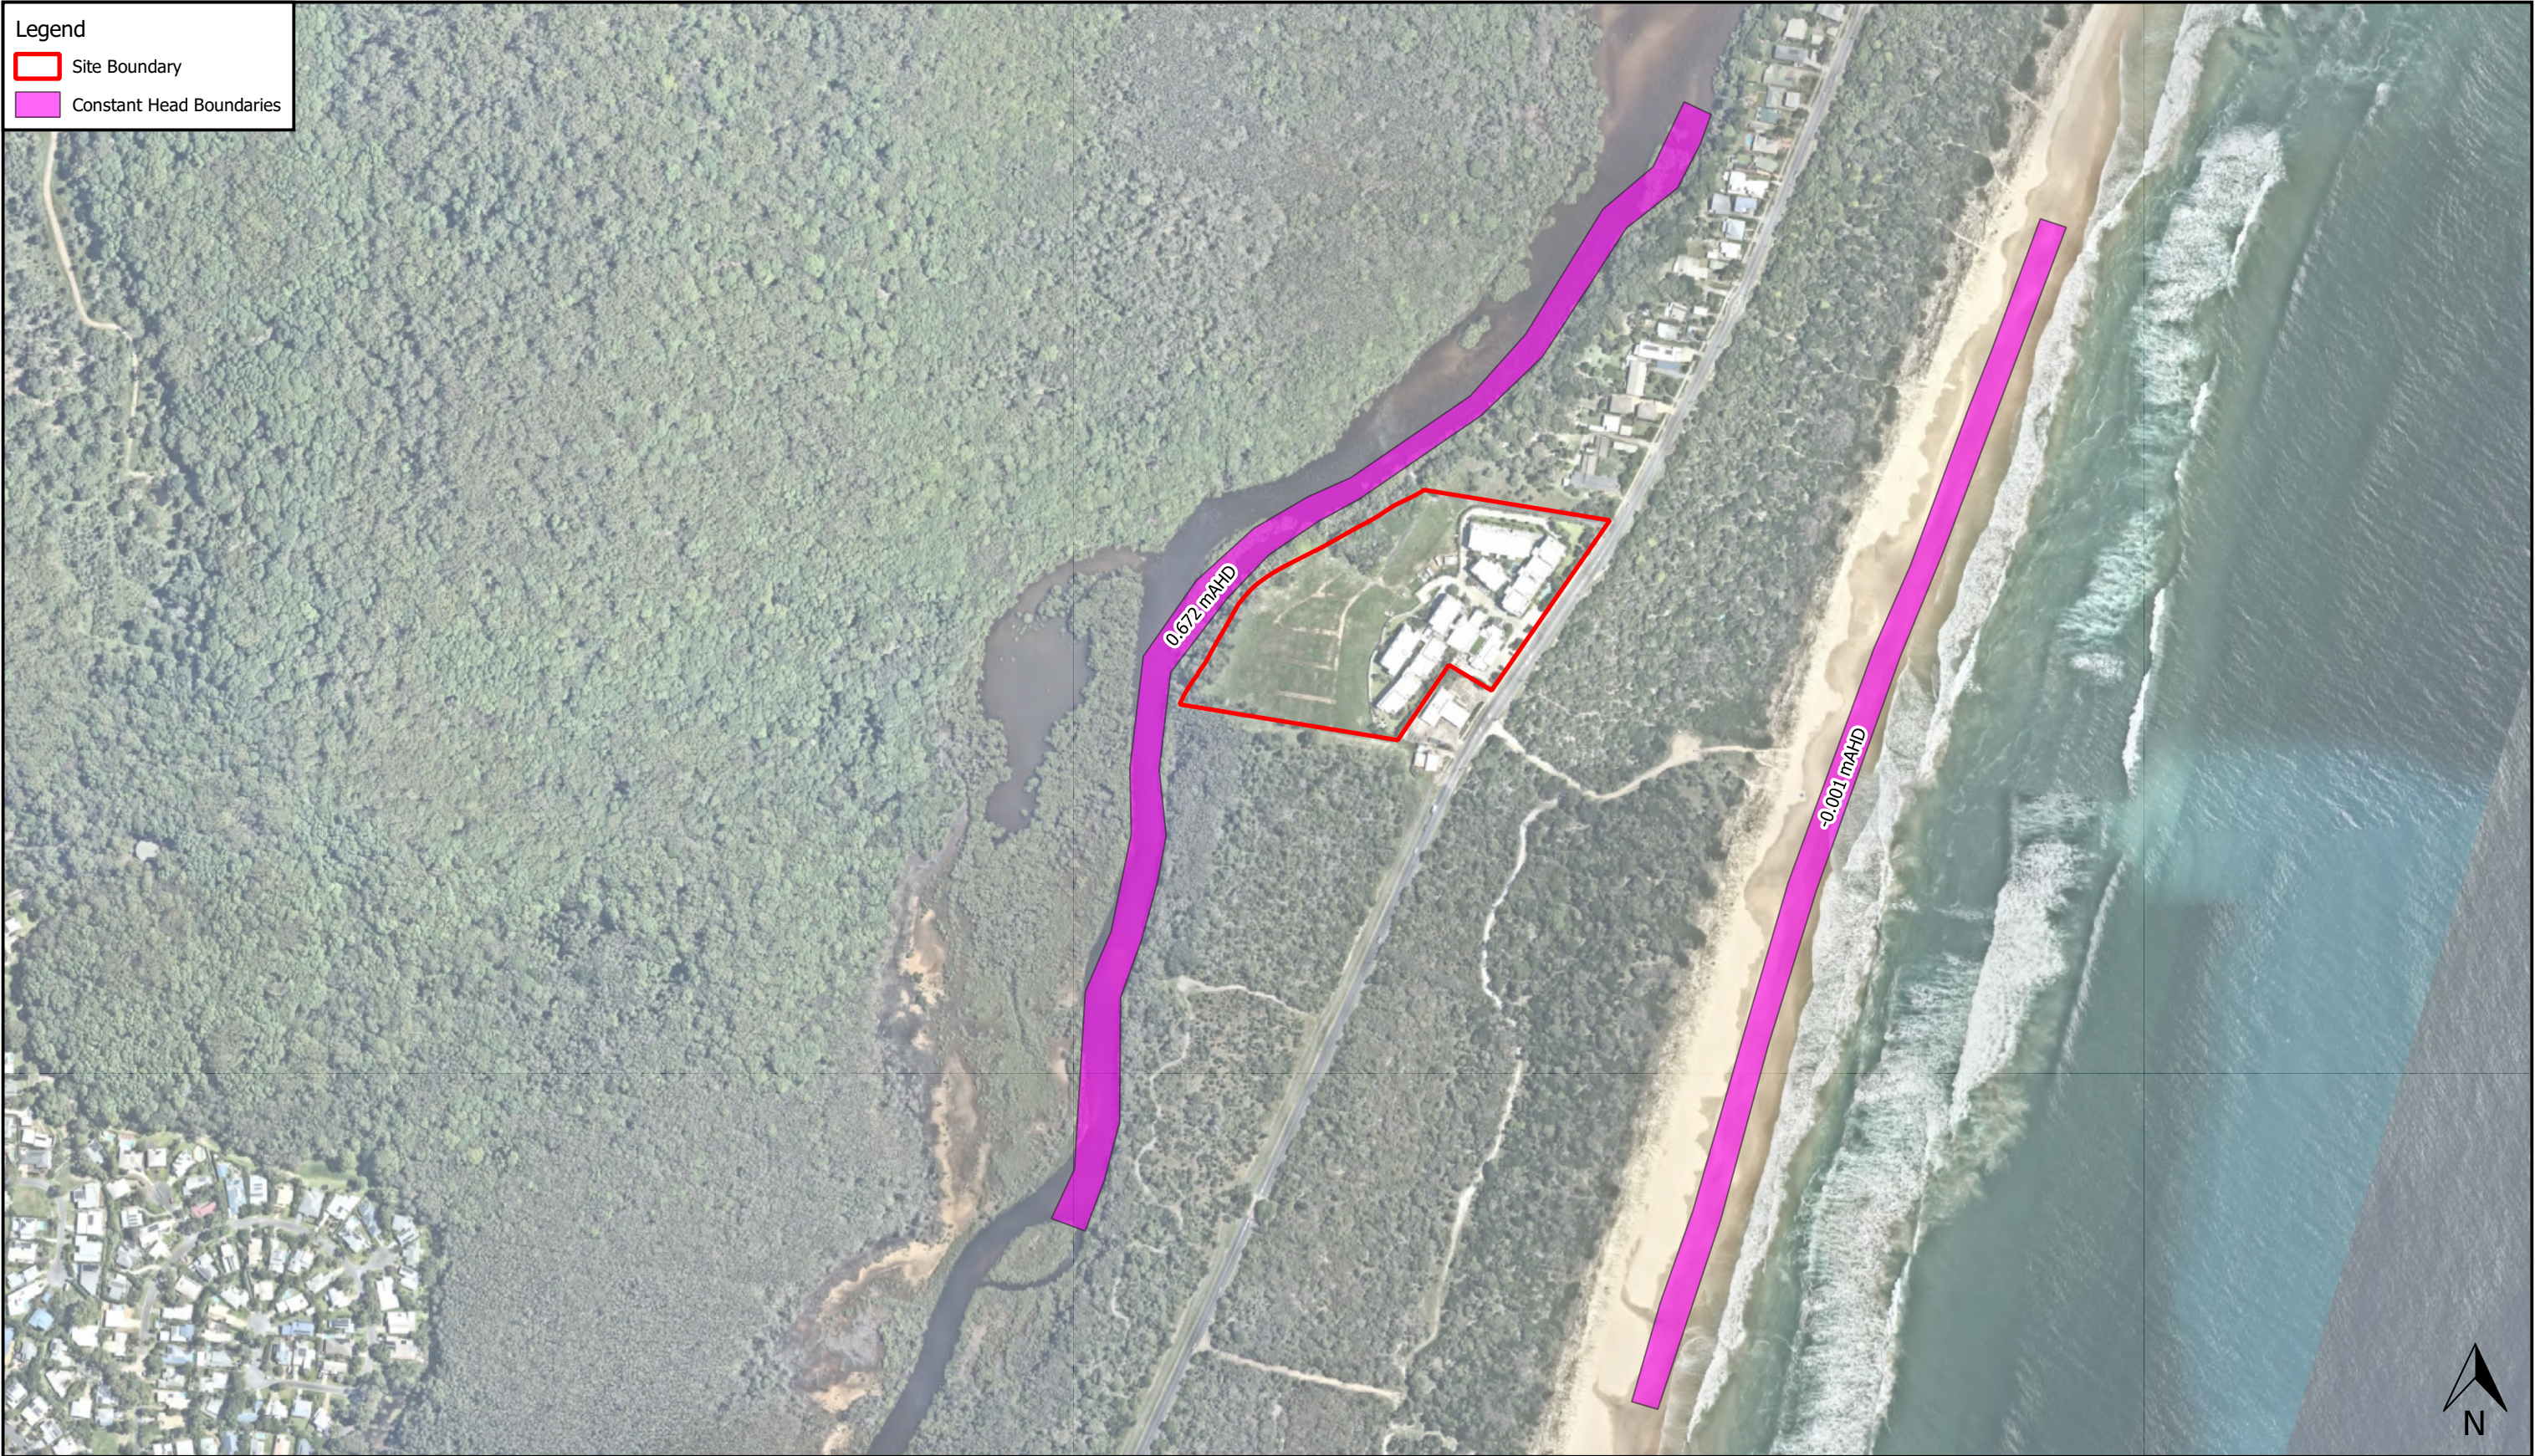
- Site Boundary
- Constant Head Boundaries

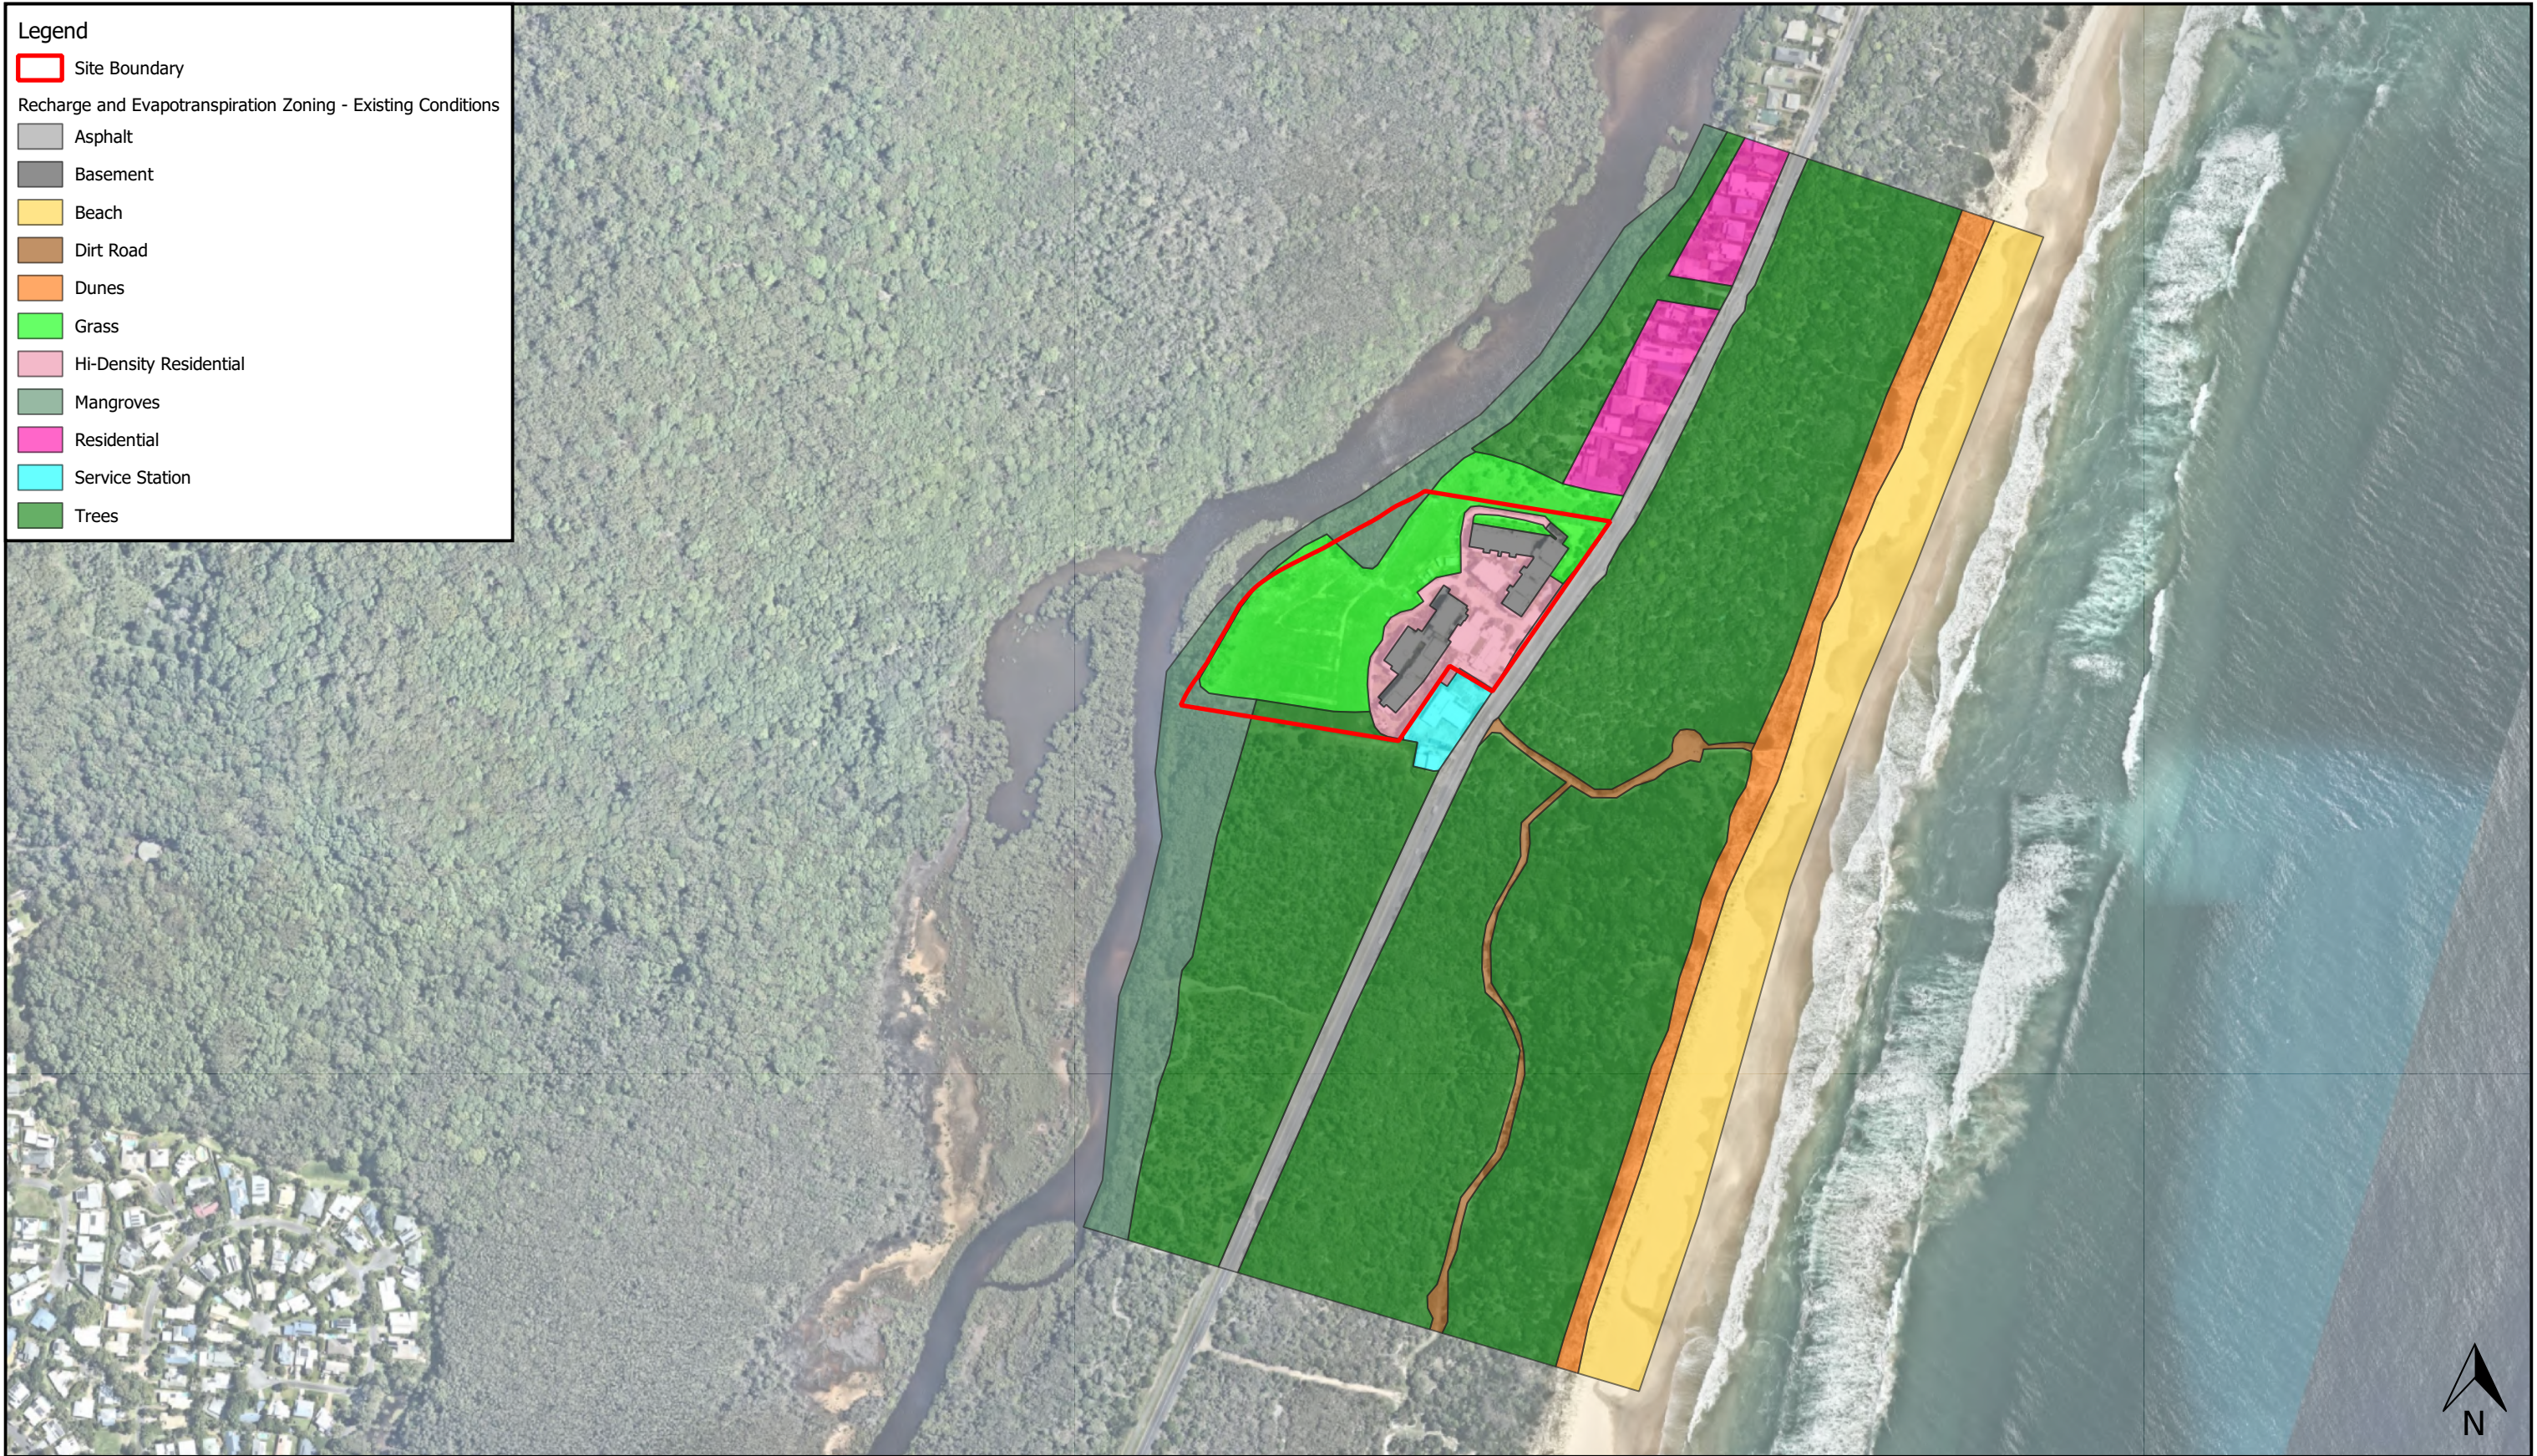
Map Title / Figure:  
**Existing Conditions Groundwater Model Recharge & Evapotranspiration Zones**

Recharge and Evapotranspiration Zoning - Existing Conditions

- Asphalt
- Basement
- Beach
- Dirt Road
- Dunes
- Grass
- Hi-Density Residential
- Mangroves
- Residential
- Service Station
- Trees

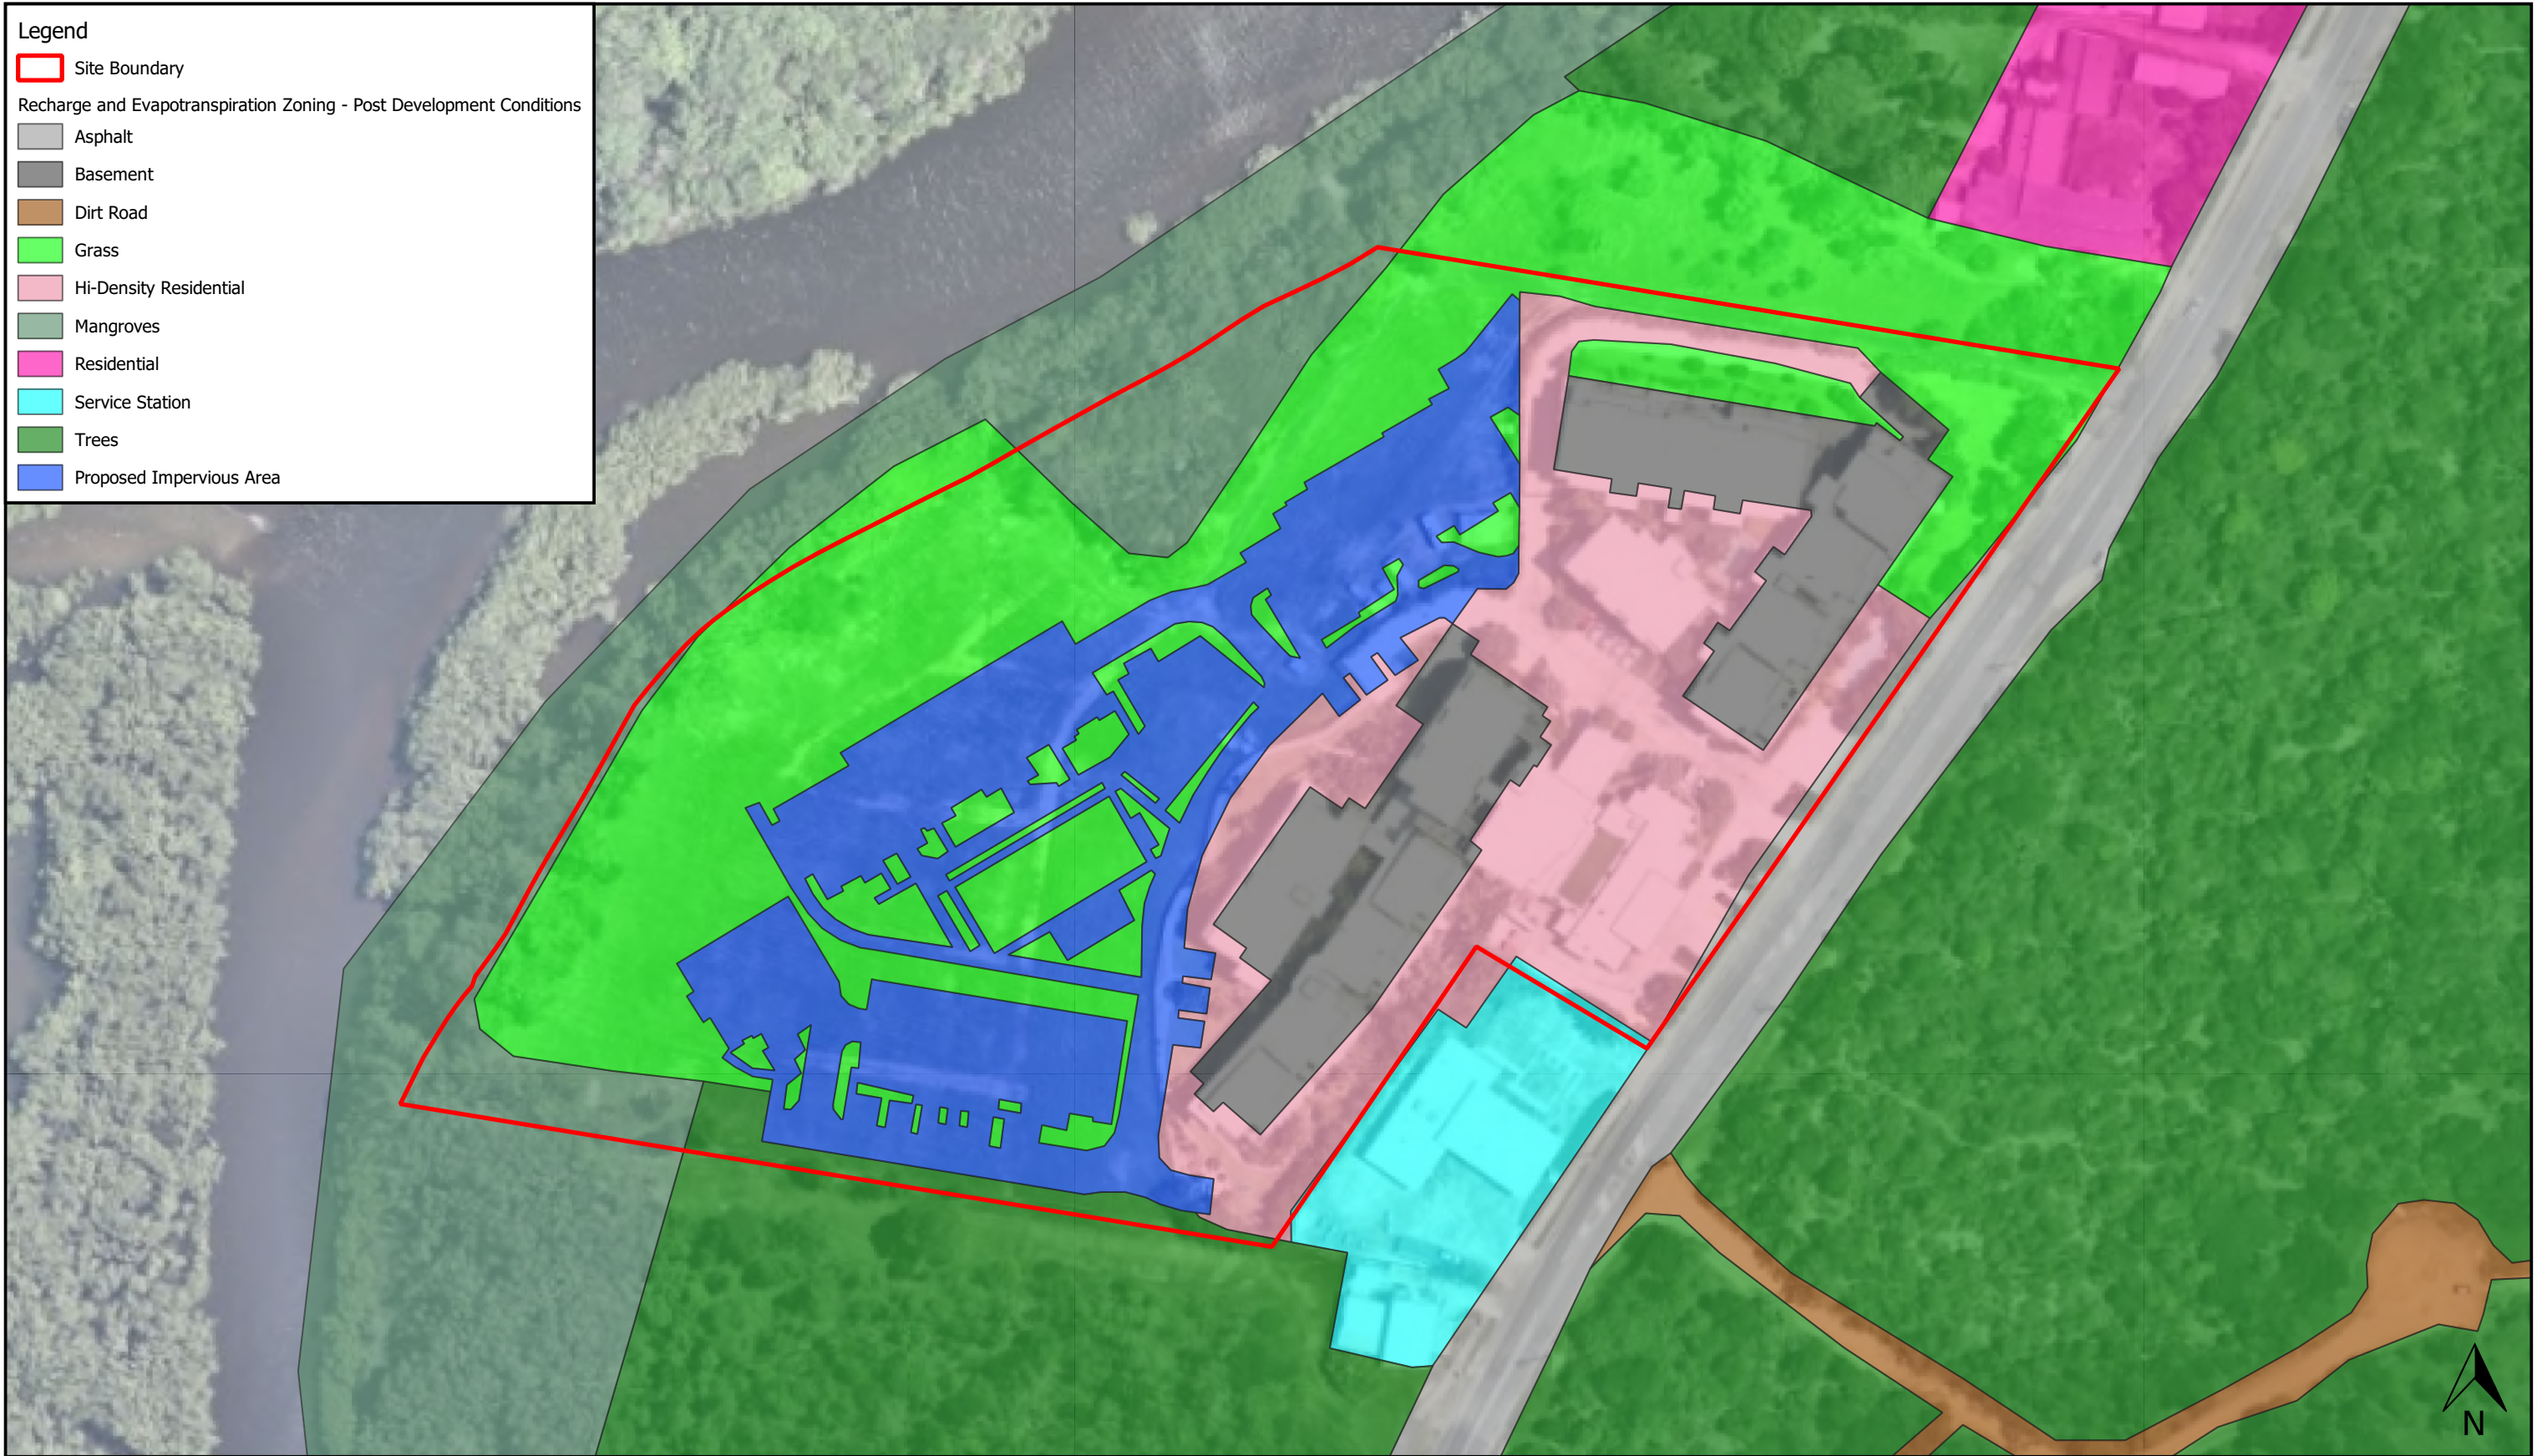
Map Title / Figure:  
**Post Development Conditions Groundwater Model Recharge & Evapotranspiration Zones**

Recharge and Evapotranspiration Zoning - Post Development Conditions

- Asphalt
- Basement
- Dirt Road
- Grass
- Hi-Density Residential
- Mangroves
- Residential
- Service Station
- Trees
- Proposed Impervious Area
