# Hydrogeological Impact Assessment

State Significant Development: Proposed Seniors Housing Development, 87-89 Tweed Coast Road, Hastings Point, NSW

P2108580JR03V03

Prepared for TriCare (Hastings) Limited

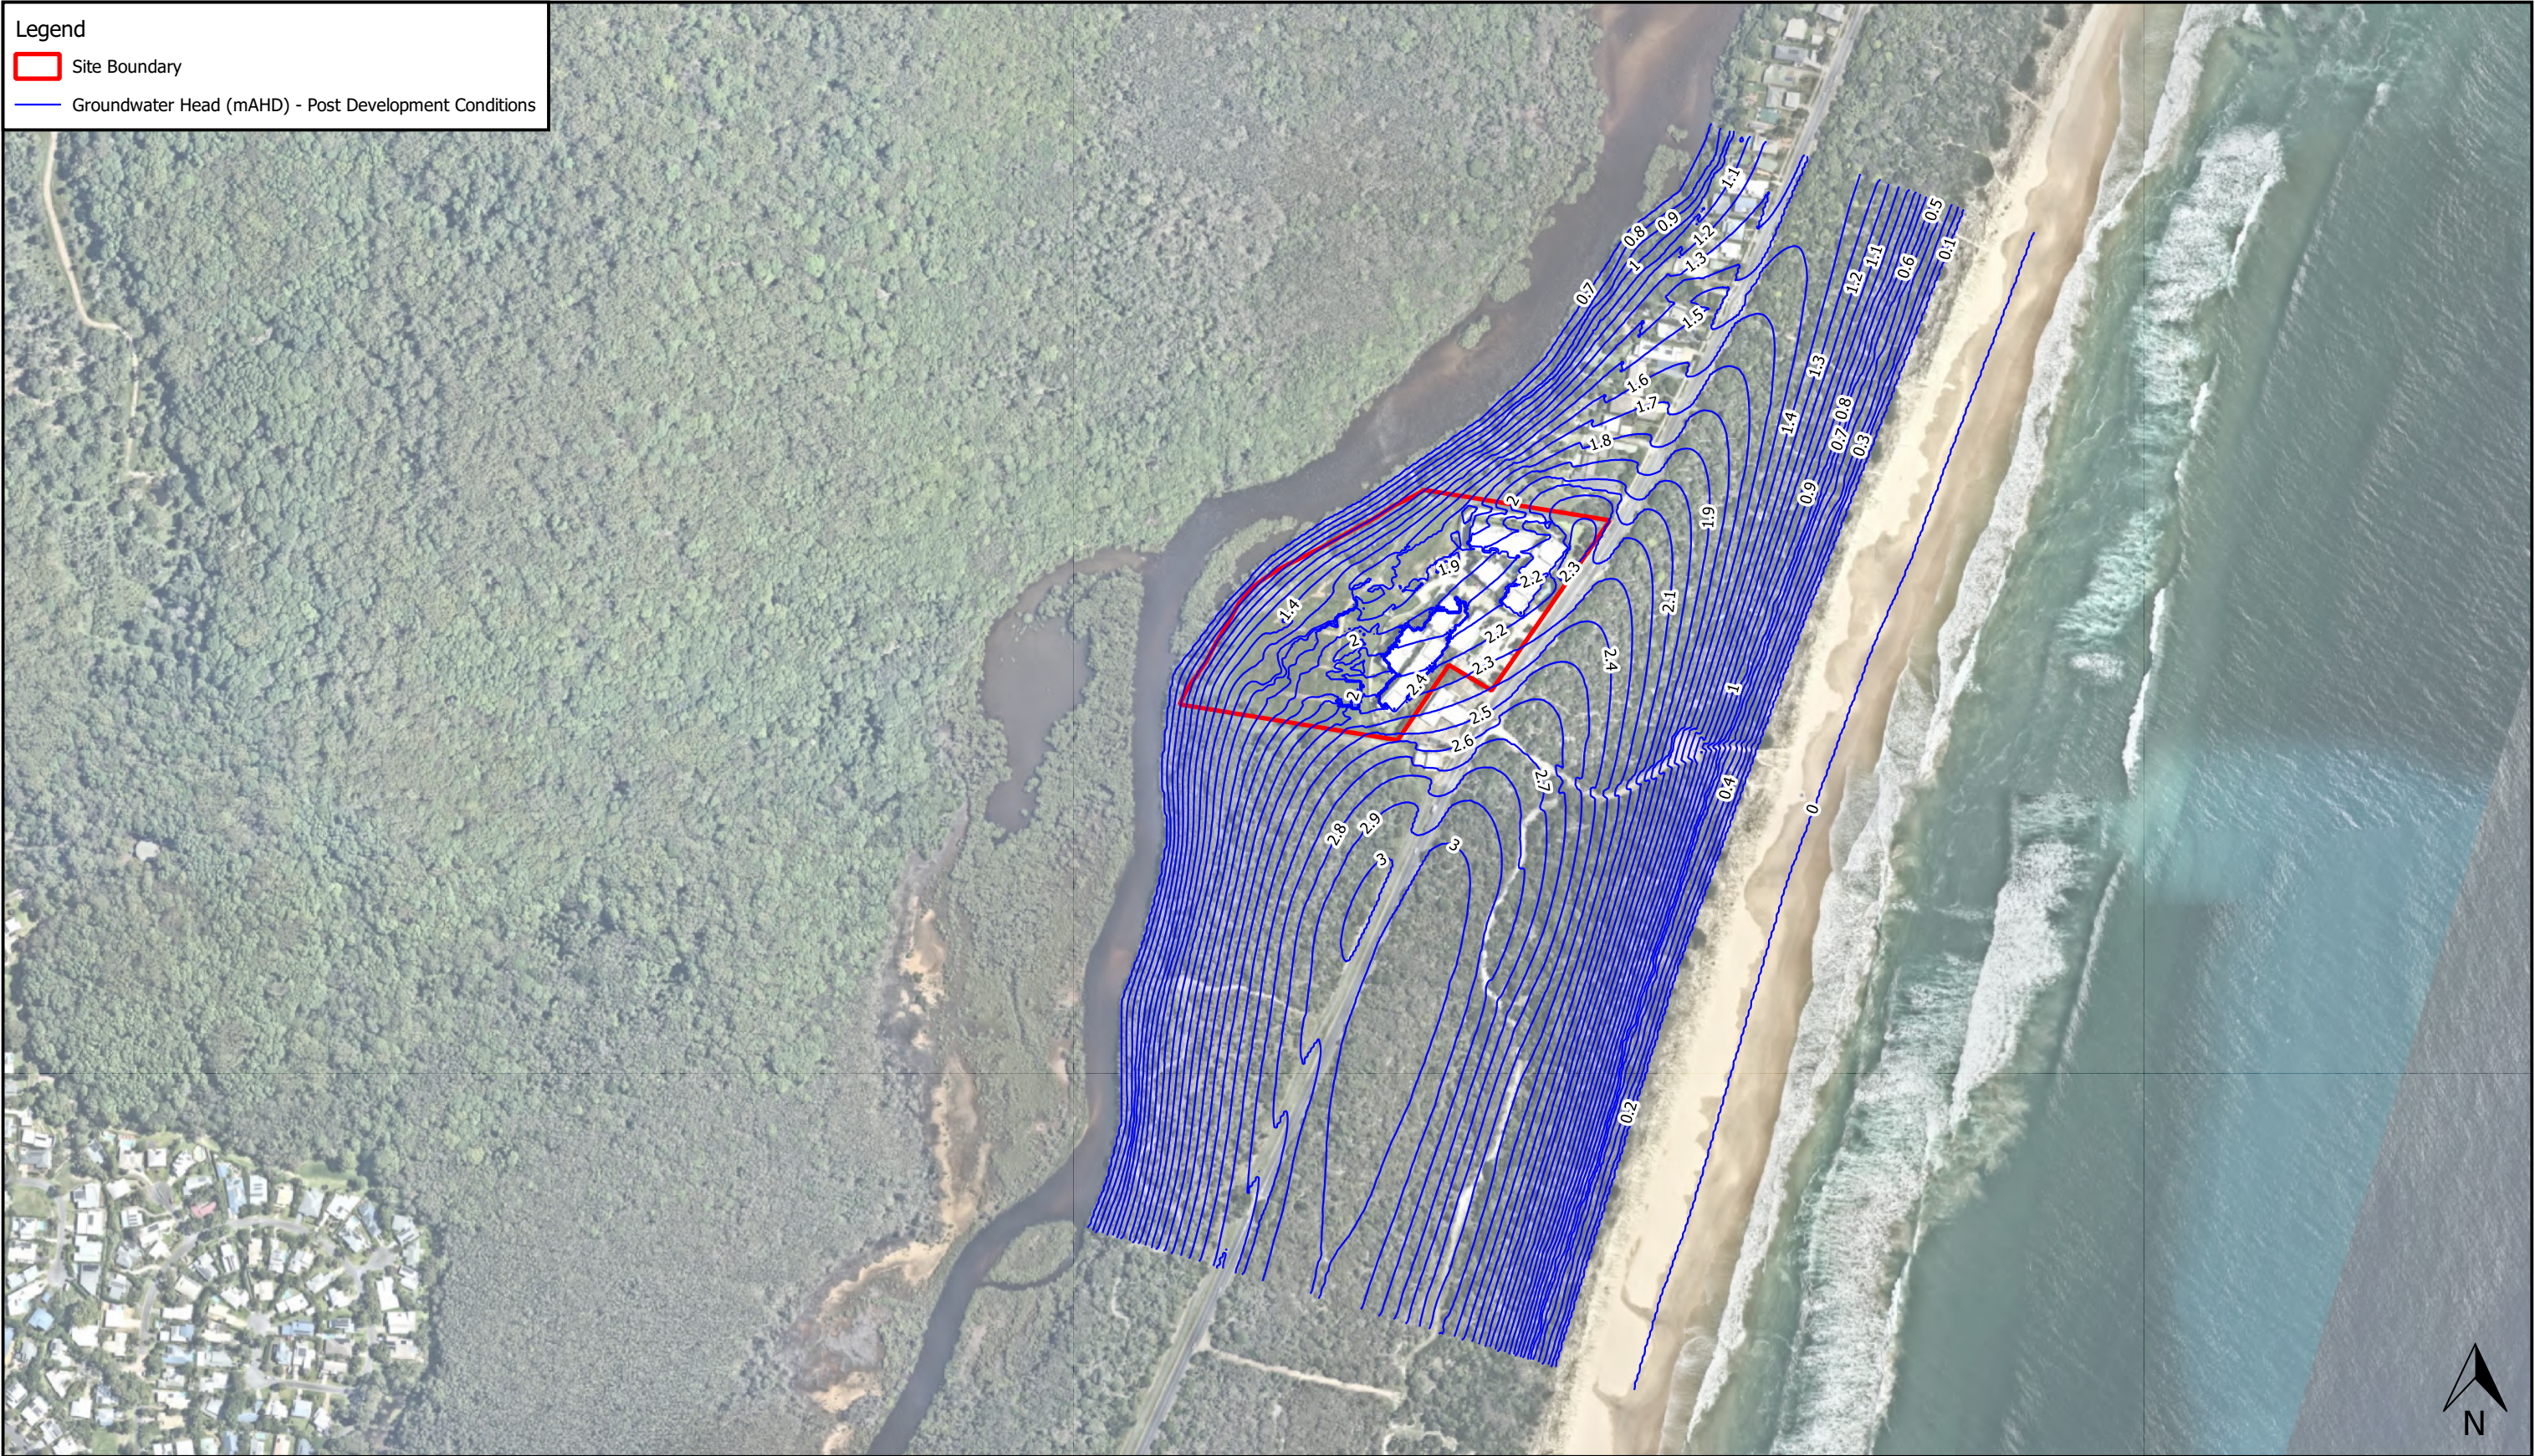
- ▭ Site Boundary
- Drawdown (m) - Post Development Conditions
- ▭ Coastal Wetland
- ▭ Littoral Rainforest

Modelling demonstrates that the proposed development is expected to cause a drawdown of up to 0.15 m within the coastal wetland in the western portion of the development. Negligible drawdown impacts are predicted in the littoral rainforest area to the northeast of the Site.

This assessment found that expected groundwater drawdown caused by the proposed development will be no greater than 0.15 m in nearby coastal wetland areas to the west of the Site. No long-term groundwater related impacts are expected on nearby properties, productive groundwater bores or littoral rainforests.

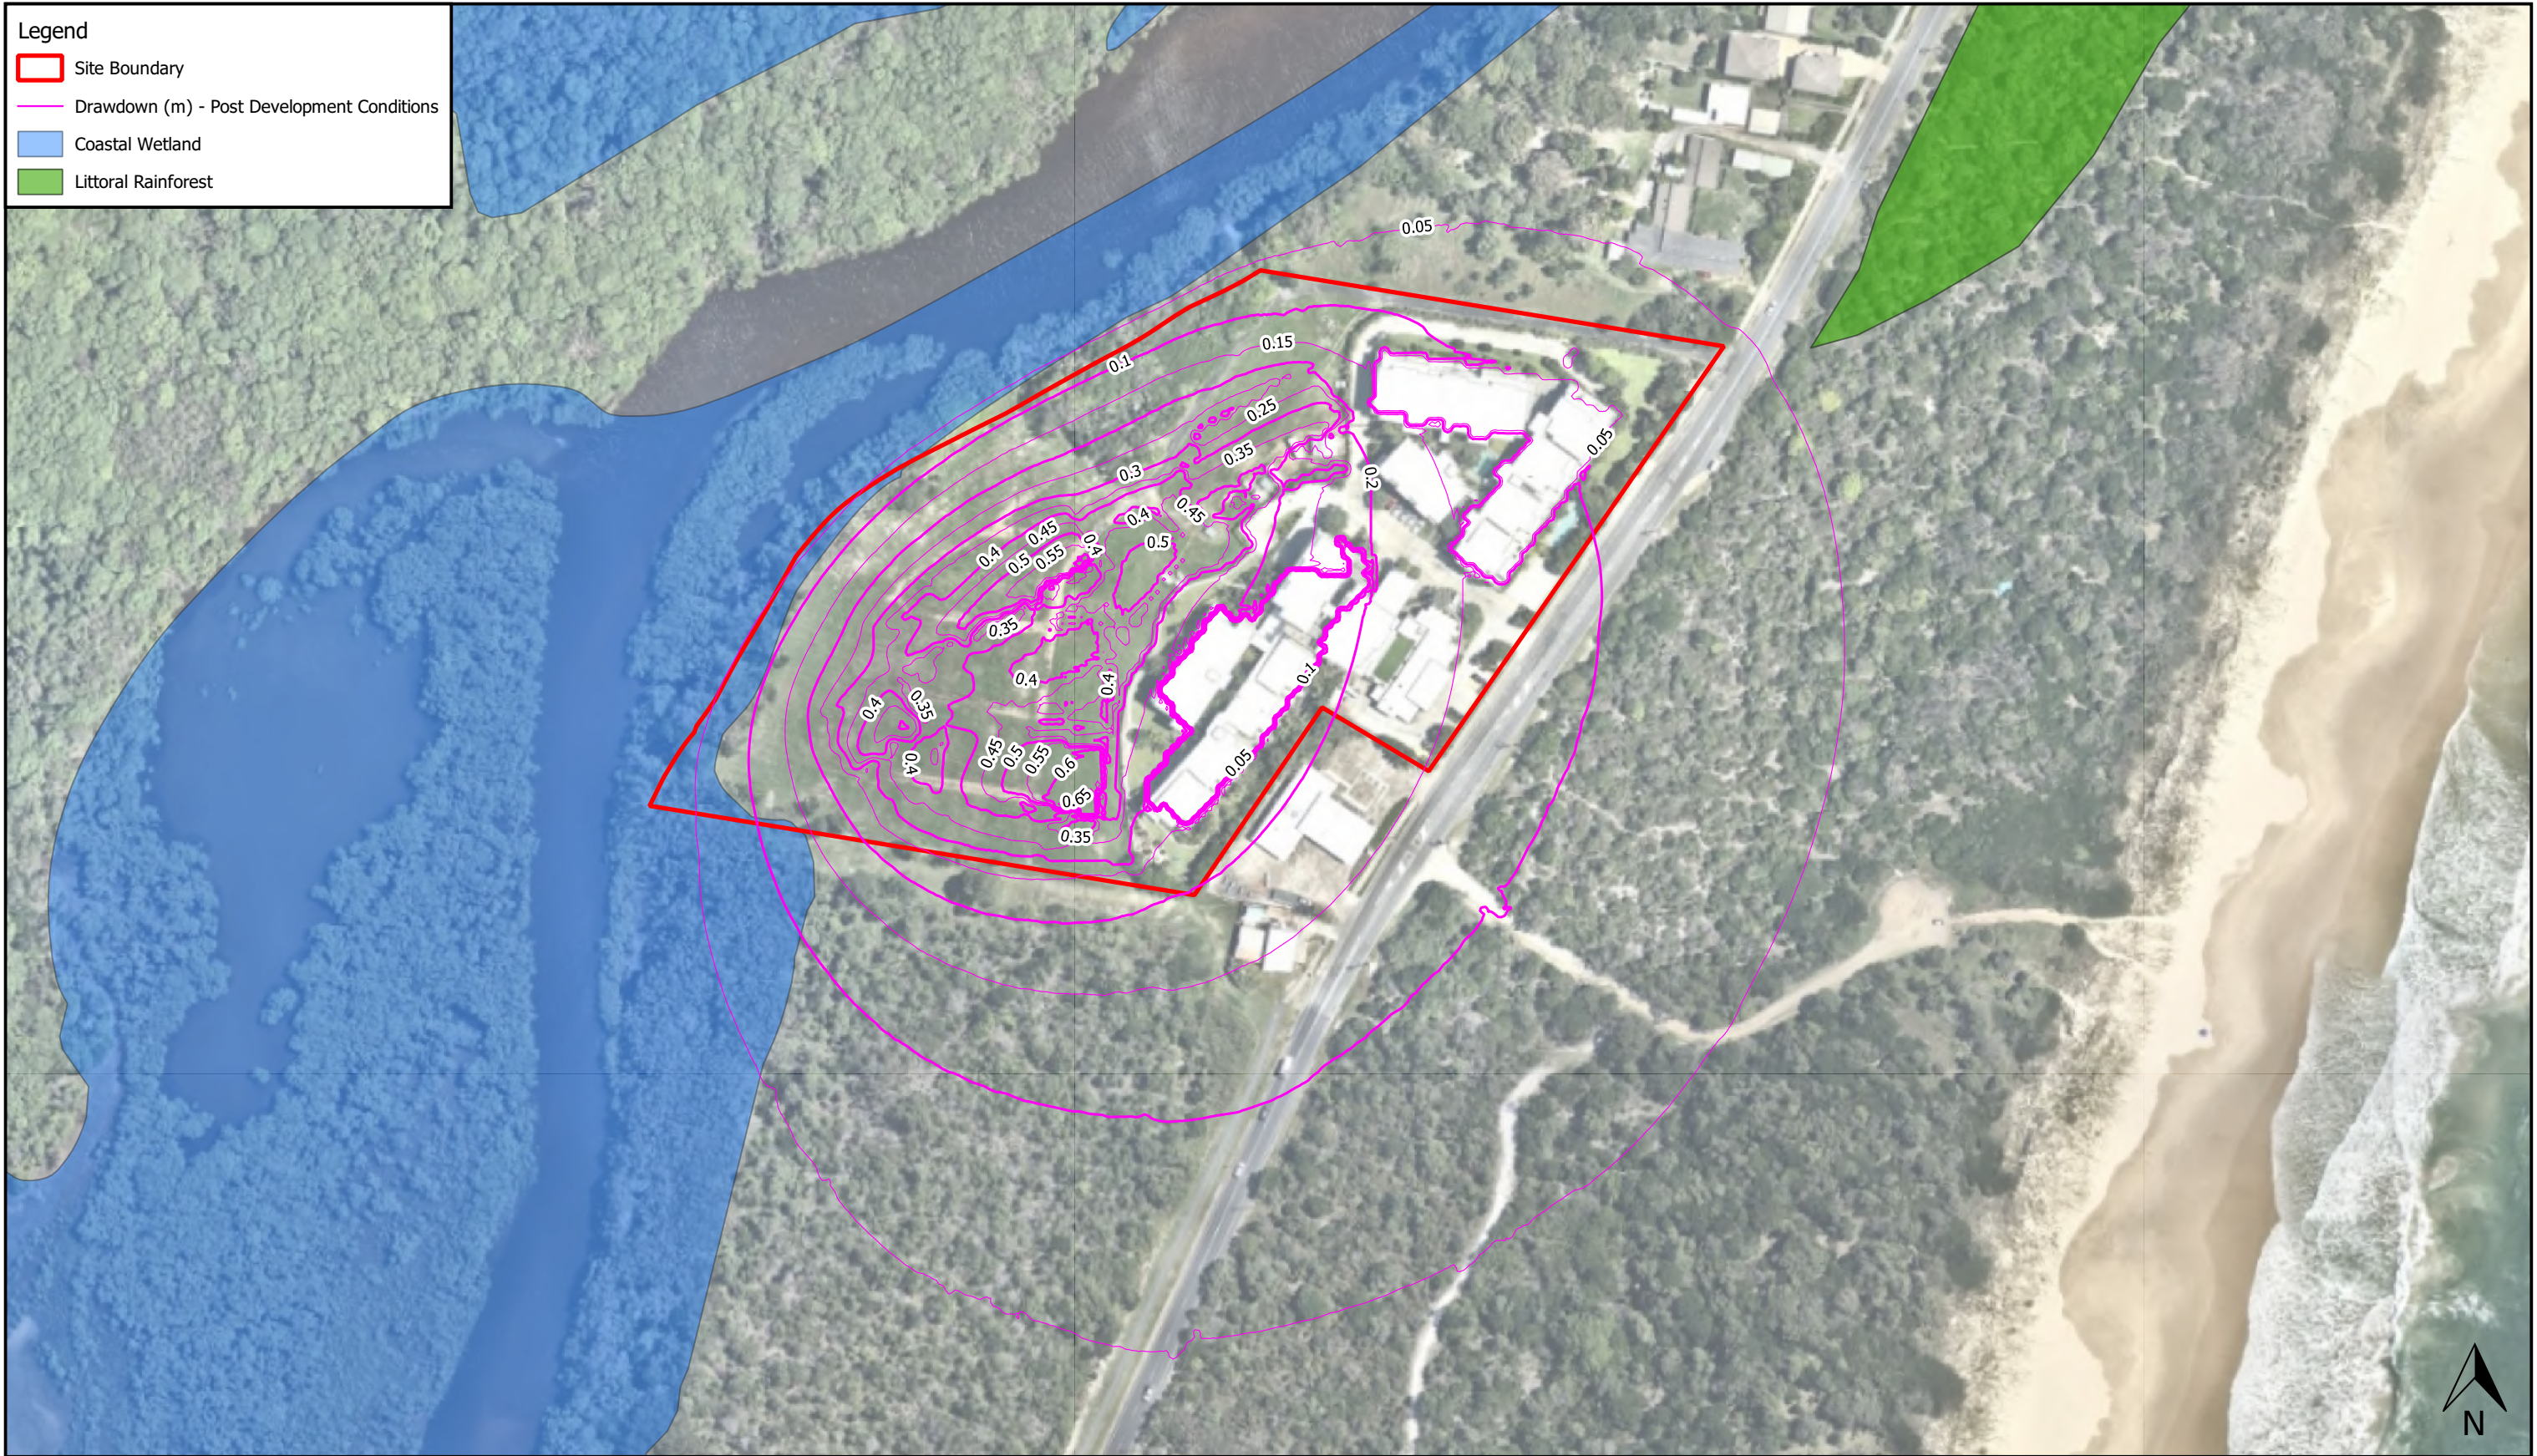
- ▭ Site Boundary
- ▭ Drawdown (m) - 6 Month Dewatering
- ▭ Coastal Wetland
- ▭ Littoral Rainforest
