# **ACID SULFATE SOIL MANAGEMENT PLAN AND RADIOACTIVE SANDS ASSESSMENT**

Staged Seniors Living Development

**87-89 Tweed Coast Road, Hastings Point**

ENV240556 (previously 20124)

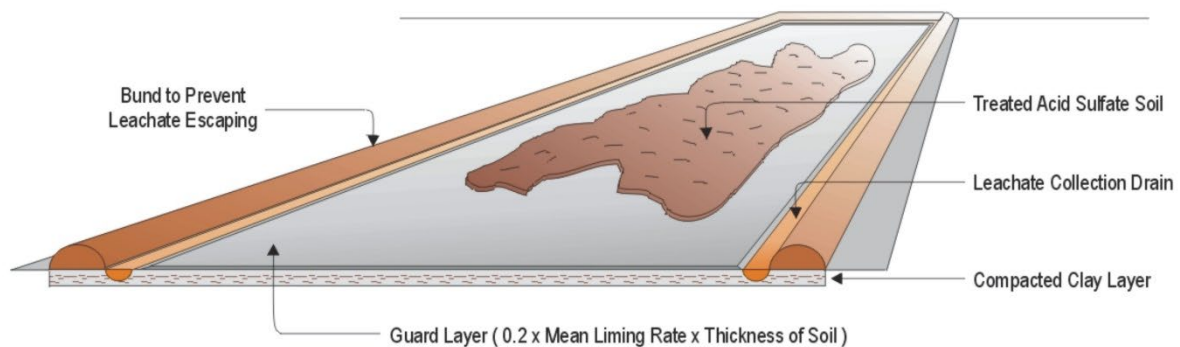
**Figure 1: Treatment Pad Design**

The liming pad should be constructed so the base of the pad is composed of compacted fine-grained material, to produce as impermeable foundation as possible. Ideally a clay liner, no less than 300 mm thick, should be placed on the base of the pad. The base of the pad should slope gently (2 – 5%) so as

For excavations surrounding depths and known locations of ASS at the proposed development, the guard-layer liming rate was calculated to be 0.2 kg/m<sup>2</sup> for a 0.5 m thick layer.

The AgLime for the guard layer should be spread using a lime/fertilizer spreader (tractor-towed) to ensure the base of the pad is evenly covered, prior to the placement of the material requiring treatment.

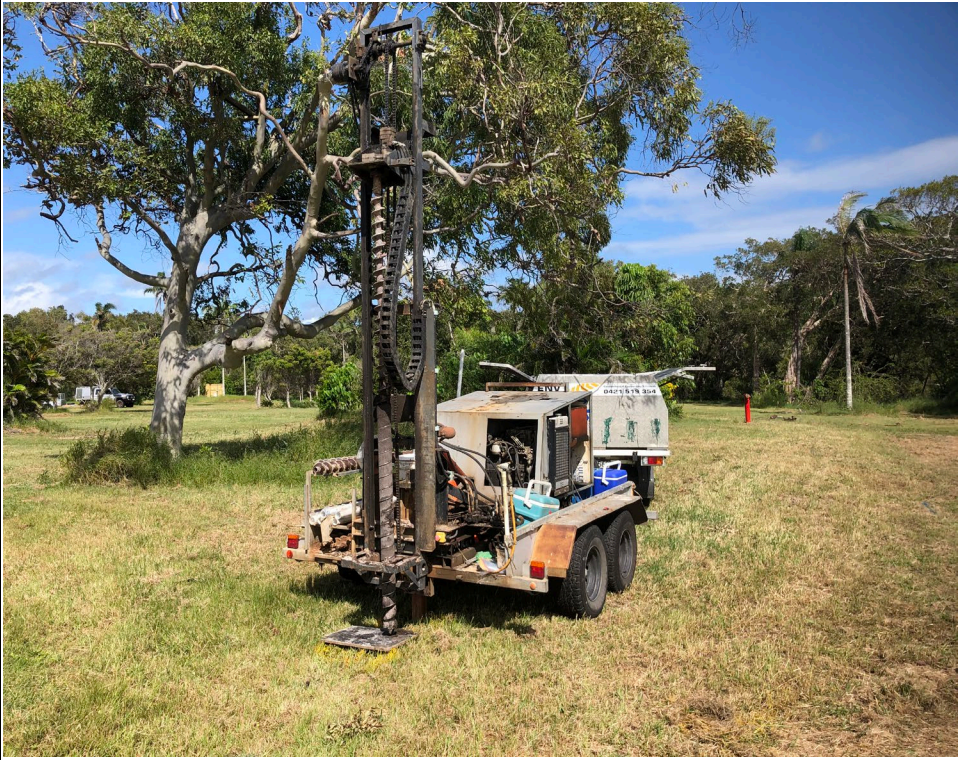
<b>Photo No.</b> 3	<b>Date</b> 17/03/2020

<b>Description</b> Drilling location BH03. Natural sands encountered from 0.2 mBGL onwards. Groundwater noted at 2.5 mBGL.  Acid sulfate soils reported at 3.0 mBGL for this location.

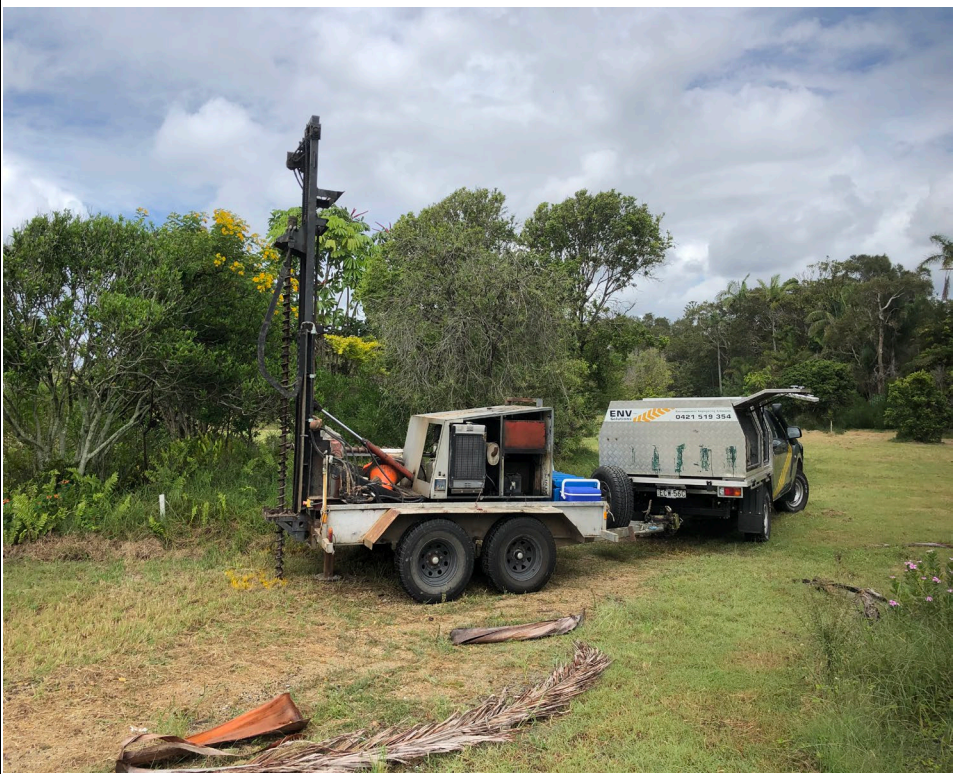
<b>Photo No.</b> 4	<b>Date</b> 17/03/2020

<b>Description</b> Drilling location BH04. Sulfuric odour noted from approximately 2.5 mBGL onwards.  Acid sulfate soils reported at 4.5 mBGL for this location.

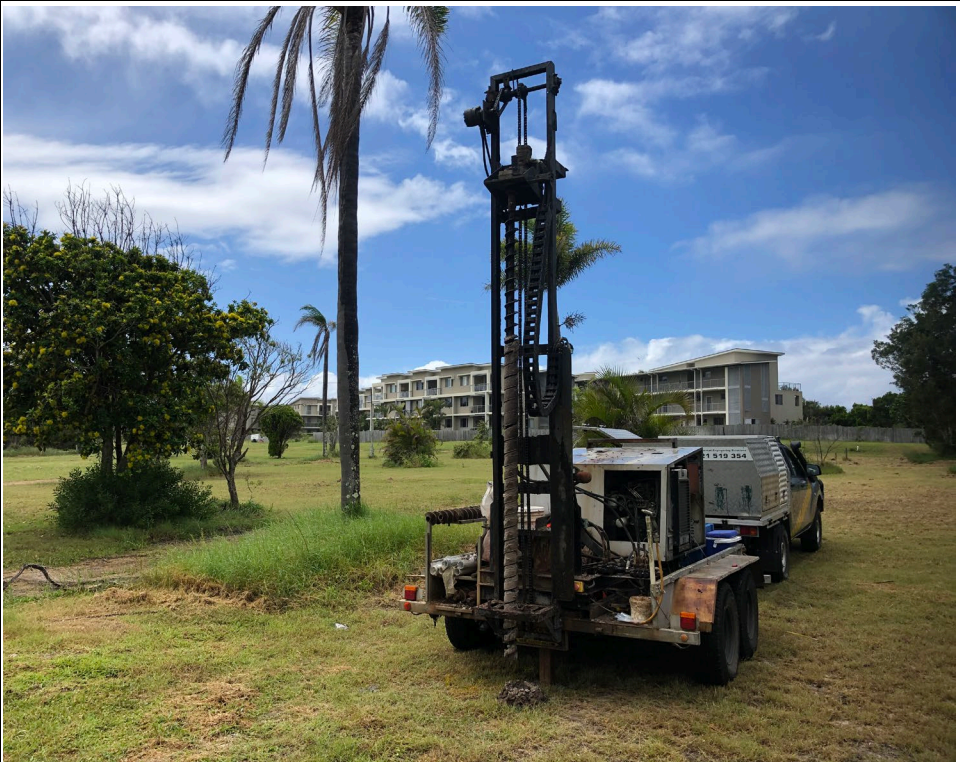
<b>Photo No.</b> 5	<b>Date</b> 17/03/2020

<b>Description</b> Drilling location BH05. Material present on auger representing approximate 0.2 – 1.5 m profile.  Acid sulfate soils reported at 4.0 mBGL for this location.

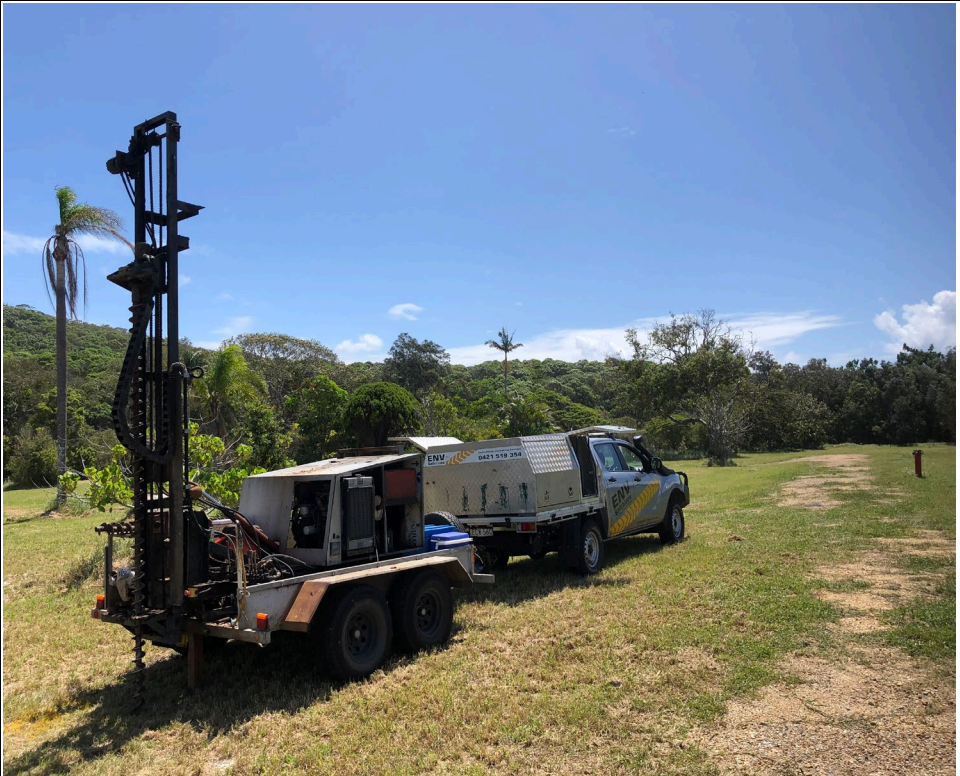
<b>Photo No.</b> 6	<b>Date</b> 17/03/2020

<b>Description</b> Drilling location BH06. Groundwater encountered at approximately 1.5 mBGL.  No acid sulfate soils encountered at location BH06.

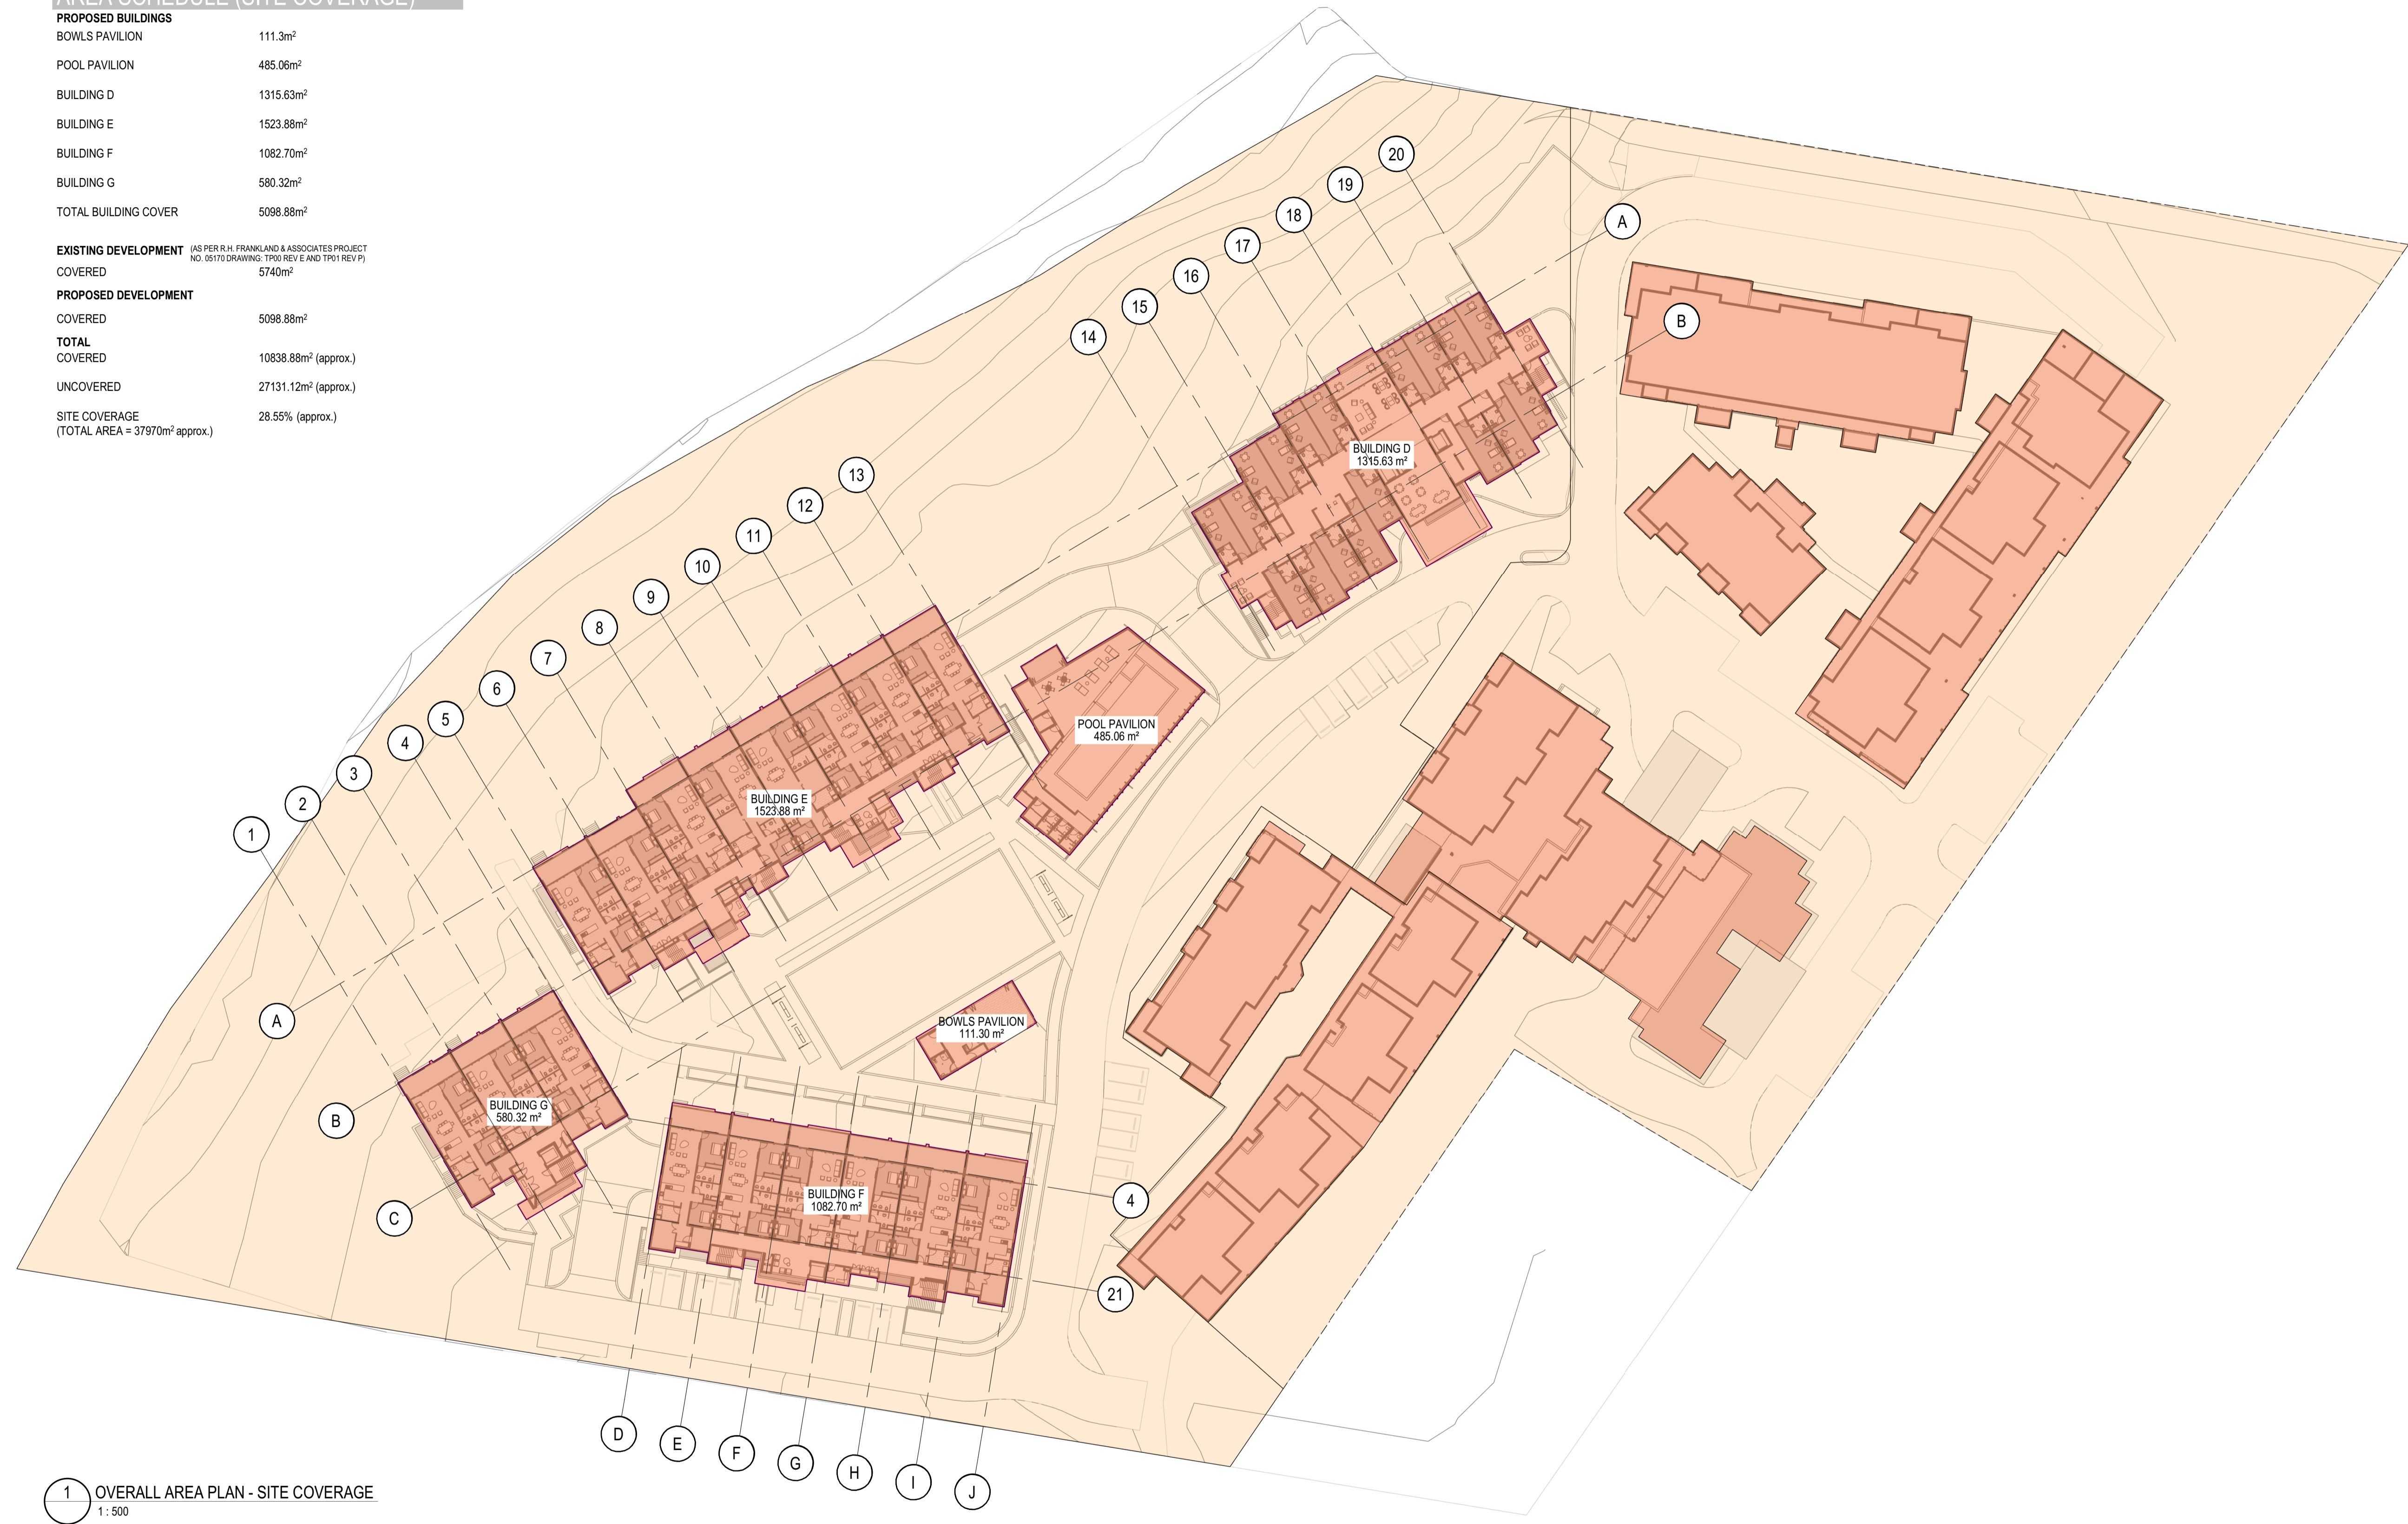
1 OVERALL AREA PLAN - SITE COVERAGE  
 1 : 500

EXISTING DEVELOPMENT <small>(AS PER R.H. FRANKLAND &amp; ASSOCIATES PROJECT NO. 05170 DRAWING: TP00 REV E AND TP01 REV F)</small>	
COVERED	5740m <sup>2</sup>

PROPOSED DEVELOPMENT	
COVERED	5098.88m <sup>2</sup>
TOTAL COVERED	10838.88m <sup>2</sup> (approx.)
UNCOVERED	27131.12m <sup>2</sup> (approx.)
SITE COVERAGE <small>(TOTAL AREA = 37970m<sup>2</sup> approx.)</small>	28.55% (approx.)
