Report on
Geotechnical Investigation

Proposed New Primary School
28 Wallarah Circuit, Gregory Hills

Prepared for
School Infrastructure NSW

Project 213594.00
October 2022

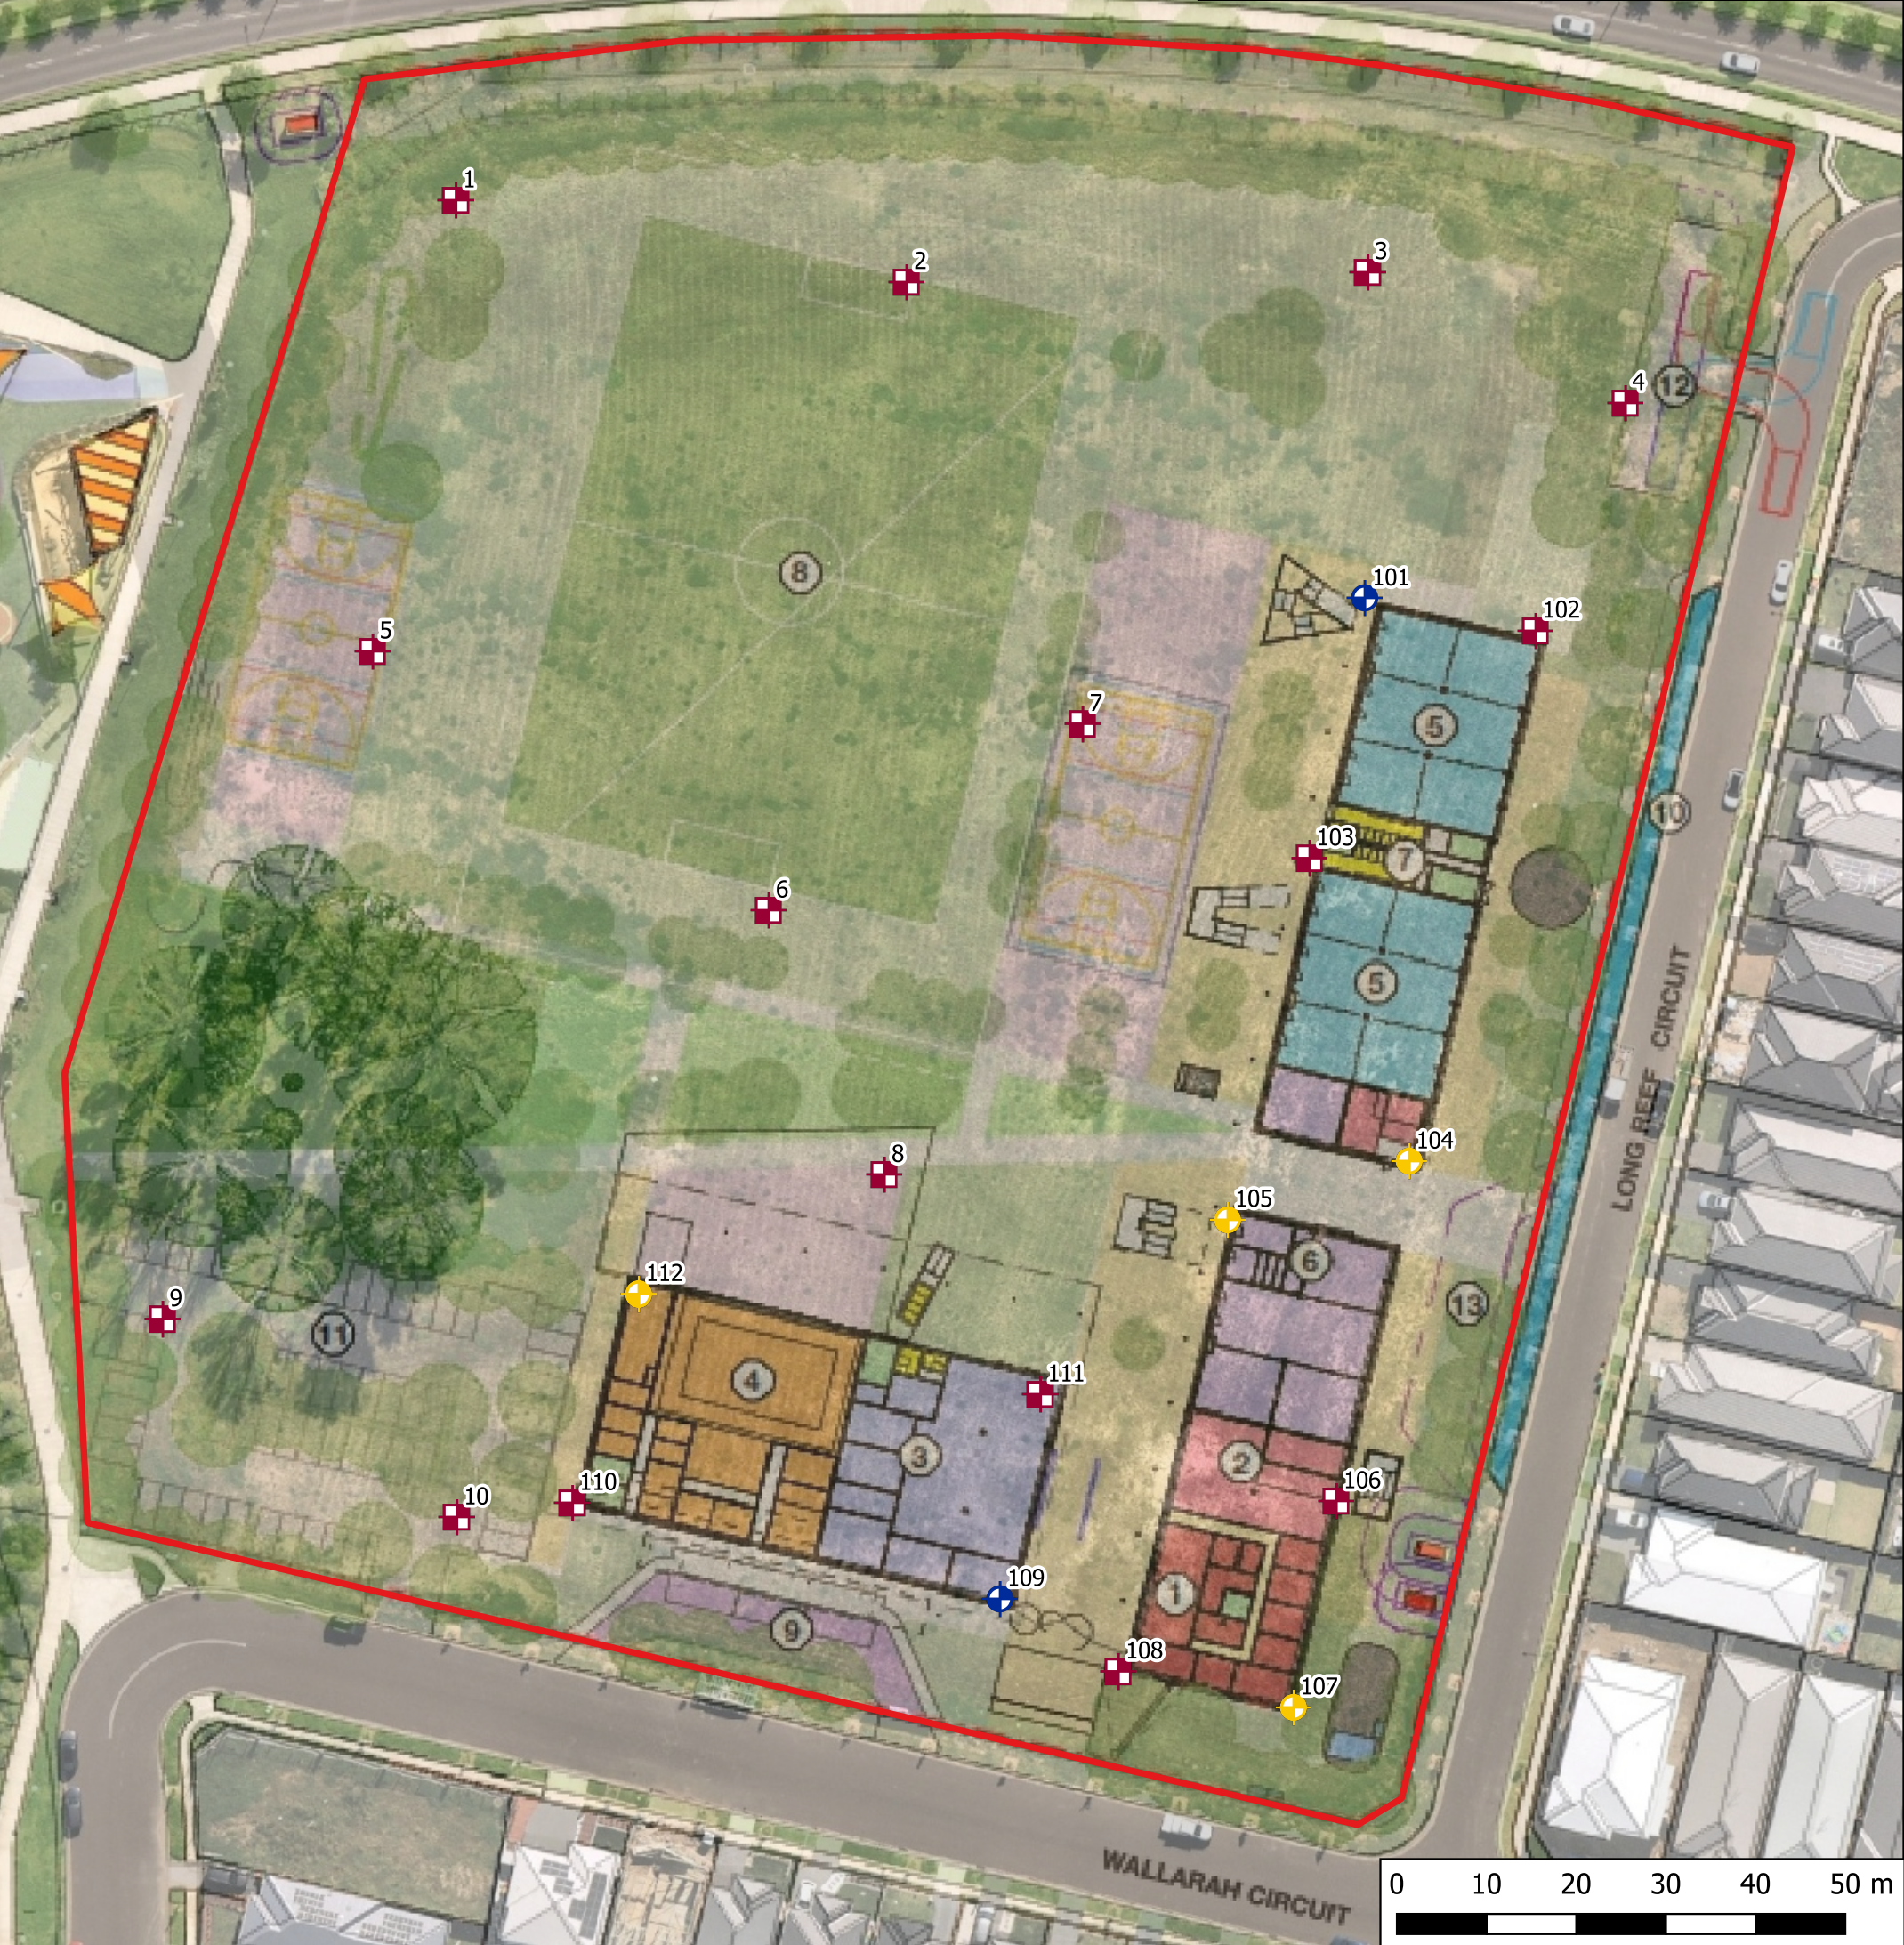
<div>Douglas Partners <i>Geotechnics Environment Groundwater</i></div>	TITLE: Test Location Plan - Main Structures Proposed School Development - GHPS Walarah Cct and Long Reef Cct, Gregory Hills

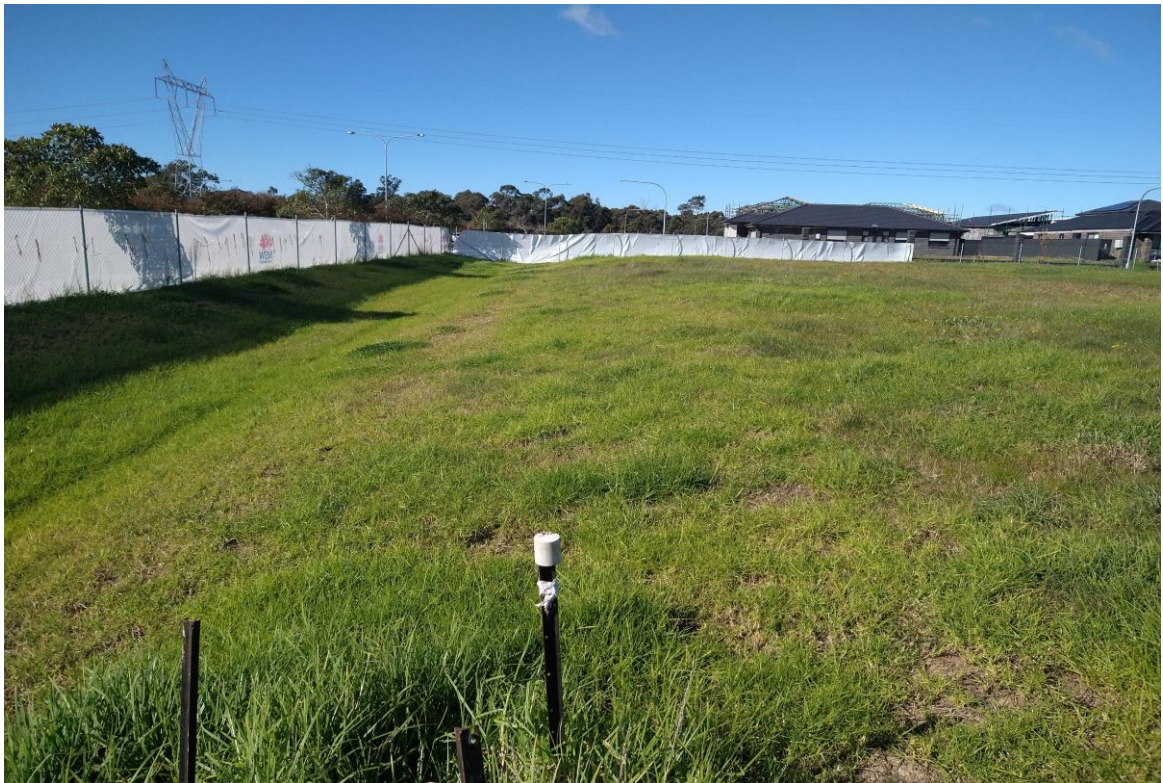
Photo 2 - Drainage Swale along northern boundary of site

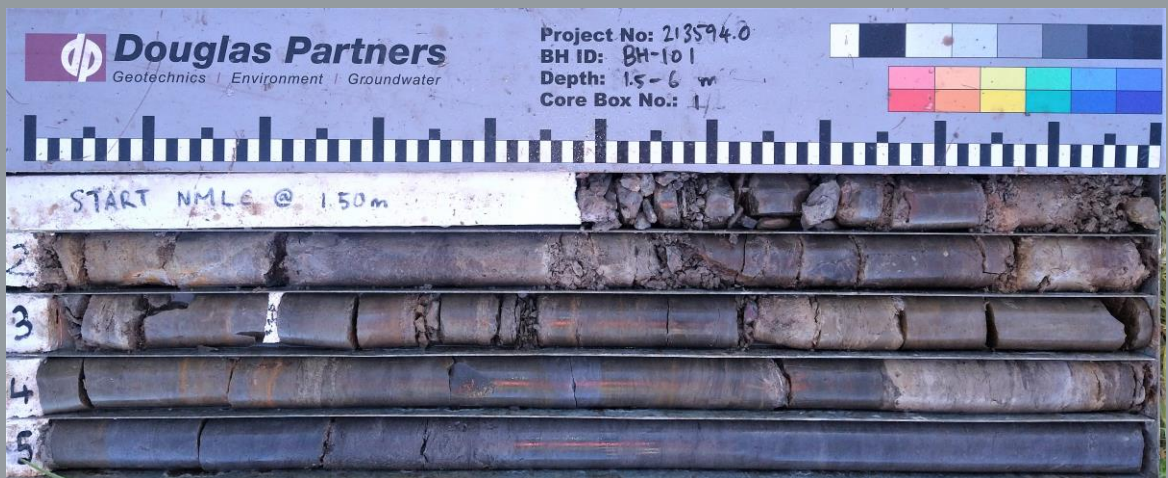
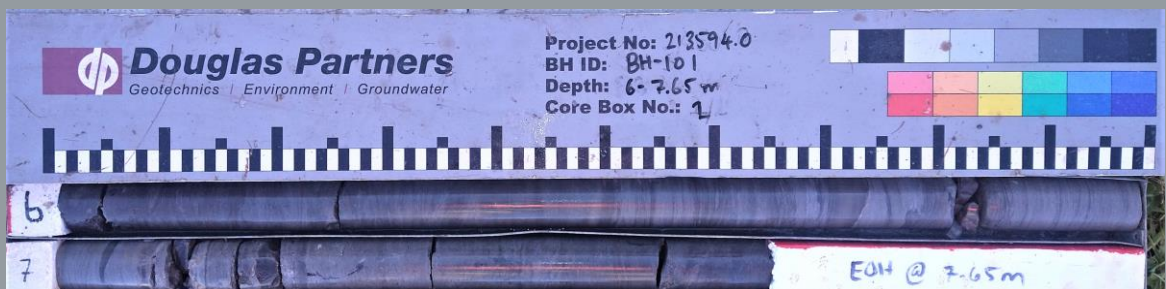
BORE: 101

1.50-6.00 m

6.00-7.65 m

The top of rock surface in the proposed building area slopes away to the south and west from a depth of approximately 0.5 m (RL 114.2) in the north west (Bore 101) to a depth of 2.4 m (RL 112.6) in the south east (Bore 112). A combination of pads and bored piles founded on the very low to low strength shale should be feasible.

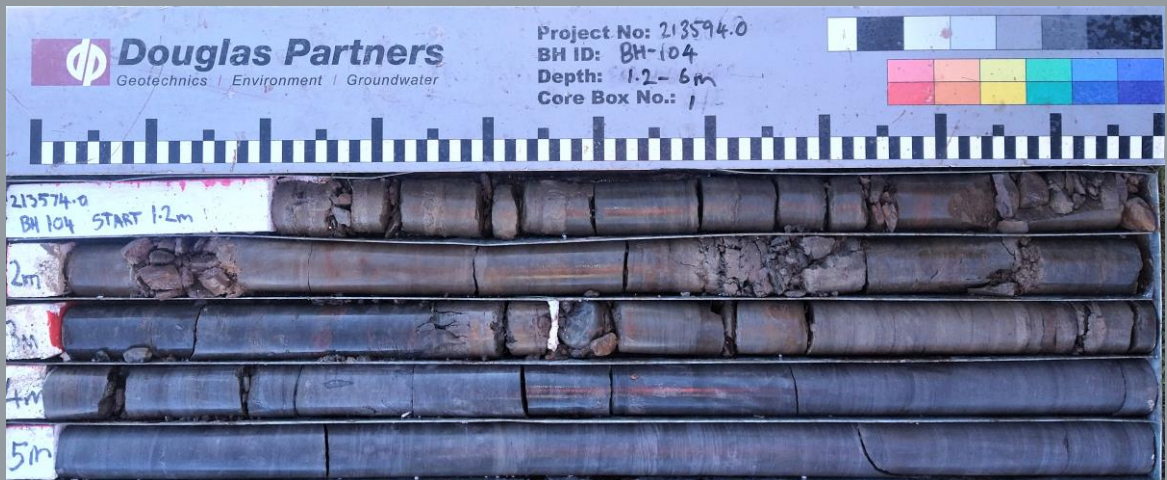
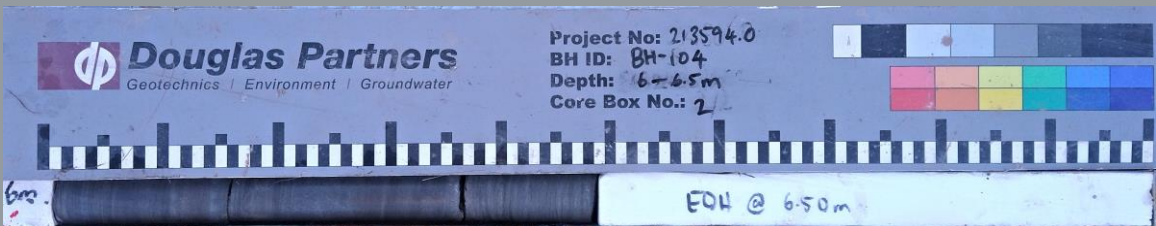
BORE: 104

1.20-6.00 m

6.00-6.50 m

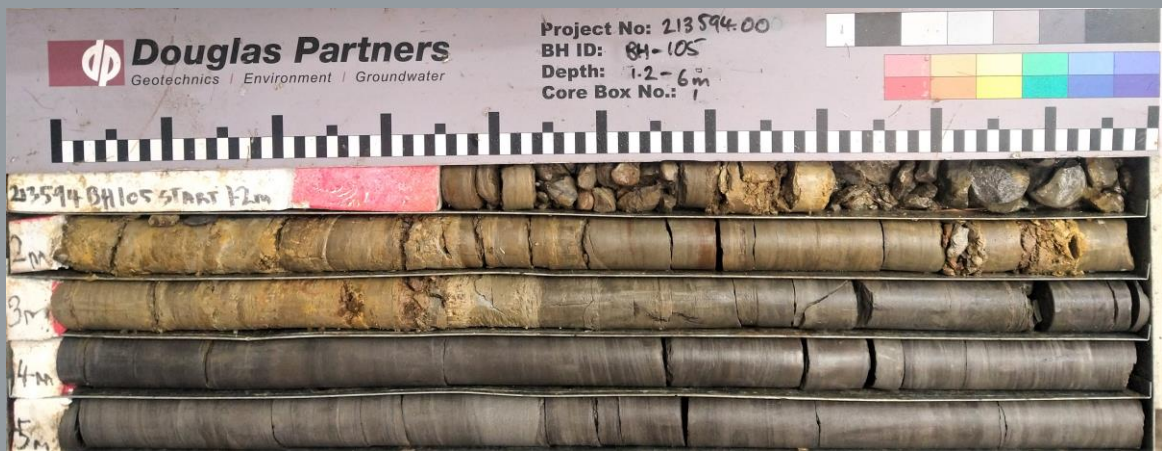
BORE: 105

1.20-6.00 m

6.00-6.57 m

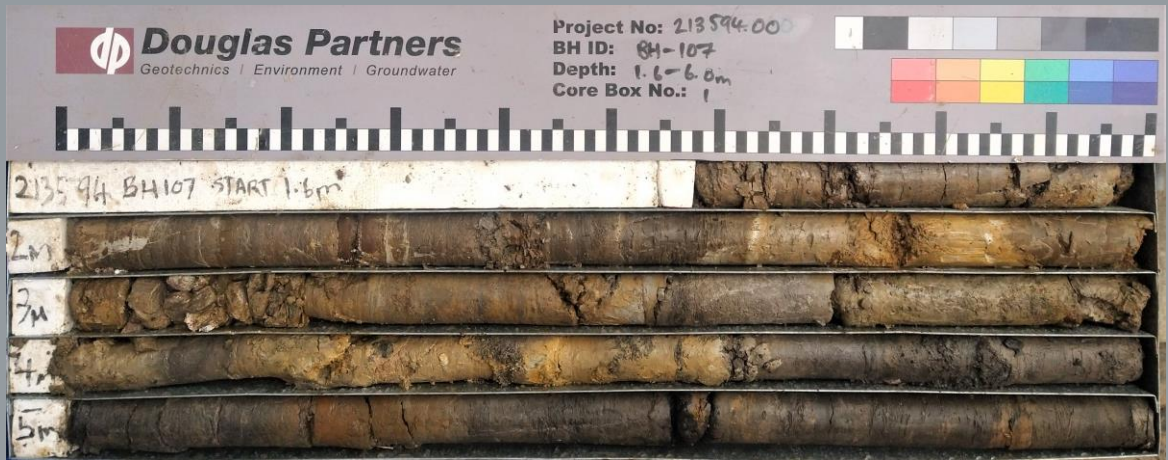
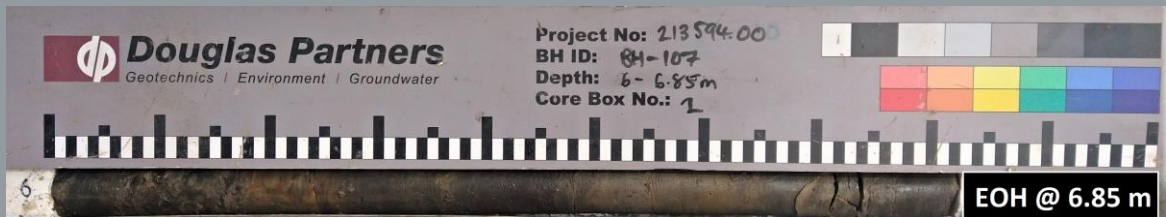
BORE: 107

1.60-6.00 m

6.00-6.85 m

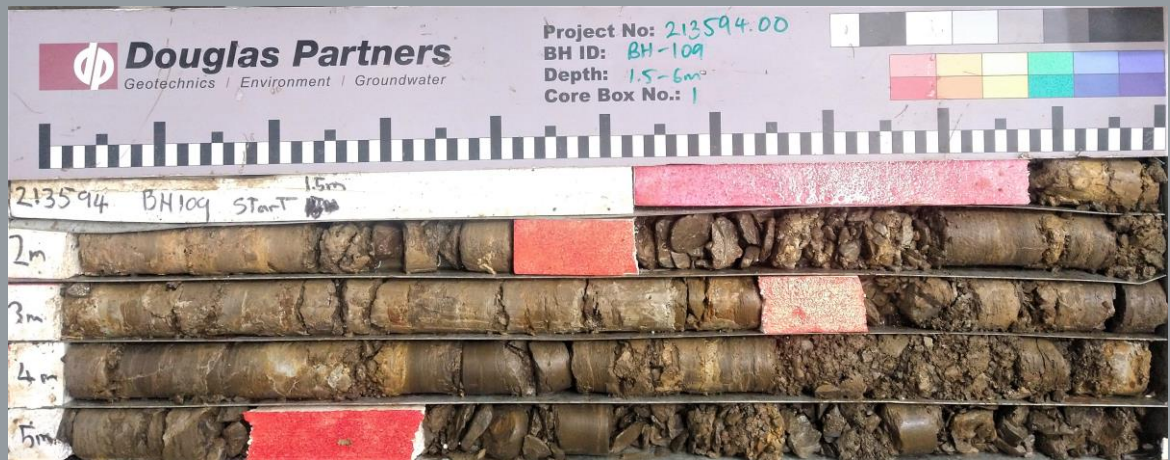
BORE: 109

1.50-6.00 m

6.00-7.20 m

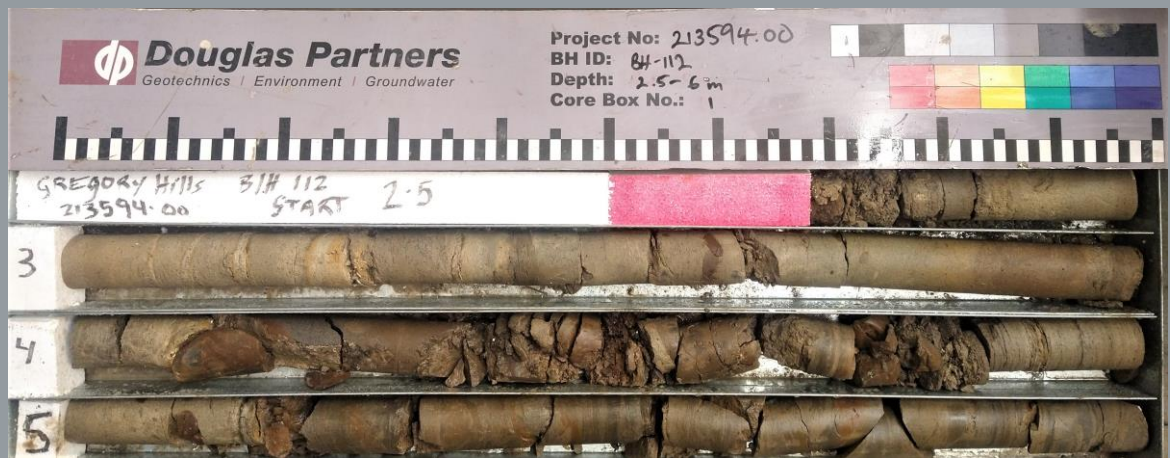
BORE: 112

2.50-6.00 m

6.00-7.70 m
