HammondCare Wahroonga Stage 2  
Archdale Walkway

# Post Office Ramp Alignment - Plan

LA-DG-80-AC

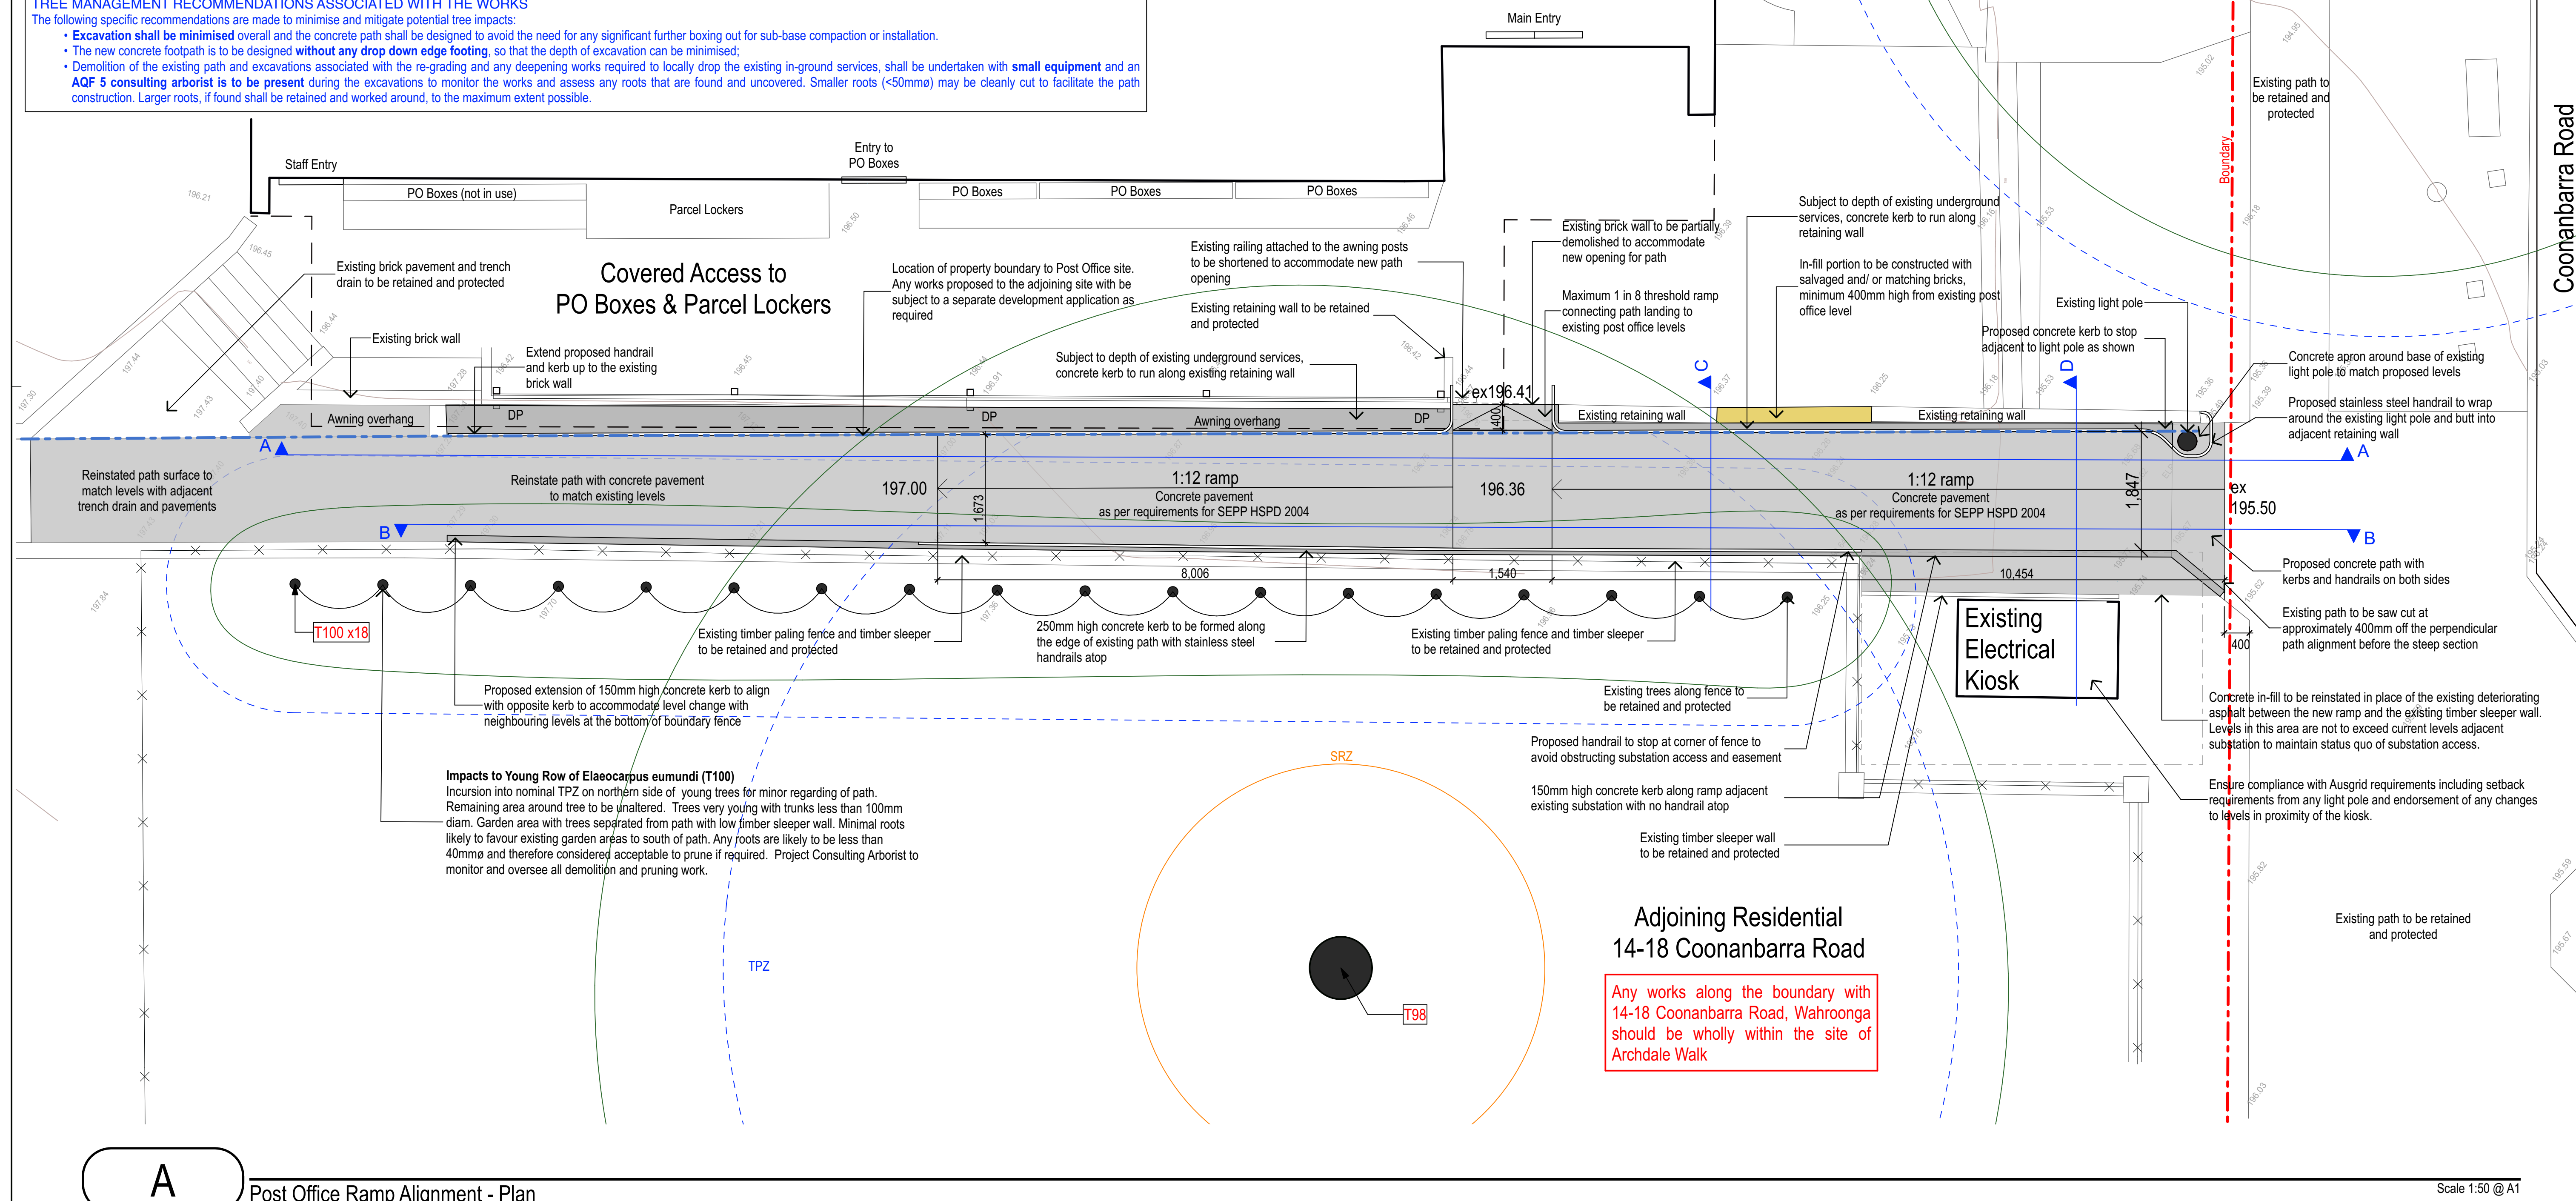
A

### Post Office Ramp Alignment - Plan

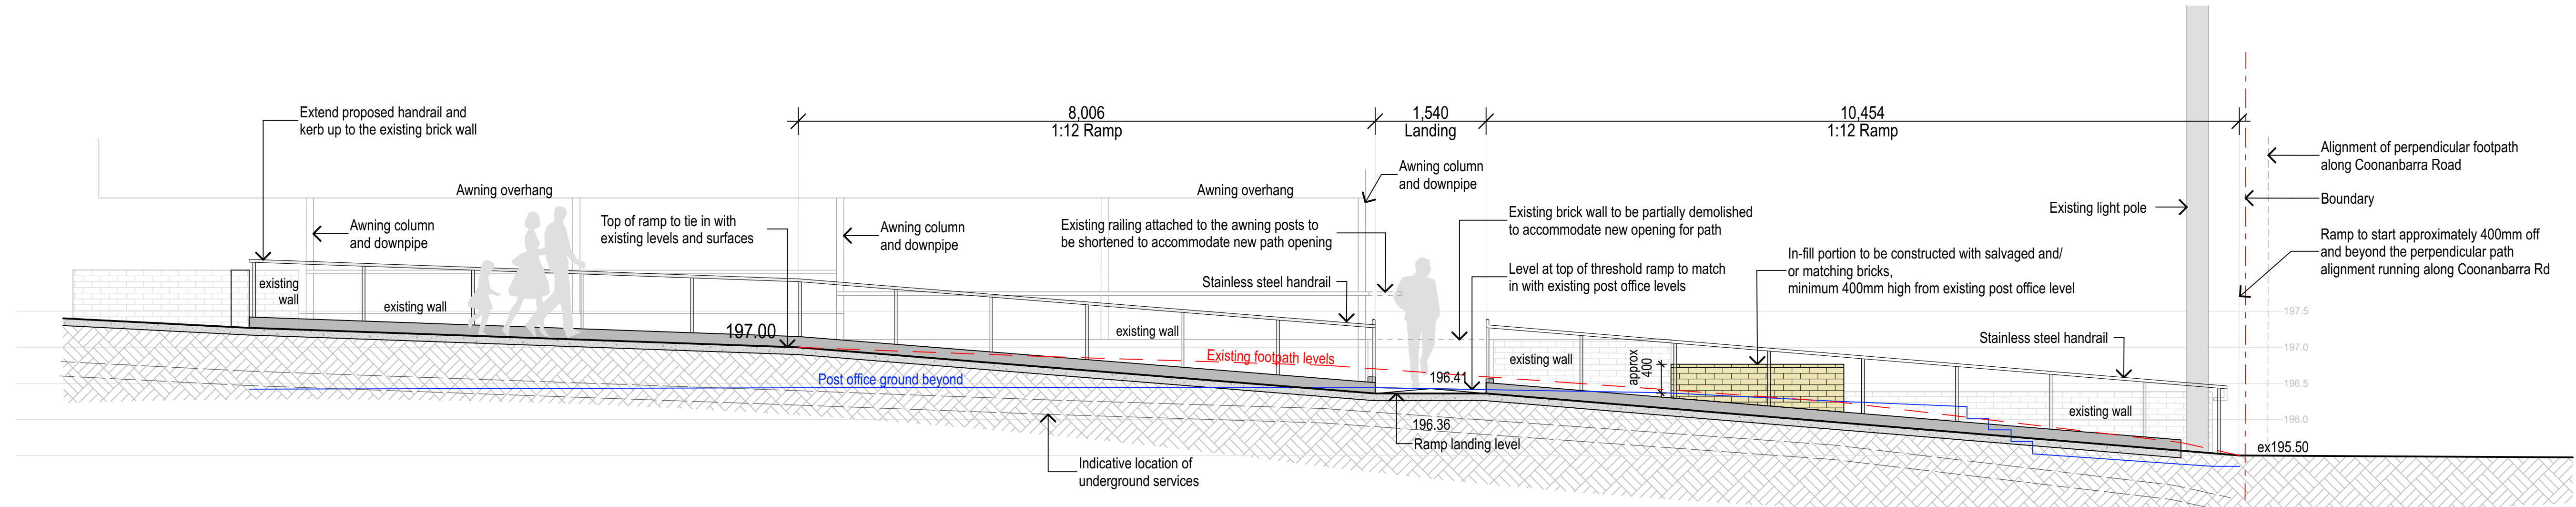
A

Sectional Elevation Through Ramp - Facing North

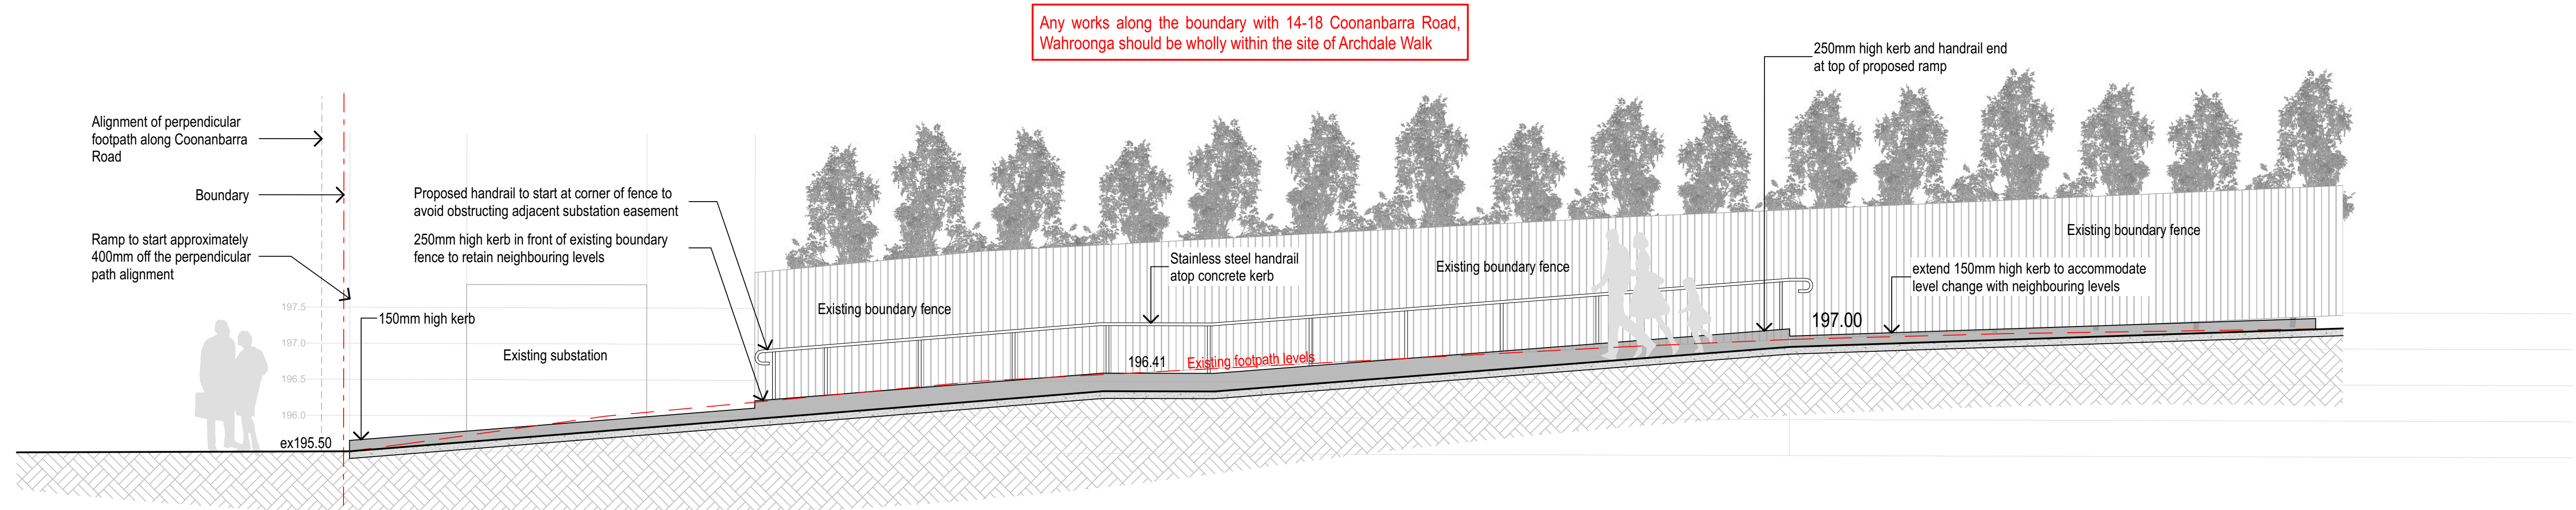
B

Sectional Elevation Through Ramp - Facing South

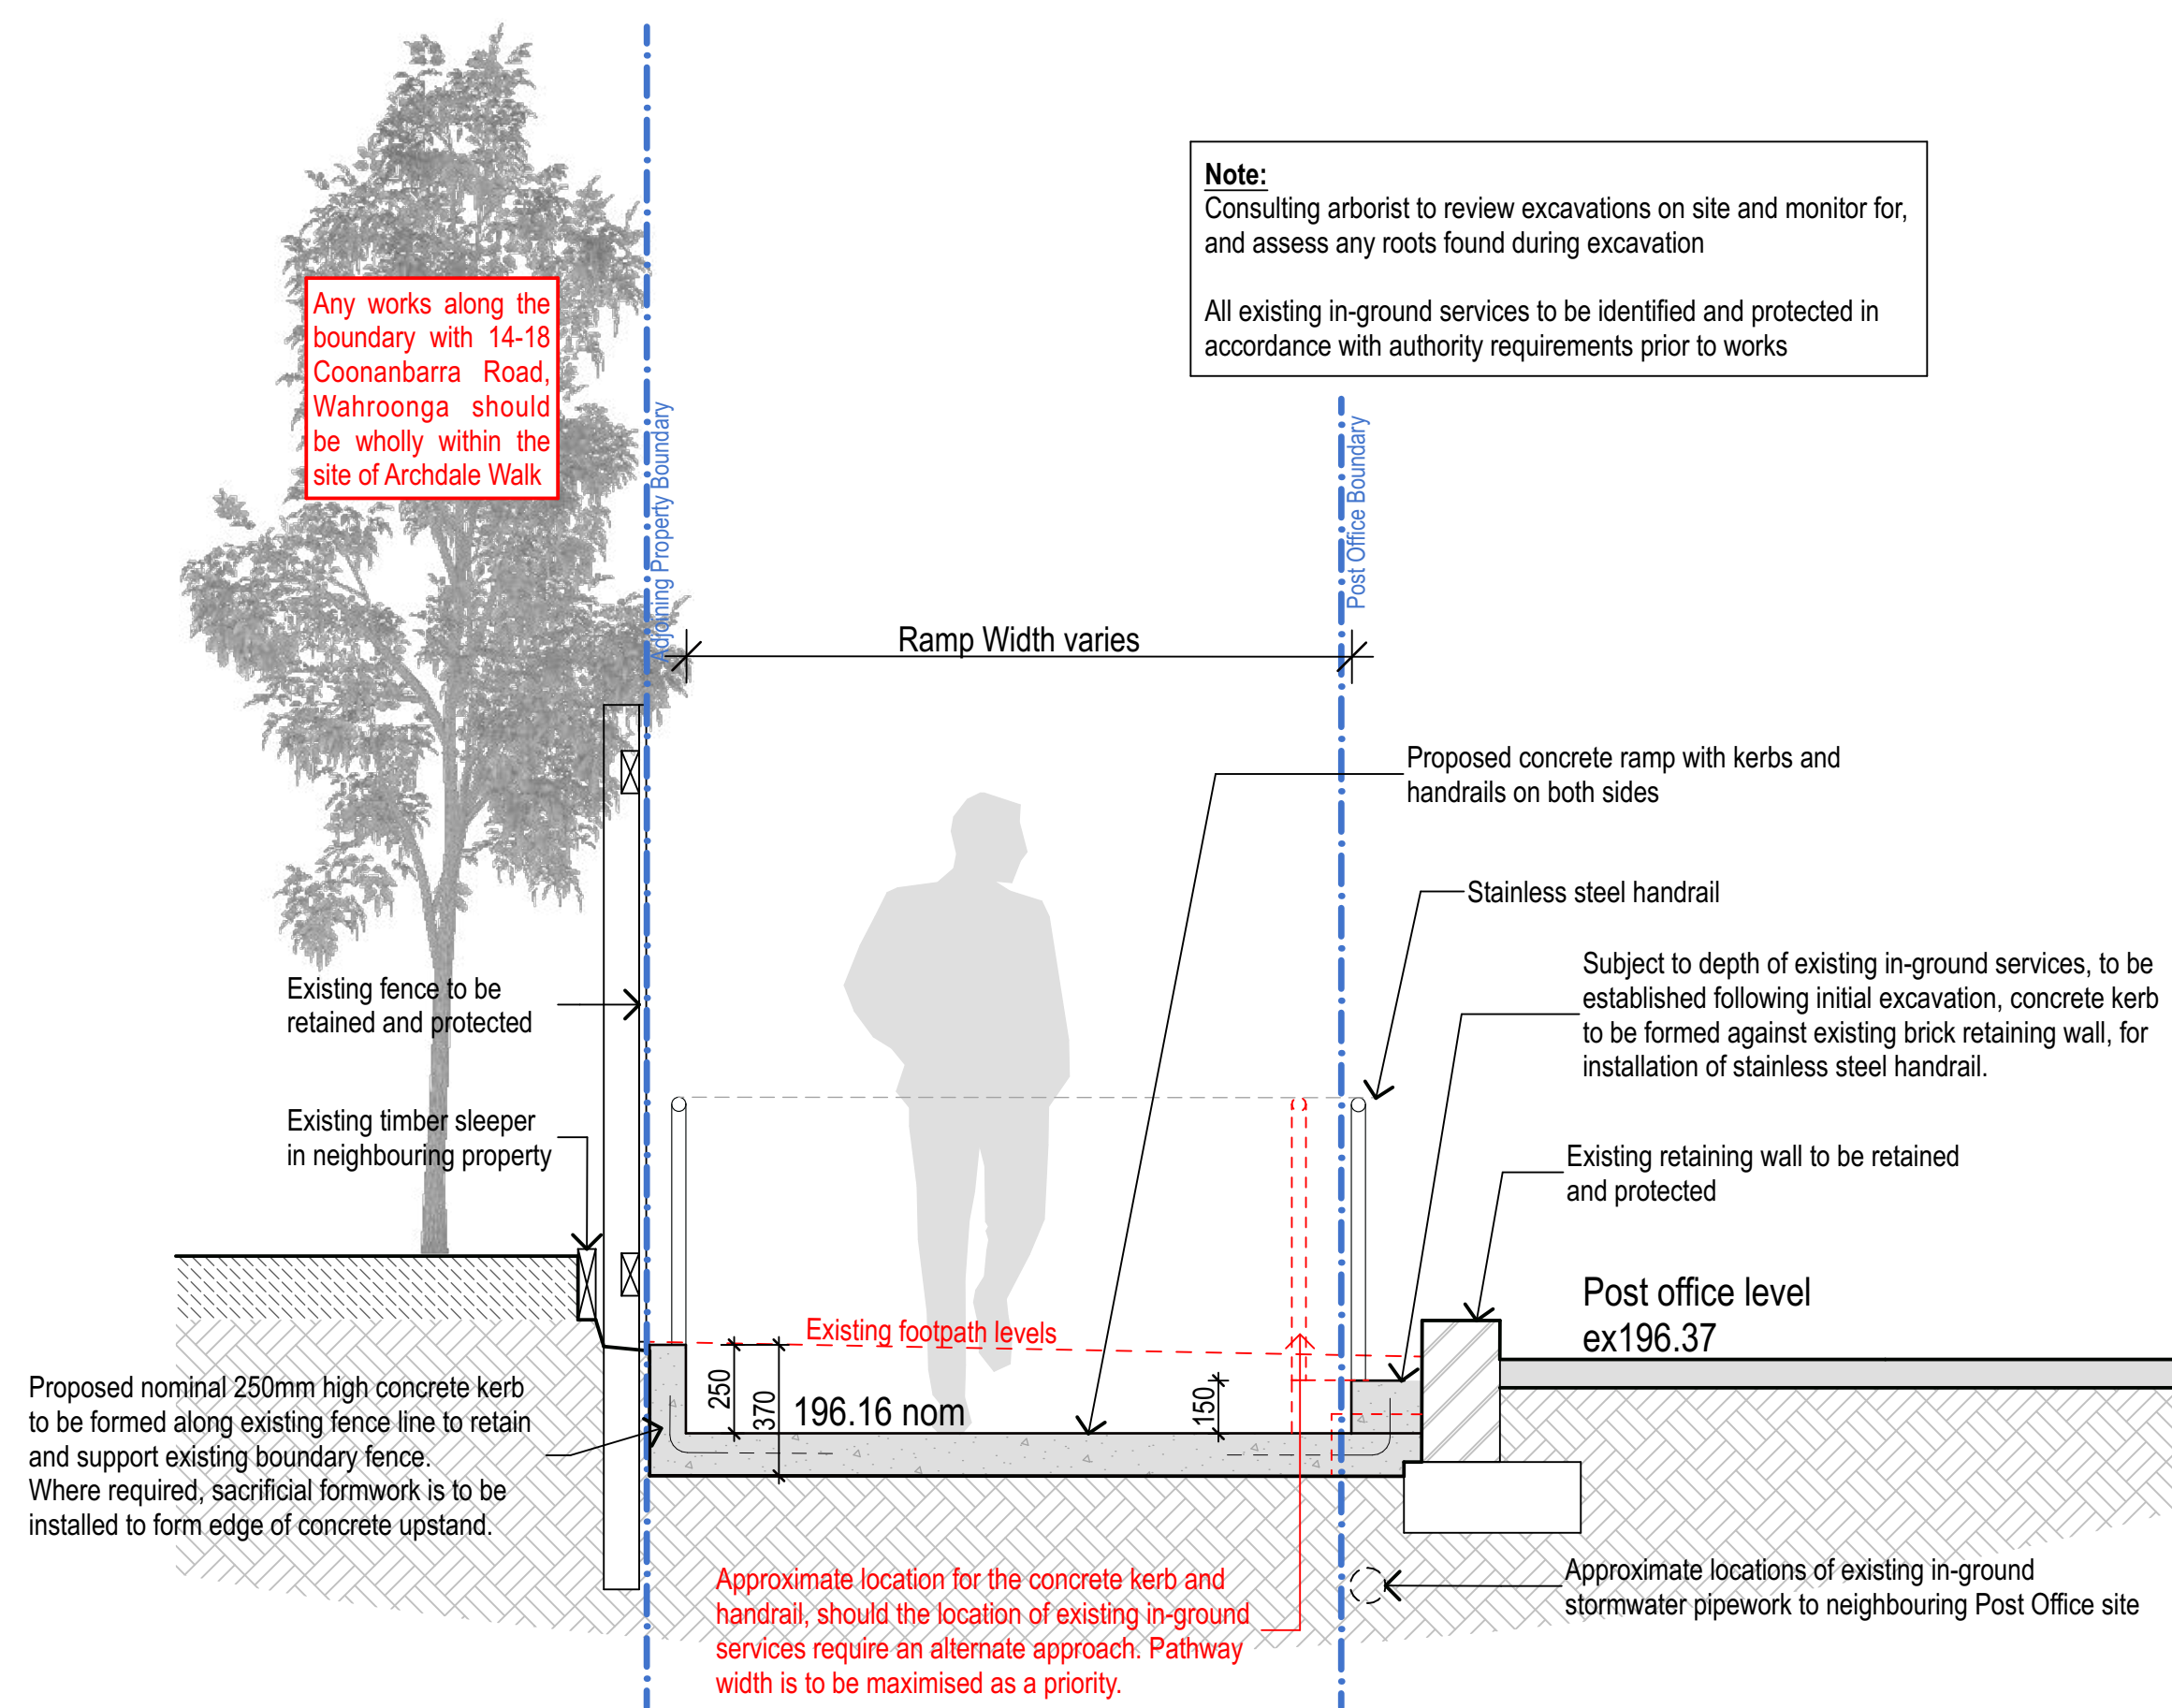
C

Typical Cross Section Through Ramp

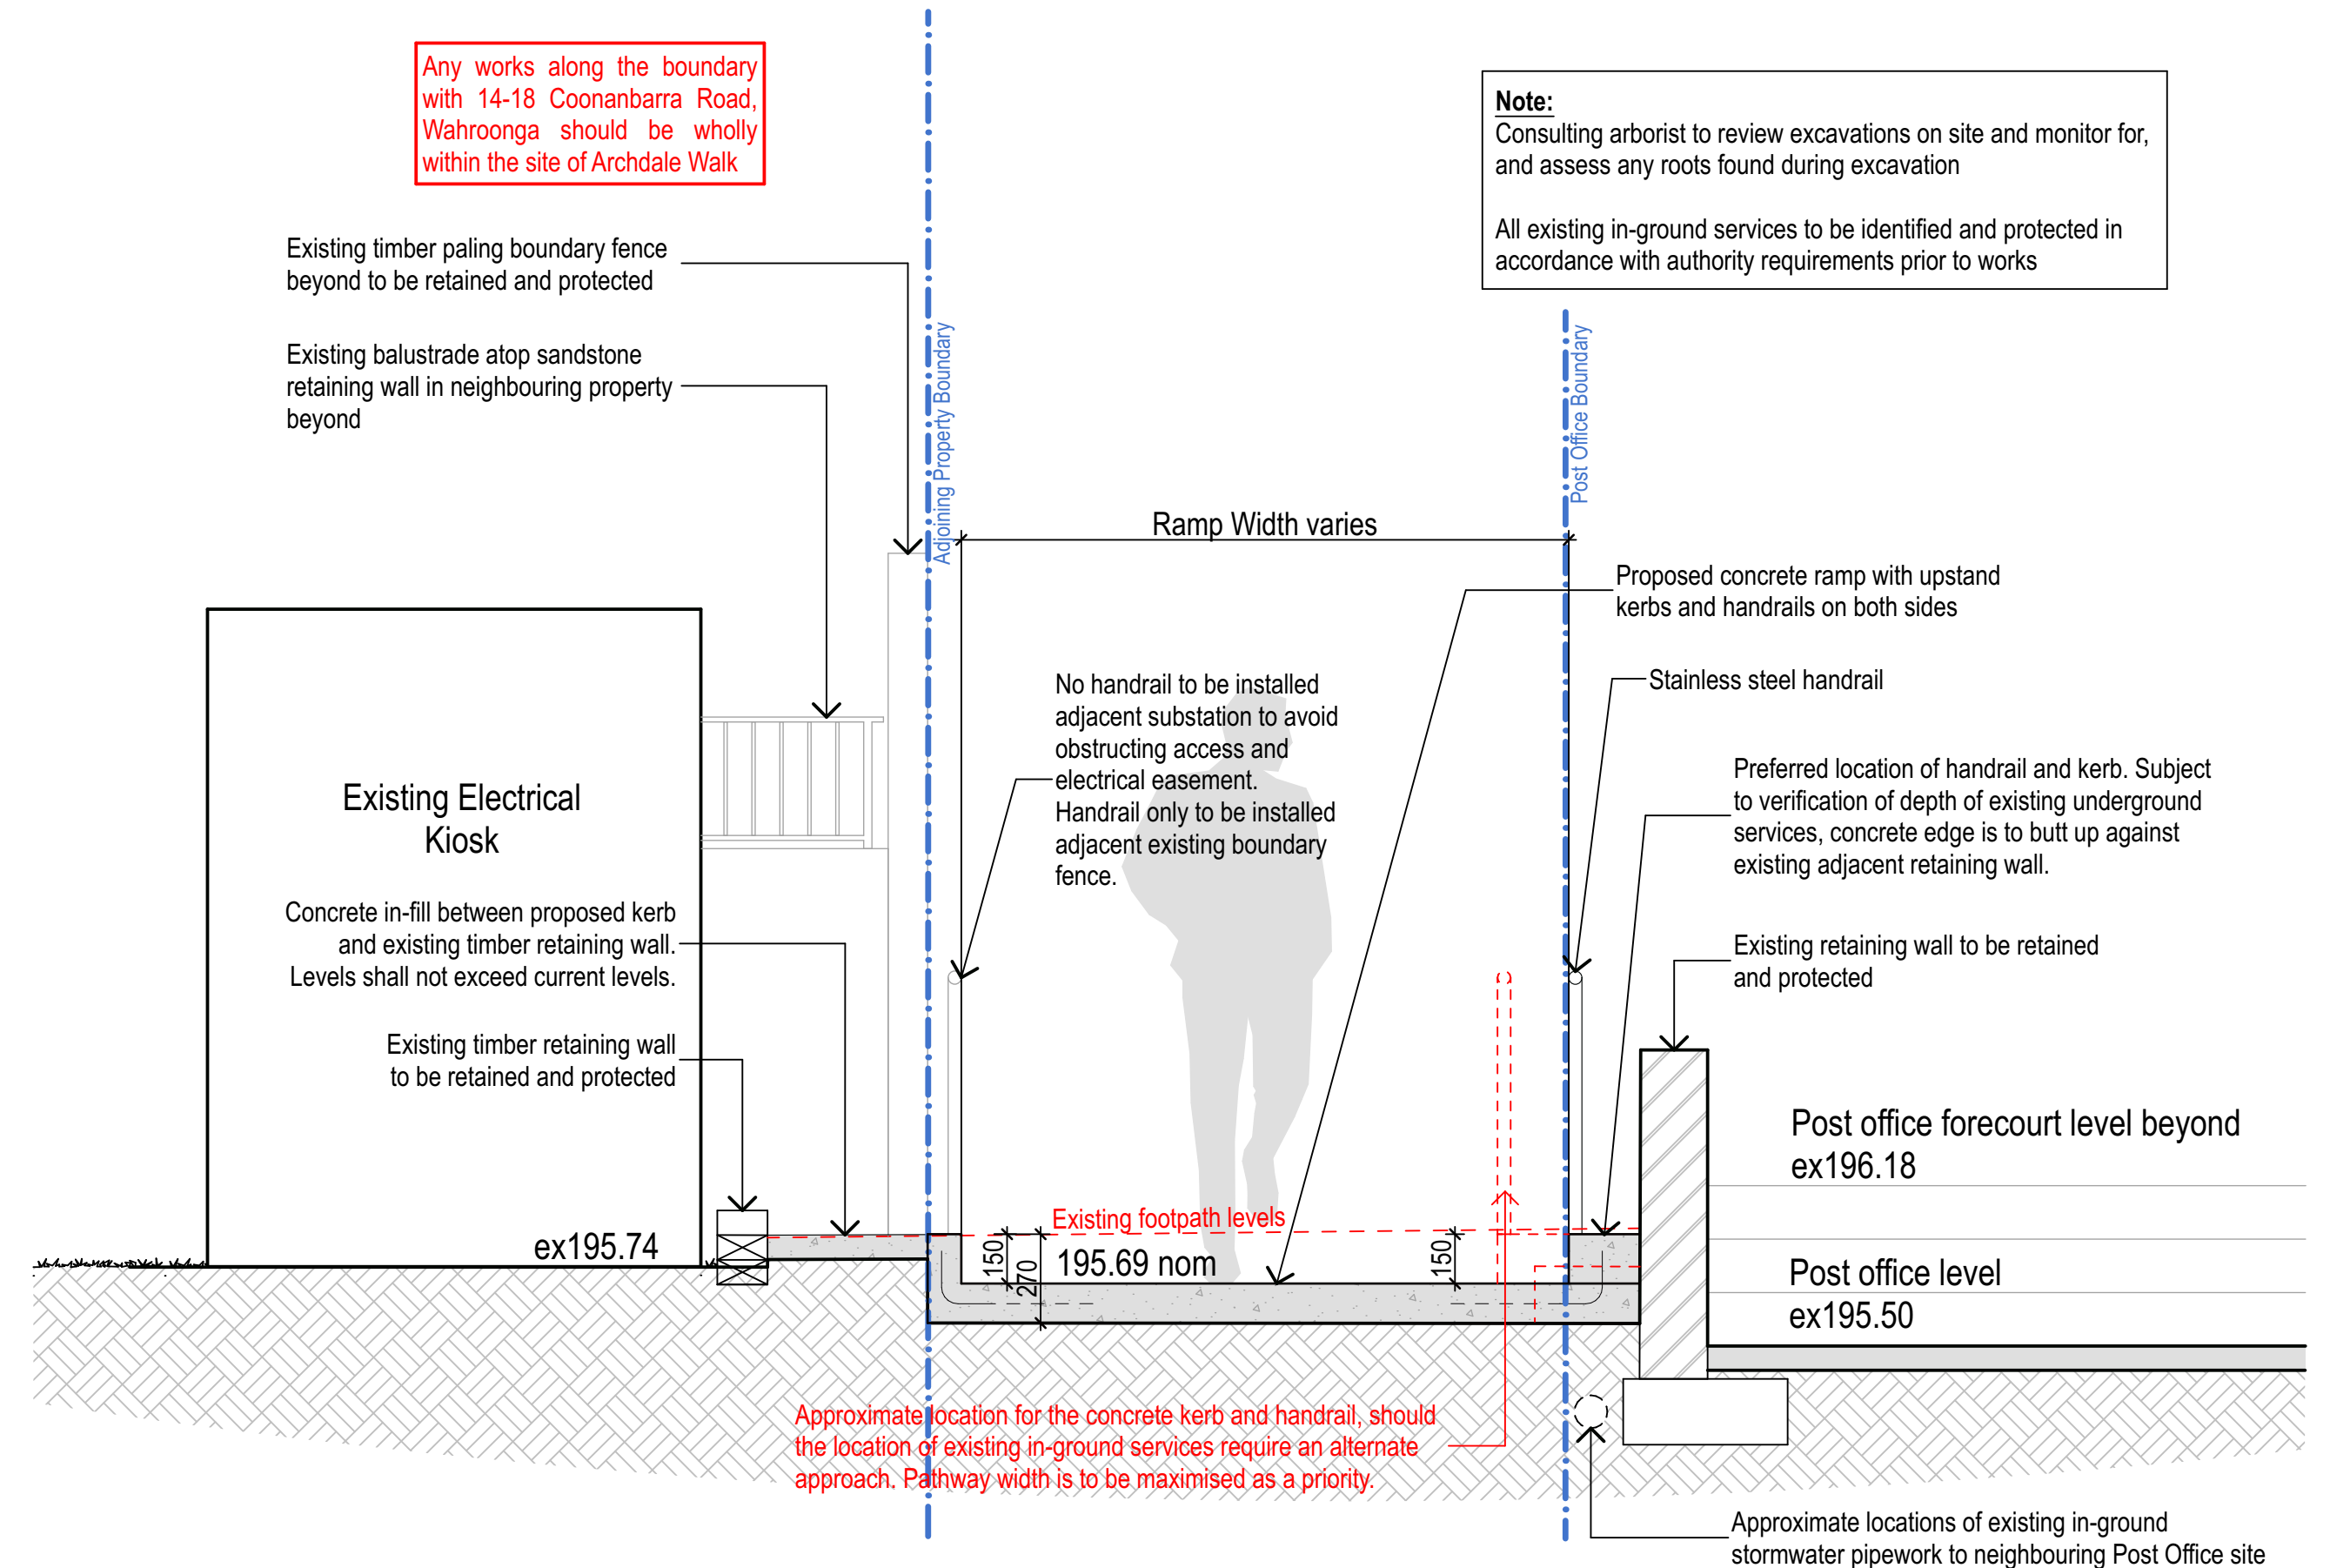
D

Cross Section Through Existing Electrical Kiosk & Ramp

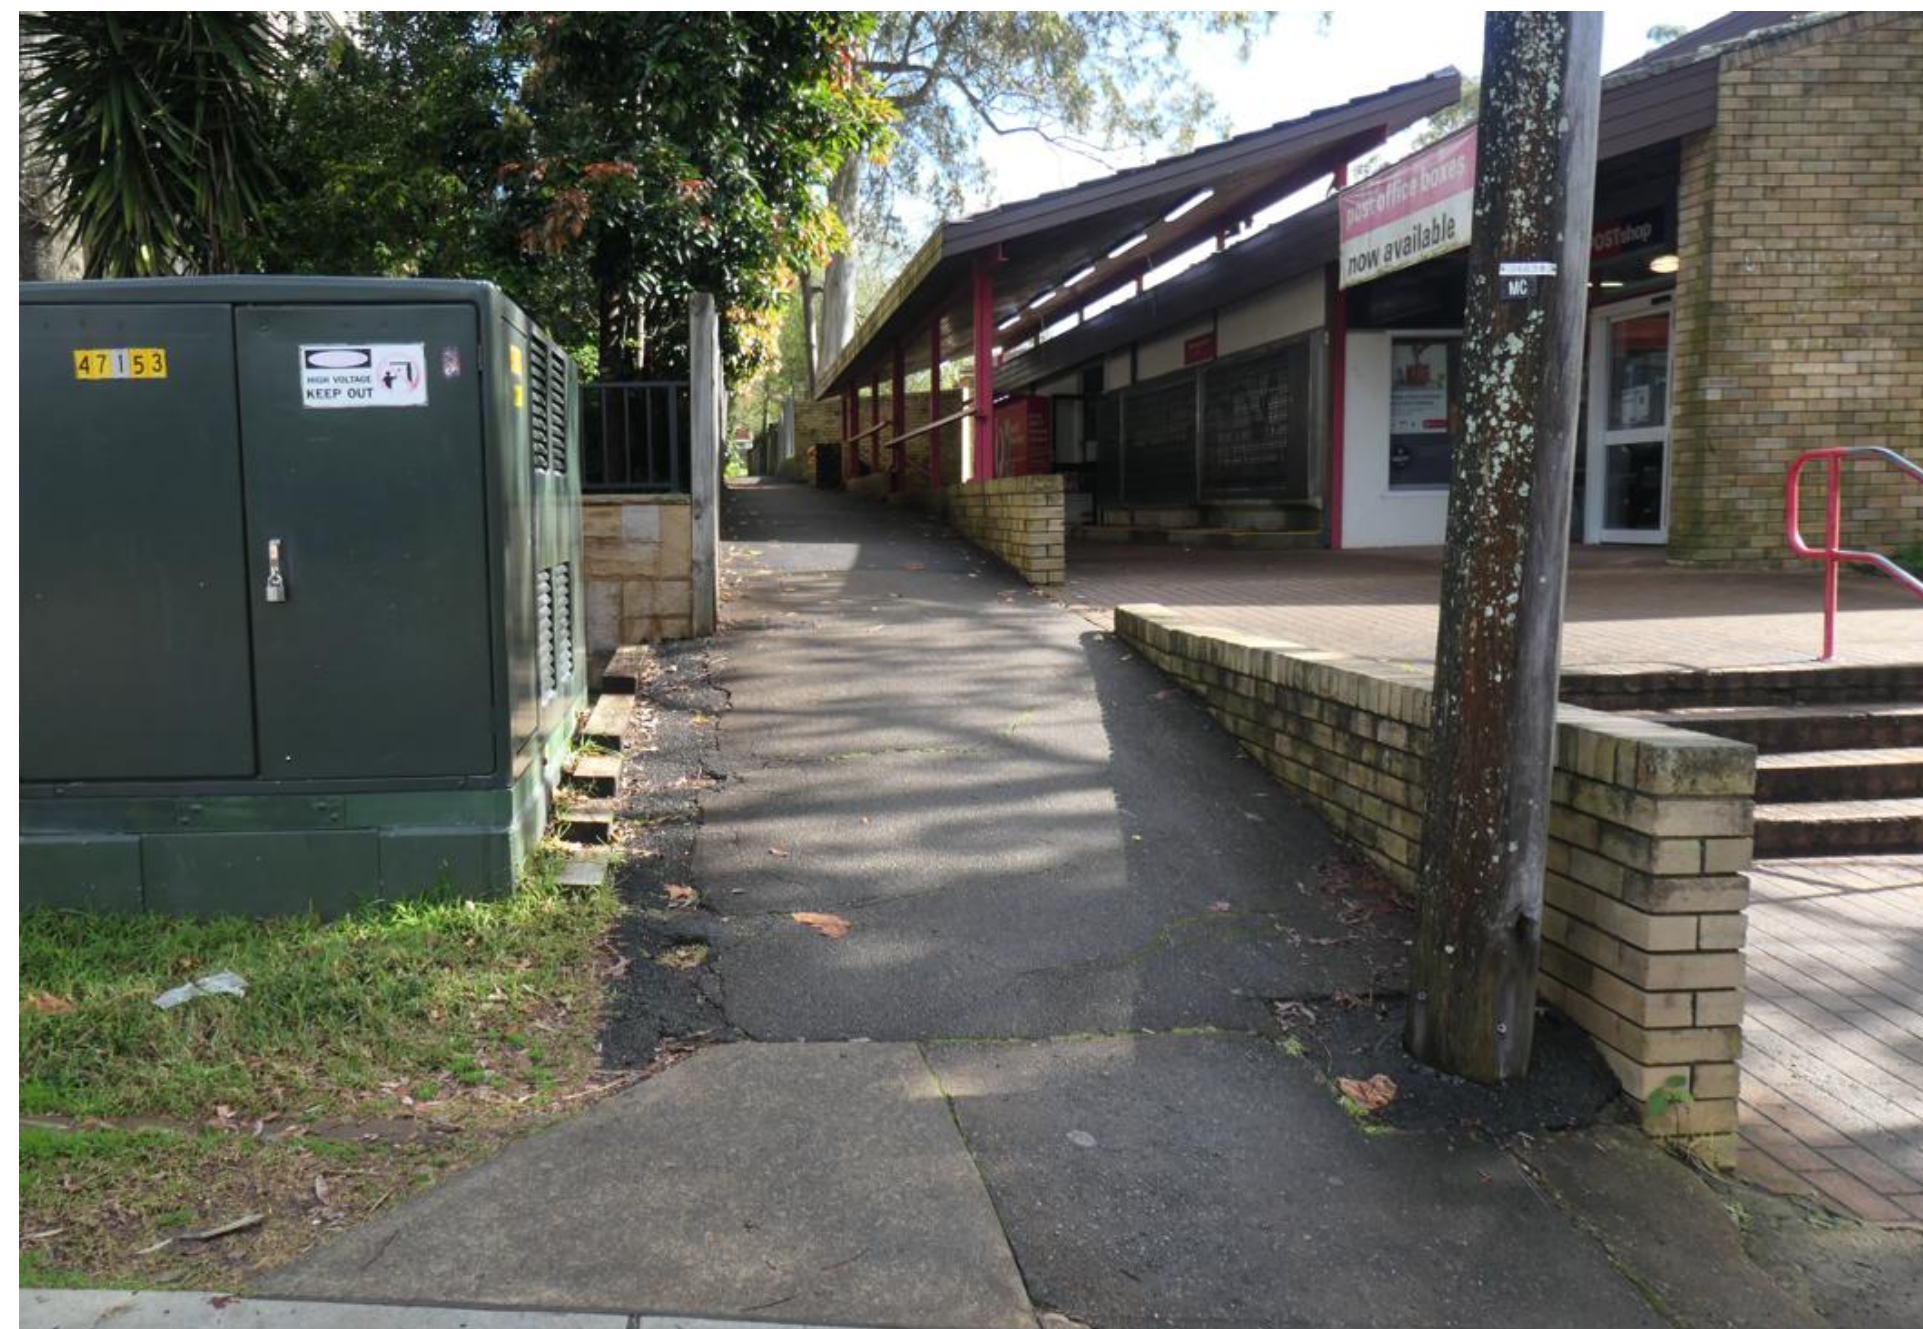
Image 1 - Existing steep path section adjacent the post office (facing west) and adjoining electrical kiosk

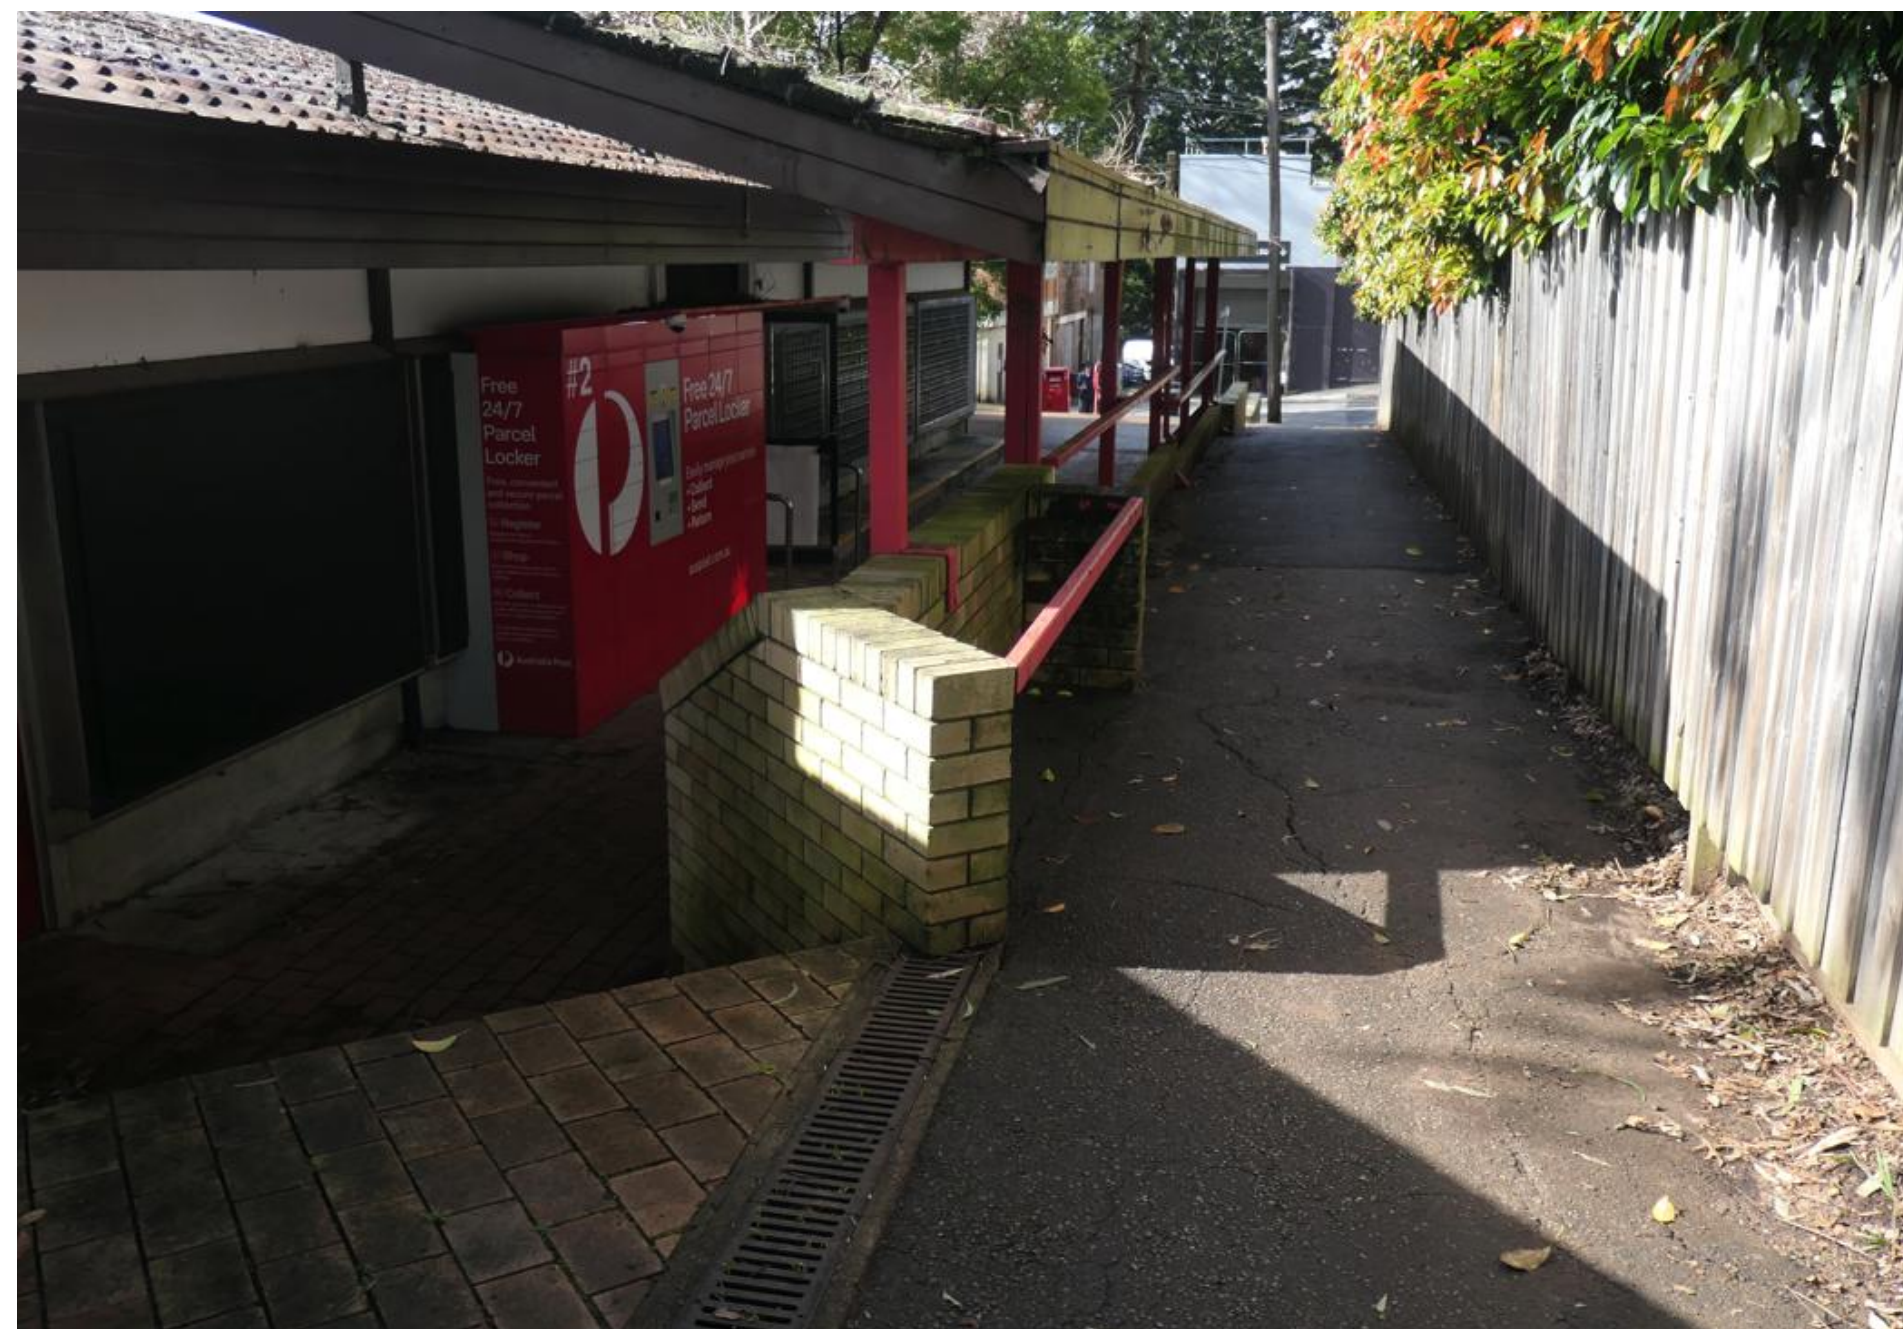
Image 2 - Existing path adjacent the post office (facing east) noting roof overhang and existing trench grate, level difference to underside of paling fence

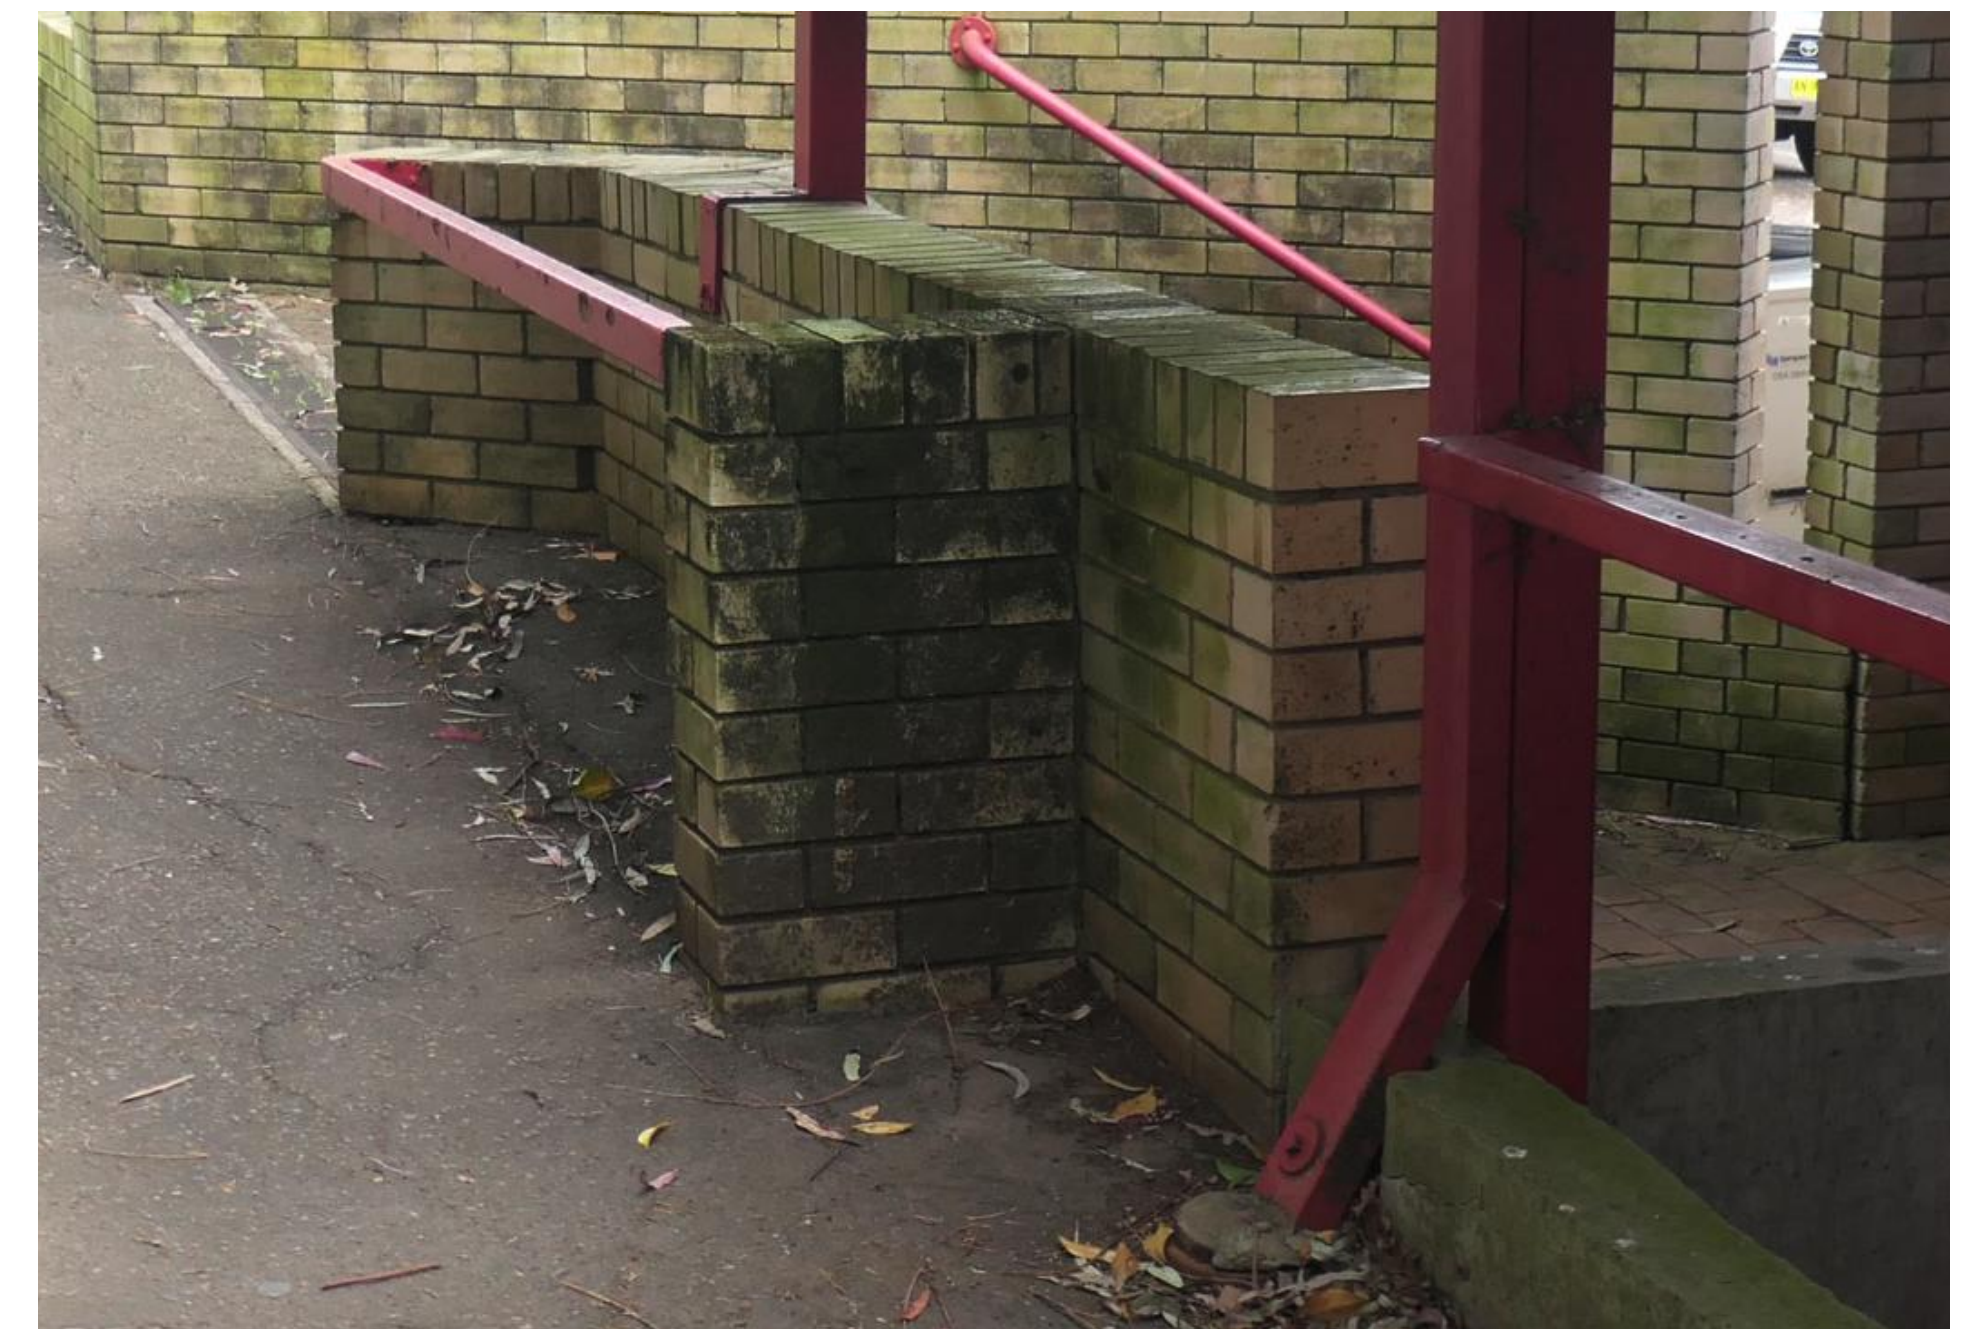
Image 3 - Existing downpipes running into the asphalt footpath and existing wall structures at the west end of awning
