**REPORT TO
HAMMONDCARE**

**ON
GEOTECHNICAL ASSESSMENT**

**FOR
PROPOSED REDEVELOPMENT OF
NERINGAH HOSPITAL**

**AT
4-12 NERINGAH AVENUE SOUTH,
WAHROONGA, NSW**

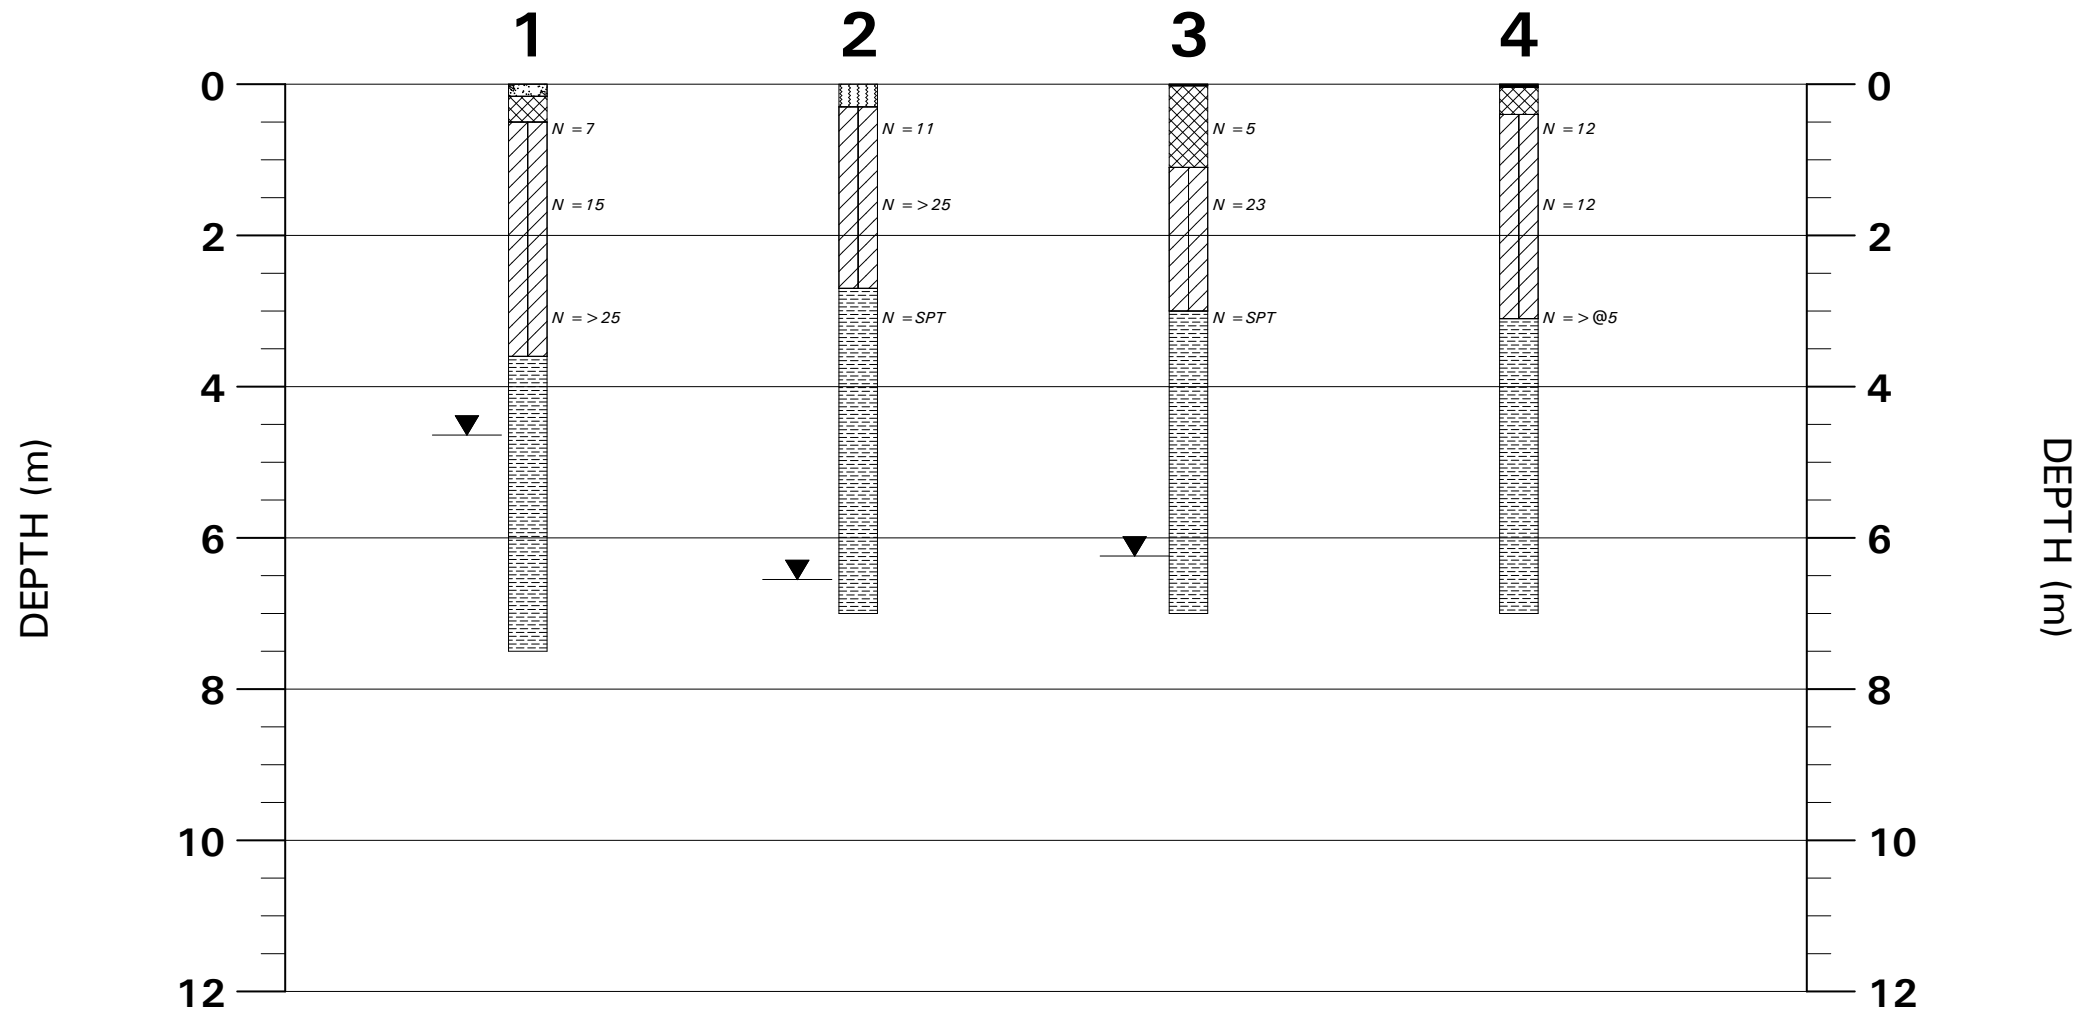
GRAPHICAL BOREHOLE SUMMARY

NOTE: REFER TO BOREHOLE LOGS

Scale: 1 : 100 (vert) ; NTS (horiz)

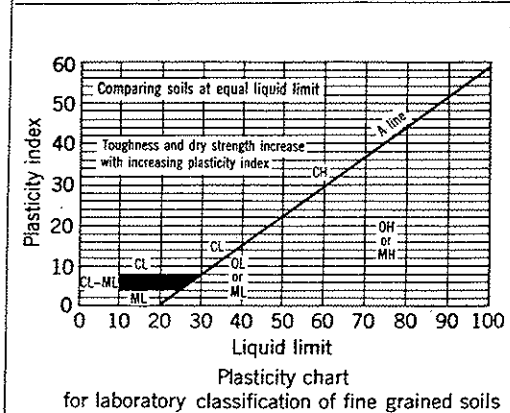
Plasticity chart for laboratory classification of fine grained soils

Determine percentages of gravel and sand from grain size curve
Depending on percentage of fines (fraction smaller than 75 µm sieve size) coarse grained soils are classified as follows:
Less than 5% GW, GP, SW, SP
More than 12% GM, GC, SM, SC
Borderline cases requiring use of dual symbols

- NOTE: 1) Soils possessing characteristics of two groups are designated by combinations of group symbols (e.g. GW-GC, well graded gravel-sand mixture with clay fines).
- 2) Soils with liquid limits of the order of 35 to 50 may be visually classified as being of medium plasticity.

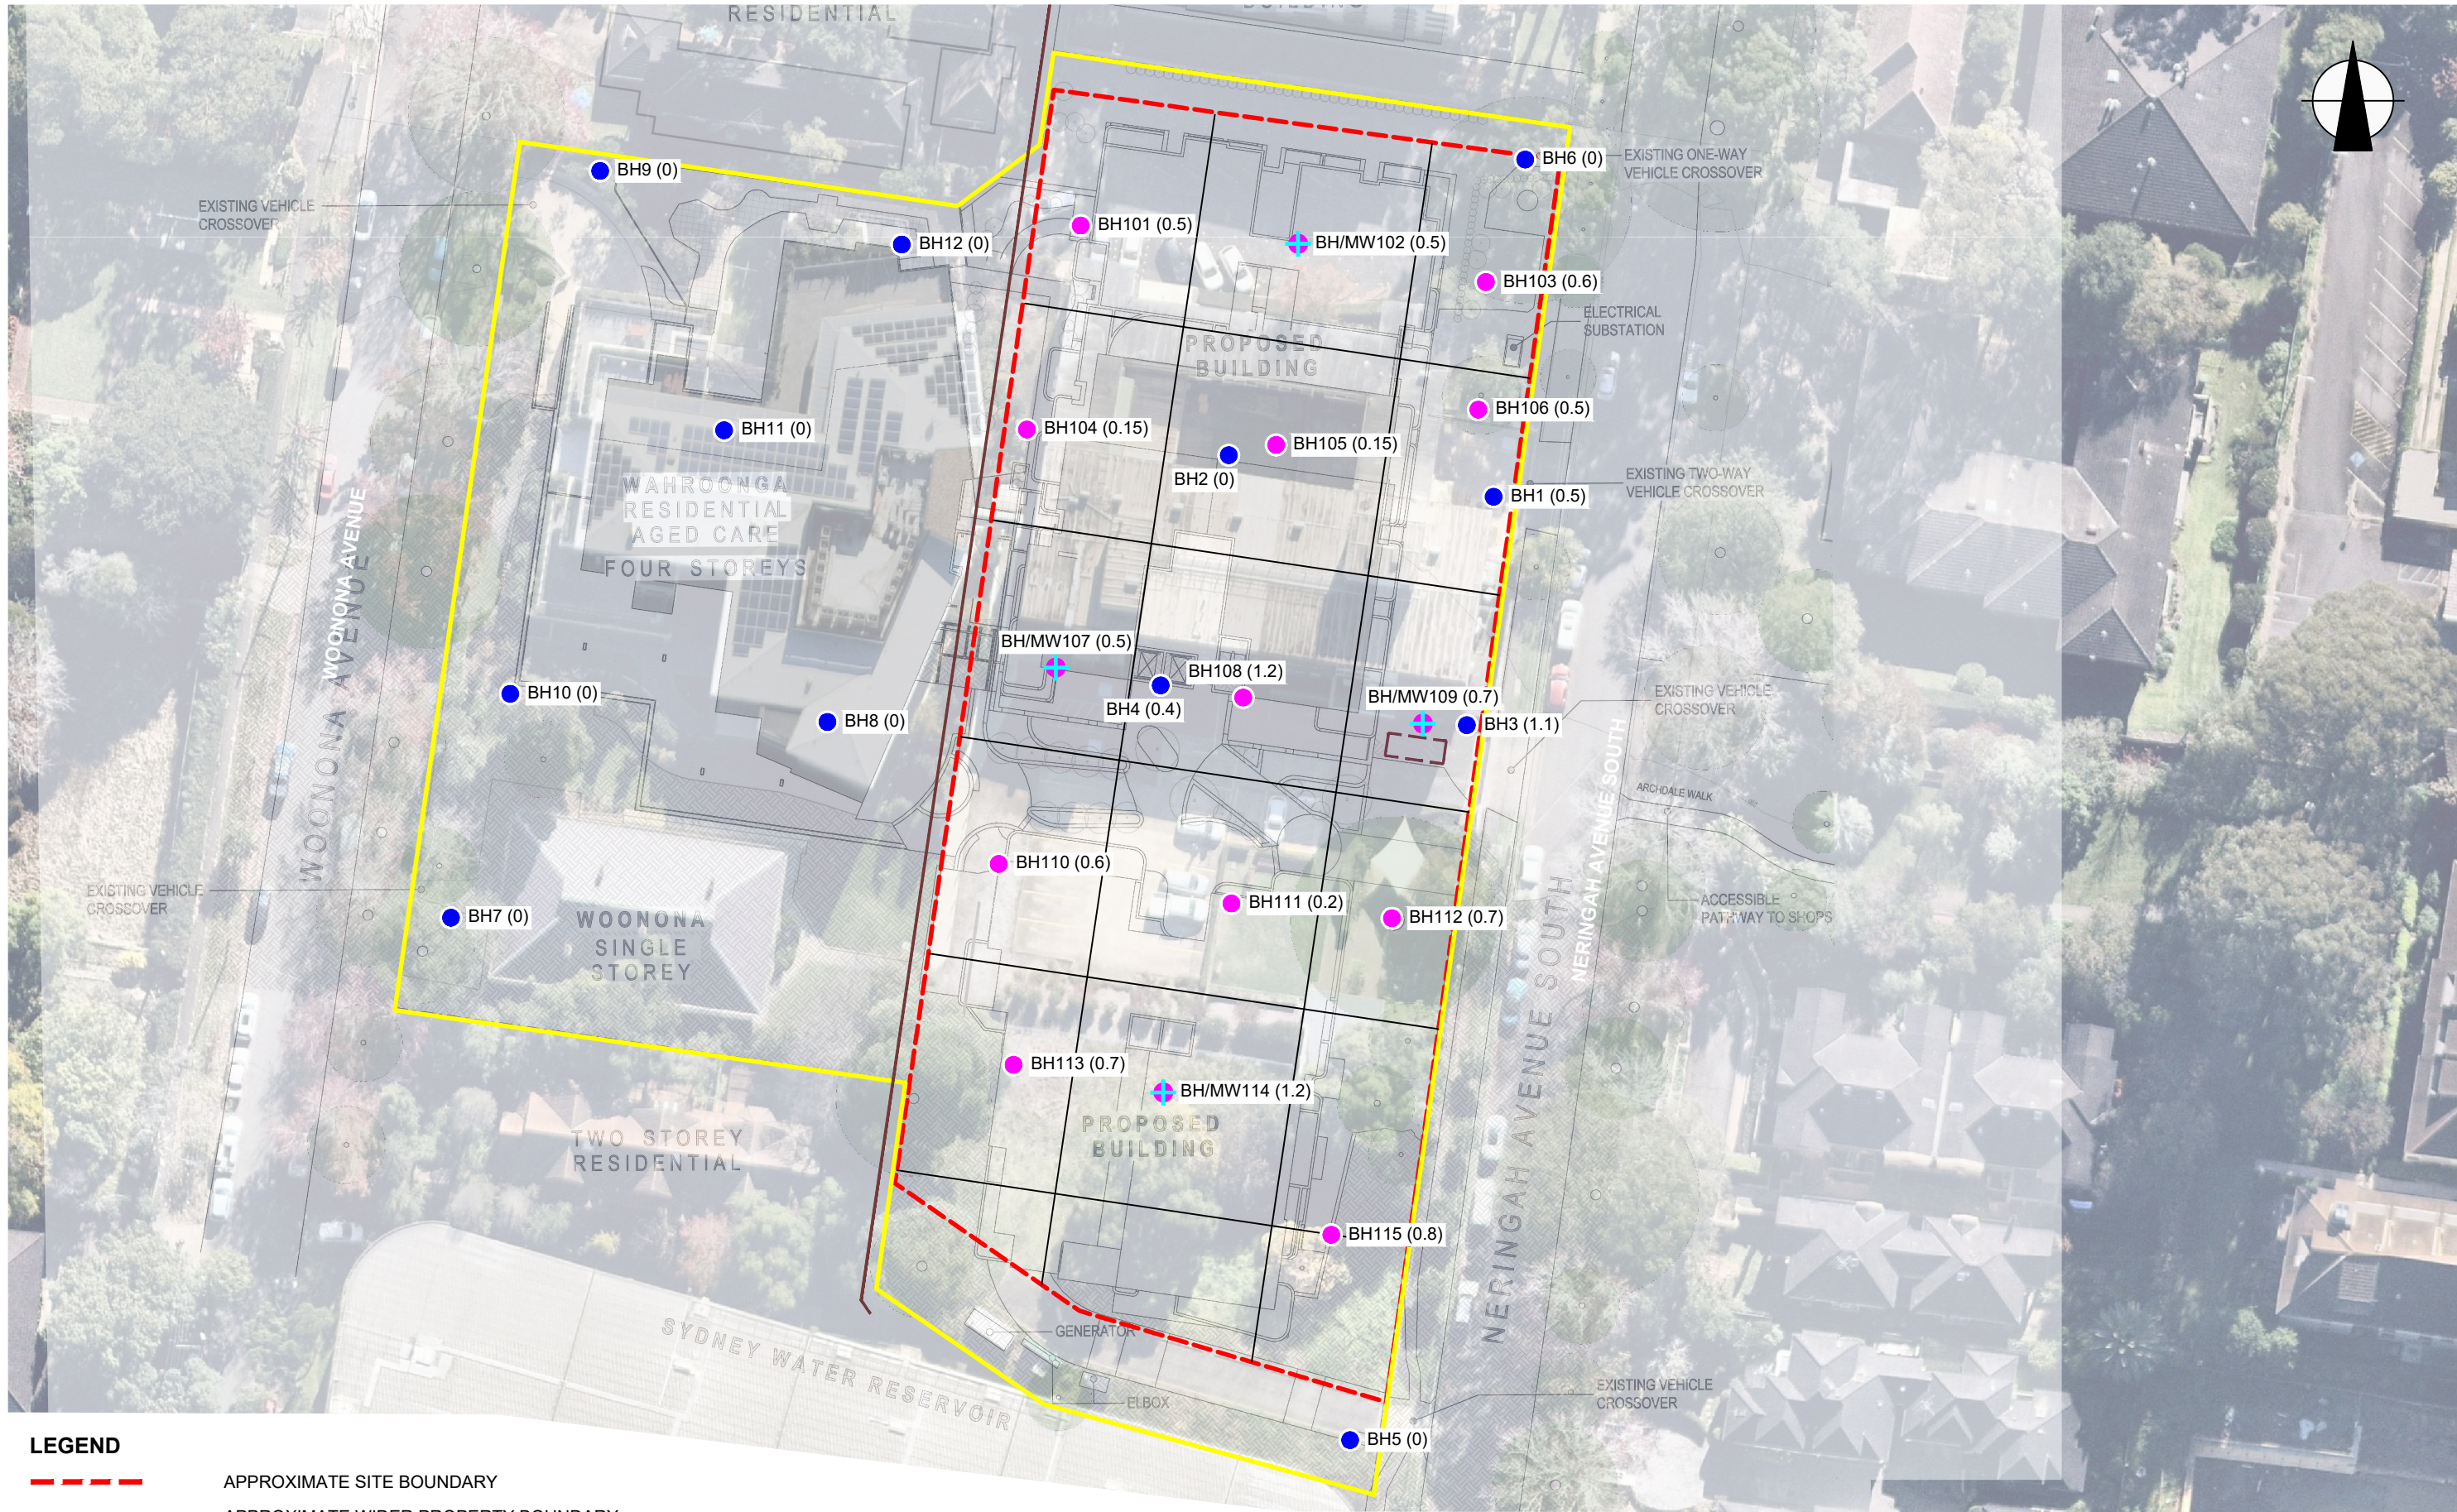
- APPROXIMATE SITE BOUNDARY
- APPROXIMATE WIDER PROPERTY BOUNDARY
- BH(Fill Depth) BOREHOLE LOCATION, NUMBER AND DEPTH OF FILL (m) (JKE, 2022)
- + BH/MW(Fill Depth) BOREHOLE AND GROUNDWATER MONITORING WELL LOCATION, NUMBER AND DEPTH OF FILL (m) (JKE, 2022)
- BH(Fill Depth) BOREHOLE LOCATION, NUMBER AND DEPTH OF FILL (m) (EIS, 2010)
- APPROXIMATE LOCATION OF SUSPECTED UNDERGROUND STORAGE TANK (UST)
- APPROXIMATE ALIGNMENT OF SEWER
