MEMORANDUM

То	Alex Lisney	From	Catherine Walker
Сору	N/A	Reference	20056-1
Date	1 November 2022	Pages	48
Subject	HammondCare Wahroonga Stage 2 – Flood Assessment

1 PROJECT BACKGROUND

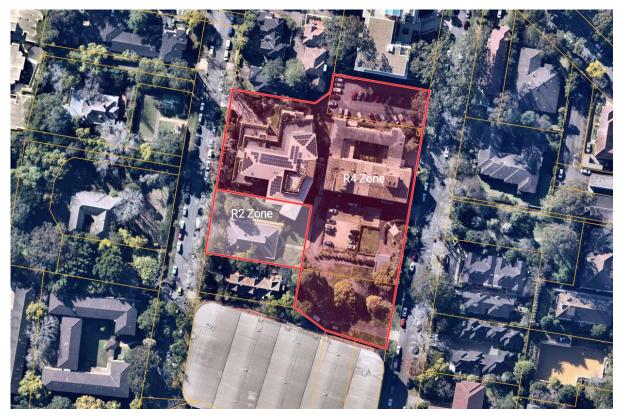
Figure 1-1 Outline of the site, with the portion of the site subject to the SCC shaded dark red (R4 zone)

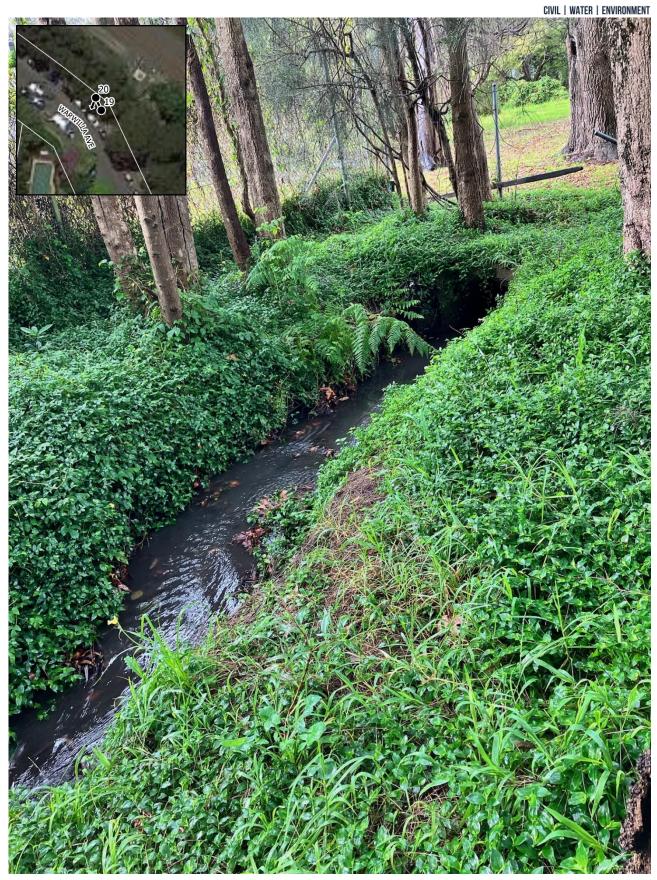
Photo 19

The closest watercourses in the vicinity of the site are a local open drainage channel at Warwilla Avenue (refer Photos 19 and 20), located approximately 150 m north (downstream) of the site, and Cockle Creek, located approximately 520 m north (downstream) of the site. There is an elevation difference of at least 10 m between the subject site and these watercourses, and, as such, it is unlikely that water from the drainage channel or Cockle Creek would reach the site in the event of a flood. Therefore, the subject site is not considered to be at risk of flooding from mainstream sources.
