**REPORT TO  
HAMMONDCARE**

**ON  
REMEDiation ACTION PLAN**

**FOR  
PROPOSED HOSPITAL REDEVELOPMENT**

**AT  
NERINGAH HOSPITAL, 4-12 NERINGAH AVENUE  
SOUTH, WAHROONGA, NSW**

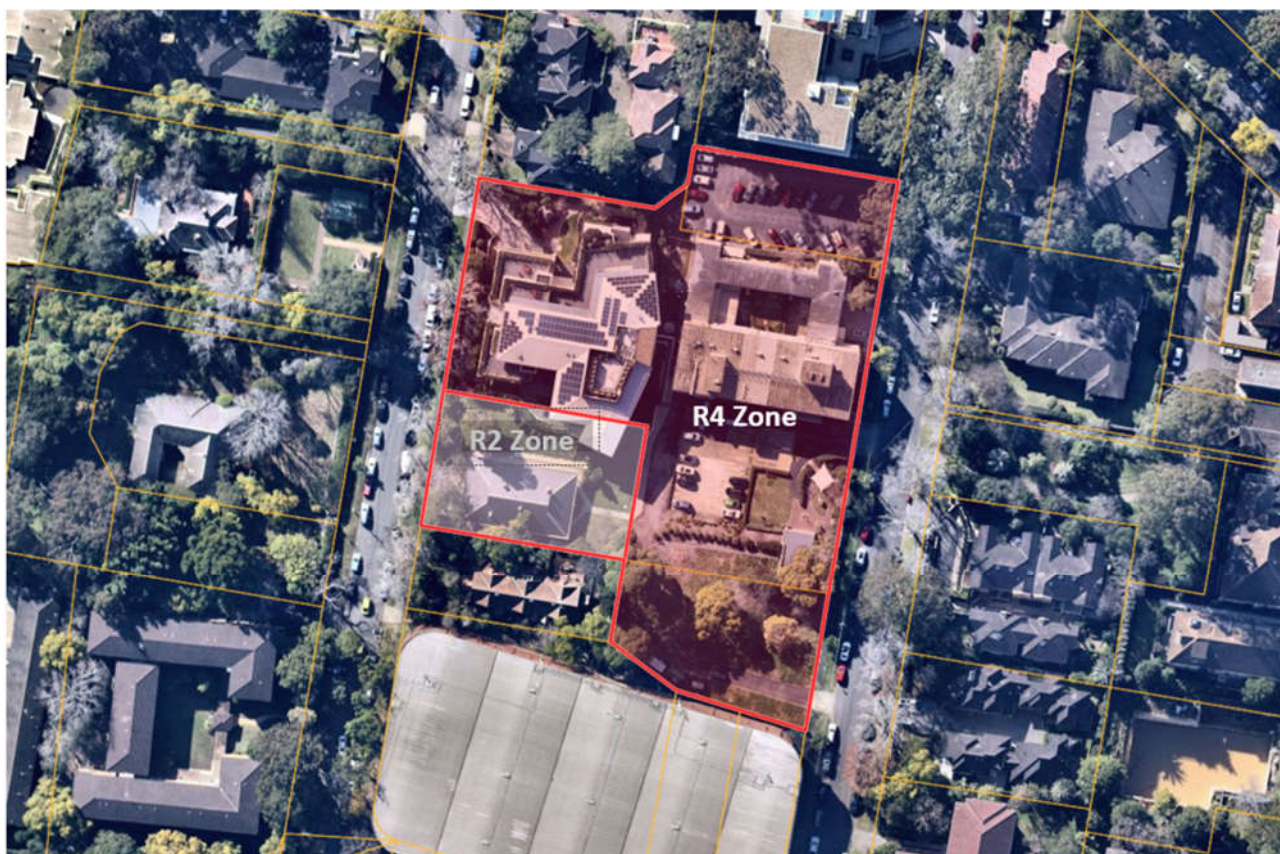
Figure A: Outline of the site, with the portion of the site subject to the SCC shaded dark red (R4 zone)

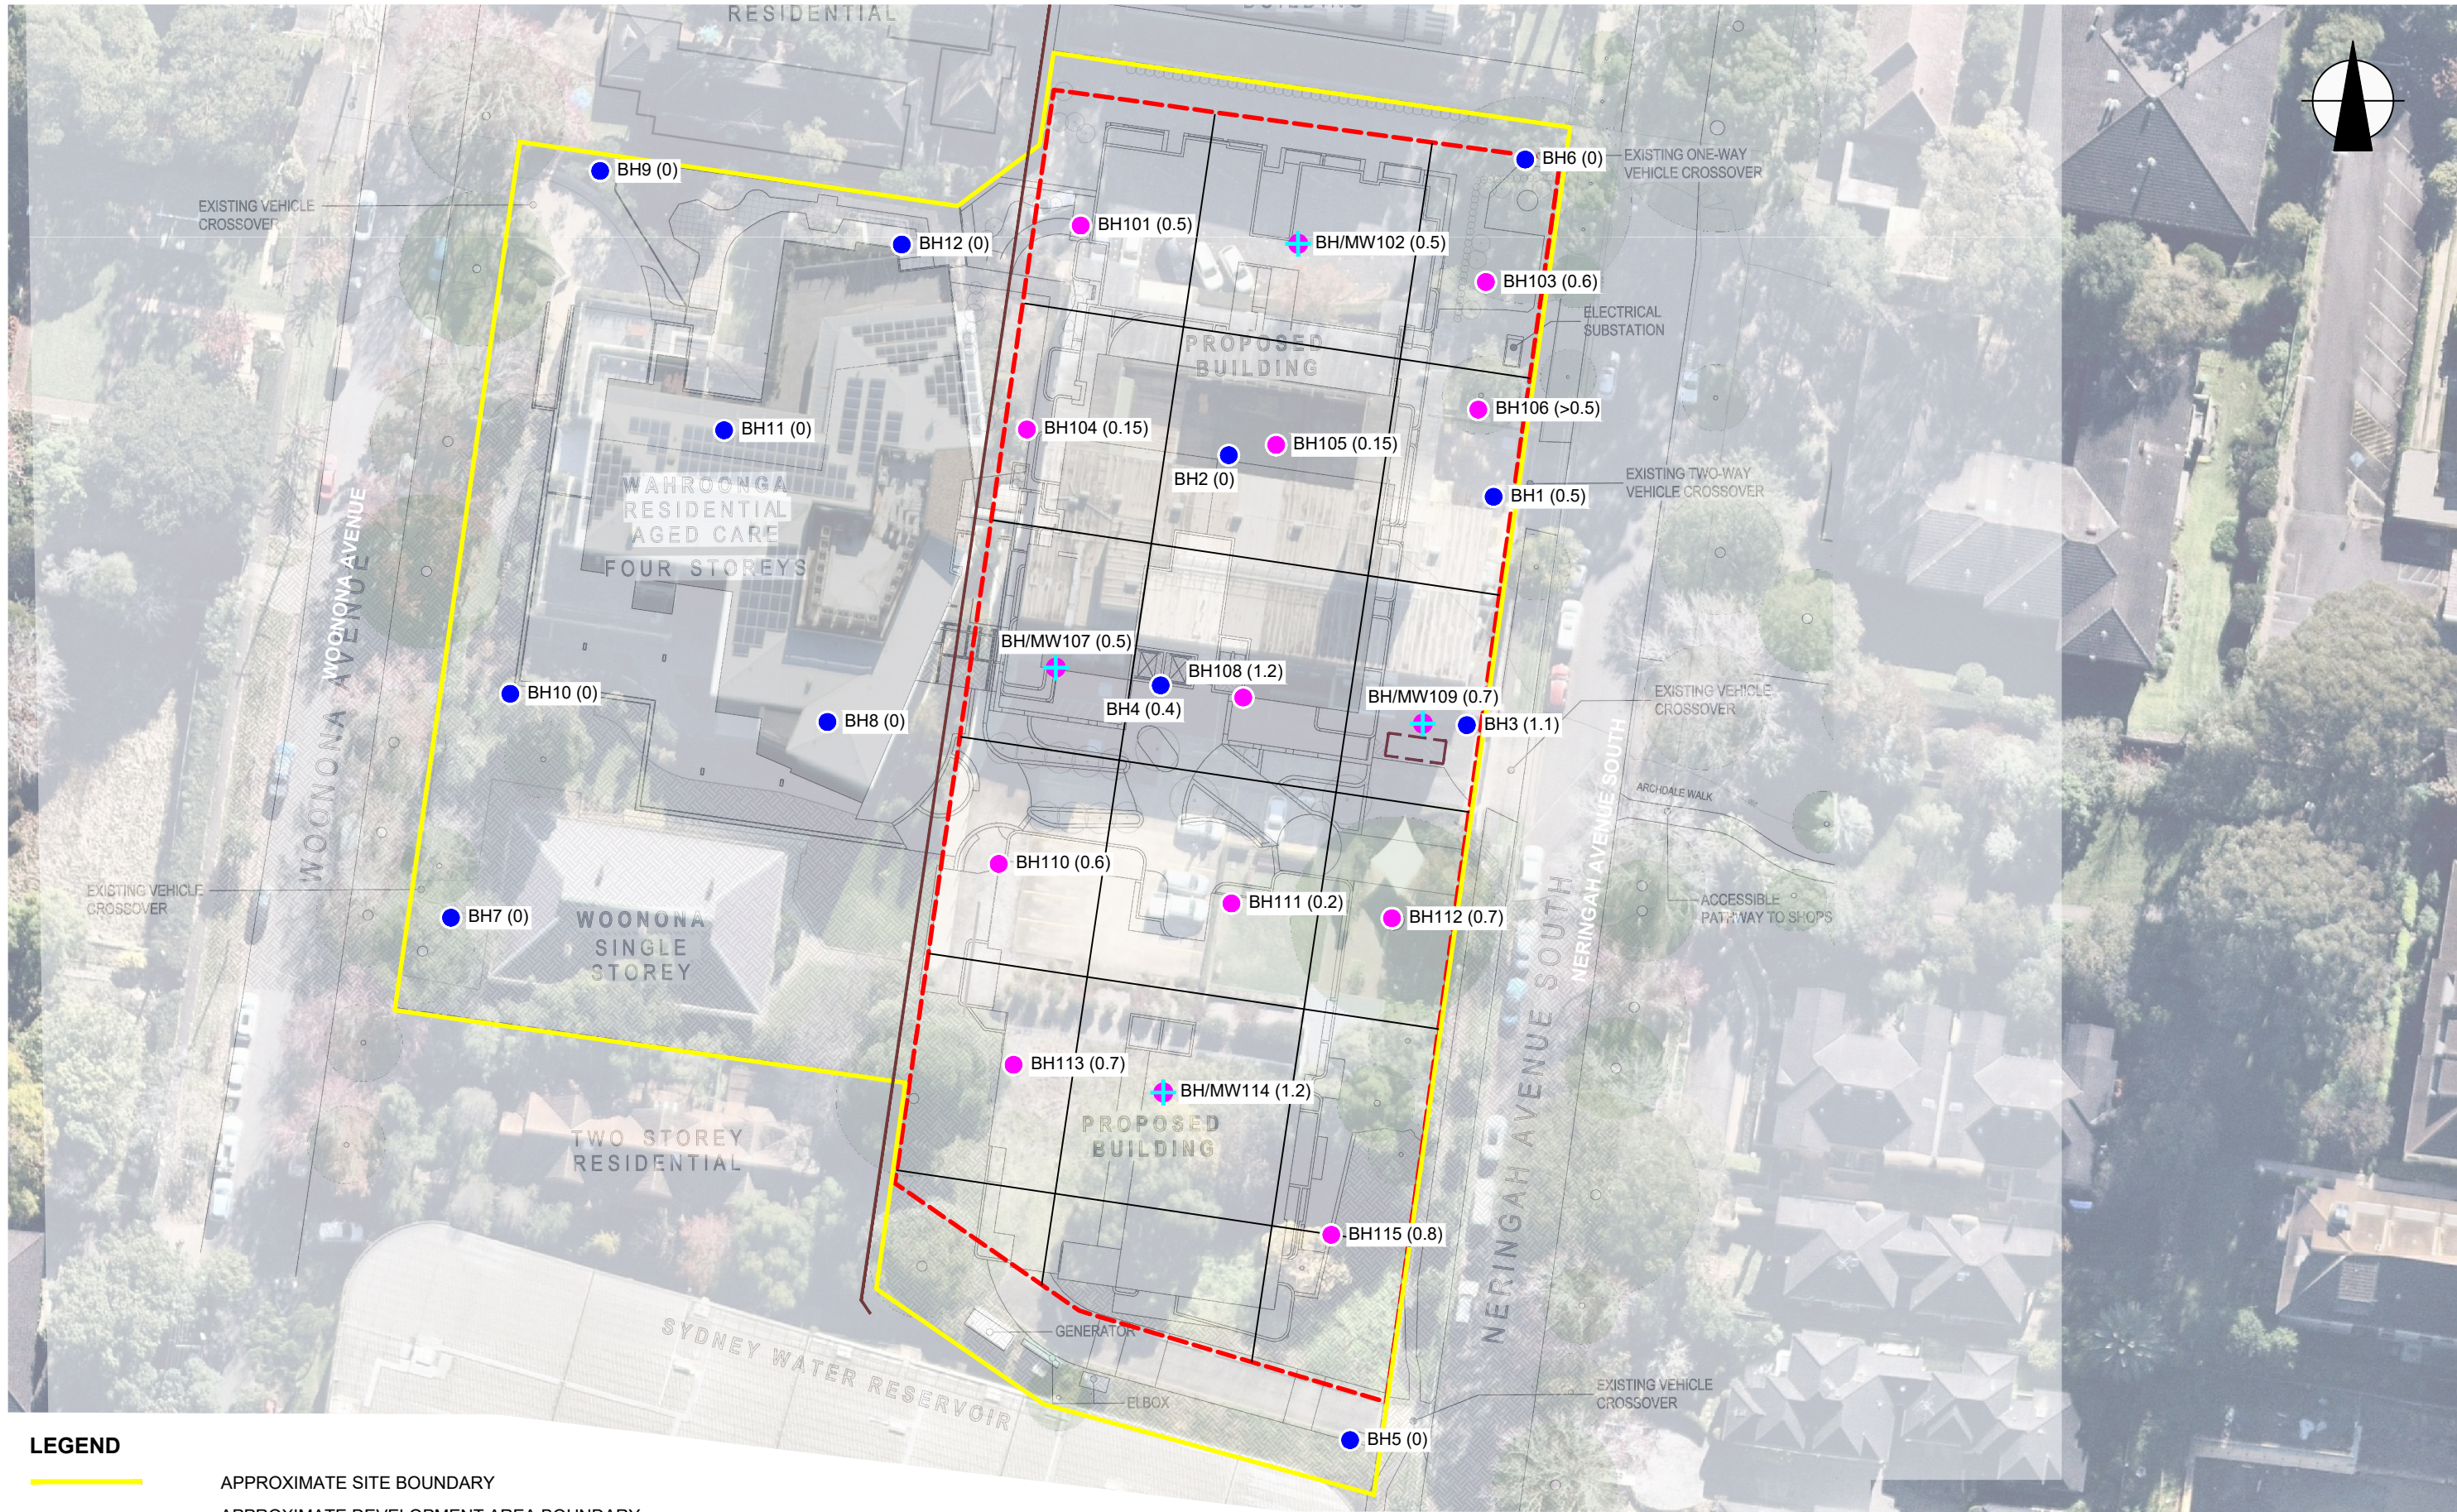
- APPROXIMATE SITE BOUNDARY
- - - APPROXIMATE DEVELOPMENT AREA BOUNDARY
- BH(Fill Depth) BOREHOLE LOCATION, NUMBER AND DEPTH OF FILL (m) (JKE, 2022)
- ⊕ BH/MW(Fill Depth) BOREHOLE AND GROUNDWATER MONITORING WELL LOCATION, NUMBER AND DEPTH OF FILL (m) (JKE, 2022)
- BH(Fill Depth) BOREHOLE LOCATION, NUMBER AND DEPTH OF FILL (m) (EIS, 2010)
- - - APPROXIMATE LOCATION OF SUSPECTED UNDERGROUND STORAGE TANK (UST)
- APPROXIMATE ALIGNMENT OF SEWER

A copy of the soil and groundwater data summary tables and borehole logs from the DSI report is included in the appendices. The SAC exceedances are shown on Figure 3 attached in the appendices. The following exceedances of the SAC were reported in the DSI:

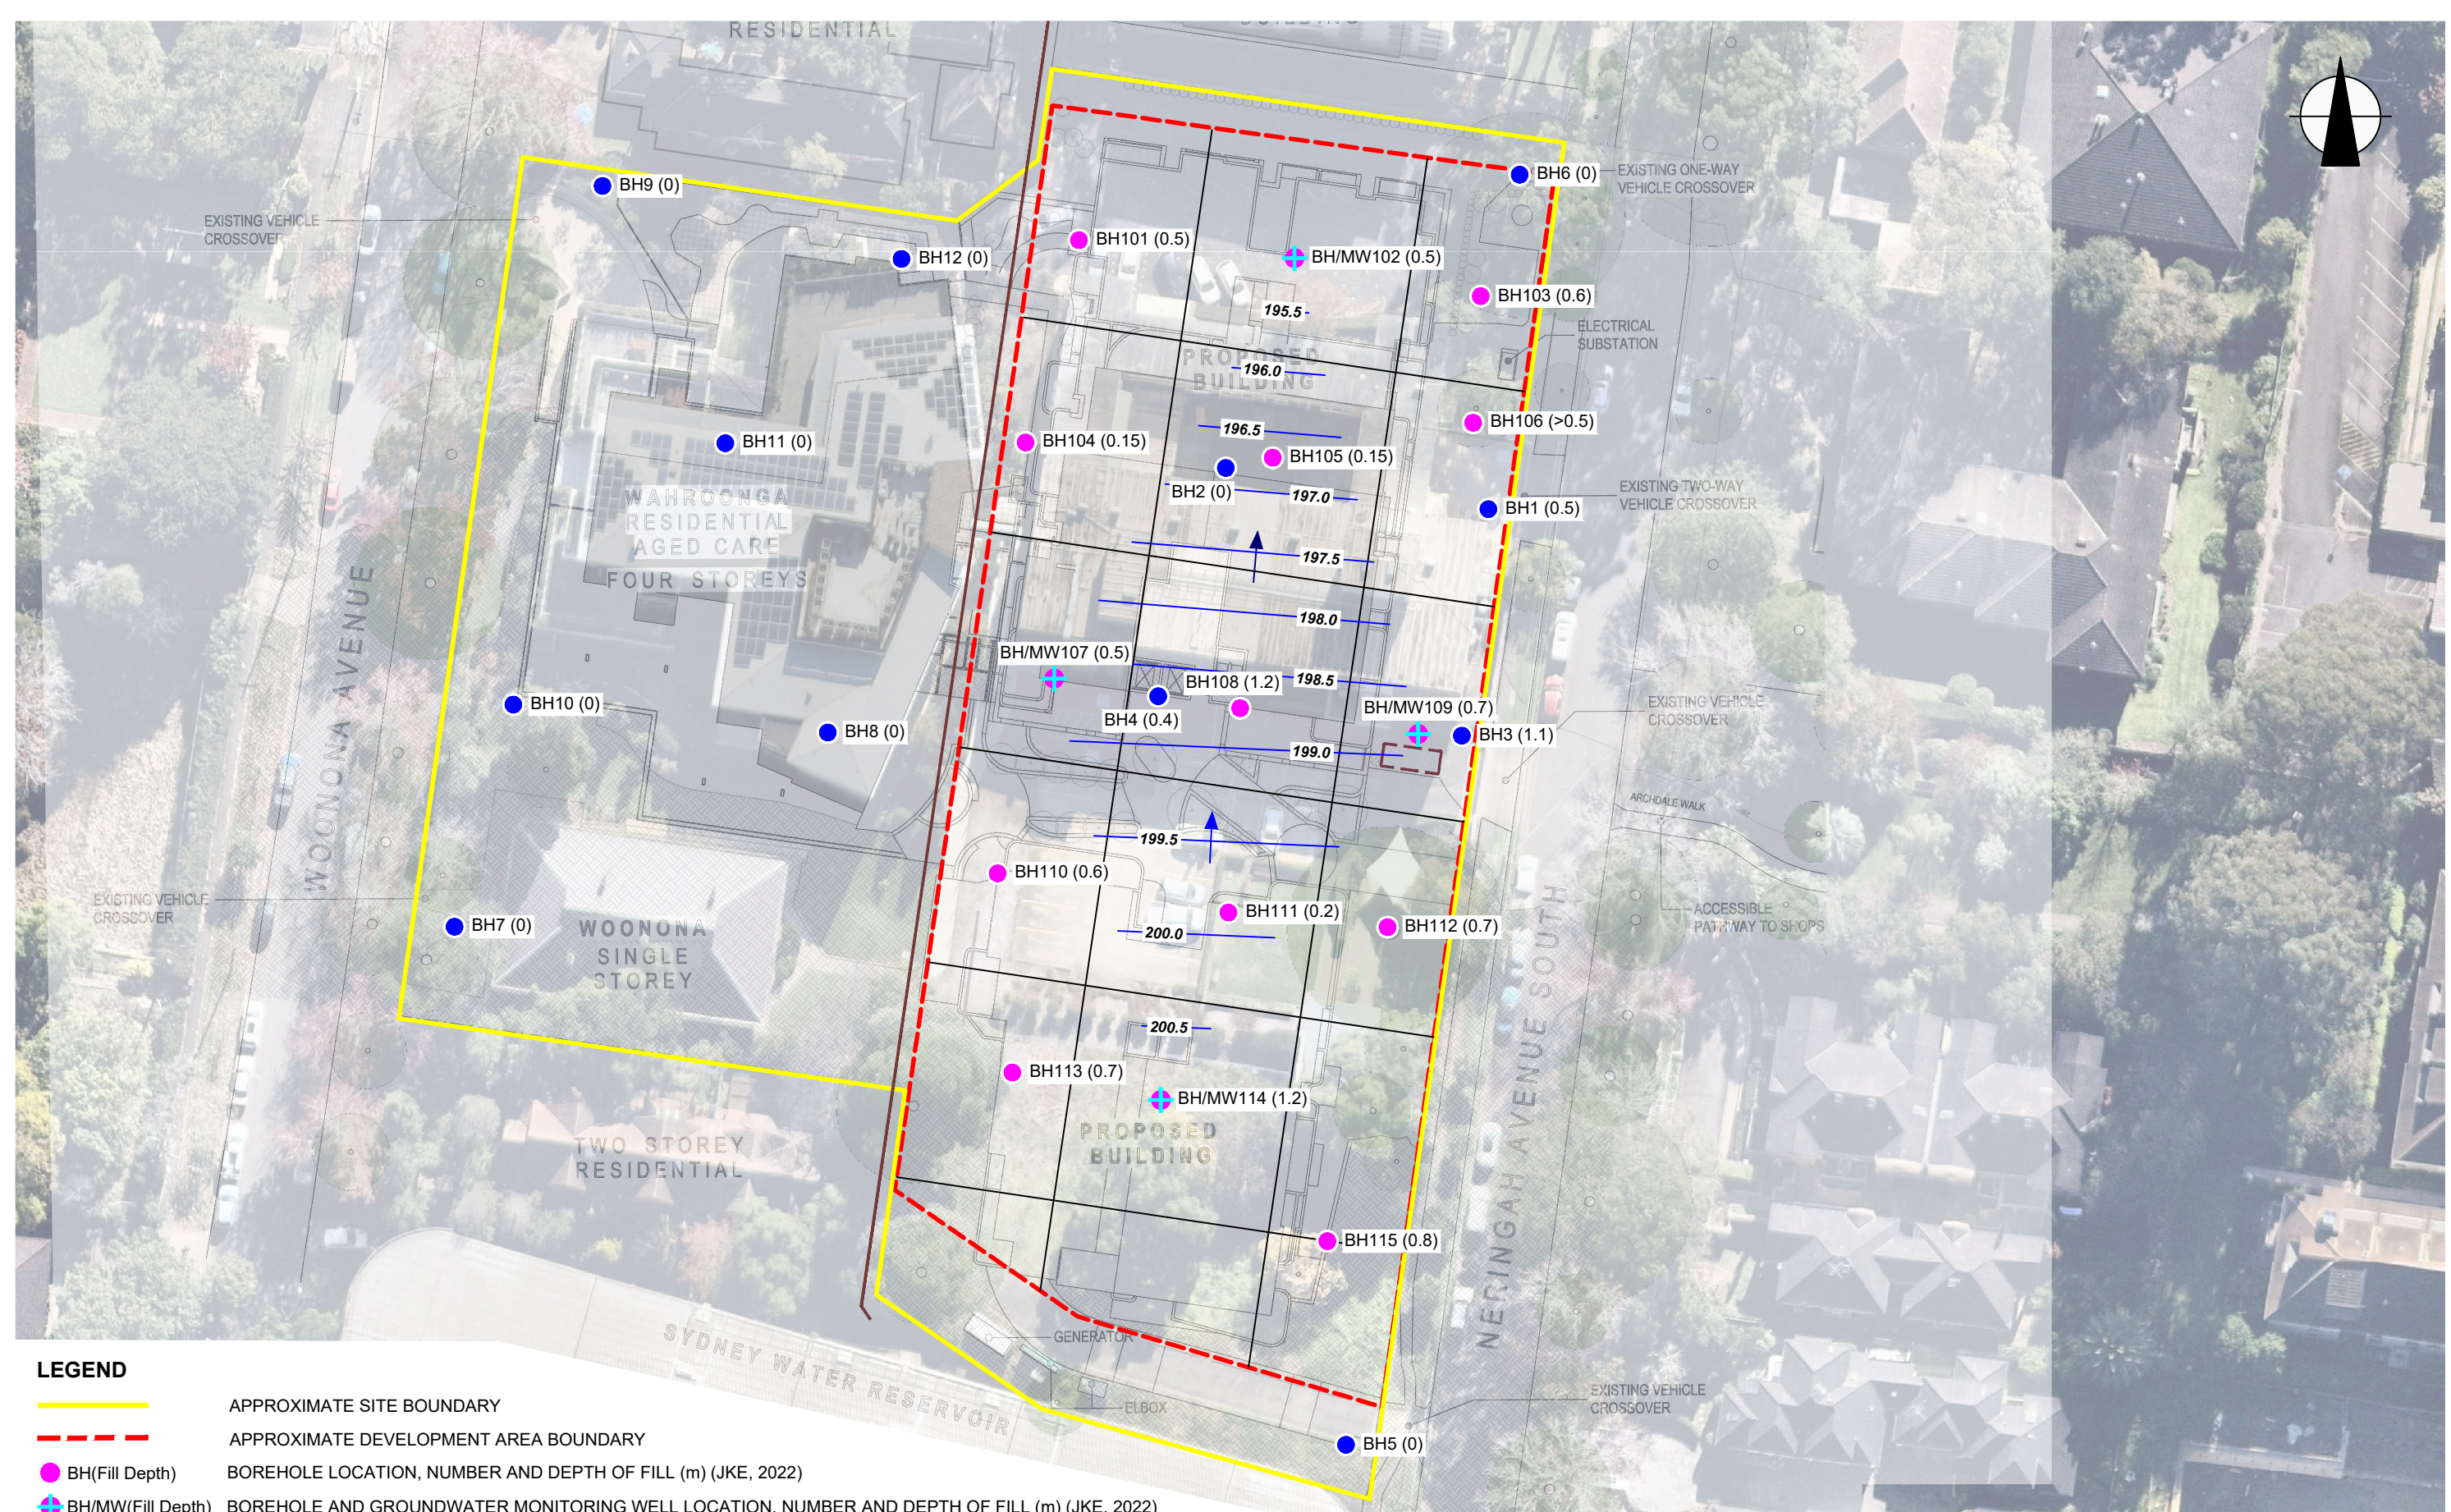
Title: <b>GROUNDWATER CONTOUR PLOT</b>	
Location: NERINGAH HOSPITAL, 4-12 NERINGAH AVENUE SOUTH, WAHROONGA, NSW	
Project No: E35312BR	Figure No: 4
<b>JKEnvironments</b>

- APPROXIMATE SITE BOUNDARY
- - - APPROXIMATE DEVELOPMENT AREA BOUNDARY
- BH(Fill Depth) BOREHOLE LOCATION, NUMBER AND DEPTH OF FILL (m) (JKE, 2022)
- ⊕ BH/MW(Fill Depth) BOREHOLE AND GROUNDWATER MONITORING WELL LOCATION, NUMBER AND DEPTH OF FILL (m) (JKE, 2022)
- BH(Fill Depth) BOREHOLE LOCATION, NUMBER AND DEPTH OF FILL (m) (EIS, 2010)
- - - APPROXIMATE LOCATION OF SUSPECTED UNDERGROUND STORAGE TANK (UST)
- - - APPROXIMATE ALIGNMENT OF SEWER
- 200.5 GROUNDWATER CONTOUR INTERVALS (m)
- INFERRED GROUNDWATER FLOW DIRECTION

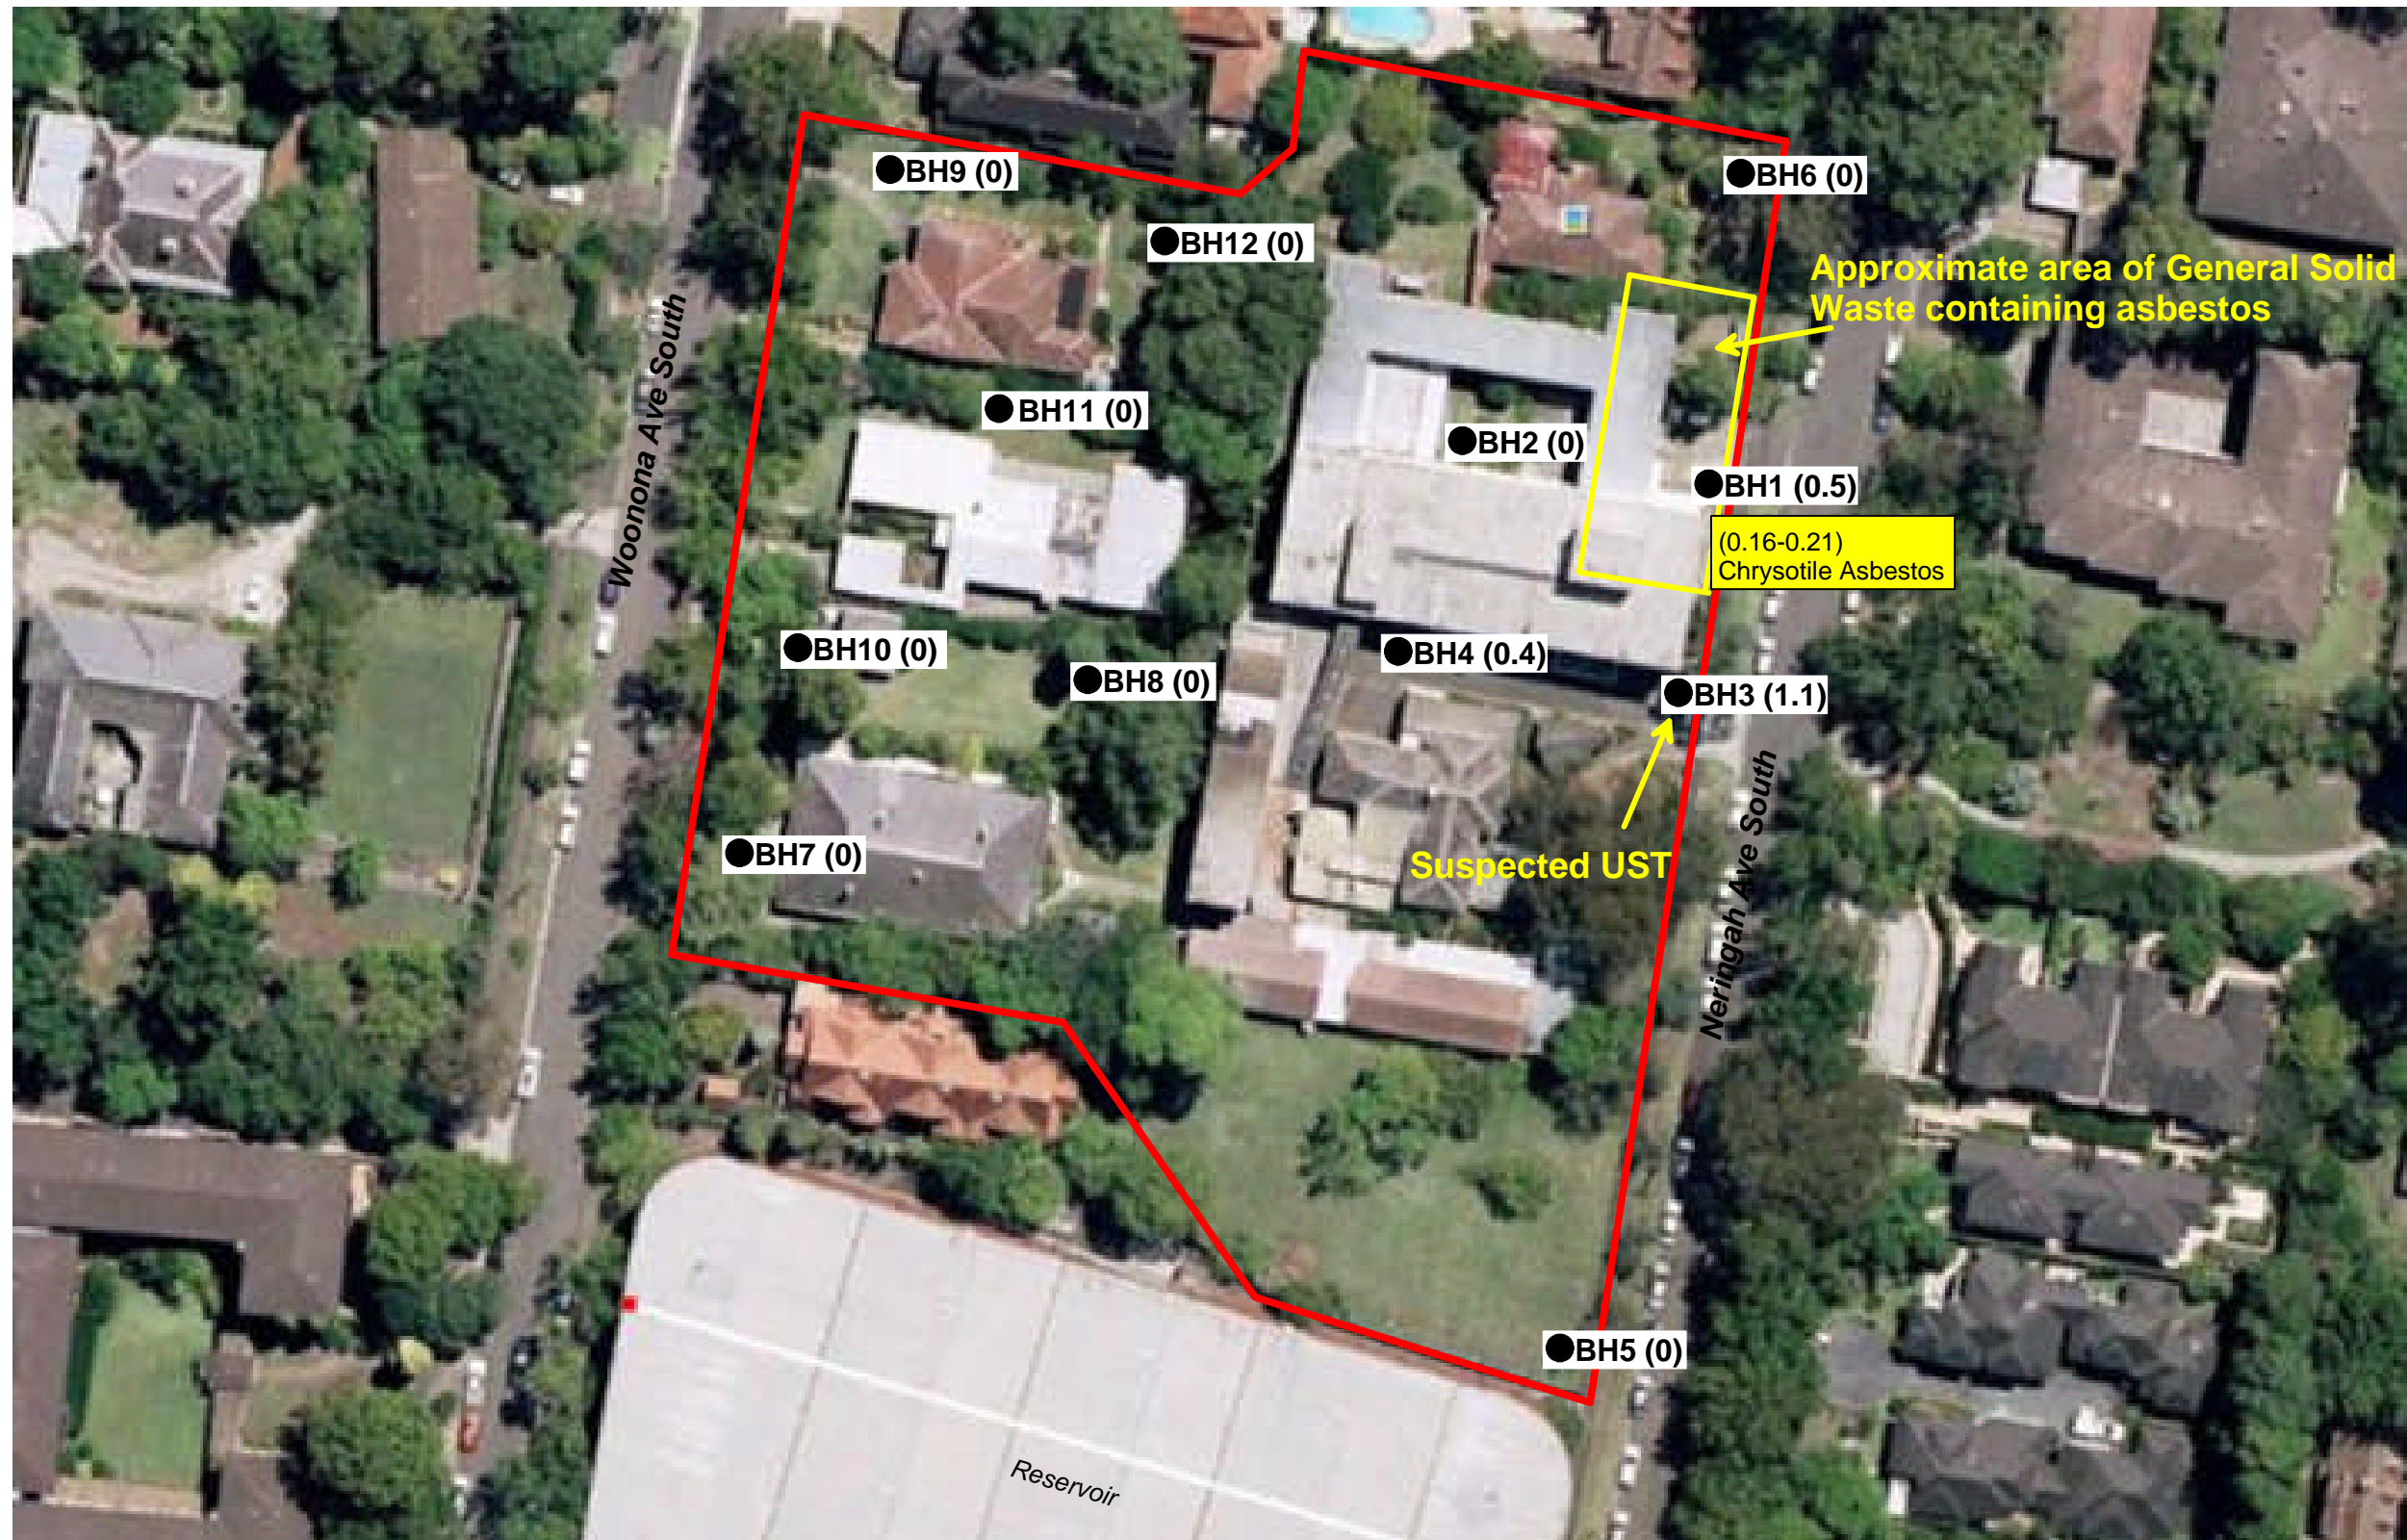
- BH1 (0.7) BOREHOLE LOCATION, NUMBER AND DEPTH OF FILL (m)
- APPROXIMATE SITE BOUNDARY
- (0.16-0.21) Chrysotile Asbestos SAMPLE DEPTH (m) CONTAMINANT

The investigation identified asbestos in one fill soil sample collected from BH1 located at the subject site (see Figure 3 attached in the appendices). All other soil results were below the site assessment criteria (SAC). The asbestos was identified as loose fibre bundles, and was considered to be asbestos fines/fibrous asbestos (AF/FA) (i.e. friable asbestos). The asbestos was identified in fill soil beneath concrete pavement (and therefore inaccessible), and was assessed to not present an immediate risk to human health.

- Asbestos, as AF/FA (loose fibre bundles) were encountered in fill soil at BH1. The fill soil was sealed beneath concrete pavement and the friable asbestos in soils were assessed to not present an immediate risk to human health.

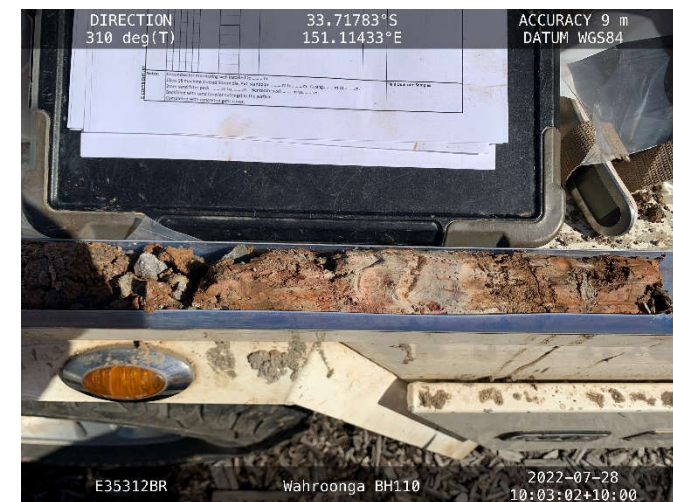
Photograph 12: Fill material from BH110.

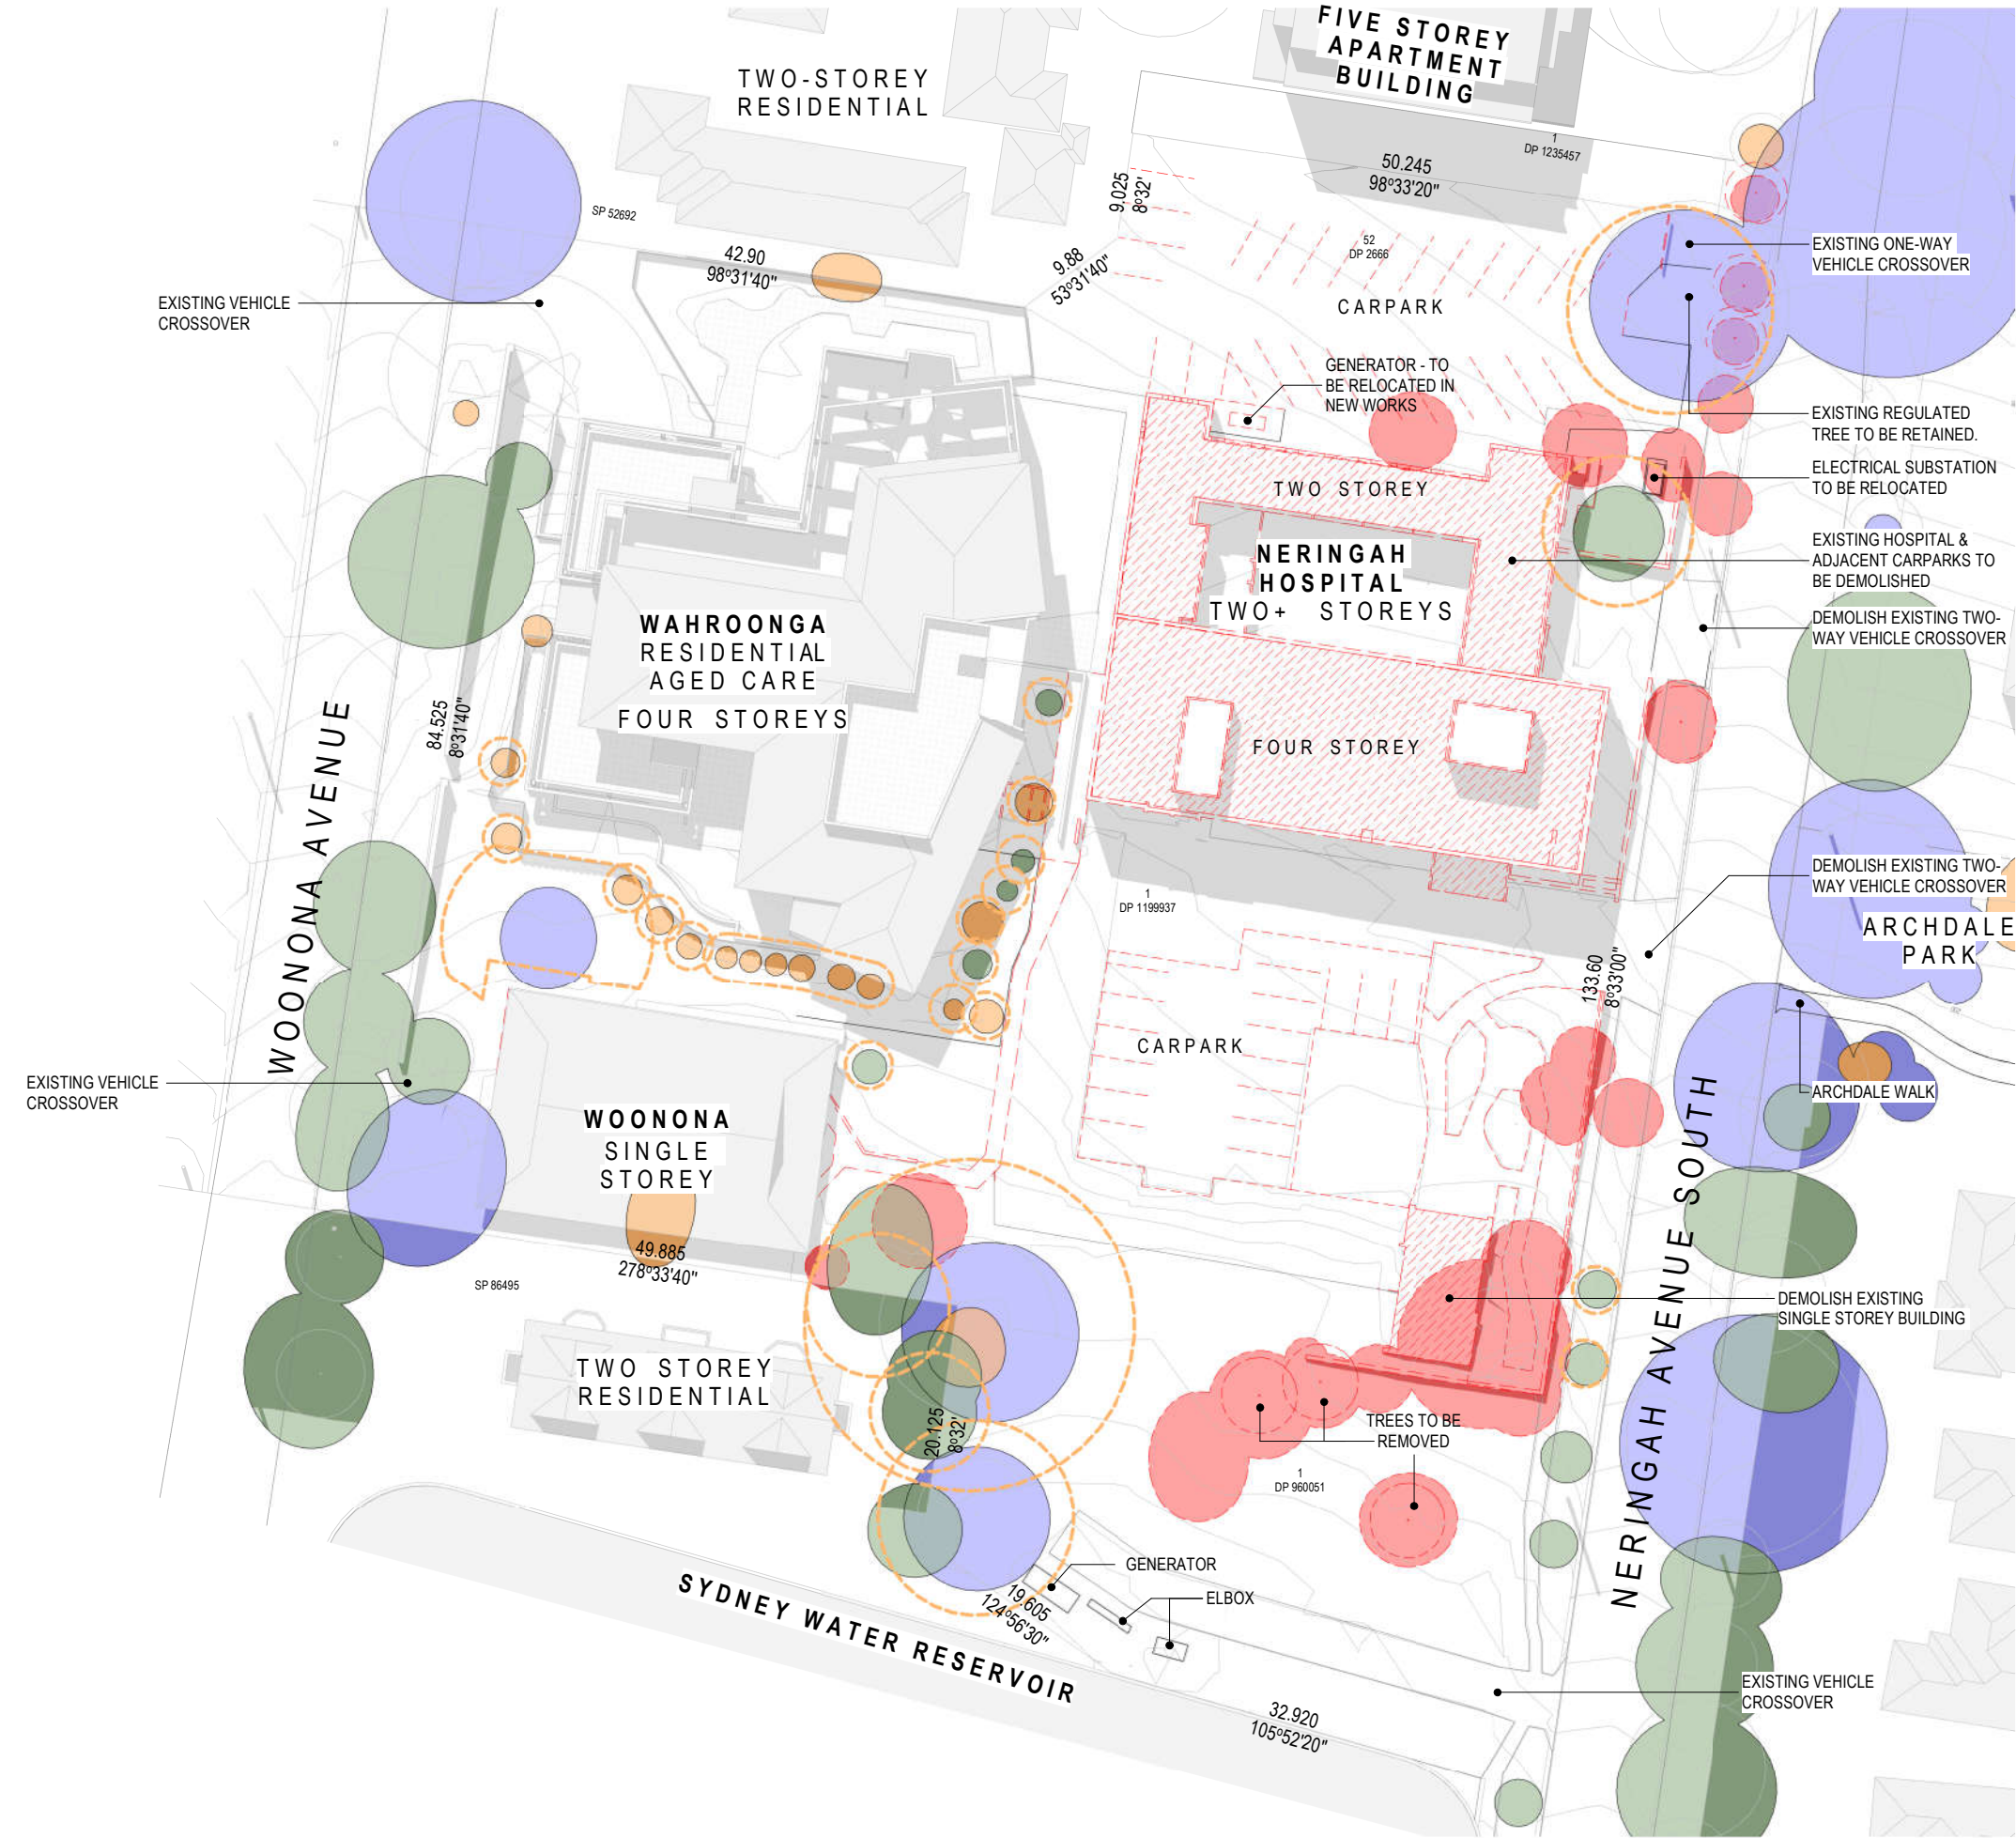
DRAWING TITLE:  
EXISTING & DEMOLITION SITE  
PLAN  
DATE: OCT. 2022  
CHECKED: BF  
DRAWN: RW, JC

LEGEND - EXISTING & DEMOLITION PLAN	
SYMBOL	DESCRIPTION
	ITEM TO BE DEMOLISHED
	SITE BOUNDARY
	TREE PROTECTION ZONE
	EXISTING TREE (LOW IMPORTANCE) - TO BE RETAINED
	EXISTING TREE (MODERATE IMPORTANCE) - TO BE RETAINED
	EXISTING TREE (HIGH IMPORTANCE) - TO BE RETAINED
	EXISTING TREE - TO BE REMOVED
