**REPORT TO
HAMMONDCARE**

**ON
ACID SULFATE SOIL ASSESSMENT**

**FOR
PROPOSED HOSPITAL REDEVELOPMENT**

**AT
NERINGAH HOSPITAL, 4-12 NERINGAH AVENUE
SOUTH, WAHROONGA, NSW**

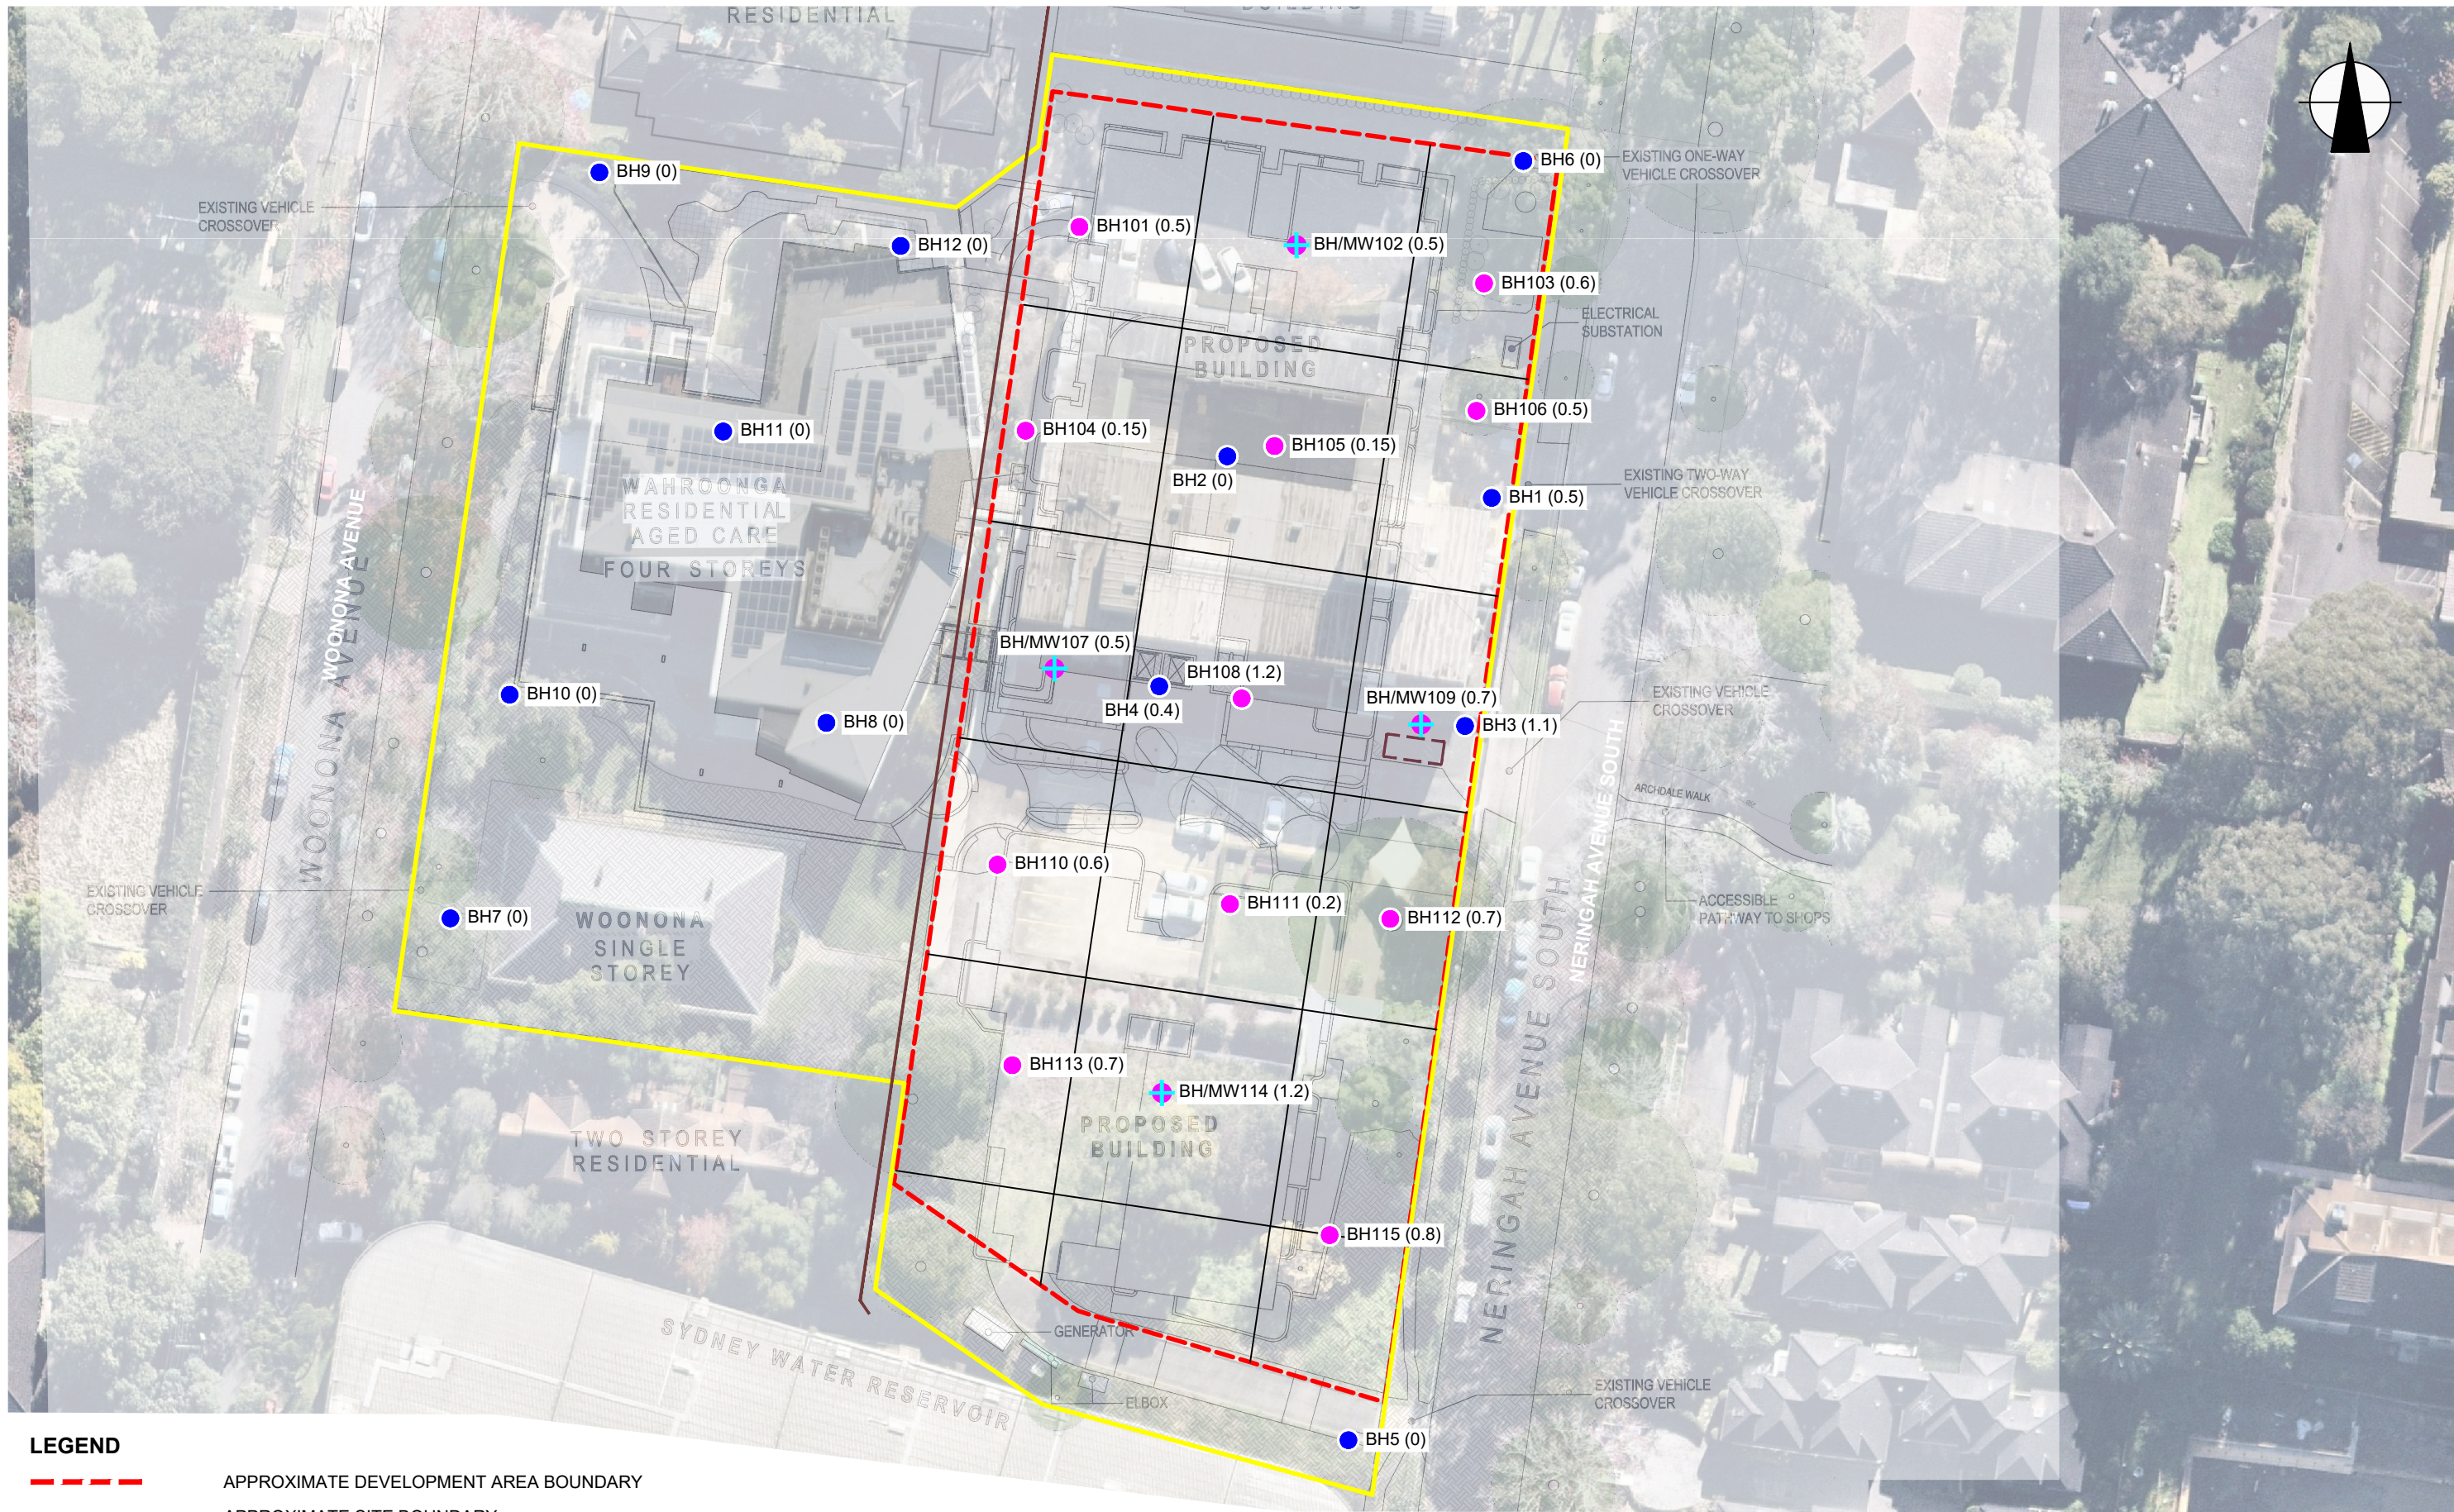
- APPROXIMATE DEVELOPMENT AREA BOUNDARY
- APPROXIMATE SITE BOUNDARY
- BH(Fill Depth) BOREHOLE LOCATION, NUMBER AND DEPTH OF FILL (m) (JKE, 2022)
- + BH/MW(Fill Depth) BOREHOLE AND GROUNDWATER MONITORING WELL LOCATION, NUMBER AND DEPTH OF FILL (m) (JKE, 2022)
- BH(Fill Depth) BOREHOLE LOCATION, NUMBER AND DEPTH OF FILL (m) (EIS, 2010)
- APPROXIMATE LOCATION OF SUSPECTED UNDERGROUND STORAGE TANK (UST)
- APPROXIMATE ALIGNMENT OF SEWER

A summary of the subsurface soil conditions encountered during the assessment is presented in the table below. For completeness, the summary below includes details from all boreholes drilled for the concurrent Detailed Site Contamination Investigation (DSI) completed by JKE for the SEARs. Reference should be made to the borehole logs attached in the appendices for further details.

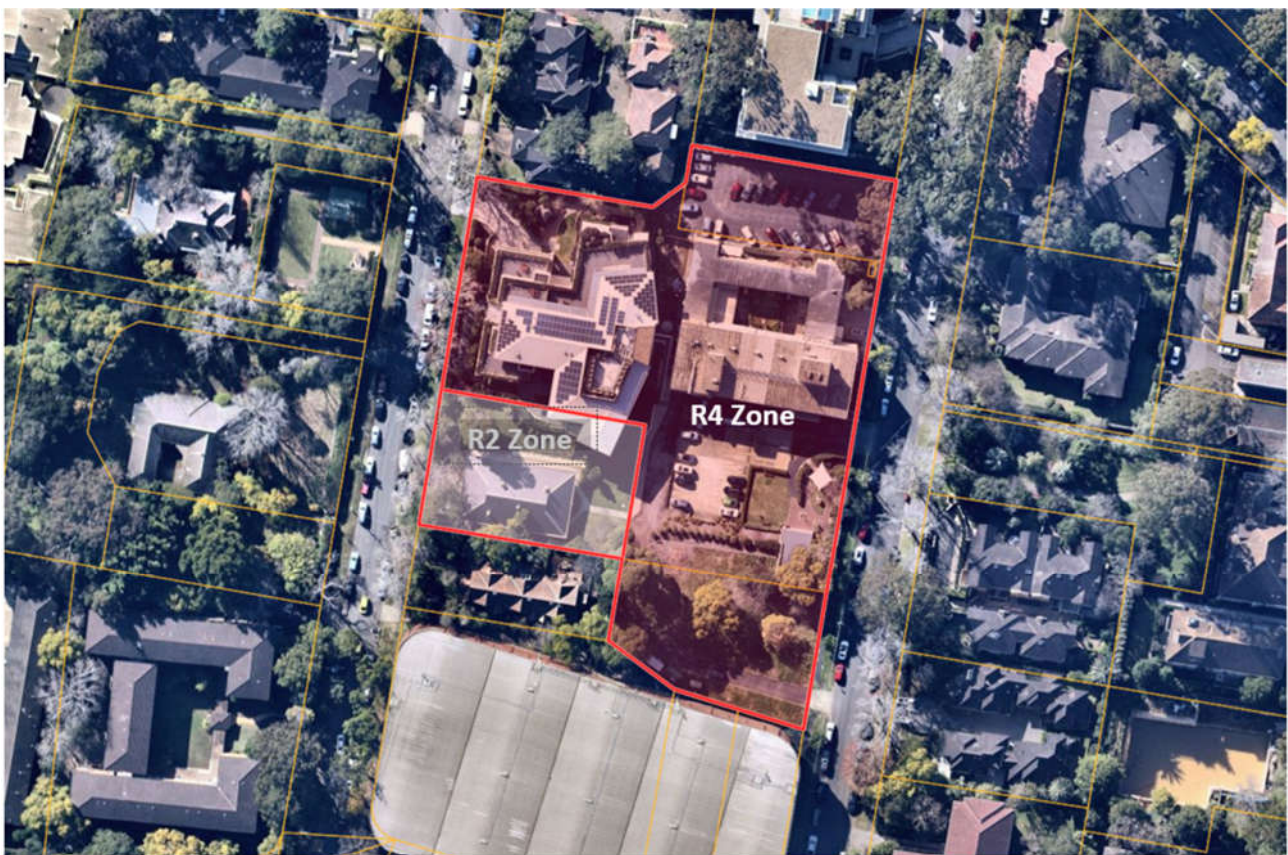
Figure A: Outline of the site, with the portion of the site subject to the SCC shaded dark red (R4 zone)
