REPORT TO
BAPTISTCARE

ON
**APPENDIX O - PRELIMINARY (STAGE 1) SITE
INVESTIGATION**

FOR
PROPOSED REDEVELOPMENT MASTERPLAN

AT
157 BALACLAVA ROAD, MACQUARIE PARK, NSW

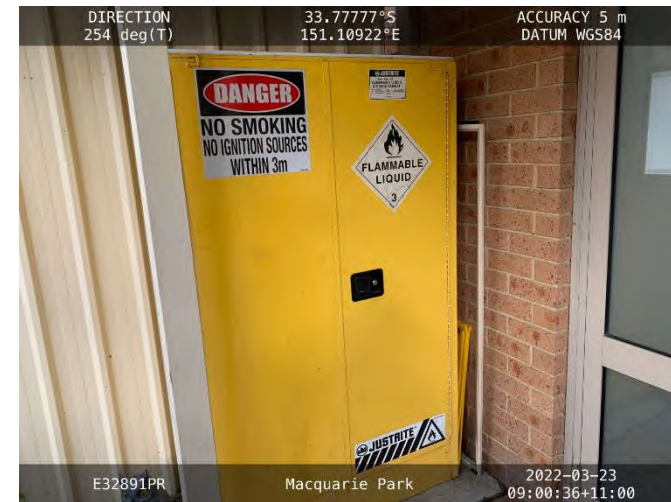
Photograph 2: Flammable Liquid Storage Cabinet

- Historical filling activities at the site;
- Historical agricultural (orchards) use;
- Use of pesticides beneath the buildings and/or around the site;
- Flammable liquid storage cabinet and chemical storage shed; and
- Hazardous building materials within current and former buildings and structures at the site.

General household waste and recycling municipal waste bins were observed at a majority of the residential dwellings within the Willandra Village. Clinical and cytotoxic waste storage containers were observed in the western and central sections of the site. A 250L flammable liquid storage cabinet and a small corrugated metal storage shed (labelled as a chemical store) were observed in the south-west of site, near the Dorothy Henderson Lodge (see Figure 2). The cabinet and chemical store were locked and were not able to be inspected. No obvious indications of spills/releases (such as staining and/or odours) were observed on the site surface in the immediate vicinity of the storage areas. Notwithstanding, as the contents of the cabinet and store could not be inspected, the area has been considered in the CSM.

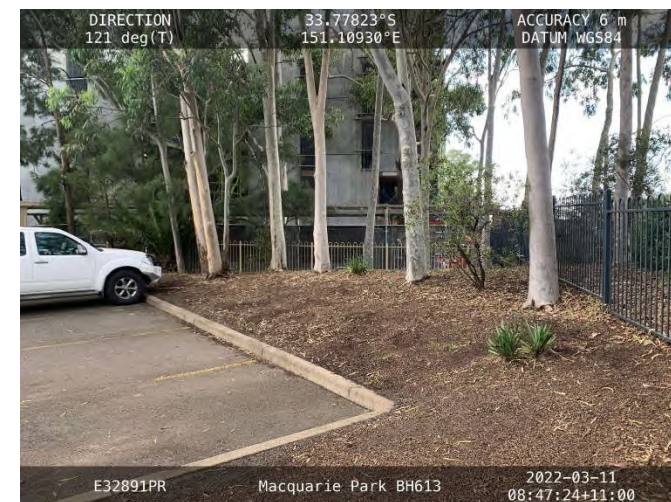
Photograph 4: BH613 (Dorothy Henderson Lodge)

The site surface in the vicinity of BH611 and BH613 was unsealed and comprised of gardens. As the site is currently occupied and the soils are accessible, there is potential for a complete SPR linkage to exist. It is noted that BH611 and BH613 are located within gardens/open space and buildings/structures were not observed in the immediate vicinity of BH611 and BH613. On this basis, JKE is of the opinion that it is unlikely for TRH concentrations in soil to volatilise, migrate into and accumulate within buildings/structures to the extent that the TRH concentrations pose an unacceptable risk to human health. JKE note that with regard to on-site ecological receptors, the vegetation across the site was considered to be healthy (based on a cursory inspection). Based on the above, the potential for TRH to pose risk to receptors in the current configuration is considered to be low. Further assessment is required to better assess the potential risks posed by TRH in the context of the proposed future developments in the vicinity of BH611 and BH613.

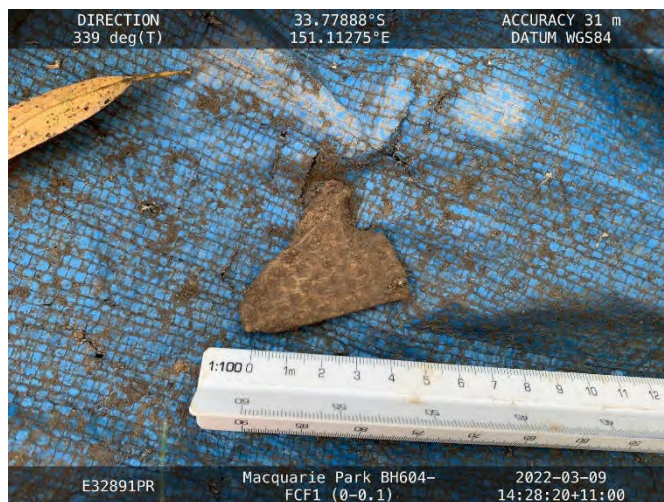
Photograph 11: FCF in BH604

The investigation identified asbestos, in the form of FCF/asbestos containing material (ACM), in surficial (0-100mm) fill soils in BH604 and BH605 at concentrations above the human health-based site assessment criteria (SAC). The source of the asbestos is considered likely to be associated with historic demolition and/or possibly historical filling activities (but more likely the former). The FCF appeared to be in reasonable to good condition (i.e. bonded/non-friable asbestos). The site surface in the vicinity of BH604 and BH605 are currently grass/mulch covered. The site is currently occupied and the areas in the vicinity of BH604 and BH605 are accessible to the site occupants. As such, the soils in these areas may be disturbed. On this basis, a complete source-pathway-receptor (SPR) linkage could occur, however, we consider

- Prepare an AMP to outline the management strategy for addressing the risks posed by asbestos. This should be prepared by the LAA;
- Undertake a Detailed Site Investigation (DSI) to better assess the risks associated with the AEC/potential sources of contamination, and to inform preparation of the Remediation Action Plan (RAP) (or RAPs), if required. The DSI should address the data gaps identified in this report. It is noted that the masterplan includes several stages of development. The staging of the development works may require separate DSIs to be undertaken for each development stage; and
