APPENDIX G
Archaeology Report

Silver City Energy Storage Project Broken Hill, New South Wales

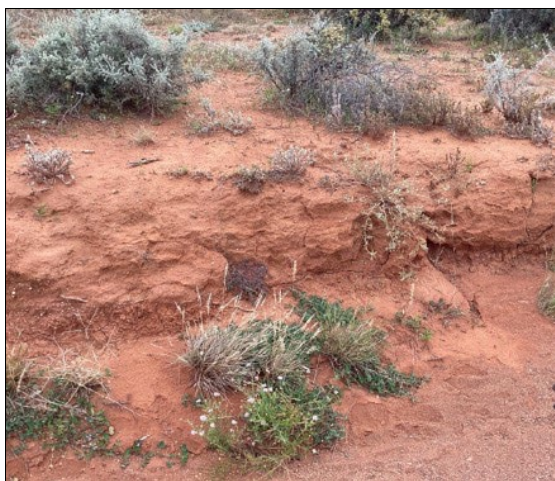
Plate 1: Example of exposure and archaeological visibility encountered in SU2 – open depression – creekline landform.

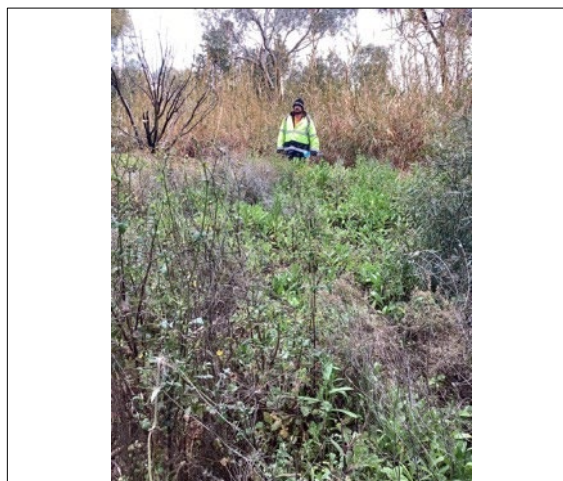
Plate 2: Example of an open depression – creekline landform unit displaying challenging survey conditions in SU74.

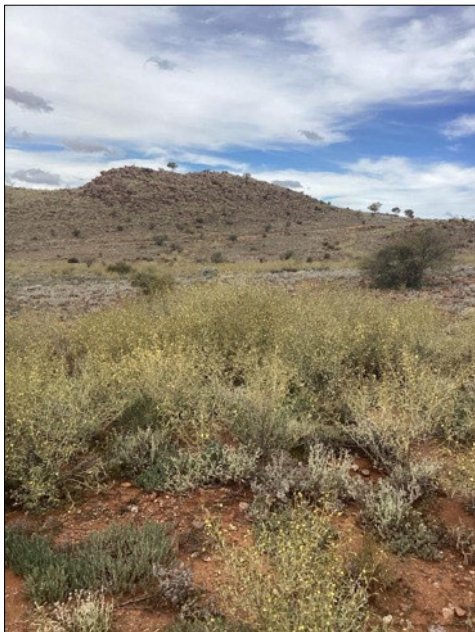
Plate 3: Example of survey conditions in SU15 – a creek flat landform.

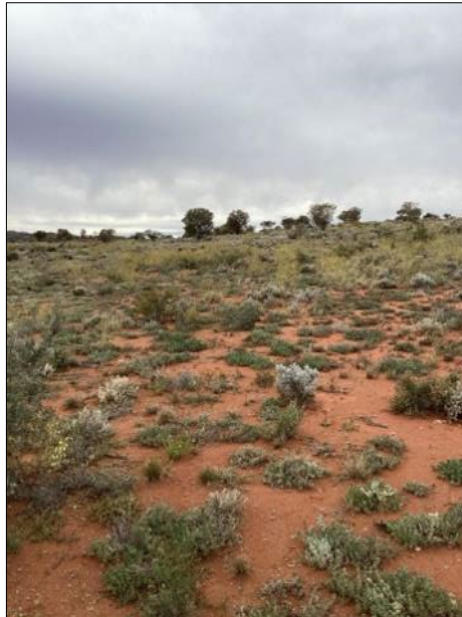
Plate 4: Example of survey conditions in SU3 – a simple slope.

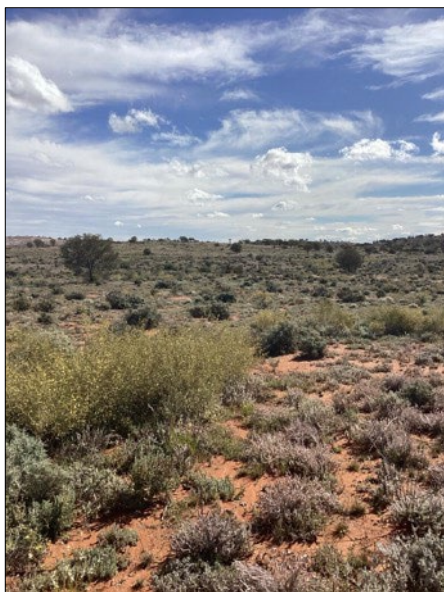
Plate 5: Example of survey conditions in SU 9– a lower slope [gentle].

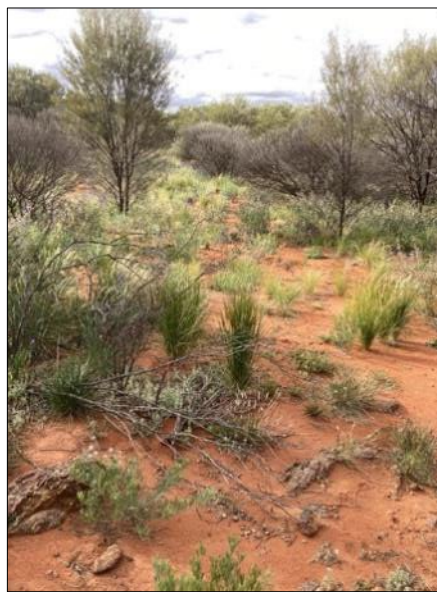
Plate 6: Example of survey conditions in SU69 – a lower slope.

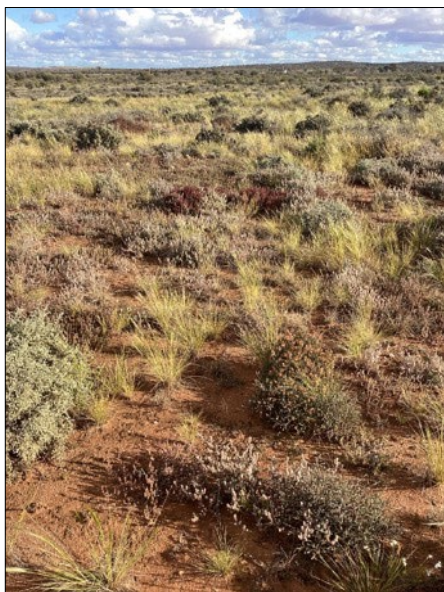
Plate 7: Example of survey conditions in SU 50– a flat landform.

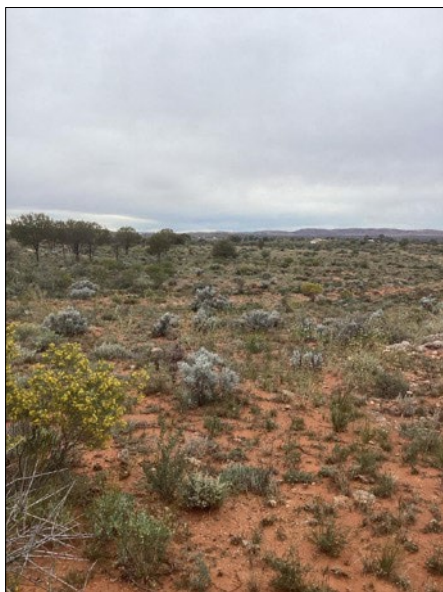
Plate 8: Example of survey conditions in SU 3– a flat landform.

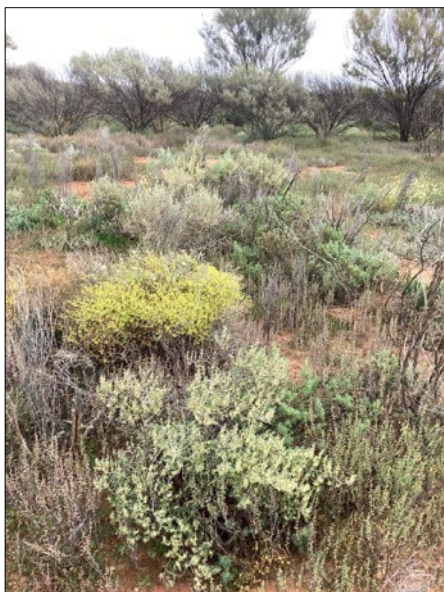
Plate 9: Example of survey conditions in SU 73– a plain landform.

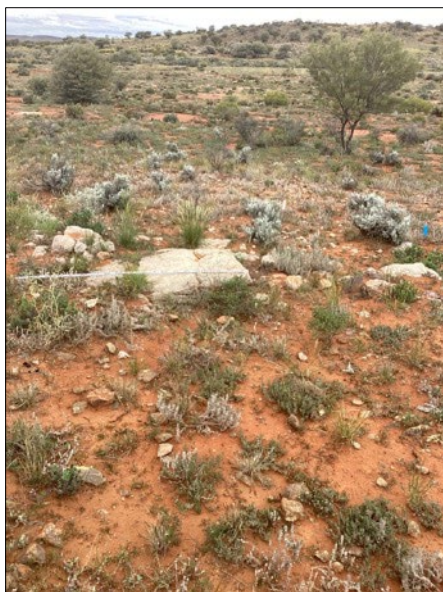
Plate 10: Example of survey conditions in SU 7 – a crest landform.

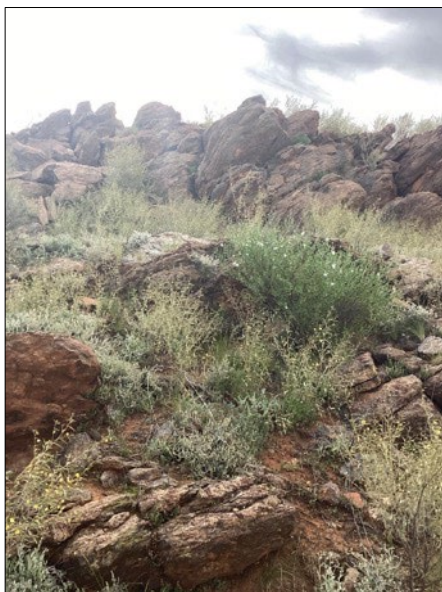
Plate 11: Example of survey conditions in SU20 showing rock outcropping– a mid and upper slope landform unit.

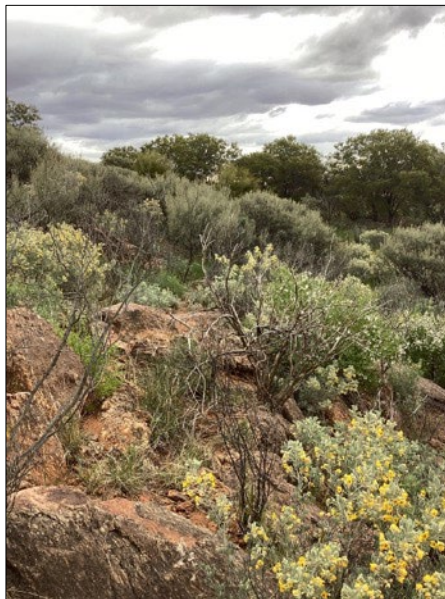
Plate 12: Example of survey conditions in SU67– a mid and upper slope [steep].

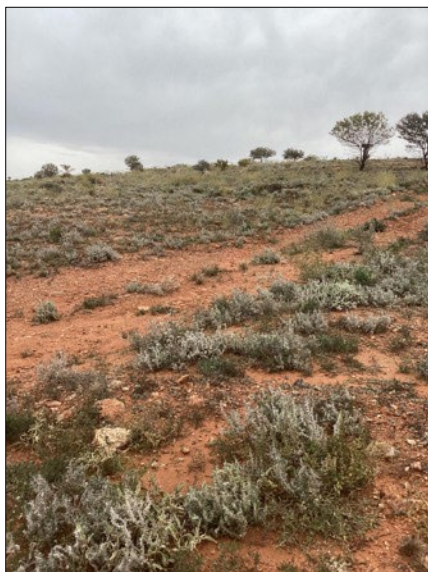
Plate 13: Example of recreational vehicle tracks in existence throughout the Project area. This image is taken at northern end of the proposed A-CAES site (SU5).

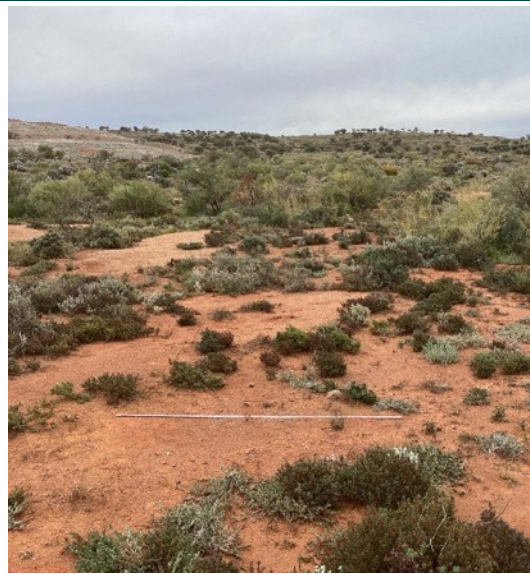
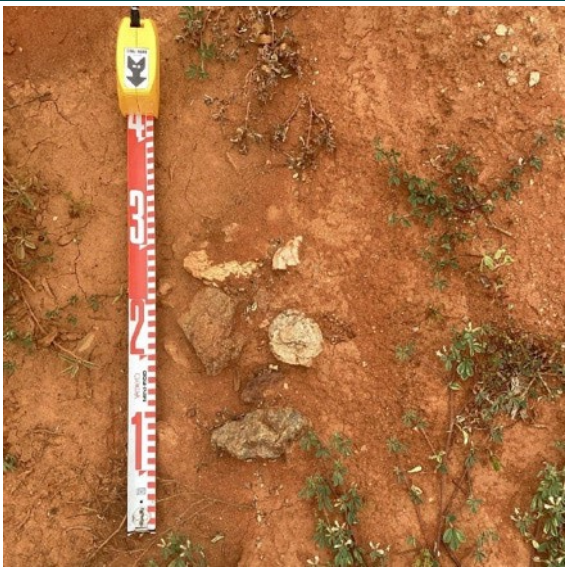
BH AFT/HTH 1, site overview, oriented west.		BH AFT/HTH 1 view of hearth materials.

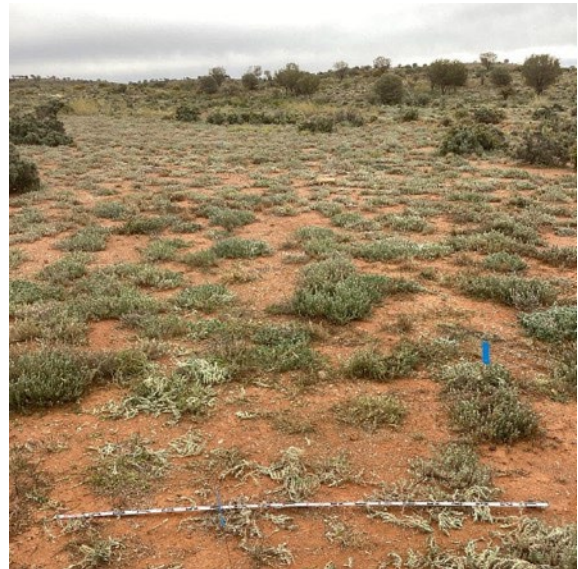
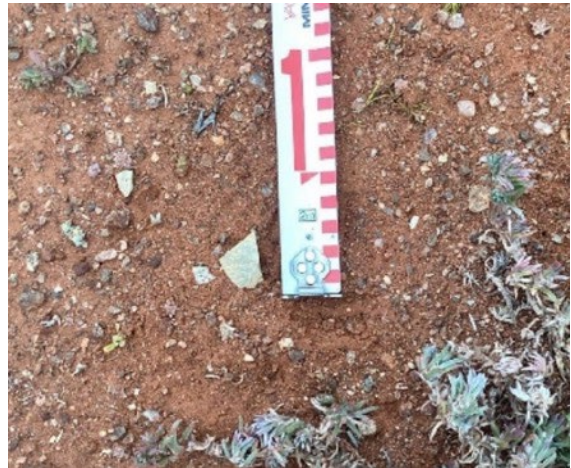
Broken Hill (A-CAES) BH1-48	
BH AFT 2, site overview, oriented south-southwest.	BH AFT 2, example artefact.

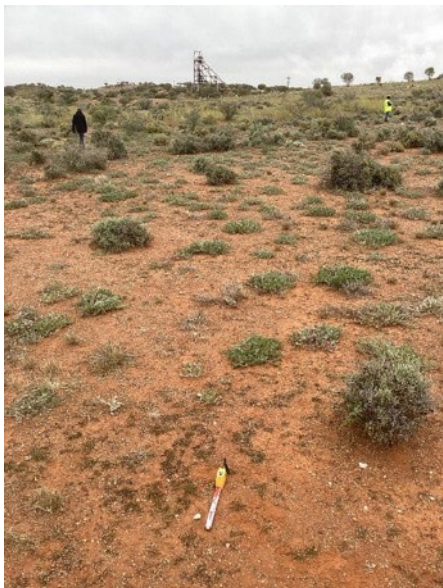
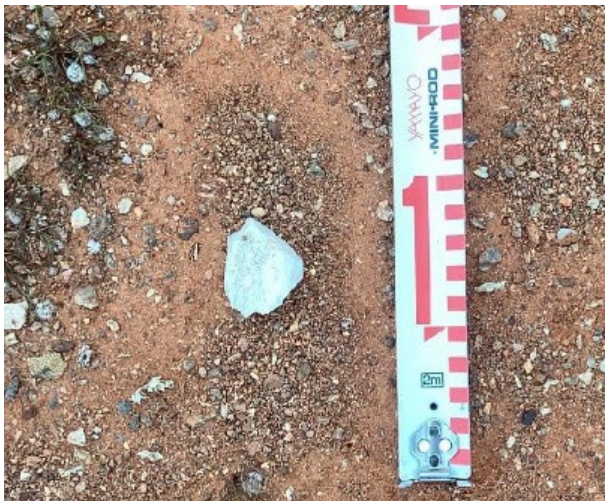
Broken Hill (A-CAES) AFT 3	
BH AFT 3, site overview, oriented southwest.	BH AFT 3, isolated artefact.

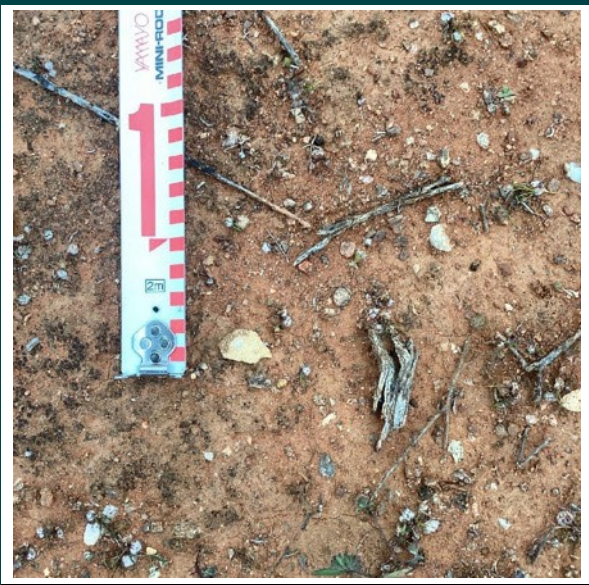
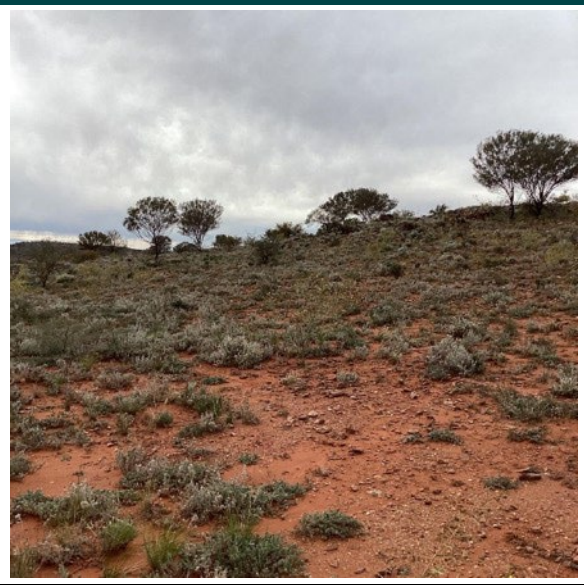
BH AFT 4, example artefact.	BH AFT 4, landform overview, oriented east.

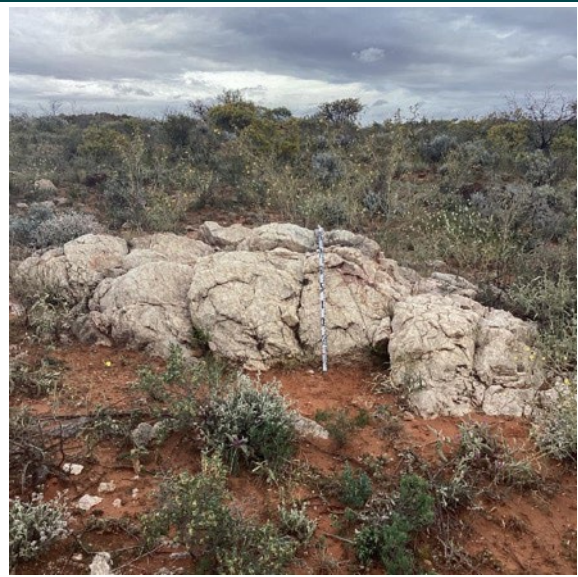
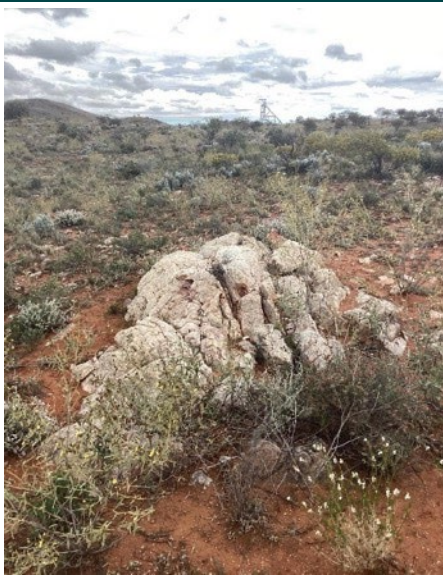
PM-Q5, site overview, oriented west-northwest.			PM-Q5, overview of outcrop, oriented southwest.

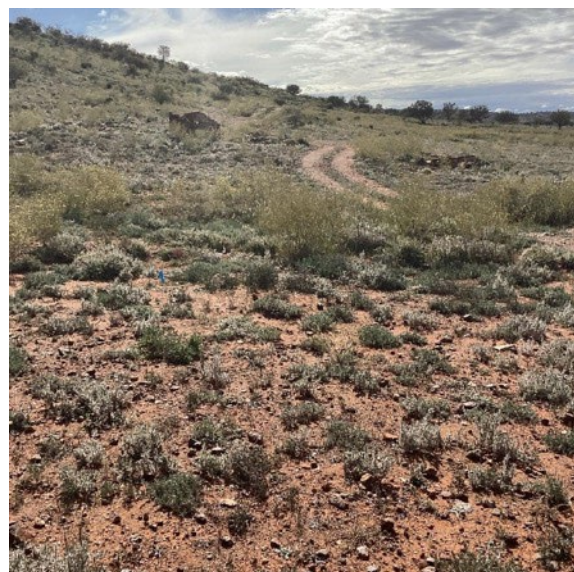
BH AFT 8, site overview, oriented north.

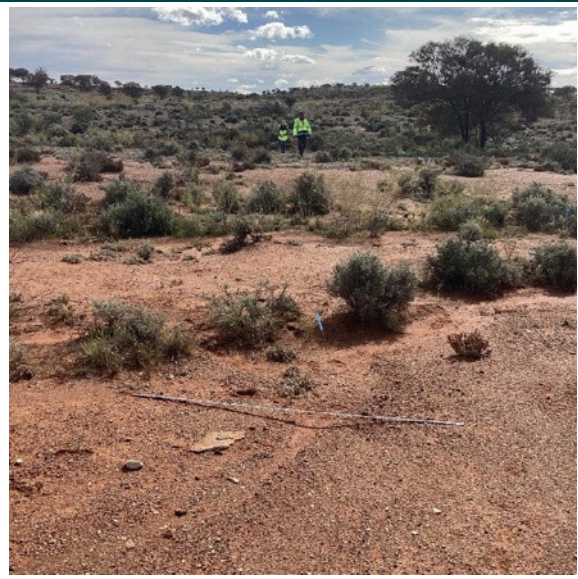
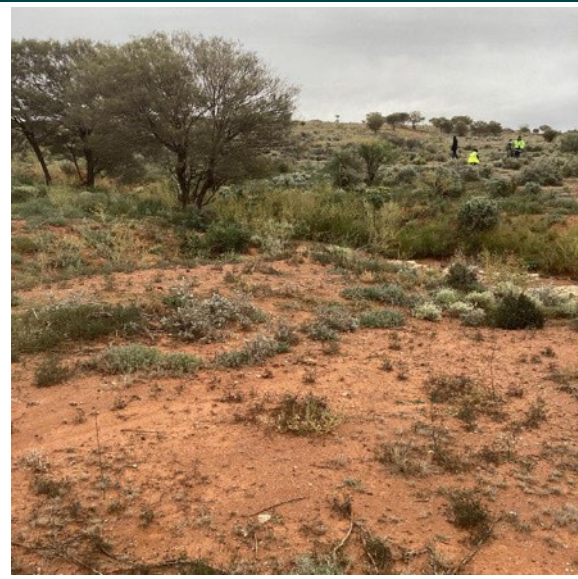
FD-IF7 site overview, oriented west.		FD-IF7 landform overview, oriented west.

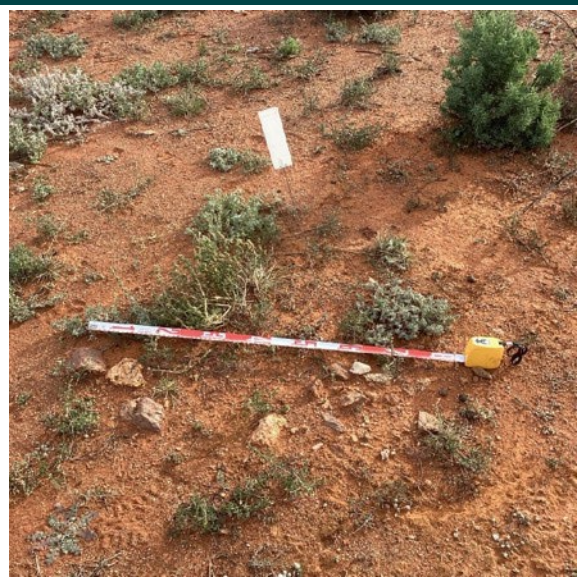
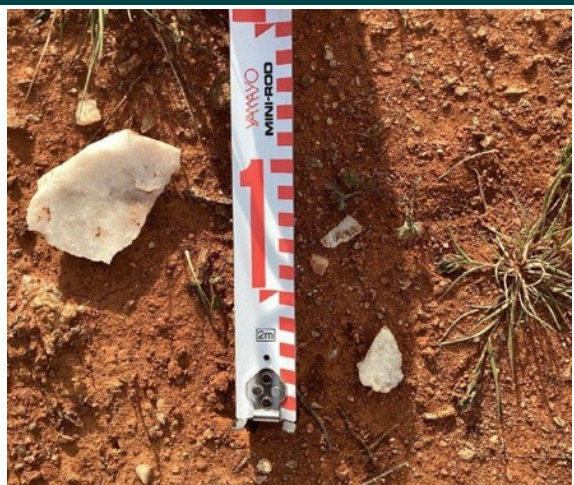
BH AFT/HTH 10, overview of hearth feature, oriented west.		BH AFT/HTH 10, example of artefacts.

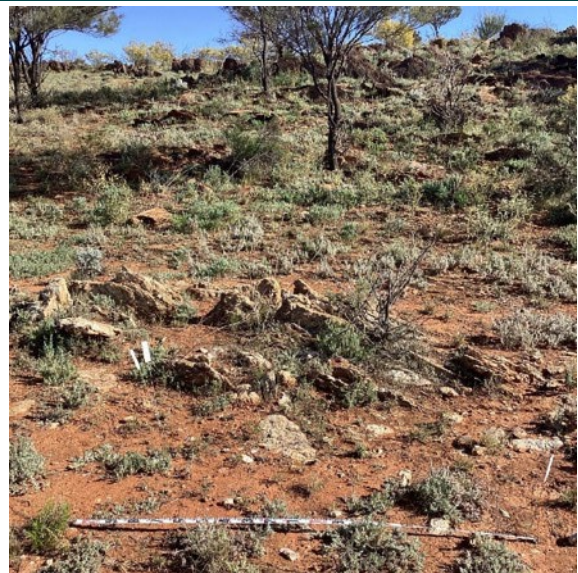
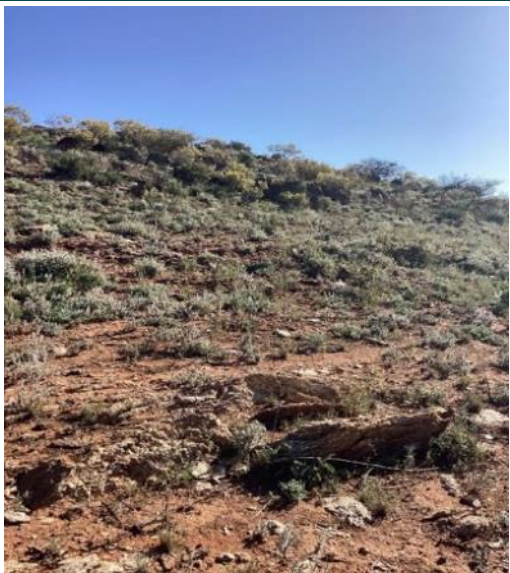
BH AFT 11, site overview, oriented west.	BH AFT 11, landform overview, oriented west.
--	--

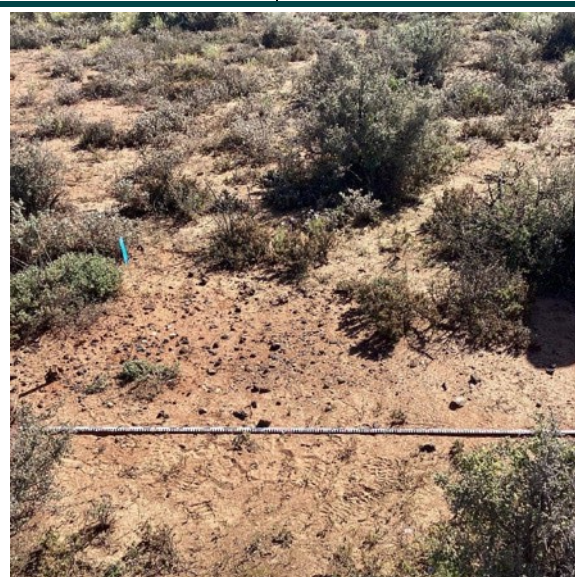
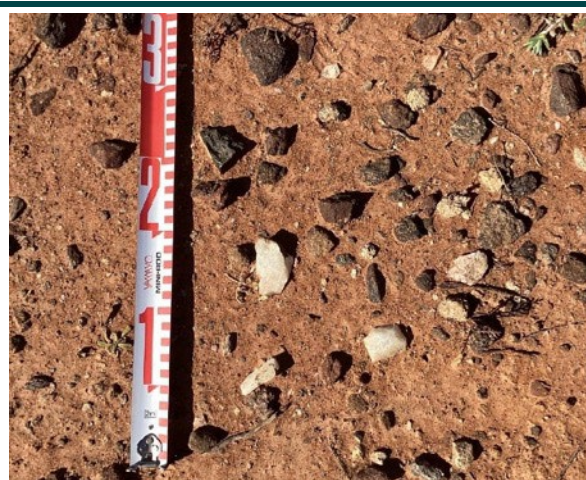
Broken Hill (A-CAES) AFT 12	
BH AFT 12, site overview, oriented west.	BH AFT 12, example artefacts.

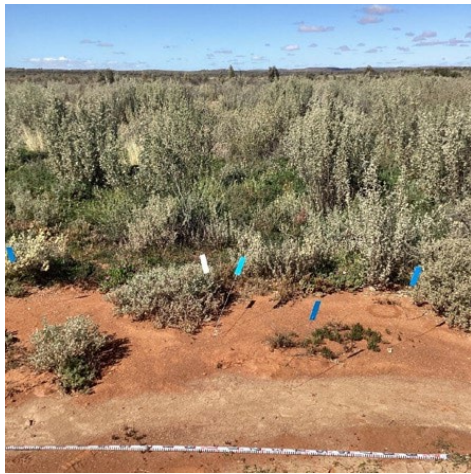
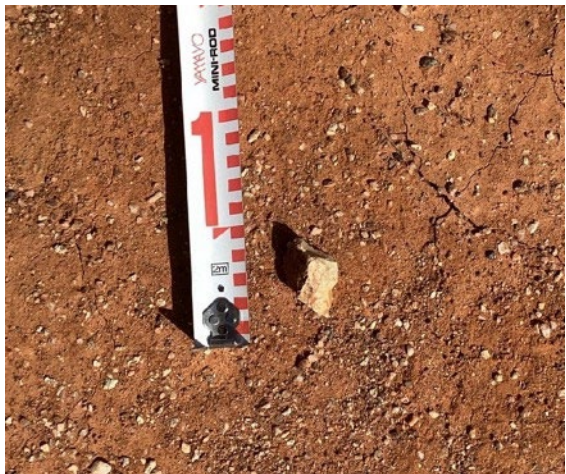
BH AFT 13, site overview, oriented southeast.	BH AFT 13 example artefact.

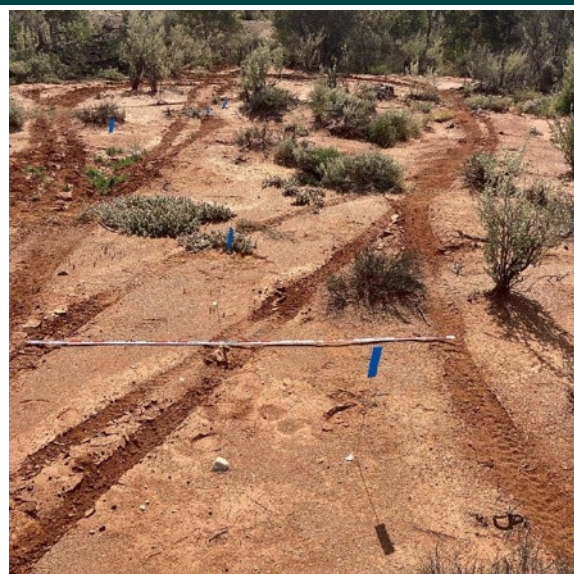
BH AFT 14, site overview, oriented west.

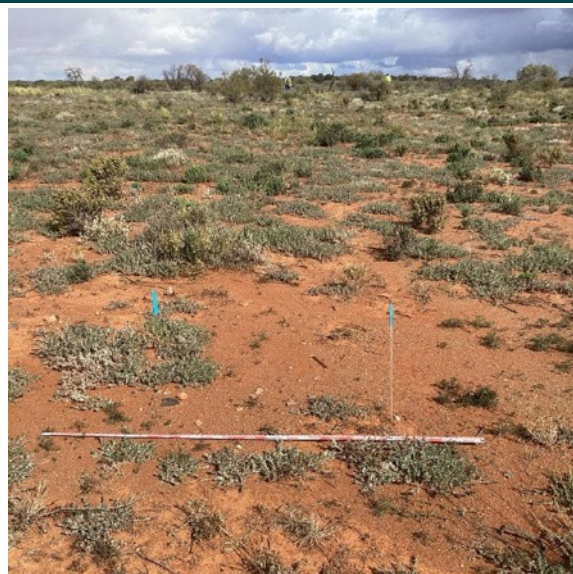
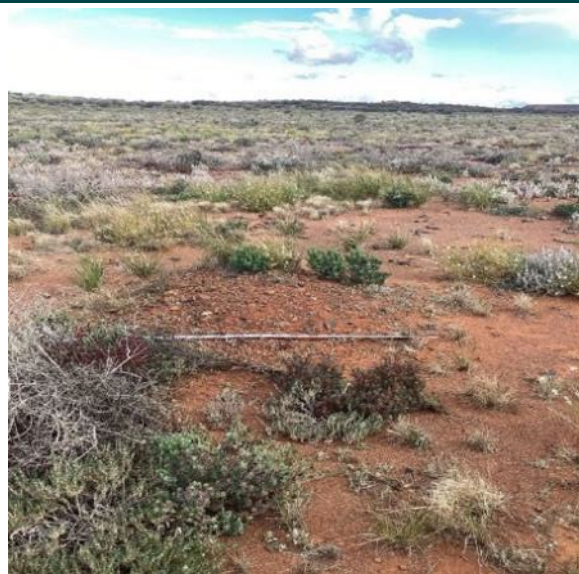
BH AFT/HTH 15, site overview, oriented southwest.		BH AFT/HTH 15, hearth feature, oriented southwest.

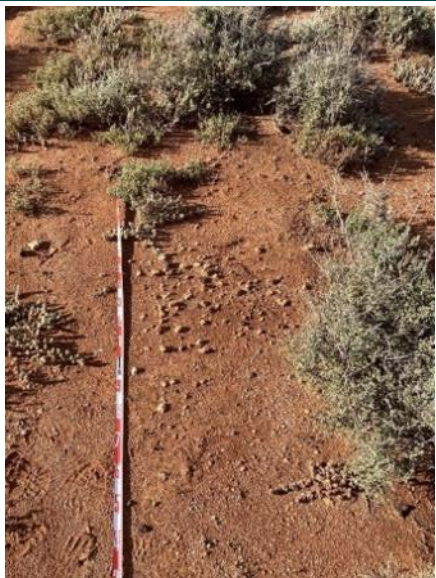
BH AFT/HTH 16, site overview, oriented southeast.	BH AFT/HTH 16 hearth feature facing north..

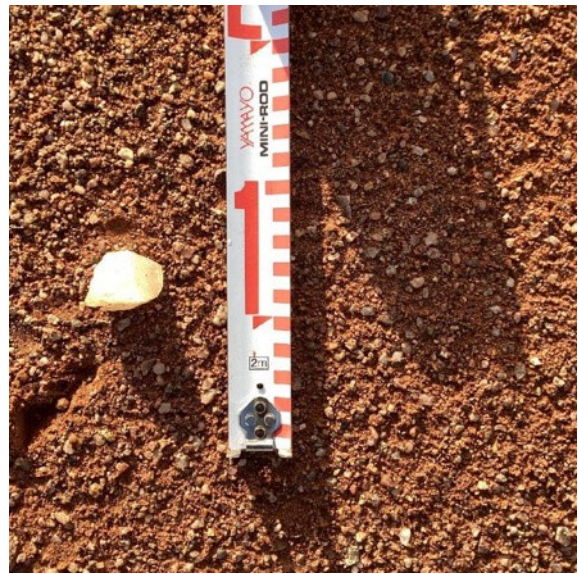
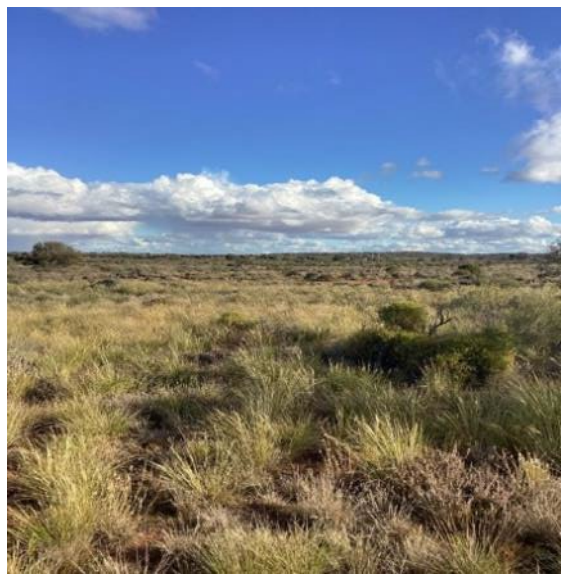
BH AFT 17, isolated artefact.			BH AFT 17 landform overview, oriented south

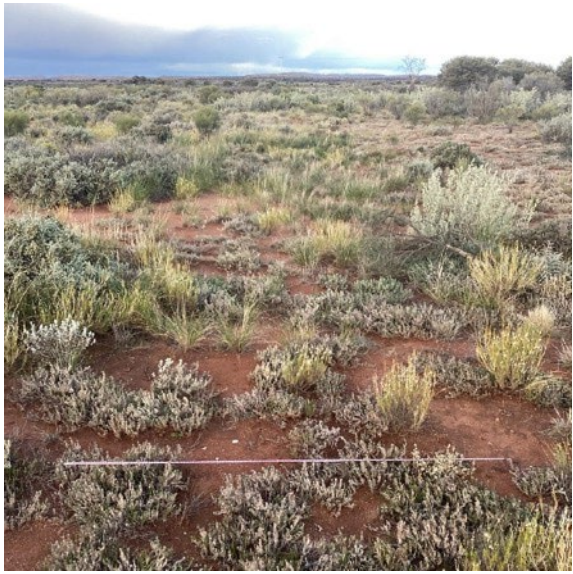
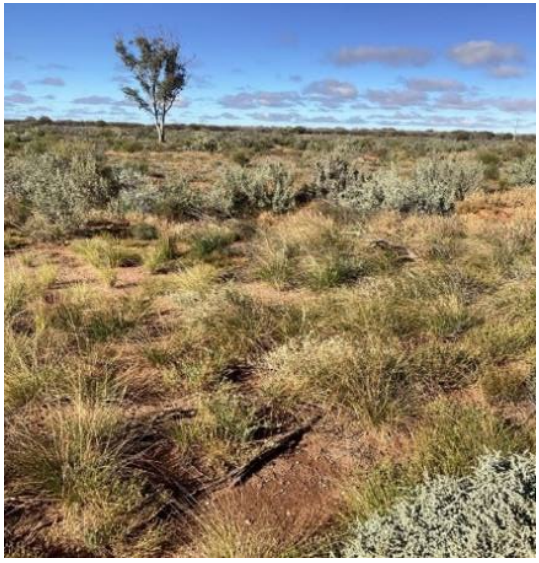
BH AFT 18, site overview, oriented east.	BH AFT 18, landform overview, oriented southwest.

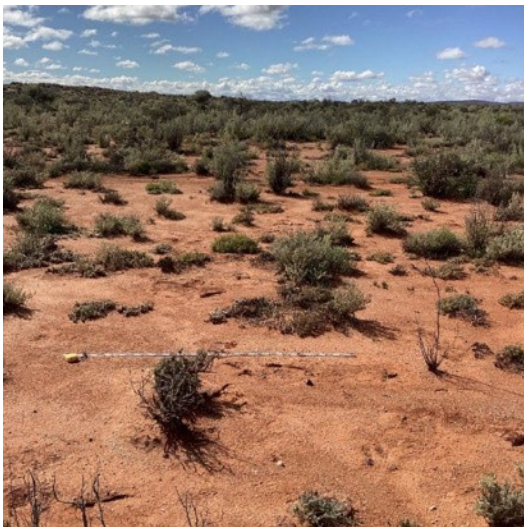
BH AFT 20, northern extent, oriented north.

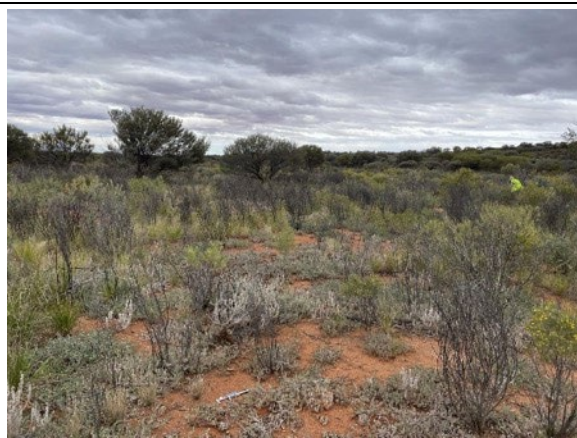
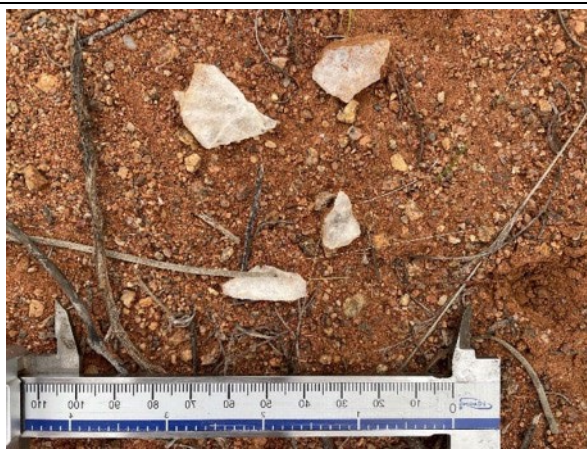
Broken Hill (A-CAES) AFT 20	
BH AFT 20, southern extent, facing south.	BH AFT 20, example of southern extent artefact scatter.

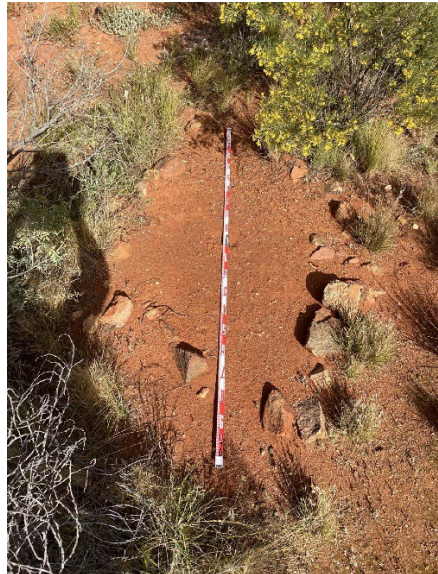
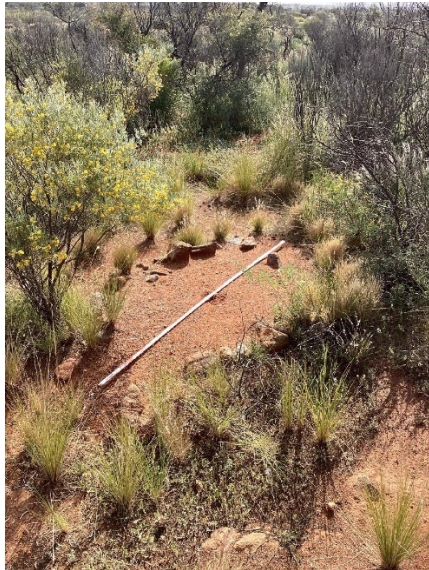
BH AFT 20, image showing stones arranged in an oval shape, facing southwest.	BH AFT 20, overview of ordered stone feature, facing south.

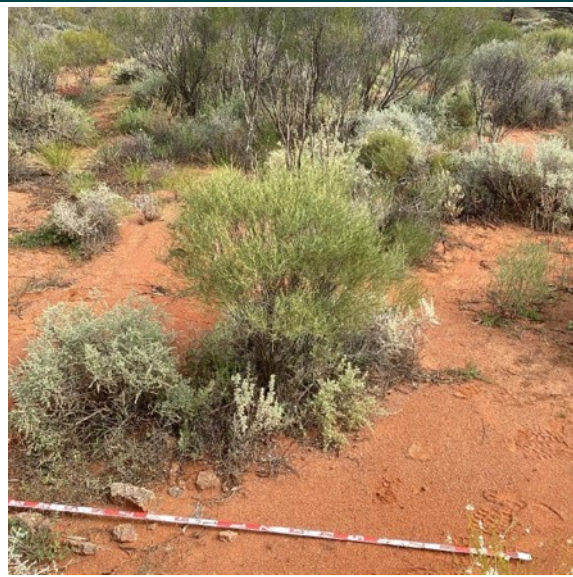
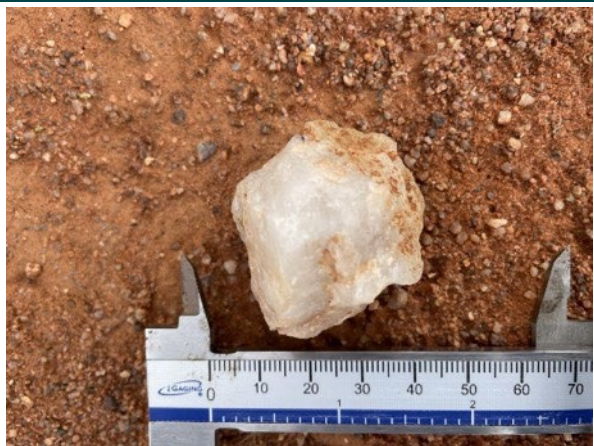
BH AFT/HTH 21, site overview, oriented west.		BH AFT/HTH 21, example artefact.

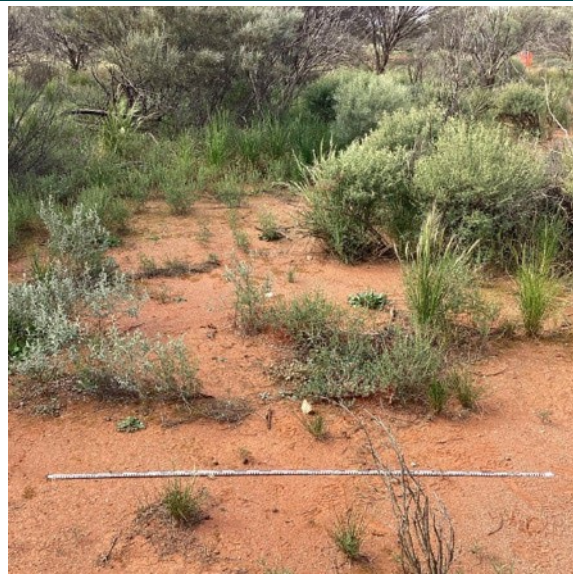
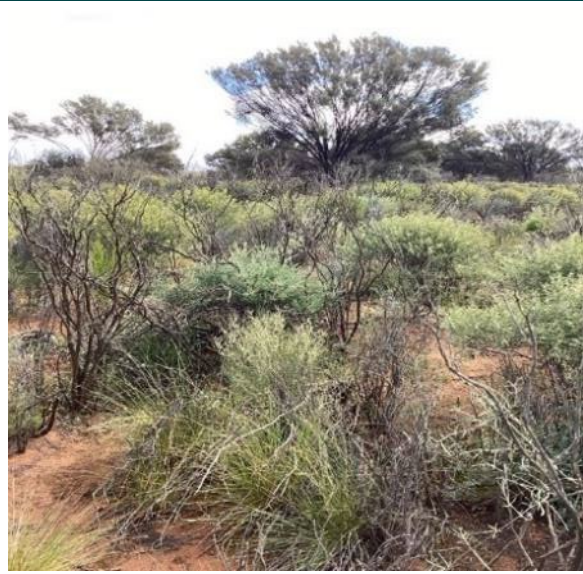
BH AFT/HTH 22, site overview, oriented north.	BH AFT/HTH 22, landform overview, oriented west.

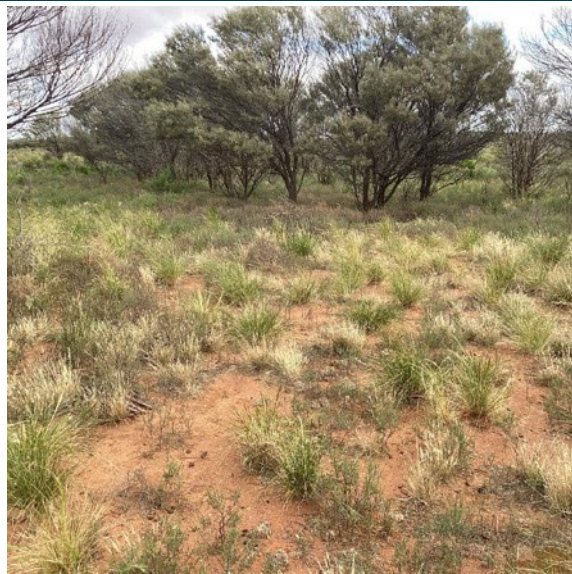
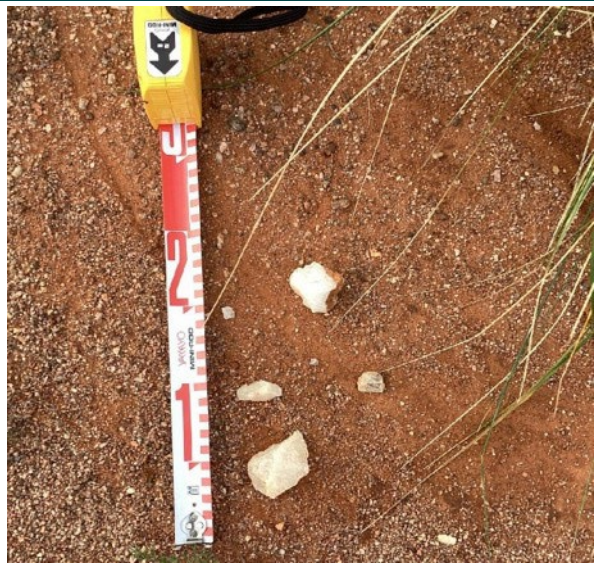
<p>BH AFT 23, site overview, oriented southeast.</p>	<p>BH AFT 23, example artefacts.</p>

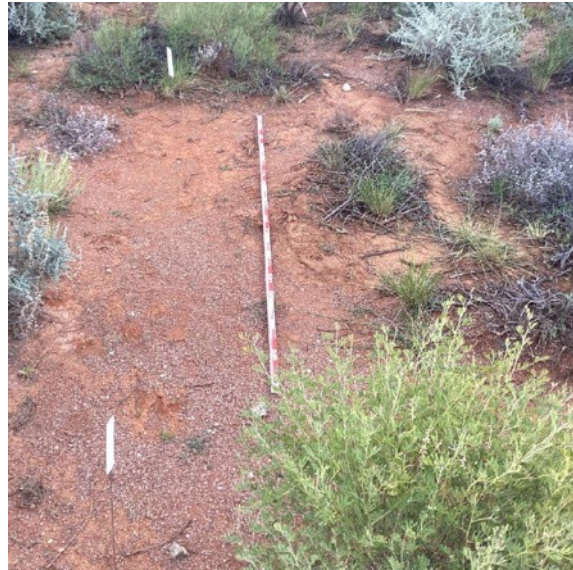
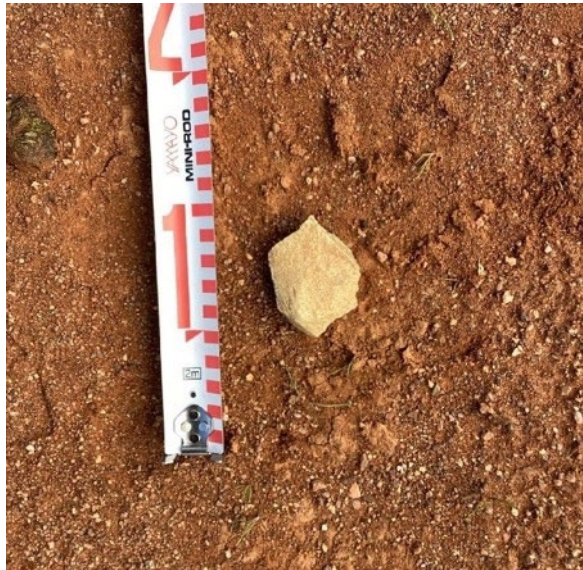
BH AFT 25, site overview, oriented southwest.	BH AFT 25, example artefact.

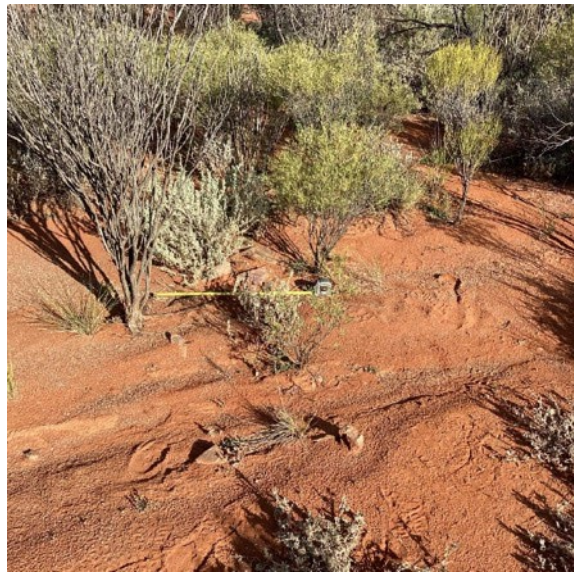
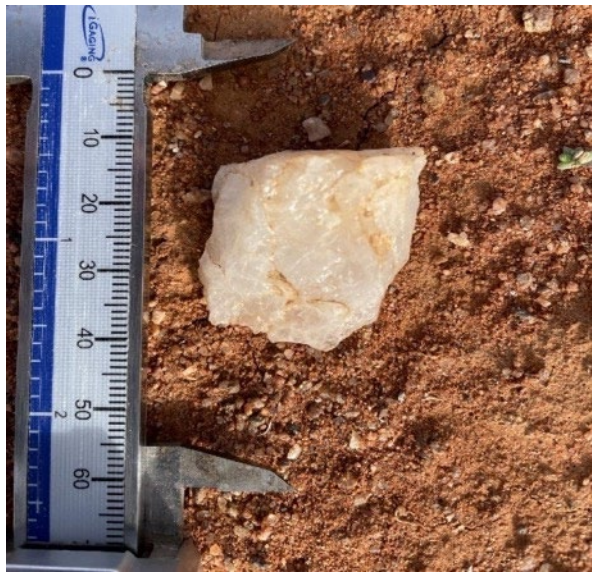
BH AFT/HTH 26, site overview, oriented east.	BH AFT/HTH 26, example artefact.

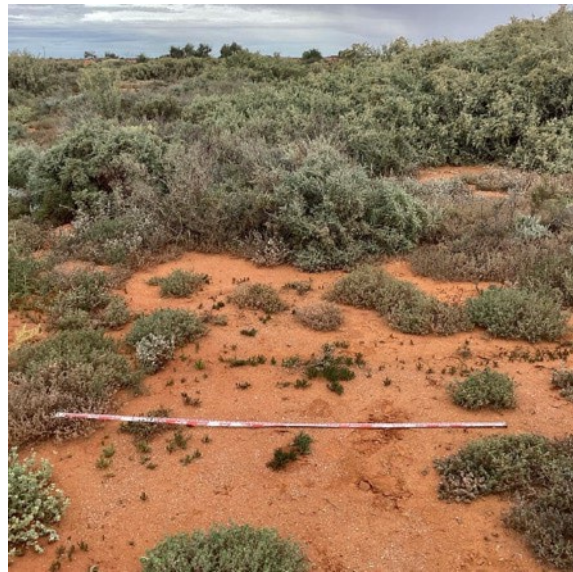
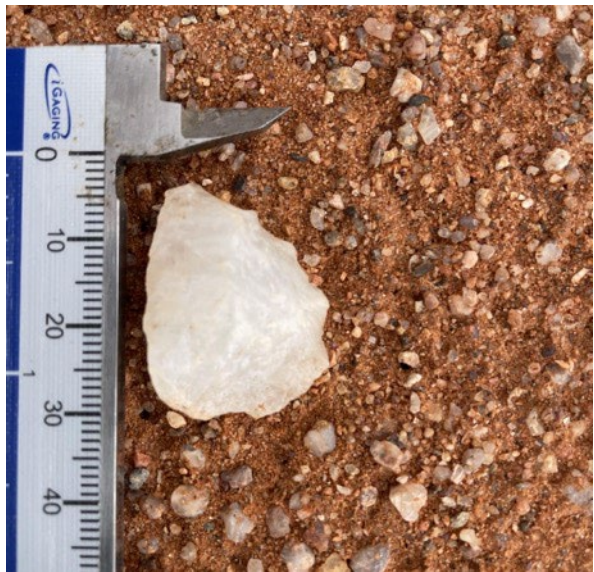
BH AFT 29, site overview, oriented south.	BH AFT 29, example artefact.

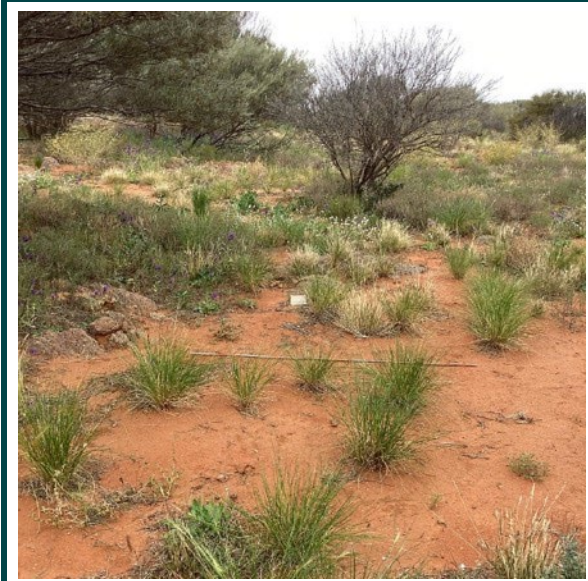
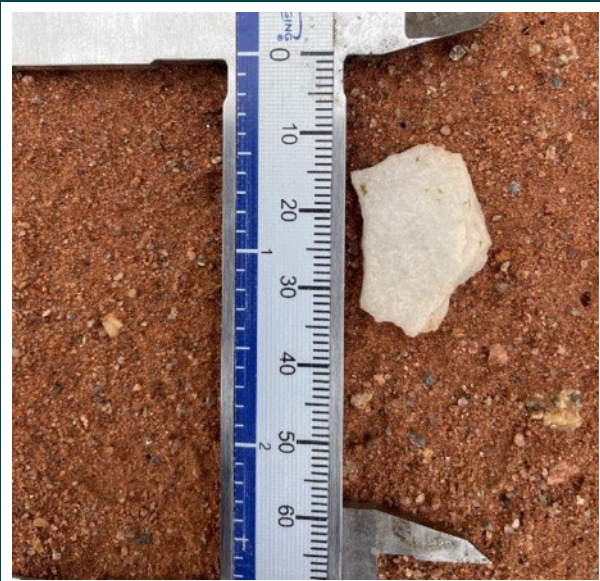
<p>BH AFT 30, site overview, oriented east.</p>	<p>BH AFT 30 isolated artefact.</p>

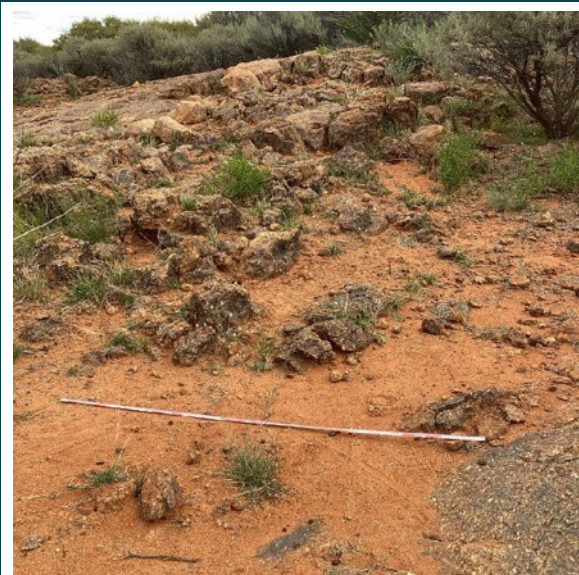
BH AFT 31, site overview, oriented south.

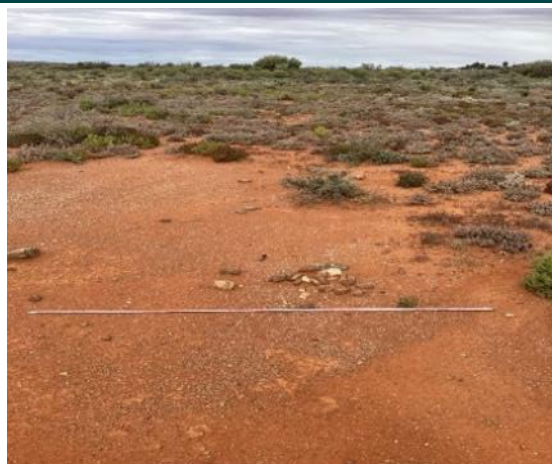
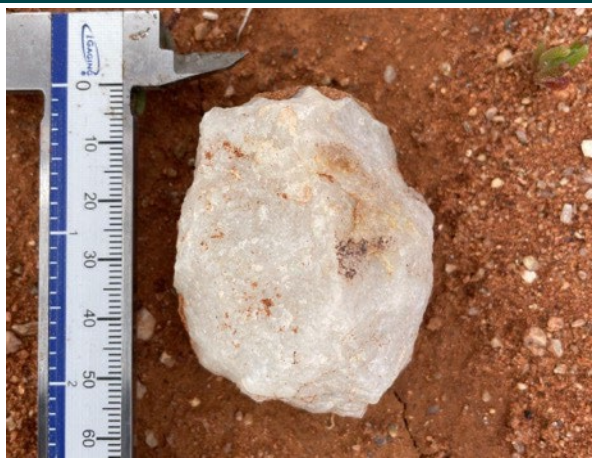
BH Site 33, site overview, oriented southeast.	BH Site 33, example artefact.

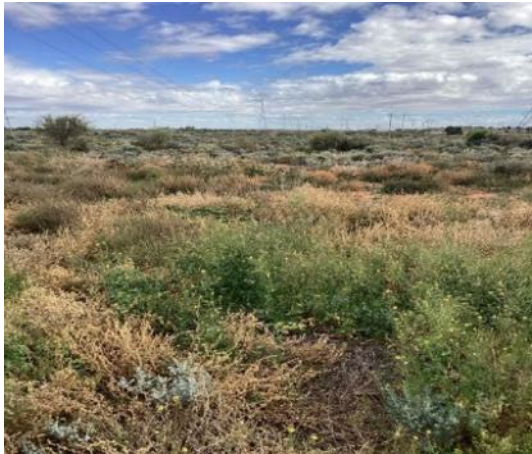
<p>BH AFT 34 site overview, oriented west.</p>

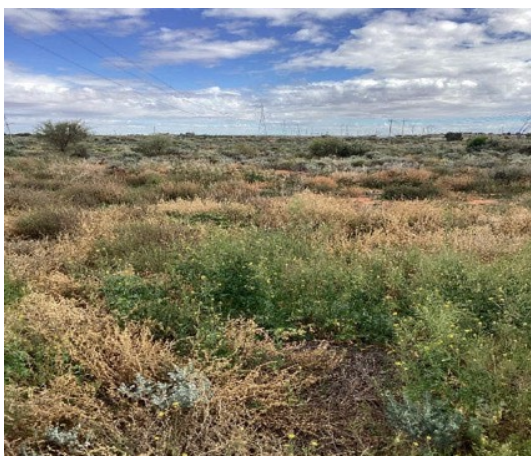
BH AFT 35, landform overview, oriented west.

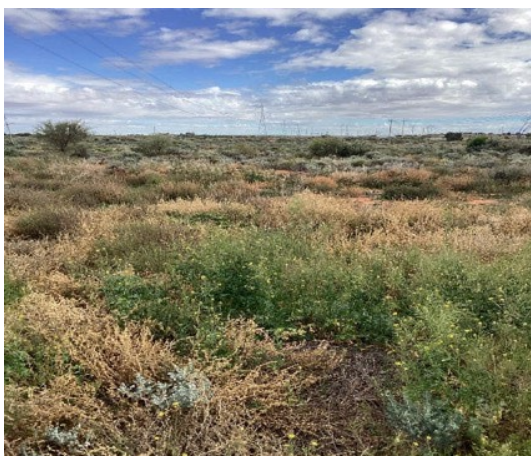
BH AFT/HTH 37 landform overview, oriented west.

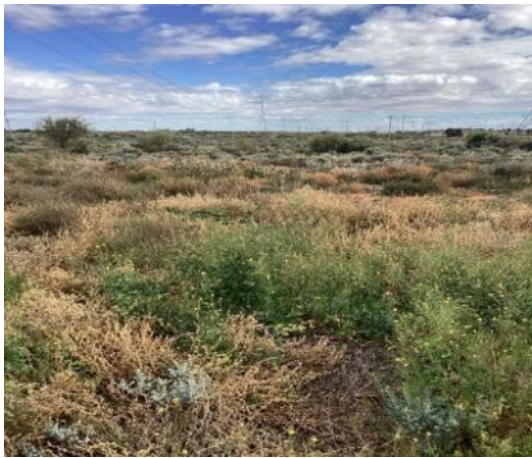
<p>BH AFT 38 landform overview, oriented west.</p>

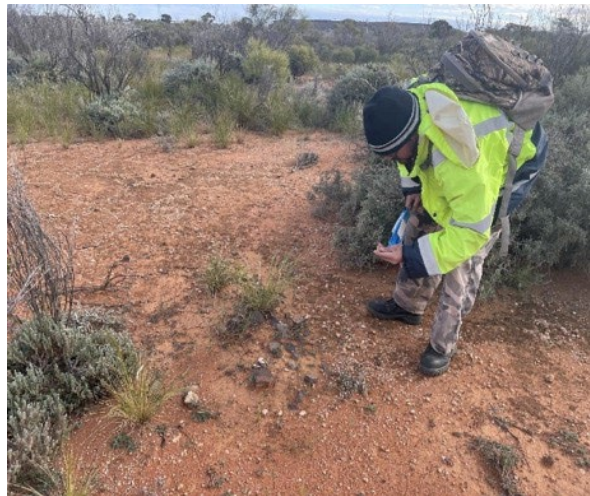
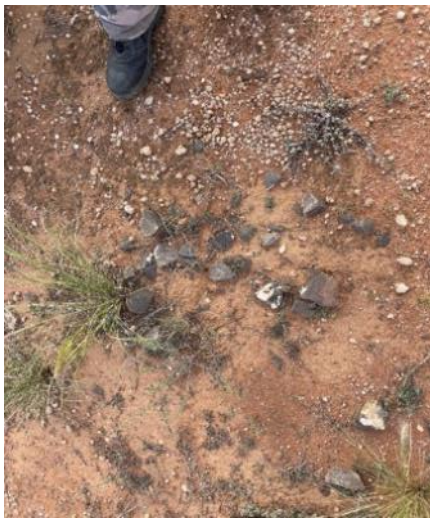
BH HTH 39, site overview, oriented south.	BH HTH 39, site feature, heat retainers.

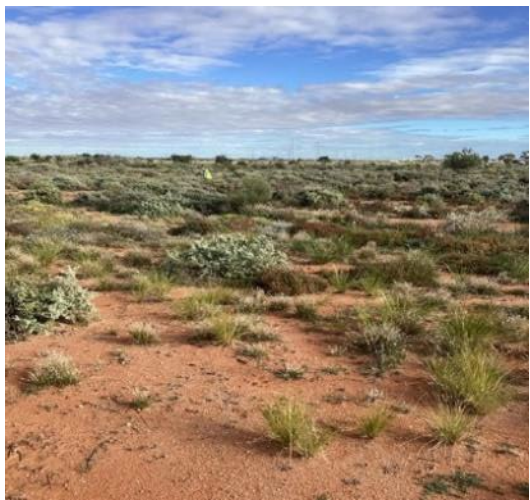
BH AFT 40, site overview, oriented west.

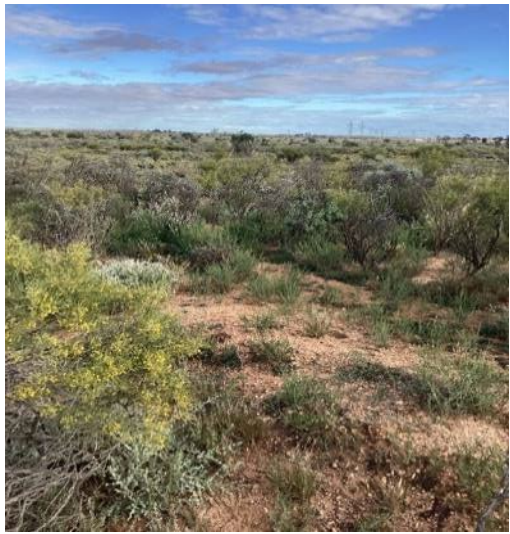
<p>BH AFT 41, landform overview, oriented west.</p>

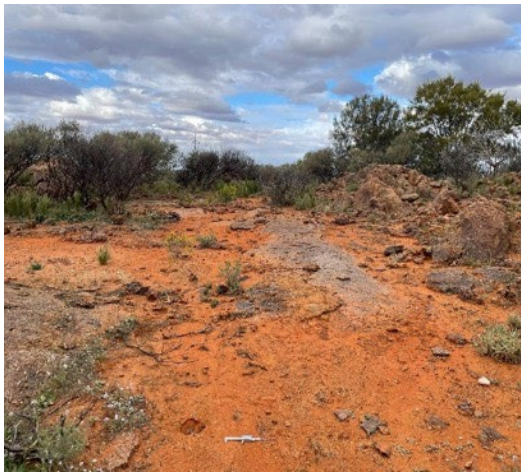
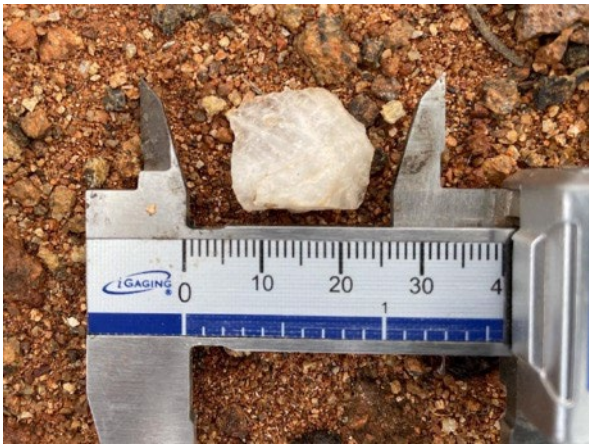
BH AFT 42, site overview, oriented southeast.	Sample artefact recorded at BH AFT 42.
