APPENDIX G
Archaeology Report

Silver City Energy Storage Project Broken Hill, New South Wales

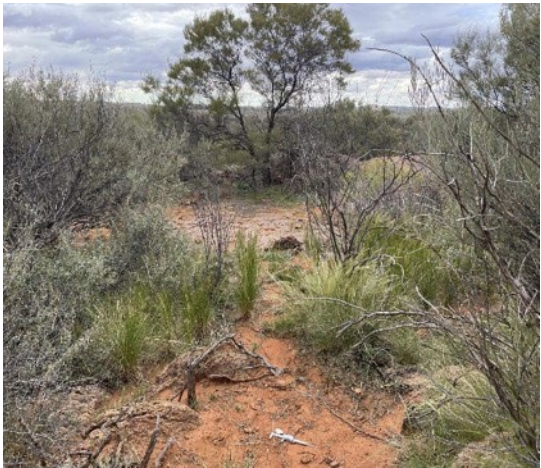
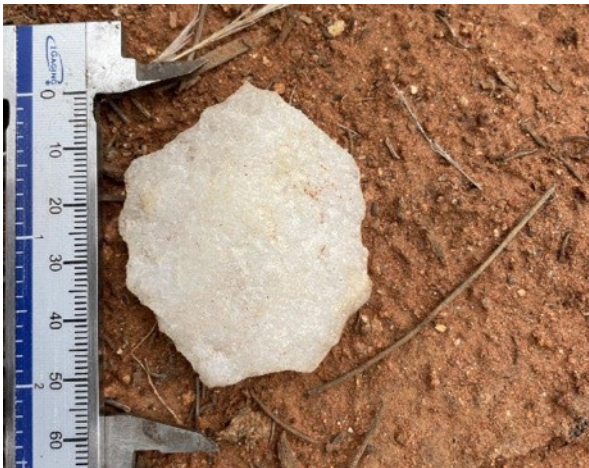
Broken Hill (A-CAES) AFT 43	
BH AFT 43, site overview, oriented northwest.	BH AFT 43, example artefact.

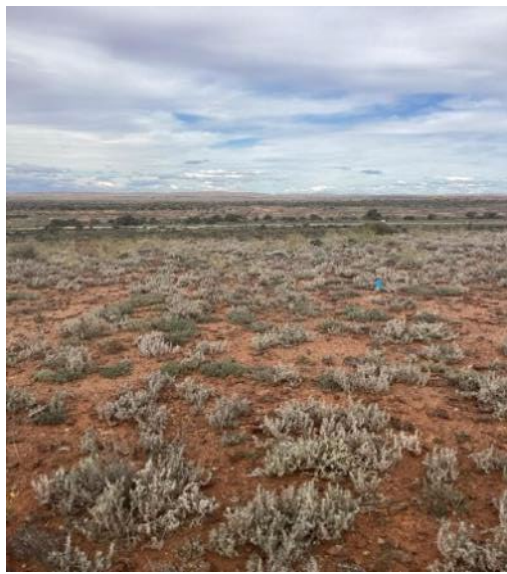
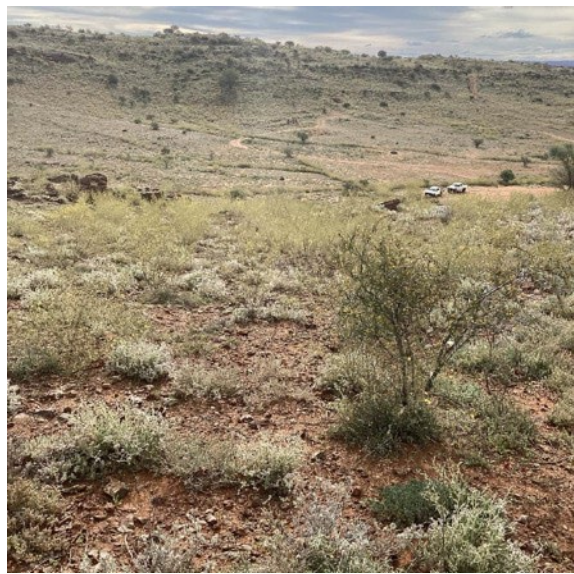
BH AFT 44, site overview, oriented southeast.	BH AFT 44, landform overview, oriented northwest.

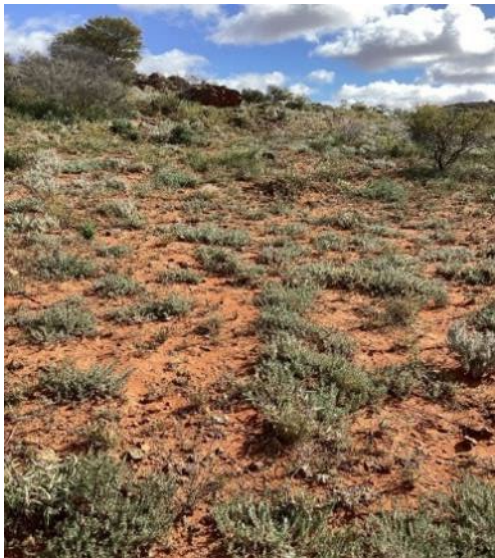
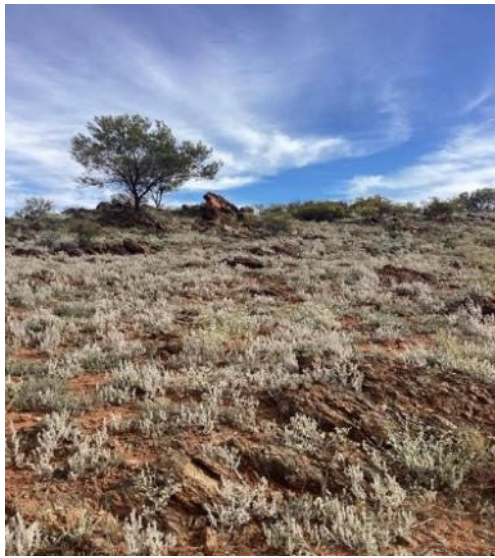
BH AFT 45, site overview, oriented northwest.			BH AFT 45, landform overview, oriented southwest.

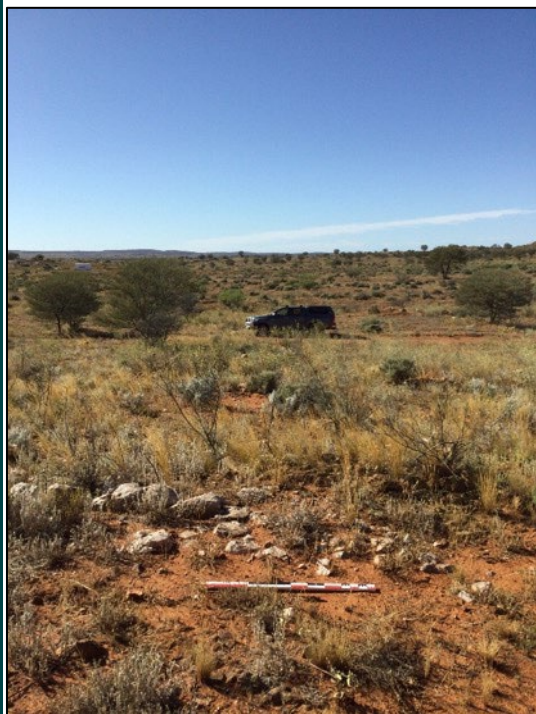
AHIMS 23-5-0120 looking southeast.

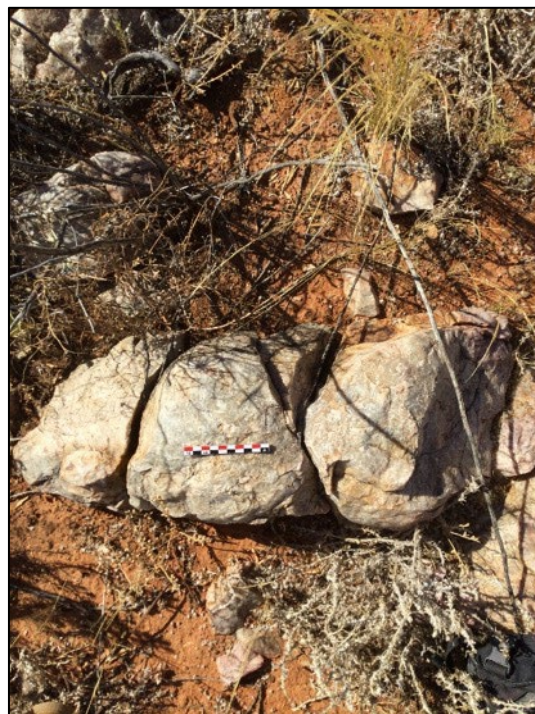
Boulder with natural fractures, ring crack and one negative scar.

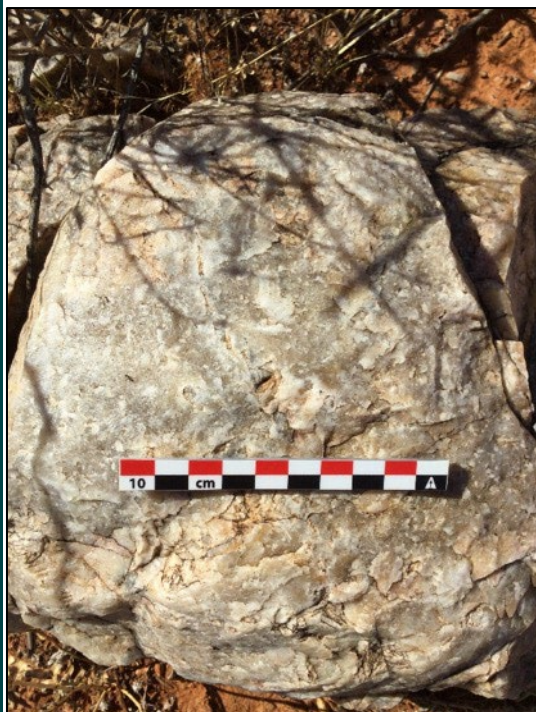
Ring crack on flat surface of boulder, possible evidence of use as an anvil.

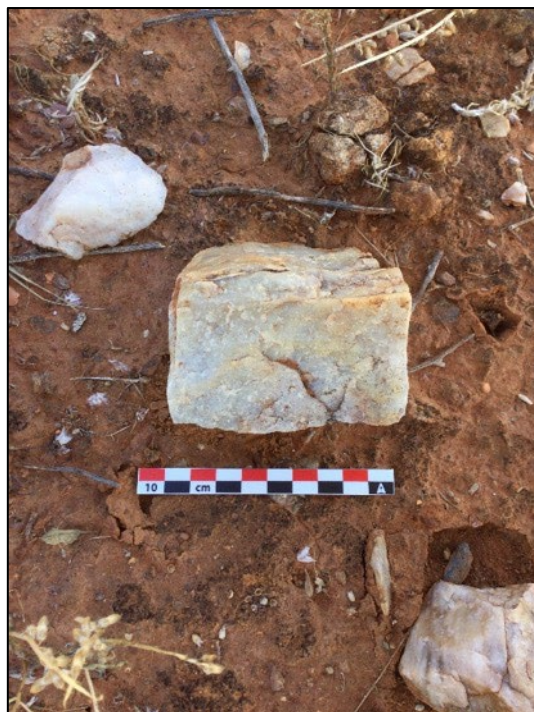
Quartz block with one negative flake scar located at AHIMS 23-5-0210.

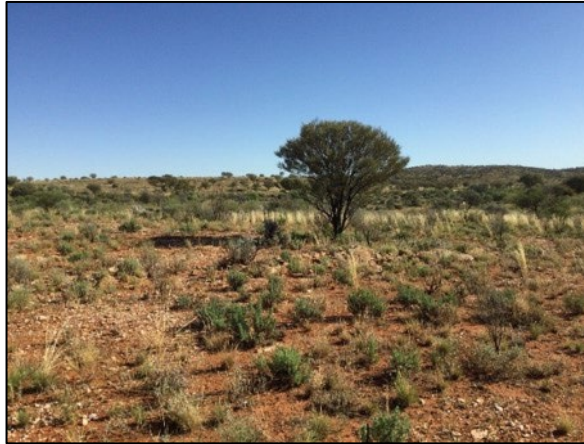
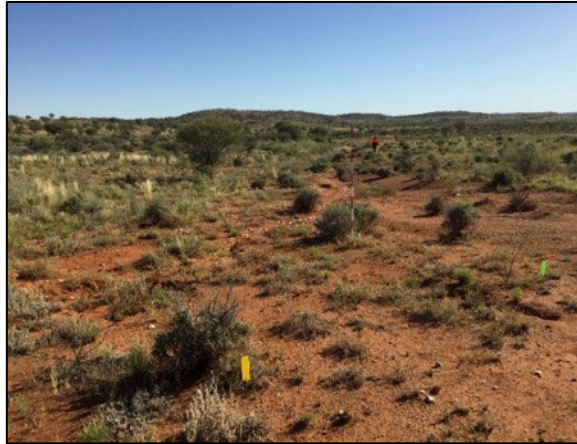
<p>AHIMS 23-5-0123 site location, looking southeast showing quartz outcrop and scattered fractured quartz.</p>			<p>AHIMS 23-5-0123 site location, looking north showing erosion and artefact locations.</p>

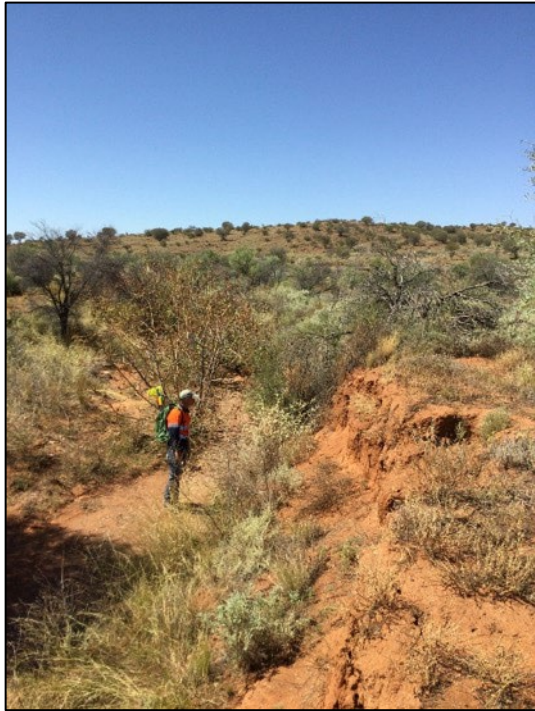
<p>AHIMS 23-5-0125 site location, looking southeast at steeply incised bank, showing erosion disturbance and vegetation coverage.</p>

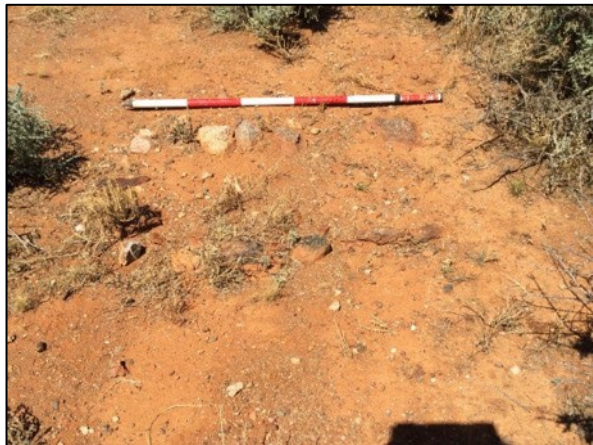
<p>AHIMS 23-5-0126 site location, looking north at stones, likely a European feature.</p>

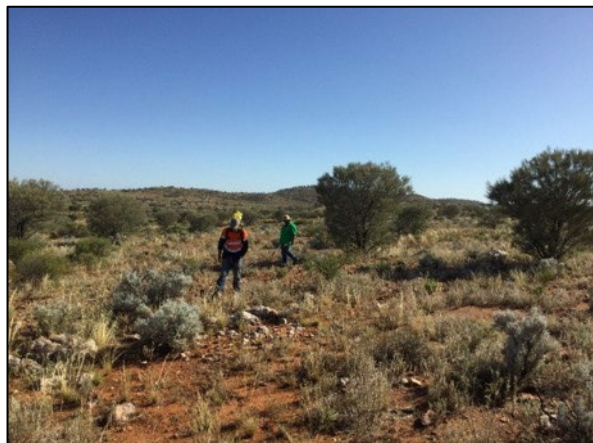
AHIMS 23-5-0127 site location, looking north showing quartz outcrop.

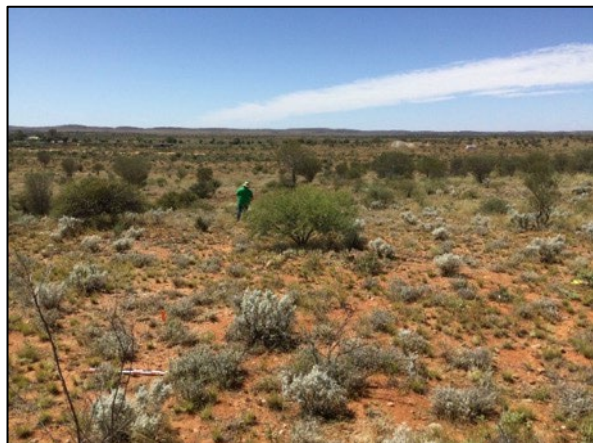
AHIMS 23-5-0141 site location, looking east showing artefact 1 location.

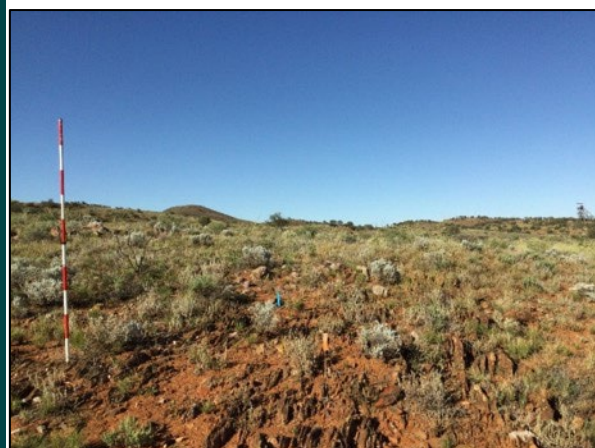
AHIMS 23-5-0154 site location, looking southwest showing quartz outcrop, outcropping schist and artefact locations.

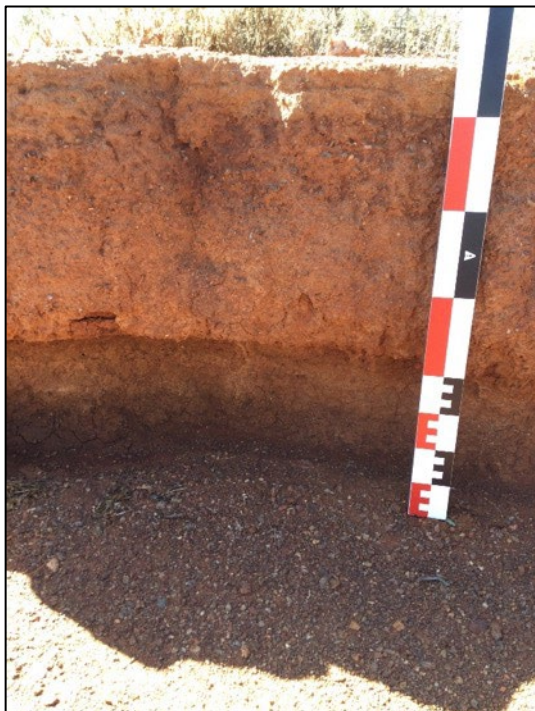
Site BH AFT/HTH 46 Looking south in gully cutting adjacent to scatter 1, showing depth of deposit.

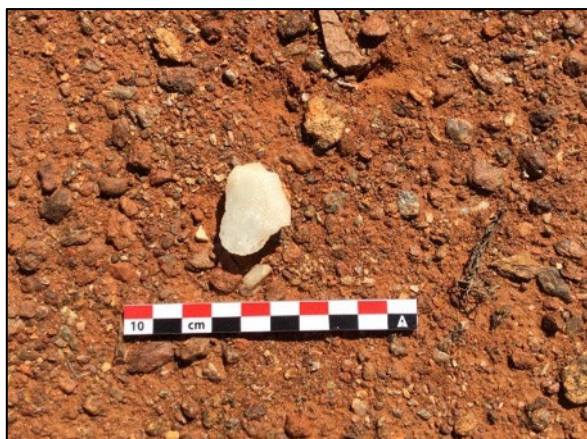
BH AFT/HTH 46 scatter 1: artefact 3, complete quartz flake.

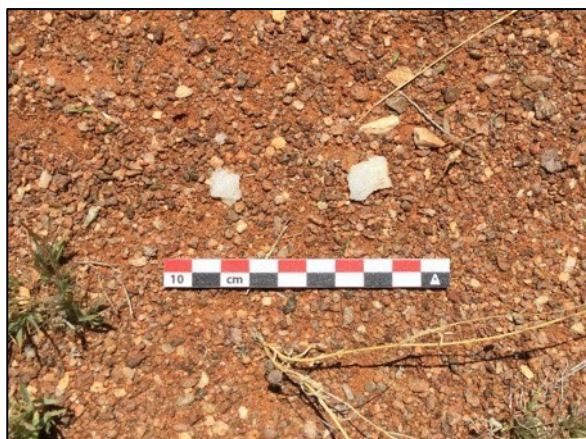
BH AFT/HTH 46 scatter 7: artefacts 1 and 2, white quartz broken flake and distal flake.

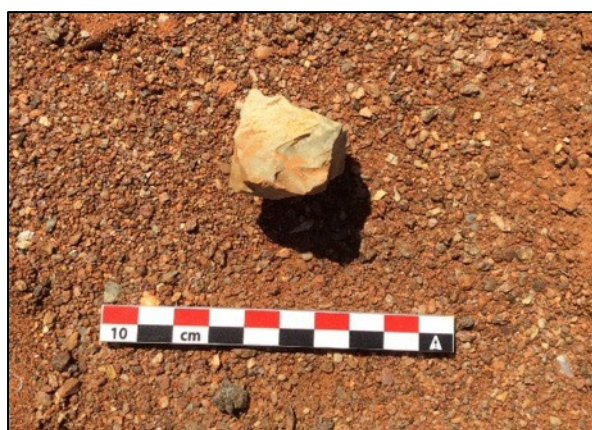
BH AFT/HTH 46 scatter 8: artefact 4, grey silcrete core.

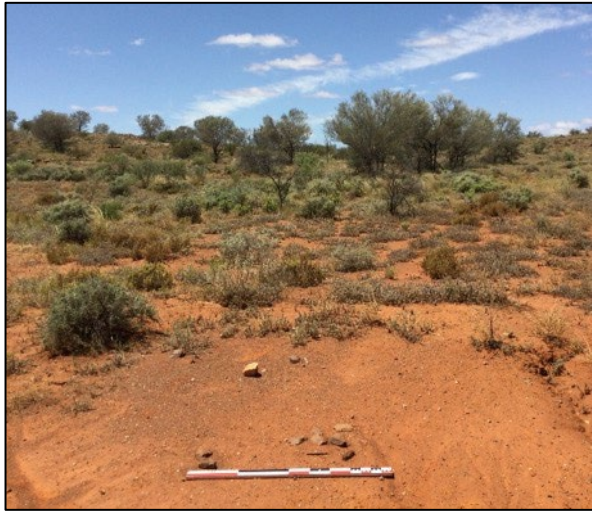
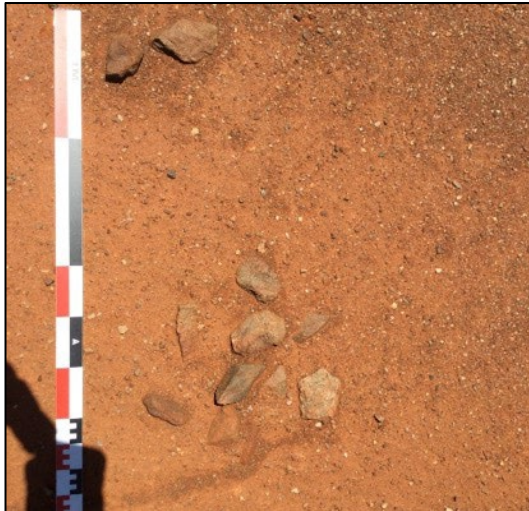
<p>Looking east at BH HTH 47, showing erosion scour.</p>	<p>BH HTH 47 potential hearth</p>

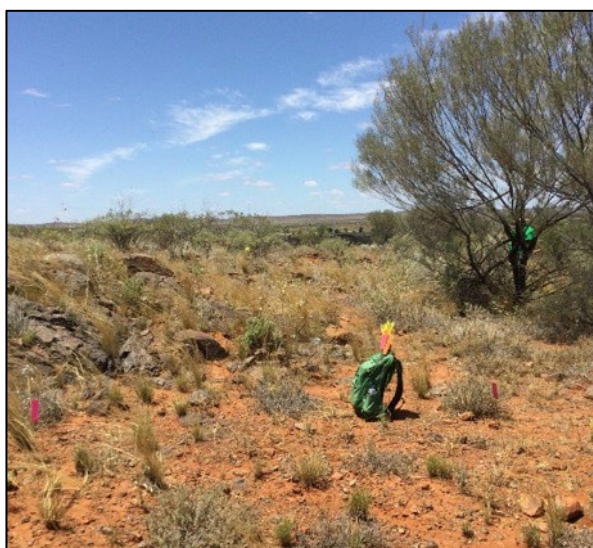
Looking south at BH AFT 48 showing artefact locations.

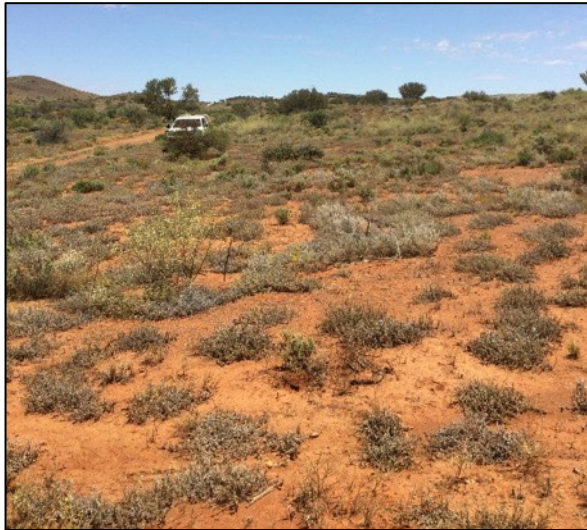
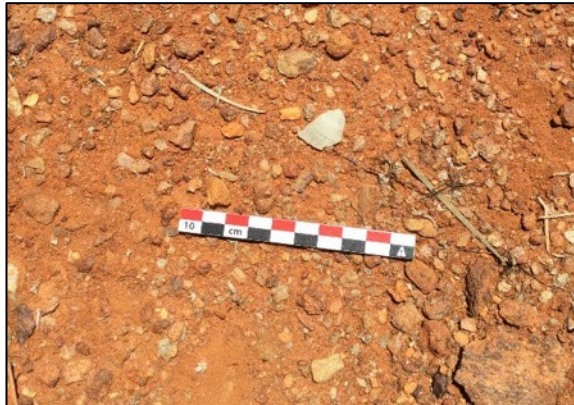
<p>Looking west at BH AFT 49, showing erosion scour.</p>	<p>BH AFT 49 artefact.</p>

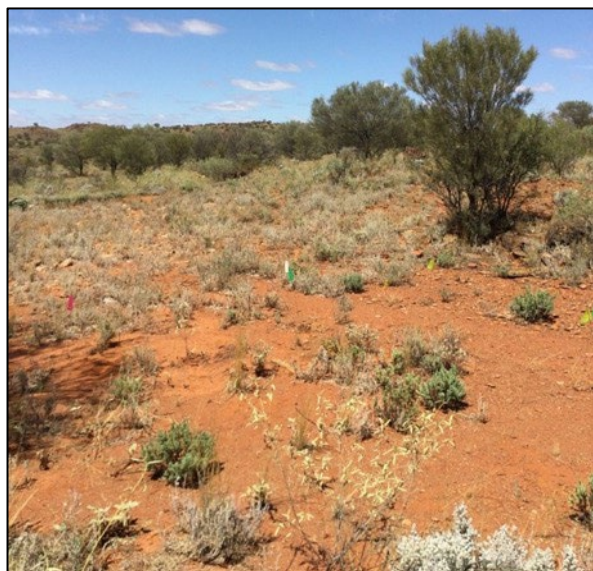
Looking west at BH AFT 50, showing ground surface visibility.

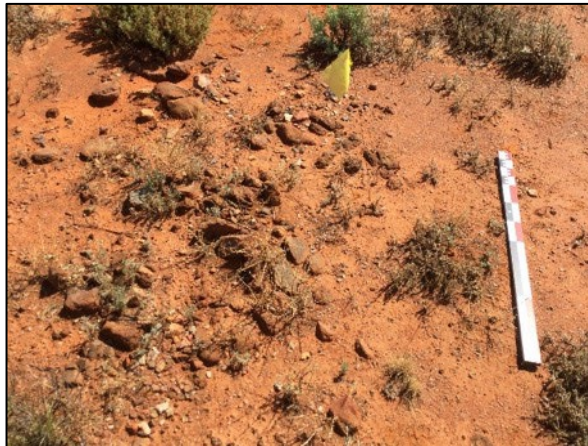
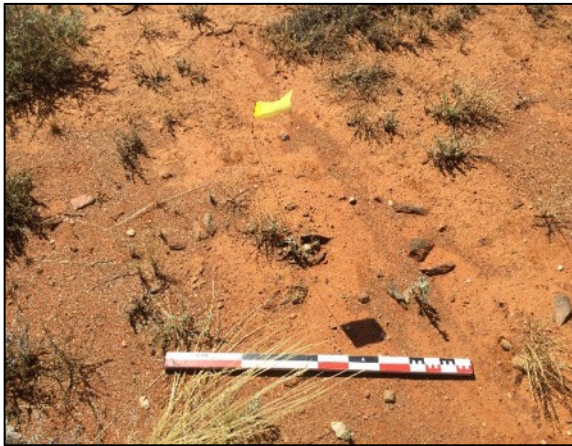
BH AFT/HTH 51 potential hearth 1		Looking south at BH AFT/HTH 51 potential disturbed hearth 2.

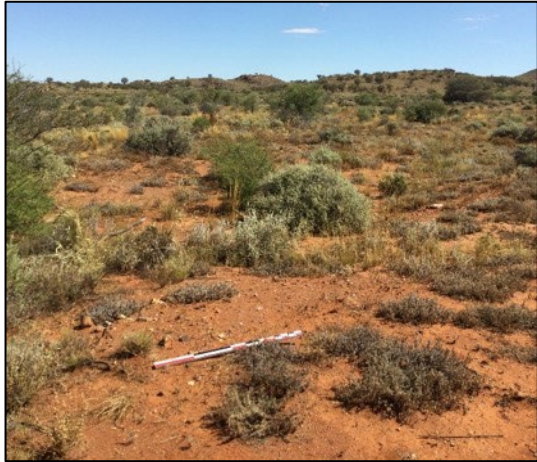
<p>Looking south at BH HTH 52 potential disturbed hearth.</p>

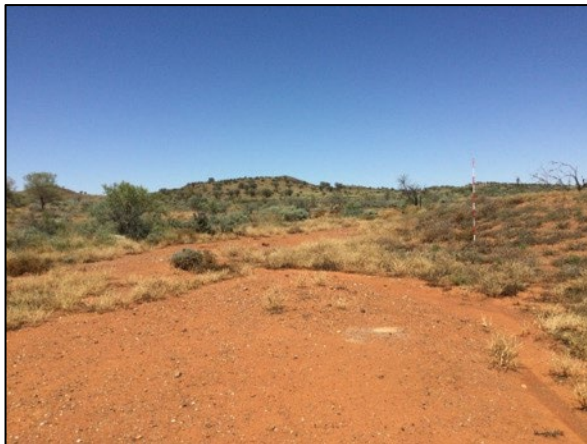
Looking southwest at BH AFT 54, showing exposure.

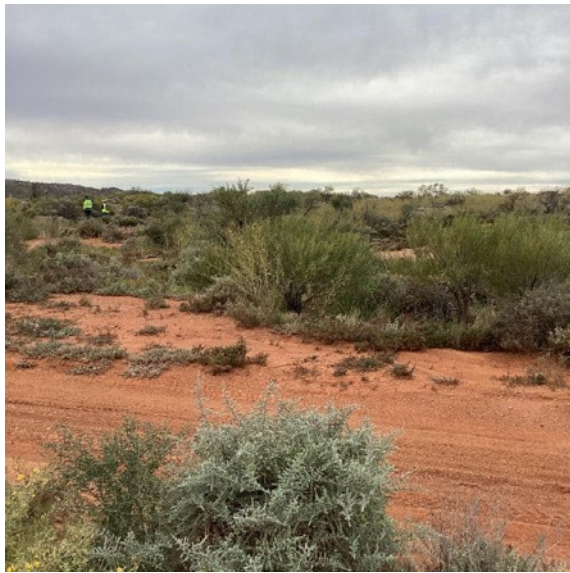
Broken Hill (ACAES) AFT 1

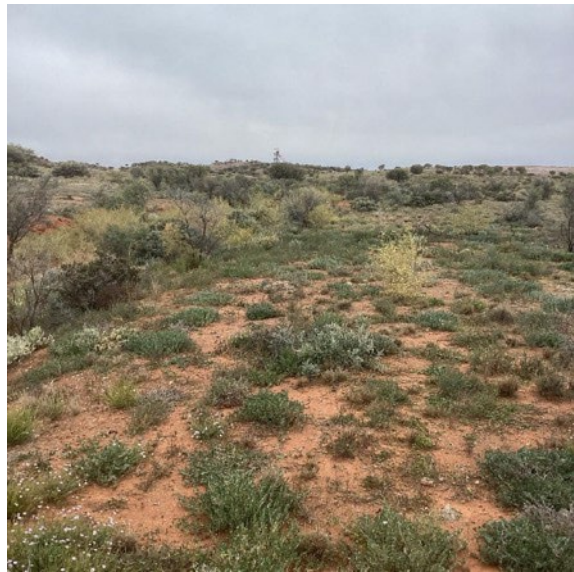
<p>Broken Hill (ACAES) AFT 3; AHIMS #23-5-0153; AHIMS #23-5-0063; AHIMS #23-5-0112</p>

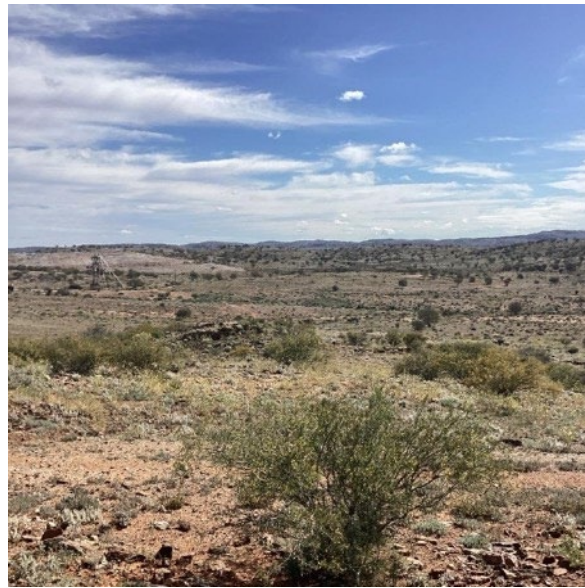
Survey Unit (SU)	Landform Element Type	Description	Photos	Sites Located Within SU
SU10	Slope - Mid- and Upper- (Steep)	<p>A steep, northwest facing slope. Exposures at approximately 40% and visibility at 30%. Vegetation is predominantly Chenopod scrubland and occasional 2m high shrubs. Ground surface consists of quartz and gneiss gravel amongst large rocks (approx 40 - 80cm diameter) with compacted, orangy red, coarse sand matrix in pockets amongst the rock. Subjected to vegetation clearance, erosion and minor vehicle track damage.</p>

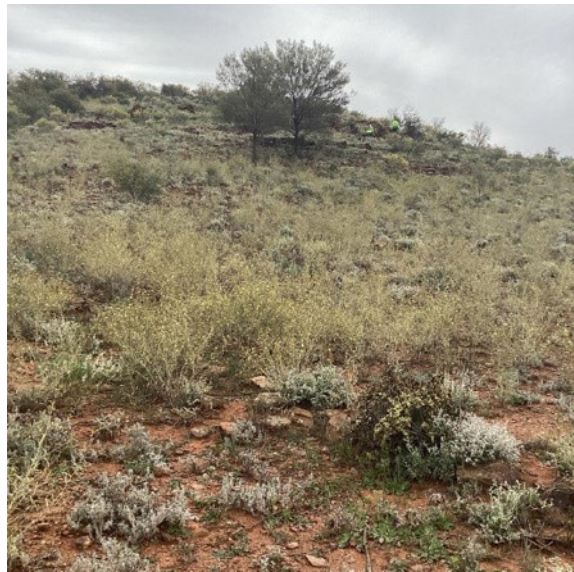
Broken Hill (ACAES) AFT 8

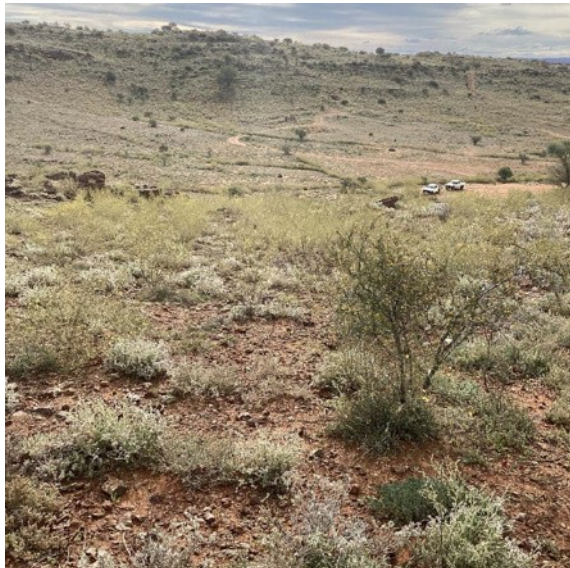
Broken Hill (ACAES) AFT 44
SU17	Slope Lower (Gentle)	<p>- A gentle, northwest facing slope. Exposures at approximately 20% and visibility at 30%. Vegetation is predominantly Chenopod scrubland and occasional 2m high shrubs. Ground surface consists of quartz and gneiss gravel in compacted, orange red, coarse sand matrix. Subjected to vegetation clearance, erosion and minor vehicle track damage.</p>	<p>Survey Unit 16, landform overview, oriented northwest.</p>	None recorded

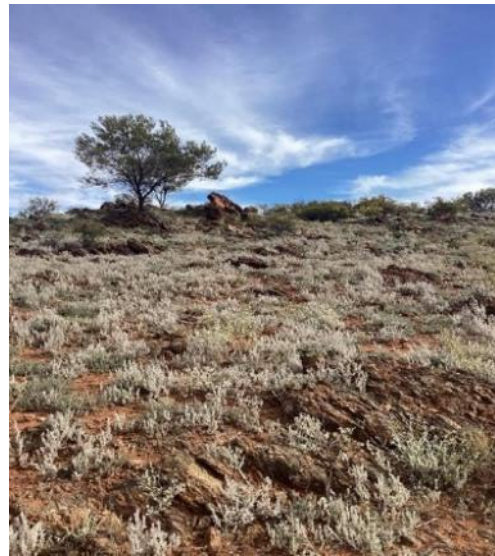
Broken Hill (ACAES) AFT 45

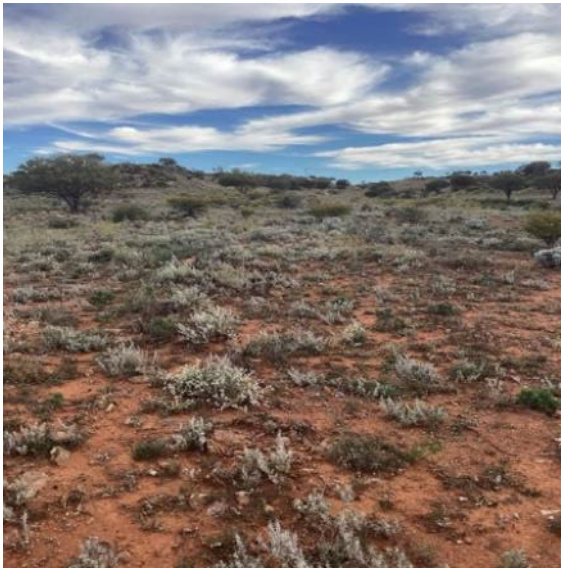
Broken Hill (ACAES) AFT/HTH 10
SU24	Open Depression - Creek Line	A first order, gentle slope, ephemeral creek line transecting in a west by southwest/east by northeast direction at approximately 10m wide. Exposures at approximately 20% and visibility at 20%. Vegetation is predominantly Chenopod scrubland with occasional shoulder high shrubs. Ground surface consists of quartz and gneiss cobbles in coarse, firm, orange red, sand matrix and some rocky exposures. Subjected to vegetation clearance and erosion. Some vehicle track impacts on eastern most edge of the SU.	<p>Survey Unit 23, landform overview, oriented southwest.</p>	None recorded

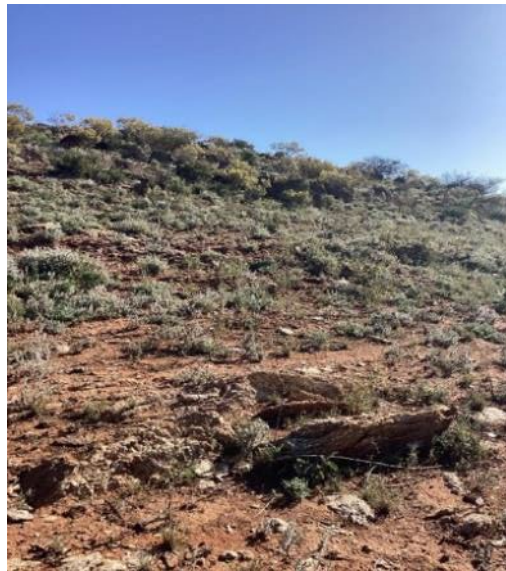
None recorded
SU28	Open Depression - Creek Line	<p>A first order, gentle slope, ephemeral creek line transecting in an east/west direction at approximately 5m wide. Exposures at approximately 20% and visibility at 20%. Vegetation is predominantly Chenopod scrubland and thick shoulder high shrubs. Ground surface consists of quartz and gneiss cobbles in coarse, firm, orangy red, sand matrix and some rocky exposures. Subjected to vegetation clearance and erosion.</p>		None recorded

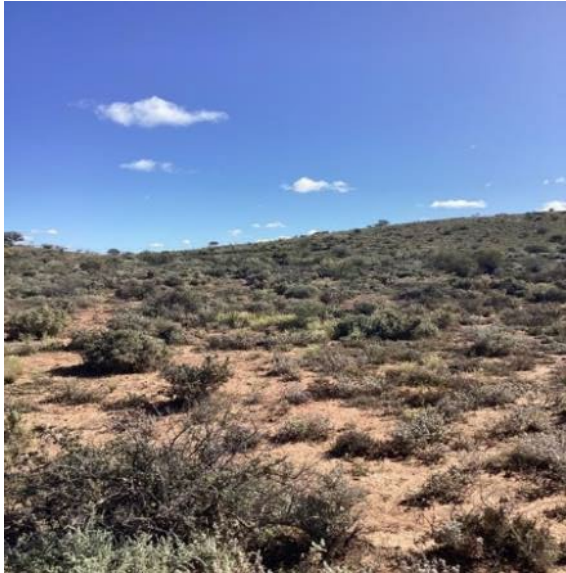
Broken Hill (ACAES) AFT12; Broken Hill (ACAES) AFT 13

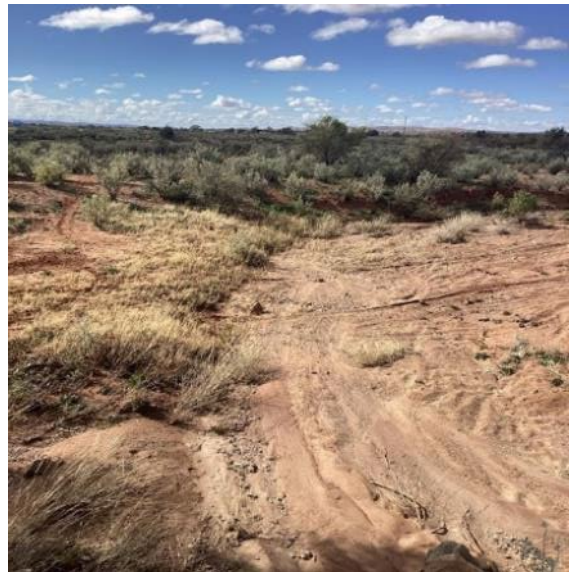
Broken Hill (ACAES) AFT 14
SU44	Plain	<p>An east facing to open gentle basal slope transitioning to flat. Exposures at approximately 40% and visibility at 60%. Vegetation is predominantly Chenopod scrubland and occasional knee high shrubs. Occasional sandstone and quartz cobble within soft, deep, silty soil matrix. Subjected to vegetation clearance, erosion and vehicle track disturbances. Medium PAD.</p>	<p>Survey Unit 43, landform overview, oriented east.</p>	Broken Hill (ACAES) AFT 15

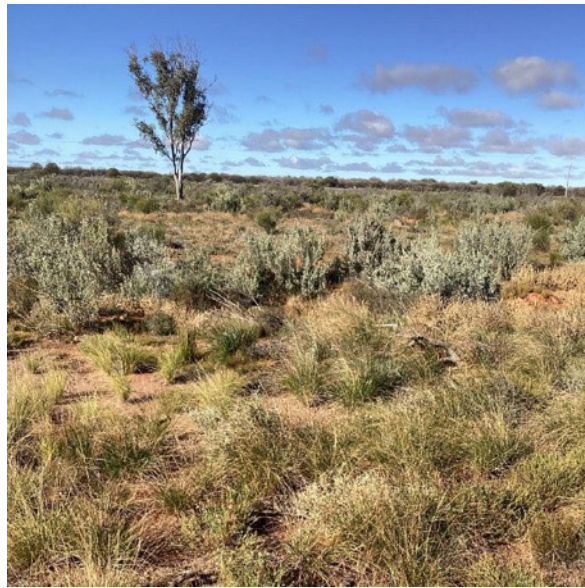
None recorded
SU56	Spur (Gentle)	<p>A northwest/southeast oriented, gentle spur. Exposures at approximately 20% and visibility at 30%. Vegetation is predominantly Chenopod scrubland and knee high grassland. Ground surface consists of quartz cobbles in coarse, loose, orange red, sand matrix. Subjected to vegetation clearance and erosion. High PAD evidenced by creek cutting to the east of the survey corridor (downstream).</p>	<p>Survey Unit 55, landform overview, oriented southwest.</p>	None recorded

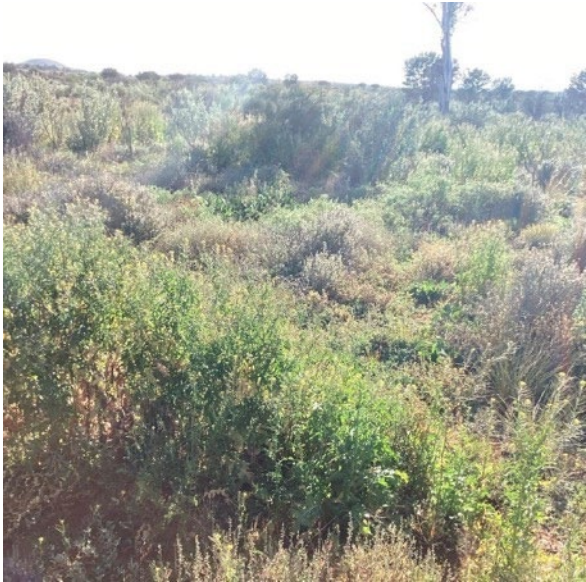
Survey Unit (SU)	Landform Element Type	Description	Photos	Sites Located Within SU
SU57	Open Depression - Creek Line	A first order, gently sloped, ephemeral creek line transecting in a west/ east direction at approximately 5m wide. Exposures at approximately 20% and visibility at 30%. Vegetation is predominantly Chenopod scrubland and knee high grassland. Ground surface consists of quartz cobbles in coarse, loose, orangy red, sand matrix. Subjected to vegetation clearance and erosion. High PAD evidenced by creek cutting to the east of the survey corridor (downstream).		None recorded
SU58	Creek Flat	An open creek flat. Nil exposures and nil visibility due to thick scrub and grass cover. Ground cover is firm, orange red, coarse sand matrix. Subjected to vegetation clearance, erosion and minor vehicle track disturbance. Deep sandy soil structure.

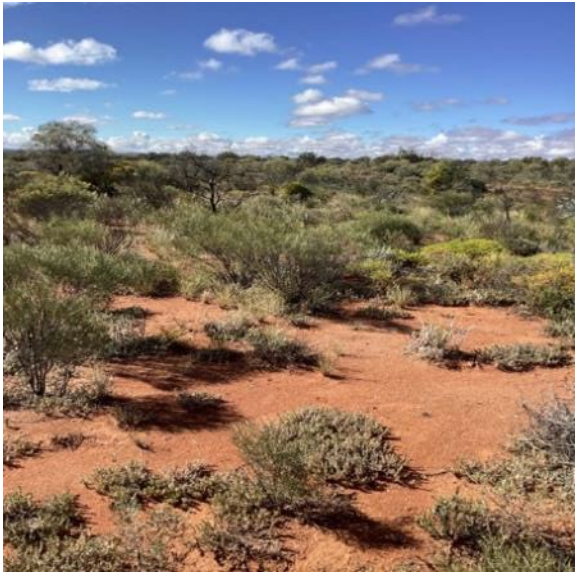
Broken Hill (ACAES) AFT 20

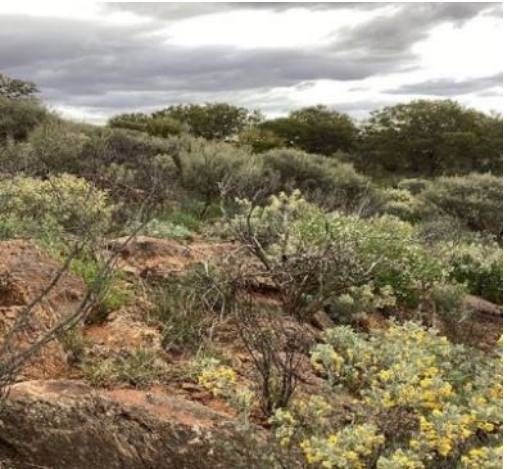
BH Site 31; BH Site 42; BH Site 43
SU68	Open Depression - Shallow Drainage Line	An open, shallow ephemeral drainage area oriented north/south. Exposures at approx. 10% and 30% visibility. Vegetation is predominantly thick expanses of Pattison's Curse amongst 3m high shrubs. Ground surface is mostly loose orange red, coarse sand. Subjected to vegetation clearing and erosion.	<p>Survey unit 67, landform overview, oriented southwest.</p>	None recorded

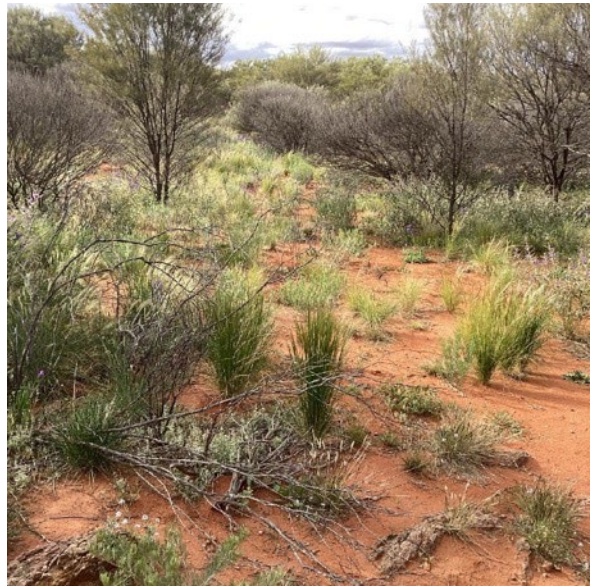
None recorded
SU70	Knoll	<p>A steep, rocky, hill crest with 2m high shrubs amongst rocky exposures.</p>		None recorded

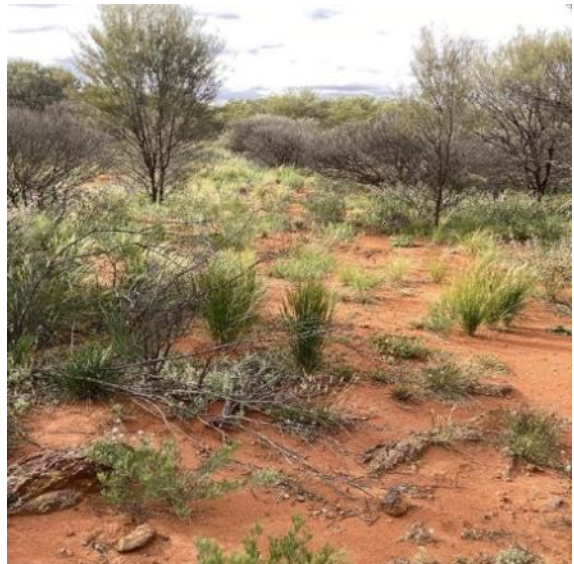
Broken Hill (ACAES) AFT 30
SU72	Slope Lower (Gentle and Undulating) slopes	- A south by southeast facing gentle slope. Granitic outcrops filled with deposits of soft, silty, red, coarse sand. Exposures at approximately 10% and visibility at 30%. Vegetation is predominantly Chenopod scrubland, 2m high scrub and knee high grassland. Ground surface consists of quartz cobbles in coarse, loose, orange red, sand matrix. Subjected to vegetation clearance, erosion and extensive vehicle track disturbance.		None recorded

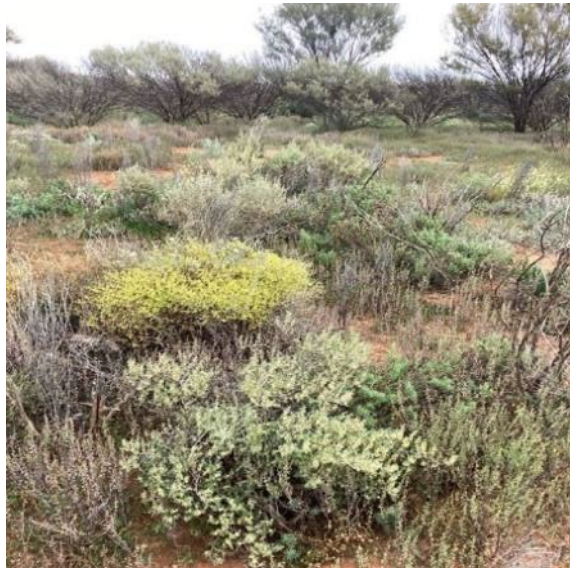
AHIMS #23-4-0682
SU74	Open Depression - Creek Line	<p>A second order, gently sloped, ephemeral creek line transecting in a north/south direction at approximately 50m wide. Exposures at approximately 5% and visibility at 30%. Dense vegetation is predominantly knee high grassland and dense 2 - 3m high thick revegetation. Ground surface consists of quartz cobbles in coarse, loose, orange red, sand matrix. Subjected to vegetation clearance and erosion.</p>	<p>Survey Unit 73, landform overview, oriented northwest.</p>	Broken Hill (ACAES) AFT/HTH 22

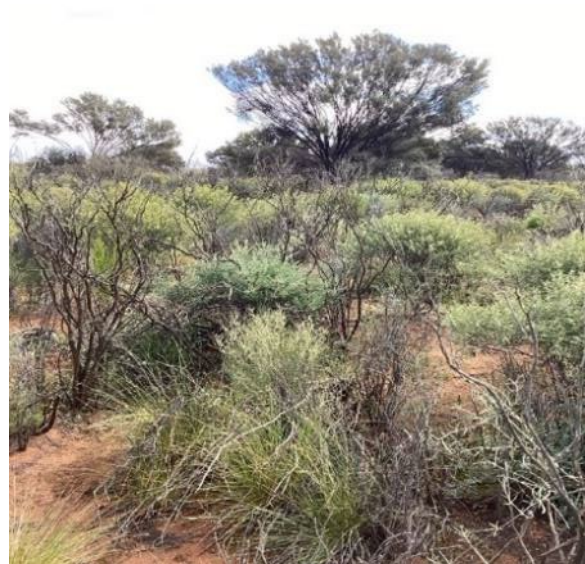
<p>Broken Hill (ACAES) AFT 23; Broken Hill (ACAES) AFT 25; Broken Hill (ACAES) HTH 26</p>

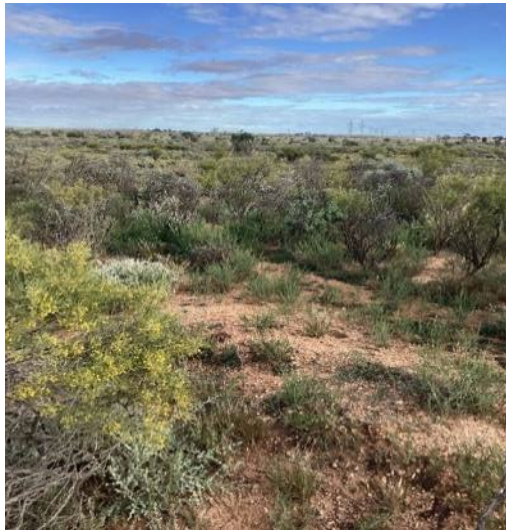
Broken Hill (ACAES) AFT 41

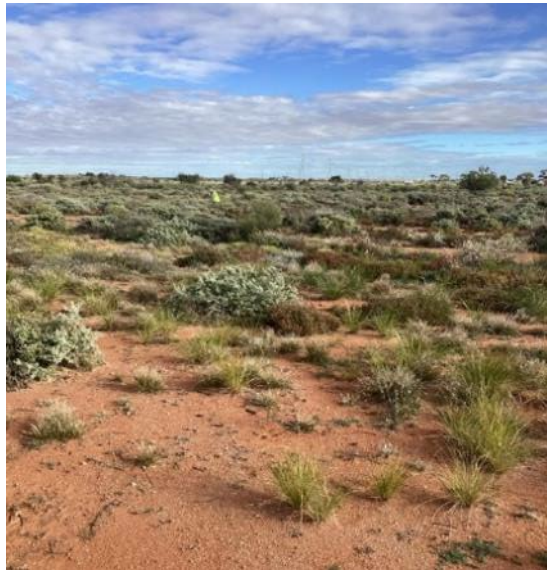
Broken Hill (ACAES) HTH 27; Broken Hill (ACAES) AFT 38; Broken Hill (ACAES) HTH 39; Broken Hill (ACAES) AFT 40
SU79	Open Depression - Drain Line	A first order, gently sloped, ephemeral drain line transecting in a northeast/southwest direction at approximately 15m wide. Dense vegetation cover resulting in exposures at approximately 5% and visibility at 10%.	<p>Survey Unit 78, landform overview, oriented west.</p>	None recorded

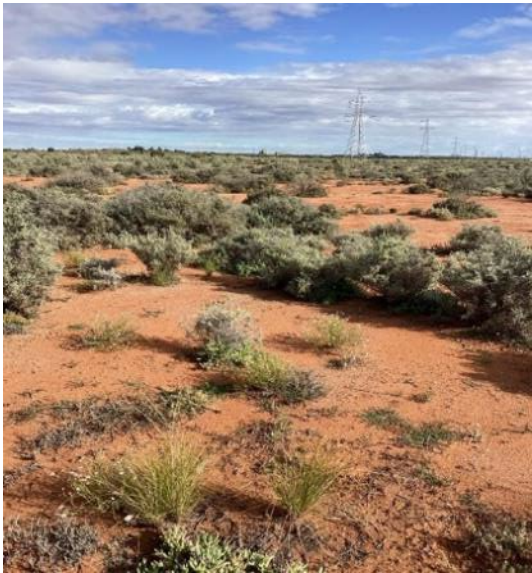
Broken Hill (ACAES) AFT 28
SU81	Open Depression - Creek Line	A first order, gently sloped, ephemeral creek line transecting in a northeast/southwest direction at approximately 10m wide. Dense vegetation cover resulting in exposures at approximately 5% and visibility at 10%.		None recorded

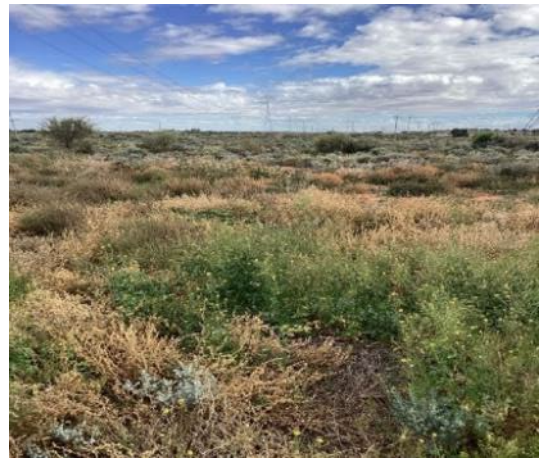
Broken Hill (ACAES) AFT 34; Broken Hill (ACAES) AFT 35; Broken Hill (ACAES) AFT 36; Broken Hill (ACAES) AFT/HTH 37
SU83	Open Depression - Drain	A gently sloped, ephemeral drain line transecting in a northwest/southeast direction at approximately 5m wide. Dense vegetation cover resulting in exposures at approximately 5% and visibility at 10%.	<p style="text-align: center;">Survey Unit 82, landform overview, oriented west.</p>	None recorded

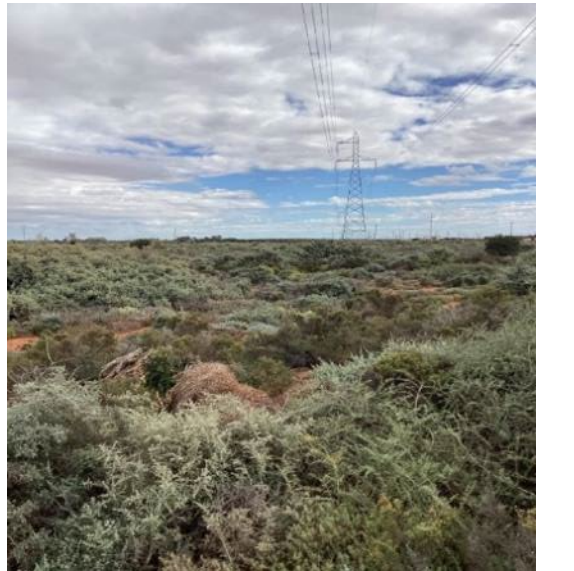
Broken Hill (ACAES) AFT 29
SU85	Open Drain - Creek Line	<p>An gentle sloped creek line transecting northwest to southeast at approximately 15m wide. Vegetation is dense waist high shrubs interspersed with ankle high grasses, Exposures are approximately <5% and <5% visibility. Ground surface is a coarse, loose, red, sandy soil matrix @>30cm deposit.</p>	<p>Survey Unit 84, landform overview, oriented southwest.</p>	None recorded

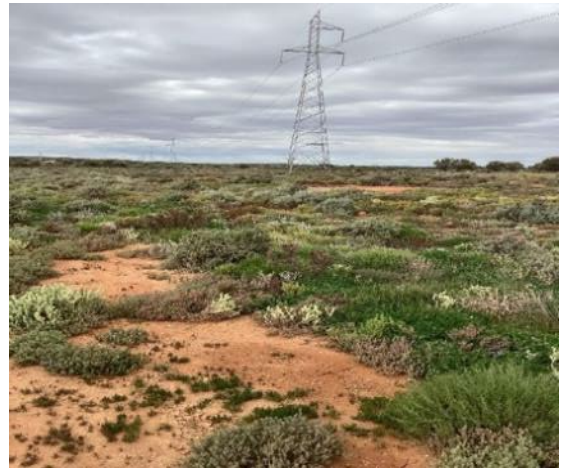
AHIMS # 23-4-0640; AHIMS #23-4-0641

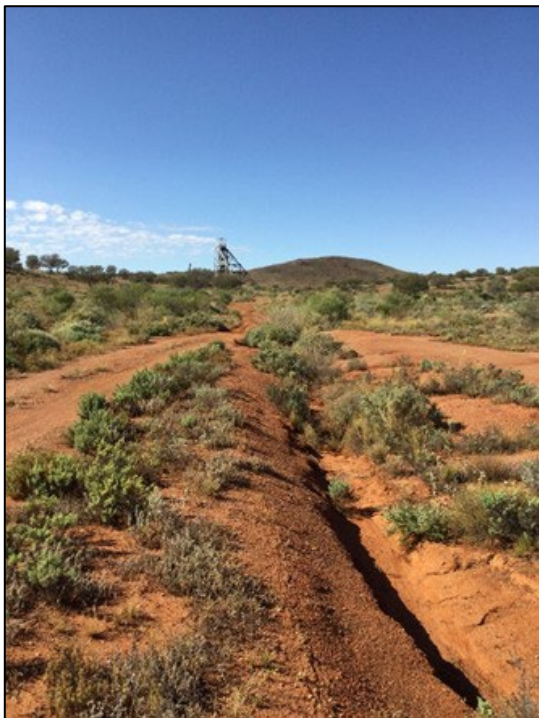
Plate 1 Looking south from the western extent of the survey area in SU87, showing vegetation coverage gully erosion and vehicle track disturbance.

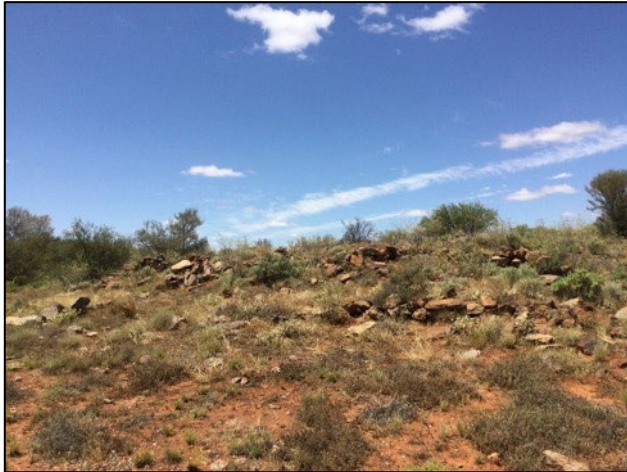
Plate 3 Looking east upslope at historic stone structure footings in SU88.

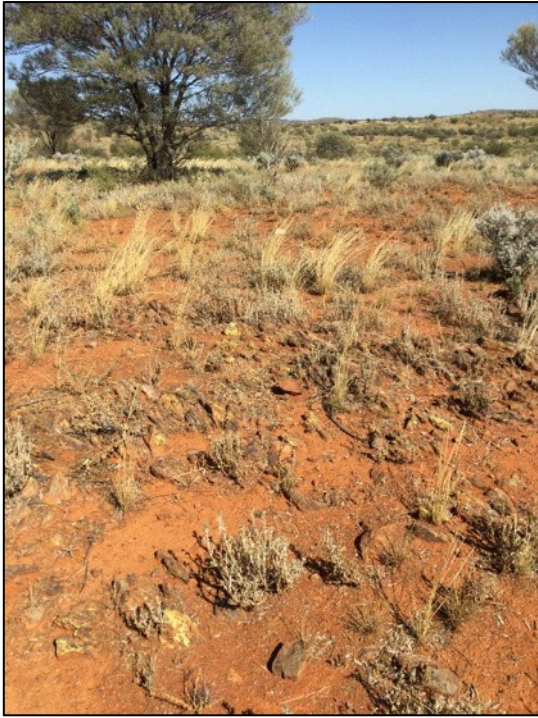
Plate 5 Looking northeast on crest showing ground surface exposure and outcropping bedrock in SU89.

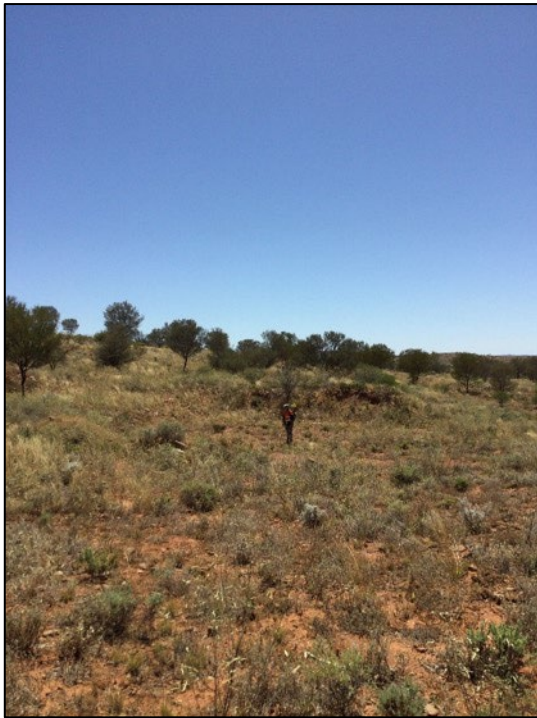
Plate 6 Looking east on at slope with machine cutting in SU90.

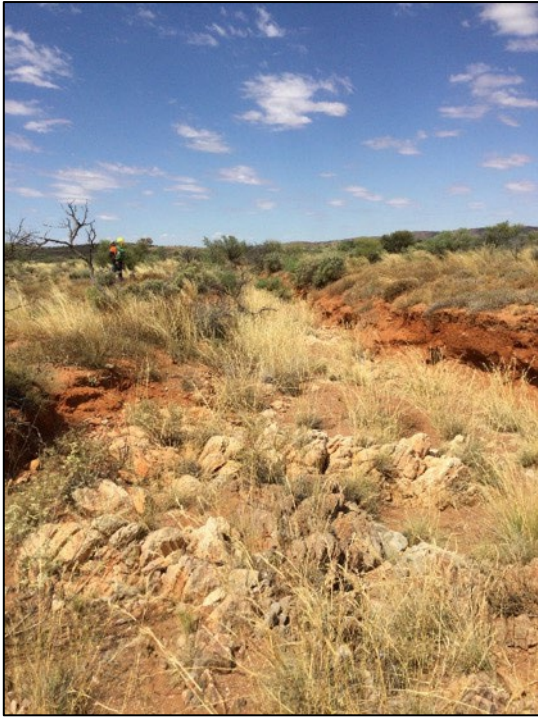
Plate 8 Looking south at exposed bed rock in the creek bed in SU91 in the south of the project area, showing depth of deposit.

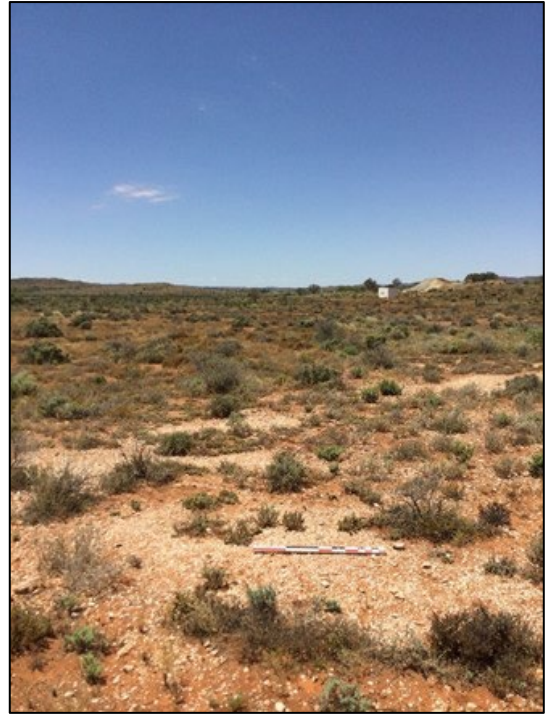
Plate 9 Looking east at a discrete area of dense quartz gravels on the ground surface in SU91, impacting visibility and ability to identify artefactual material from naturally fractured material.

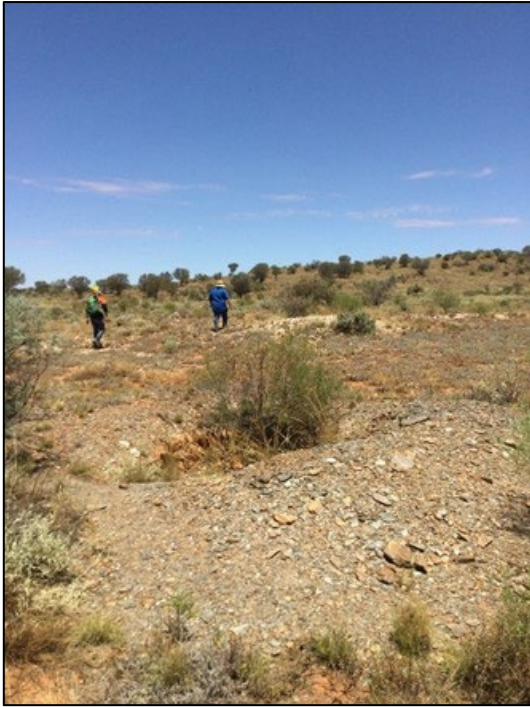
Plate 10 Looking south at pitting and spoil piles associated with historic prospecting activity in SU91 in the south of the project area.

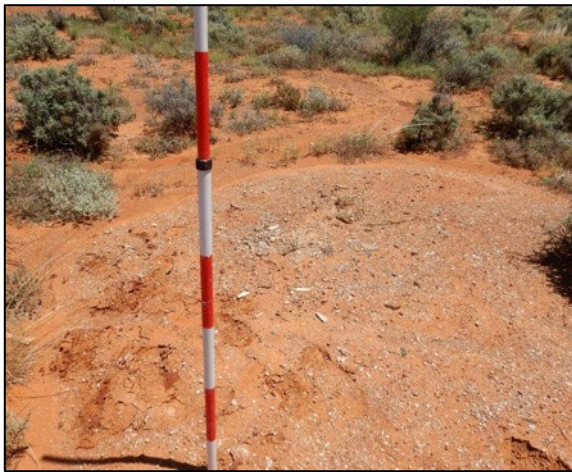
Plate 17 Historic dump in test zone 2.

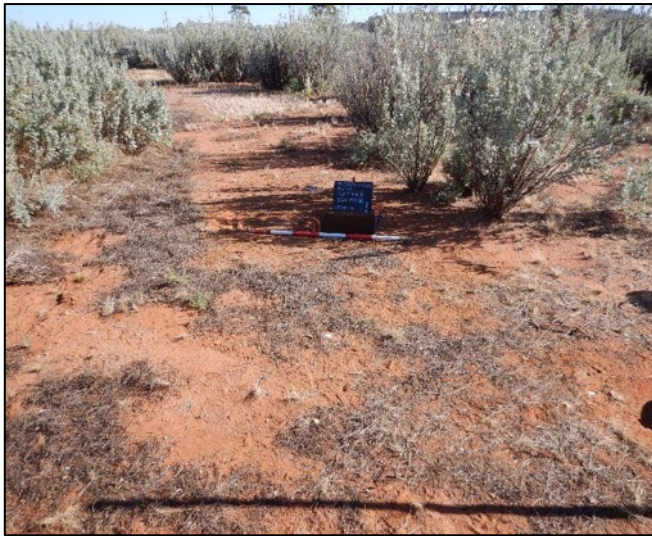
Plate 20 Looking north towards pit 1 showing surface artefact locations (white marker paint spots) in test zone 11.
