APPENDIX G
Archaeology Report

Silver City Energy Storage Project Broken Hill, New South Wales

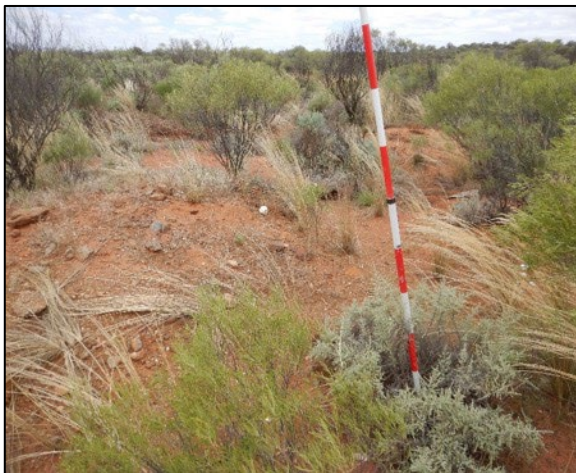
Plate 21 Example of building rubble dump pile near pit 6 in test zone 6.

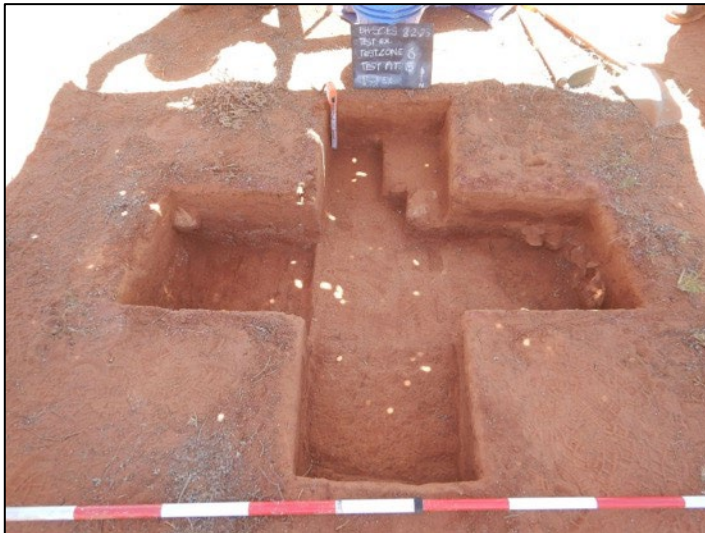
Plate 23 Looking north at pits 8, 9, 13, 14 and 15 at base of excavation.

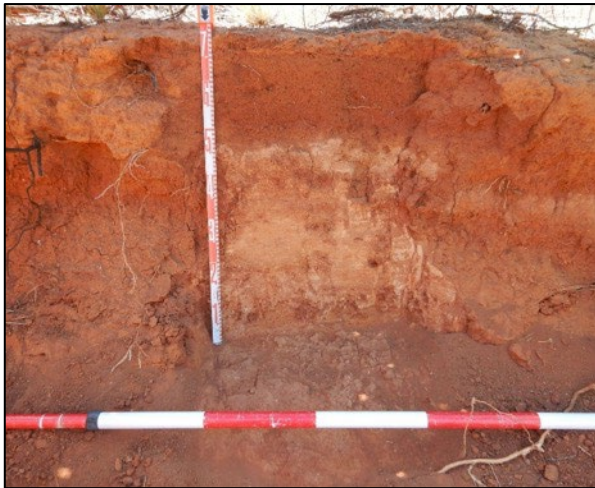
Plate 25 Section in creek bank at zone 5, showing deposit type and depth.

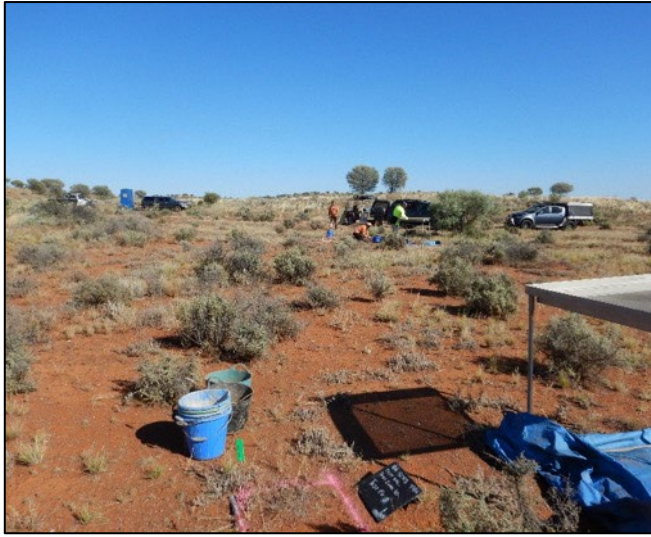
Plate 27 Looking northwest from pit 3 to pit 1 showing track and drain construction disturbance in zone 10.

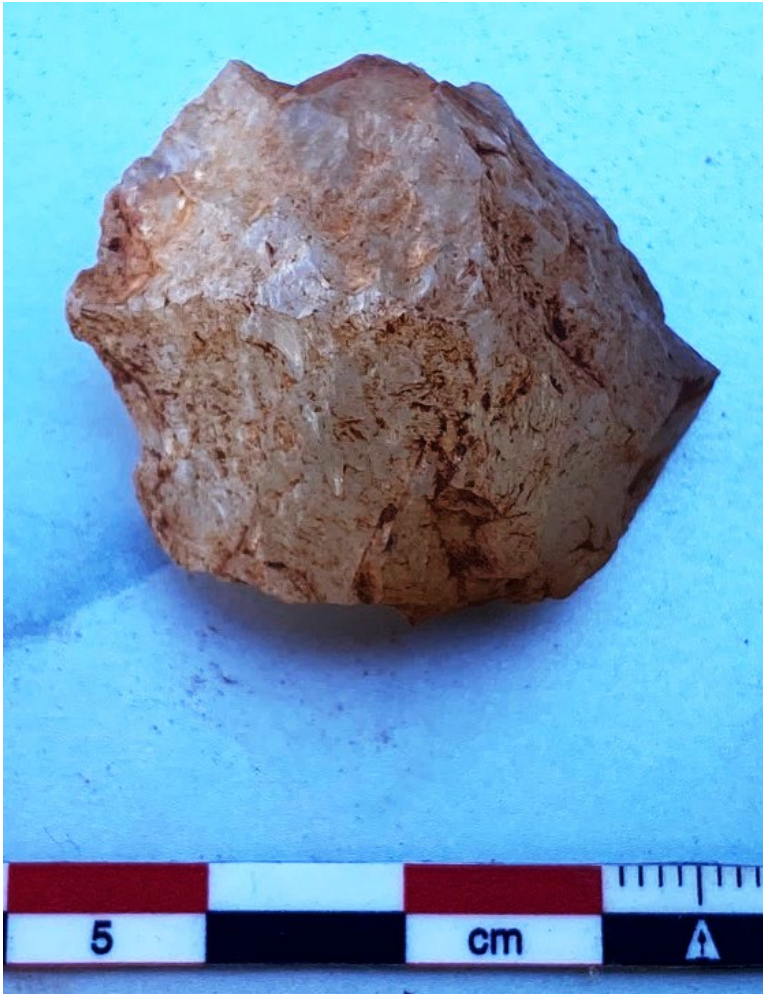
Plate Z: #18 disoidal quartz core.

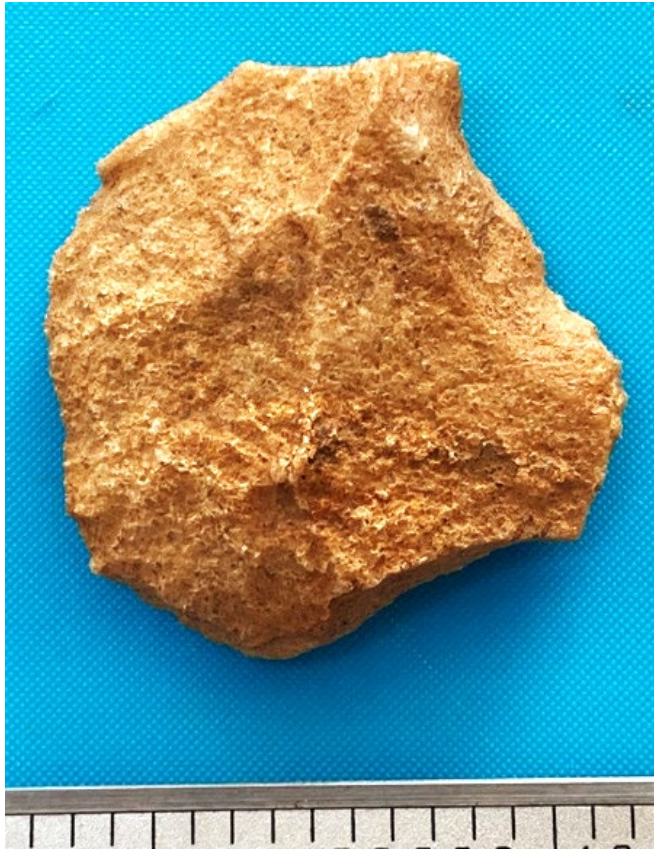
Plate B: The only retouched flake found during the test excavations (#15).
