Our Ref: 304100230_RPA_Western Campus_HLS Carpark_Lift_ver2:BD
Contact: Bikesh Deoju

ROYAL PRINCE ALFRED HOSPITAL STAGE 1 REDEVELOPMENT WORKS FOR HELICOPTER LANDING SITE

- Helicopter Landing Site (HLS) – Multistorey Car Park – Lift Pit

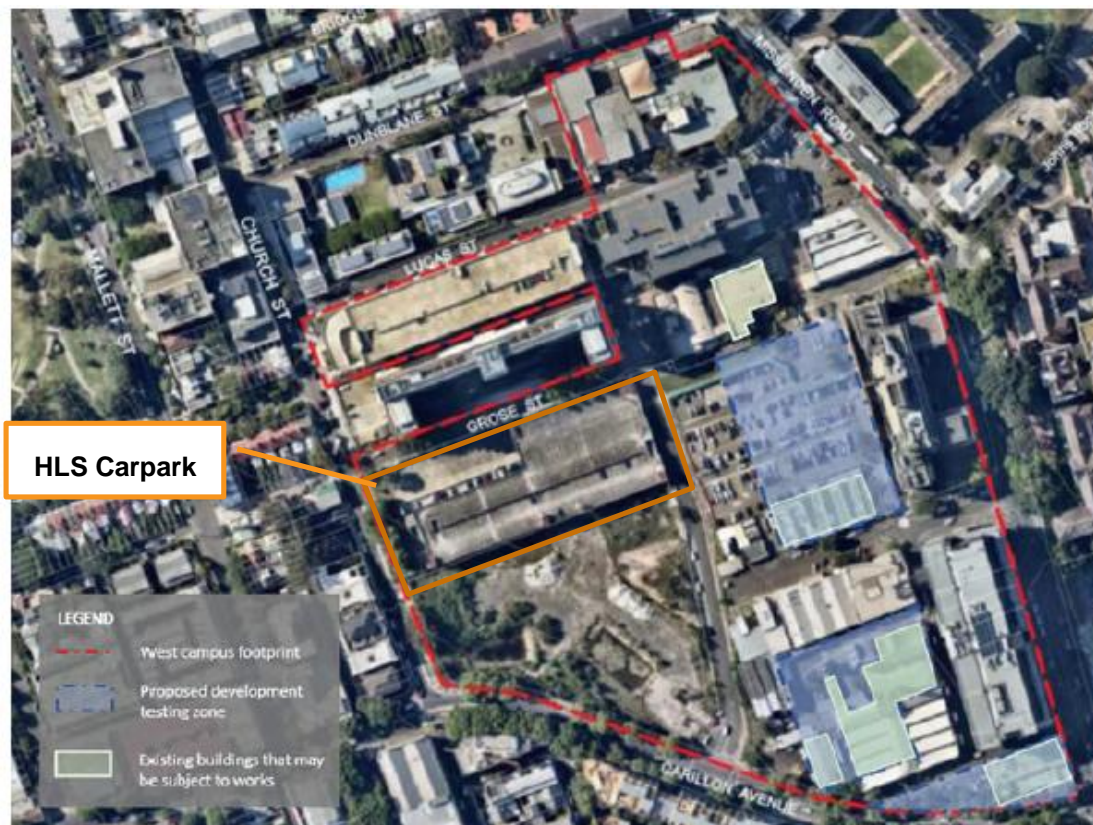
Figure 1-2 Proposed Development Zone – West Campus

The subject area consisting of multi storey carpark is shown on **Figure 1-2** below
