**Interim Site Audit Advice No 01, BE167, Royal Prince Alfred Hospital, Remediation Action Plan review**

**1.0 Introduction and Site Audit Background**

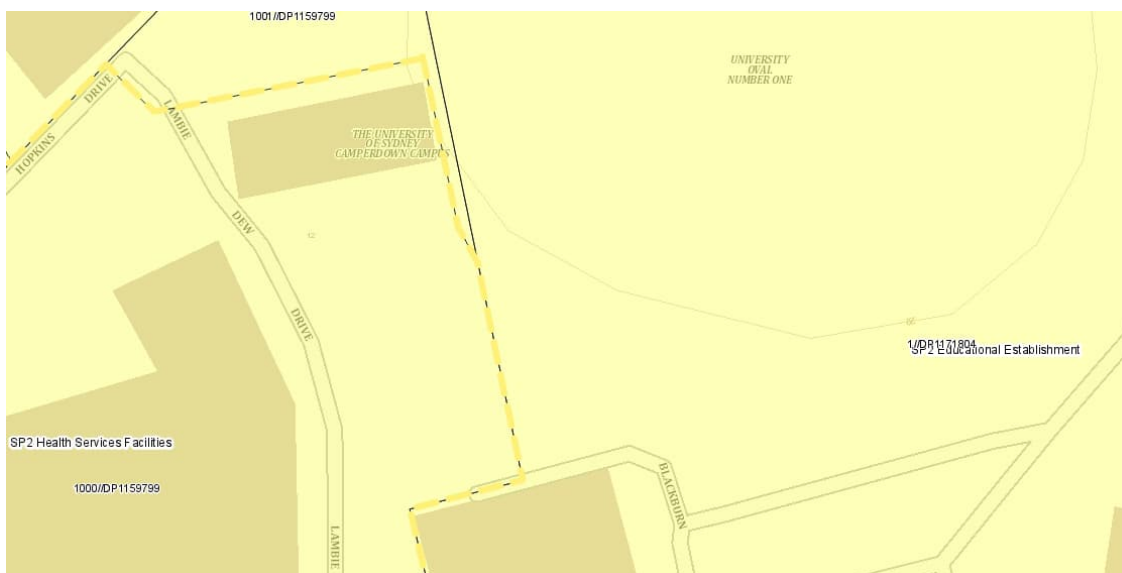
**Figure 1 Lot and DP plan from <https://www.planningportal.nsw.gov.au/spatialviewer/>**

- Based on figures in the Cardno (2022j) RAP and the Cardno (2022g) DSI, the area of disturbance (i.e., the area that will potentially be subject to remediation) includes a portion of adjacent Sydney University land, identified as part Lot 1001 DP 1159799 and part Lot 1 DP 1171804. See Figure 1 and Figure 2 below.

- Based on <https://www.planningportal.nsw.gov.au/spatialviewer/>, Lot 1000 and Lot 1001 DP 1159799 are zoned SP2: Health Services Facilities and Lot 1 DP 1171804 is zoned SP2: Educational Establishment.

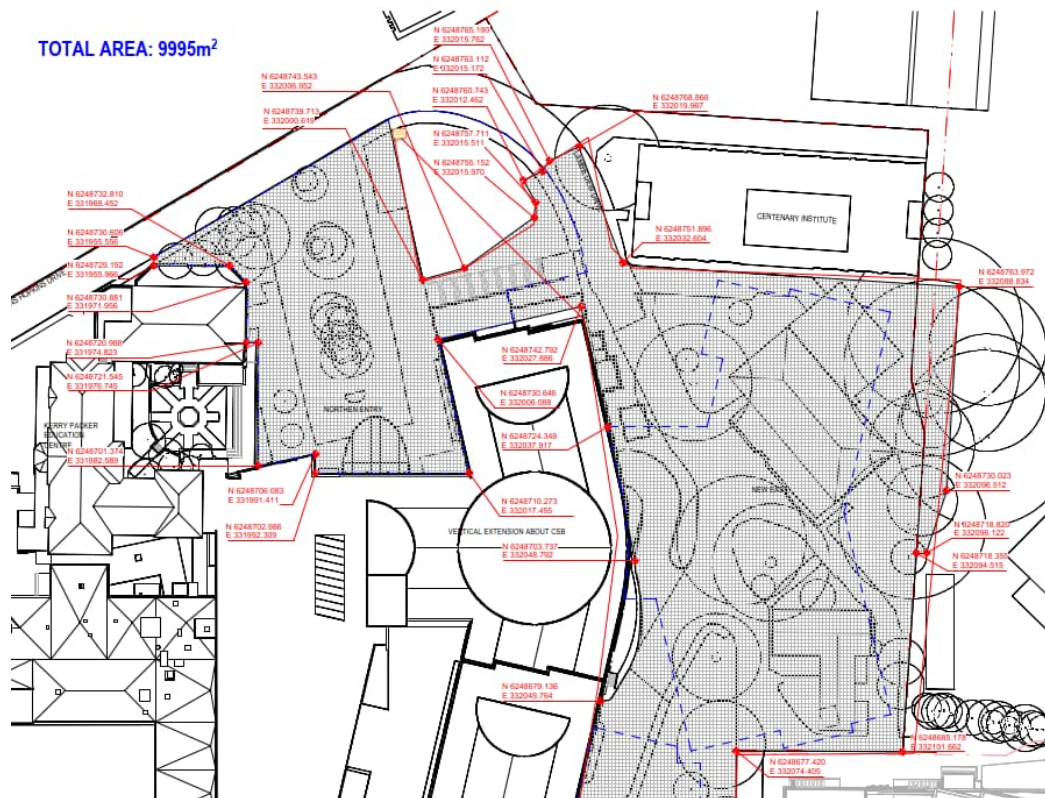
Figure 2 Northeast portion of Drawing 11/02/22\_ IA0251300- SK-SK-2001 Extent of Works Diagram

- The total area described in Drawing 11/02/22\_ IA0251300- SK-SK-2001 Extent of Works Diagram included in the Cardno (2022i) DSI indicated the total area to be 9,995m<sup>2</sup>. The site identification table in the DSI indicated the total area to be 9,320m<sup>2</sup> (1,205+155+6,748+1,212) when the areas are added (see Table 2 below). The Auditor considers that these discrepancies should be addressed by providing a survey plan of final the remediated area in the validation report.

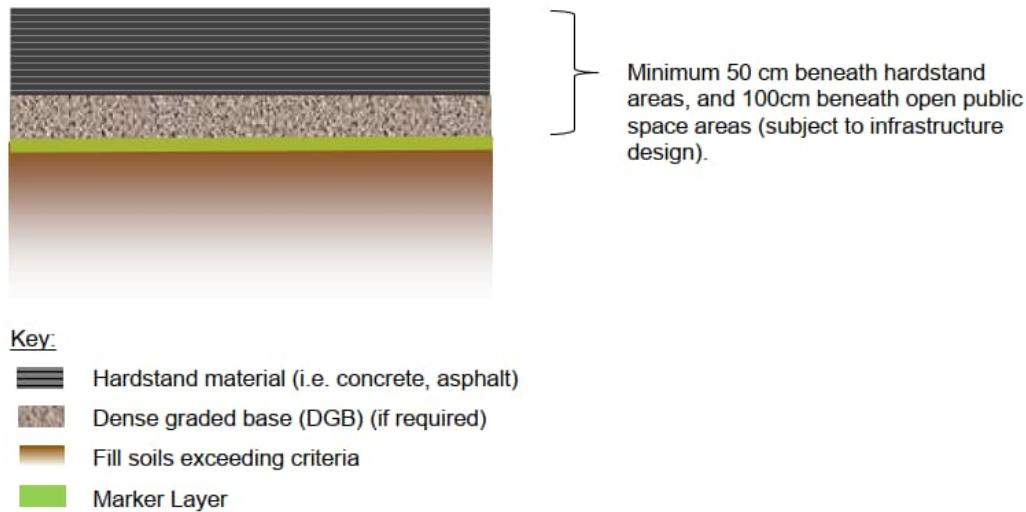
**Figure 3 Proposed Schematic of Capping (Cardno, 2022j)**

With regards to on-site encapsulation, the following schematic capping design was provided:

The Cardno (2022j) RAP “recommended that prior to construction, a design specification is prepared consistent with the clients civil and structural requirements for the proposed encapsulation area. Each element of the design must be validated at construction prior to continuing with construction.”

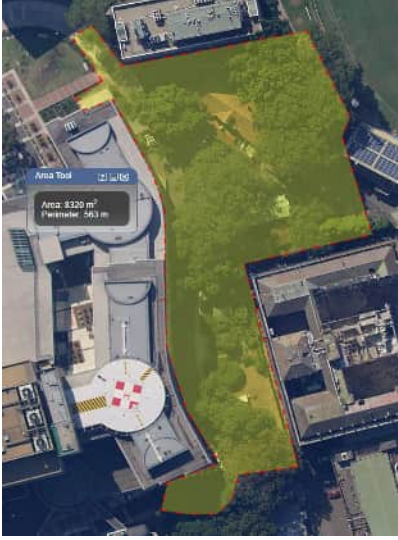
| Item No | Document Reference | Auditor's Comments | Consultant's Response (Cardno now Stantec) | Auditor's Response (11- Nov-2022) |
|---|---|---|---|---|
| 3 | Section 1.2, Figure 2 and Figure 4 | <p>The area of the East Area of the Eastern Development (formerly Area B) is stated to be approximately 3,550m<sup>2</sup>, which does not appear to be correct based on a quick estimation using SIXMAPS (see screenshot below), and appears to be at least twice the size. Please confirm.</p> <p>The Auditor also notes that Drawing 11/02/22_ IA0251300- SK-SK-2001 included in the RevB DSI shows the "TOTAL AREA" as 9,995 m<sup>2</sup>, which appears to include the Maternity Ward Parking Area (formerly Area A) and the Emergency Bay Area (not previously included).</p> <p>What implications does the larger disturbance area have on the sampling density in the DSI and validating larger areas, such as where trees will be removed, which are presumably in the heterogeneous fill material?</p> | <p>The area of the East Area of the Eastern Development (formerly Area B) is approximately 6,758m<sup>2</sup>. This is based on the GIS measurements which used the architectural plans provided by the client. Please refer to Figure 2 of Appendix A.</p> <p>As outlined in the DSI (RevB) and the RAP, Eastern development now includes the former Area B and Area A (the Maternity Ward area), which as per the architectural plans, has a total combined area of 8,803 m<sup>2</sup>. All areas are clearly outlined in Table 2-1. The Total Area of 9,995m<sup>2</sup>, as outlined in the Drawing 11/02/22_ IA0251300- SK-SK-2001, is referring to Maternity ward, former Area B which is now referred to eastern area of East Campus and the Emergency Bay Area.</p> <p>The number of investigation locations (33) to date is more than sufficient to meet the sampling design guidelines for a site area of 8,803 m<sup>2</sup> (i.e. 20 number of investigation locations required). However, Cardno recommends that additional investigation locations are completed as part of data gap investigation as the three areas of site expansion are located near site boundaries and are not small (i.e. northern extension of Lambie Dew Drive, extension onto Whale Garden, extension into University of Sydney Lands, and southern extension of Lambie Dew Drive). It was also considered that investigation near the Whale Garden and northern extension of Lambie Dew Drive (i.e. BH407, shallow terminated on buried concrete slab) was insufficient. These additional investigation locations are shown in RAP, Figure 3, Appendix A. A snapshot of this figure is provided to the right of this cell for ease of reference.</p> <p>Given that the Emergency Bay area is not within close vicinity of the Eastern Development, Cardno considered the EBA to be a separate area to the Eastern Development. As such, the data gap investigation in the EBA is independent from the Eastern Development.</p> | See response to Item No 1. |

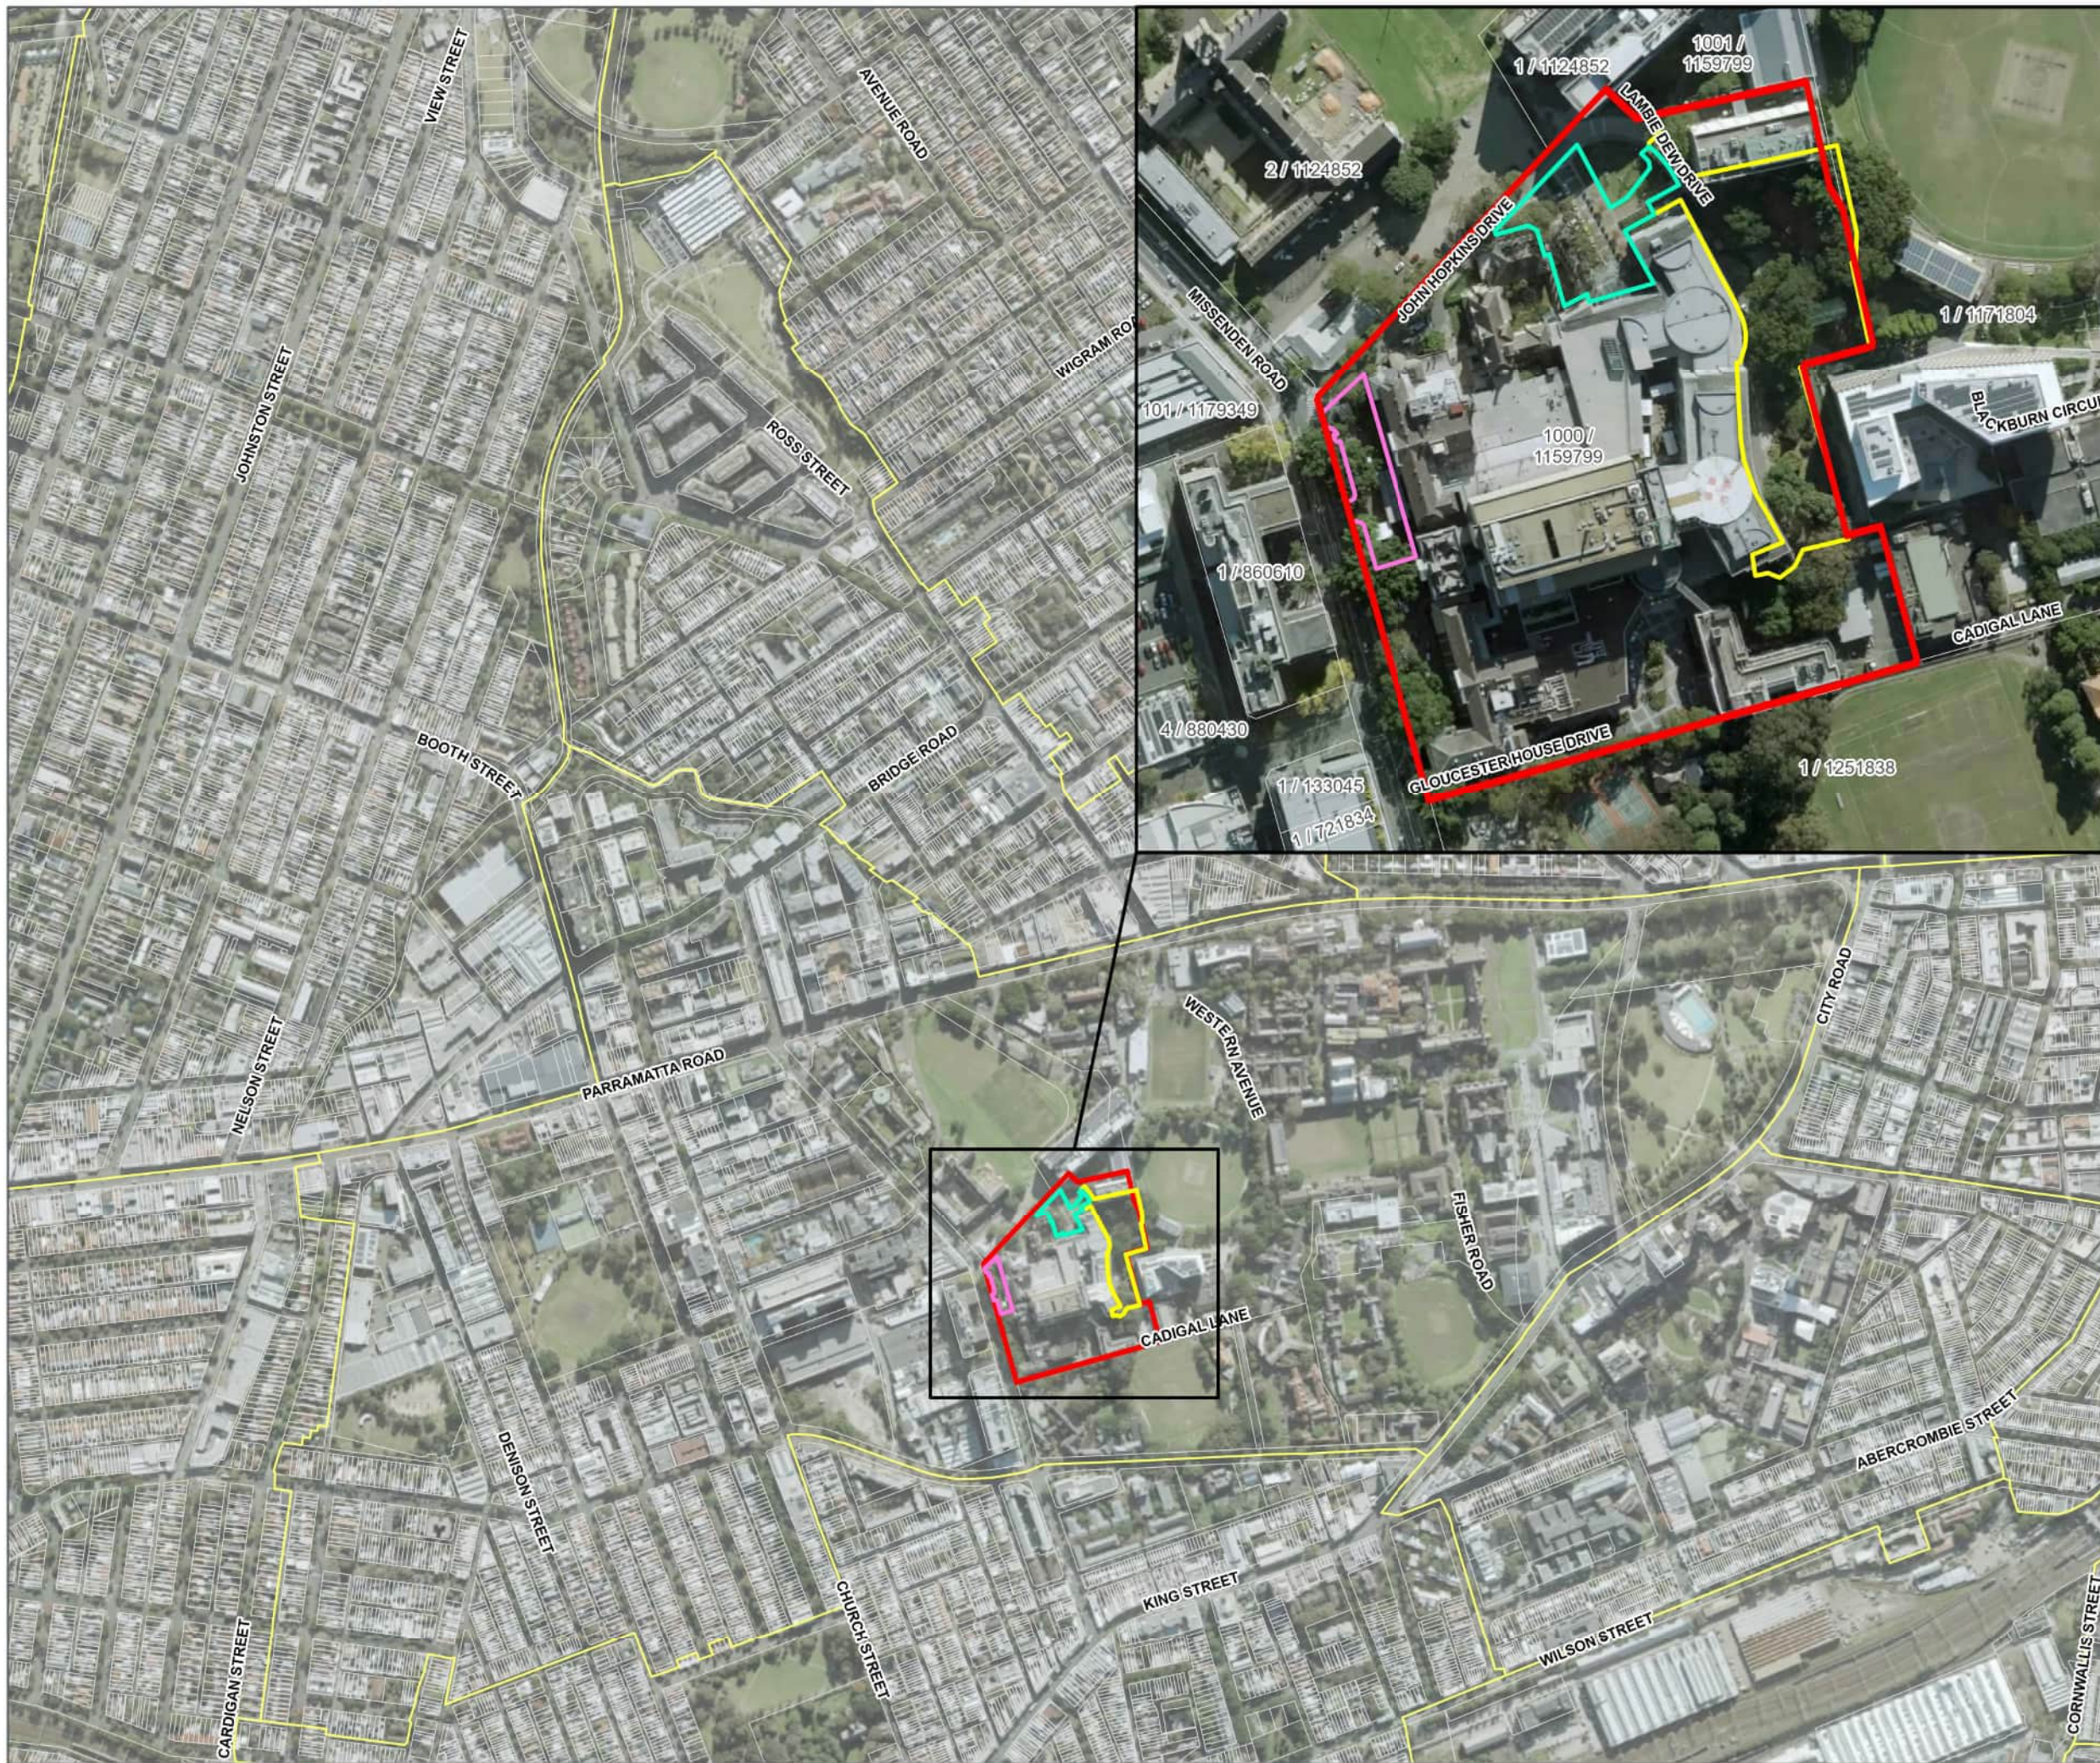
## Site Location Plan

ROYAL PRINCE ALFRED HOSPITAL
