Geotechnical Interpretative Report

Royal Prince Alfred Hospital – Eastern Campus

80022026

Prepared for TSA Management c/o NSW Health Infrastructure (NSW HI)

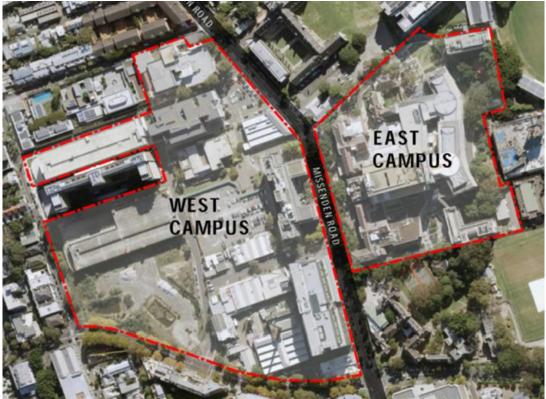
Figure 2-1 RPA Hospital Campus

The Royal Prince Alfred Hospital (RPA) campus is located in Sydney's inner west suburb of Camperdown. It is situated between Sydney University to the east and the residential area of Camperdown to the west. The campus is divided by Missenden Road, which runs north to south dividing the campus into two distinct portions, called East Campus and West Campus as show in Figure 2-1 below:

The RPA Hospital campus (outlined in red in Figure 2-1 above) incorporates a diverse range of operations including research, education, student housing, acute quaternary health services, as well as healthcare in both private and public domains.

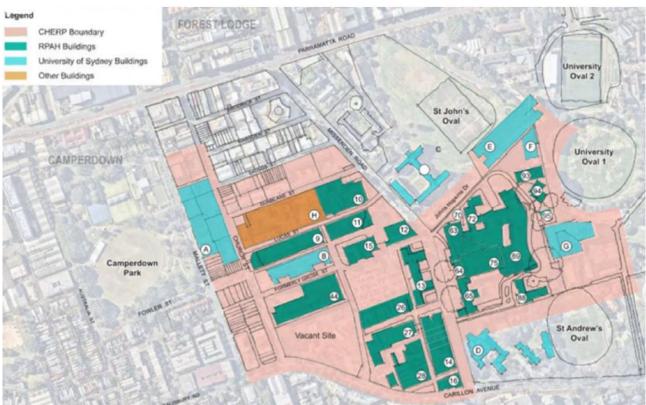
Figure 2-2 RPA Hospital Campus with building numbers

The following figure shows the locations of RPA buildings with unique building numbers for the entire eastern and western campus.

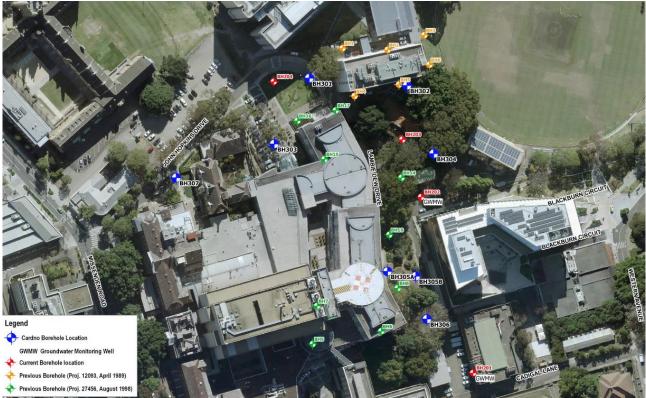
Figure 2-3 Approximate Borehole Locations

The investigatory boreholes undertaken for the hospital redevelopment are shown in Figure 2-3 below, which are also attached in **Appendix A – Site Plan**:

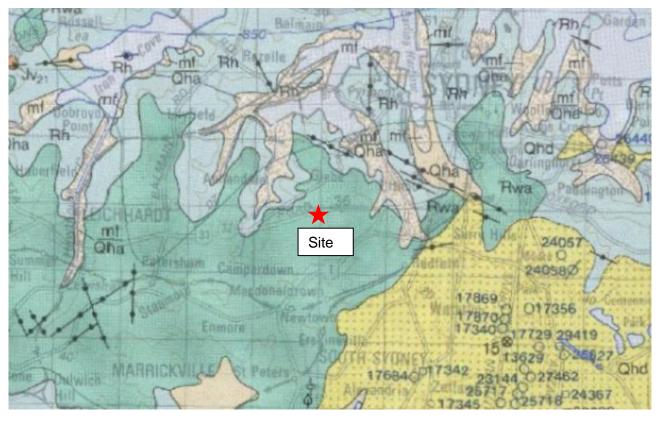
Figure 2-4 Geological Map, Herbert C., 1983, 1st Edition

Regional geology of the site area is presented in Figure 2-4 below:

The ground conditions across the subject site were relatively uniform and resembled with the geology (Rwa – Ashfield Shale) as shown on the published map.

The general ground conditions encountered on site have been discussed in Section 6 of this report. In summary the ground condition encountered are relatively similar comprising asphaltic pavement / concrete paver overlying fill, overlying residual soil and siltstone / laminite bedrock. From the borehole investigation undertaken on site, the subsurface ground profile was generally consistent with the geology maps.

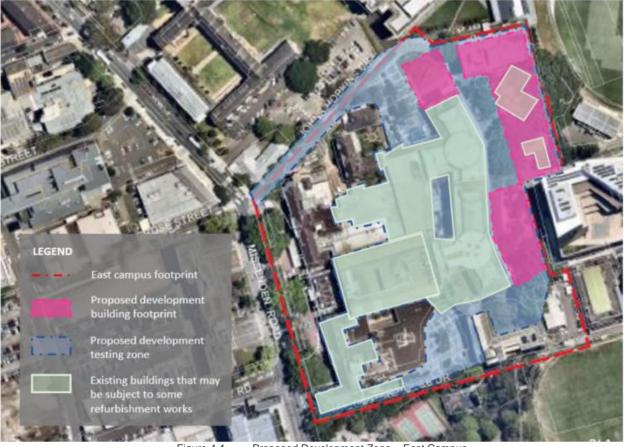
Figure 4-1 Proposed Development Zone – East Campus

- i) the building footprints of the new proposed development;
- ii) areas between the existing buildings and new proposed development;
- iii) John Hopkins Drive and Lambie Dew Drive due to potential civil works for road realignment/ enhancements and service diversions;
- iv) Gloucester House Drive due to potential civil works for new in-ground services/ services connections;
- v) existing Building 89 which may be subject to vertical expansion and refurbishment works to some levels;
- vi) New Mortuary drop off within the access lift between levels 1 and 2 of Building 89;
- vii) Relocation of the existing roller shutter door on the eastern side of the Clinical Services Building; and
- viii) some departments within some levels of existing Buildings 63, 75, 94 and 95 which may be subject to refurbishment works

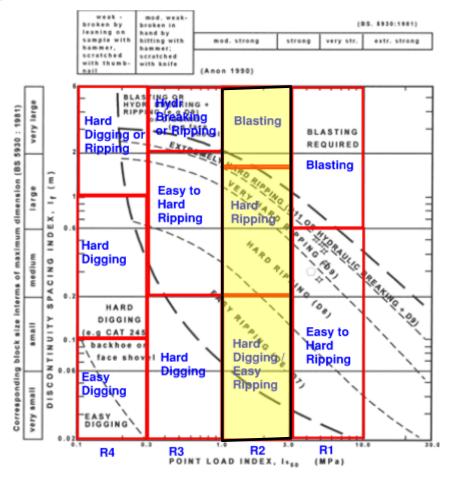
Figure 6-1 Zoning of excavatability based on Pettifer and Fookes (1994)

It is recommended that construction contractors assess the engineering logs, core photographs and rock cores to make their own assessment of excavation plant and production rates. Below recommendations are preliminary only and based on the geotechnical information across the site. Assessment of material excavatability can be based on the method published by Pettifer and Fookes (1994). The degree of excavatability of rock is based on its Point Load Index (Is50) and fracture spacing.

Excavatability categories range from easy to hard digging, through easy to hard ripping, to blasting.

Examination of Figure 7-1 shows that the excavatability zones are delineated according to rock strength categories (R4-low strength, R3-medium strength, R2-high strength, R1-very high strength), and further subdivided based on the defect spacing of the rock.

Our review of the borehole logs indicates that bedrock conditions encountered were generally moderate with defect spacing in the order of 10mm – 2970mm. It is therefore expected:

- i) hard digging to easy ripping conditions in Class III to Class V Siltstone / Laminite
- ii) hard ripping to blasting in Class II Siltstone / Laminite

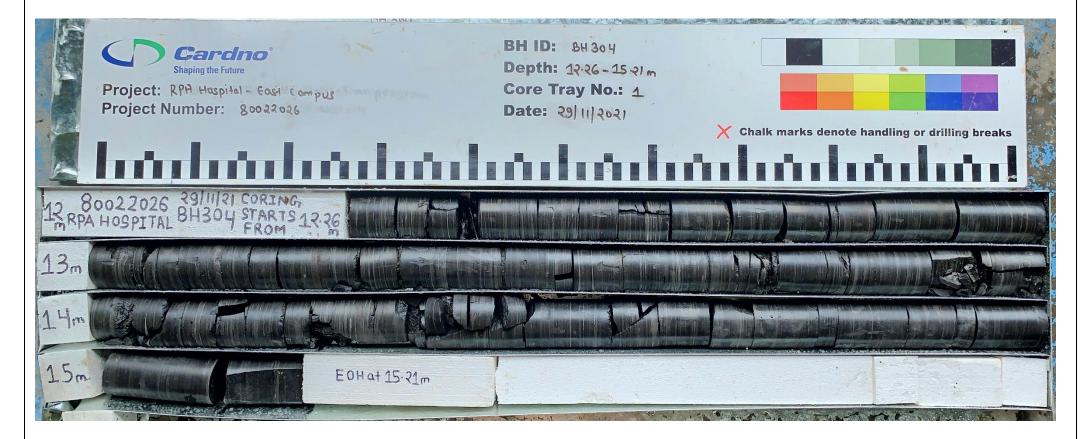
TITLE: Borehole Core Photographs – BH304 Geotechnical Investigation – RPA East Campus									
C) Cardno	PROJECT NO: 80022026	TEST DATE: 29/11/2021	INCLINATION: -90 degree	CORED LENGTH: BOX 1 OF 1 12.26 m to 15.21 m – 2.95 m Length						
	DRILL RIG: Geoproble 6620DT	CONTRACTOR: Cardno & Stratacore Drilling	LOGGED BY: RK	CHECKED BY: BD

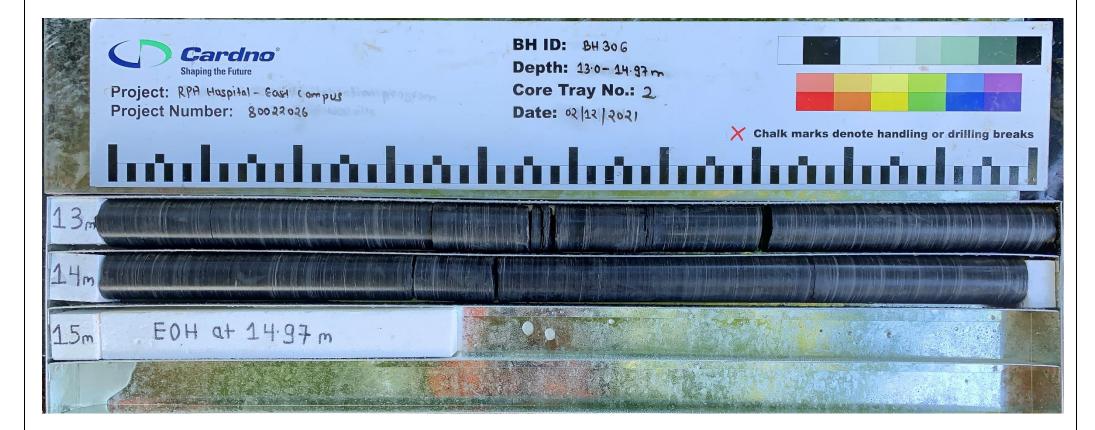
TITLE: Borehole Core Photographs – BH306 Geotechnical Investigation – RPA East Campus									
C Cardno	PROJECT NO: 80022026	TEST DATE: 02/12/2021	INCLINATION: -90 degree	CORED LENGTH: BOX 2 OF 2 13.00 m to 14.97 m – 1.97 m Length						
	DRILL RIG: D-4T Ute Rig	CONTRACTOR: Cardno & Stratacore Drilling	LOGGED BY: RK	CHECKED BY: BD

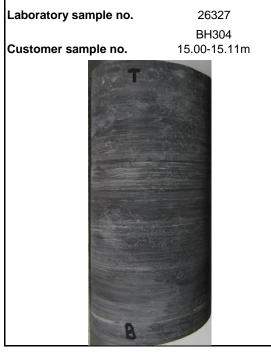
Laboratory sample no.	26328	
Customer sample no.	BH302 10.68-10.85m	
and the second second		
and the second		
	Contraction of the local division of the loc	
	1	
	AND TO A

Uniaxial Compressive Strength of Rock Core

Specimen prior to testing

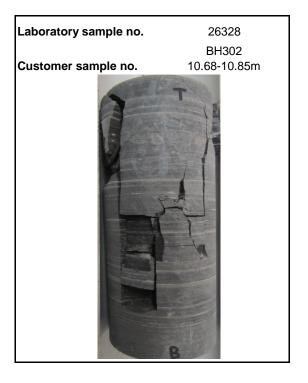
Laboratory sample no.	26327 BH304
Customer sample no.	15.00-15.11m

Specimen after failure

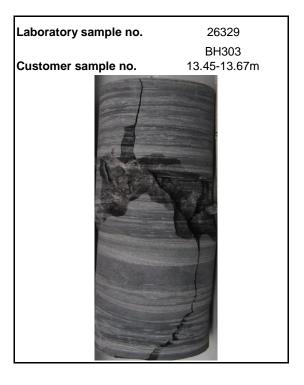
Specimen after failure

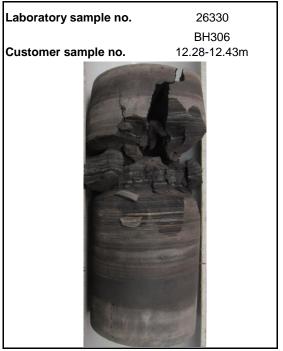
PROJECT			026 RPAH		1				(a) the dia	imetral test te	. (b) the axial est.	test, (c) the			egular lump	
LOCATIO SAMPLE	N:	BH30					DATE:	1/12/2021			Coring s		NMLC			
DEPTH / NTERVAL (m)	TEST No.	ROCK TYPE #	TYPE OF TEST	L LENGTH (mm)	SHAPE OK ?	D DISTANCE (mm)	W WIDTH (mm)	P LOAD (KN)	De ² (mm)	De (mm)	ls (MPa)	Size Corr. F	ls(50) (MPa)	Empirica UCS (MPa)	Rock Strength (MPa)	FAILUR TYPE

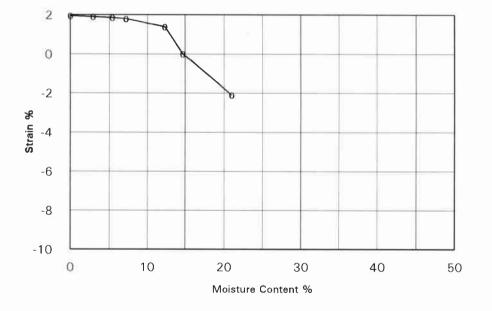
Pocket penetrometer reading at initial moisture content	>400	kPa
Pocket penetrometer reading at final moisture content	200	kPa
Initial Moisture Content	15.1	%
Final moisture content	21.0	%
Swell under 25kPa	2.1	%

SHRINK-SWELL INDEX I_{ss} 1.7 % per Δ pF

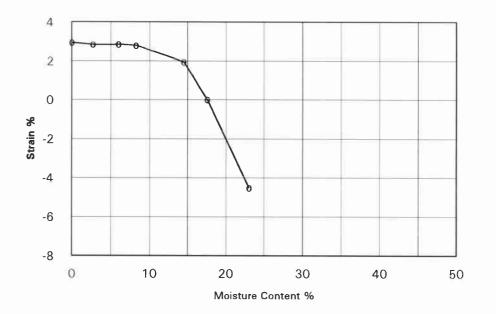
Shrinkage - air dried	2.9 %	Pocket penetrometer reading	
Shrinkage - oven dried	3.0 %	at initial moisture content	>400 kPa
Significant inert inclusions	- %	Pocket penetrometer reading	
Extent of cracking	- %	at final moisture content	250 kPa
Extent of soil crumbling	- %	Initial Moisture Content	18.6 %
Moisture content of core	17.5 %	Final moisture content	23.0 %
		Swell under 25kPa	4.5 %

SHRINK-SWELL INDEX I_{SS} 2.9% per Δ pF

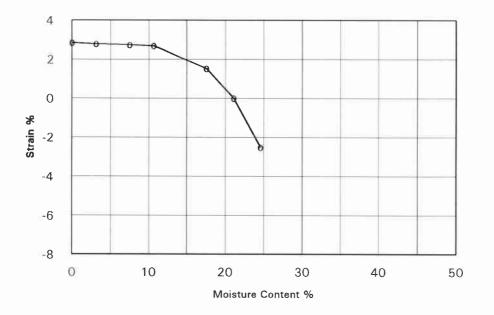
Shrinkage - air dried	2.8 %	Pocket penetrometer reading	
Shrinkage - oven dried	2.8 %	at initial moisture content	>400 kPa
Significant inert inclusions	- %	Pocket penetrometer reading	
Extent of cracking	1 %	at final moisture content	200 kPa
Extent of soil crumbling	- %	Initial Moisture Content	20.8 %
Moisture content of core	21.1 %	Final moisture content	24.7 %
		Swell under 25kPa	2.5 %

SHRINK-SWELL INDEX I_{SS} 2.3% per Δ pF

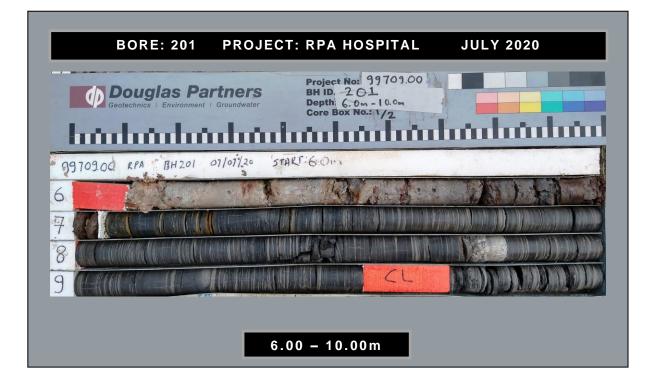
Douglas Par	Project No: 99 BH ID. 201 Depth: to 1 Core Box No: 2/	0.0m - 15m	
10,000				
2				
3
