Remediation Action Plan

Royal Prince Alfred Hospital

304100230

10 November 2022

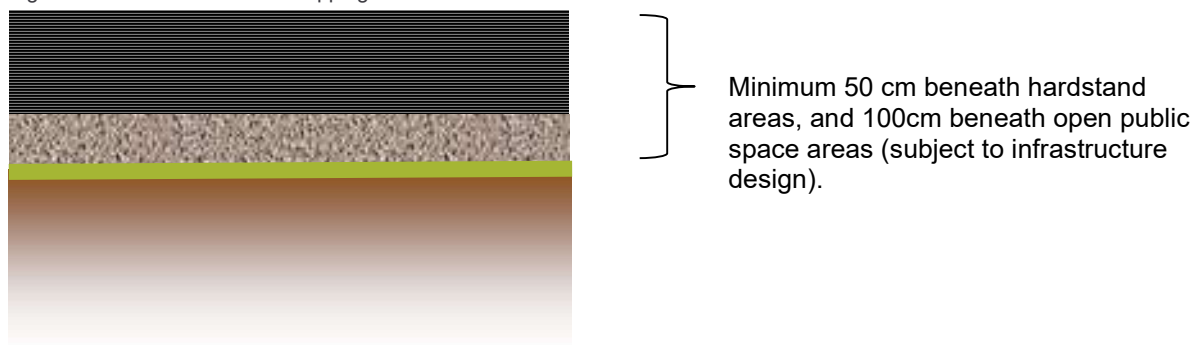
Figure 8-1 Schematic of Capping

A schematic of the proposed capping is shown below as **Figure 8-1**.
