# GEOTECHNICAL REPORT

285-289, 293-295 Mona Vale Road & 1 Flinders Road  
St Ives NSW 2075

Opal HealthCare – November 2025

**Report reference:** 2501056GTRpt01FinalV02\_20Nov2025

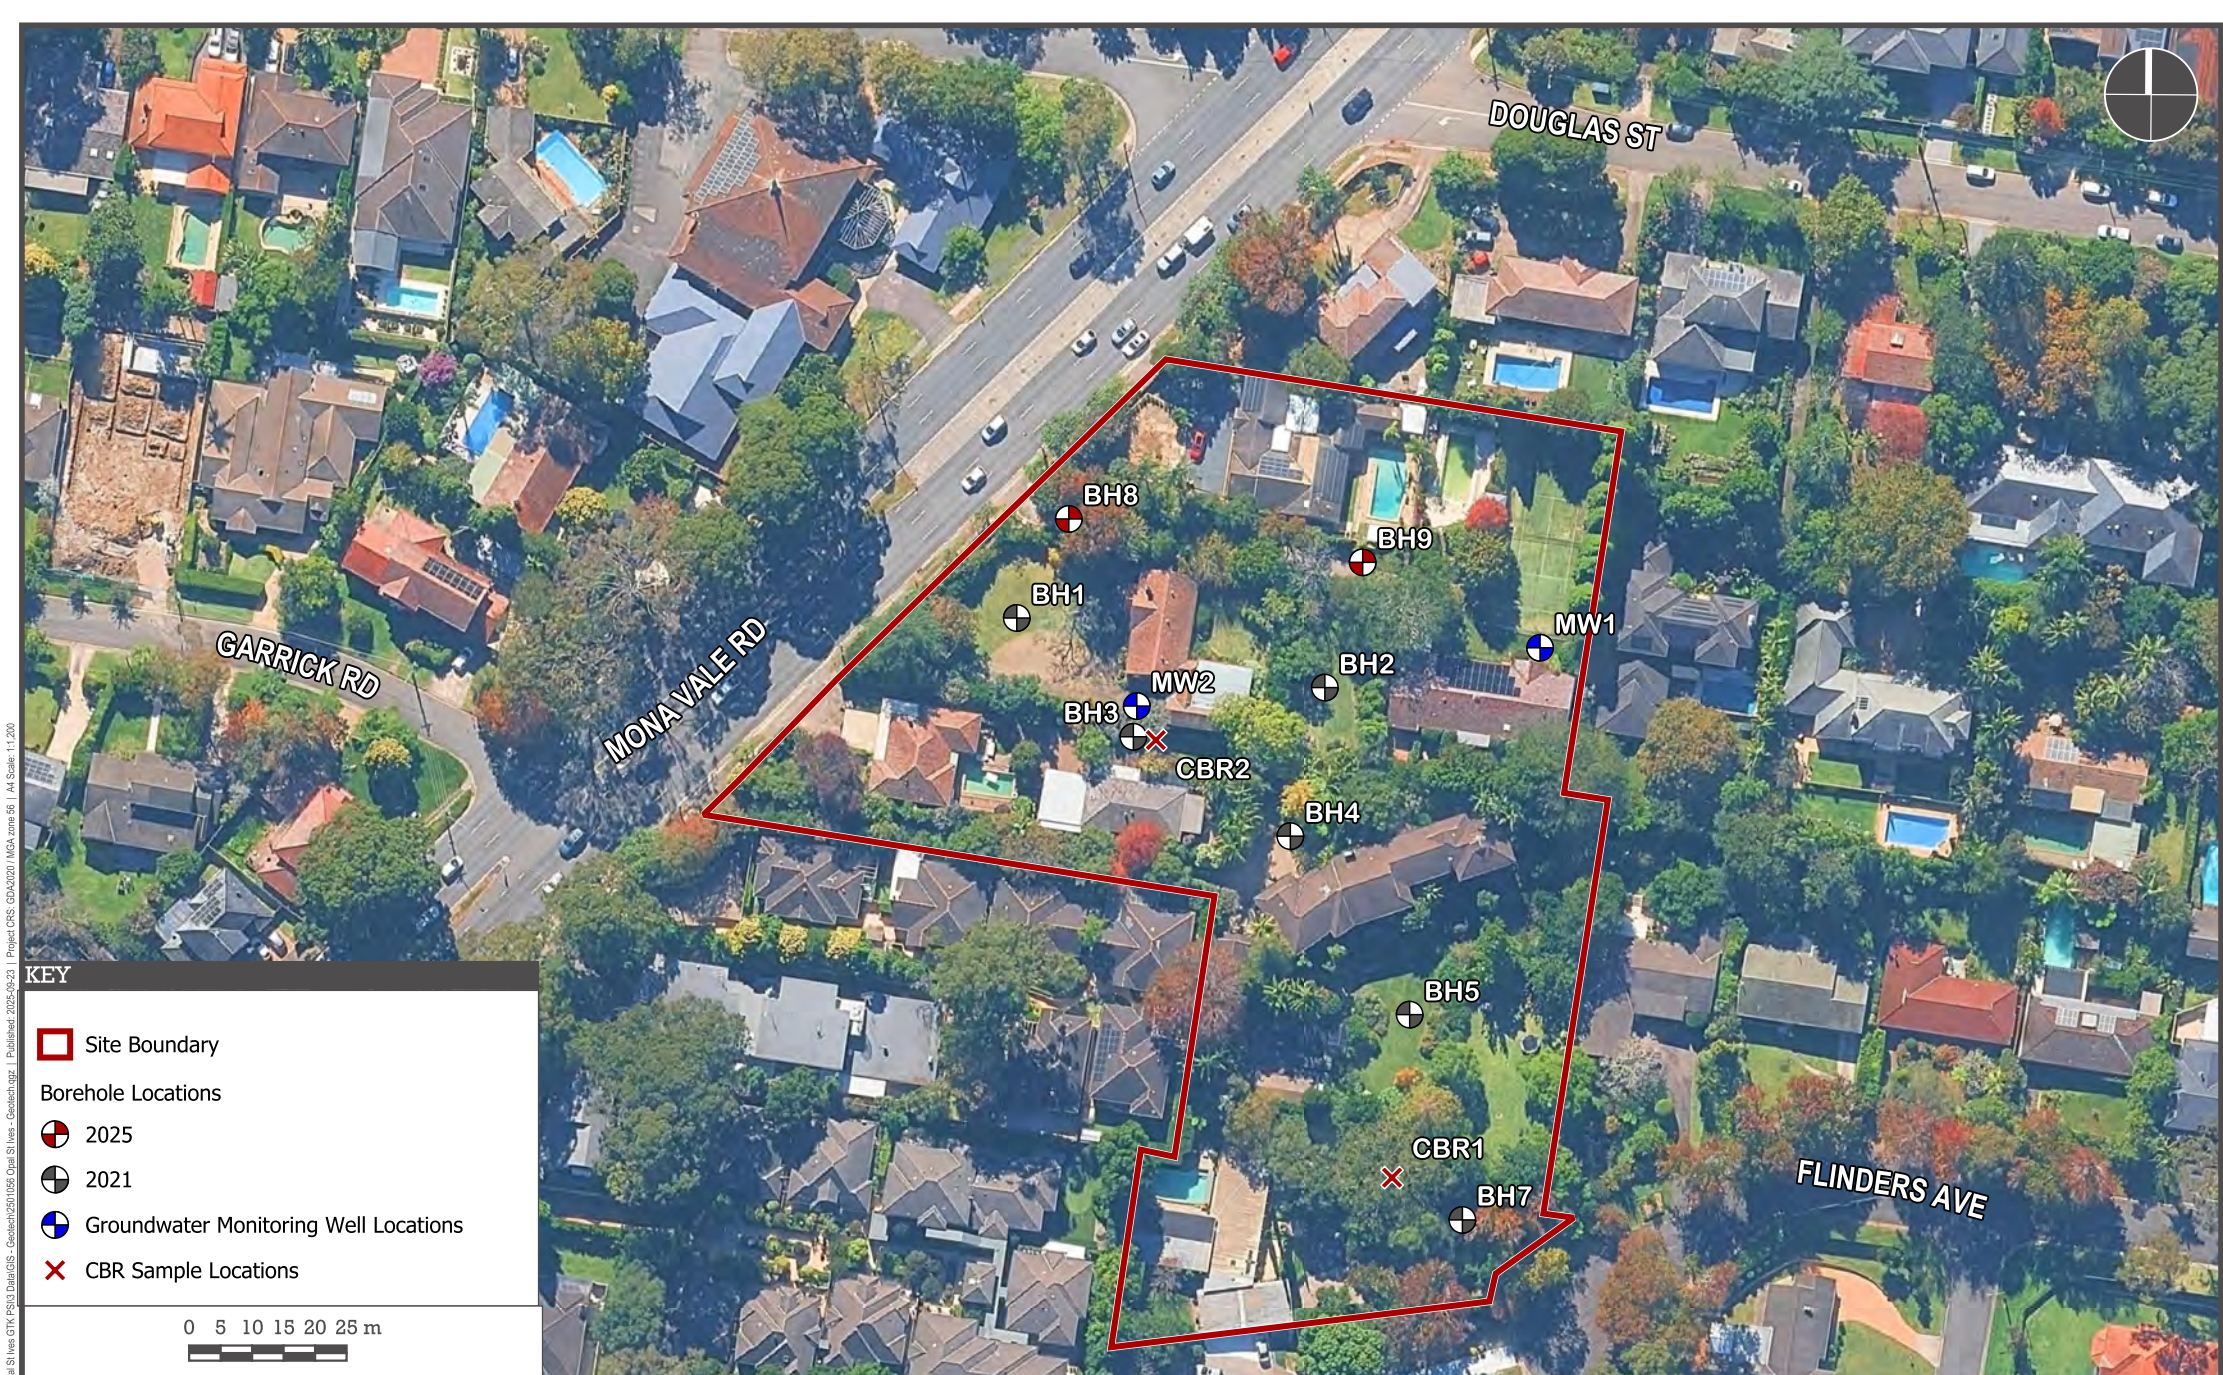
Figure 1

KEY

Site Boundary

Geo-Logix Pty Ltd (Geo-Logix) was engaged by Midson Group Pty Ltd on behalf of Opal HealthCare to conduct a geotechnical investigation of the property located at 285-289, 293-295 Mona Vale Road & 1 Flinders Road, St Ives NSW 2075 (Figure 1). Geo-Logix understands that the purpose of the investigation is to characterise subsurface conditions to assist with design and construction of a proposed development.

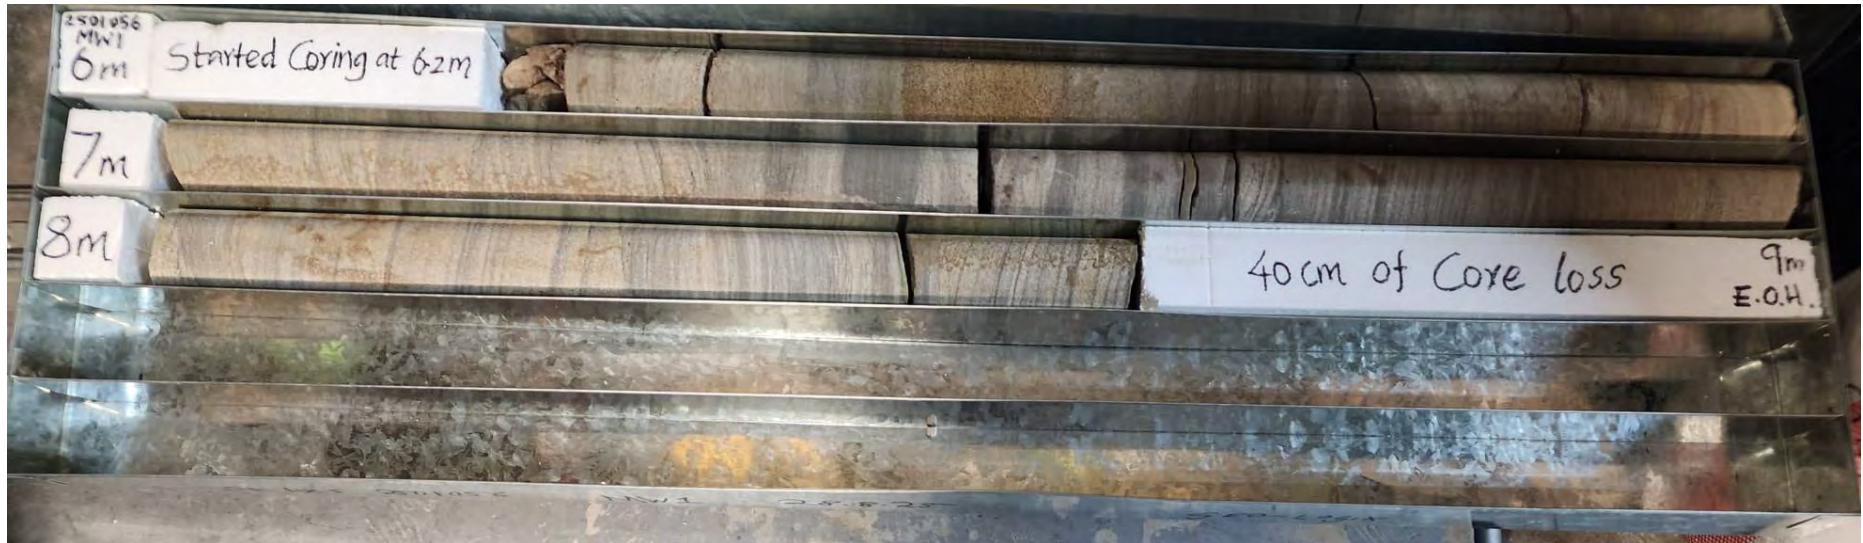
Borehole MW1: 6.2 – 9 m.

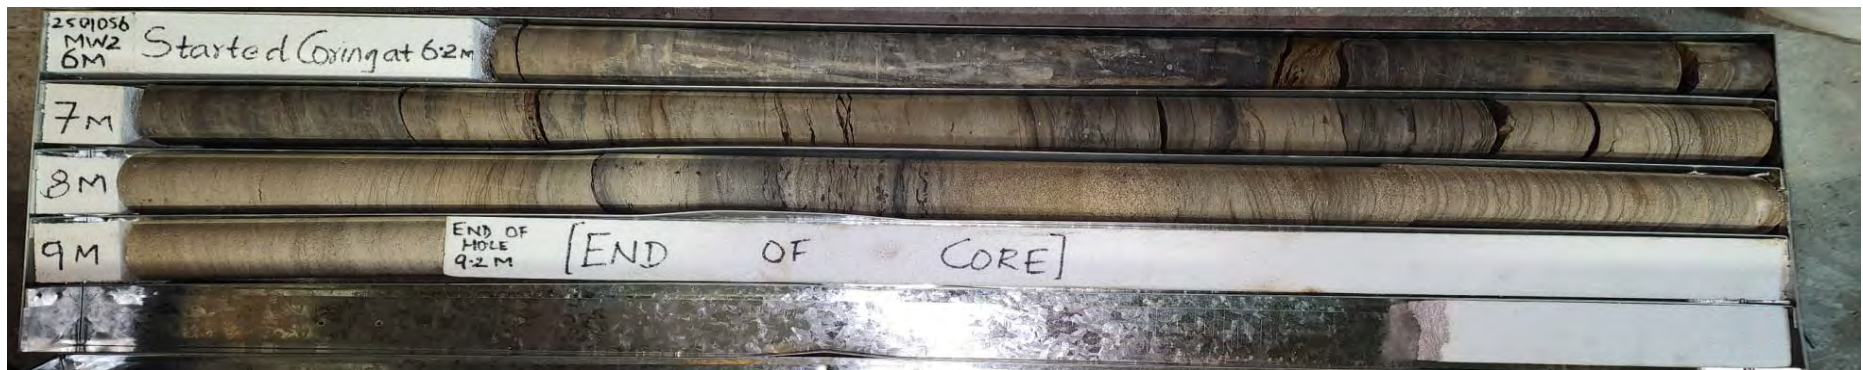
Borehole MW2: 6.2 – 9.2 m.
