## APPENDIX 8

### Aboriginal Cultural Heritage Impact Assessment

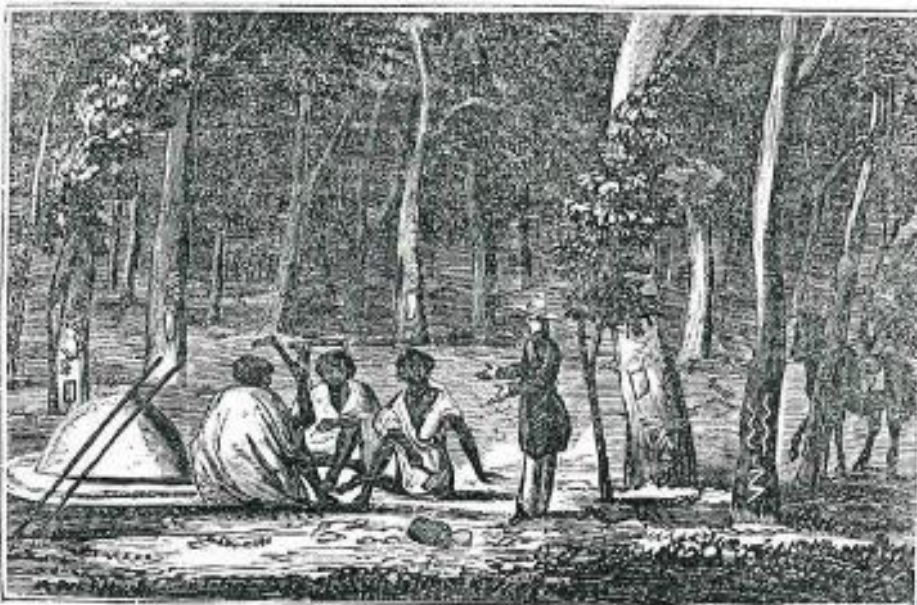
**Figure 4.1 Three women mourning at a grave near Mount Wayo**

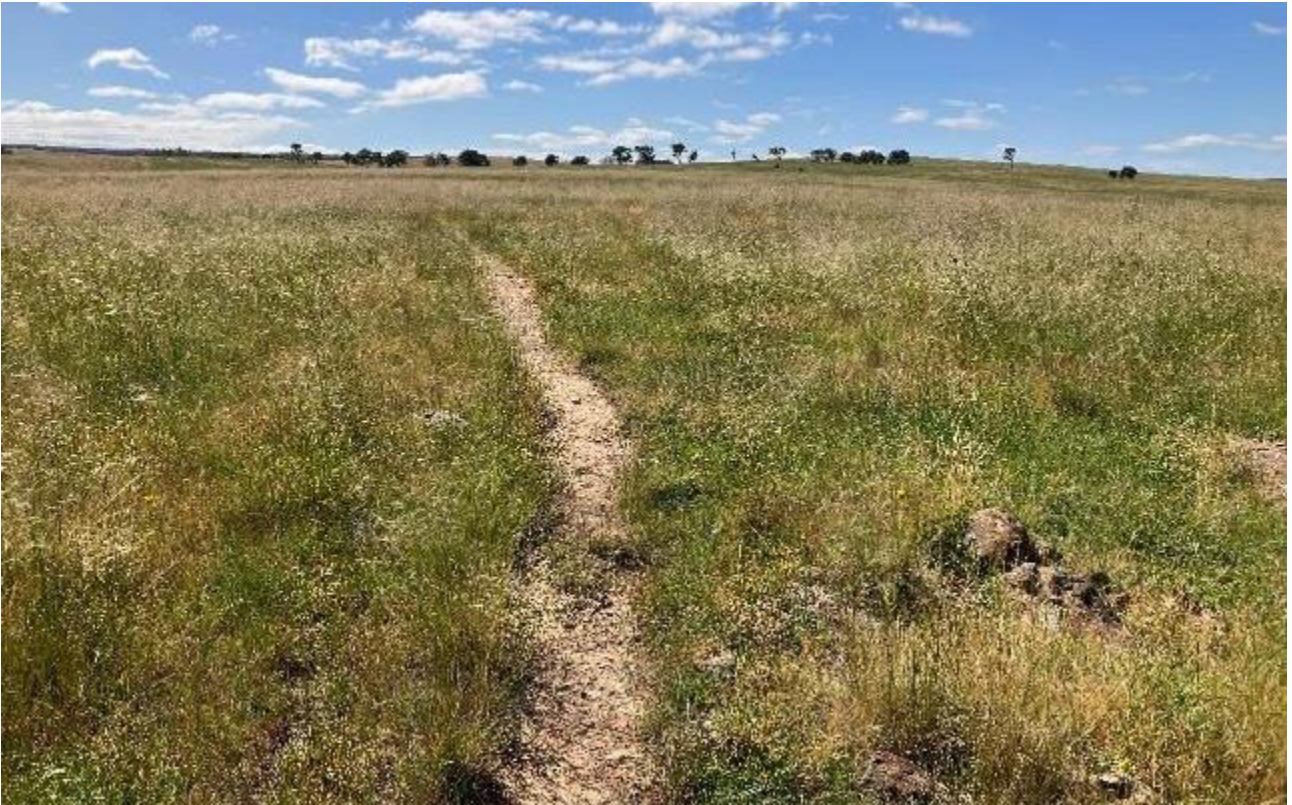
**Photo 5.8** View east across mid-slope survey unit along the northern edge of Project Area. Survey Unit 4

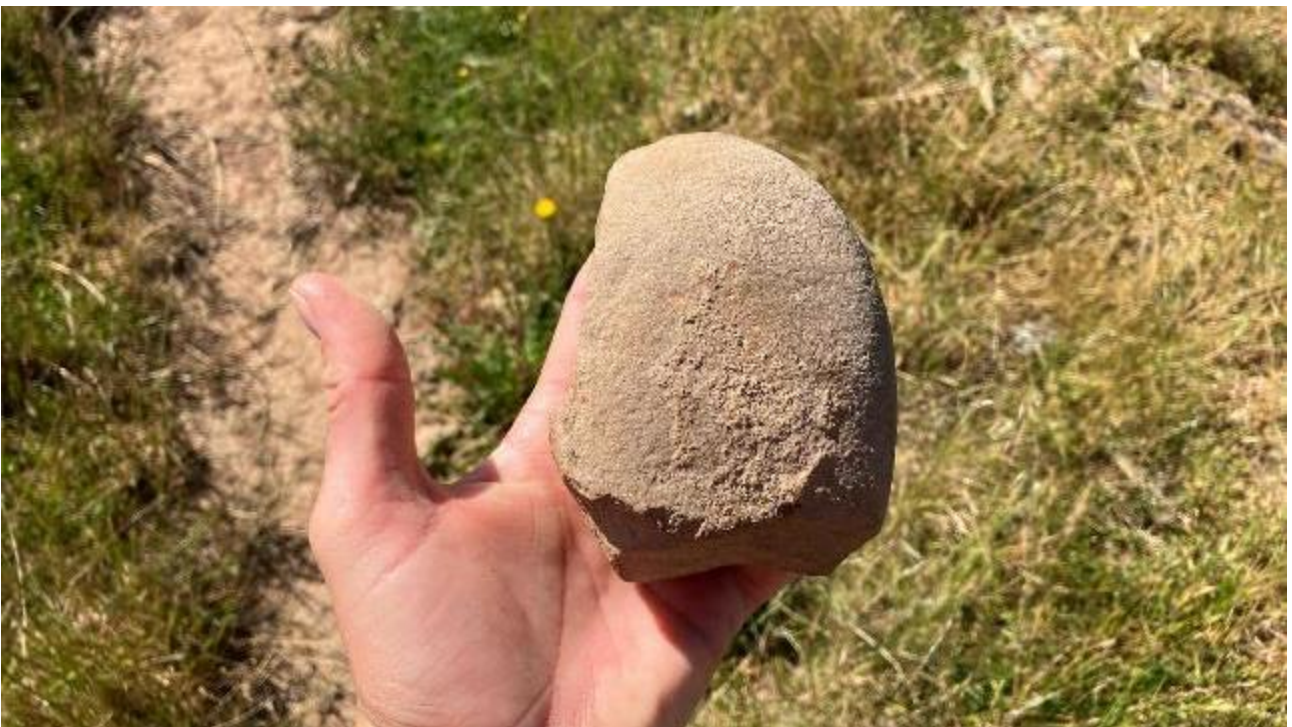
**Photo 5.9** Broken basalt hammerstone, part of UMW-GSF-1. Survey Unit 4.

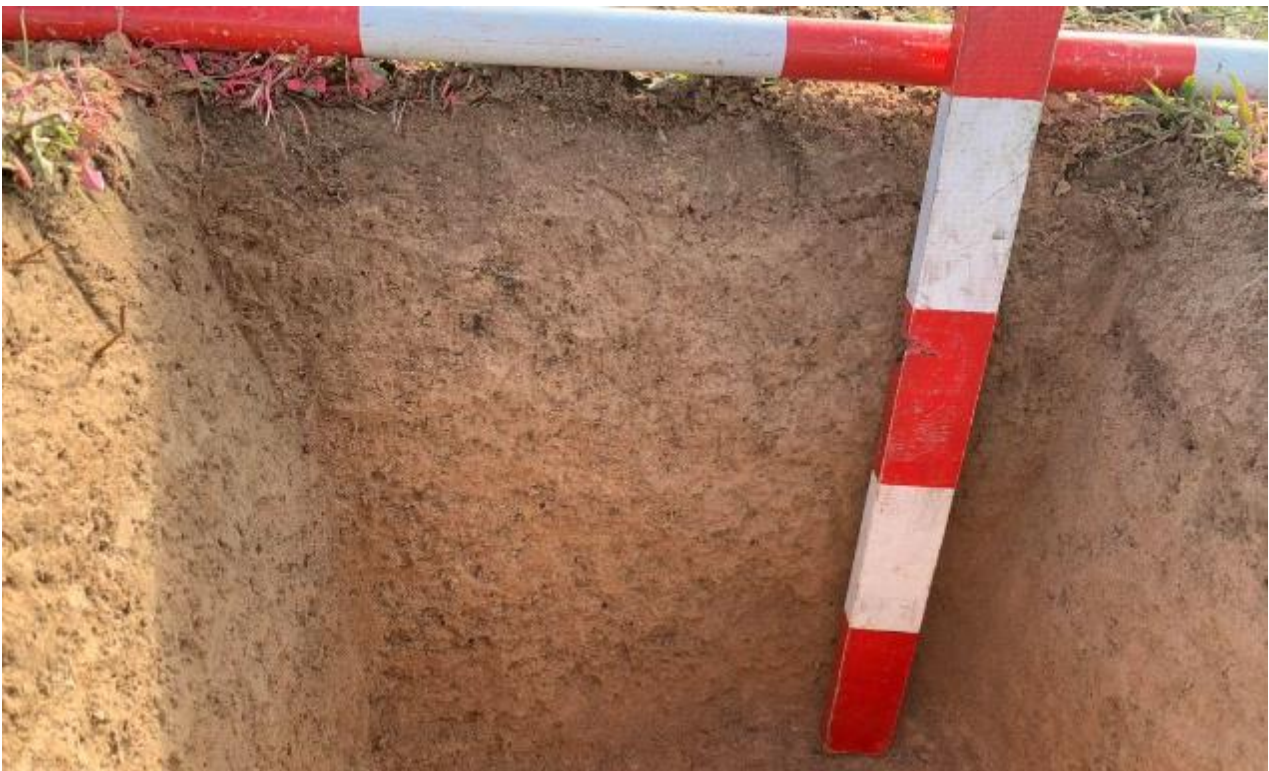
**Photo 5.11** Example of soil profile in Area A (North Section of 10E)

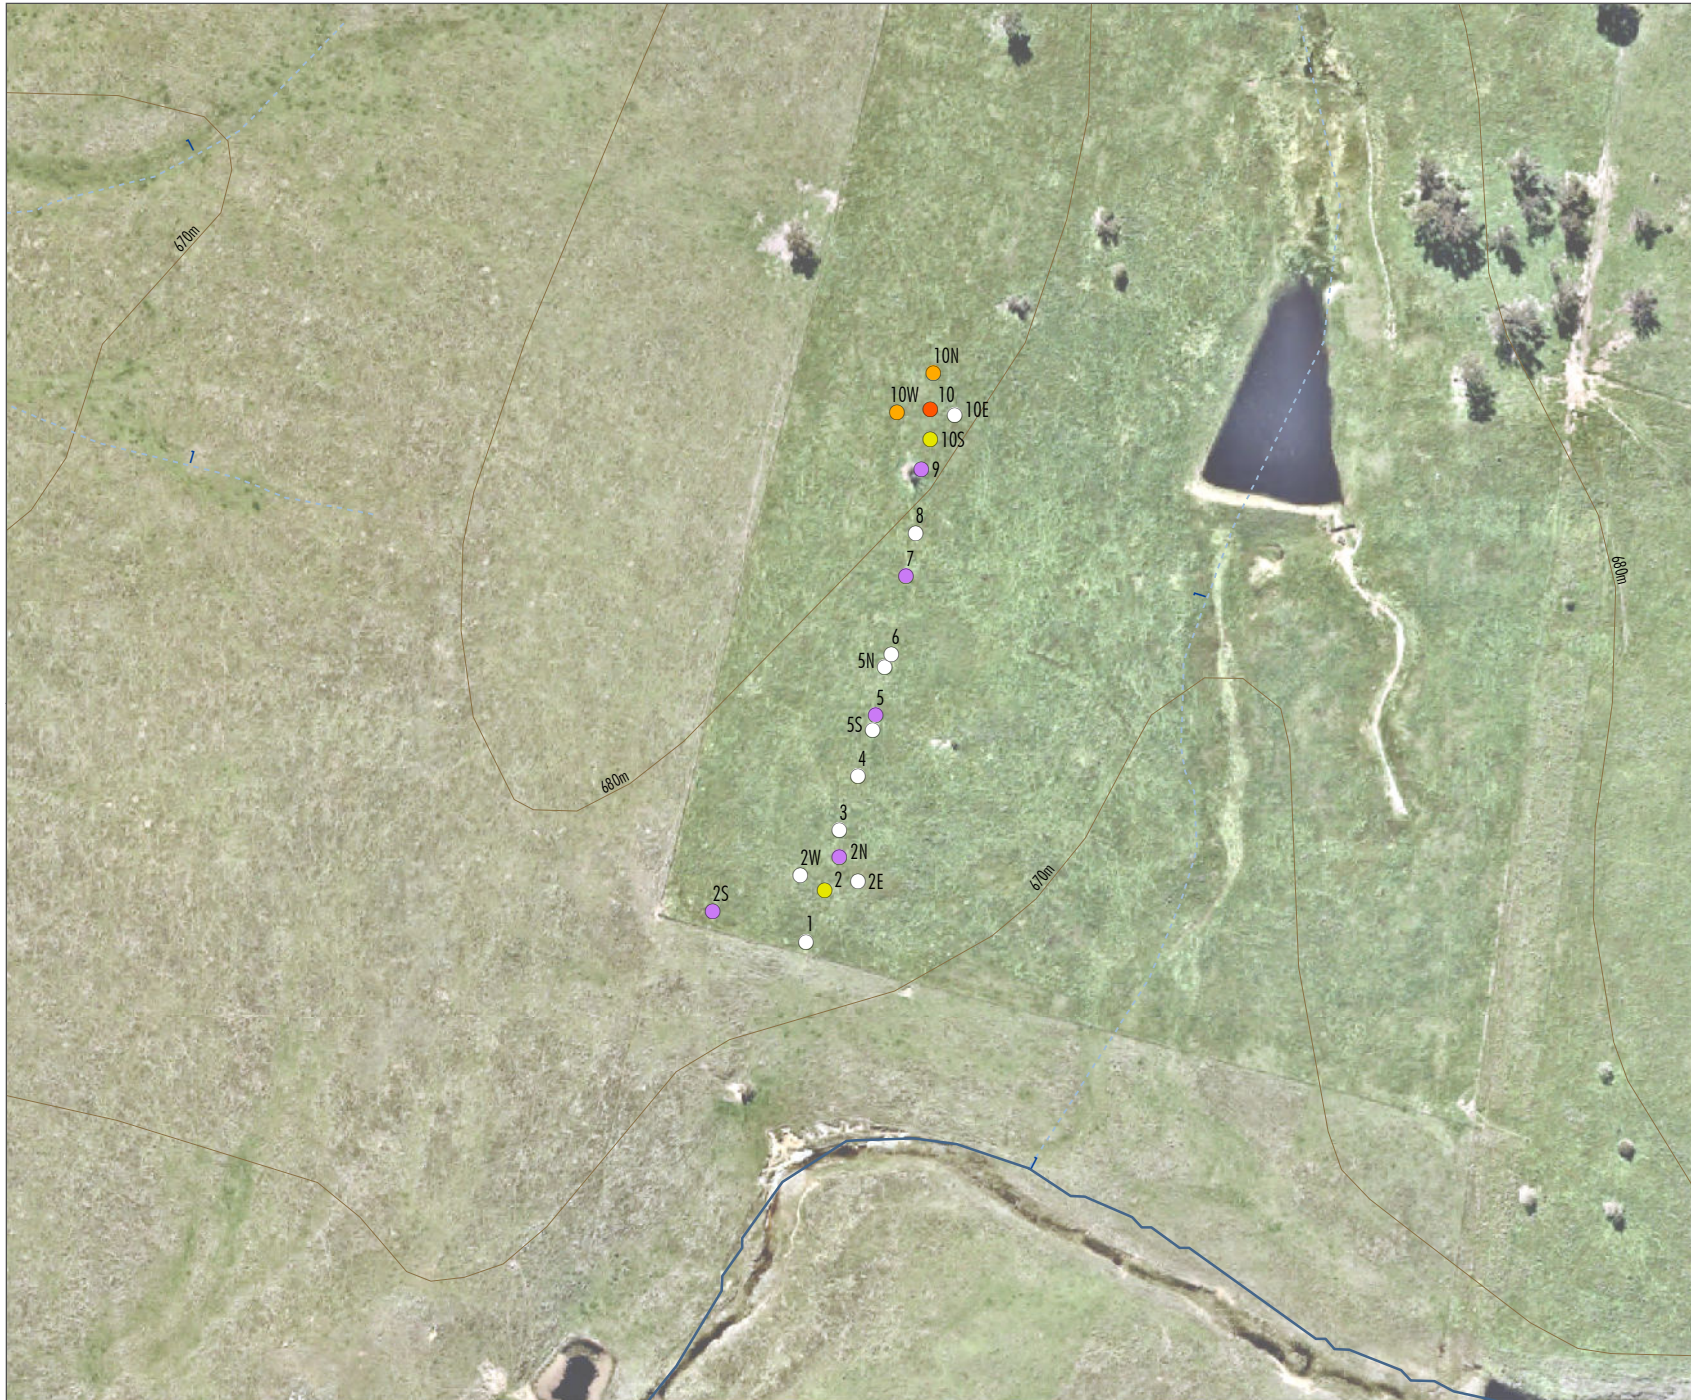
Scale: 1:0 at A4  
 GDA2020 MGA Zone 55

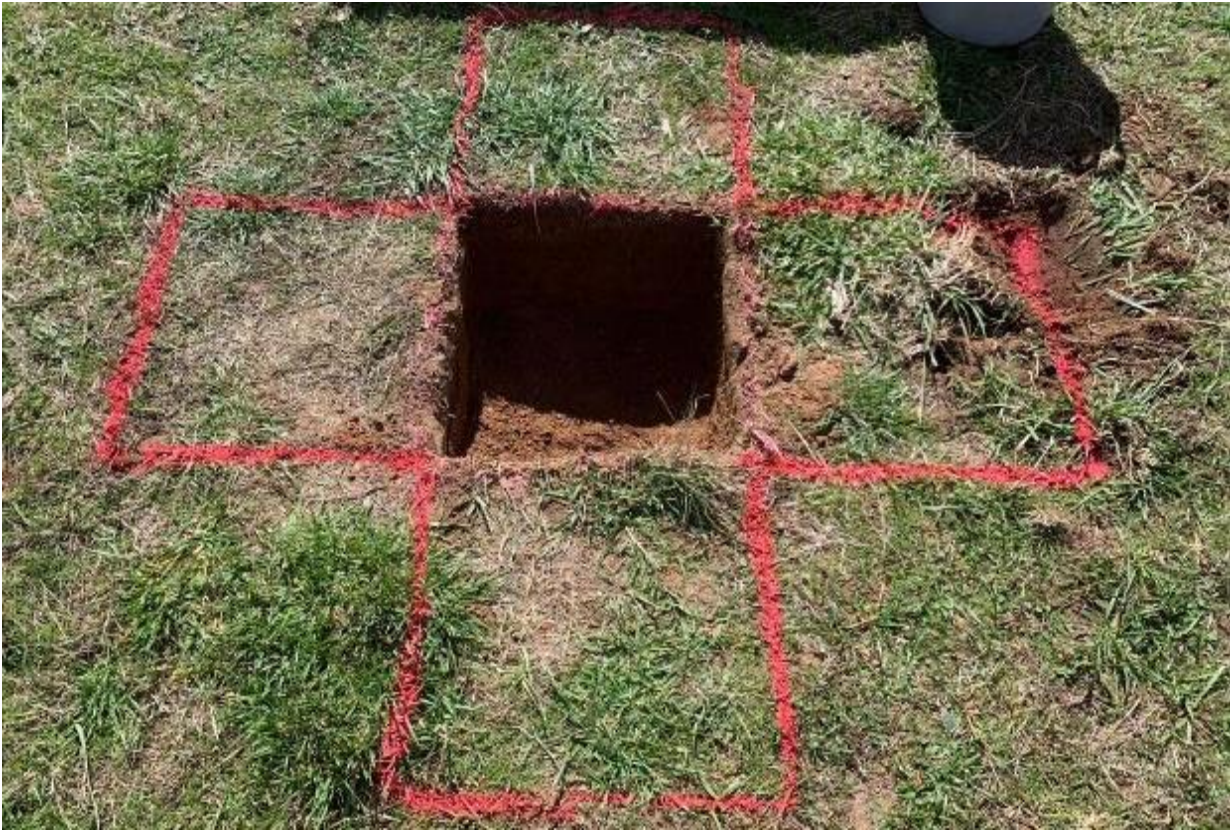
**Photo 5.12** Test Unit 10, showing unexcavated north, south, east, west extensions

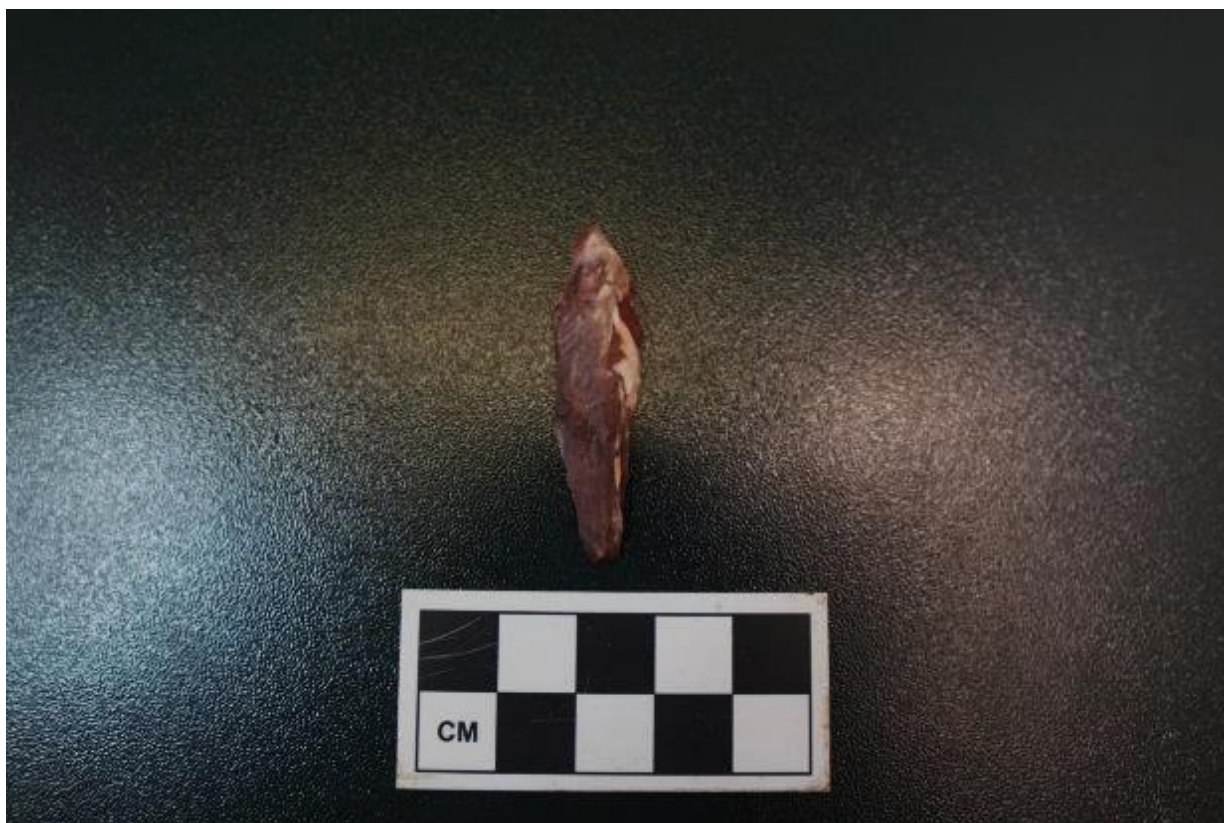
**Photo 5.14** Elongated backed artefact of silicified wood found in test unit 10W, Spit 2

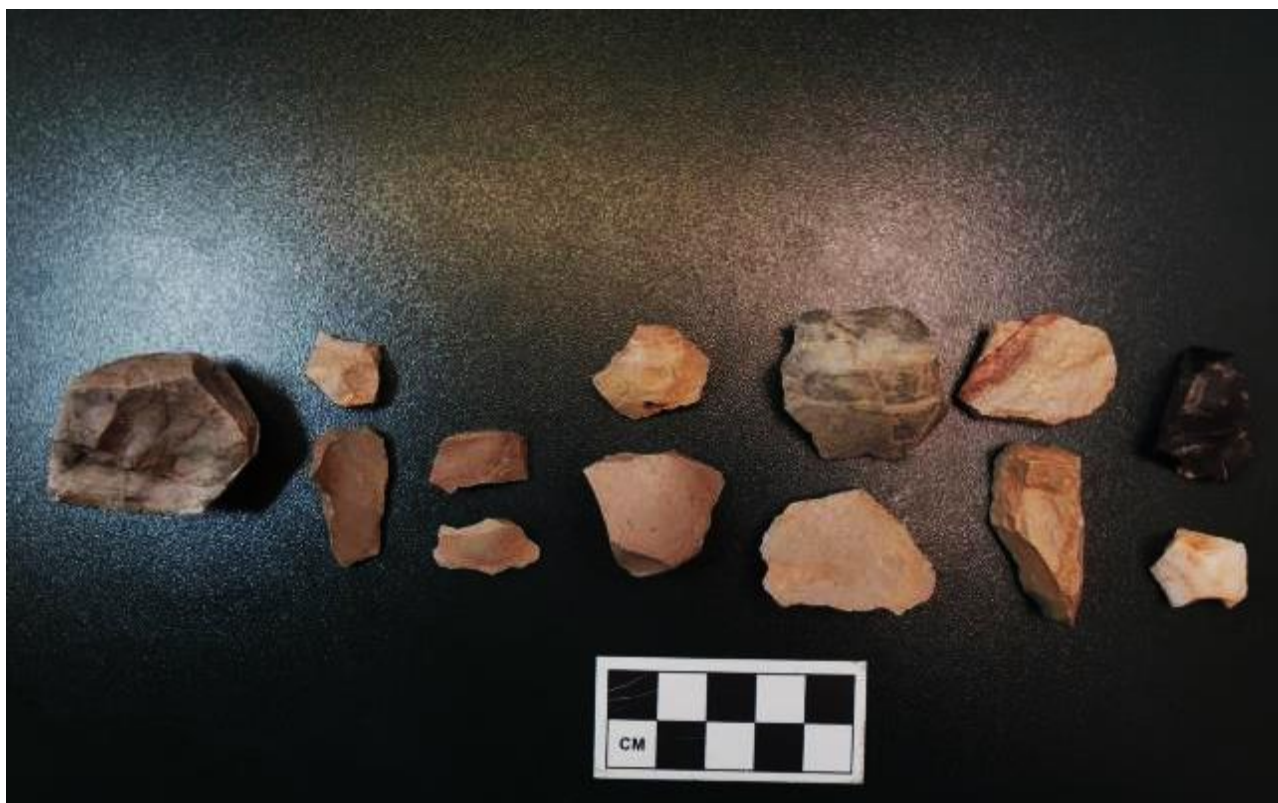
**Photo 5.15 Artefacts from test unit 13**

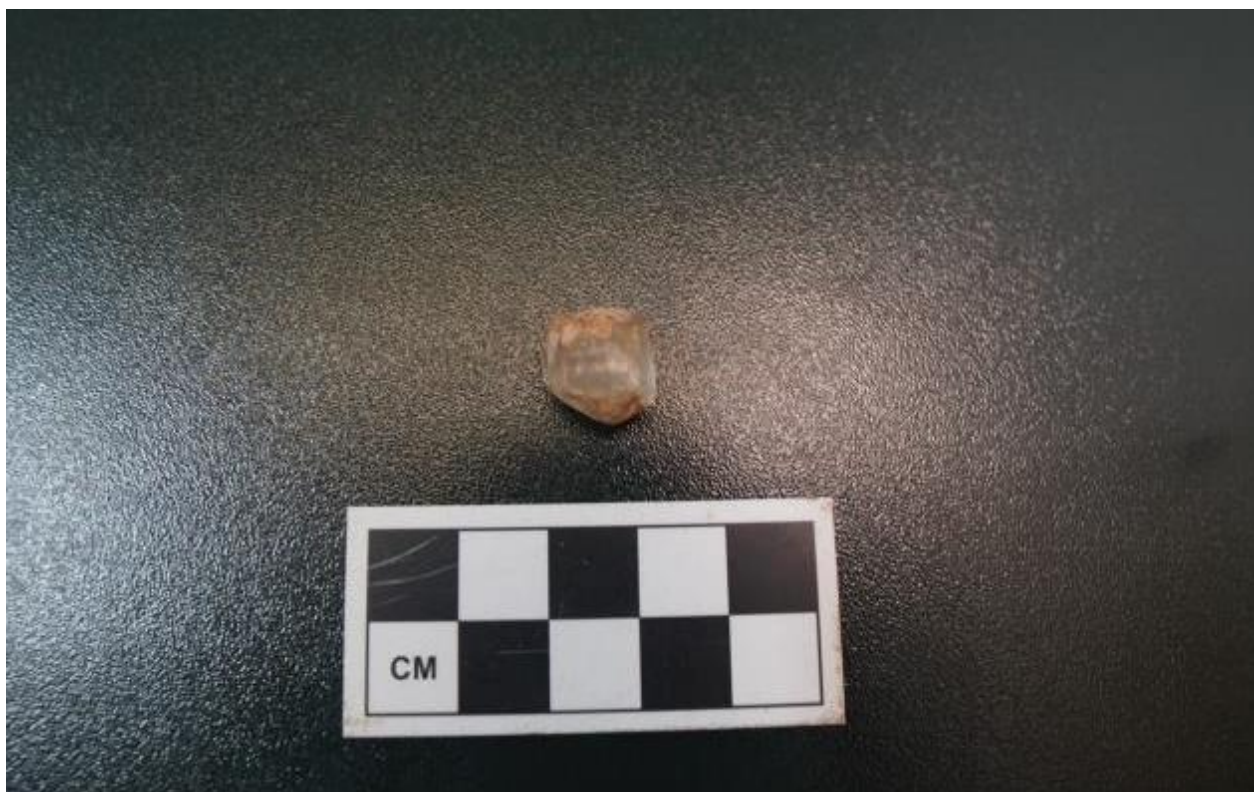
**Photo 5.16** Quartz from test unit 21, Spit 1 (ID 86)

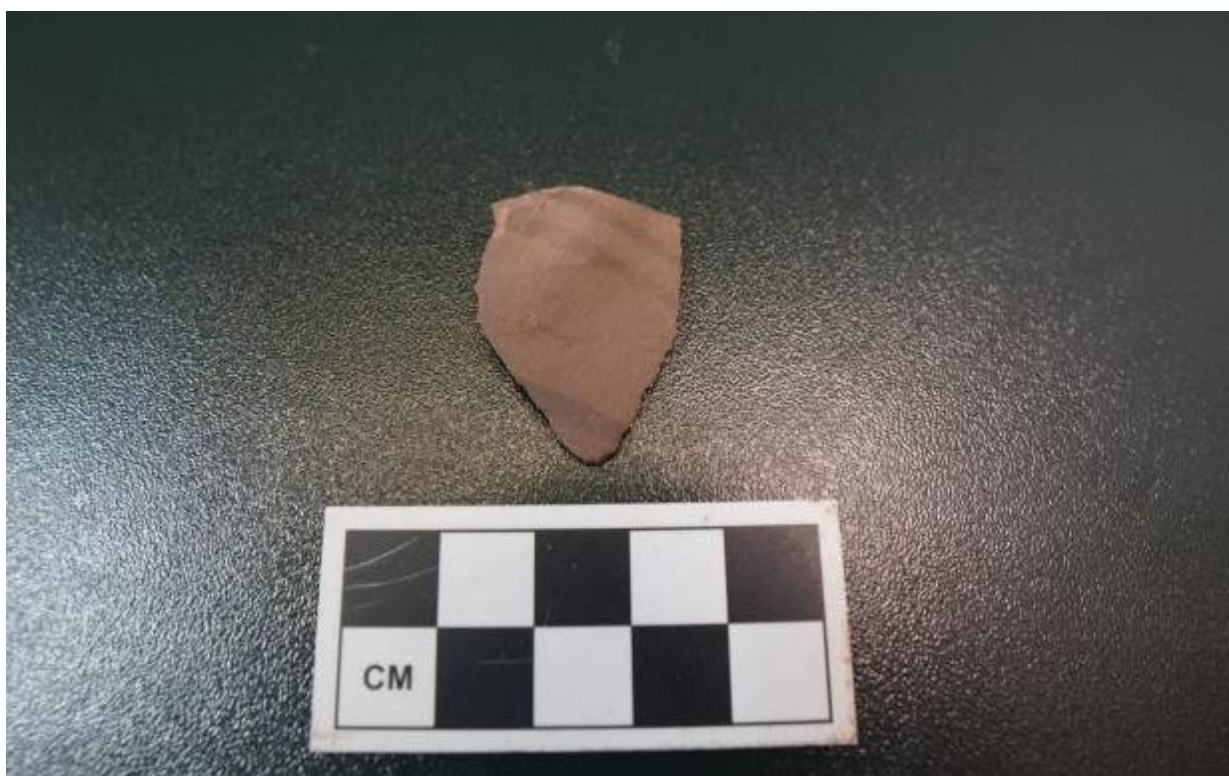
**Photo 5.17** IMT artefact with signs of usewear along edges, found from test unit 23, Spit 1 (ID 87)

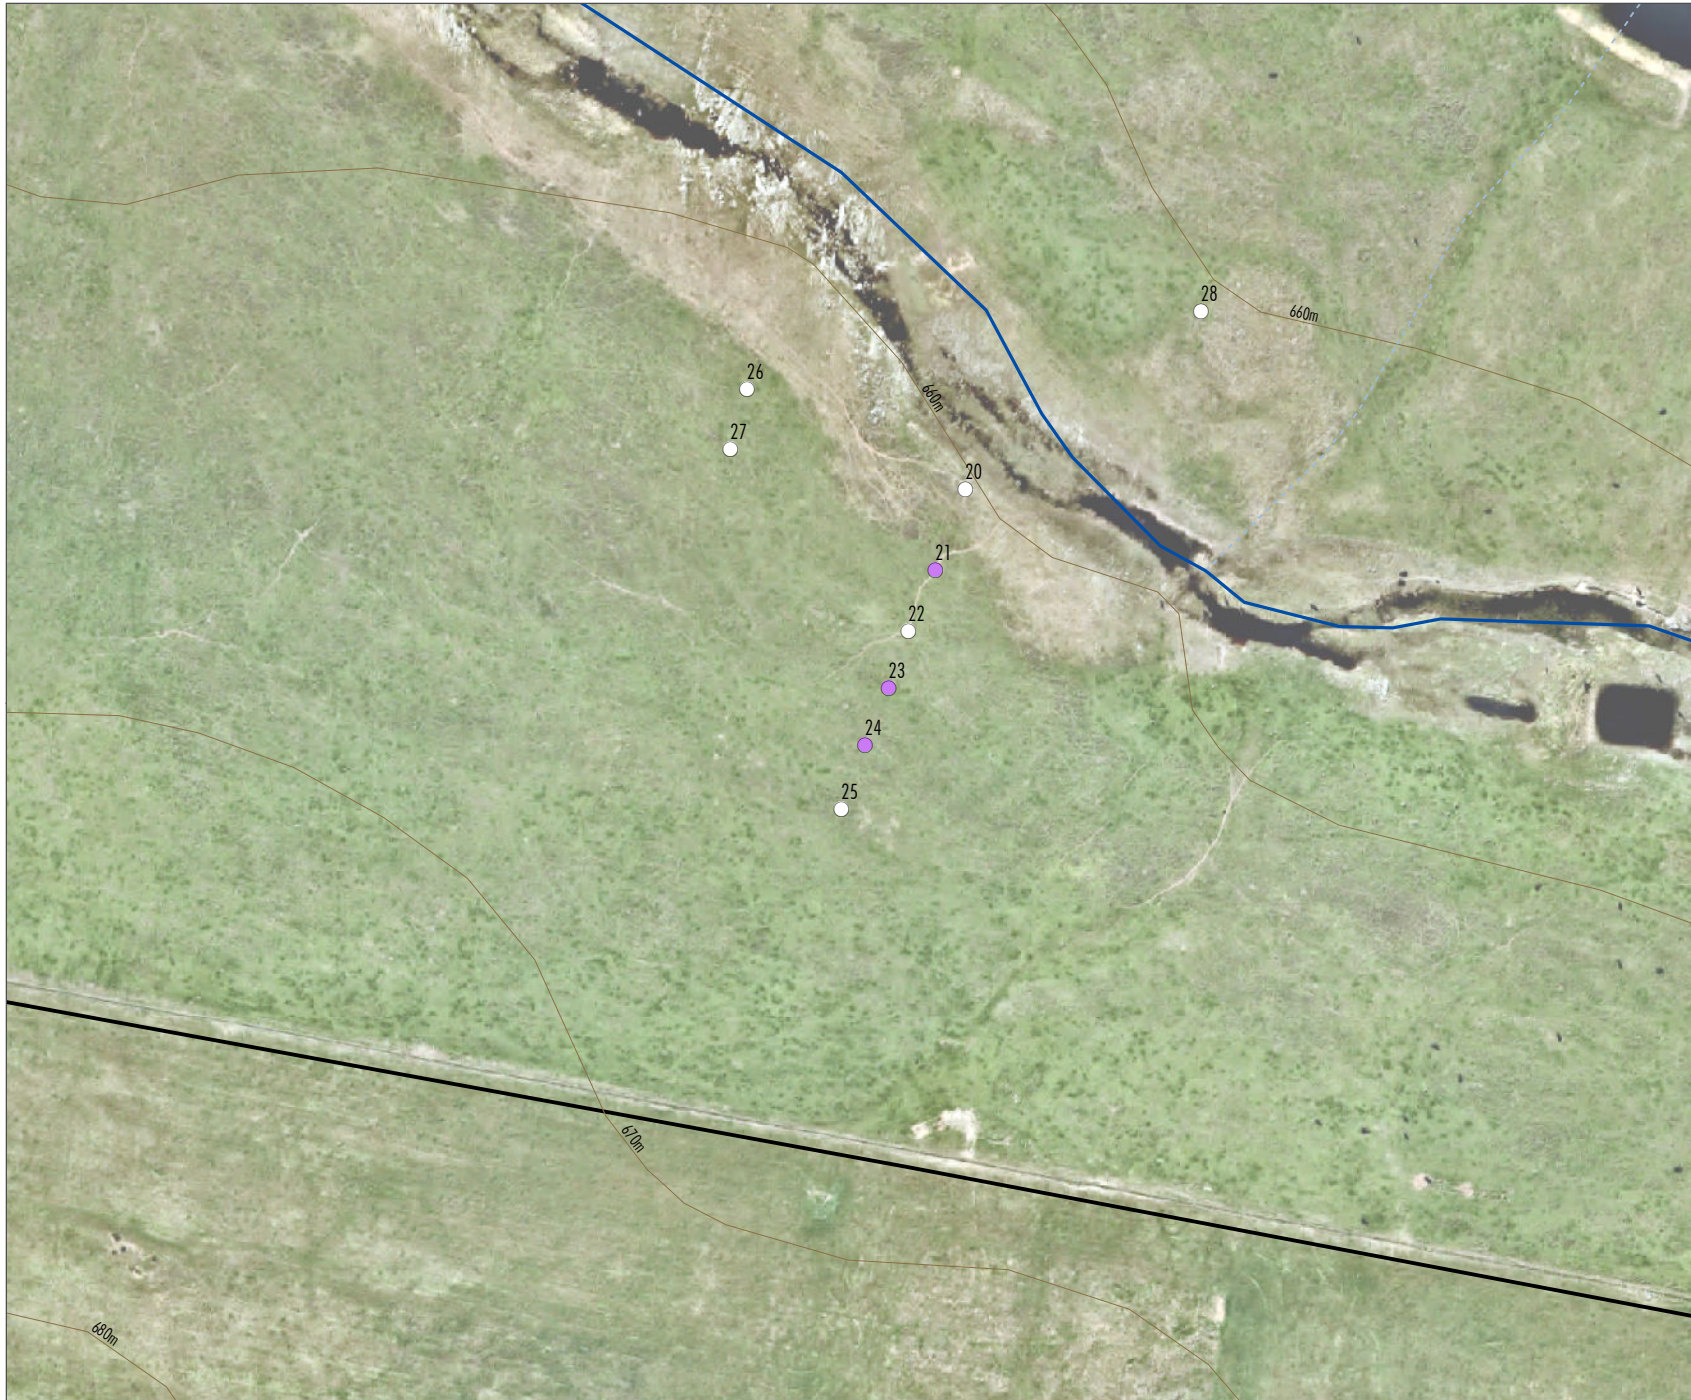
Scale: 1:0 at A4  
 GDA2020 MGA Zone 55

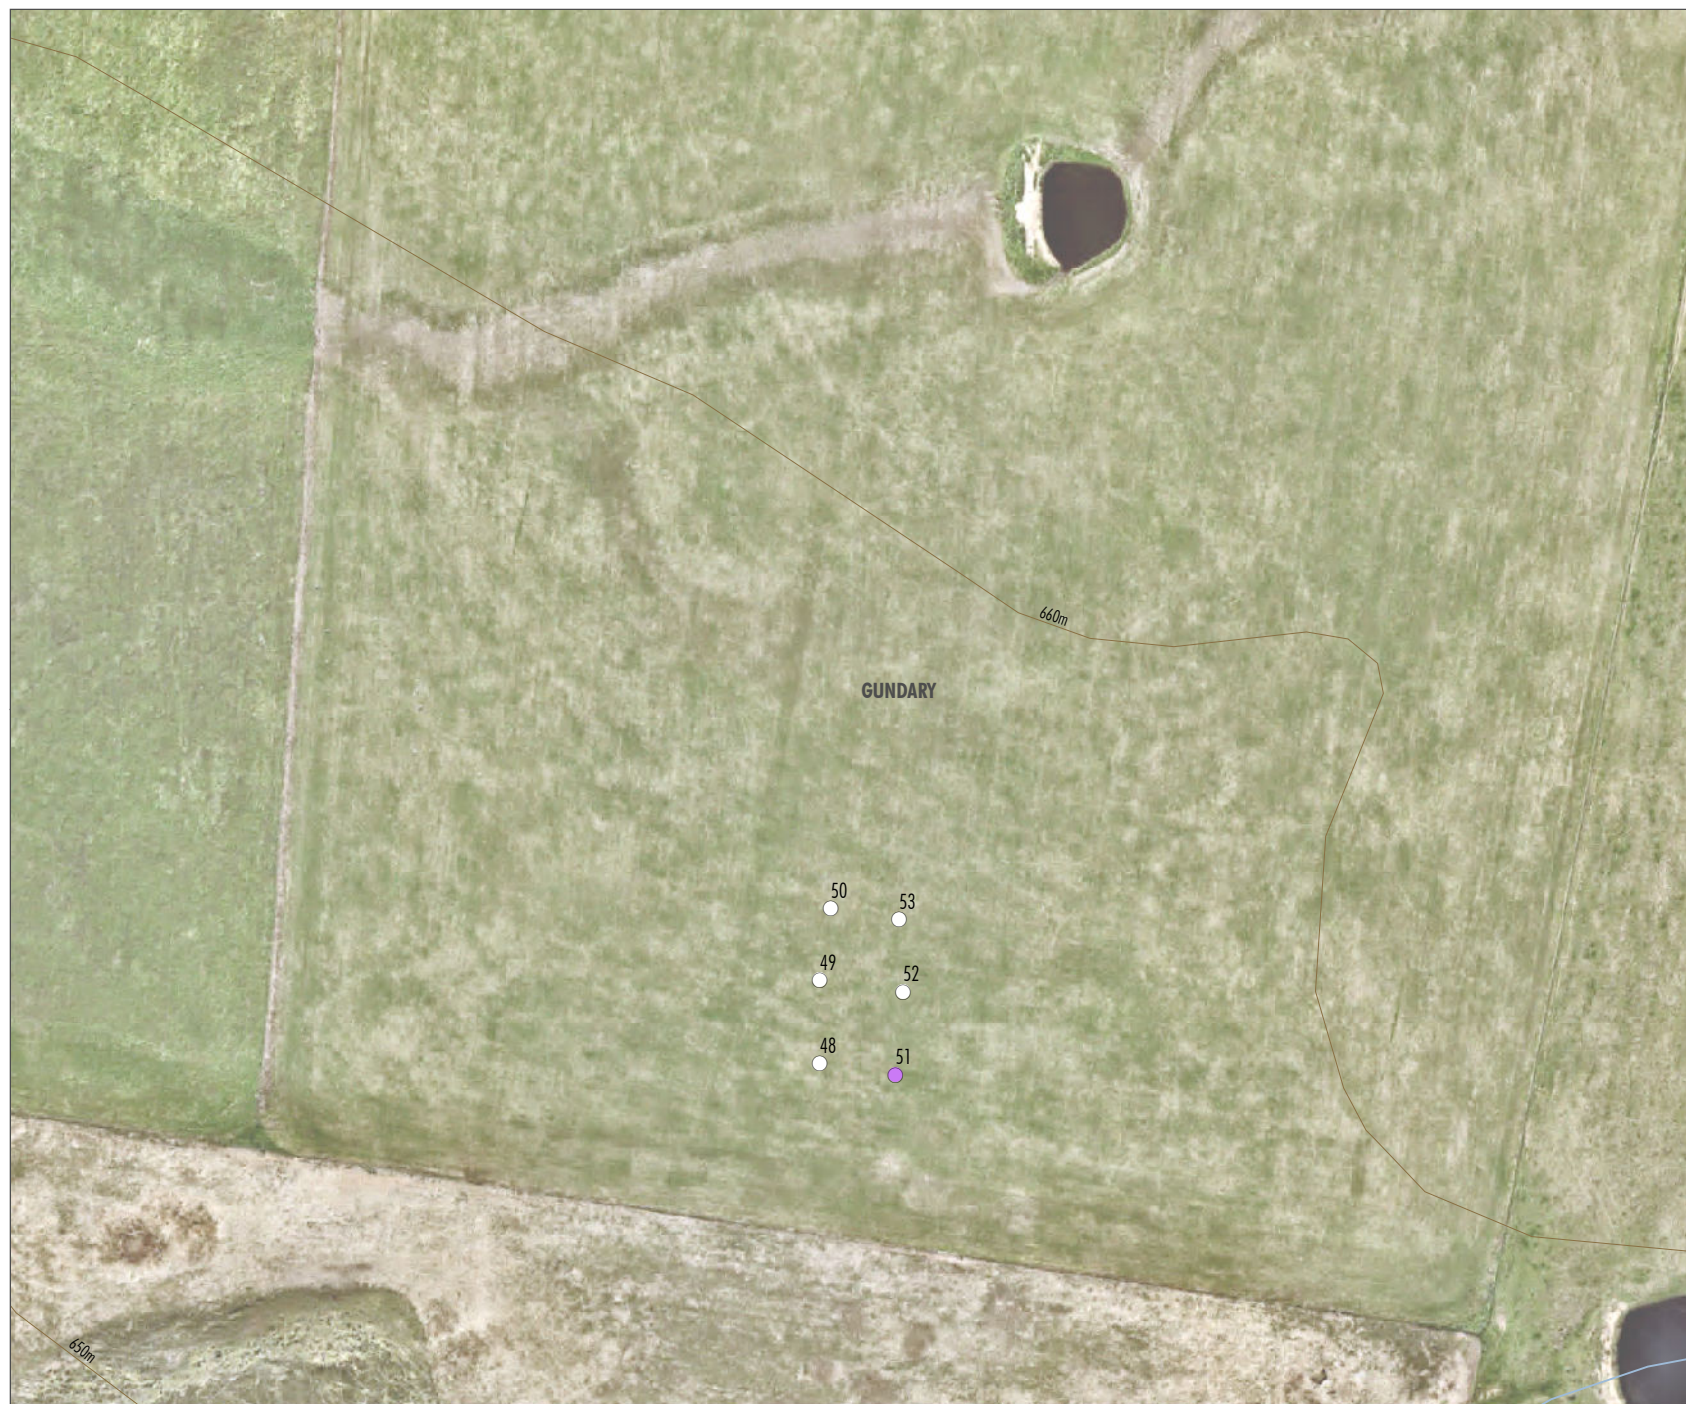
Scale: 1:0 at A4  
GDA2020 MGA Zone 55

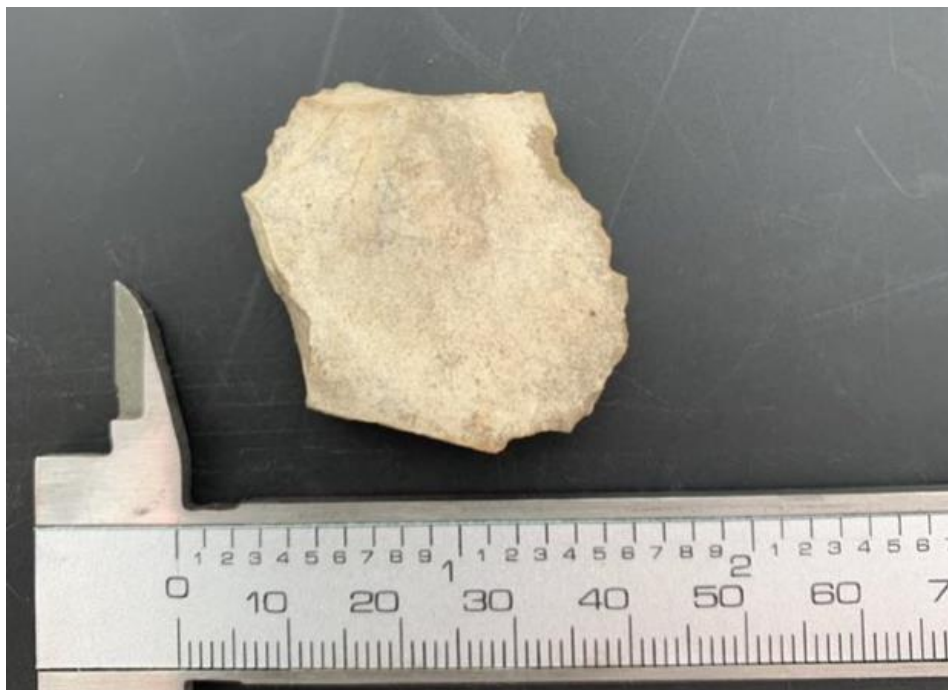
**Photo 5.20** Artefact from site GSF-UMW-11

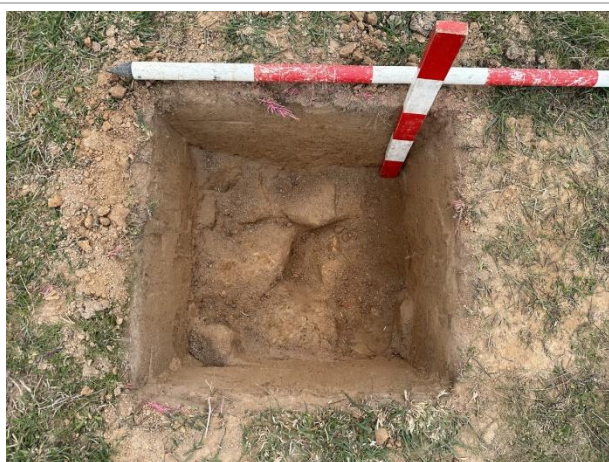
End of excavation, facing north

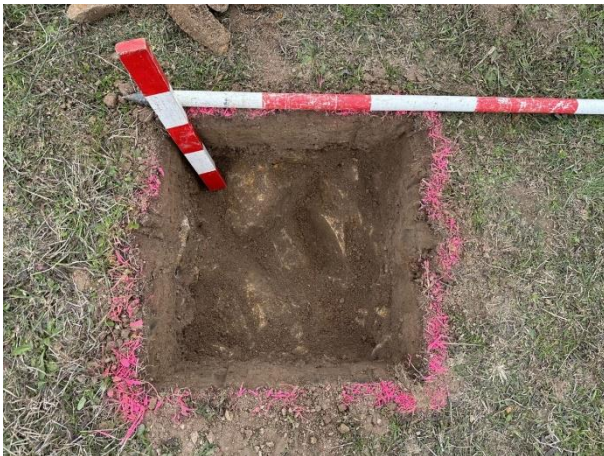
End of excavation, facing north

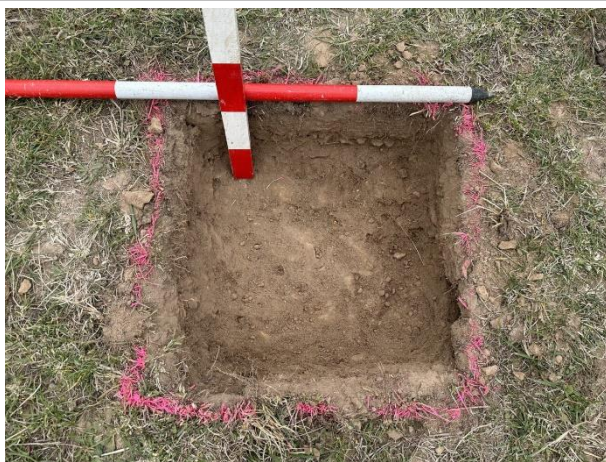
B/C Degraded sandstone mudstone and sandstone with clay

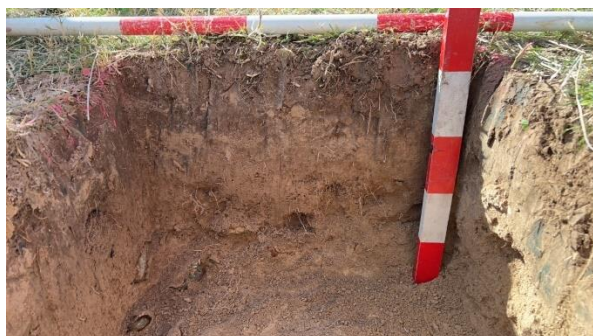
B horizon/bedrock, spit 4, terminated due to gradual increase in degraded bedrock

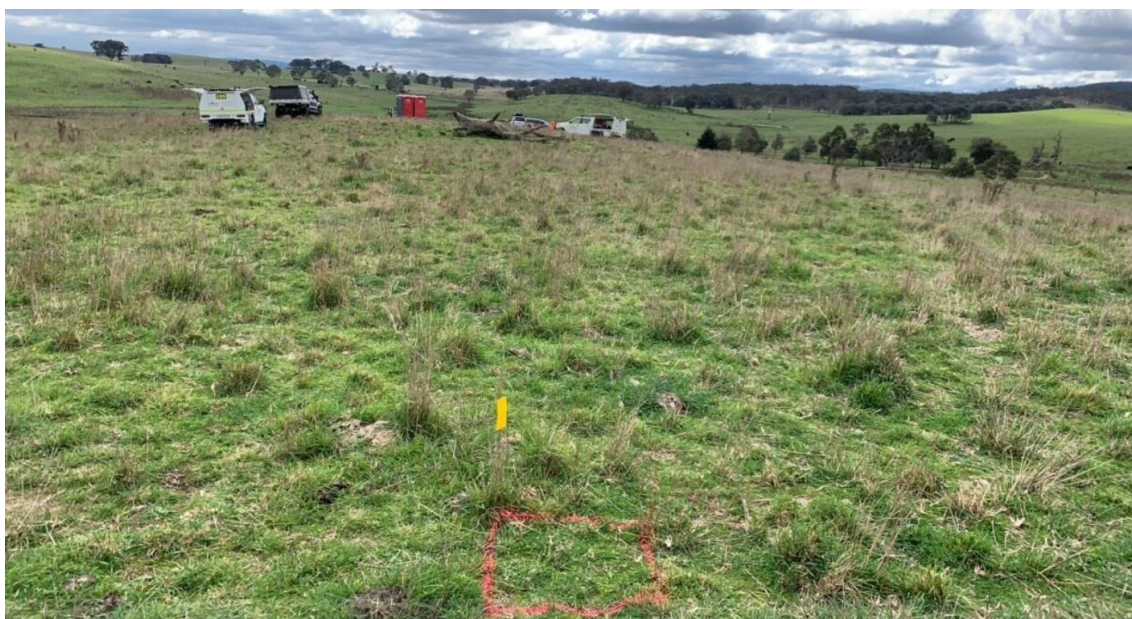
Pre-excavation, facing north

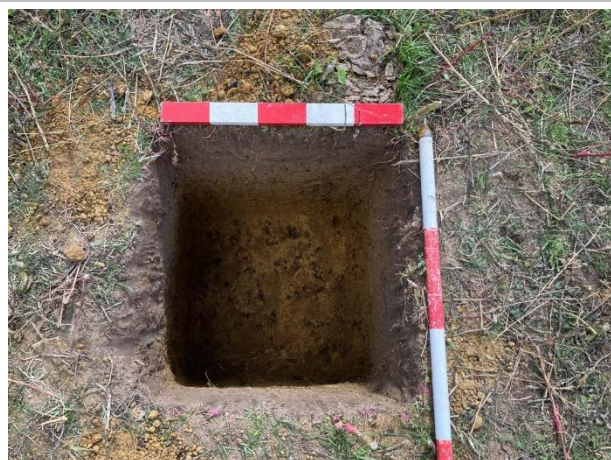
3/4 Orange, damp, clayey silt to silty clay with frequent degrading ironstone

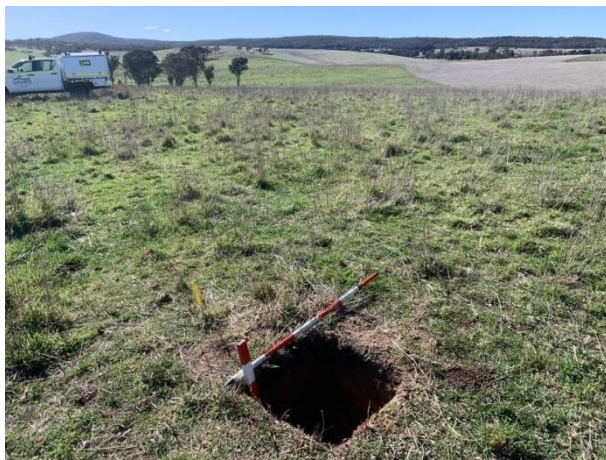
Pre-excavation, view north-east

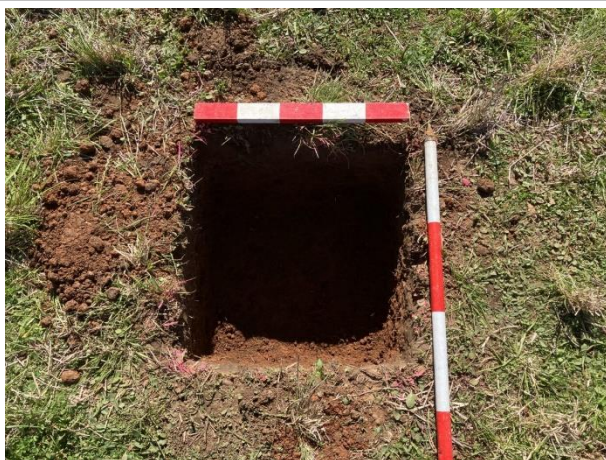
B Red brown compacted slightly sticky clay with small degrading ironstone pebbles

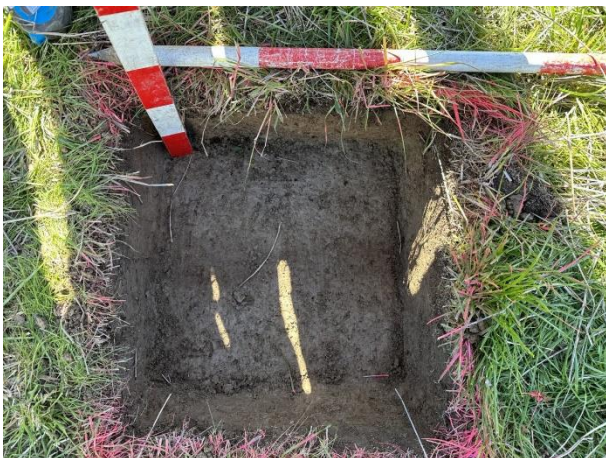
End of trench excavation
