## **REPORT ON GEOTECHNICAL SITE INVESTIGATION**

### **PROPOSED NEW TEACHING BLOCK**

**THE KINGS SCHOOL, 87-129 PENNANT HILLS ROAD,  
NORTH PARRAMATTA, NSW**

**Project No.: 2022-155**

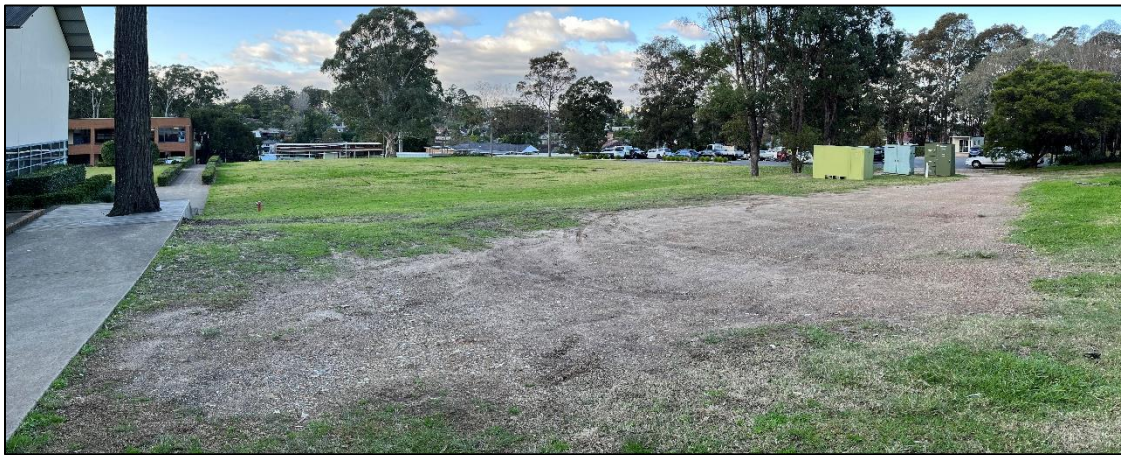
*Photograph 2: View of the location of the proposed STEAM building looking broadly north*

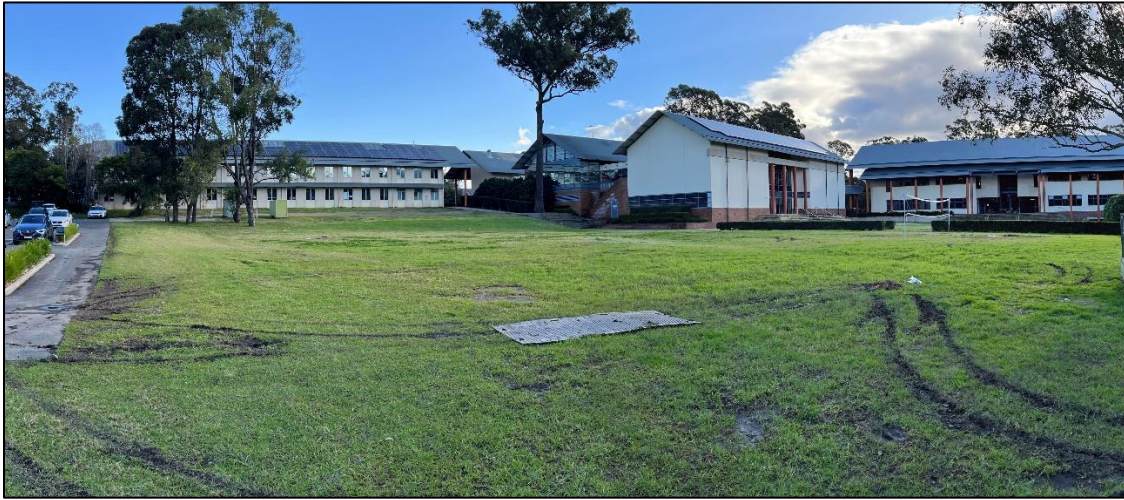
*Photograph 3: View of the site looking broadly south*

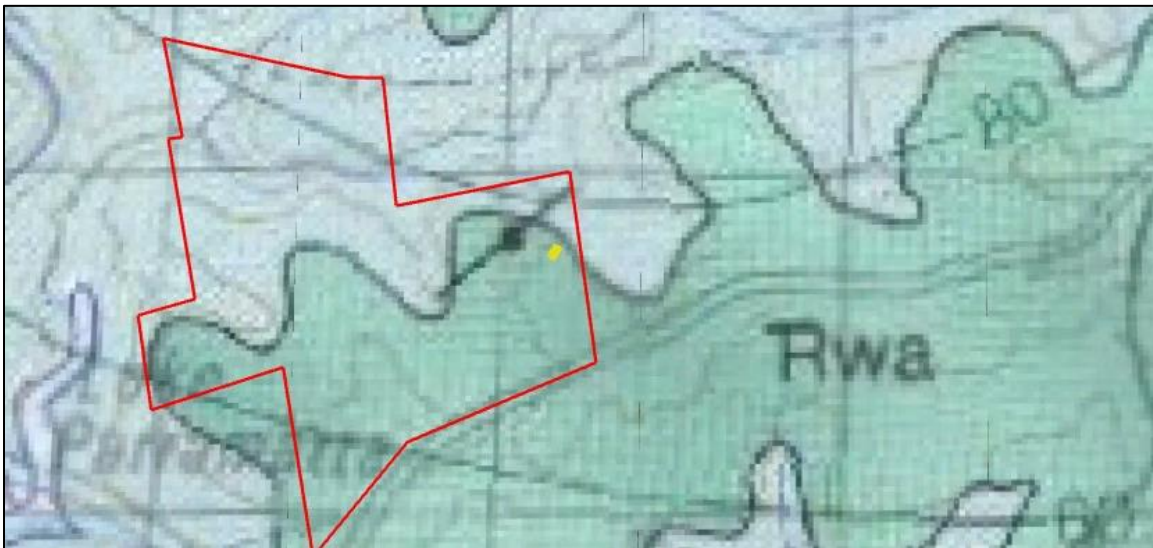
Reference to the Penrith 1:100,000 Geological Series sheet (9030) indicates that the site is in an area underlain by deposits of the Wianamatta Group Shales (Rwa). This rock unit generally comprises an interbedded sequence of shale and laminite which are prone to weather at the surface to clays of medium to high plasticity.

*Extract 2: Extract from the 9130 Sydney Series sheet with school grounds (outlined red) and location of the proposed STEAM building (highlighted yellow) indicated.*

The Hawkesbury Sandstone is shown to the north of the site however the boundaries should be considered approximate at a 1:100,000 scale.

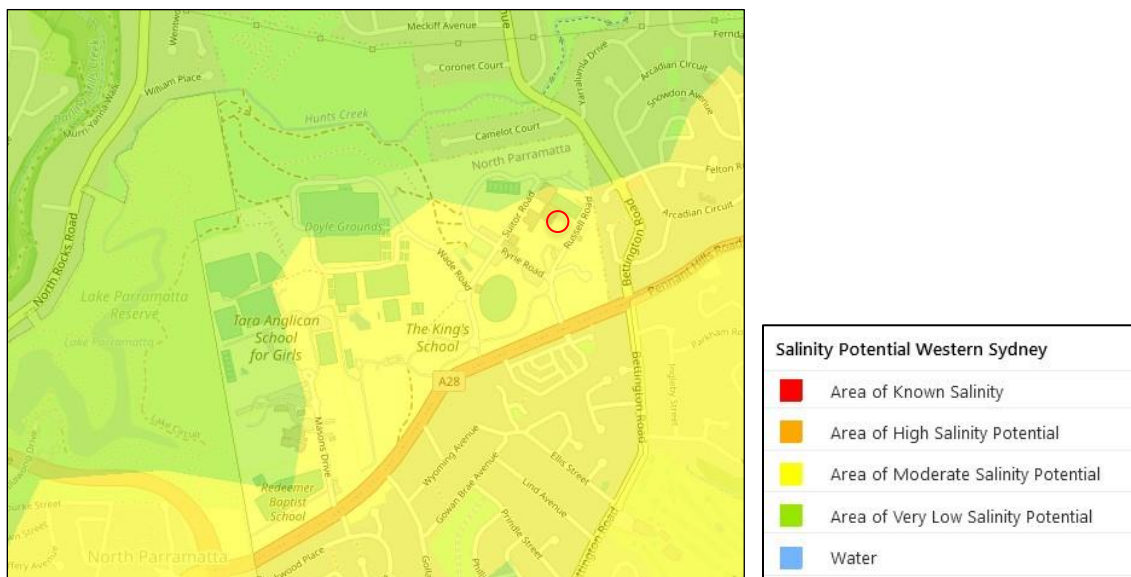
Reference to the NSW Government spatial data website (SEED mapping tool) indicates that the site lies within an area of moderate salinity potential near the boundary of a very low salinity potential area. An extract of the SEED map with the salinity potential layer overlain is provided as Extract 4.

Extract 4: Extract from the NSW Government SEED mapping tool showing Salinity Potential in relation to the approximate site location (circled red)

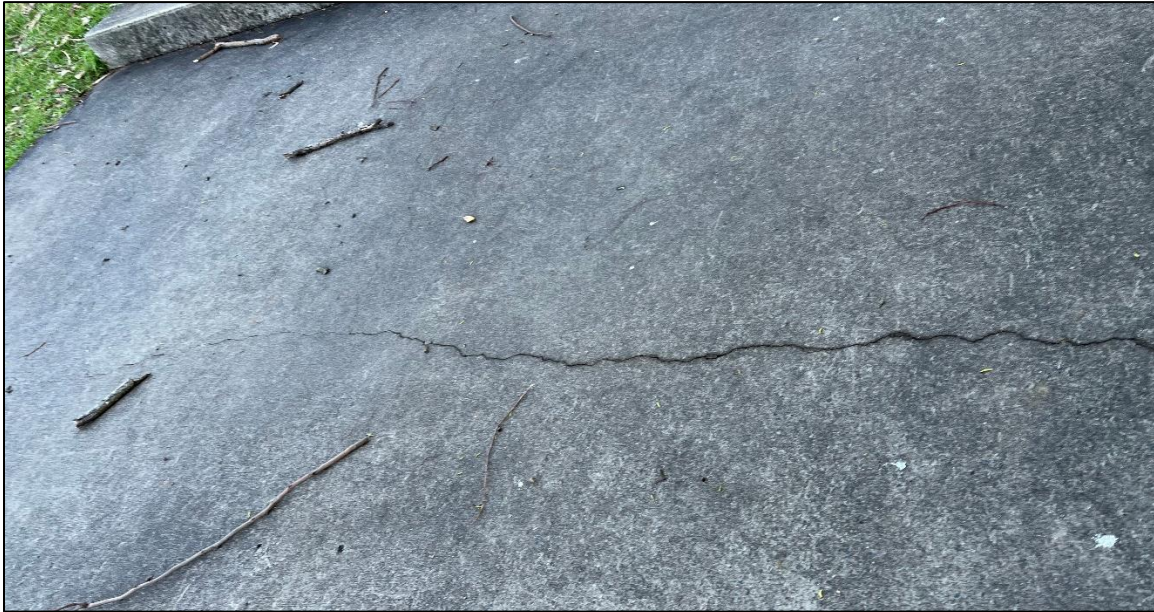
The walkover inspection of the site and surrounding area did not identify any obvious geotechnical constraints to the development. No significant cracking, settlement, or movement was observed within the structures adjacent to the proposed new teaching block. Some cracking was observed within a walkway to the west of the site however it is not considered to represent a geotechnical issue. (See Photograph 4).

*Photograph 4: Views of the cracking in an access ramp to the west of the site*

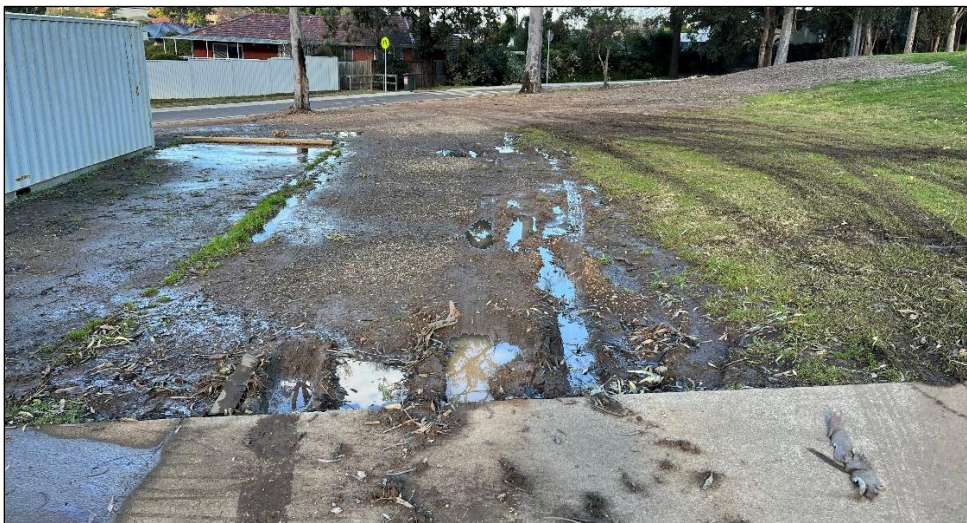
Signs of some poor drainage were observed to the north of the site with rutting and ponded water present within an area of grass (See Photograph 5). The field investigation was undertaken following a period of rainfall.

*Photograph 5: View of ponded water/rutting to the south of the site looking east*
