# GEOTECHNICAL INVESTIGATION REPORT

The King's School, North Paramatta

PSM4935-005R REV2

24 October 2023

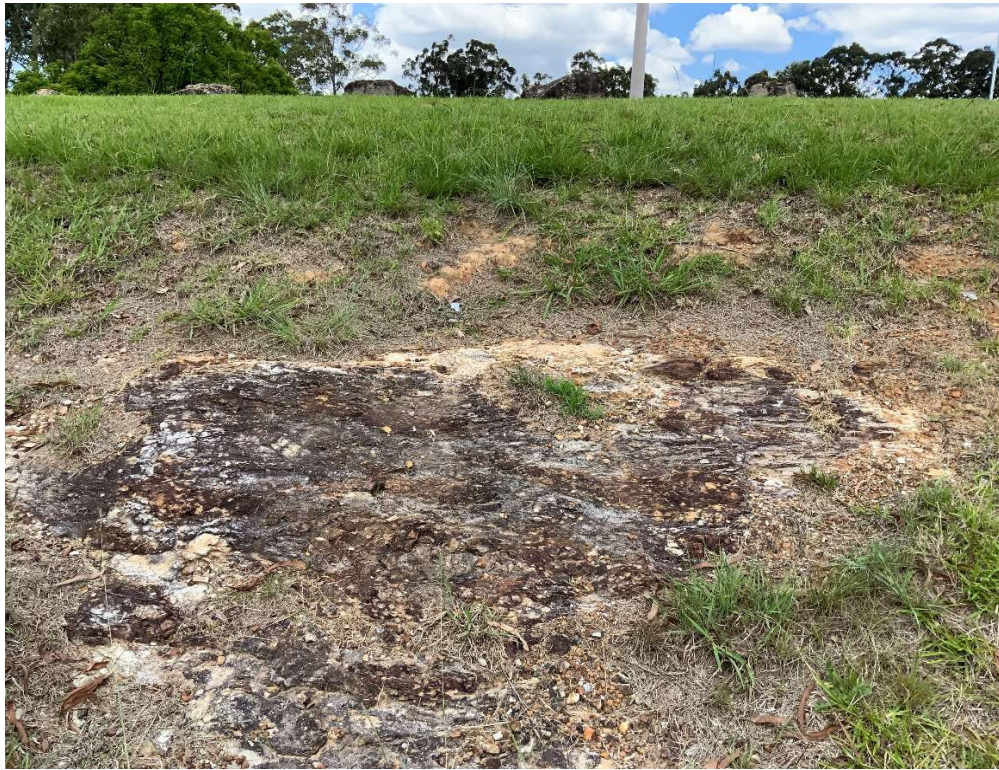
Photo 13 - Exposed outcrop on western sports field, 24 January 2023

| Proposed Development | Surface Conditions |
|---|---|
| Sports Pavilion | Grassed surface and lies over an approximately 1.5H:1V batter. This indicates that some earthworks have been completed in this area to form the current level area associated with the sports fields.<br>Some outcrops of medium to high strength SANDSTONE were observed nearby (Appendix D7, Photo 13). |

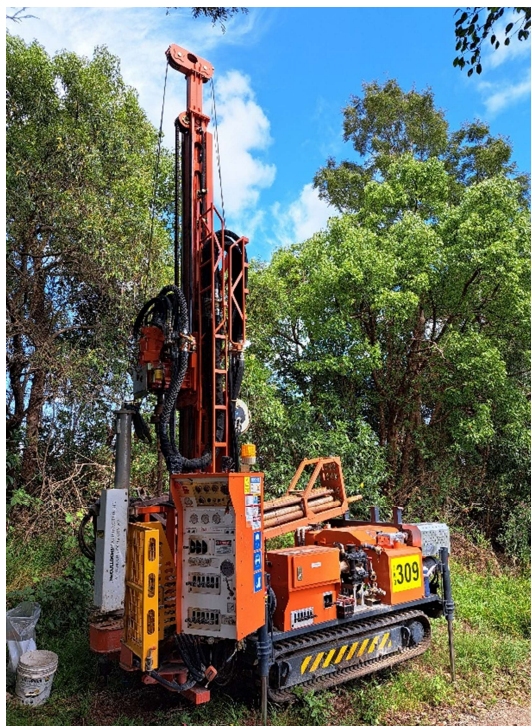
Photo 14 - Hanjin DB8 drill rig, 24 January 2023

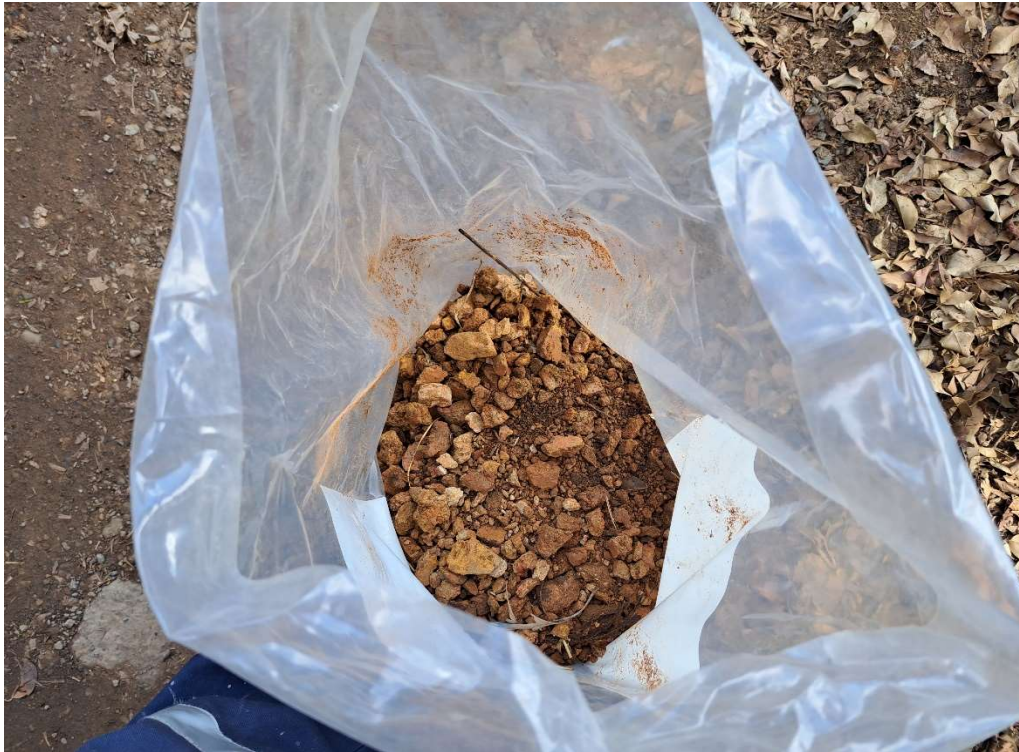
Photo 15 - Typical RESIDUAL recovery (BH04)

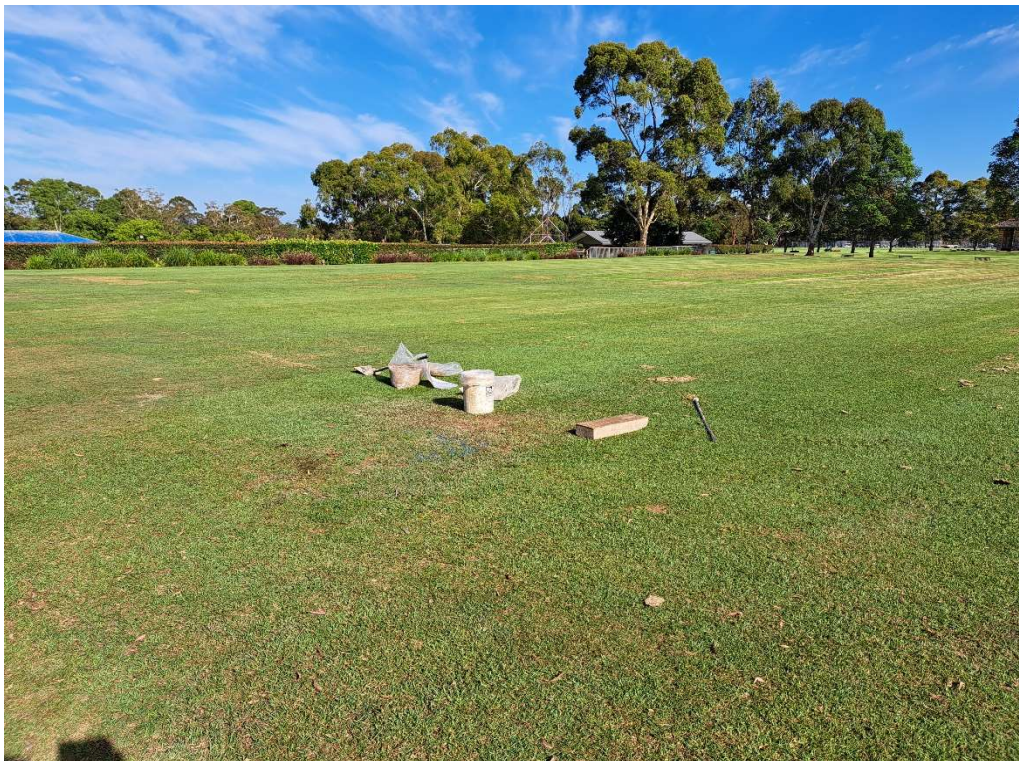
Photo 16 - Typical reinstated borehole (BH07)
