**SPECIALIST ADVICE TO  
PATHWAYS RESIDENCES CREMORNE**

**ON  
GEOTECHNICAL INVESTIGATION**

**FOR  
PROPOSED SENIORS LIVING DEVELOPMENT**

**AT  
50-88 PARRAWEEEN STREET AND  
59-67 GERARD STREET, CREMORNE, NSW**

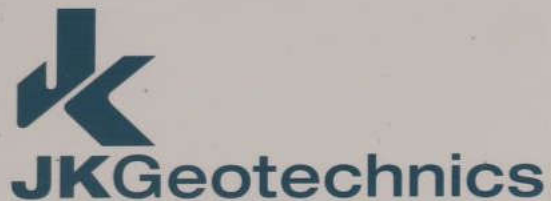
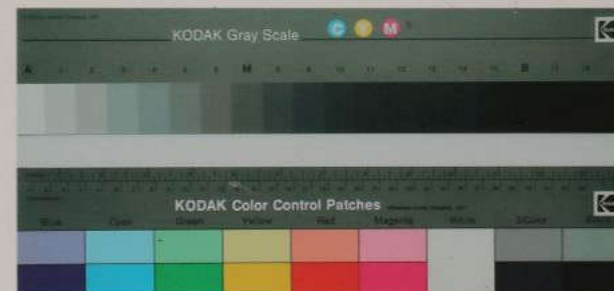
Job No: 357365  
Borehole No: BH1  
Depth: 3.40 m to 10.10 m

357365 BH1 START CORING AT 3.40m

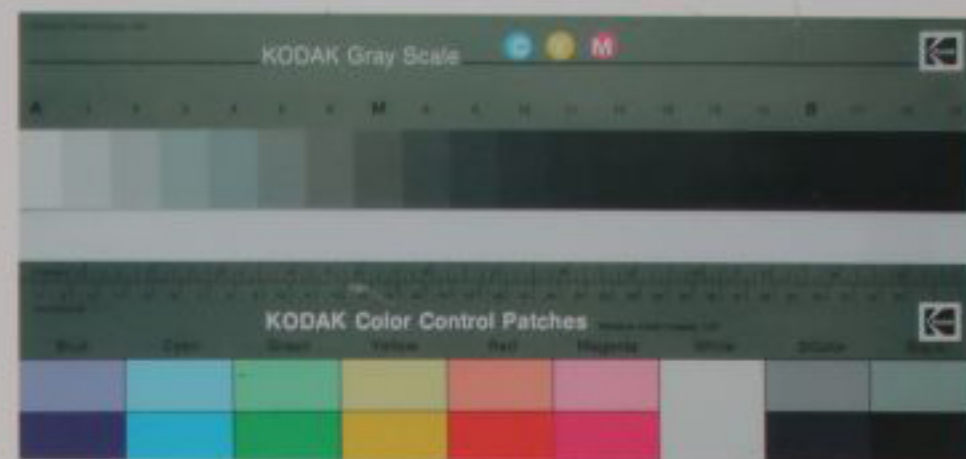
Job No: 357365  
Borehole No: BH2  
Depth: 4.28 m to 13.00m

357365 BH2 START CORING AT 4.28m

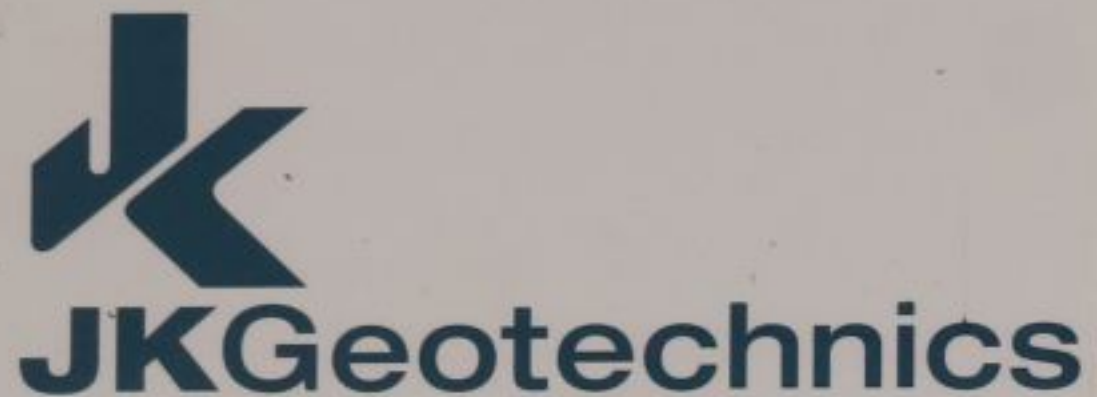
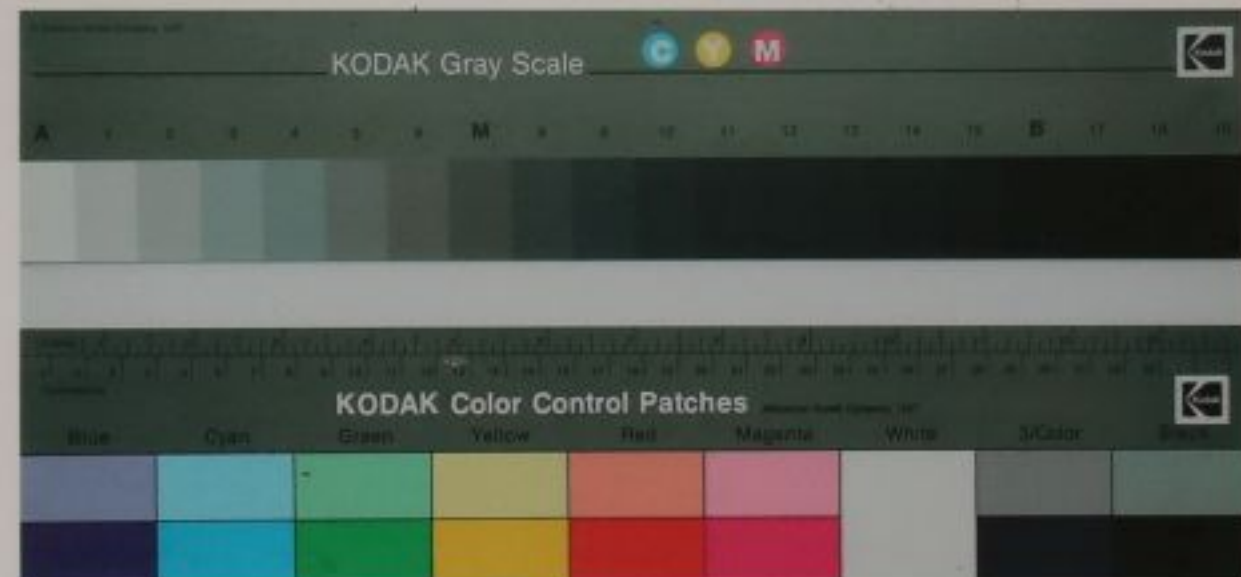
Job No: 357365  
Borehole No: BH 3  
Depth: 2.84 m to 5.82 m

357365 BH3 START CORING AT 2.84m
