Aboriginal Cultural Heritage Assessment

ABORIGINAL CULTURAL HERITAGE ASSESSMENT

MODIFICATION TO THE BULGA OPTIMISATION PROJECT EASTERN EMPLACEMENT AREA: DISTURBANCE BOUNDARY MODIFICATION

JUNE 2016

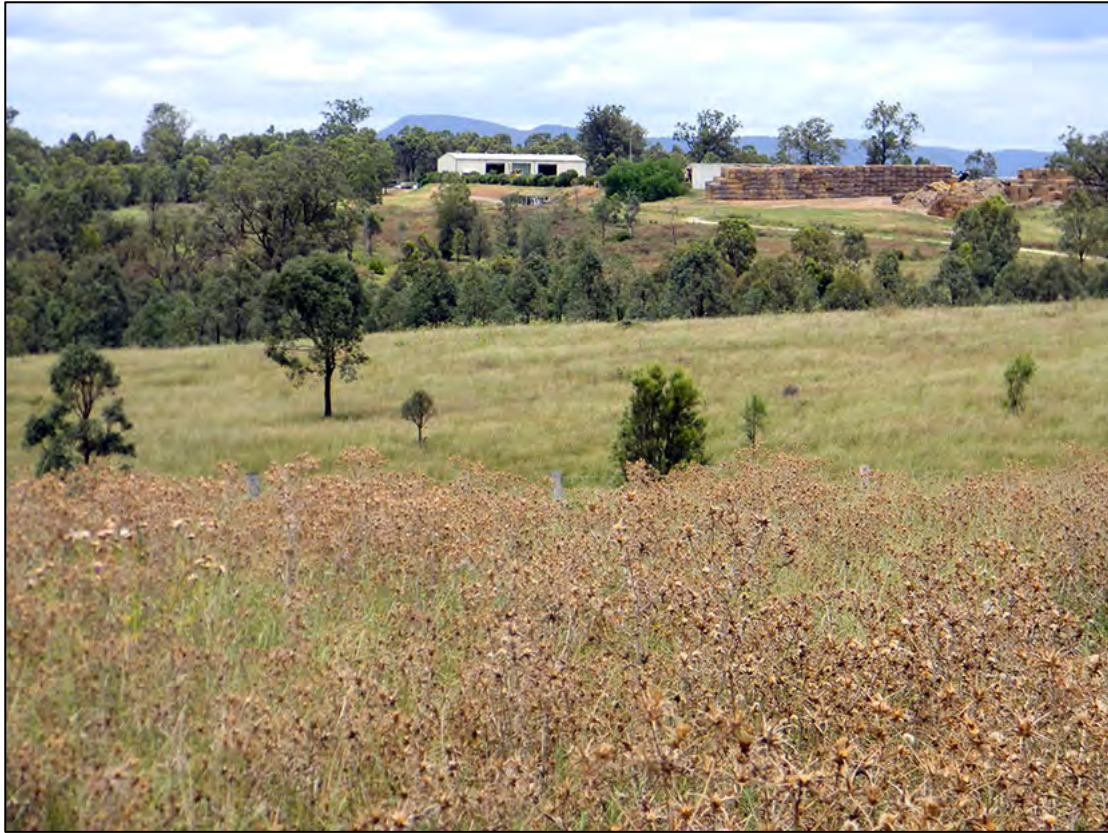
Plate 1: View of the ridge landform looking towards the Mushroom Composters.

Landform type	Landform type within Modification Area (m ²)	Percentage of Modification Area	Plates
Ridge/crest	156,590	17.6	Plate 1
Upper slope	115,230	12.9	Plate 2
Mid slope	566,573	63.7	Plate 3
Minor drainage	51,607	5.8	Plate 2
Total	890,000 (89ha)	100

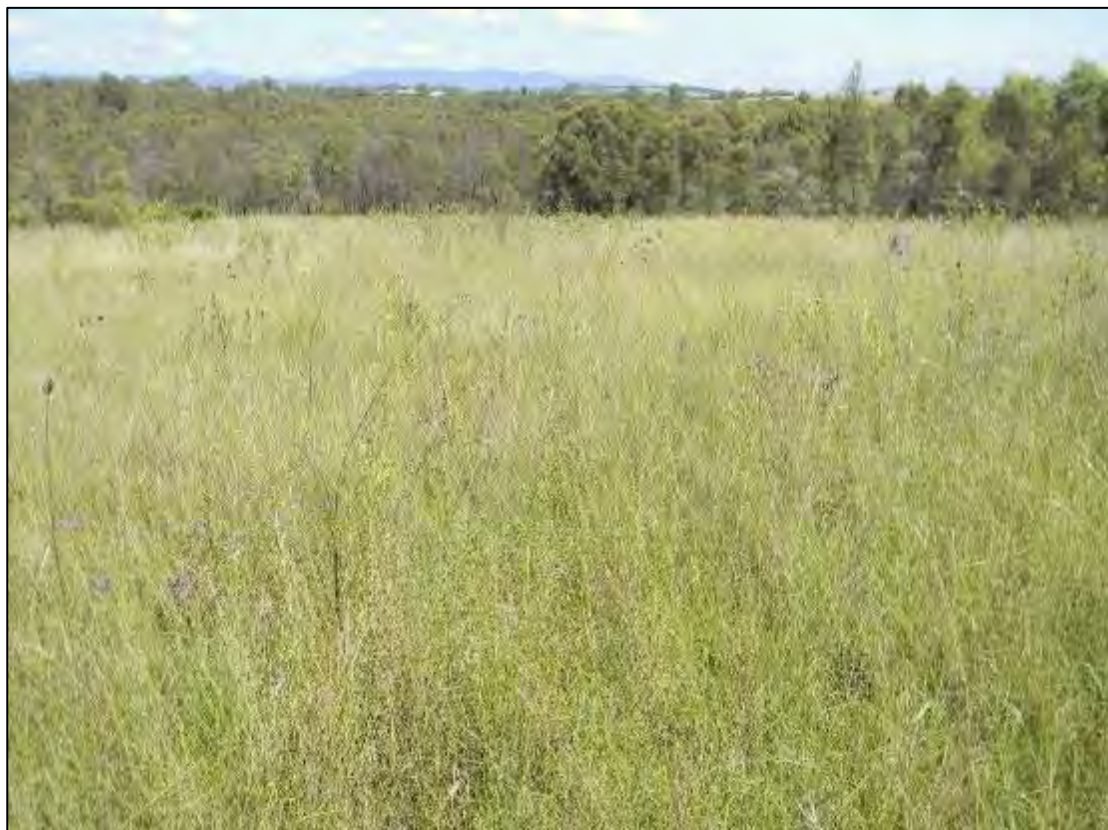
Plate 2: View from upper slope overlooking the Modification Area. Note no GSV.

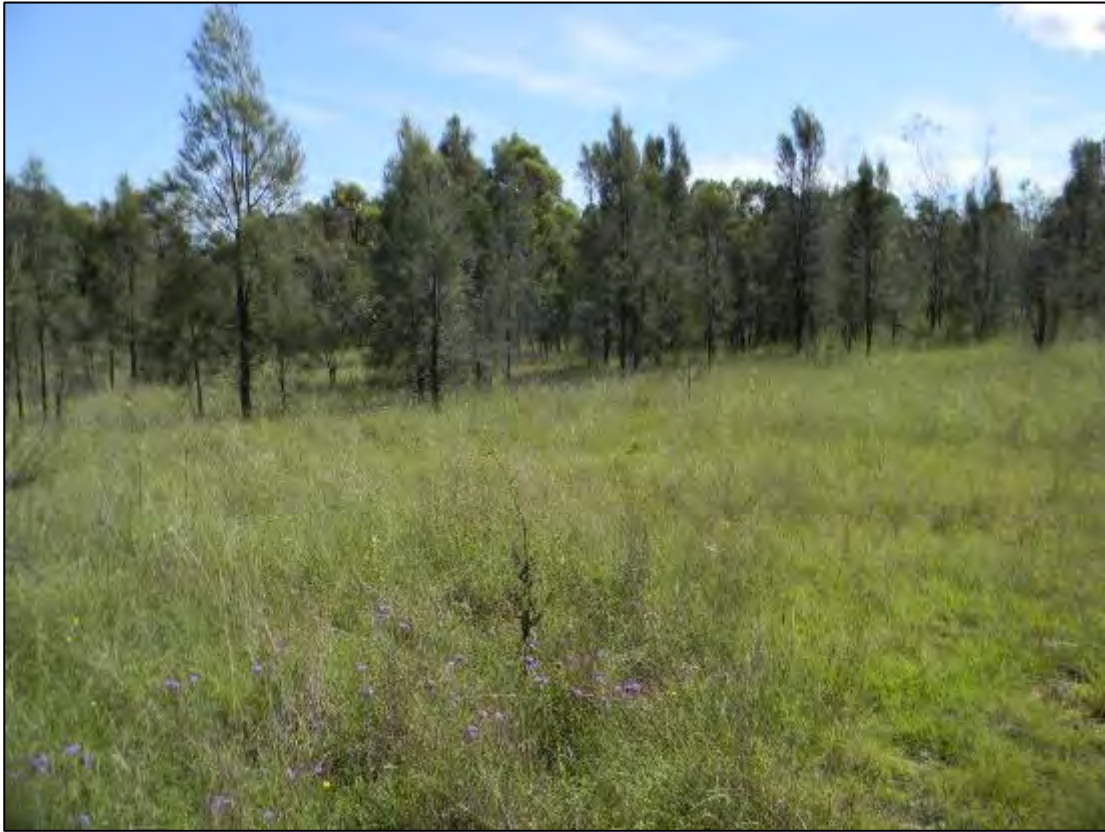
Plate 3: View of mid-slope landform surveyed by Transect 1. Note the regenerating vegetation.

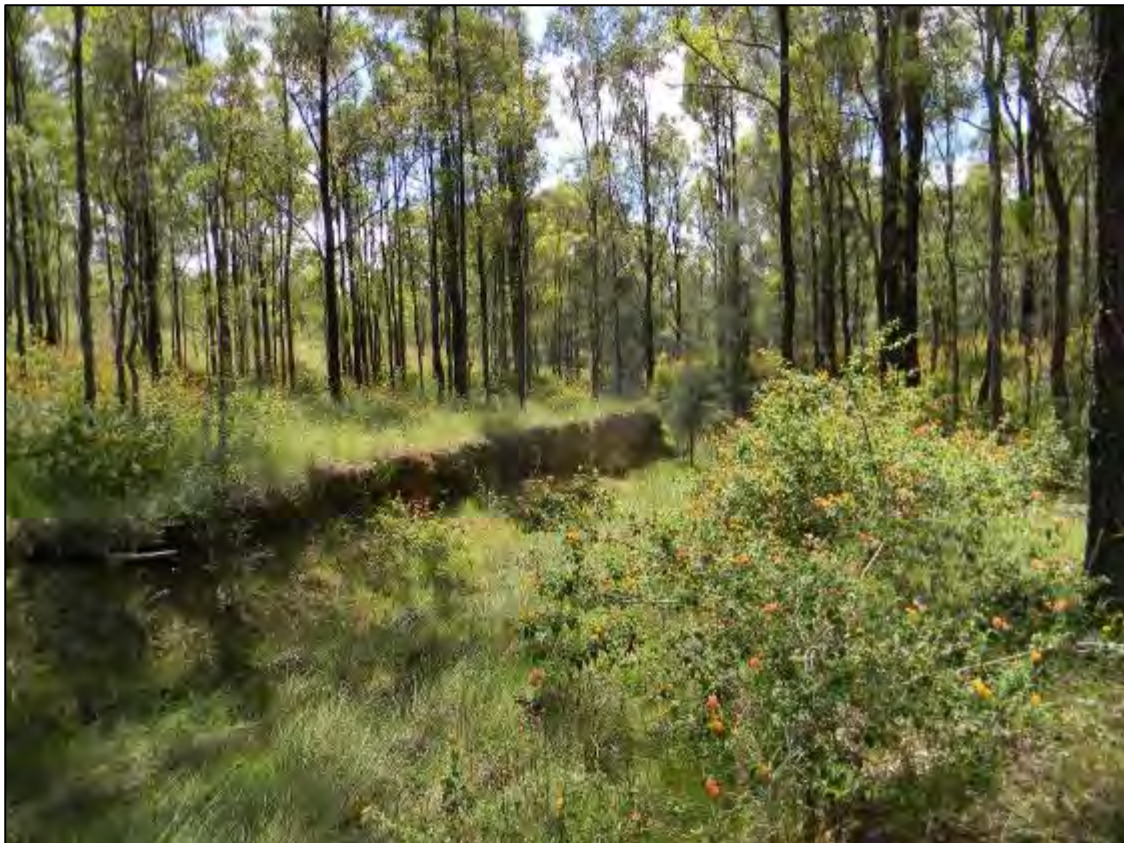
Plate 4: View of tributary to the northeast drainage showing gully erosion and incision.

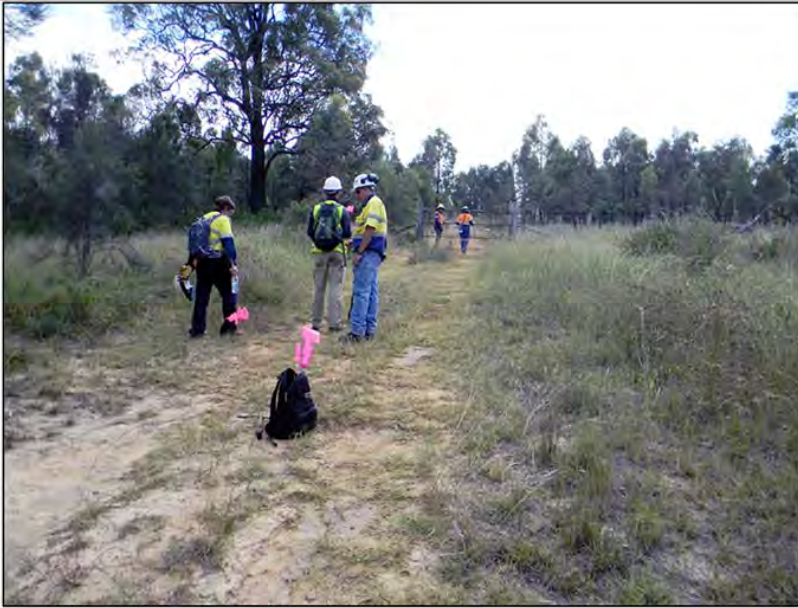
LOCATION OF BOP OS-2 WITHIN THE MODIFICATION AREA.

The BOP assessment identified two sites within the Modification Area: BOP OS-2 and the northern portions of BOP SC-3. The southern portions of BOP SC-3 are in the area of approved disturbance by the BOP and were salvaged during the BOP salvage program during 2015.

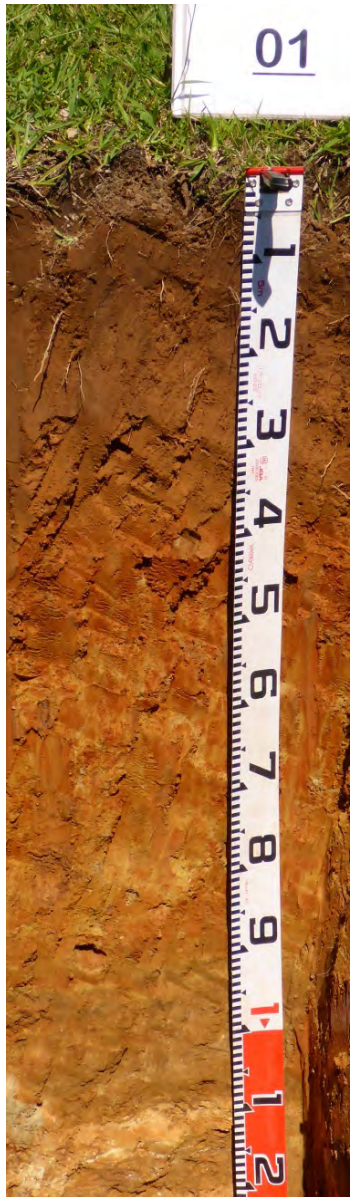
A1 0.0 – 0.15	Dark brown (7.5YR 3/4) loamy sand, weakly structured 2-5 mm crumb peds with weak consistence and a rough fabric. Nil mottling, nil stone content, abundant fine roots. Moderately drained with a gradual and even boundary.
	A2 0.15 – 0.35	Strong brown (7.5YR 4/6) loamy sand, weakly structured 5-10 mm crumb peds with weak consistence and a rough fabric. Nil mottling, <5% pebbles 10-20 mm, abundant fine roots. Moderately drained with a clear and even boundary.
	B21 0.35 – 0.50	Yellowish red (5YR 5/8) medium clay, moderately structured 20-40 mm subangular blocky peds with moderate consistence and a rough fabric. 30% distinct yellow mottles; nil stone content, few coarse roots. Poorly drained with a gradual and even boundary.
	B22 0.50 – 0.90	Strong brown (7.5YR 5/8) medium clay, moderately structured 40-80 mm subangular blocky peds with moderate consistence and a rough fabric. 30% distinct yellow and 30% distinct red mottles, nil stone content, few coarse roots. Poorly drained with a gradual and even boundary.

BC +0.90	Weathered parent material

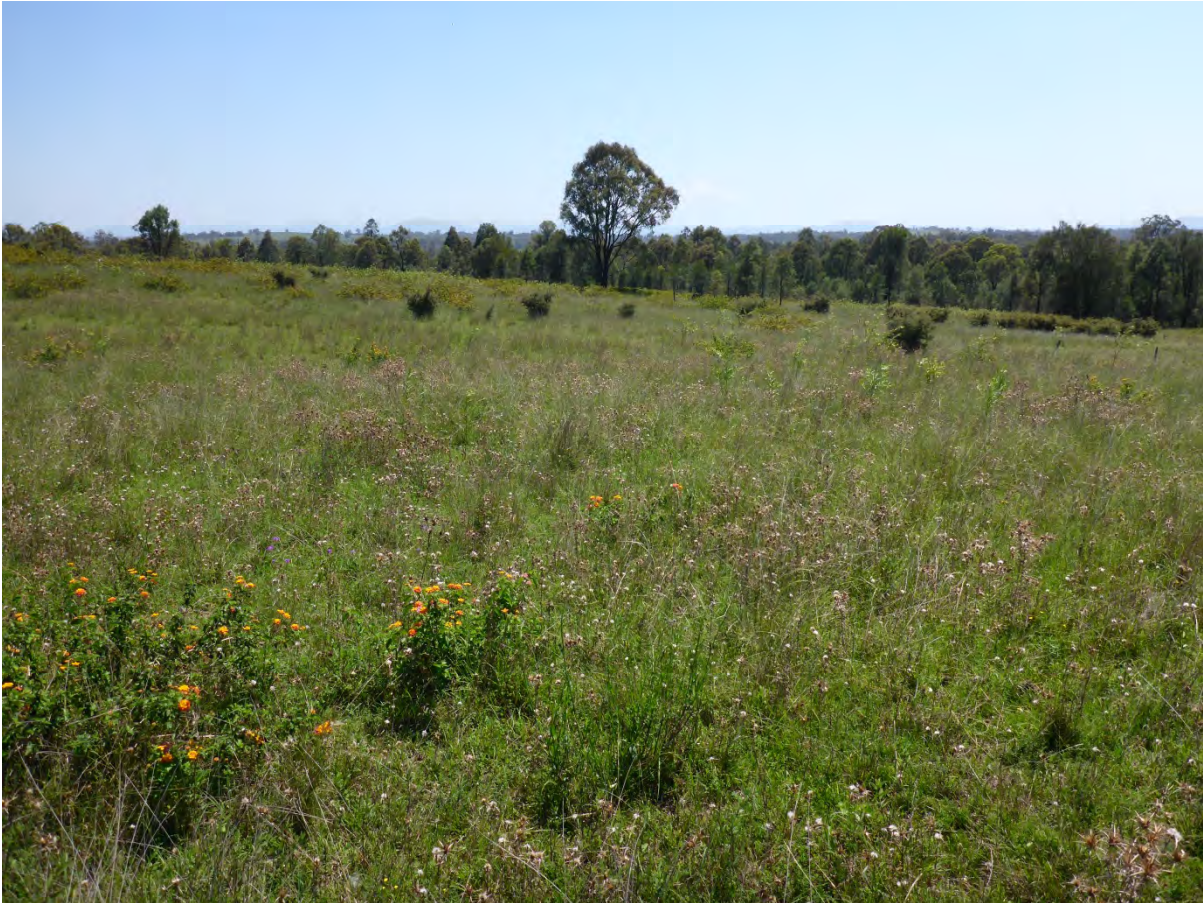
Table 7 Summary: Eutrophic Red Chromosol (Site 2)

Landscape Site 2	
ASC Name	Eutrophic Red Chromosol
Representative Site	Site 2
Survey Type	Detail
Dominant Topography	Hillcrest Plateau
Current Land Use	Cattle Grazing
Vegetation	Casuarina, Lantana, Wiregrass, Saffron Thistle
Inherent Soil Fertility	Moderately High
Slope	7%

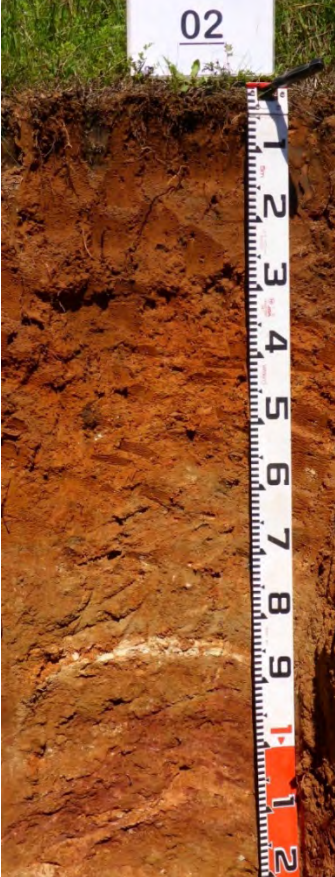
Table 8 Profile: Eutrophic Red Chromsol (Site 2)

A1 0.0 – 0.10	Brown (7.5YR 4/4) loamy sand, weak crumb structure 1-5 mm peds with weak consistence and a rough fabric. Nil mottling. <5% pebbles 10-20 mm, abundant fine roots. Well drained with a gradual and even boundary.
	A2 0.10 – 0.30	Strong brown (7.5YR 4/6) loamy sand, weak crumb structure 2-10 mm peds with weak consistence and a rough fabric. Nil mottling, 5% pebbles 10-20 mm, abundant fine roots. Well drained with a clear and wavy boundary.
	B21 0.30 – 0.40	Red (2.5YR 4/8) medium clay, moderate structure of 20-40 mm subangular blocky peds with a moderate consistence and a rough fabric. 20% distinct yellow mottles, nil stone content, few coarse roots. Moderately drained with a gradual and wavy boundary.
	B22 0.40 – 0.60	Yellowish red (5YR 4/6) clay loam, moderate structure of 40-80 mm subangular blocky peds with a strong consistence and a rough fabric. 30% distinct yellow mottles, <10% pebbles 10-20 mm, few coarse roots. Poorly drained with a clear and wavy boundary.

BC +0.60	Weathered parent material

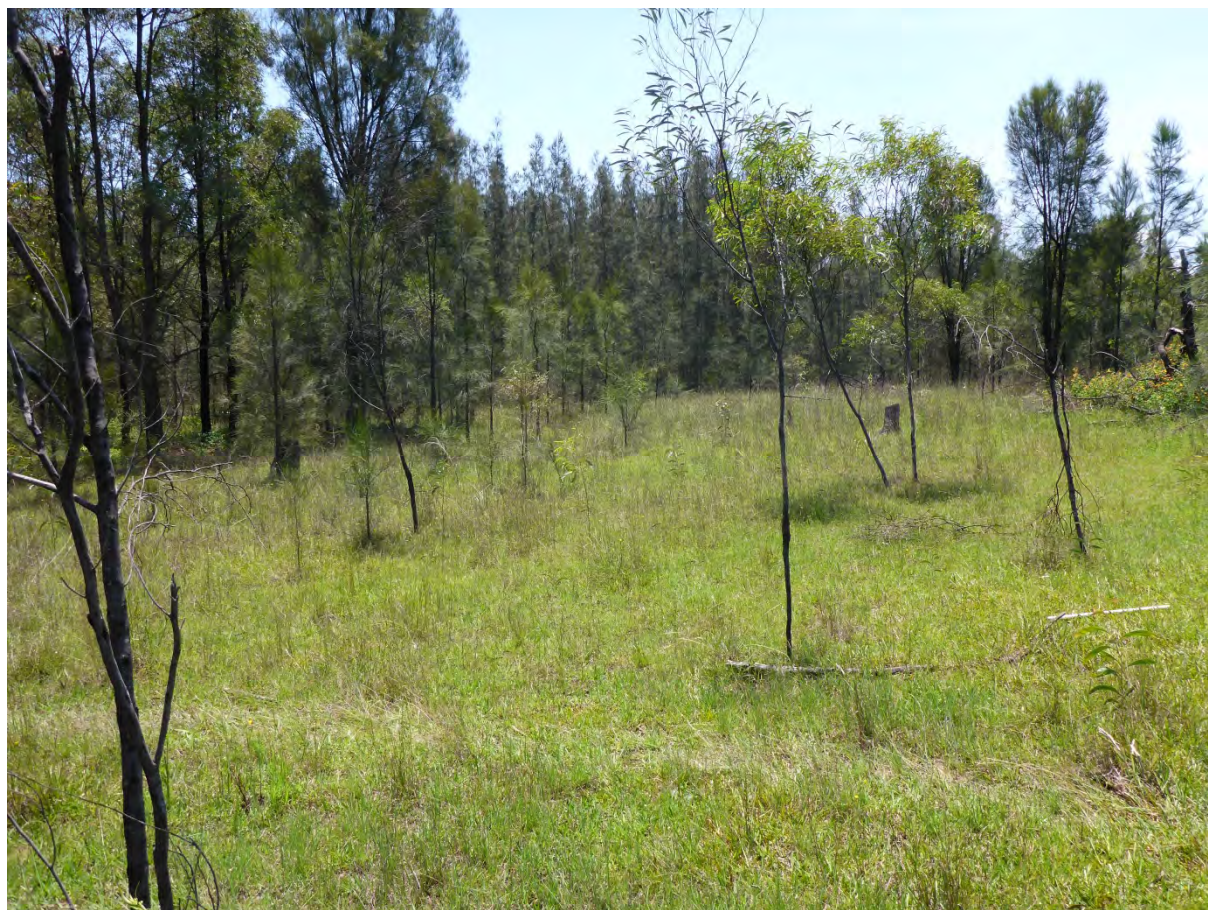
Table 13 Summary: Subnatric Brown Sodosol (Site 5)

Landscape Site 5	
ASC Name	Subnatric Brown Sodosol
Representative Site	Site 5
Survey Type	Detail
Dominant Topography	Lower Hillslope
Current Land Use	Cattle Grazing
Vegetation	Casuarina, Acacia, Pigeon Grass
Inherent Soil Fertility	Moderately Low
Slope	7%

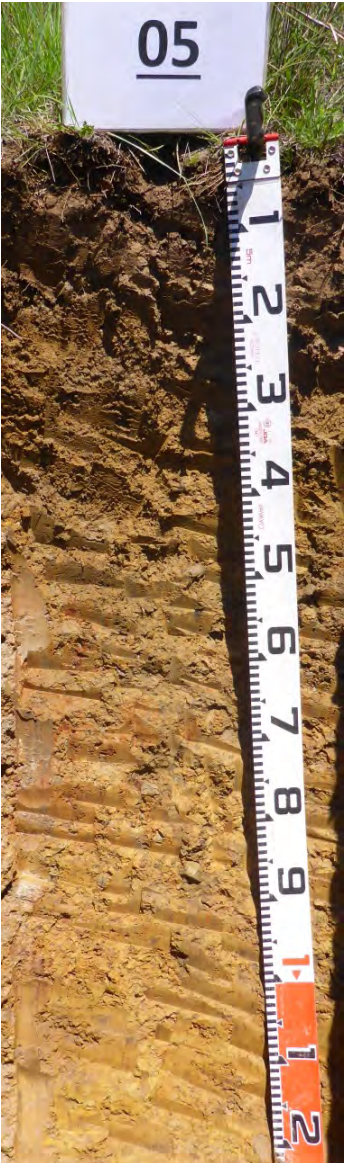
Table 14 Profile: Subnatric Brown Sodosol (Site 5)

A1 0.0 – 0.15	Dark yellowish brown (10YR 4/4) loamy sand, weak crumb structure 1-10 mm peds with weak consistence and a rough fabric. Nil mottling, 5% pebbles 10-20 mm, abundant fine roots. Well drained with a clear and even boundary.
	B21 0.15 – 0.50	Dark yellowish brown (10YR 4/6) light medium clay, moderate structure of 20-40 mm subangular blocky peds with a moderate consistence and a rough fabric. 20% distinct red mottles, 5% pebbles 10-20 mm, common coarse roots. Moderately drained with a gradual and even boundary.
	B22 +0.50	Dark yellowish brown (10YR 4/6) light clay, moderate structure of 40-80 mm subangular blocky peds with a strong consistence and a rough fabric. 30% distinct grey mottles, 15% gravel 10-20 mm, few coarse roots. Moderately drained with a gradual and even boundary.

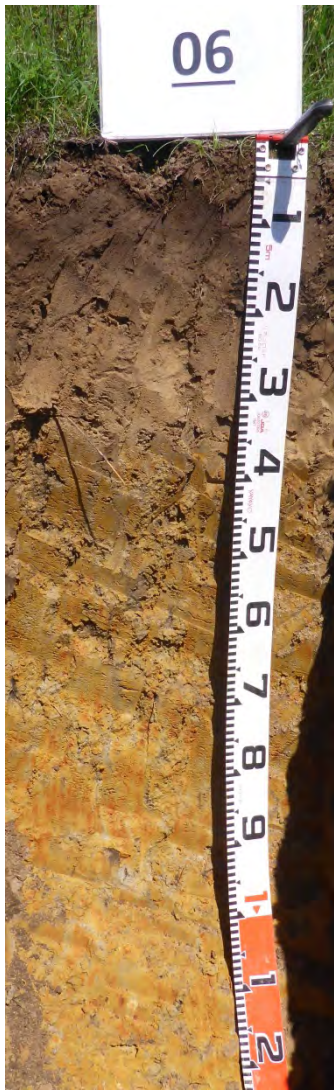
Table 17 Profile: Mesonatric Brown Sodosol (Site 6)

A1 0.0 – 0.20	Dark brown (7.5YR 3/3) loamy sand, weak crumb structure 1-10 mm peds with weak consistence and a rough fabric. Nil mottling, <5% pebbles 10-20 mm, abundant fine roots. Well drained with a gradual and even boundary.
	A2 0.20 – 0.35	Dark yellowish brown (10YR 4/4) bleached loamy sand, weak crumb structure 2-10 mm peds with weak consistence and a rough fabric. Nil mottling, <5% pebbles 10-20 mm, abundant fine roots. Well drained with a clear and even boundary.
	B21 0.35 – 0.60	Dark yellowish brown (10YR 4/6) light medium clay, moderate structure of 20-40 mm subangular blocky peds with a moderate consistence and a rough fabric. 20% distinct brown mottles; nil stone content, common coarse roots. Poorly drained with a gradual and even boundary.
	B22 0.60 – 1.10	Dark yellowish brown (10YR 4/6) light clay, moderate structure of 40-80 mm subangular blocky peds with a strong consistence and a rough fabric. 20% distinct red and 20% distinct grey mottles, nil stone content, few coarse roots. Poorly drained with a gradual and even boundary.

BC +1.10	Weathered parent material

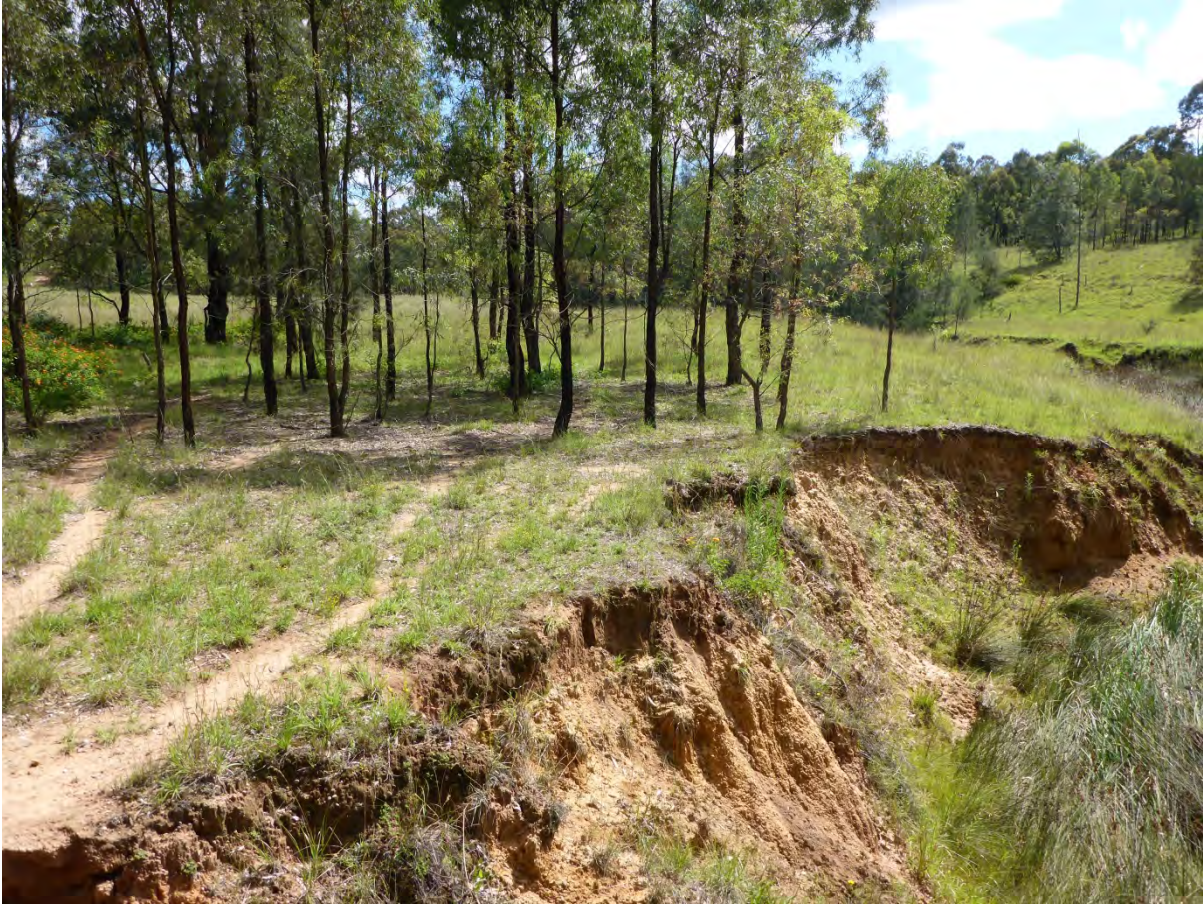
Table 19 Summary: Subnatric Brown Sodosol (Site 8)

Landscape Site 8	
ASC Name	Subnatric Brown Sodosol
Representative Site	Site 8
Survey Type	Detail
Dominant Topography	Drainage Flat
Current Land Use	Cattle Grazing
Vegetation	Ironbark, Stringybark, Wiregrass, Lantana
Inherent Soil Fertility	Moderately Low
Slope	10%

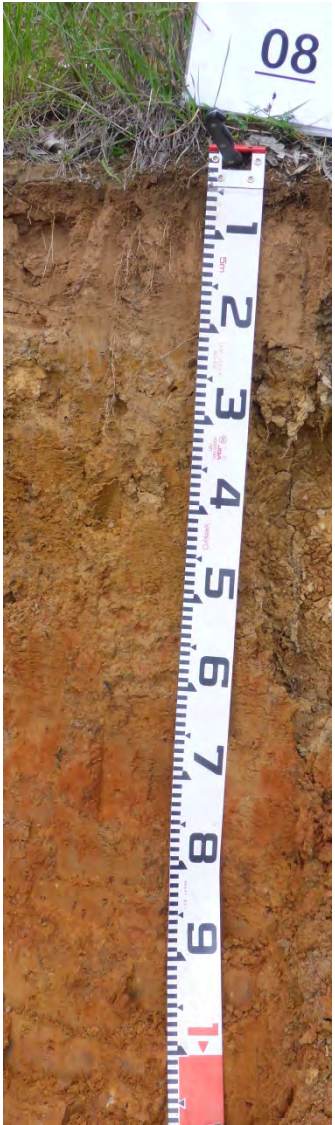
Table 20 Profile: Subnatric Brown Sodosol (Site 8)

A1 0.0 – 0.05	Brown (7.5YR 4/3) loamy sand, weak crumb structure 5-10 mm with weak consistence and a rough fabric. Nil mottling, <5% pebbles 20 mm, abundant fine roots. Well drained with a gradual and even boundary.
	A2 0.05 – 0.20	Dark yellowish brown (10YR 4/6) bleached loamy sand, weak crumb structure 5-10 mm with weak consistence and a rough fabric. Nil mottling, <5% pebbles 20 mm, common fine roots. Well drained with a clear and even boundary.
	B21 0.20 – 0.60	Dark yellowish brown (10YR 4/6) light medium clay, strong structure 20-40 mm subangular blocky peds with moderate consistence and a rough fabric. 30% distinct-red mottles, <5% pebbles 20 mm, common coarse roots. Poorly drained with a gradual and even boundary.
	B22 +0.60	Yellowish red (5YR 4/6) medium clay loam, strong structure 20-40 mm subangular blocky peds with moderate consistence and a rough fabric. 20% distinct yellow mottles, <5% gravel 10-20 mm, few coarse roots. Poorly drained.

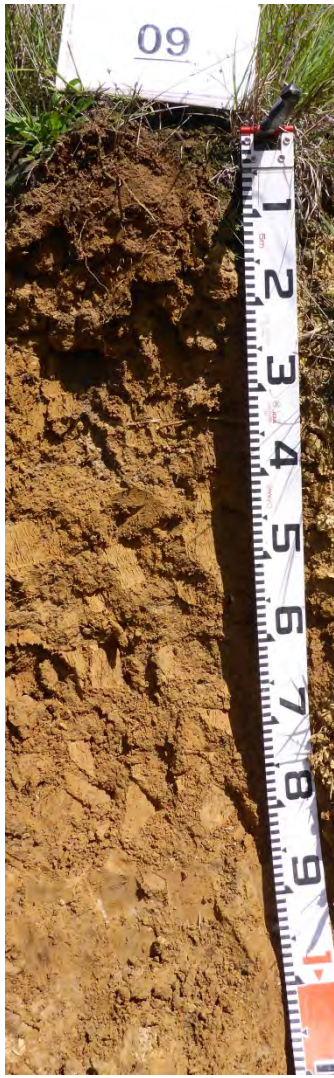
Table 23 Profile: Brown Sodosol (Site 9)

A1 0.0 – 0.10	Dark brown (7.5YR 3/2) loamy sand, weak crumb structure 5-10 mm with weak consistence and a rough fabric. Nil mottling, 10% gravel <10 mm, abundant fine roots. Well drained with a gradual and even boundary.
	A2 0.10 – 0.20	Brown (7.5YR 5/4) bleached loamy sand, weak crumb structure 10-20 mm with weak consistence and a rough fabric. Nil mottling, 10% gravel <10 mm, abundant fine roots. Well drained with a clear and even boundary.
	B21 0.20 – 0.50	Brown (7.5YR 5/4) light medium clay, moderate structure 20-50 mm subangular blocky peds with moderate consistence and a rough fabric. 10% faint grey mottles, 10% gravel <10 mm, common coarse roots. Poorly drained with a gradual and even boundary.
	B22 +0.50	Strong brown (7.5YR 5/6) medium clay, moderate structure 40-60 mm subangular blocky peds with moderate consistence and a rough fabric. 30% distinct grey mottles, 10% gravel <10 mm, common coarse roots. Poorly drained. Dispersive B22 horizon.

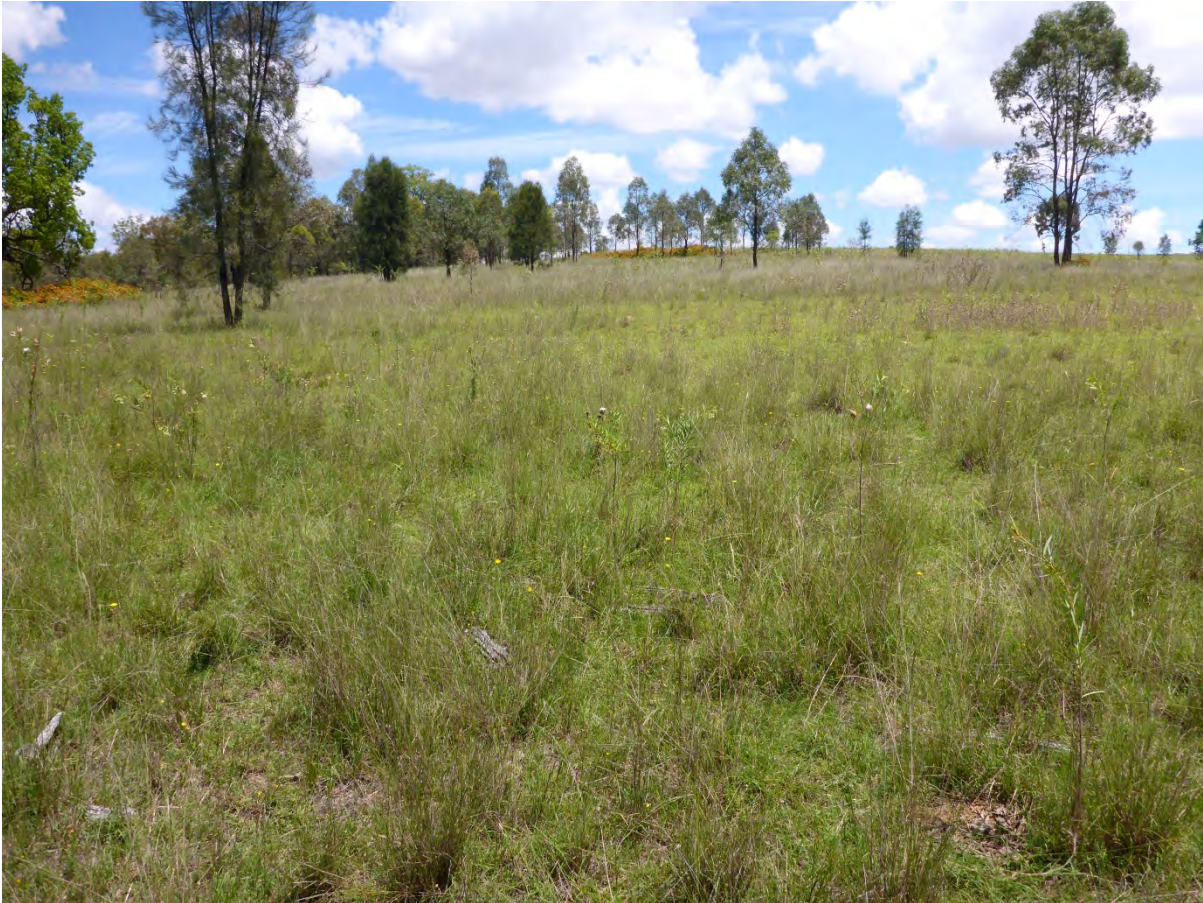
Table 25 Summary: Brown Sodosol (Site 10)

Landscape Site 10	
ASC Name	Brown Sodosol
Representative Site	Site 10
Survey Type	Check
Dominant Topography	Mid Hillslope
Current Land Use	Cattle Grazing
Vegetation	Ironbark, Casuarina, Wiregrass, Lantana
Inherent Soil Fertility	Moderately Low
Slope	8%

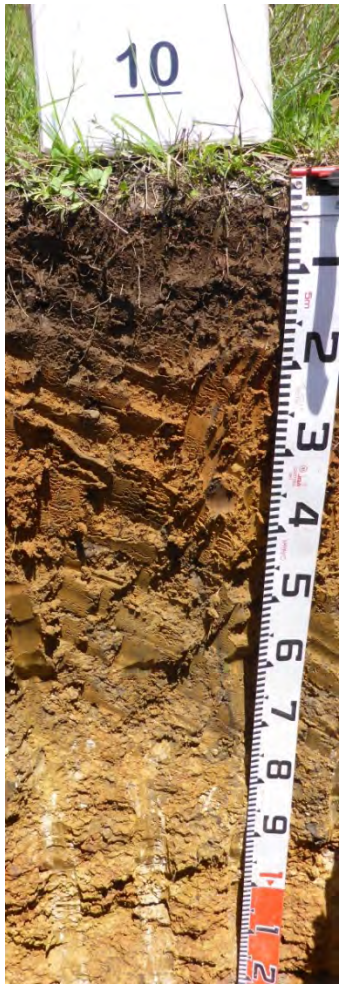
Table 26 Profile: Brown Sodosol (Site 10)

A1 0.0 – 0.15	Dark brown (7.5YR 3/2) sandy loam, weak crumb structure 5-10 mm with weak consistence and a rough fabric. Nil mottling, 20% gravel 20 mm, abundant fine roots. Well drained with a clear and wavy boundary.
	B21 0.15 – 0.40	Strong brown (7.5YR 5/6) medium clay, moderate structure 20-40 mm subangular blocky peds with moderate consistence and a rough fabric. 10% distinct brown mottling, 10% gravel 20 mm. Moderately drained with a gradual and wavy boundary.
	B22 0.40 – 0.70	Brown (7.5YR 5/4) medium clay, moderate structure 20-40 mm subangular blocky peds with moderate consistence and a rough fabric. 30% distinct grey mottling, 10% gravel 20 mm. Poorly drained with a gradual and wavy boundary. Dispersive B22 horizon
	B23 0.70 – 1.0	Reddish yellow (7.5YR 6/6) medium clay, moderate structure 60-80 mm subangular blocky peds with moderate consistence and a rough fabric. 30% distinct brown mottling, 50% gravel 20 mm, 20% hard calcium nodules 20 mm at +0.70. Poorly drained with a gradual and wavy boundary. Dispersive B23 horizon.

BC +1.00	Weathered parent material

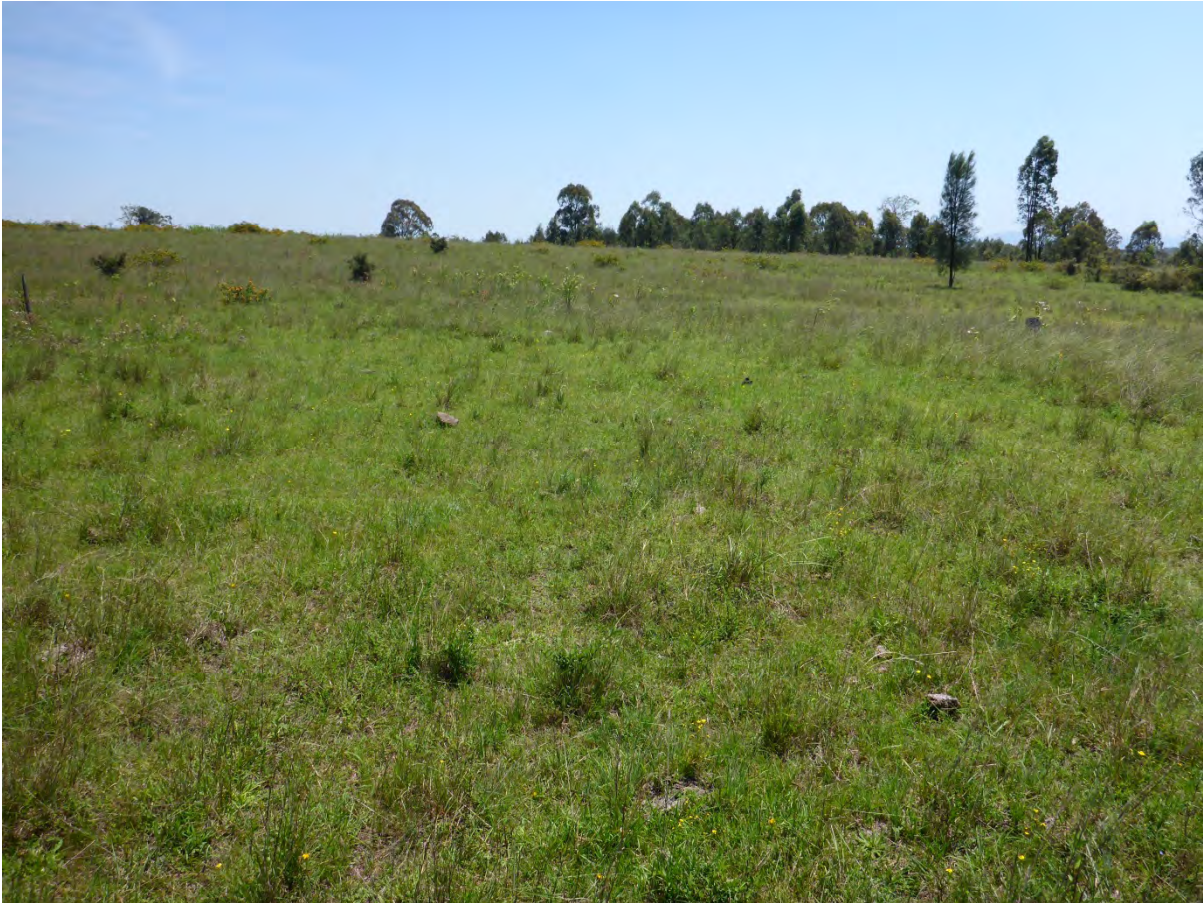
Table 28 Summary: Subnatric Red Sodosol (Site 3)

Landscape Site 3	
ASC Name	Subnatric Red Sodosol
Representative Site	Site 3
Survey Type	Detail
Dominant Topography	Mid Hillslope
Current Land Use	Cattle Grazing
Vegetation	Ironbark, Casuarina, Grevillea, Wiregrass
Inherent Soil Fertility	Moderately Low
Slope	1%

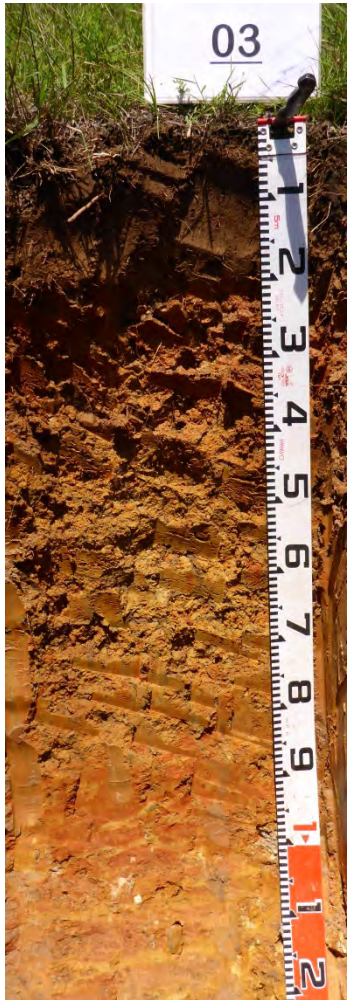
Table 29 Profile: Subnatric Red Sodosol (Site 3)

A1 0.0 – 0.20	Dark brown (7.5YR 3/3) loamy sand, weak crumb structure 2-5 mm peds with weak consistence and a rough fabric. Nil mottling, <5% pebbles 10-20 mm, abundant fine roots. Well drained with a clear and wavy boundary.
	B21 0.20 – 0.35	Yellowish red (5YR 4/6) heavy clay, moderate structure of 20-40 mm subangular blocky peds with a moderate consistence and a rough fabric. 30% distinct yellow mottles; nil stone content, common coarse roots. Moderately drained with a gradual and wavy boundary.
	B22 0.35 – 0.85	Yellowish brown (10YR 5/6) medium clay, moderate structure of 40-80 mm subangular blocky peds with a moderate consistence and a rough fabric. 40% distinct red mottles, nil stone content, common coarse roots. Poorly drained with a clear and wavy boundary.
	BC +0.85	Weathered parent material

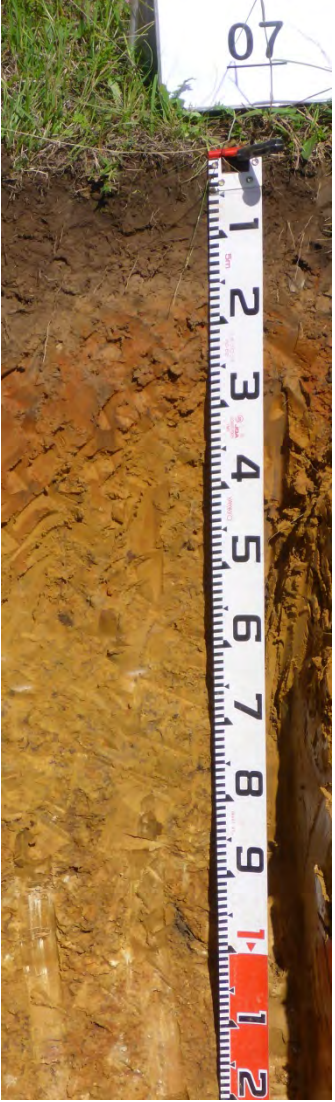
Table 32 Profile: Red Sodosol (Site 7)

A1 0.0 – 0.10	Dark brown (7.5YR 3/2) loamy sand, weak crumb structure 5-10 mm with weak consistence and a rough fabric. Nil mottling, 20% pebbles 20 mm, abundant fine roots. Well drained with a gradual and wavy boundary.
	A2 0.10 – 0.20	Brown (7.5YR 4/3) bleached loamy sand, weak crumb structure 5-10 mm with weak consistence and a rough fabric. Nil mottling, 20% pebbles 20 mm, abundant fine roots. Well drained with a clear and wavy boundary.
	B21 0.20 – 0.40	Yellowish red (5YR 5/6) medium clay, strong structure 20-40 mm subangular blocky peds with strong consistence and a rough fabric. 50% distinct-yellow mottles, 20% pebbles 20 mm, common coarse roots. Poorly drained with a gradual and even boundary.
	B22 0.40 – 0.85	Yellowish brown (7.5YR 5/6) medium clay, strong structure 40-80 mm subangular blocky peds with strong consistence and a rough fabric. 10% faint grey mottles; 20% gravel 10-20 mm, few coarse roots. Poorly drained with a gradual and wavy boundary.

B23 +0.85	Reddish yellow (7.5YR 6/6) medium clay, strong structure 60-80 mm subangular blocky peds with strong consistence and a rough fabric. 20% faint red mottles; 20% gravel 10-20 mm, few coarse roots, <10% soft calcium nodules 10 mm at +0.85 m. Poorly drained.
