**APPENDIX A**

**EPBC Approvals Compliance Reports**

**Air Quality Monitoring Data Review and Analysis at Bulga Complex 2022 (Todoroksi, 2023)**

### **Annual Rehabilitation Report and Forward Program**

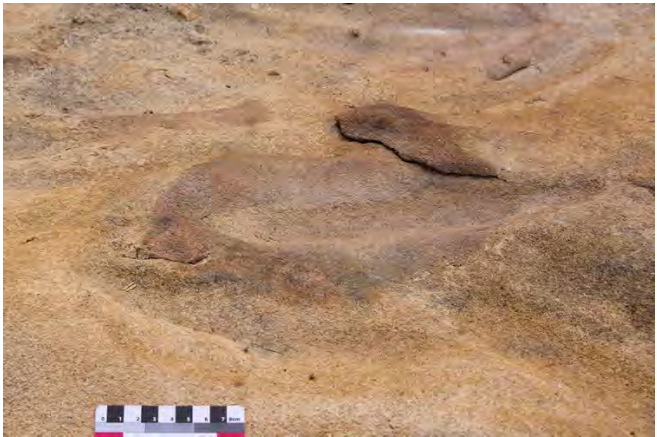
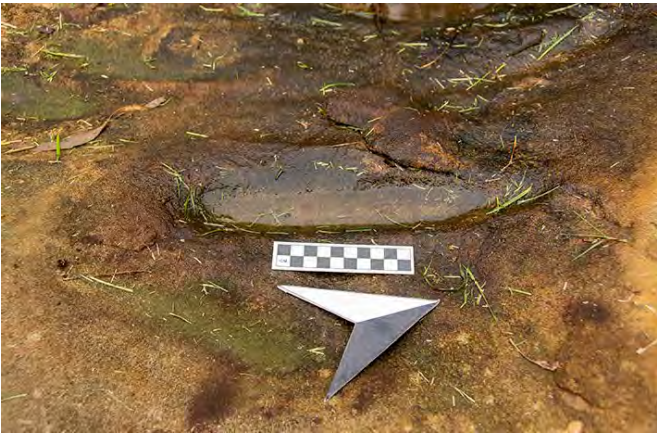
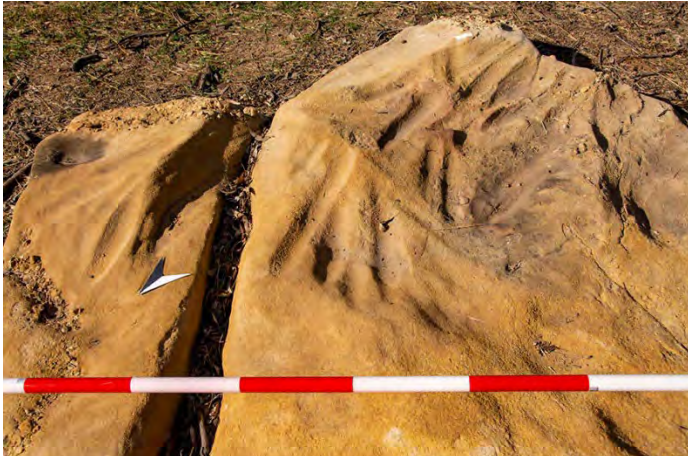
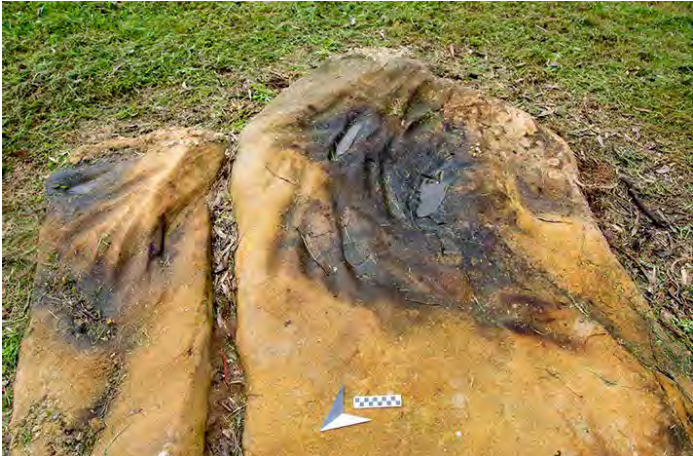
| Condition | Actions During the Reporting Period | Status |
|---|---|---|
| 13. The approval holder must notify the Department in writing of any: incident, or non-compliance with the conditions, or non-compliance with the commitments made in plans. The notification must be given as soon as practicable, and no later than two business days after becoming aware of the incident or non-compliance. The notification must specify: a. any condition which is in breach, b. a short description of the incident and/or non-compliance, and c. the location (including co-ordinates), date, and time of the incident and/or non-compliance. In the event the exact information cannot be provided, provide the best information available. | There have not been any incidents or non-compliances with the conditions which have required notification. | Compliant |

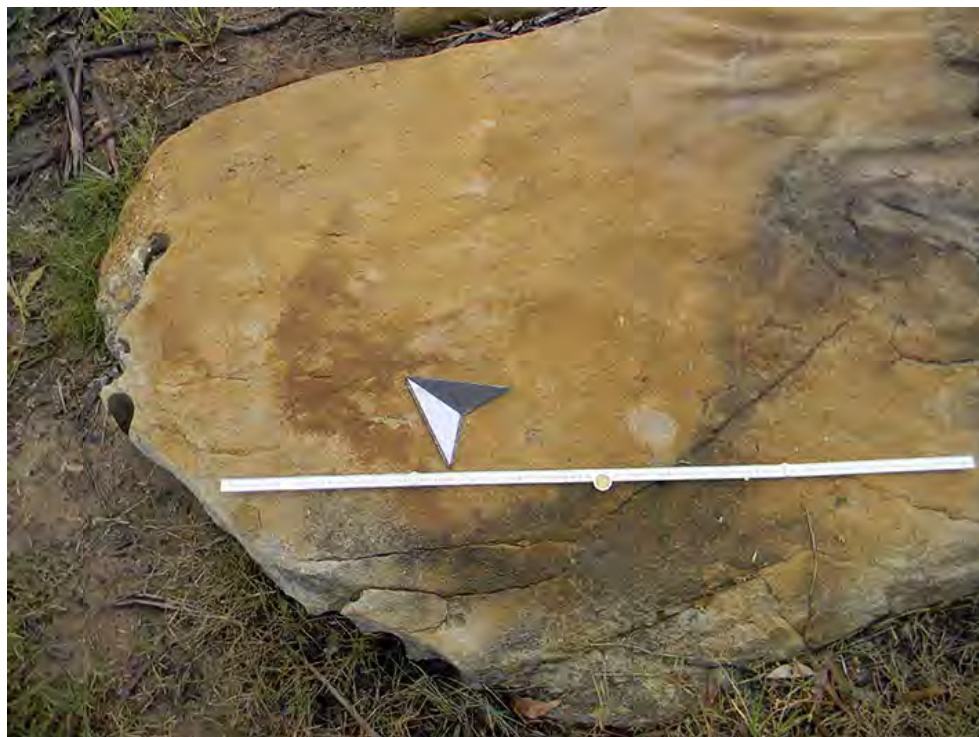
| Condition | Actions During the Reporting Period | Status |
|---|---|---|
| 16. For each independent audit, the approval holder must: a. provide the name and qualifications of the independent auditor and the draft audit criteria to the Department, b. only commence the independent audit once the audit criteria have been approved in writing by the Department, and c. submit an audit report to the Department within the timeframe specified in the approved audit criteria. | This condition has not been triggered. No requests for an audit have been received by the Minister to date. | Not Applicable |

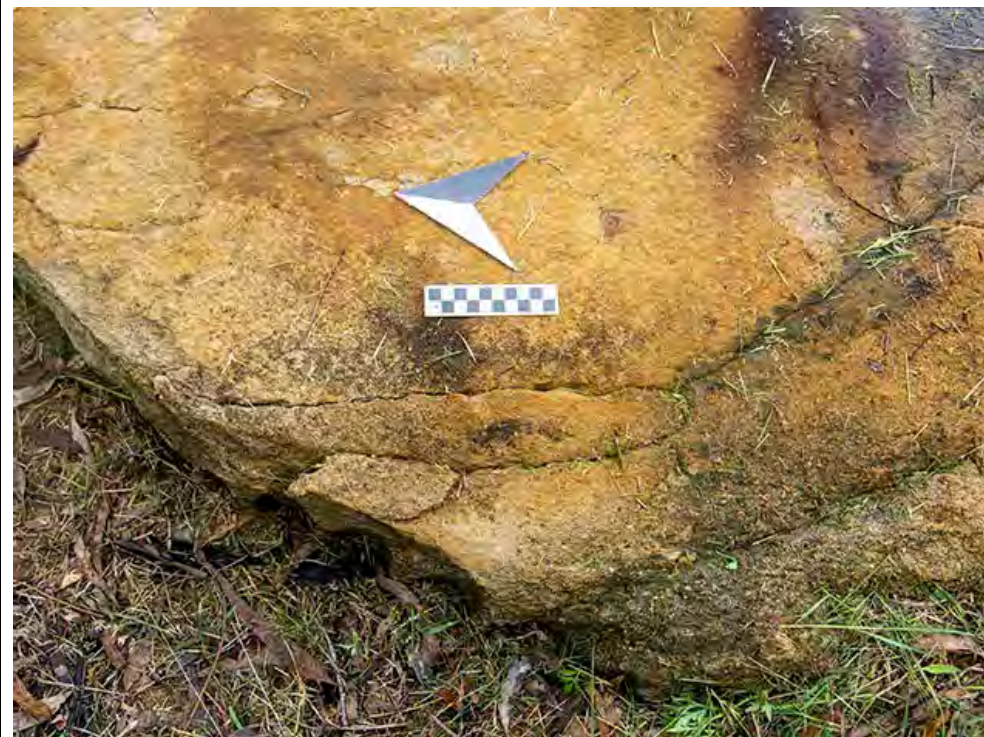
| Condition | Actions During the Reporting Period | Status |
|---|---|---|
| 18. The approval holder must comply with the State development consent condition 5 in Schedule 2. | Noted. Condition 5 in Schedule 2 states that the Applicant may carry out mining operations on site until 31 December 2039. | Compliant |

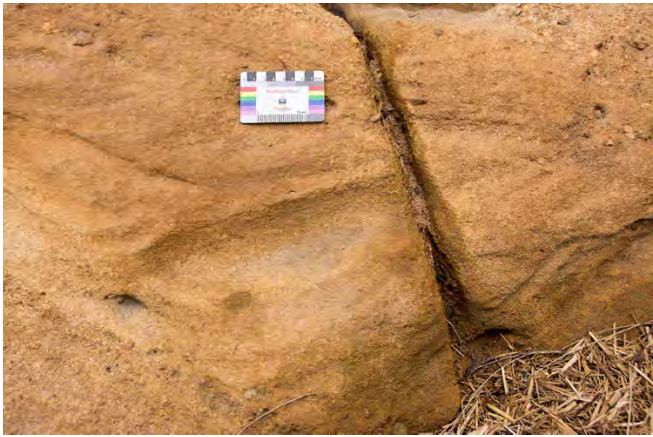
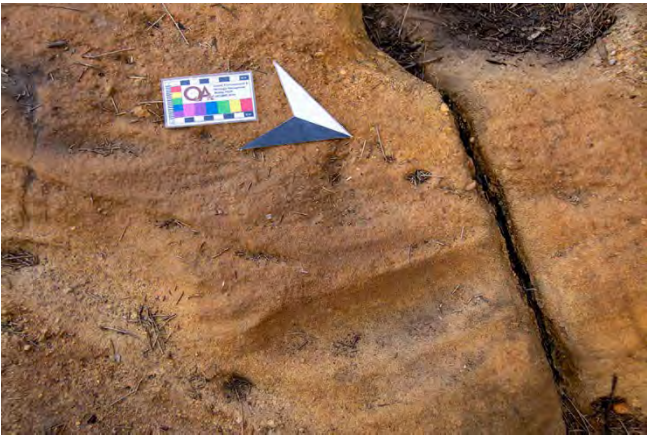
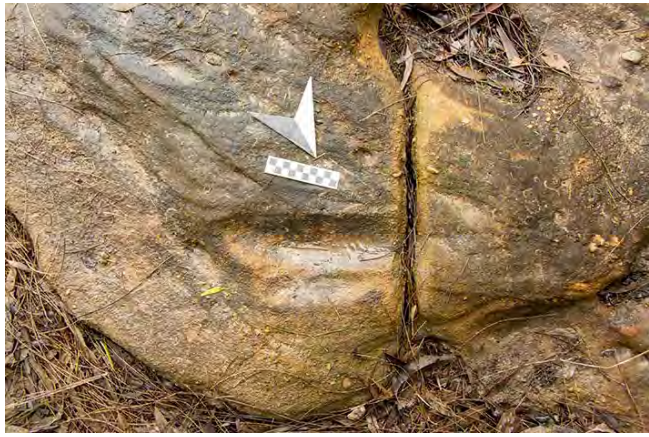
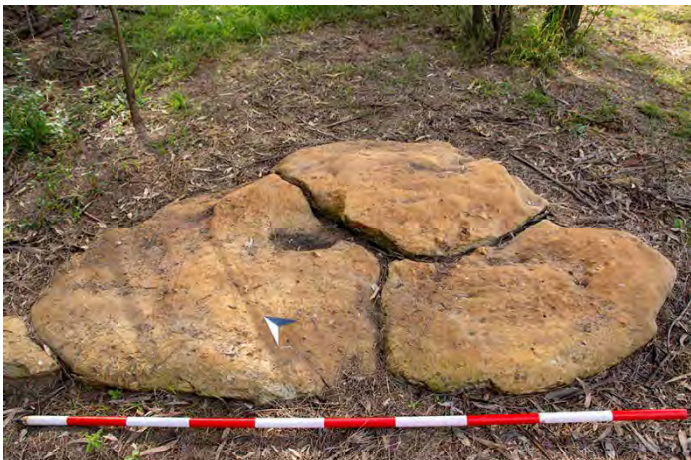
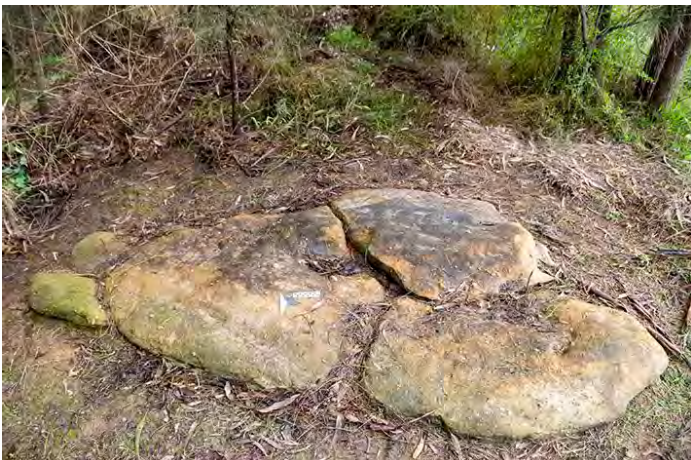
| Condition | Actions During the Reporting Period | Status |
|---|---|---|
| 23. The approval holder may choose to revise an action management plan approved by the Minister under conditions 3 and 5.a, or as subsequently revised in accordance with these conditions, without submitting it for approval under section 143A of the EPBC Act, if the taking of the action in accordance with the RAMP would not be likely to have a new or increased impact. | This condition has not been triggered during the reporting period. | Not Applicable |

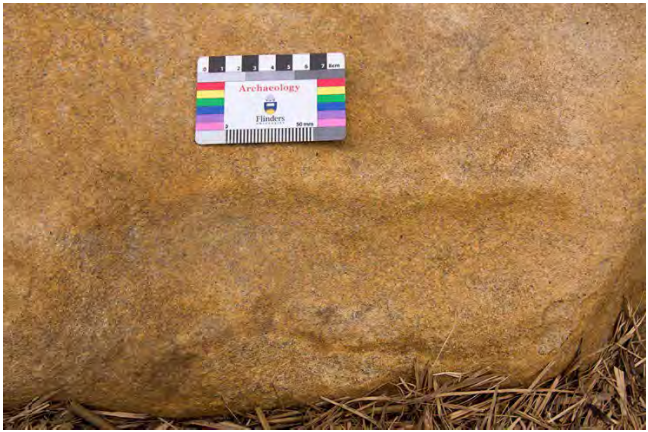
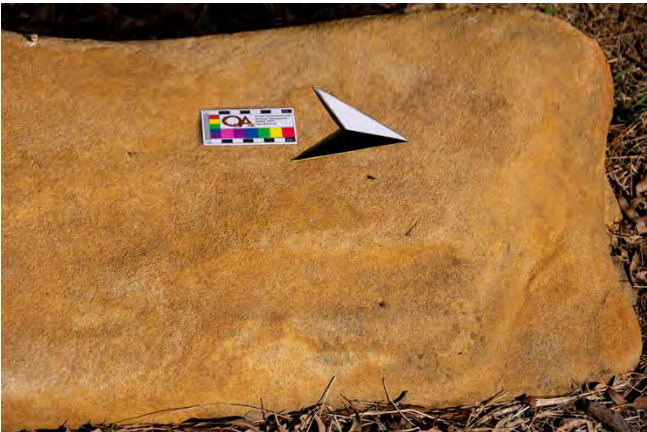
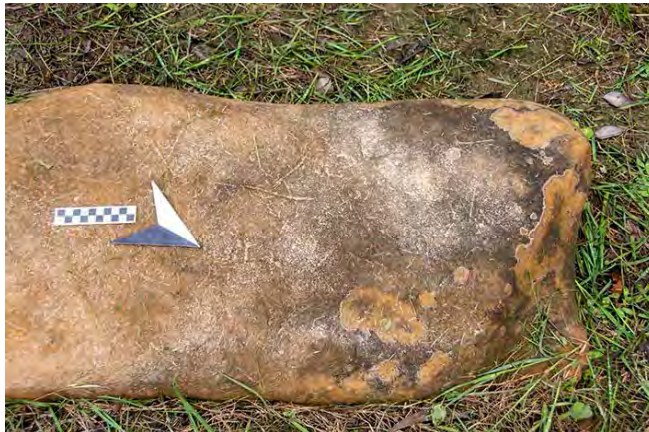
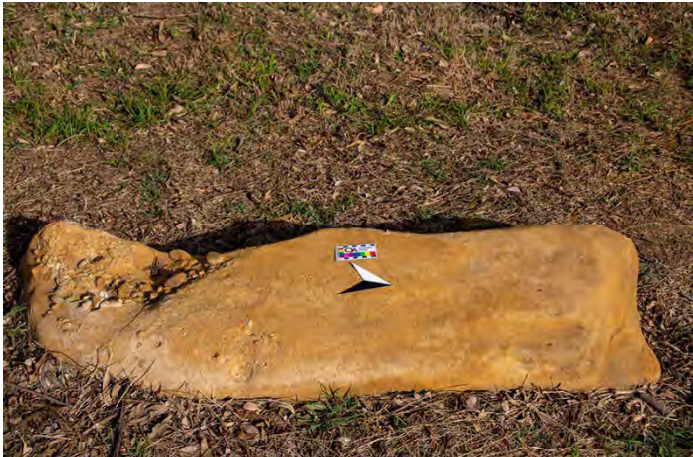
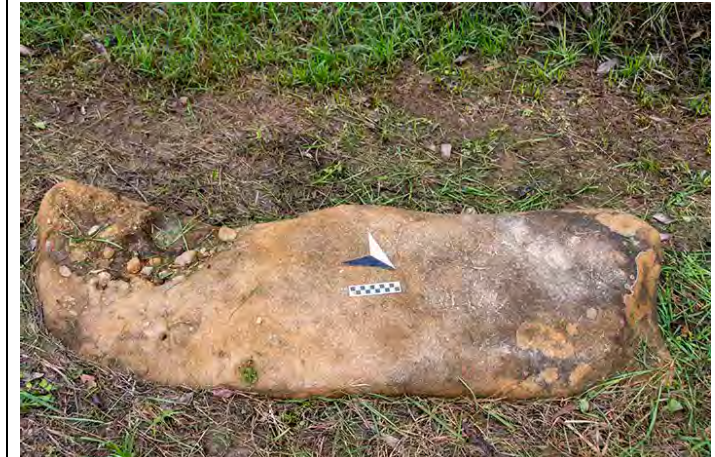
| Condition | Actions During the Reporting Period | Status |
|---|---|---|
| 27. At the time of giving the notice under condition 24, the Minister may also notify that for a specified period of time, condition 21 does not apply for one or more specified action management plans. Note: conditions 21, 22, 23 and 24 are not intended to limit the operation of section 143A of the EPBC Act which allows the approval holder to submit a revised action management plan, at any time, to the Minister for approval. | This condition has not been triggered during the reporting period. | Not Applicable |

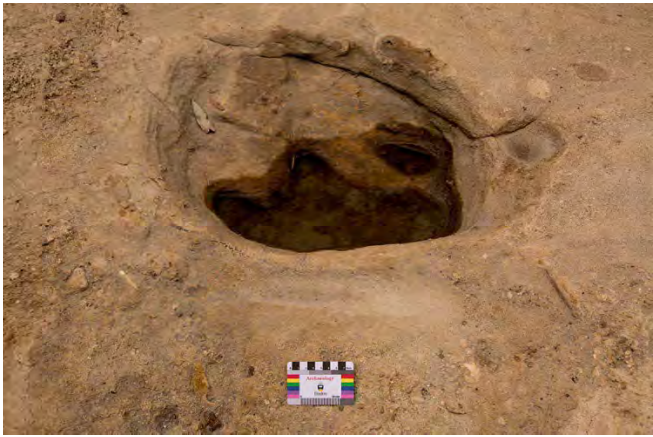
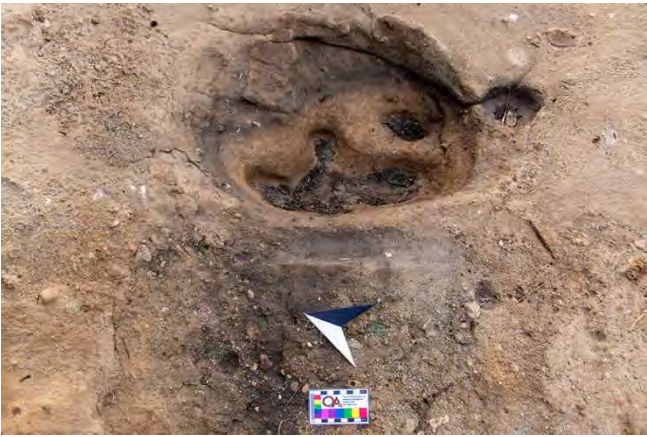
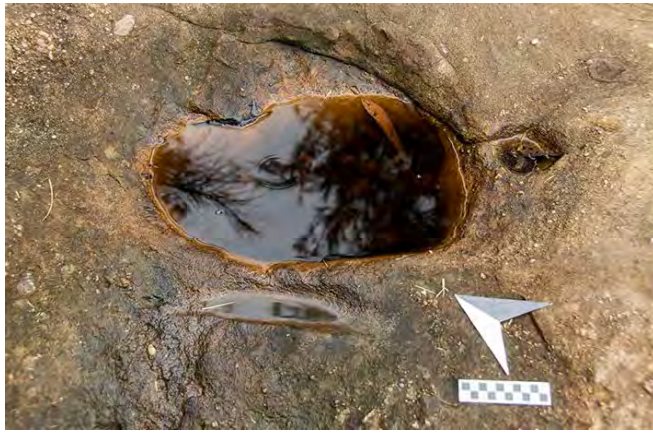
| Condition | Actions During the Reporting Period | Status |
|---|---|---|
| <b>The approved plan must be implemented</b> | | |

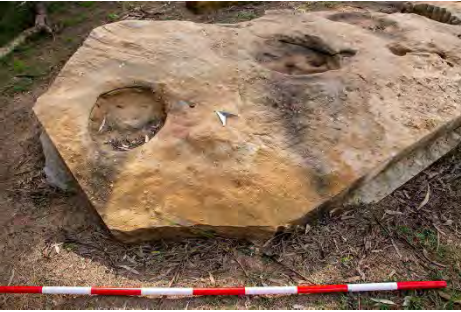
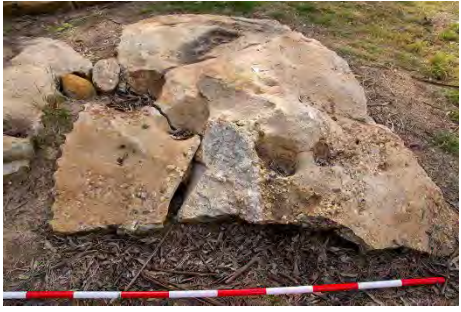
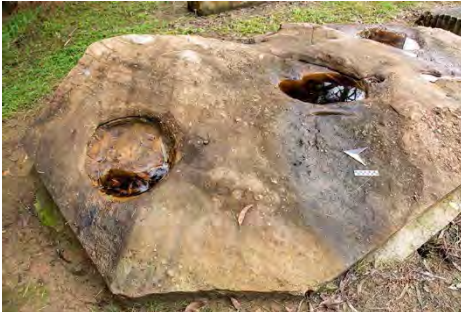
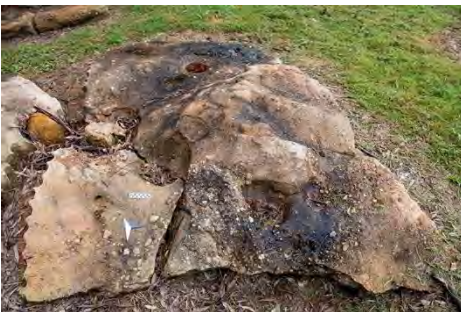
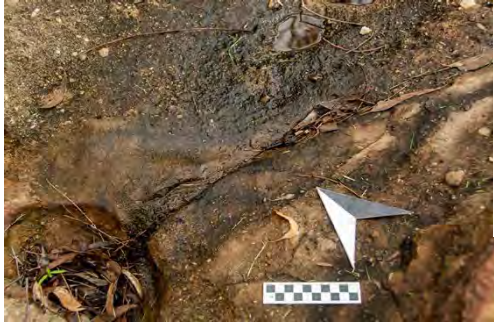
| | | <p>GROUP E CONSISTS OF A NUMBER OF SLABS THAT HAD TO BE CUT AND SPLIT FROM THE ROCK SHELVING WHEN THE GROOVES WERE BEING REMOVED. THERE HAS BEEN NO DISCERNIBLE WEATHERING OF THE AREAS SURROUNDING THE GROOVES IN THE SIX AND A HALF YEARS SEPARATING THE PHOTOGRAPHIC MONITORING EVENTS. IN 2019 SOME EXFOLIATION OF SMALL PORTIONS OF ROCK FROM THE EDGE OF THE SLAB WAS NOTICED. THESE PORTIONS WERE AWAY FROM THE GRINDING GROOVES AND DO NOT APPEAR HAVE WORSENERD IN THE INTERVENING YEARS.</p> <p>VIEW OF THE SECOND GROOVE AT GROUP E IN 2022.</p> |

**Figure 2-4** to **Figure 2-9** provide details of the slabs containing grooves to assess whether there has been any change in their condition between 2015 and 2022. Notes on any observable changes are provided in this figure.
