## **COAL PROJECT**

### **ENVIRONMENTAL IMPACT STATEMENT**

# Watermark Coal Project Geomorphological Impact Assessment

September 2012

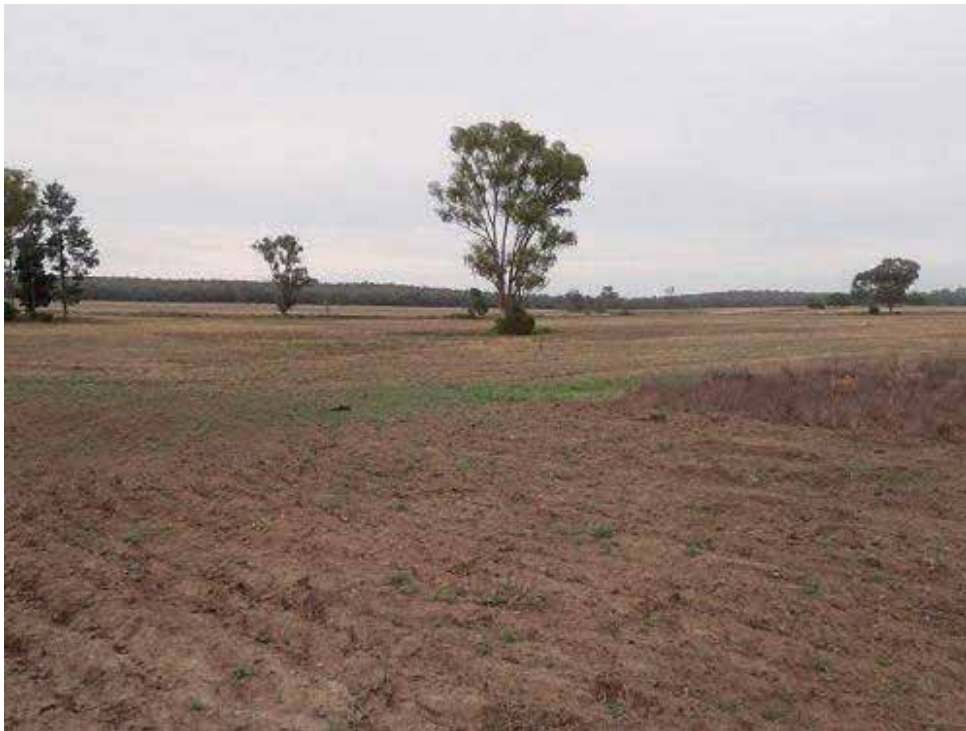
An Undefined Drainage Line was identified at the upstream 1<sup>st</sup> order extent of Watermark Gully (Figure 3-3). Several other Undefined Drainage Lines were identified to the west of Watermark Gully. These are unnamed waterways and are not mapped as connecting to Watermark Gully. However it is assumed that these would drain into Watermark Gully during high rainfall events. These drainage lines also exist through agricultural areas and are affected by artificial contour banks. They are geomorphologically stable with no visible signs of erosion or instability.

**Figure 3-3 Upstream View of an Undefined Drainage Line Section of Watermark Gully**

Undefined Drainage Lines exist on a range of gradients that usually consist of a very slight depression in which it is assumed water will flow via sheet flow when available. That is, these systems do not exhibit a defined channel and floodplains are non-existent. Within the Study Area, these systems have often been altered through agricultural activities and contouring.

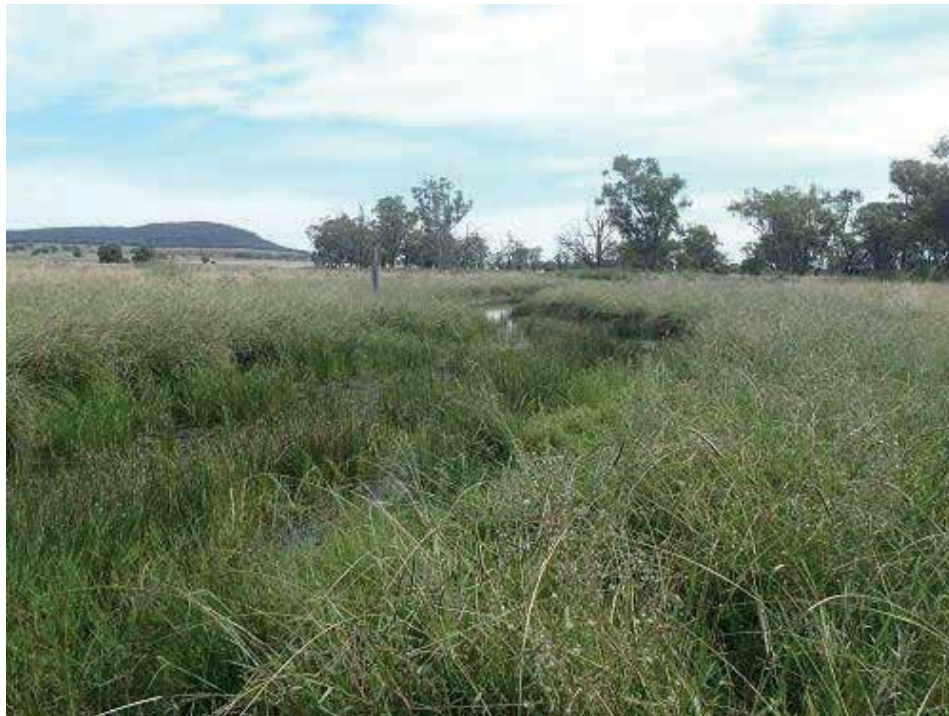
The Low sinuosity, fine grained systems identified in the Study Area include the Mooki River and the lower reaches of Watermark Gully (Figure 3-4) and Native Dog Gully.

**Figure 3-4 Downstream View of a Low Sinuosity Fine Grained Section of Watermark Gully**

This waterway type exhibits a low sinuosity channel with wide, continuous floodplains and relatively stable, cohesive banks due to the fine-grained material. The channel generally holds water in isolated pools between flows. The channel itself is of low gradient and low energy such that sediment transported is predominantly limited to fine grained silts and clays in suspension. The low capacity channel allows overbank flows to be readily dissipated across the floodplain surfaces, activating flood channels and depositing fine grained sediments on the floodplain

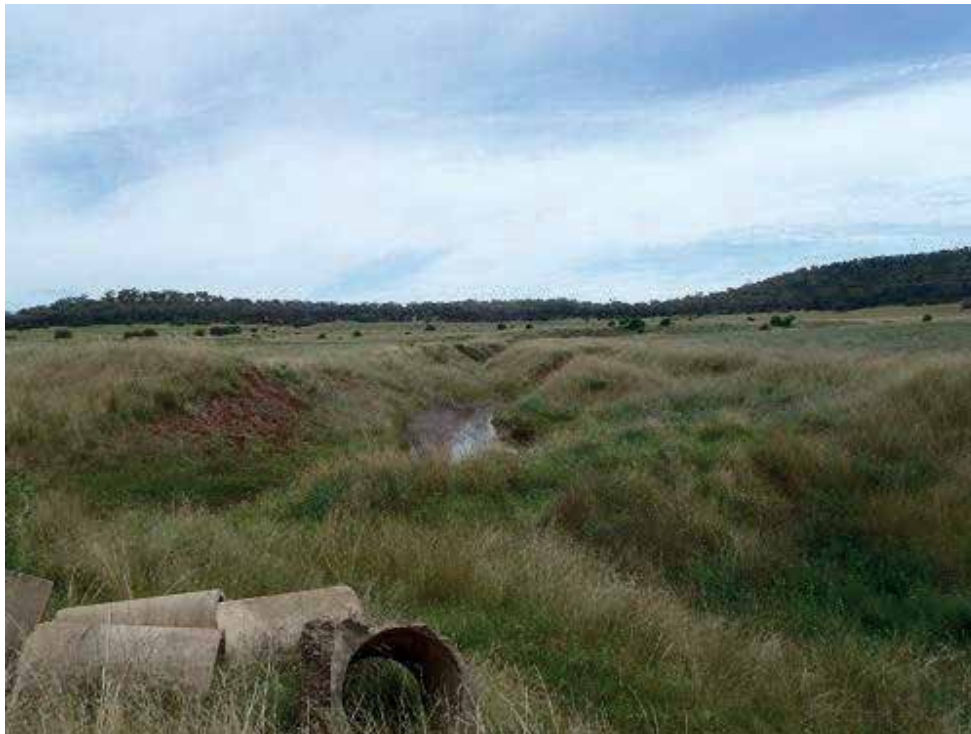
The channelised fill systems identified on the Study Area are located in the upper to middle reaches of Watermark Gully including some associated unnamed tributaries (Figure 3-5) and the upper extent of Native Dog Gully.

**Figure 3-5 Upstream View of a Channelised Fill Section of an Unnamed Western Tributary of Watermark Gully**

Channelised Fill is, in relative terms, a laterally stable channel of low sinuosity incised within flat and featureless floodplains. Headcuts, which are usually the cause of the channeling, can progress upstream as a result of disturbances and unprotected banks will erode during times of higher flow. Most channels have incised to a point where all flows are contained within the channel such that the former fill surfaces are rarely inundated.

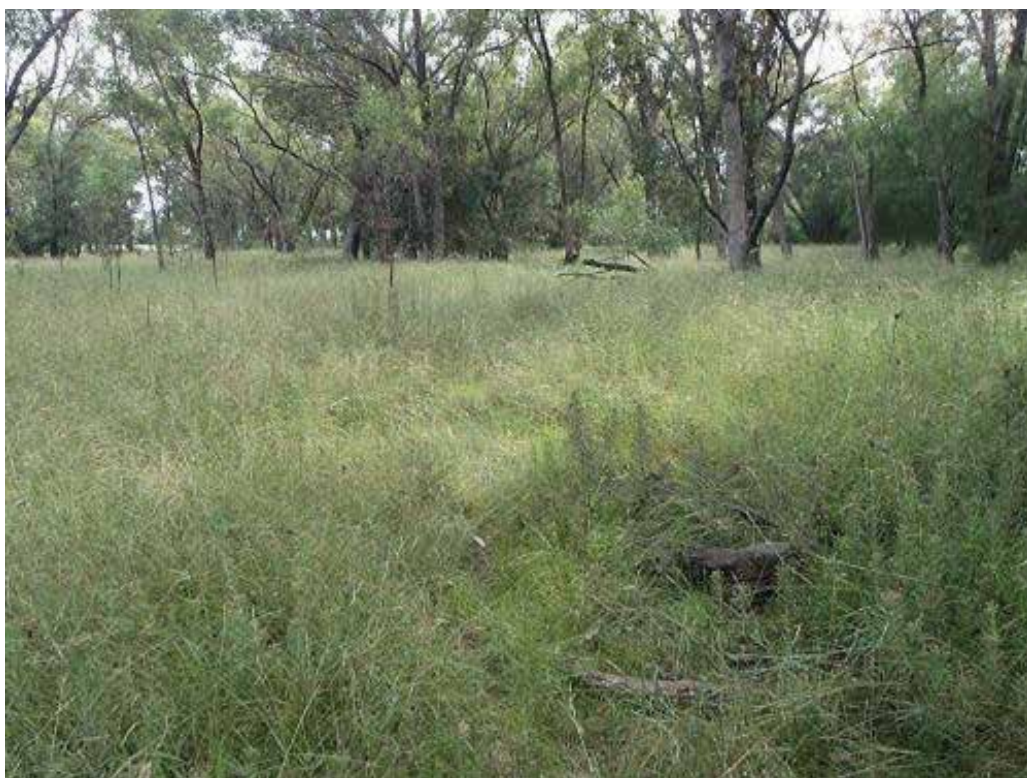
The valley fill systems identified in the Study Area are located in sections of Watermark Gully (Figure 3-6) including some associated unnamed tributaries and some small unnamed tributaries of Native Dog Gully and the Mooki River.

**Figure 3-6 Downstream View of a Valley Fill Section of Watermark Gully**

These systems are characterised by a relatively flat, featureless valley floor surface that lacks a continuous, well-defined channel. Substrates comprised of alluvial fine silts and muds vertically deposited out of suspension as flow velocity and competence is lost. Material eroded from the catchment is not transported through the reach resulting in the long-term deposition and storage of sediment. Hence, these stream types act as long term sediment accumulation zones. Degradation of these systems generally occurs through incisional processes such that a continuous channel forms within the valley floor sediments. Once incised, recovery back to an intact valley system is limited.

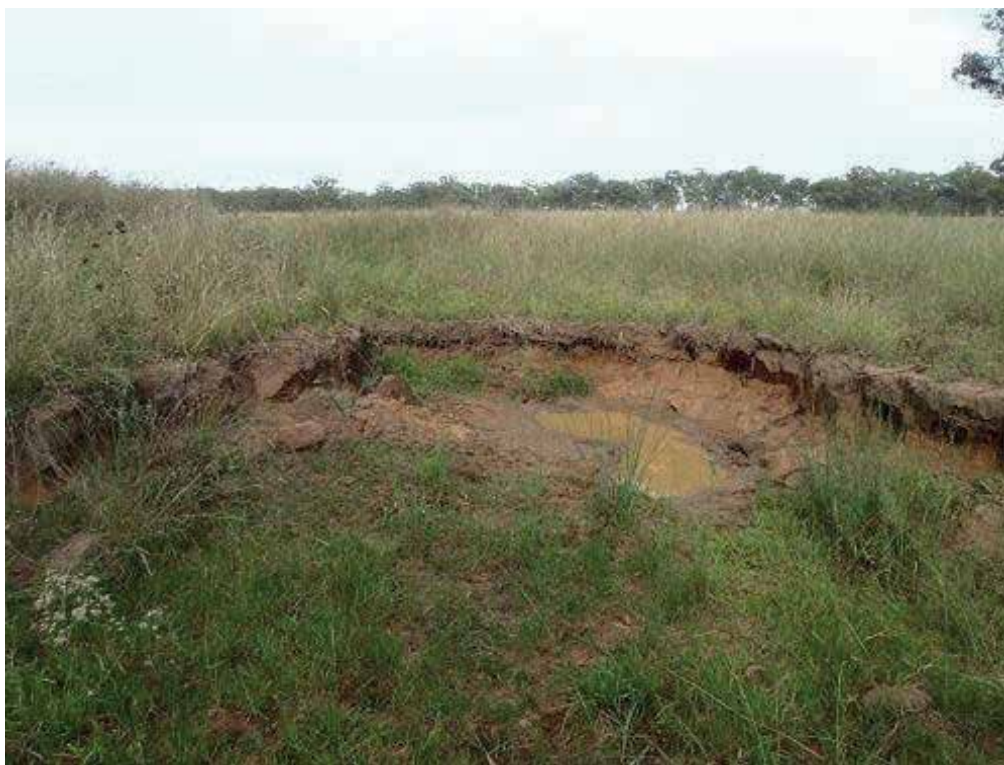
Watermark Gully displays numerous earthen dams and small constructed levees along its length. Headcuts (Figure 3-8) and evidence of past incision and/or artificial channelling were also observed in some reaches. As a result, this waterway is largely considered to be in moderate geomorphic condition. The poor condition reaches generally exhibit active headcutting, ongoing localised bank erosion and degraded riparian vegetation conditions. The downstream extent of Watermark Gully is in good geomorphic condition with no identified instabilities or erosion and the limited presence of agricultural modifications such as dams and levees.

**Figure 3-8 Upstream View of a Headcut on Watermark Gully**

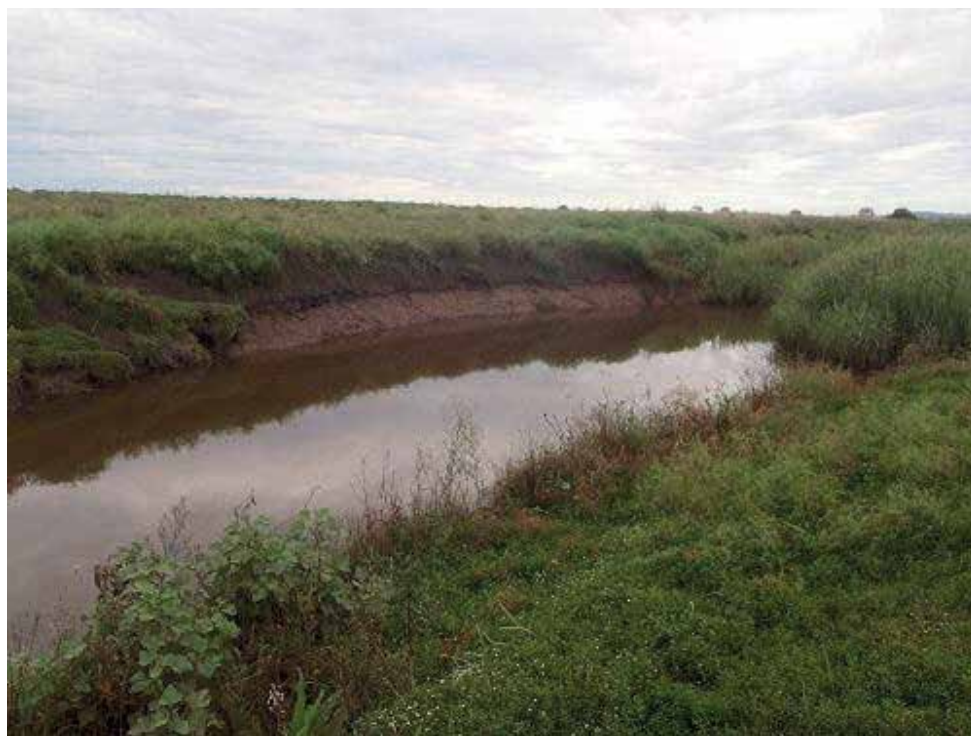
The downstream extent of Native Dog Gully exhibits locations of ongoing bank failure through undercutting and slumping (Figure 3-9). There are also several small weirs constructed of loose rock along this length and riparian vegetation associations are largely limited to pasture grasses. As a result, this reach is considered to be in poor geomorphic condition.

**Figure 3-9 Evidence of Bank Failure is Common Along the Lower Reach of Native Dog Gully**

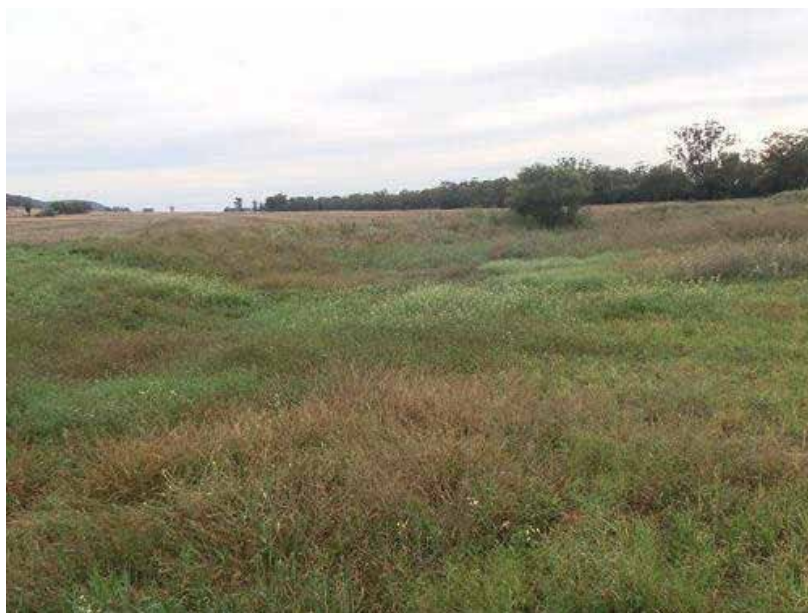
This section of Watermark Gully is a channelised fill in moderate condition. As a result, it displays a grassed channel with minimal instream form (Figure 4-1) and exhibits past modifications including flow diversion bunds and an instream dam. Construction of a diversion channel for this section of Watermark Gully therefore is not considered to be inappropriate due to the relatively noncomplex and modified form and functioning of the existing waterway. With construction of a diversion, the impact of encroachment of the Western Mining Area on geomorphic functioning is considered low.

**Figure 4-1 Downstream View of the Section of Watermark Gully that may Require Diversion as Result of Encroachment of the Western Mining Area**

- ▶ An appropriately designed channel diversion should be provided for the section of Watermark Gully subject to encroachment by the Western Mining Area.

On exiting the encroached section, the modelling indicates an increase in the gradient of flow surface profiles and flow velocities. This may result in erosion of the waterway at this point. Further, the encroachment may impede low flows from passing downstream entirely. Hence, it is likely that diversion of this section of Watermark Gully will be required so that flows are not impeded nor concentrated such that flow energies exceed erosion thresholds.

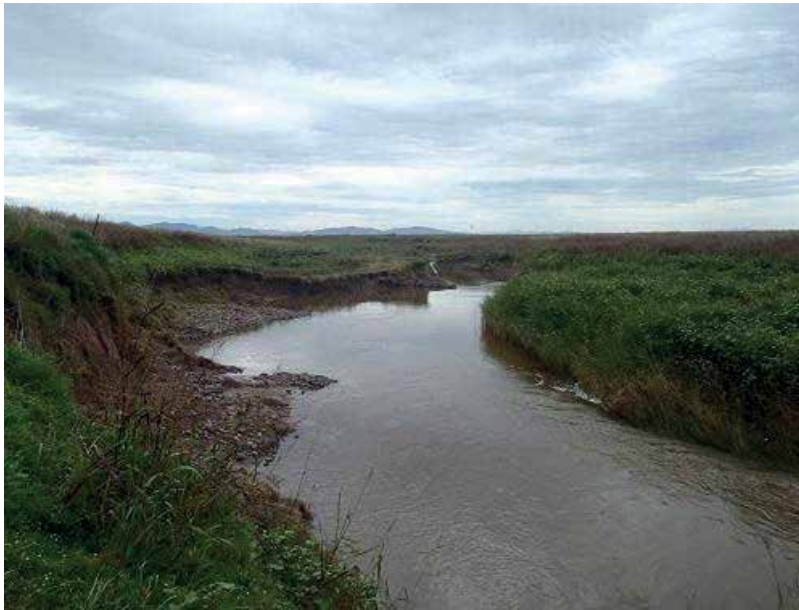
The proposed pump station on the Mooki River (shown in Figure 1-2) is located on the outside bank of a bend and exhibits active erosion (Figure 4-2). The bank is approximately six metres high and composed of alluvial silt materials. Without appropriate bank stabilisation measures, construction of the pump station may exacerbate the existing erosion issues at this location, as well as place the pump station at risk from channel erosion. In terms of exacerbating the existing erosion, the level of impact would be localised to the site without any significant change in stream form and functioning. However, given the risk to the proposed infrastructure from erosion, bank stabilisation measures will be required. With such mitigation, the impact of the pump station on channel stability and geomorphic processes is considered negligible.

**Figure 4-2 Downstream View of the Actively Eroding Bank of the Mooki River at the Location of the Proposed Pump Station**

- ▶ At the proposed pump station location on the Mooki River, appropriate bank protection measures should be implemented to address the existing erosion and to protect the pump station into the future.
