## **Site Audit Report**

**138 and 140 Campbell Hill Road,  
Chester Hill NSW 2162**

## **Final Report**

**Report Reference: 600218\_0301-2307**

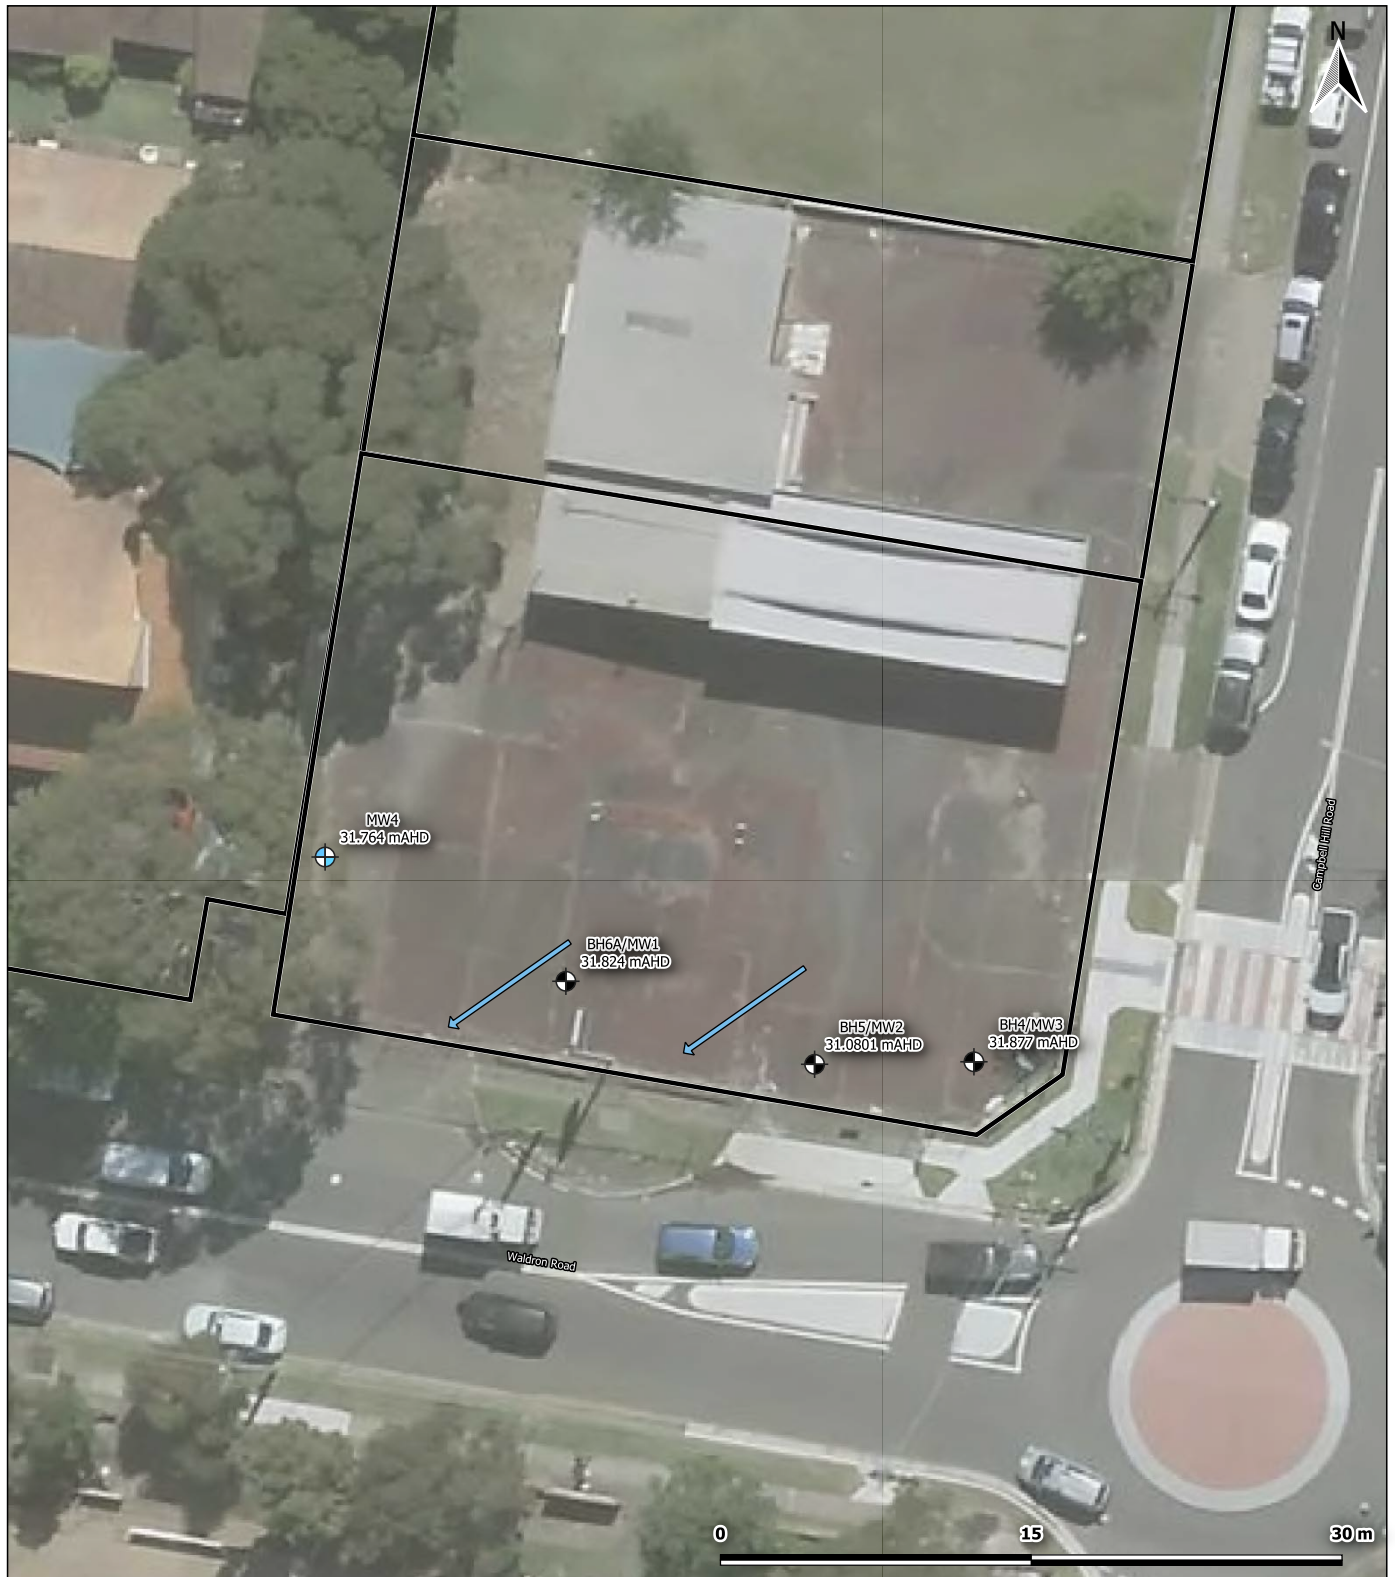
The consultant noted that due to the approximate linear arrangement of the wells at the site, and absence of triangulation, meaningful groundwater contours were not able to be produced. However, the groundwater flow direction was inferred to flow to the southwest, conforming with local topography.

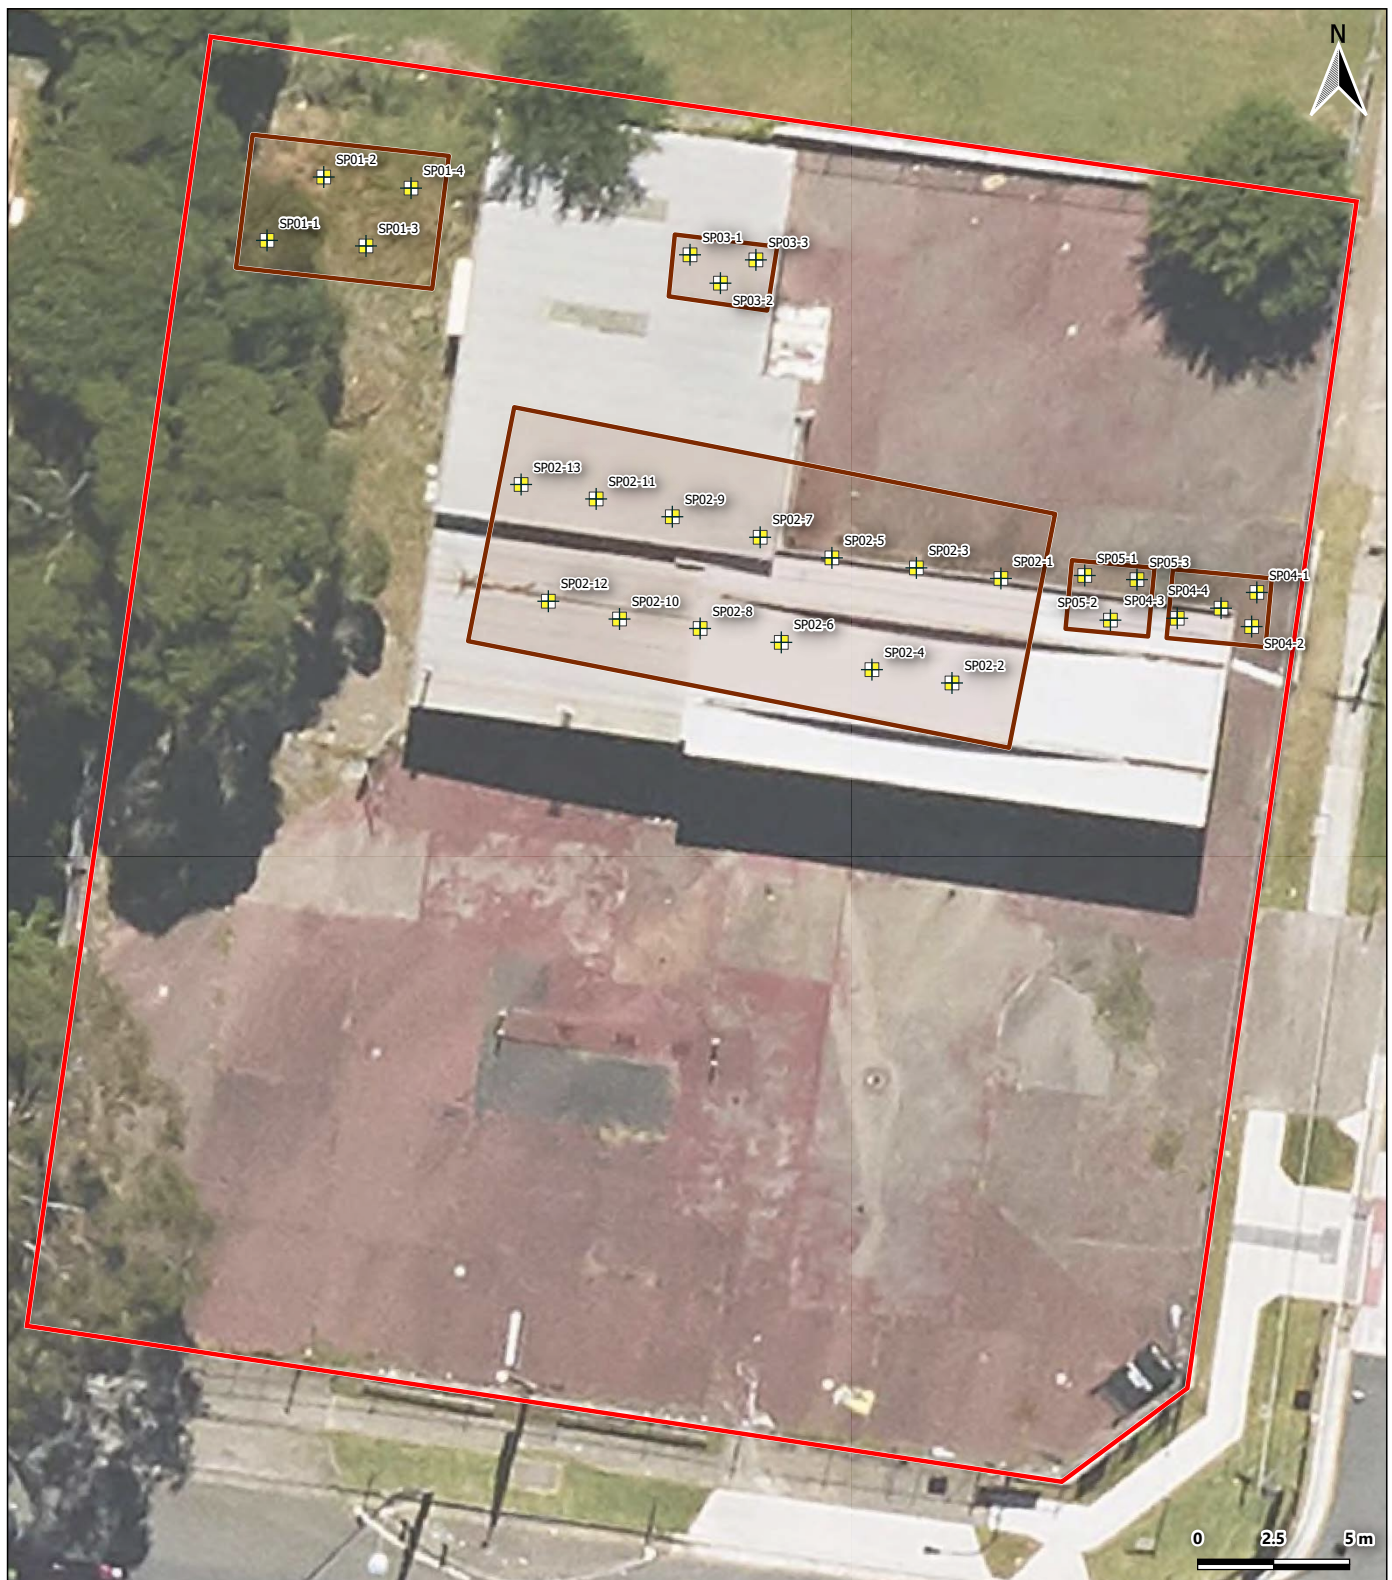
The soil sample analytical results for stockpile SP04 reported elevated TRH concentrations which exceeded the validation criteria in soil sample SP04-1 and SP04-2. Sample SP04-3 reported all analytical results below the validation criteria. It is noted that the total volume of stockpile SP04 was estimated to be approximately 5 m<sup>3</sup>, equivalent to approximately 10 tonnes (t). Given the soil analytical results, Reditus advised the contractor to remove the impacted soils unsuitable for reuse on-site to the cleanest sample location, being SP04-3. This resulted in a total of 5.9 t (or 2.95 m<sup>3</sup>) being disposed off-site, and equivalent to almost two-thirds of the total volume of the stockpile. Given the over excavation of the TRH impacted soils in stockpile SP04, Reditus are satisfied that the soil which was retained on-site (approximate 4.1 t or 2.05 m<sup>3</sup>) was suitable for on-site reuse. It is also noted that the additional material generated during the excavation and validation of sample location V50a-0.6 was added to SP04 and included in the material disposed off-site.
