**STAGE 1 AND PRELIMINARY STAGE 2  
ENVIRONMENTAL SITE ASSESSMENT**

**PROPOSED AIN BUILDING**

**UNIVERSITY OF SYDNEY, CAMPERDOWN, NSW**

**REF: E24782Krpt**

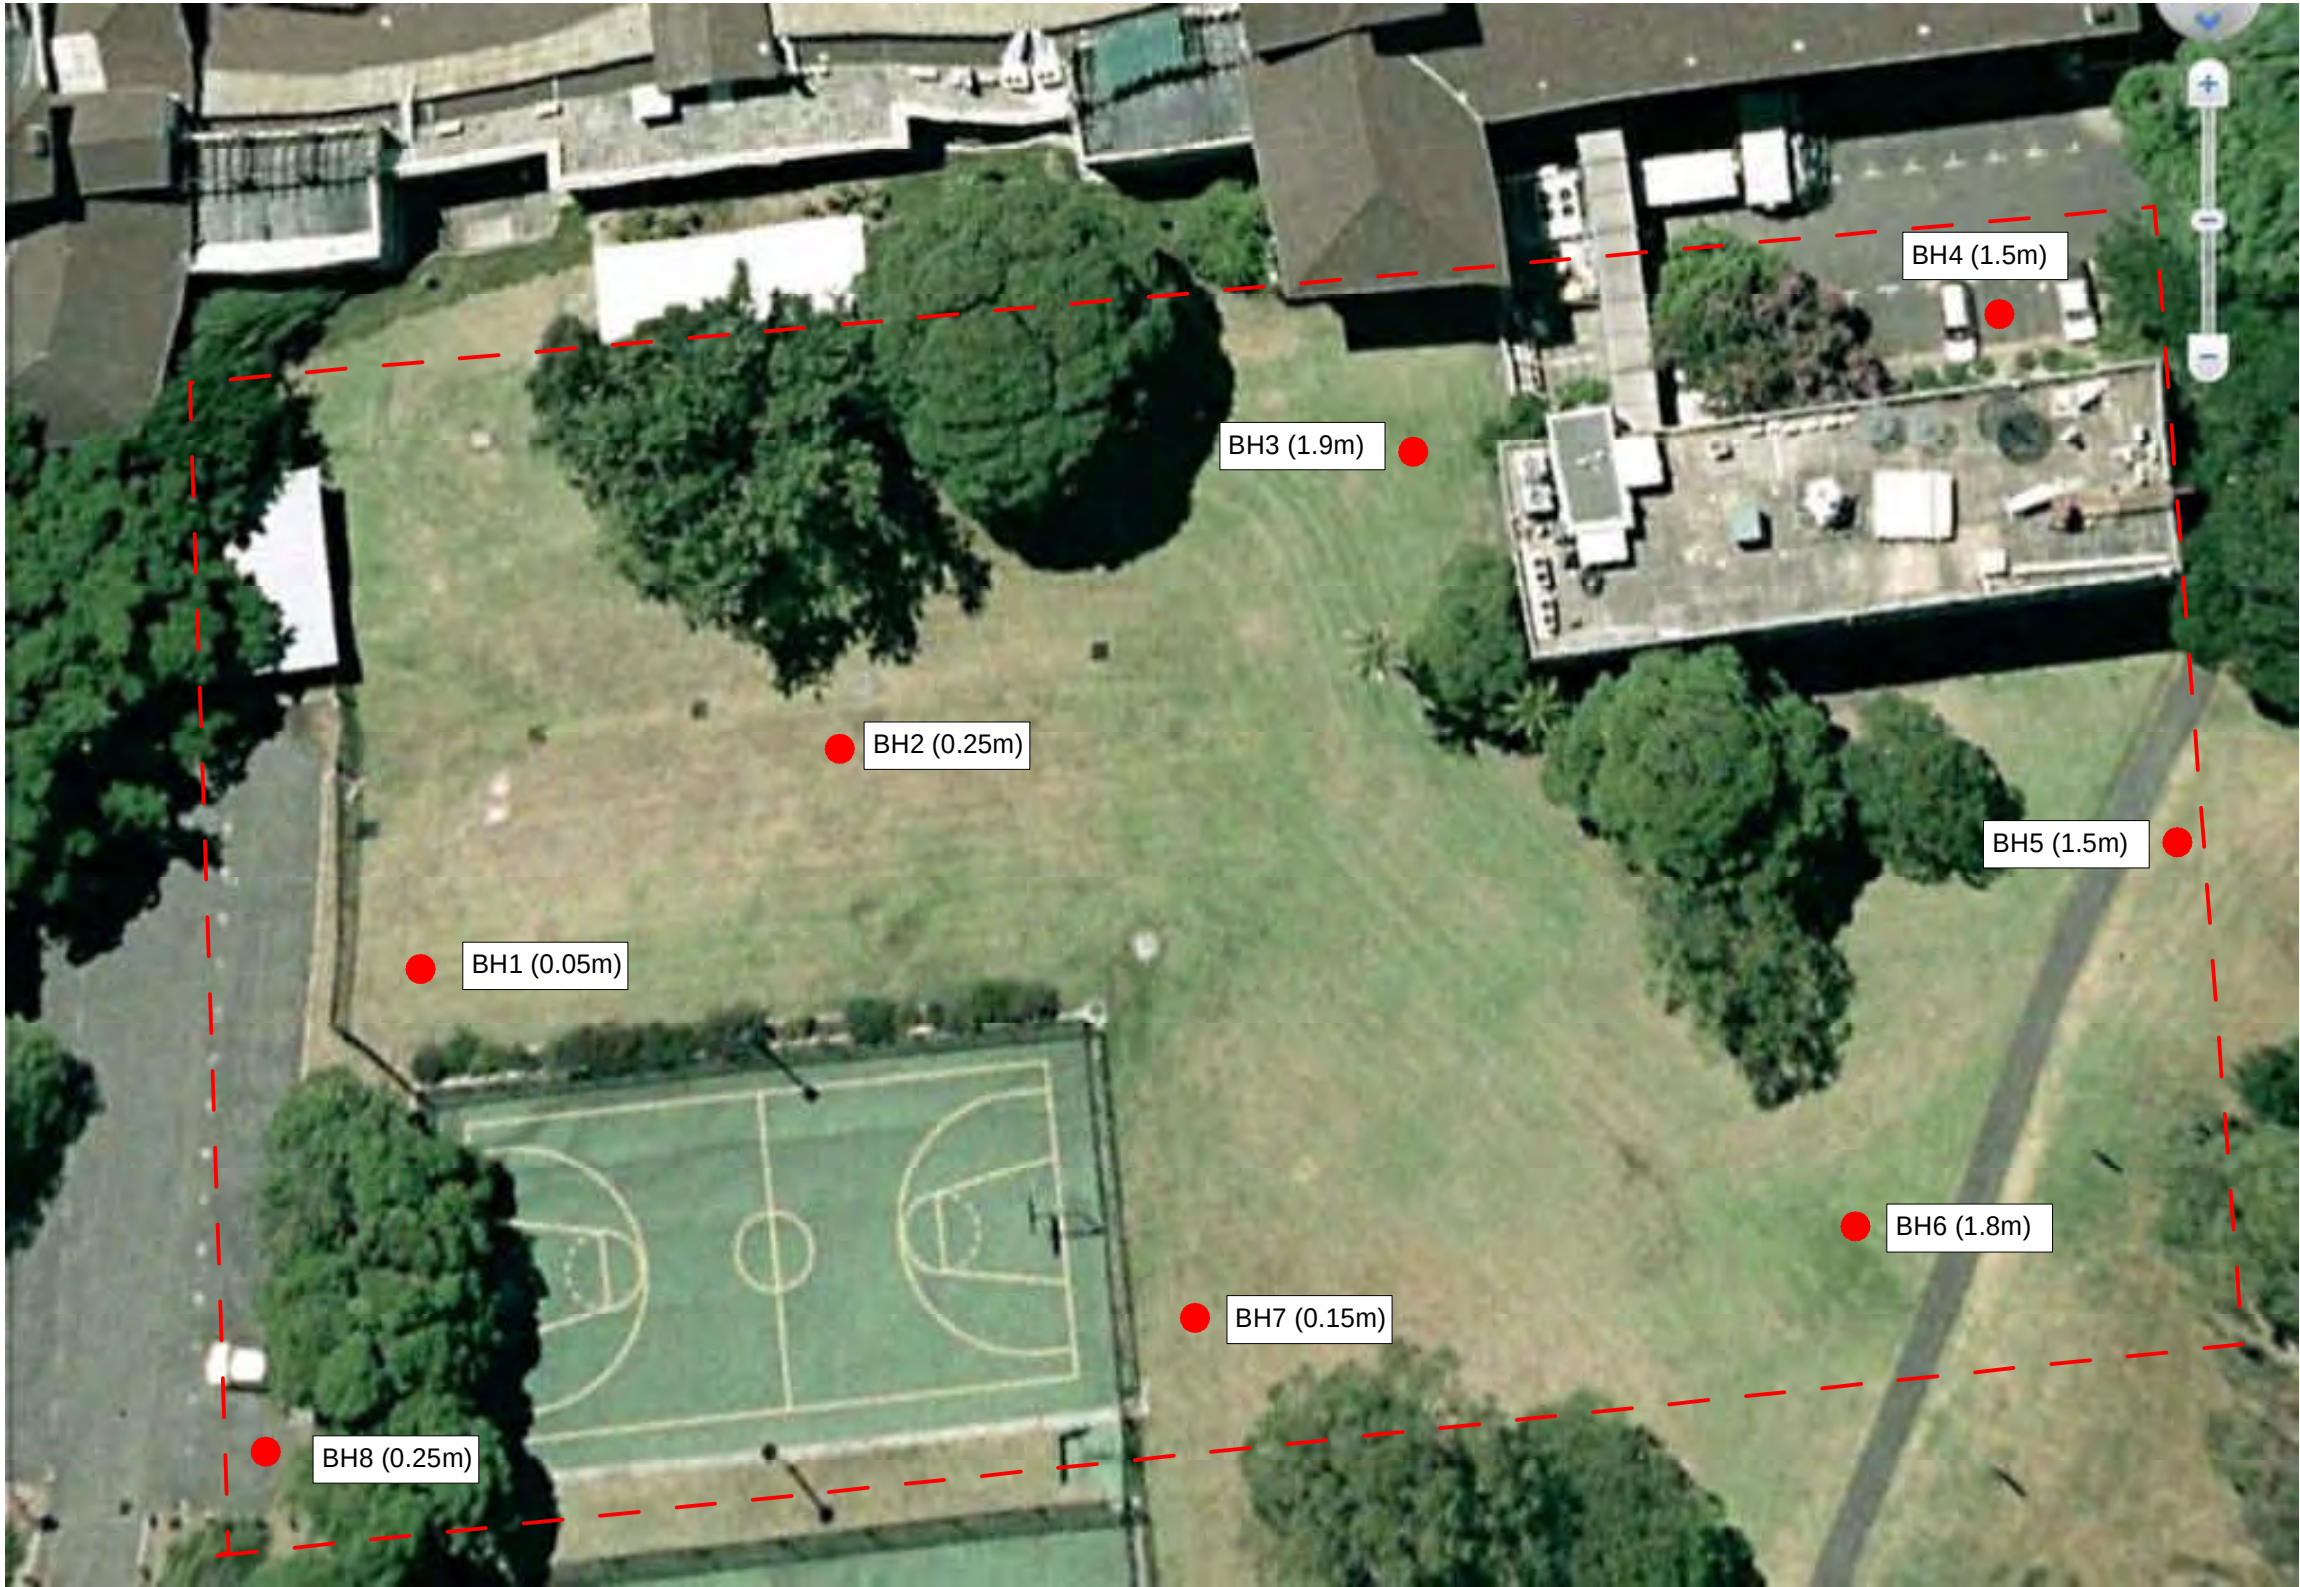
NOTES:  
Figure 2 has been recreated from Google Earth

The borehole locations presented on this plan have been established from site measurements only and should not be construed as survey points.

Borehole locations are shown on Figure 2. For details of the subsurface soil profile reference should be made to the borehole logs in Appendix A. A summary of the subsurface conditions encountered in the boreholes is presented below:
