**GEOTECHNICAL INVESTIGATION – WALLGROVE BUSINESS HUB, 97-123 & 125-151 WALLGROVE ROAD, CECIL PARK NSW 2178**

Prepared for Western Sydney Parklands Trust

Prepared for	Western Sydney Parklands Trust
Job Title	GEOTECHNICAL INVESTIGATION – Wallgrove Business Hub, 97-123 & 125-151 Wallgrove Road, Cecil Park NSW
Job Reference	10791E-P-710
File Reference	10791E-P-710-A
Quote Reference	10791E-Q-1057-P1_Rev1
Date	6 September 2023
Revision Number	00

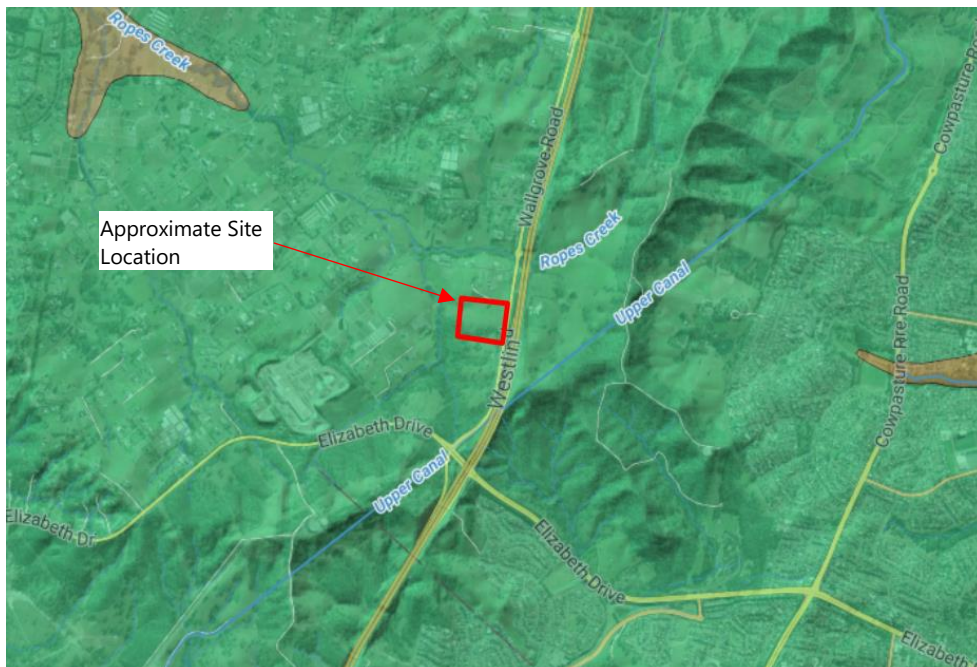
Figure 2 Surface Geology. Source: MINVIEW

The MINVIEW online geological mapping database indicates that the investigation area is underlain primarily by Bringelly Shale, a subgroup of the Wianamatta Group. Bringelly Shale was deposited in the Middle Triassic era and comprises shale, claystone, laminate, sandstone and rare coal. Site locality overlain on geological mapping (Minview, 2023) is shown below in Figure 2. No other geological formation is known to be within an applicable distance to the site.

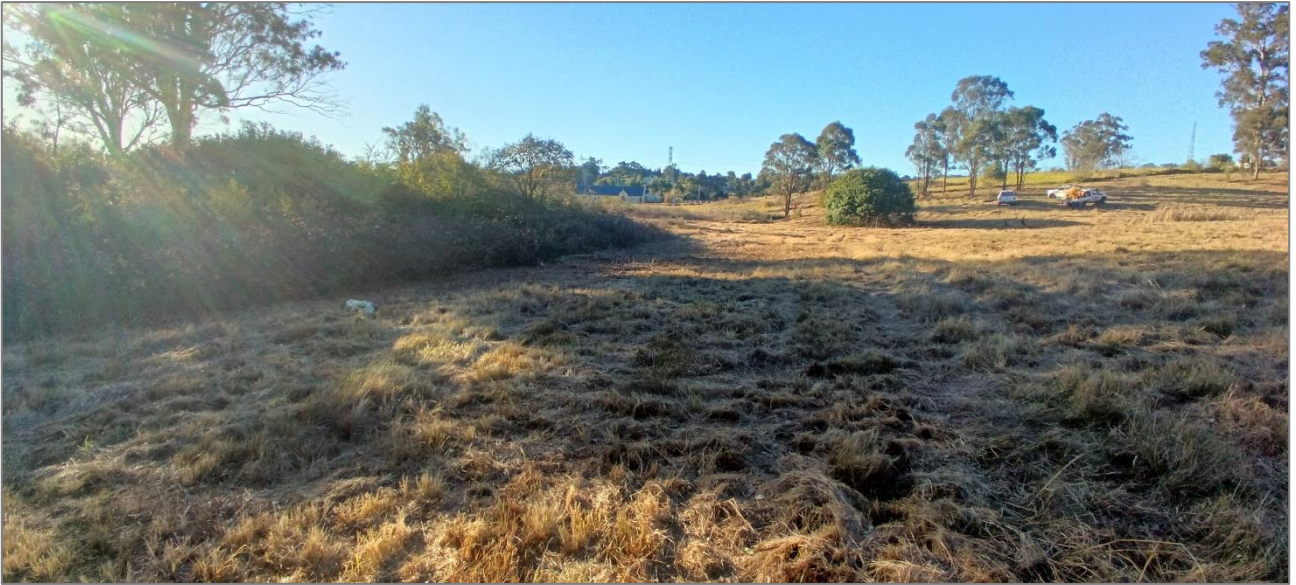
Figure 3: Zone 2, far north-western and western portion of the site, low level alluvial soils. Image looking north.

- Zone 2: Local Alluvial soils deposited by erosion of the surrounding hills, underlain by residual soils or bedrock. This zone is generally located at the western and north-eastern part of the site. Minor alluvium was logged in BH01 as a silty topsoil to a depth of 0.25m. BH03 and BH05 were drilled within the vicinity of Zone 2 but did not encounter alluvium. It is anticipated that alluvium in the lower parts of the site, represented by shallow marshy or boggy surface conditions which were not accessible by the drilling rigs. Refer figure 3.

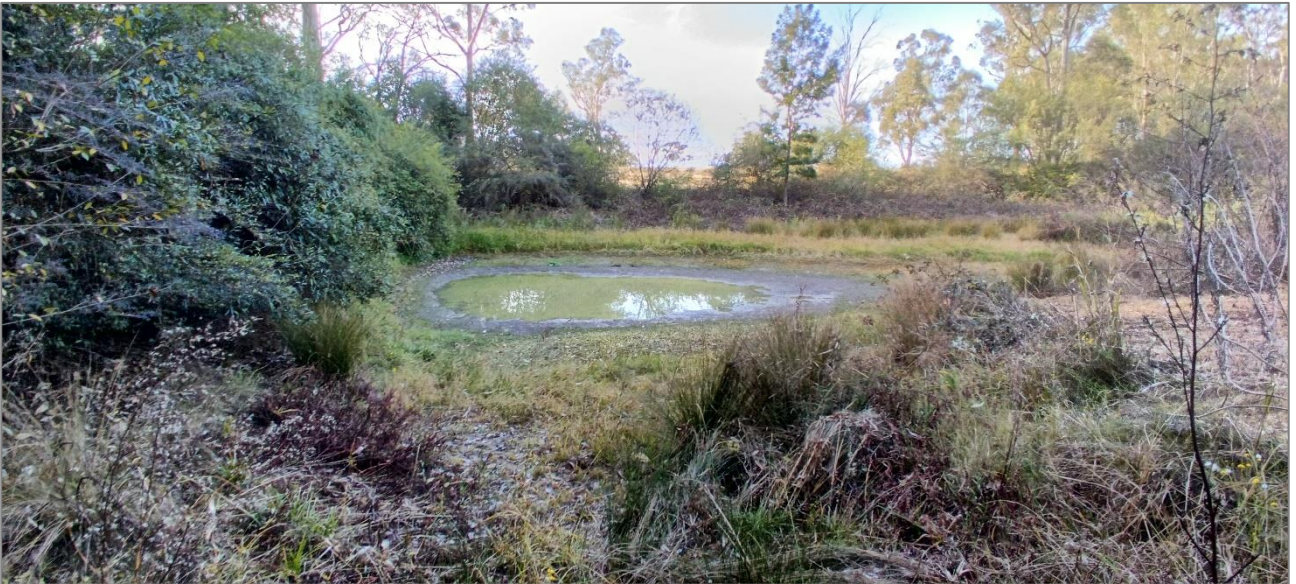
Figure 4: Zone 5, farm pond / dam

- Zone 5: A semi-circular pond/dam located at the south-western portion of the proposed development, about 20m in diameter. Surface conditions were not accessible for drilling in this zone, however fill, local silty alluvium and topsoil are expected in this zone. Refer figure 4.

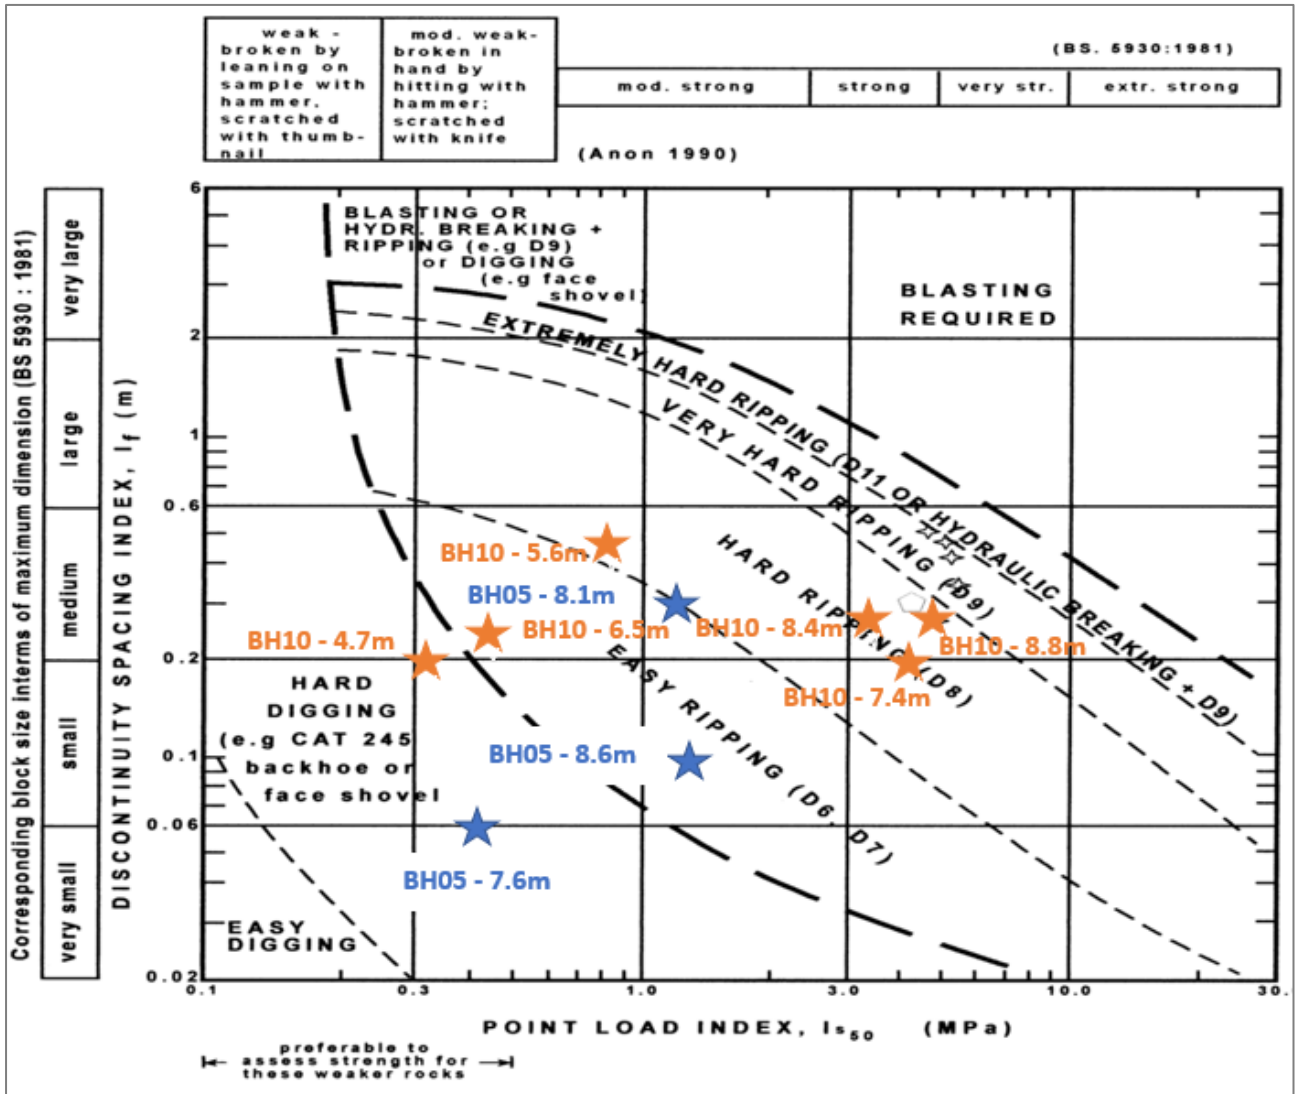
Figure 5: Excavatability of Rock using  $I_s(50)$  test results

The excavatability assessment is based on the Pettifer & Fookes chart (BS 5930:1981) using point load test results and borehole logs. Figure 5 reproduces the Pettifer & Fookes chart (BS 5930: 1981) for excavatability guidance of rock encountered in BH05 and BH10. The figure shows that the excavatability of the rock generally becomes more difficult with depth as strength and discontinuity spacing increases, it serves as guidance only as the rock conditions may vary considerably across the site. Excavation of the residual soil can be readily excavated using conventional earthmoving equipment. Deeper excavations that encounter extremely weathered material will require larger machinery and possibly prior ripping at depth with a tyne attachment. Excavation into bedrock if required would necessitate significant excavation equipment, such as a large excavator and rock-hammer attachment. It is the responsibility of the construction contractor to determine suitable sized machinery to ensure efficiency considering the nature of proposed construction and encountered subsurface conditions.

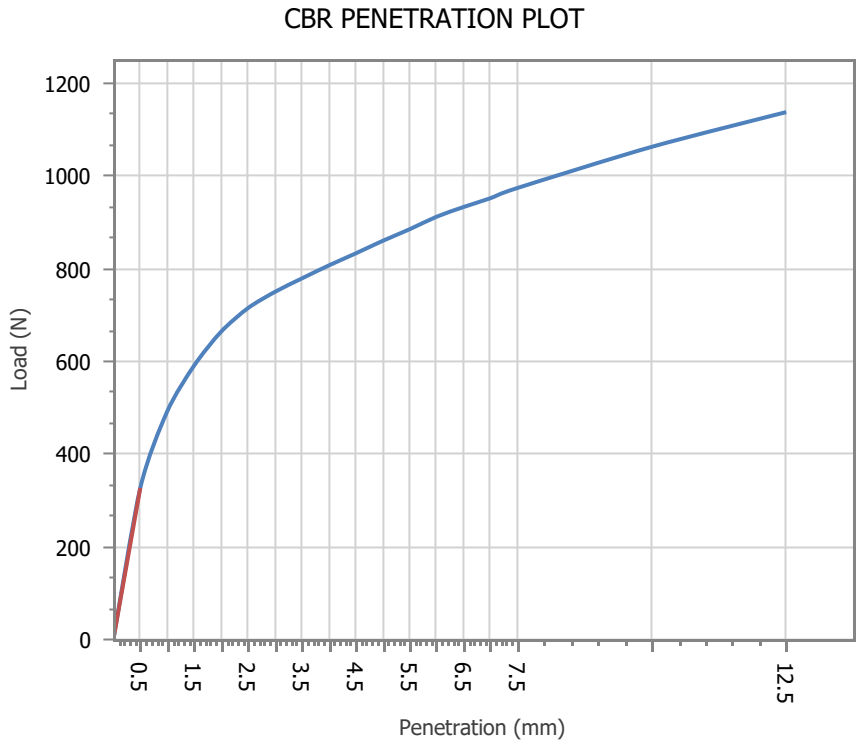
Material Description Clay

Maximum Dry Density (t/m <sup>3</sup> ):	1.56
Optimum Moisture Content (%):	24.5
Field Moisture Content (%):	26.4
Sample Percent Oversize (%):	0.0
Oversize Included / Excluded	Excluded
Target Density Ratio (%):	100
Target Moisture Ratio (%):	100
Placement Dry Density (t/m <sup>3</sup> ):	1.57
Placement Dry Density Ratio (%):	100.5
Placement Moisture Content (%):	24.6
Placement Moisture Ratio (%):	100.0
Test Condition / Soaking Period:	Soaked / 4 Days
CBR Surcharge (kg)	9.0
Dry Density After Soak (t/m <sup>3</sup> ):	1.56
Total Curing Time (hrs)	n/a
Liquid Limit Method	n/a
Moisture (top 30mm) After Soak (%)	27.5
Moisture (remainder) After Soak (%)	25.2
CBR Swell (%):	1.0
Minimum CBR Specification (%):	-
<b>CBR Value @ 2.5mm (%):</b>	<b>5</b>

Limited CBR testing has been carried out at this stage of investigation due to significant anticipated earthworks. Both CBR tests were carried on residual high plasticity clay found across the site identified as unit 2. Testing resulted in a CBR of 3% and 5% for samples recovered from BH01 (0.5-1.0m) and BH11 (0.5-1.0m), respectively. In view of the above, current site conditions would dictate that a low design CBR of 3% would need to be adopted, subject to additional CBR testing, for pavements founded on unit 2. Subgrade remediation would likely be necessary in the weak areas identified in Section 6.3. Remediation could include subgrade replacement using better quality crushed rock and possibly the use of a geogrid, otherwise lime stabilisation may be suitable if the pavement footprint geometry and exposed subgrade materials permit. In the instance where subgrade remediation is required, further geotechnical assessment would be required to determine appropriate remedial measures.

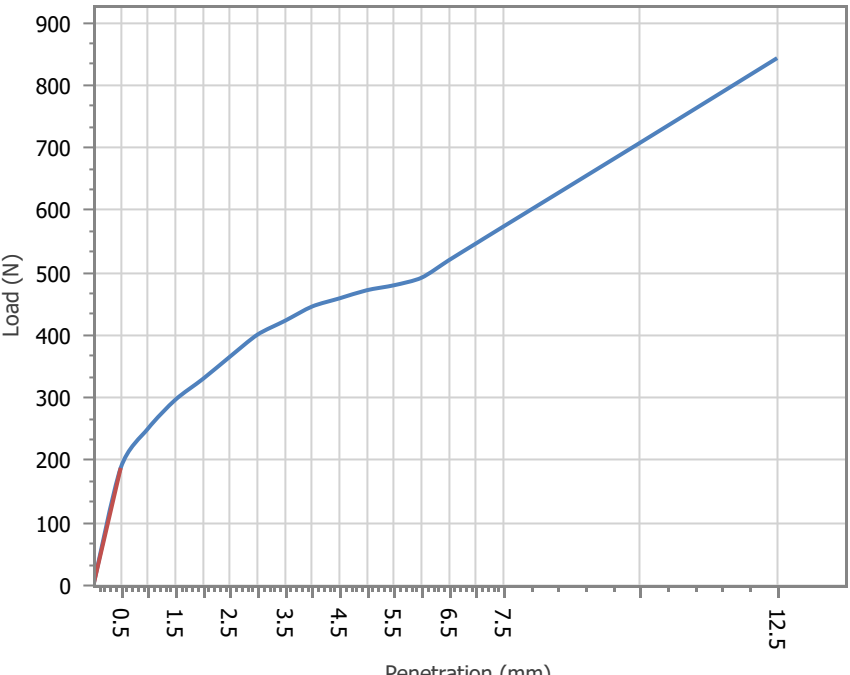
**Material Description** Brown Clay

<b>Maximum Dry Density (t/m<sup>3</sup>):</b> 1.64 <b>Optimum Moisture Content (%):</b> 19.0 <b>Field Moisture Content (%):</b> 18.0 <b>Sample Percent Oversize (%):</b> 0.0 <b>Oversize Included / Excluded</b> Excluded <b>Target Density Ratio (%):</b> 100 <b>Target Moisture Ratio (%):</b> 100 <b>Placement Dry Density (t/m<sup>3</sup>):</b> 1.65 <b>Placement Dry Density Ratio (%):</b> 100.0 <b>Placement Moisture Content (%):</b> 18.9 <b>Placement Moisture Ratio (%):</b> 100.5 <b>Test Condition / Soaking Period:</b> Soaked / 4 Days <b>CBR Surcharge (kg)</b> 9.0 <b>Dry Density After Soak (t/m<sup>3</sup>):</b> 1.60 <b>Total Curing Time (hrs)</b> 52 <b>Liquid Limit Method</b> Estimation <b>Moisture (top 30mm) After Soak (%):</b> 30.2 <b>Moisture (remainder) After Soak (%):</b> 21.2 <b>CBR Swell (%):</b> 3.0 <b>Minimum CBR Specification (%):</b> - <b>CBR Value @ 2.5mm (%):</b> 3.0	<h3>CBR PENETRATION PLOT</h3>
