WALLGROVE BUSINESS HUB, CECIL PARK VISUAL IMPACT ANALYSIS

REV 6 - JUNE 2025

The Visual Impact Assessment relates to the proposed development of 97-151 Wallgrove Road, Cecil Park. This comprises of two separate warehouses, including ancillary office spaces, internal driveway, hard stand areas, and associated earthworks and landscaping.

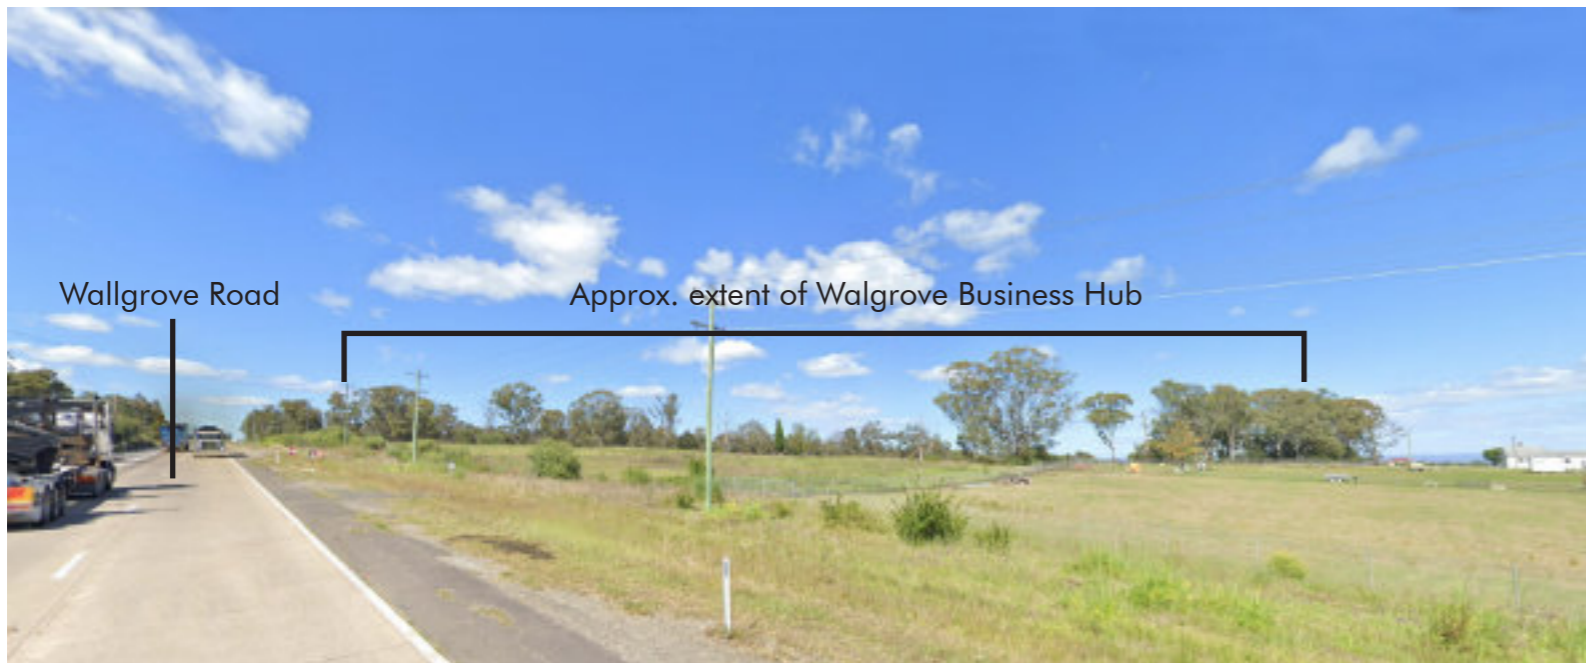
BASELINE PHOTO

Existing condition on the site with a grassed road embankment and existing vegetation within the site

Approx. Viewing Distance from Site Boundary	50m
View description & prominence of the development	View looking south-west from Wallgrove Road with direct line of sight to the site
Visual Sensitivity	The location of this view from the site is considered high due to its prominence in the elevated view across the proposed development.
Magnitude of Change	The change is considered moderate due to the minimal visual change in context with the other future industrial developments surrounding. Landscaping overtime will cause the most change.
Significance of Visual Impact	The significance of this view is considered high due to the proximity to Wallgrove Road with minimal surrounding developments.
Significance of Visual Cumulative Impact	The visual impact is considered acceptable due to the materiality of the landscaping overtime.

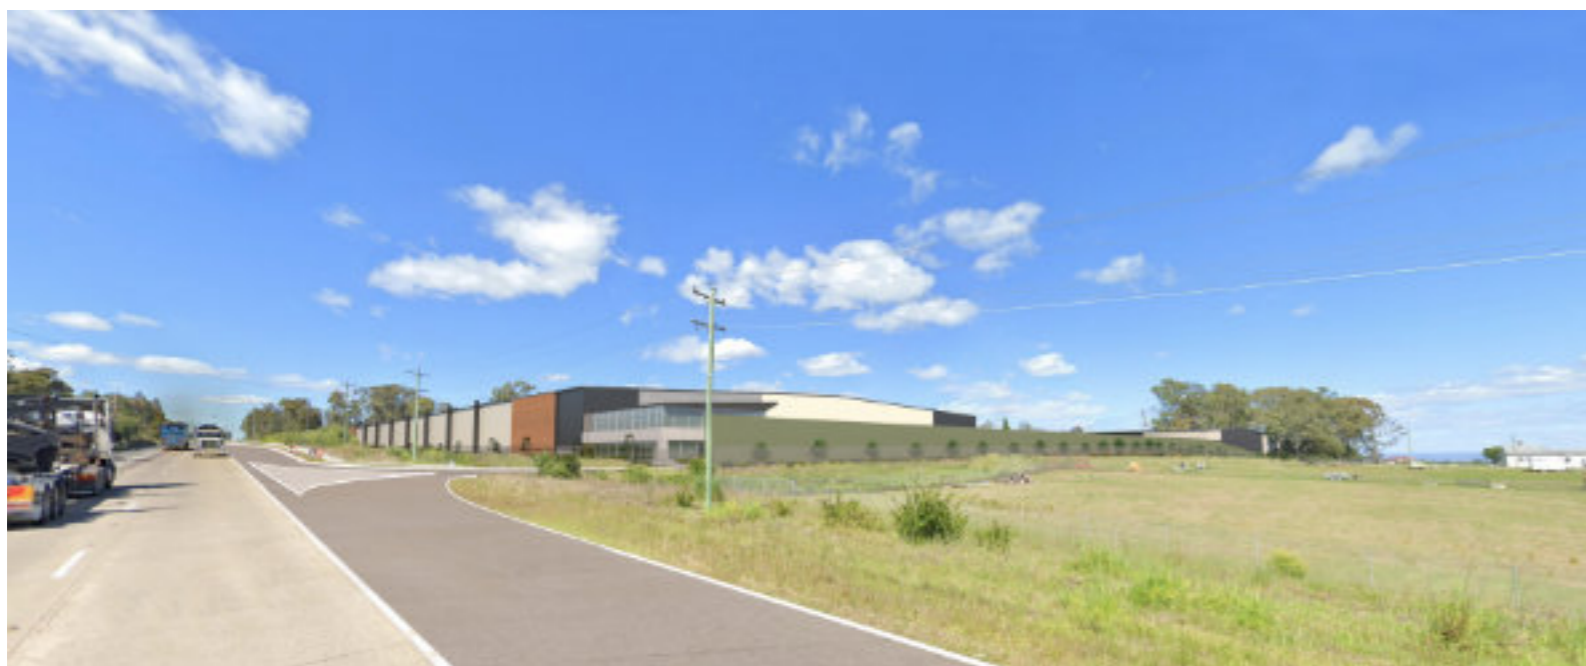
PHOTOMONTAGE - YEAR 0

The same view with the proposed development overlaid upon completion.

Muted landscape colour tones on the building form have been used to align with its surrounds and with the speed of visual interaction from the motorway

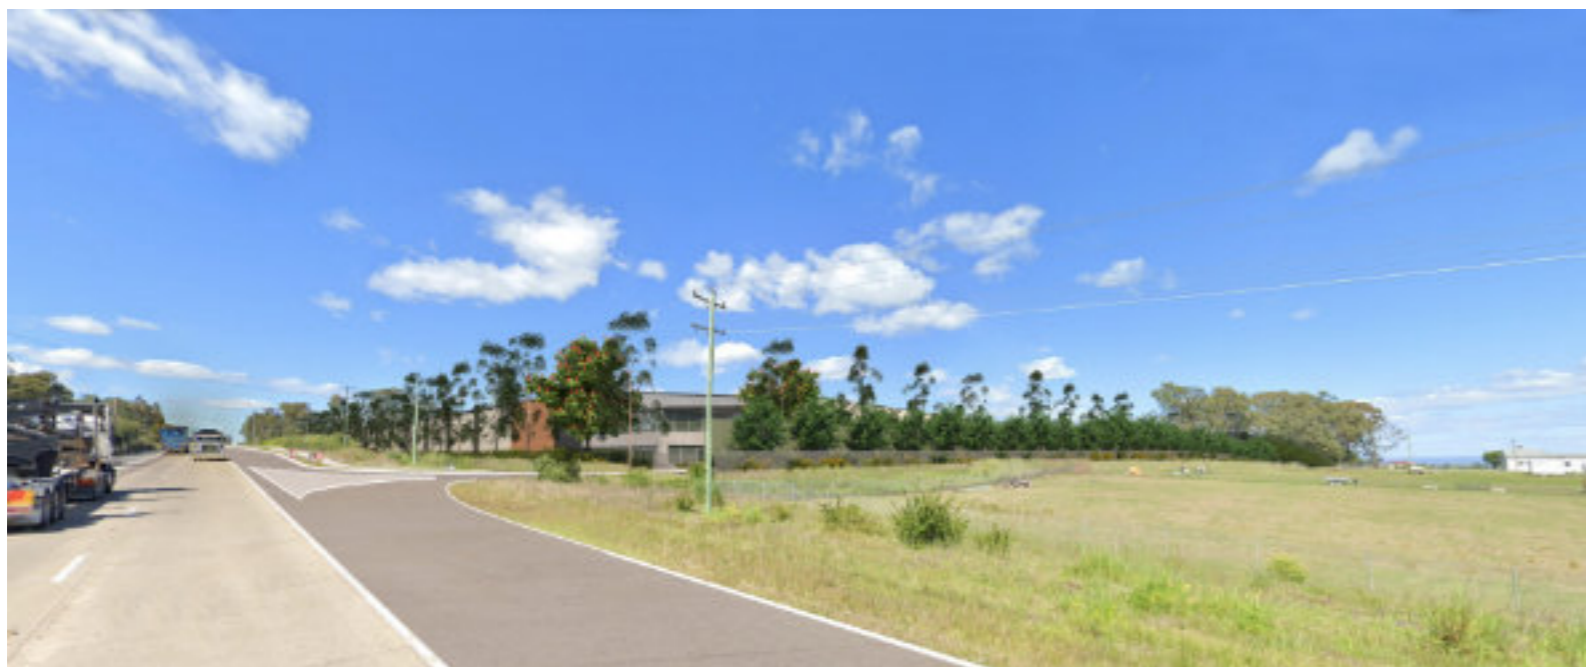
PHOTOMONTAGE - YEAR 10

The same view again in 10 years once the concept landscape treatment has matured. As you can see the trees at maturity and the tones of the warehouse combine to blend this interphase to its surroundings

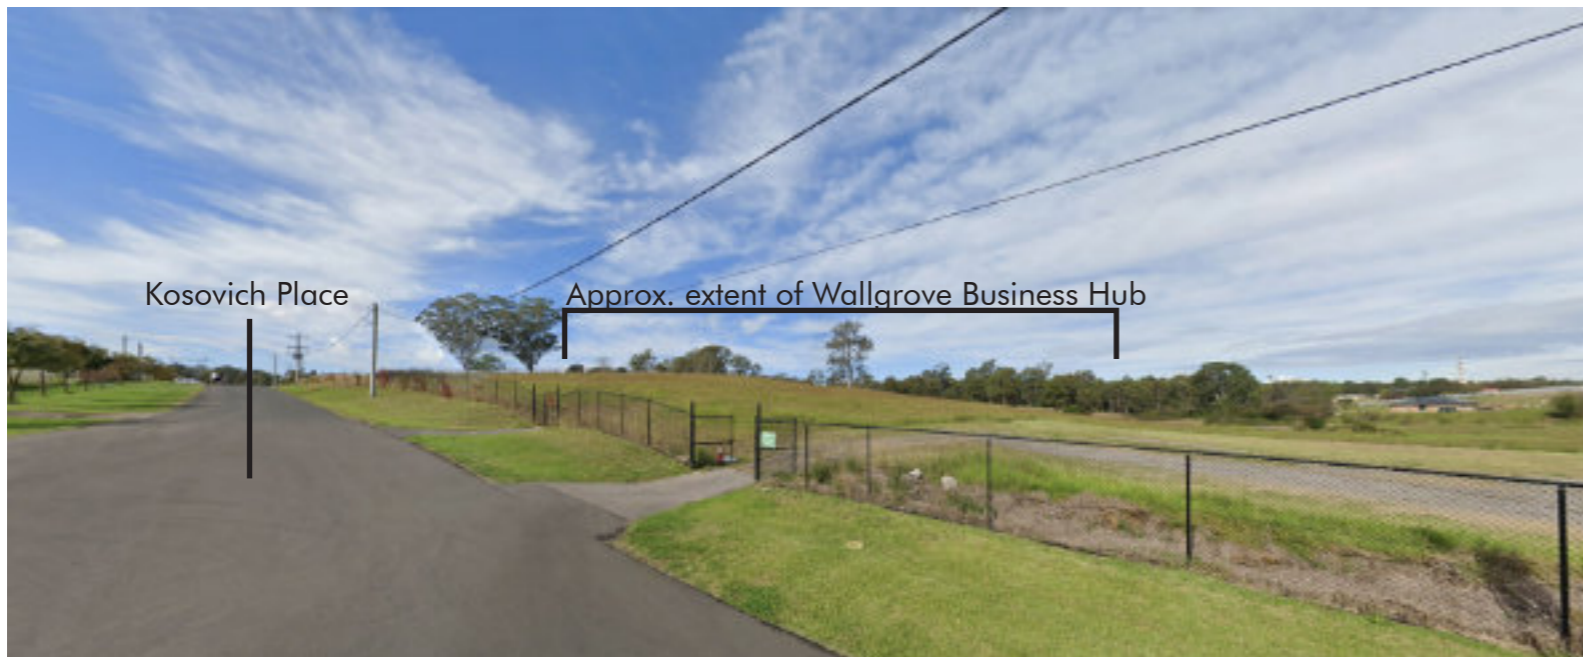
BASELINE PHOTO

Existing condition of the site

Approx. Viewing Distance from Site Boundary	200m
View description & prominence of the development	View from the end of Kosovich Place looking South into the site
Visual Sensitivity	The visual sensitivity is considered low due to the existing topography/landscape screening.
Magnitude of Change	The magnitude of the change is relatively small, initially the development is almost visible through the existing landscape. In time (10 years) the new landscape further screens this view.
Significance of Visual Impact	The significance of the view is low due to viewing elevation of this location and the existing landscape screening.
Significance of Visual Cumulative Impact	The visual impact is considered acceptable due to the elevation of this location, existing screening, new landscaping and building design, which will make the development slightly visible overtime.

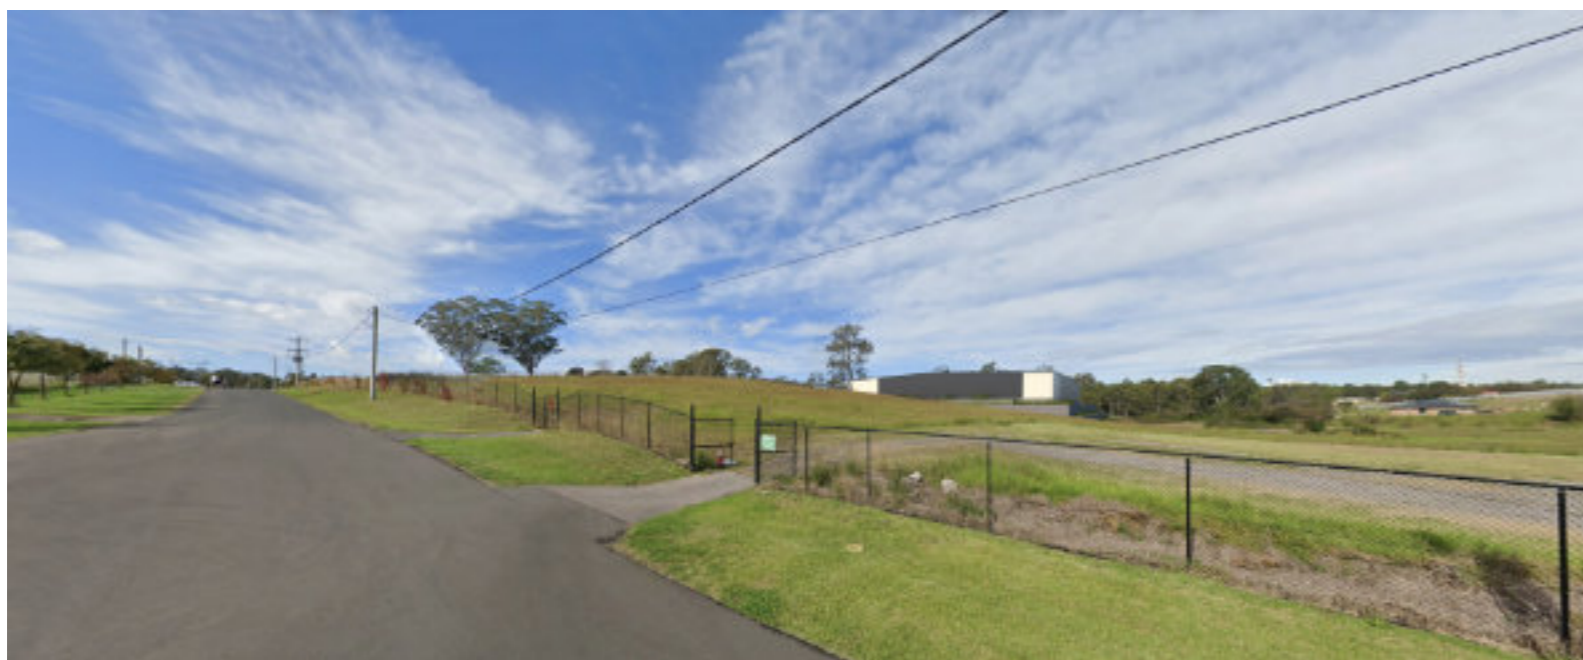
PHOTOMONTAGE - YEAR 0

Same view with the overlay of the development superimposed. Noting the minimal visual change due to the approximate viewing distance and also the typography interference with the associated elevation.

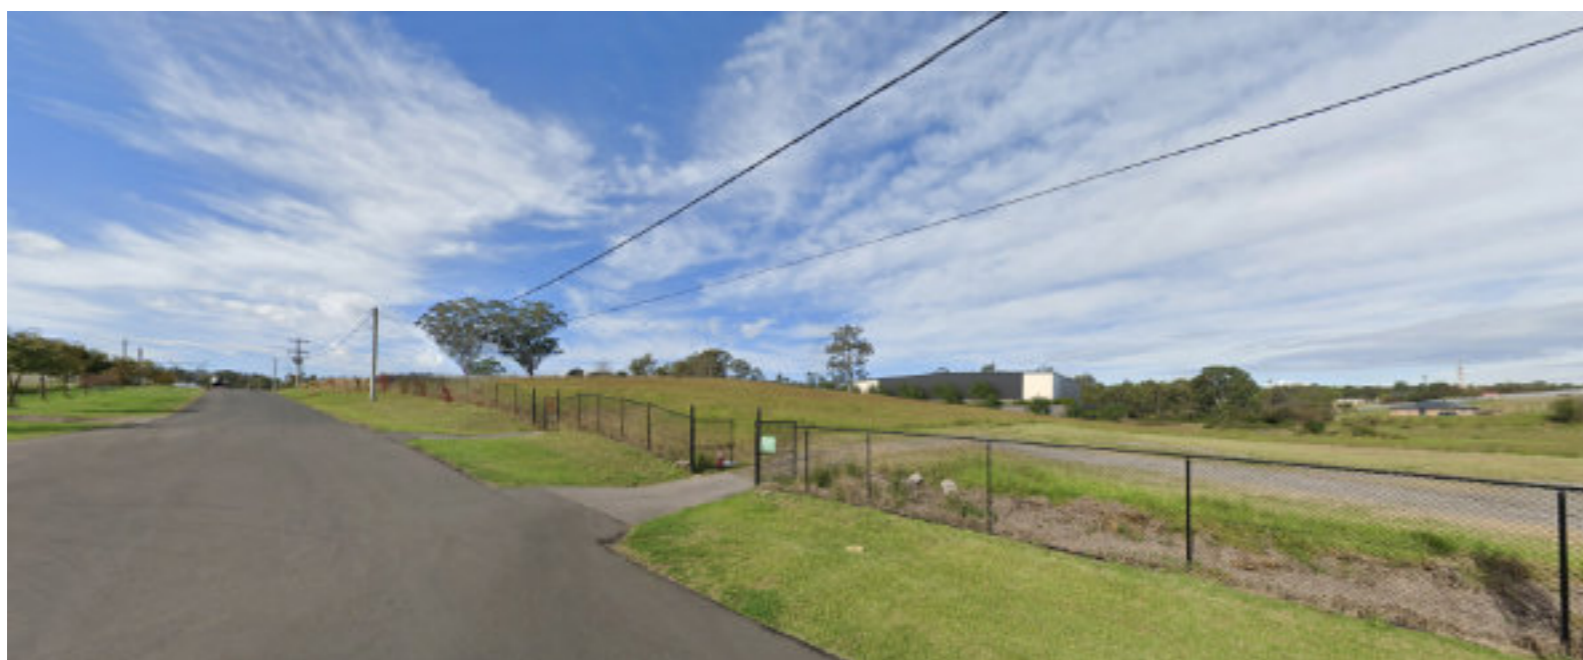
PHOTOMONTAGE - YEAR 10

The proposed view in 10 years with the concept landscape treatment maturing

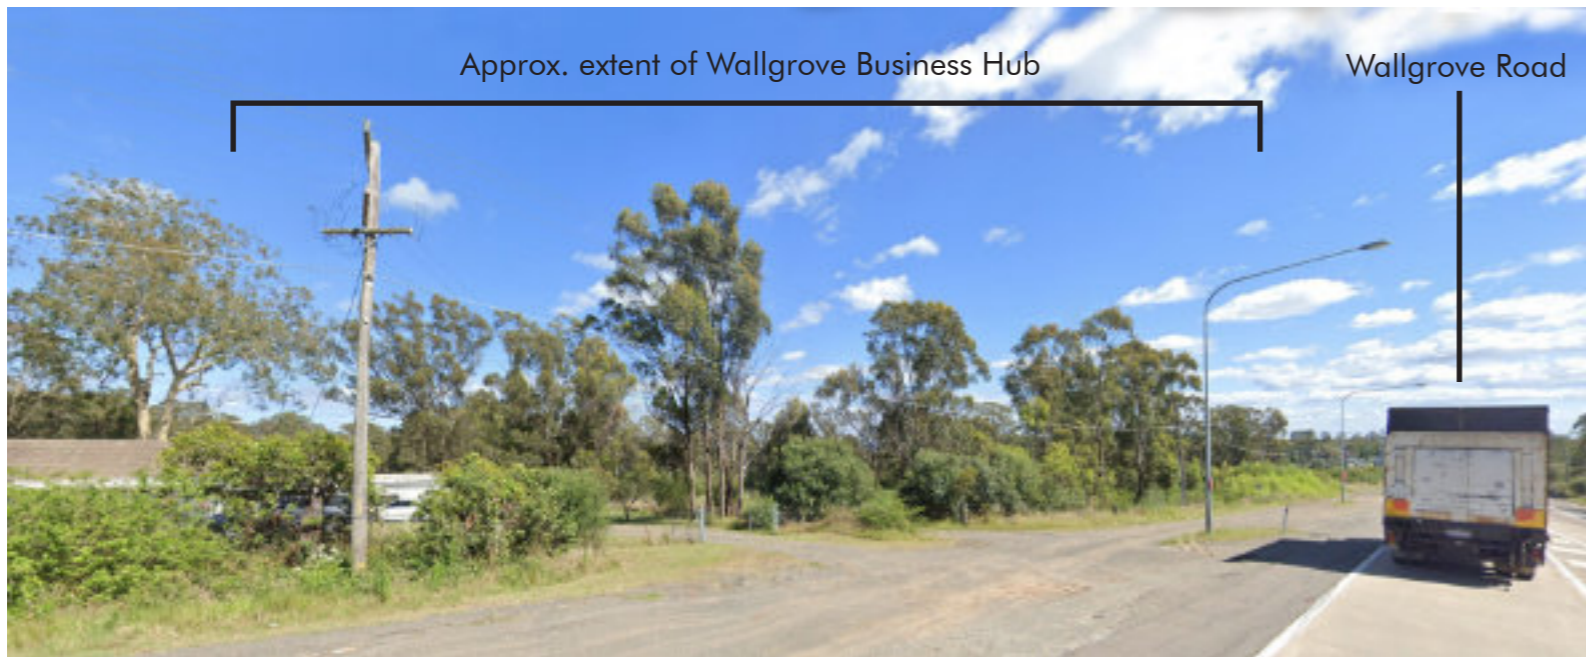
BASELINE PHOTO

Existing condition adjacent the Motorway

Approx. Viewing Distance from Site Boundary	50m
View description & prominence of the development	View from Wallgrove Road looking toward the site on the left-hand side.
Visual Sensitivity	The locality of this interphase being next to the road is High. The visual is a vehicle travelling at up to 80km/hr. Due to the minimal surrounding developments the built form stands out considerably.
Magnitude of Change	The change in visual appearance in the location is considered moderate. The buildings will be highly visible initially, however over time (10 years) the proposed landscaping will change this appearance and blend into the surroundings. They have been designed and orientated with neutral tones to blend into the surroundings. The orientation of the buildings has also been considered so as utilitarian areas of the building face away from this viewpoint.
Significance of Visual Impact	The significance of the impact is considered High due to the location on the road.

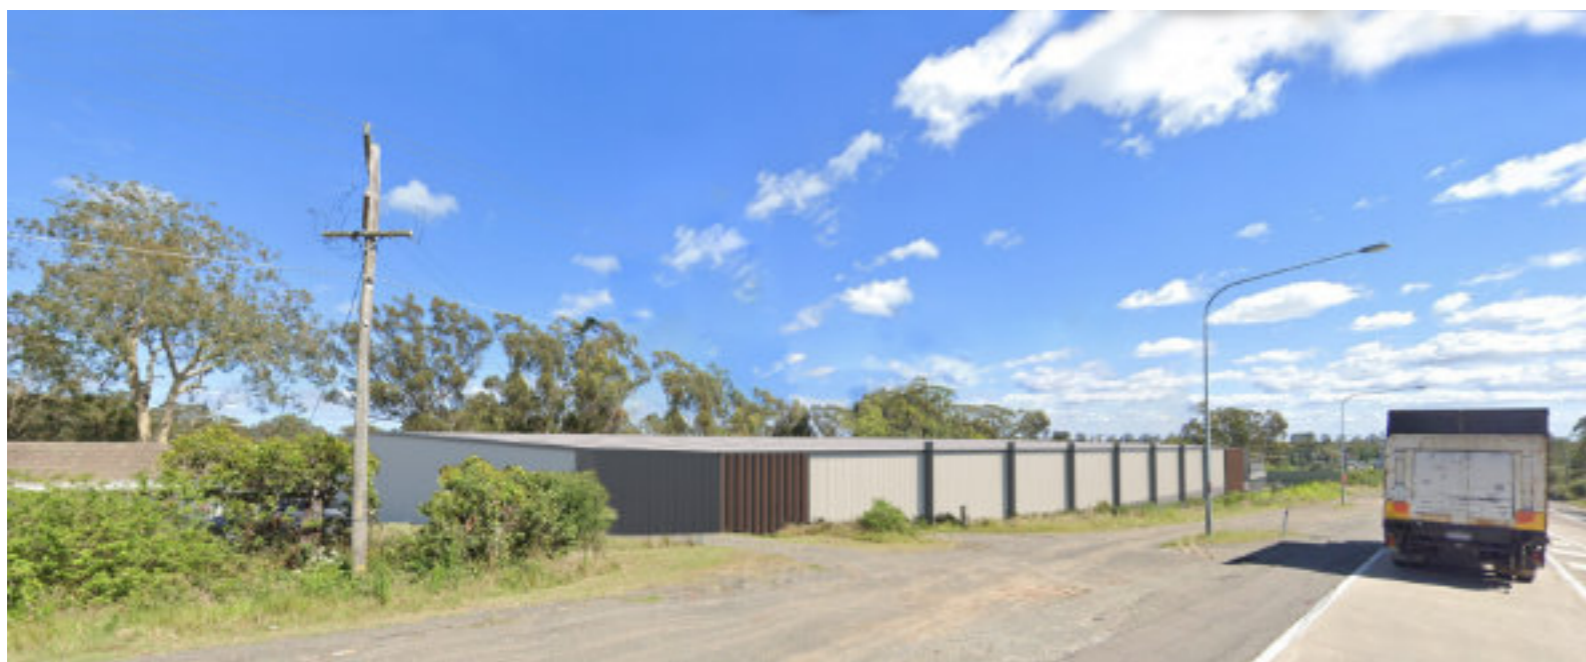
PHOTOMONTAGE - YEAR 0

Proposed building is highly visible but muted slightly through the landscape that is existing along this interphase.

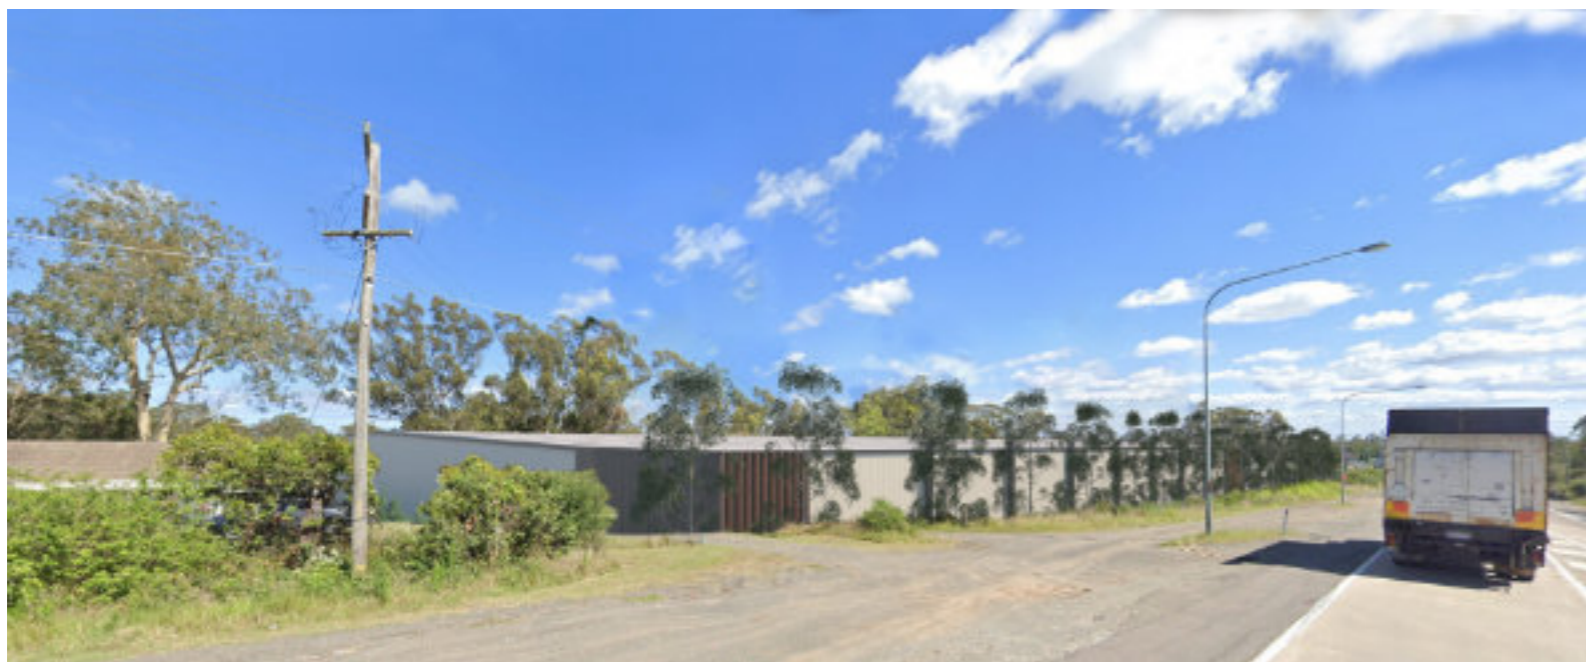
PHOTOMONTAGE - YEAR 10

The proposed view in 10 years with the concept landscape treatment maturing

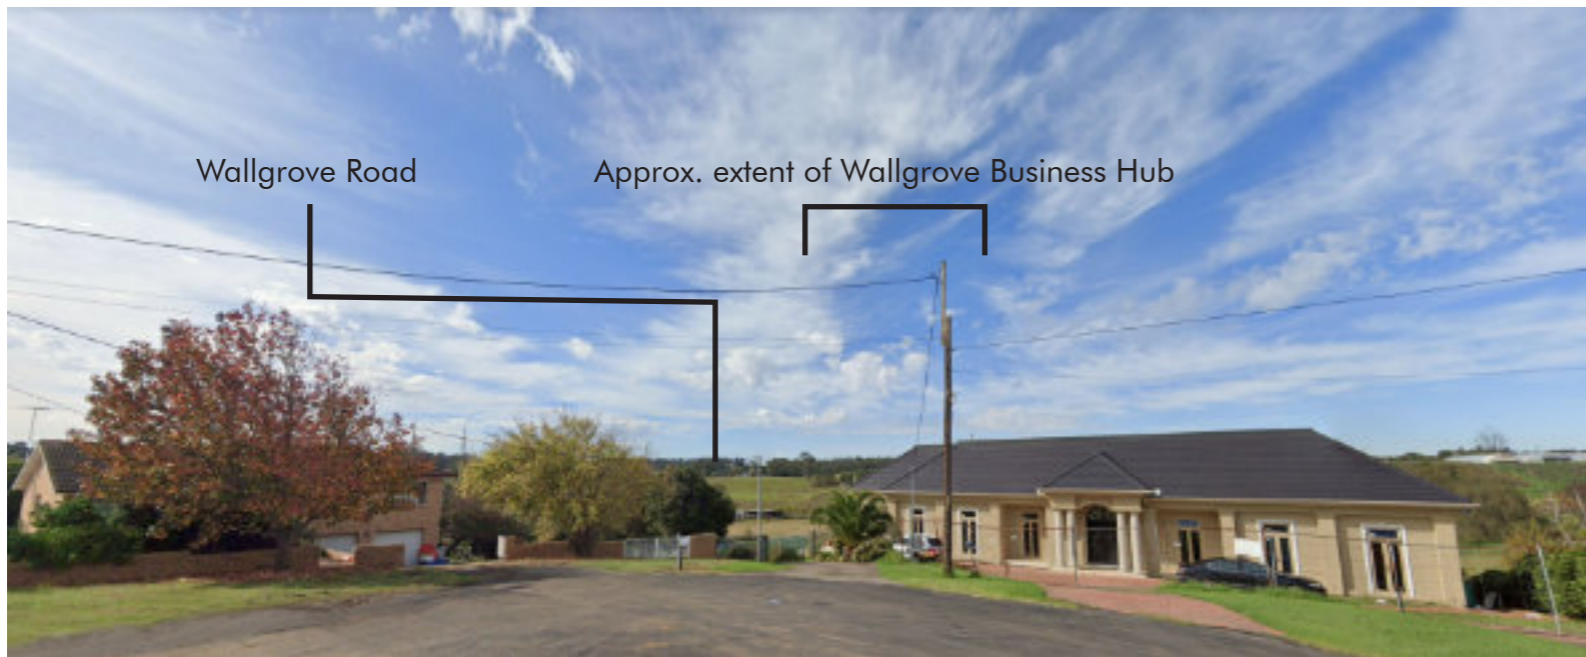
BASELINE PHOTO

Existing condition at the end of Washington Place looking East to the Site.

Approx. Viewing Distance from Site Boundary	550m +
View description & prominence of the development	View from the end of Washington Way looking East into the site
Visual Sensitivity	The visual sensitivity is considered low due to the viewpoint distance being far away from the site/landscape screening and the changing typography along the viewpoint
Magnitude of Change	The magnitude of the change is relatively small, initially the development is slightly visible through the existing landscape. In time (10 years) the new landscape further screens this view.
Significance of Visual Impact	The significance of the view is low due to the distance of this location and the existing landscape screening.
Significance of Visual Cumulative Impact	The visual impact is considered acceptable due to the distance of the location away from the site, existing screening, new landscaping and building design, which will make the development blend into its surrounding landscape overtime.

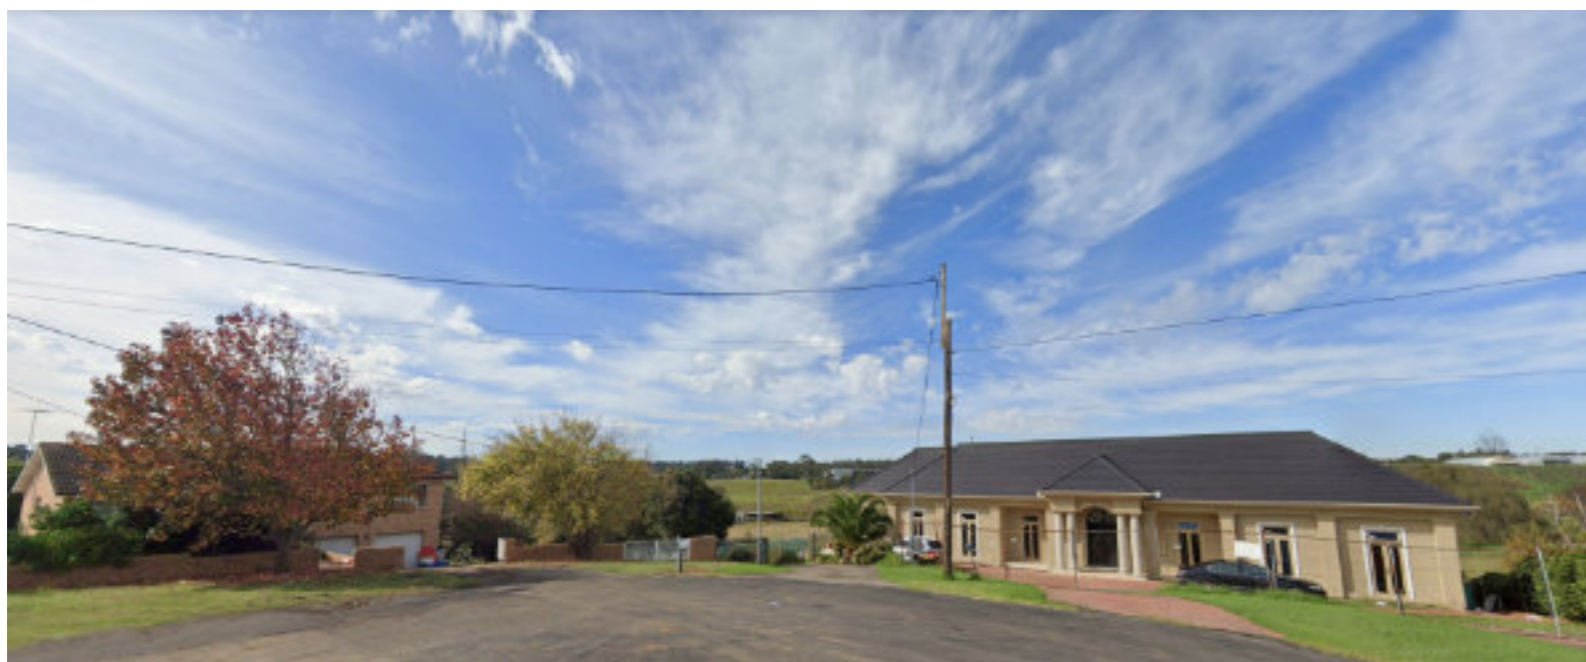
PHOTOMONTAGE - YEAR 0

Proposed building are visible but muted through the landscape that is existing along this interphase.

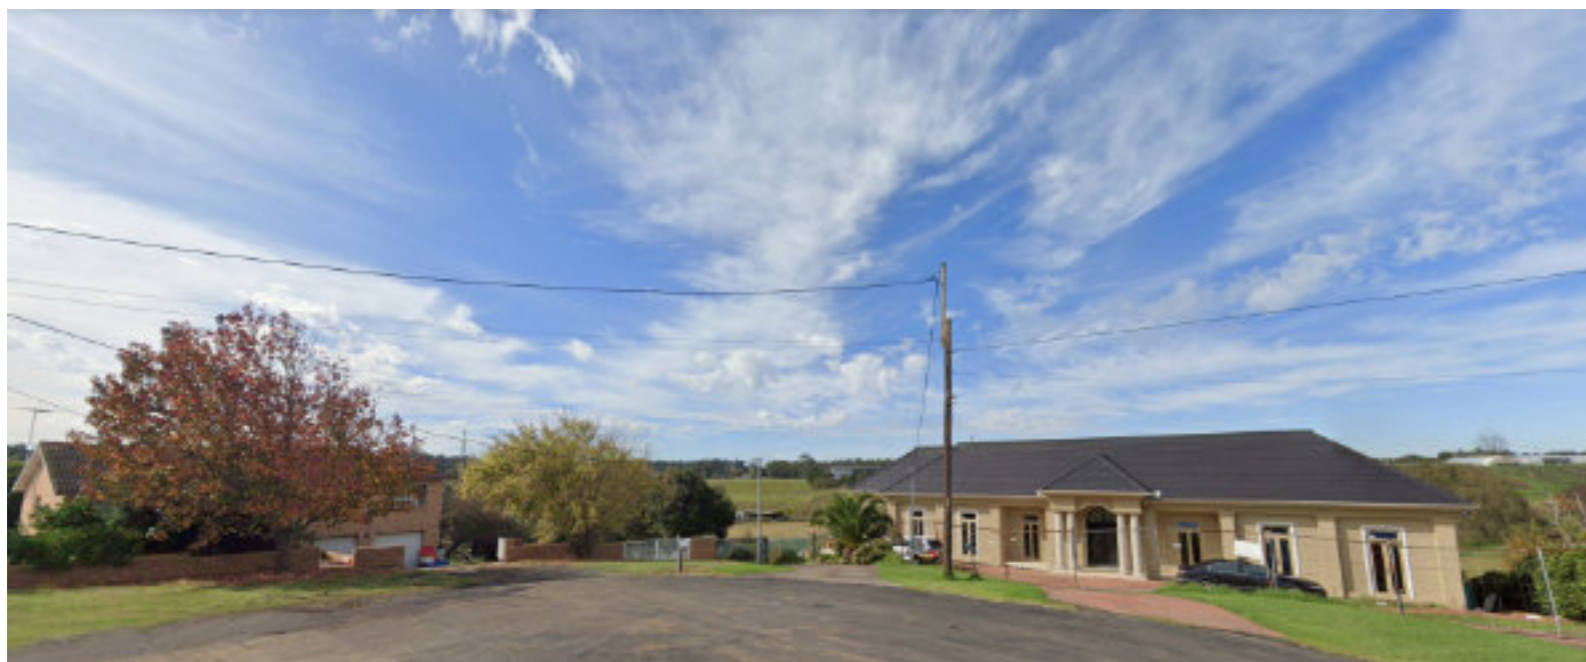
PHOTOMONTAGE - YEAR 10

The proposed view in 10 years with the concept landscape treatment maturing

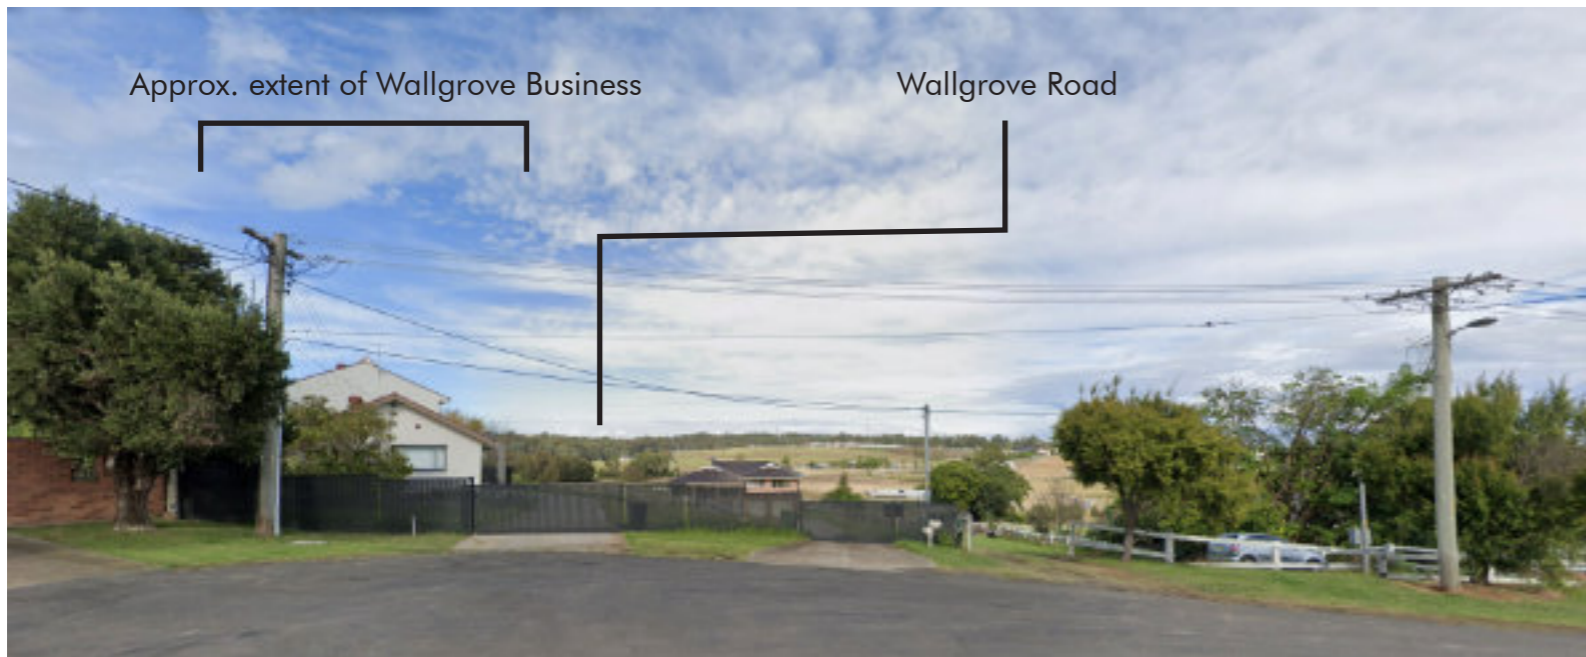
BASELINE PHOTO

Existing condition at the end of Goodrich Road

Approx. Viewing Distance from Site Boundary	650m +
View description & prominence of the development	View from the end of Goodrich Road looking South into the site
Visual Sensitivity	The visual sensitivity is considered extremely low due to the existing landscape screening
Magnitude of Change	The magnitude of the change is extremely small, initially the development is slightly visible through the existing landscape. In time (10 years) the new landscape further screens this view.
Significance of Visual Impact	The significance of the view is extremely low due to the changing topography of this location and the existing landscape screening.
Significance of Visual Cumulative Impact	The visual impact is considered acceptable due to the distance away from the site, existing screening, new landscaping and building design, which will make the development all but invisible in this viewpoint.

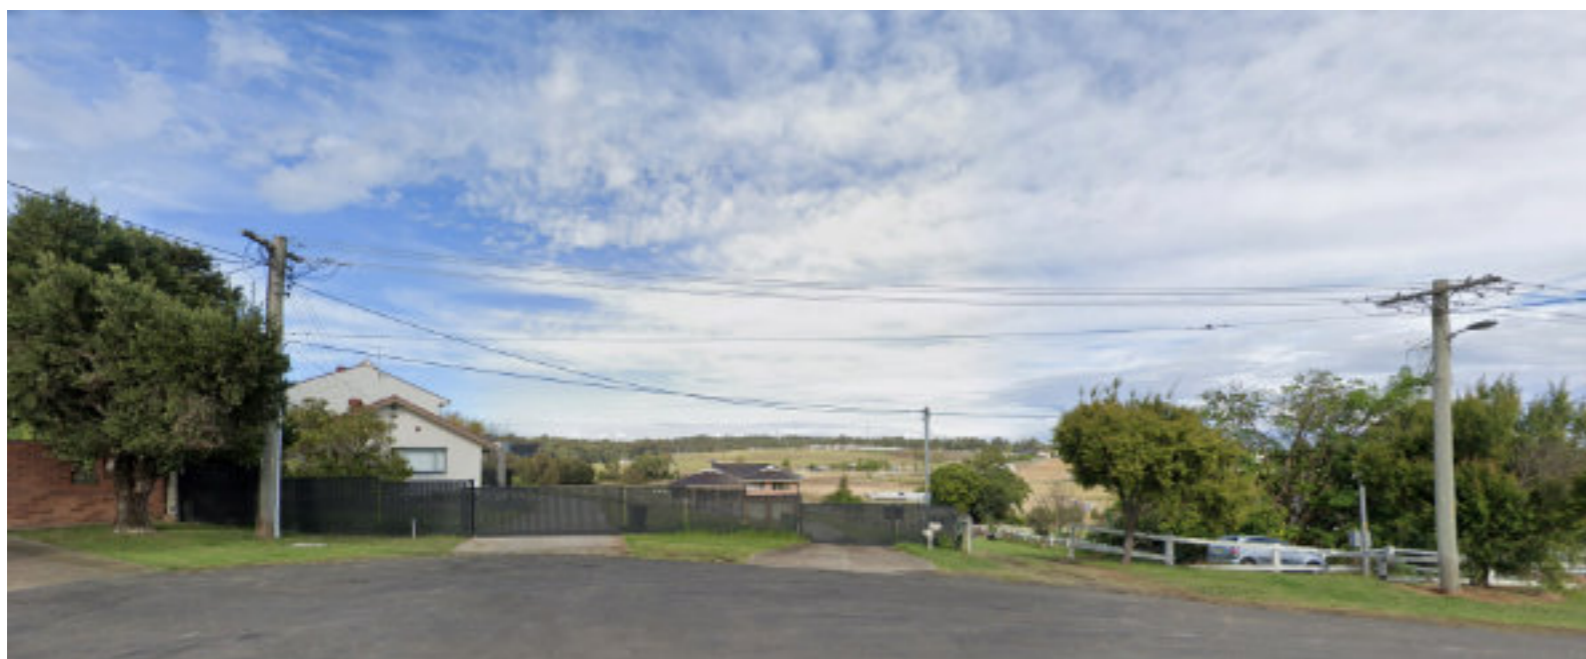
PHOTOMONTAGE - YEAR 0

Proposed building is visible but muted through the existing built form and landscape that is along this interphase.

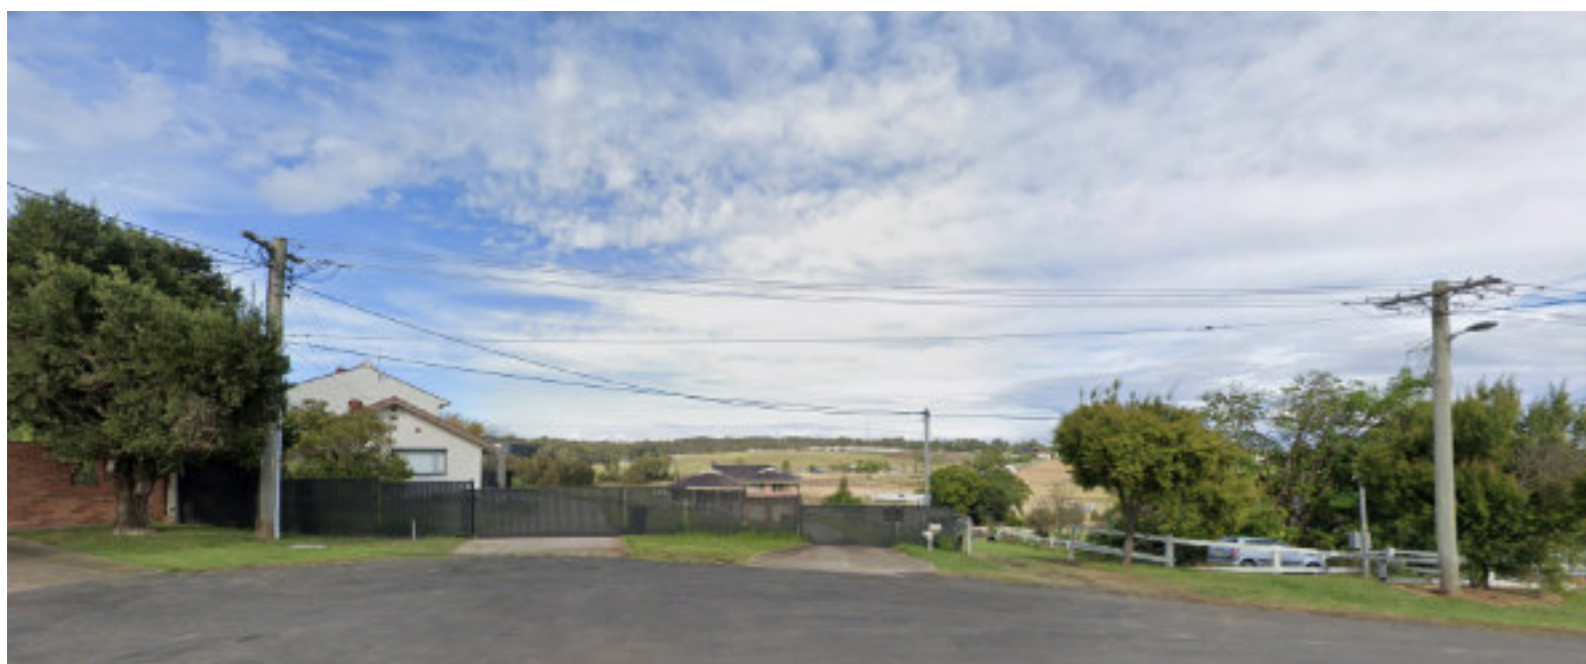
PHOTOMONTAGE - YEAR 10

The proposed view in 10 years with the concept landscape treatment maturing

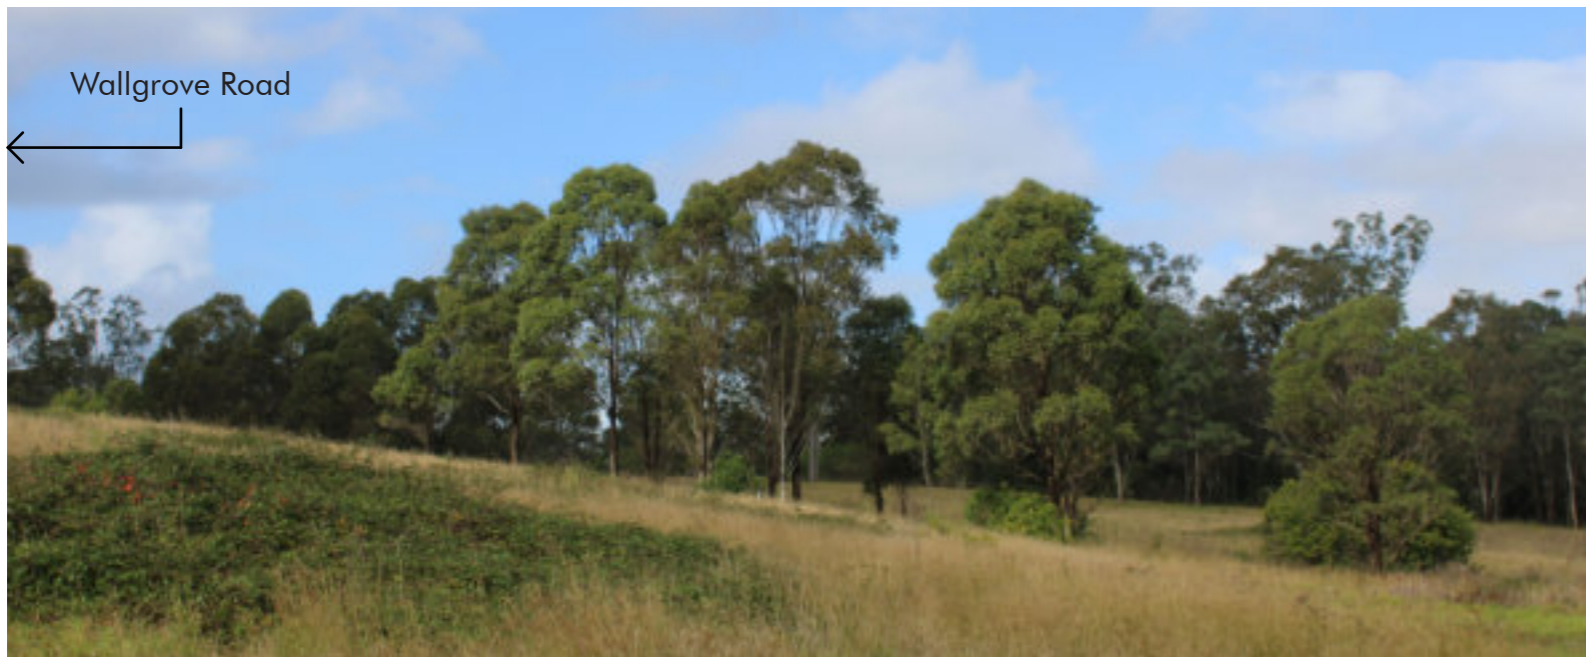
BASELINE PHOTO

Existing condition view from within 19 Kosovich Place

Approx. Viewing Distance from Site Boundary	85m
View description & prominence of the development	View from within the empty lot of 19 Kosovich Place looking South into the site
Visual Sensitivity	The visual sensitivity is considered moderate as this may become a frequent static view once the land of 19 Kosovich Place is developed/inhabited.
Magnitude of Change	The magnitude of change is considered high from this viewpoint but will soften as the landscape buffer matures.
Significance of Visual Impact	The visual impact significance is considered low as this view will only be available to people who have access to the private property (once developed).
Significance of Visual Cumulative Impact	The cumulative visual impact is considered acceptable due to the limited audience of impact, landscape buffering that will soften the magnitude over time, and a material and colour palette that helps the development blend in with the surroundings.

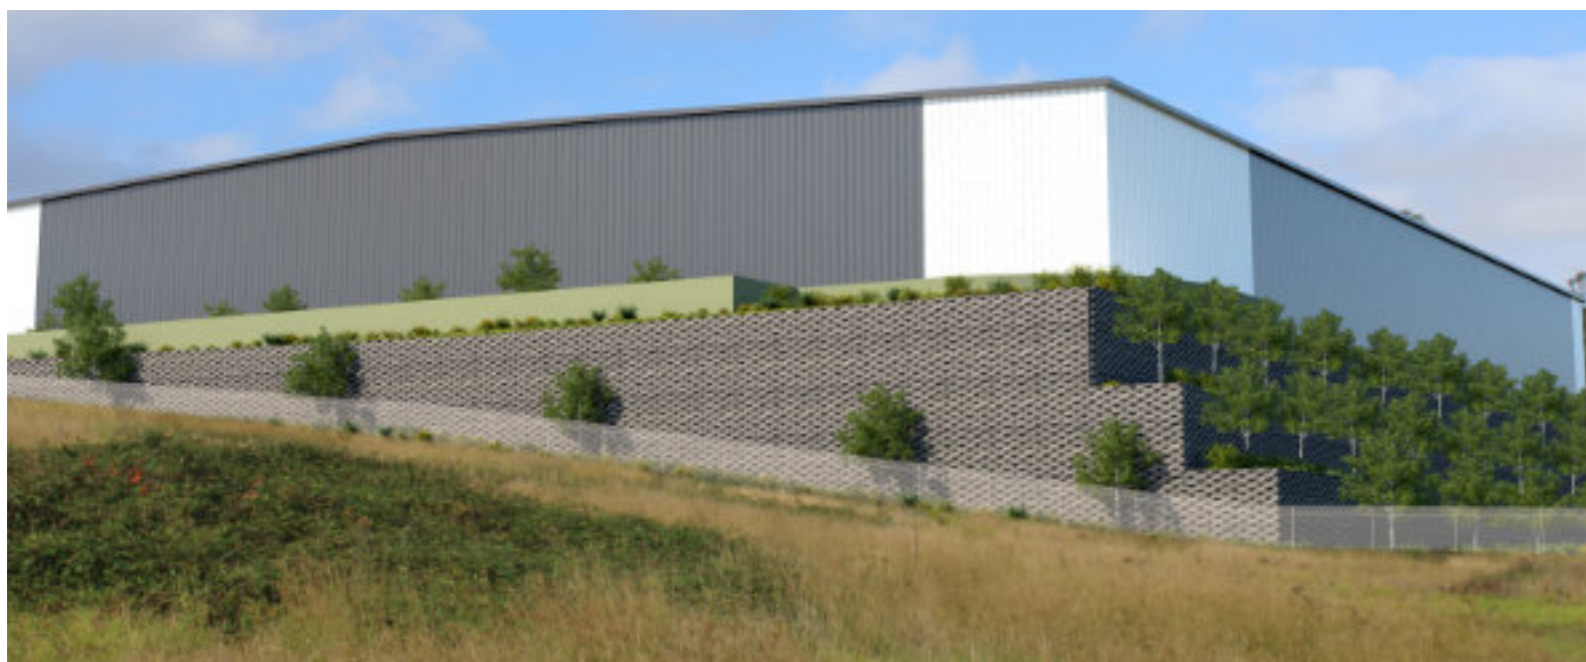
PHOTOMONTAGE - YEAR 0

Proposed building is highly visible but muted slightly with a colour pallet that's reflective of its surroundings.

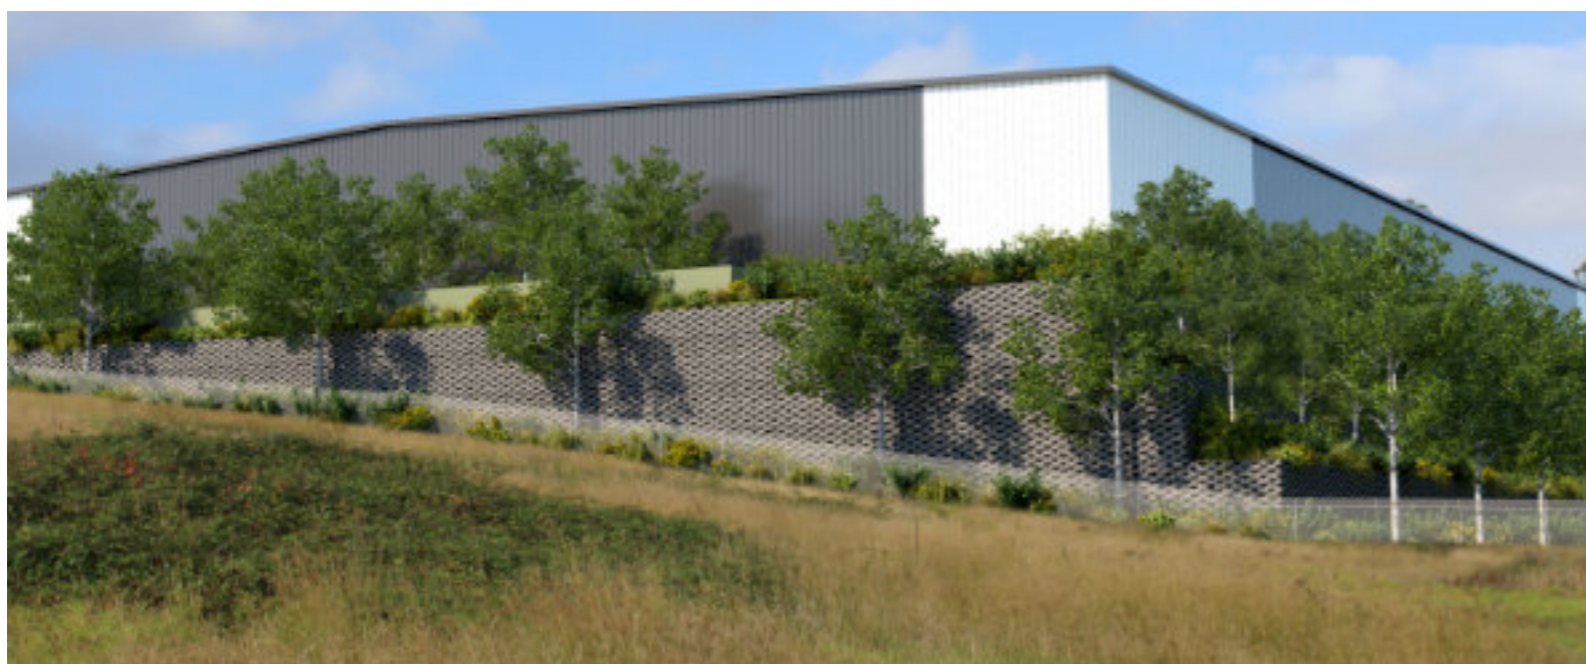
PHOTOMONTAGE - YEAR 10

The proposed view in 10 years with the concept landscape treatment maturing

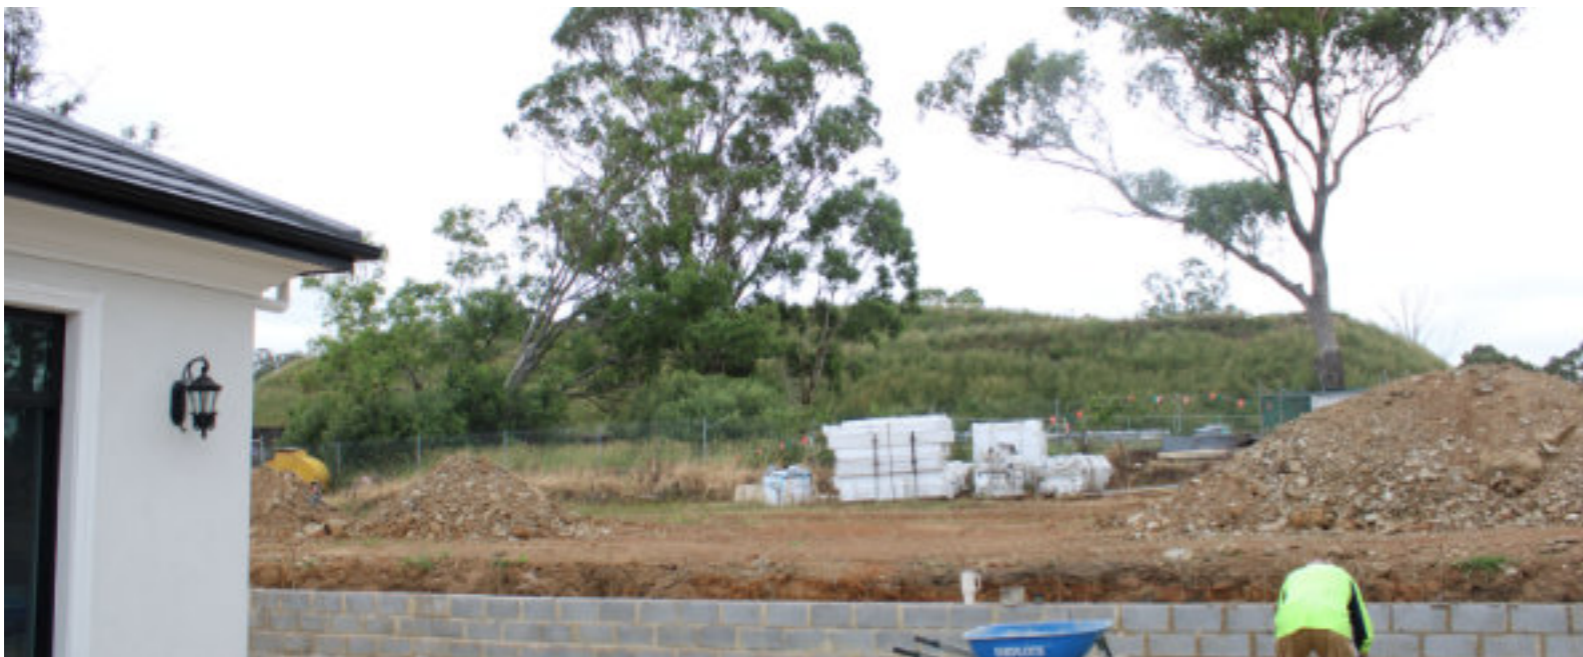
BASELINE PHOTO

Existing condition view from within 11 Kosovich Place

Approx. Viewing Distance from Site Boundary	85m
View description & prominence of the development	View from within the lot of 11 Kosovich Place looking South into the site
Visual Sensitivity	The visual sensitivity is considered low-moderate due to the existing topography/landscape screening.
Magnitude of Change	The magnitude of change is considered moderate from this viewpoint but will soften as the landscape buffer matures.
Significance of Visual Impact	The visual impact significance is considered low as this view will only be available to people who have access to the private property (once developed).
Significance of Visual Cumulative Impact	The cumulative visual impact is considered acceptable due to the limited audience of impact, landscape buffering that will soften the magnitude over time, and a material and colour palette that helps the development blend in with the surroundings.
