WALLGROVE BUSINESS HUB, CECIL PARK VISUAL IMPACT ANALYSIS

REV 6 - JUNE 2025

The Visual Impact Assessment relates to the proposed development of 97-151 Wallgrove Road, Cecil Park. This comprises of two separate warehouses, including ancillary office spaces, internal driveway, hard stand areas, and associated earthworks and landscaping.

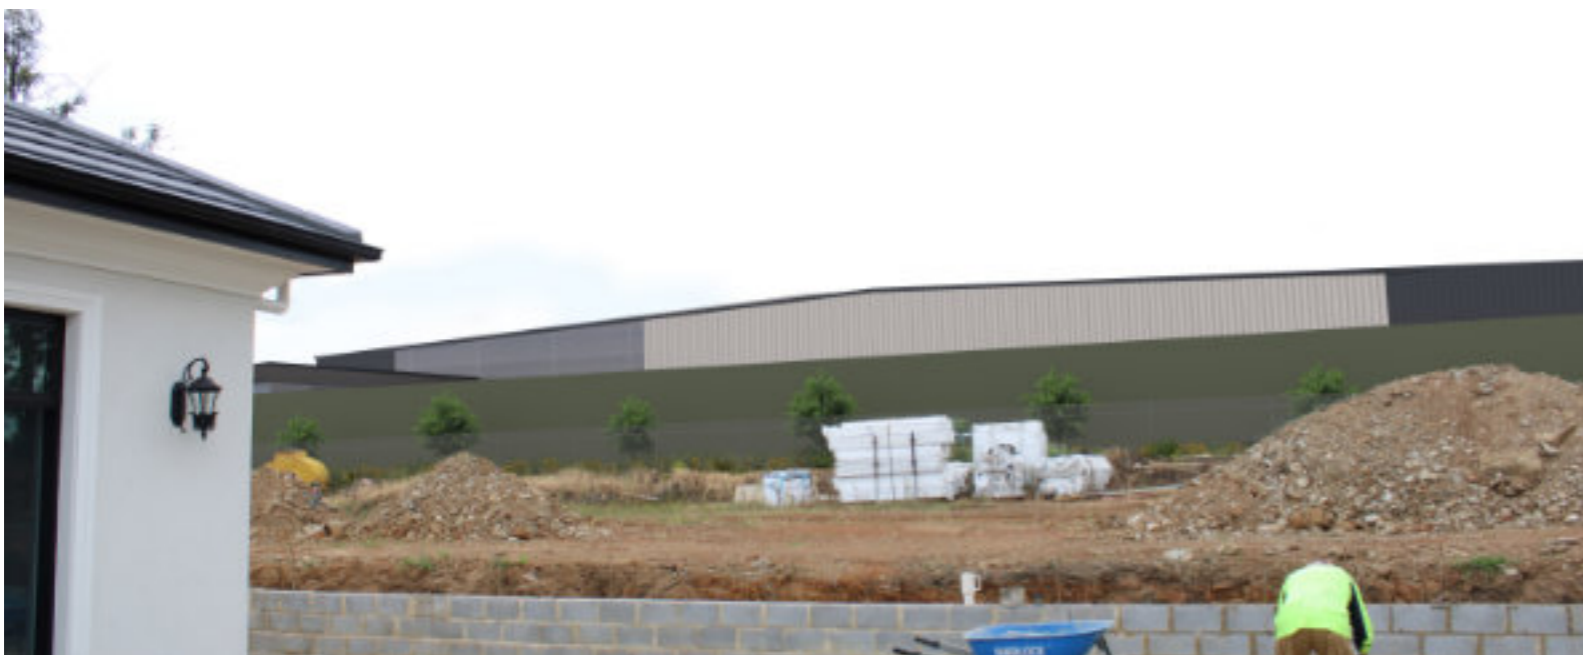
PHOTOMONTAGE - YEAR 0

Proposed building is highly visible but muted slightly with a colour pallet that's reflective of its surroundings.

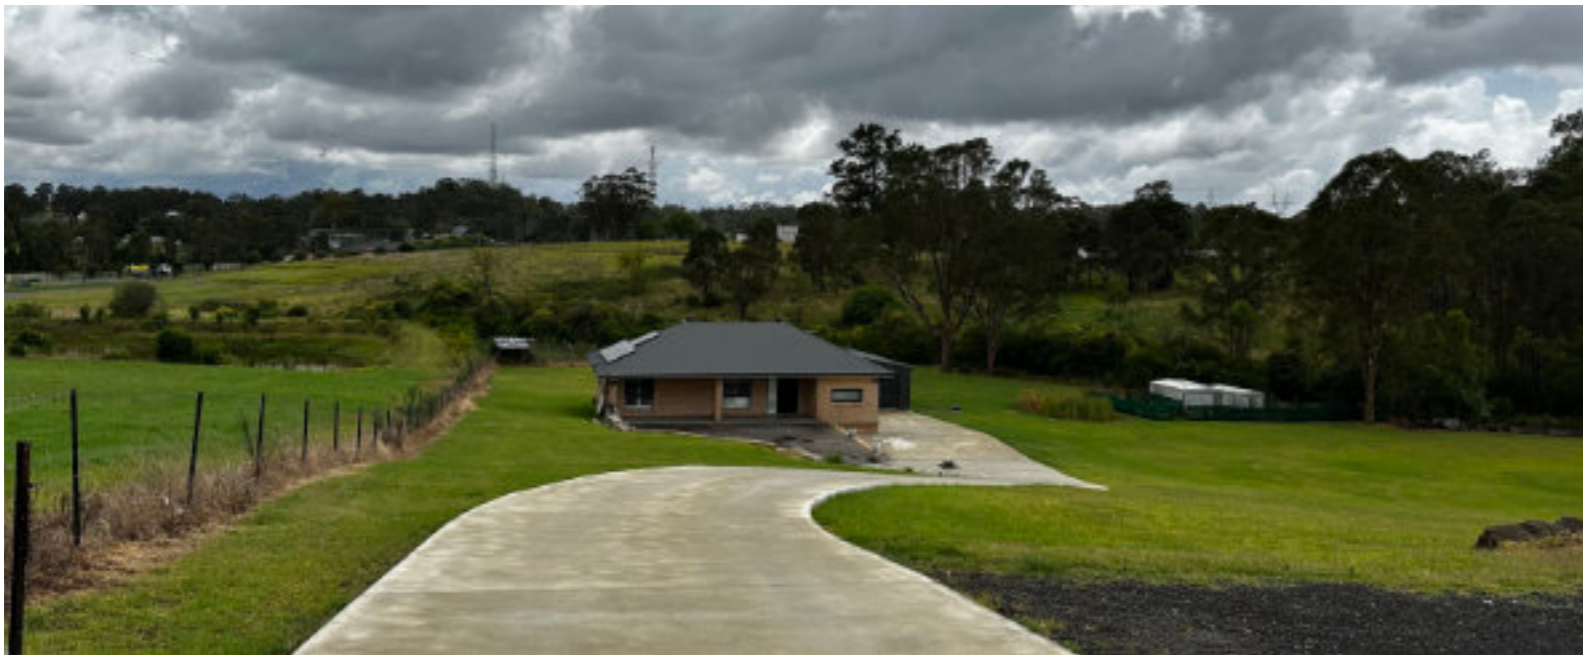
BASELINE PHOTO

Existing condition view from within 56 Cecil Road

Approx. Viewing Distance from Site Boundary	150m
View description & prominence of the development	View from within the lot of 56 Cecil Road looking East towards the site
Visual Sensitivity	The visual sensitivity is considered moderate as this may become a frequent static view for the existing landowner.
Magnitude of Change	The magnitude of change is considered high from this viewpoint but will soften as the landscape buffer matures.
Significance of Visual Impact	The visual impact significance is considered moderate, as this view will only be available to people who have access to the private property. Impacts to adjacent site have been mitigated by internalising utility areas including the truck hardstand, which slightly increases the built form in view.
Significance of Visual Cumulative Impact	The cumulative visual impact is considered acceptable due to the limited audience of impact, landscape buffering that will soften the magnitude over time, and a material and colour palette that helps the development blend in with the surroundings.

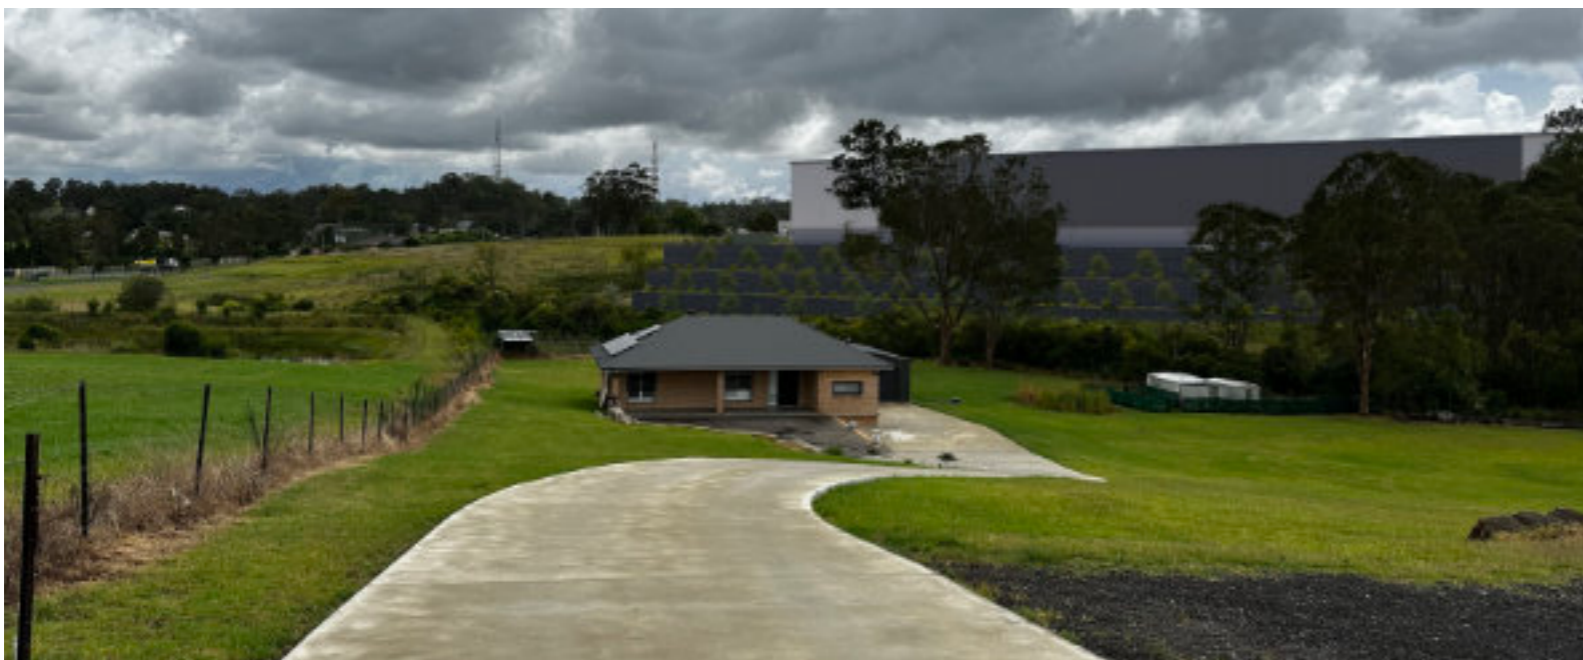
PHOTOMONTAGE - YEAR 0

Proposed building is highly visible but muted slightly with a colour pallet that's reflective of its surroundings.

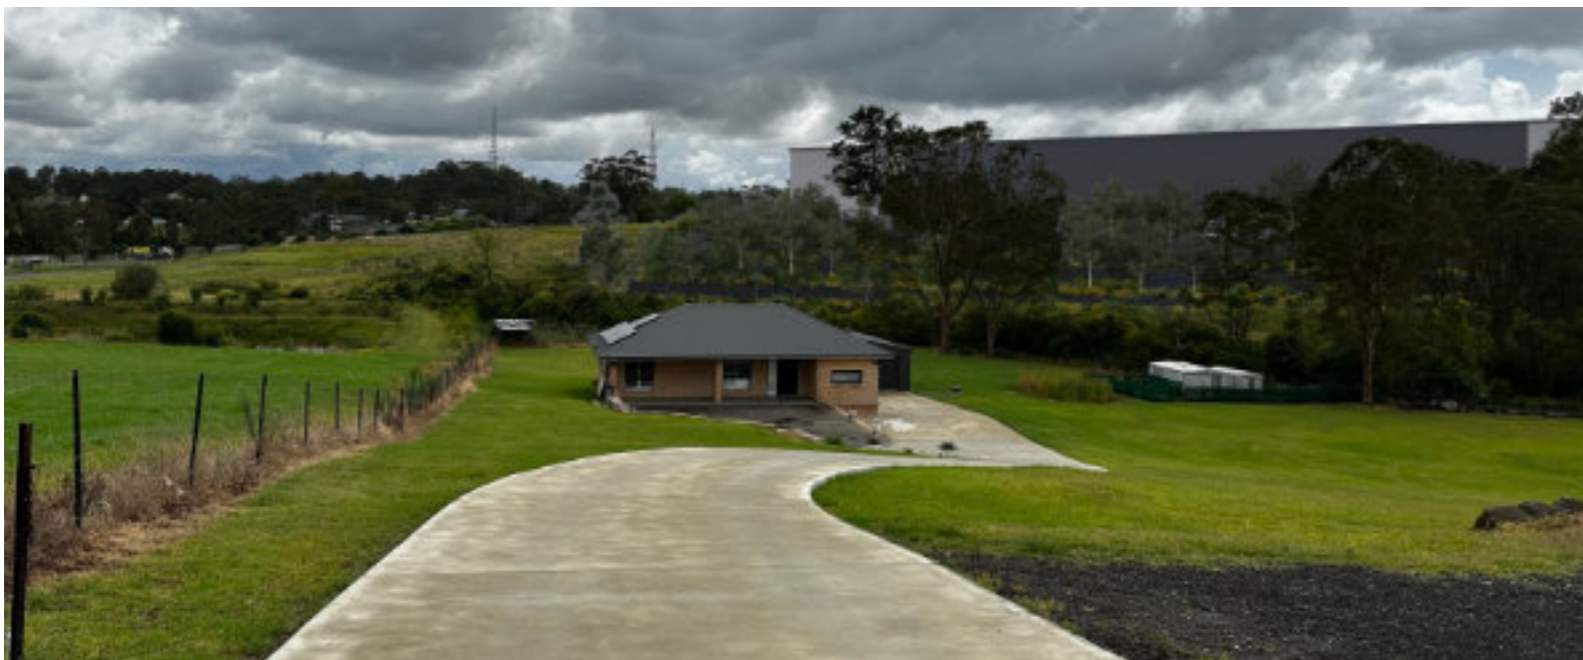
PHOTOMONTAGE - YEAR 10

The proposed view in 10 years with the concept landscape treatment maturing
