Phase 1 Environmental Site Assessment and Geotechnical Desktop Study

600-660 Elizabeth Street, Redfern NSW

Client: New South Wales Land and Housing Corporation

22-May-2018

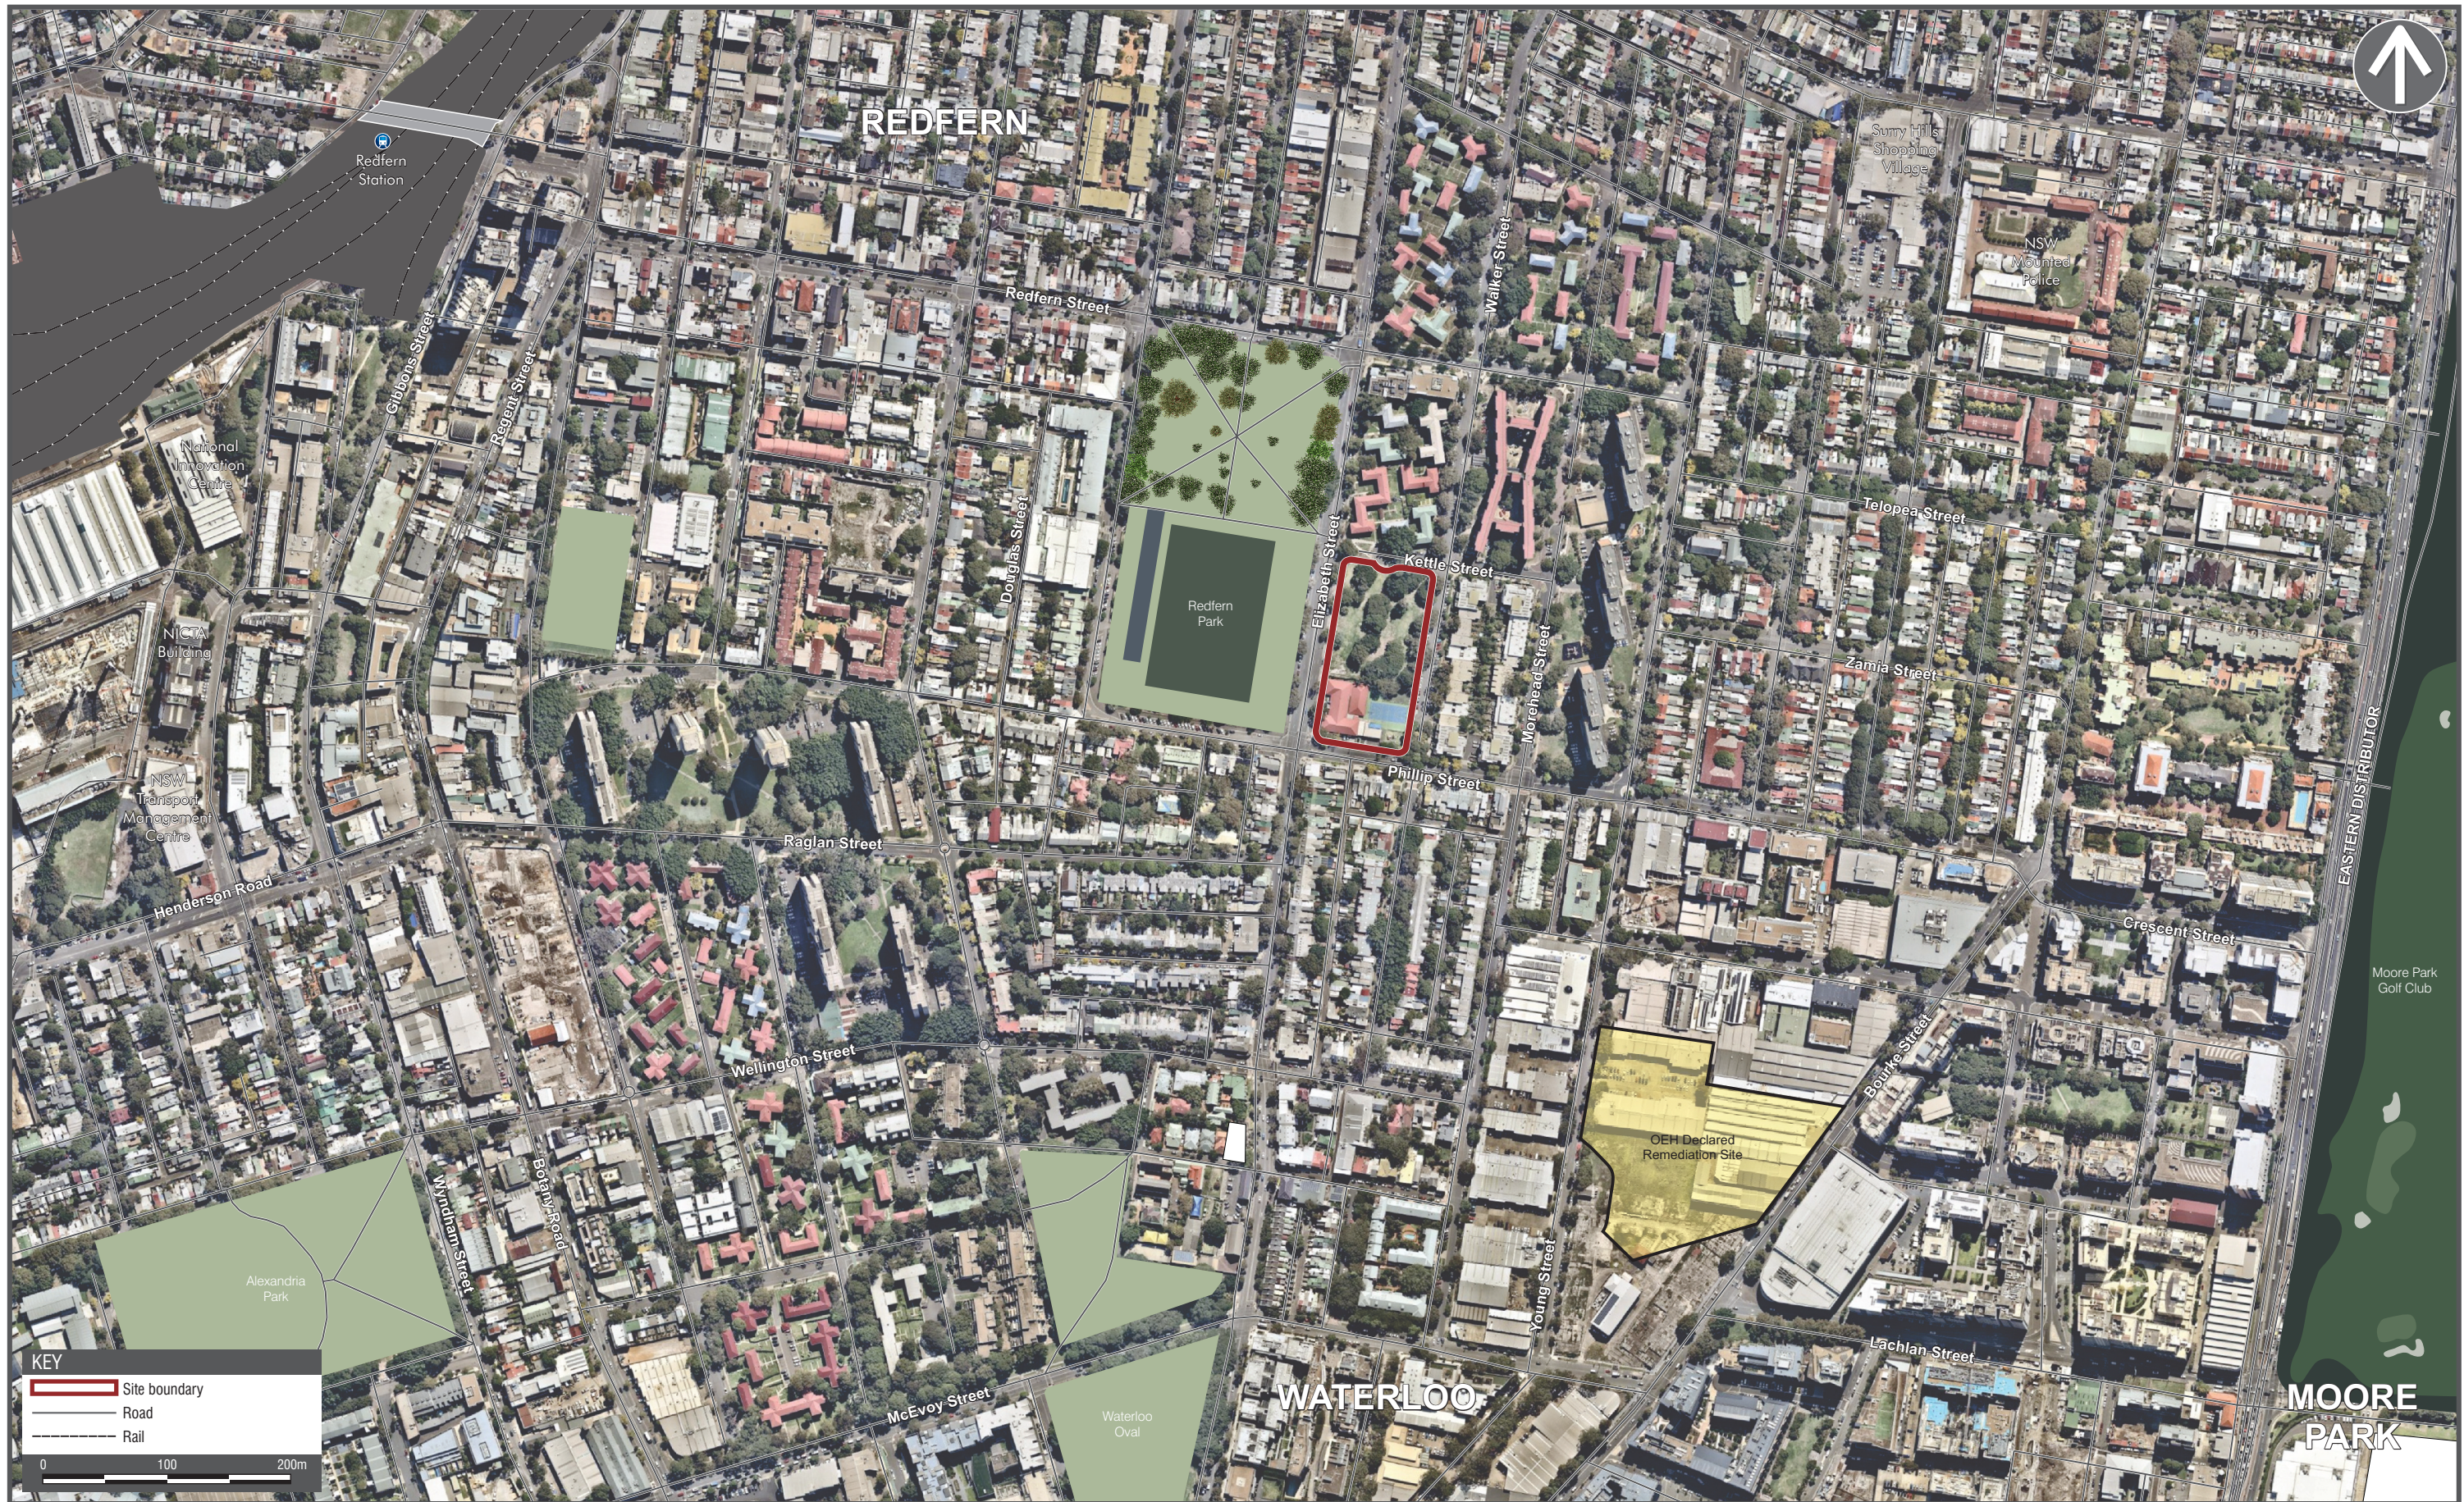
FIGURE 2

Phase 1 Environmental Site Assessment and Geotechnical Desktop Study
 Geotechnical and Contamination Assessment
 600-660 Elizabeth Street, Redfern NSW 2016

The Site comprises Lots 3, 4 and 5 in deposited plan (DP) 456634 and covers an area of 1.077 hectares (ha). The location of the Site is shown on Figure 1 and the Site Layout is shown on Figure 2 in **Appendix A**.

The Figure 2 sampling location plan indicates that five (BH1 to BH5) of the 10 boreholes were located on the Site located at 600-660 Elizabeth Street Redfern and five boreholes (BH6 to BH10) were located to the east of the Site between Moorehead and Walker Streets.

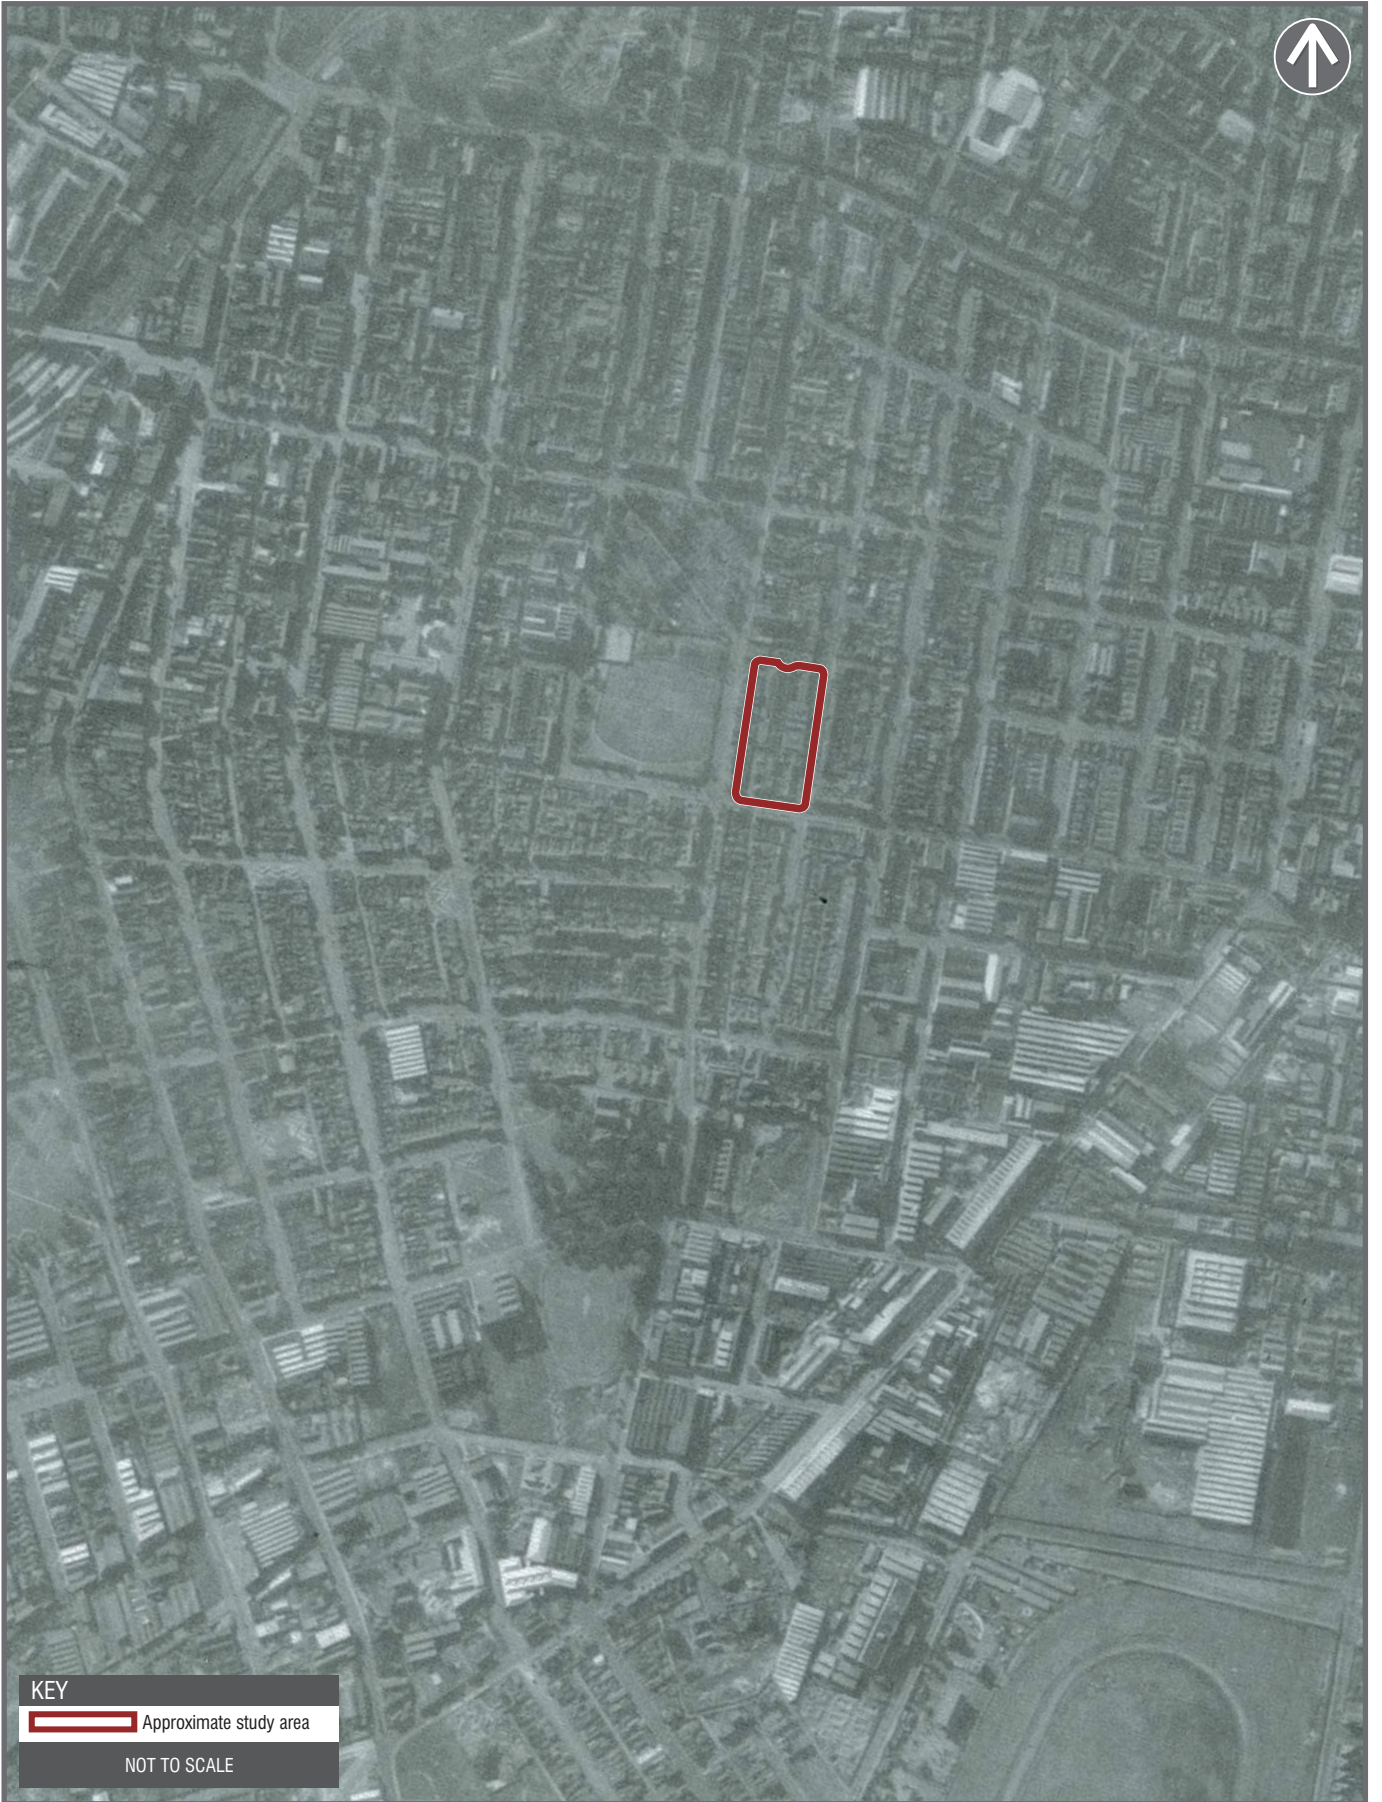
FIGURE 4

AERIAL PHOTOGRAPH - 1942
Phase 1 Environmental Site Assessment and Geotechnical Desktop Study
Geotechnical and Contamination Assessment
600-660 Elizabeth Street, Redfern NSW 2016
