Acid Sulfate Soils Management Plan

600-660 Elizabeth Street, Redfern
(Redfern Place)

E25947.E14_Rev4
21 June 2024

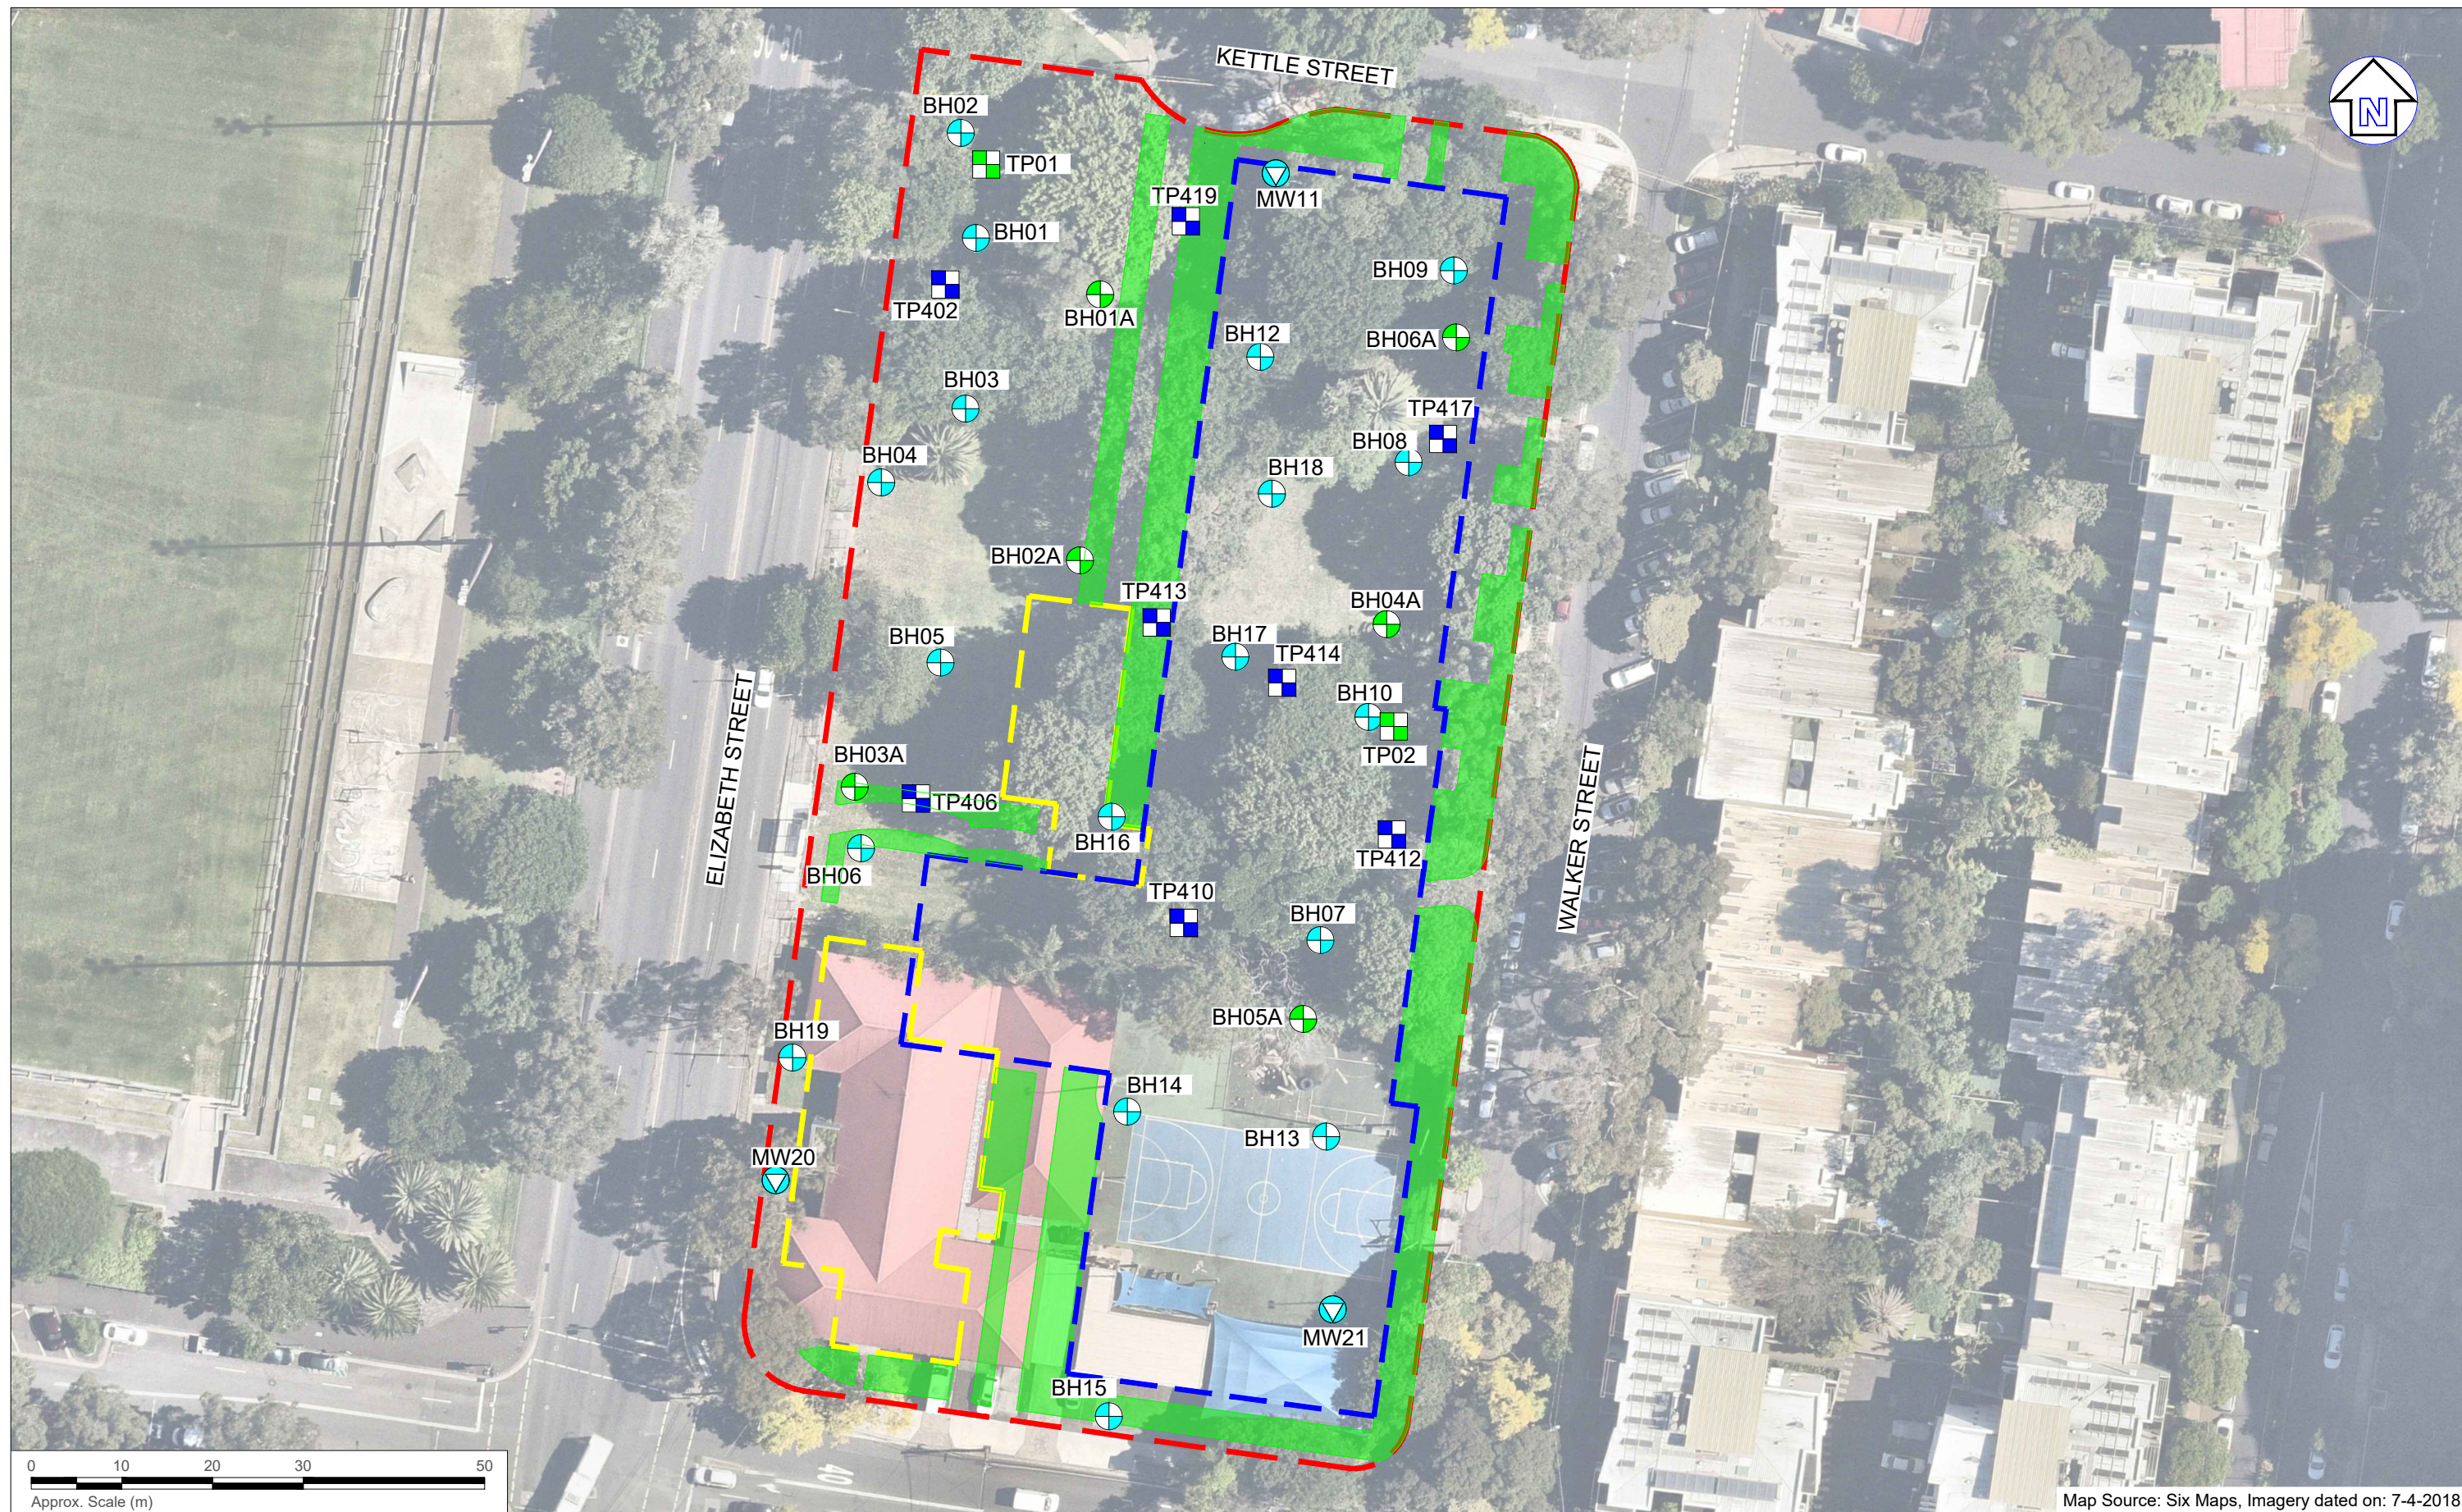
LEGEND (Note: All locations are approximate)

- Site boundary
- Proposed basement footprint
- Flood storage and OSD tank excavation area
- Proposed deep soil area

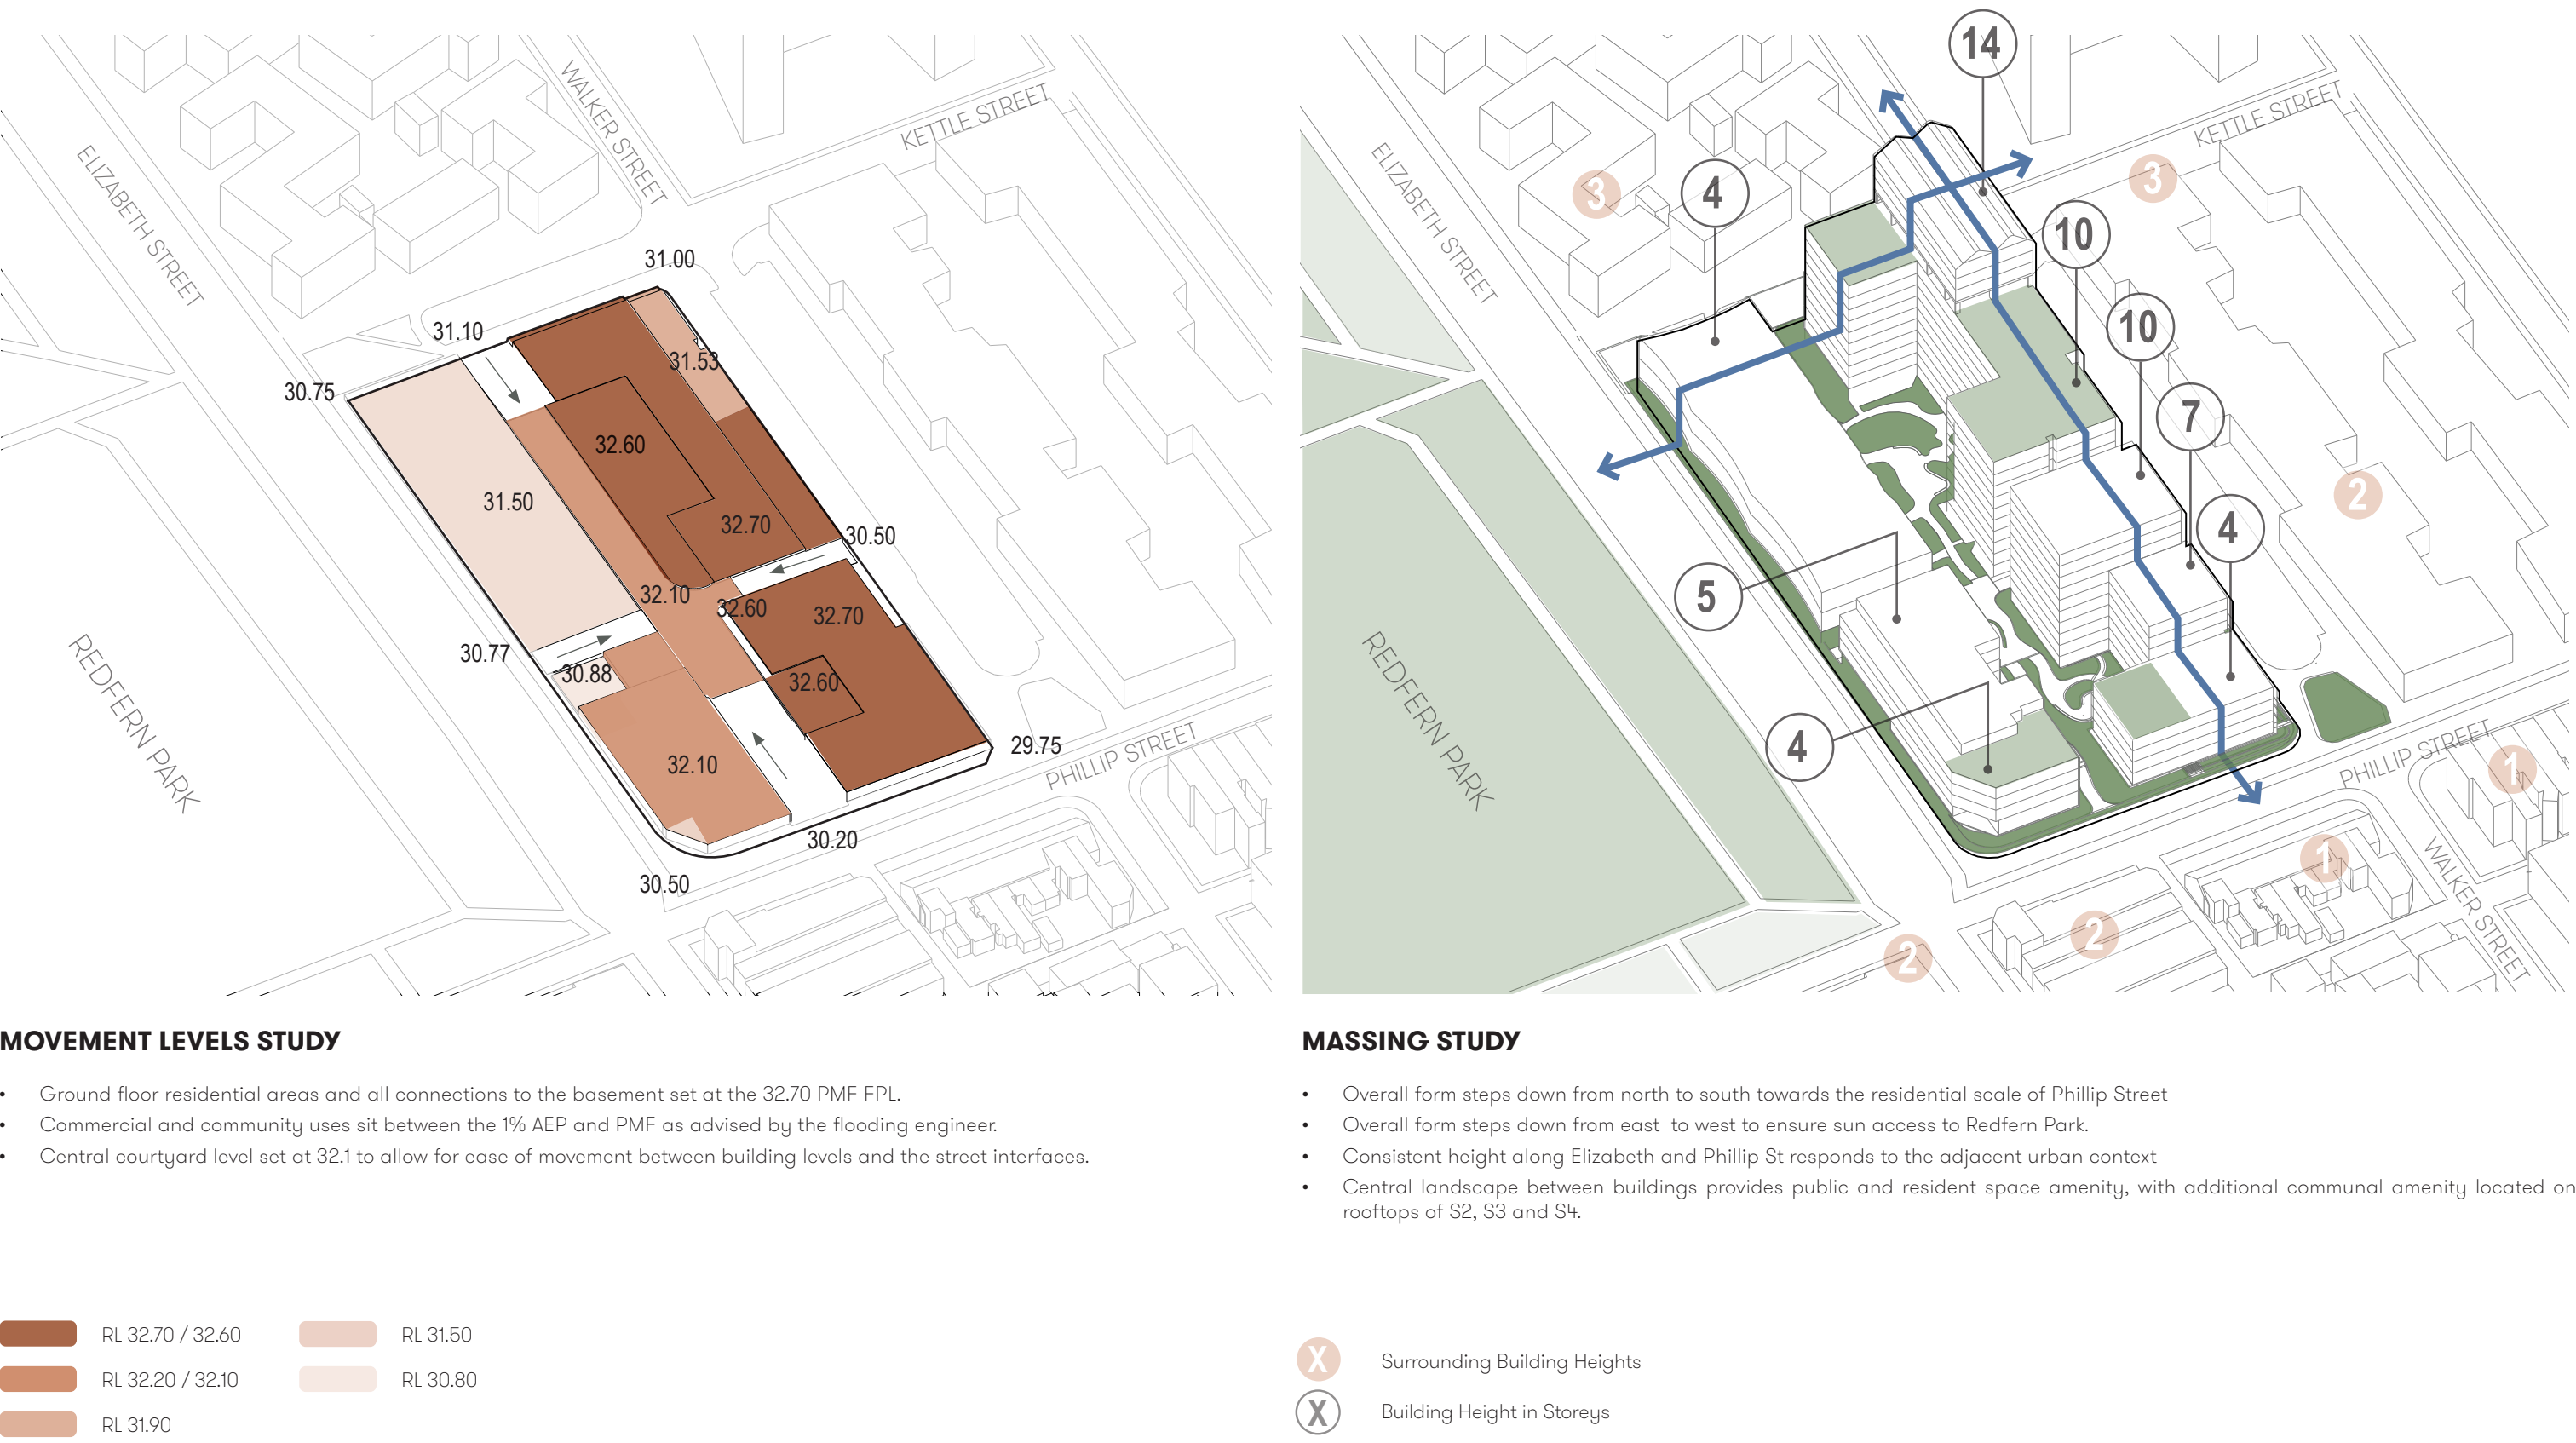
GROUND PLAN

- Central landscape space sitting 1-1.6m above street level providing access and activation to the internal facades of the development.
- Ramped through site links providing clear and legible pedestrian movement through the site.
- Clear residential entries on Kettle St and Phillip St, and PCYC entry on Kettle St.
- PCYC Multi courts located at southern end of S1 with large areas of glazing to activate the central courtyard space
- Activate entrances on all corners of S4 to activate the through site links and central courtyard space
- Vehicle entry on Kettle St with a long ramp with peak at PMF to access basement.
- Refer to Aspect's design report for further detail on the landscape response.

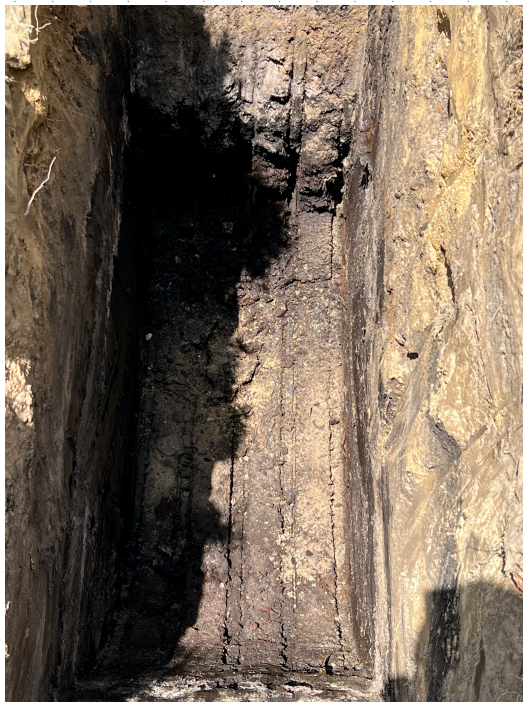
Sketch & Other Observations

2.0	2.00	TP414_1.9-2.0						
									Hole Terminated at 2.00 mBGL; Target Depth Reached.		
			2.5								
			3.0

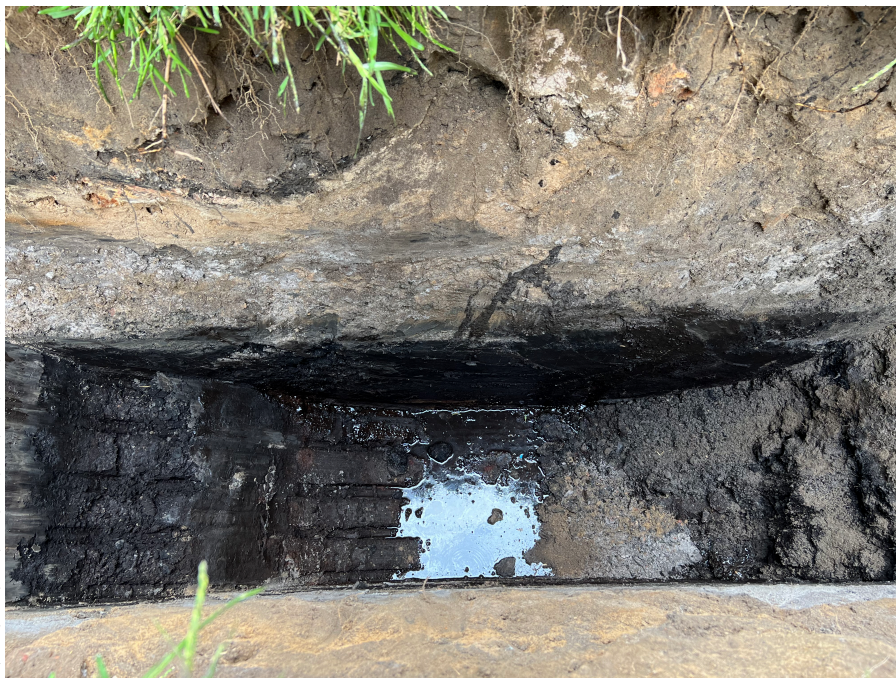
Sketch & Other Observations

CL	CLAY; low plasticity, dark brown, with a weak sulfur odour.					
			1.80										
			2.0					Hole Terminated at 2.00 mBGL; Target Depth Reached.
