**Report on Previous Geotechnical
Investigation**

Proposed Redfern Place

600-660 Elizabeth Street, Redfern NSW

Project 99510.02

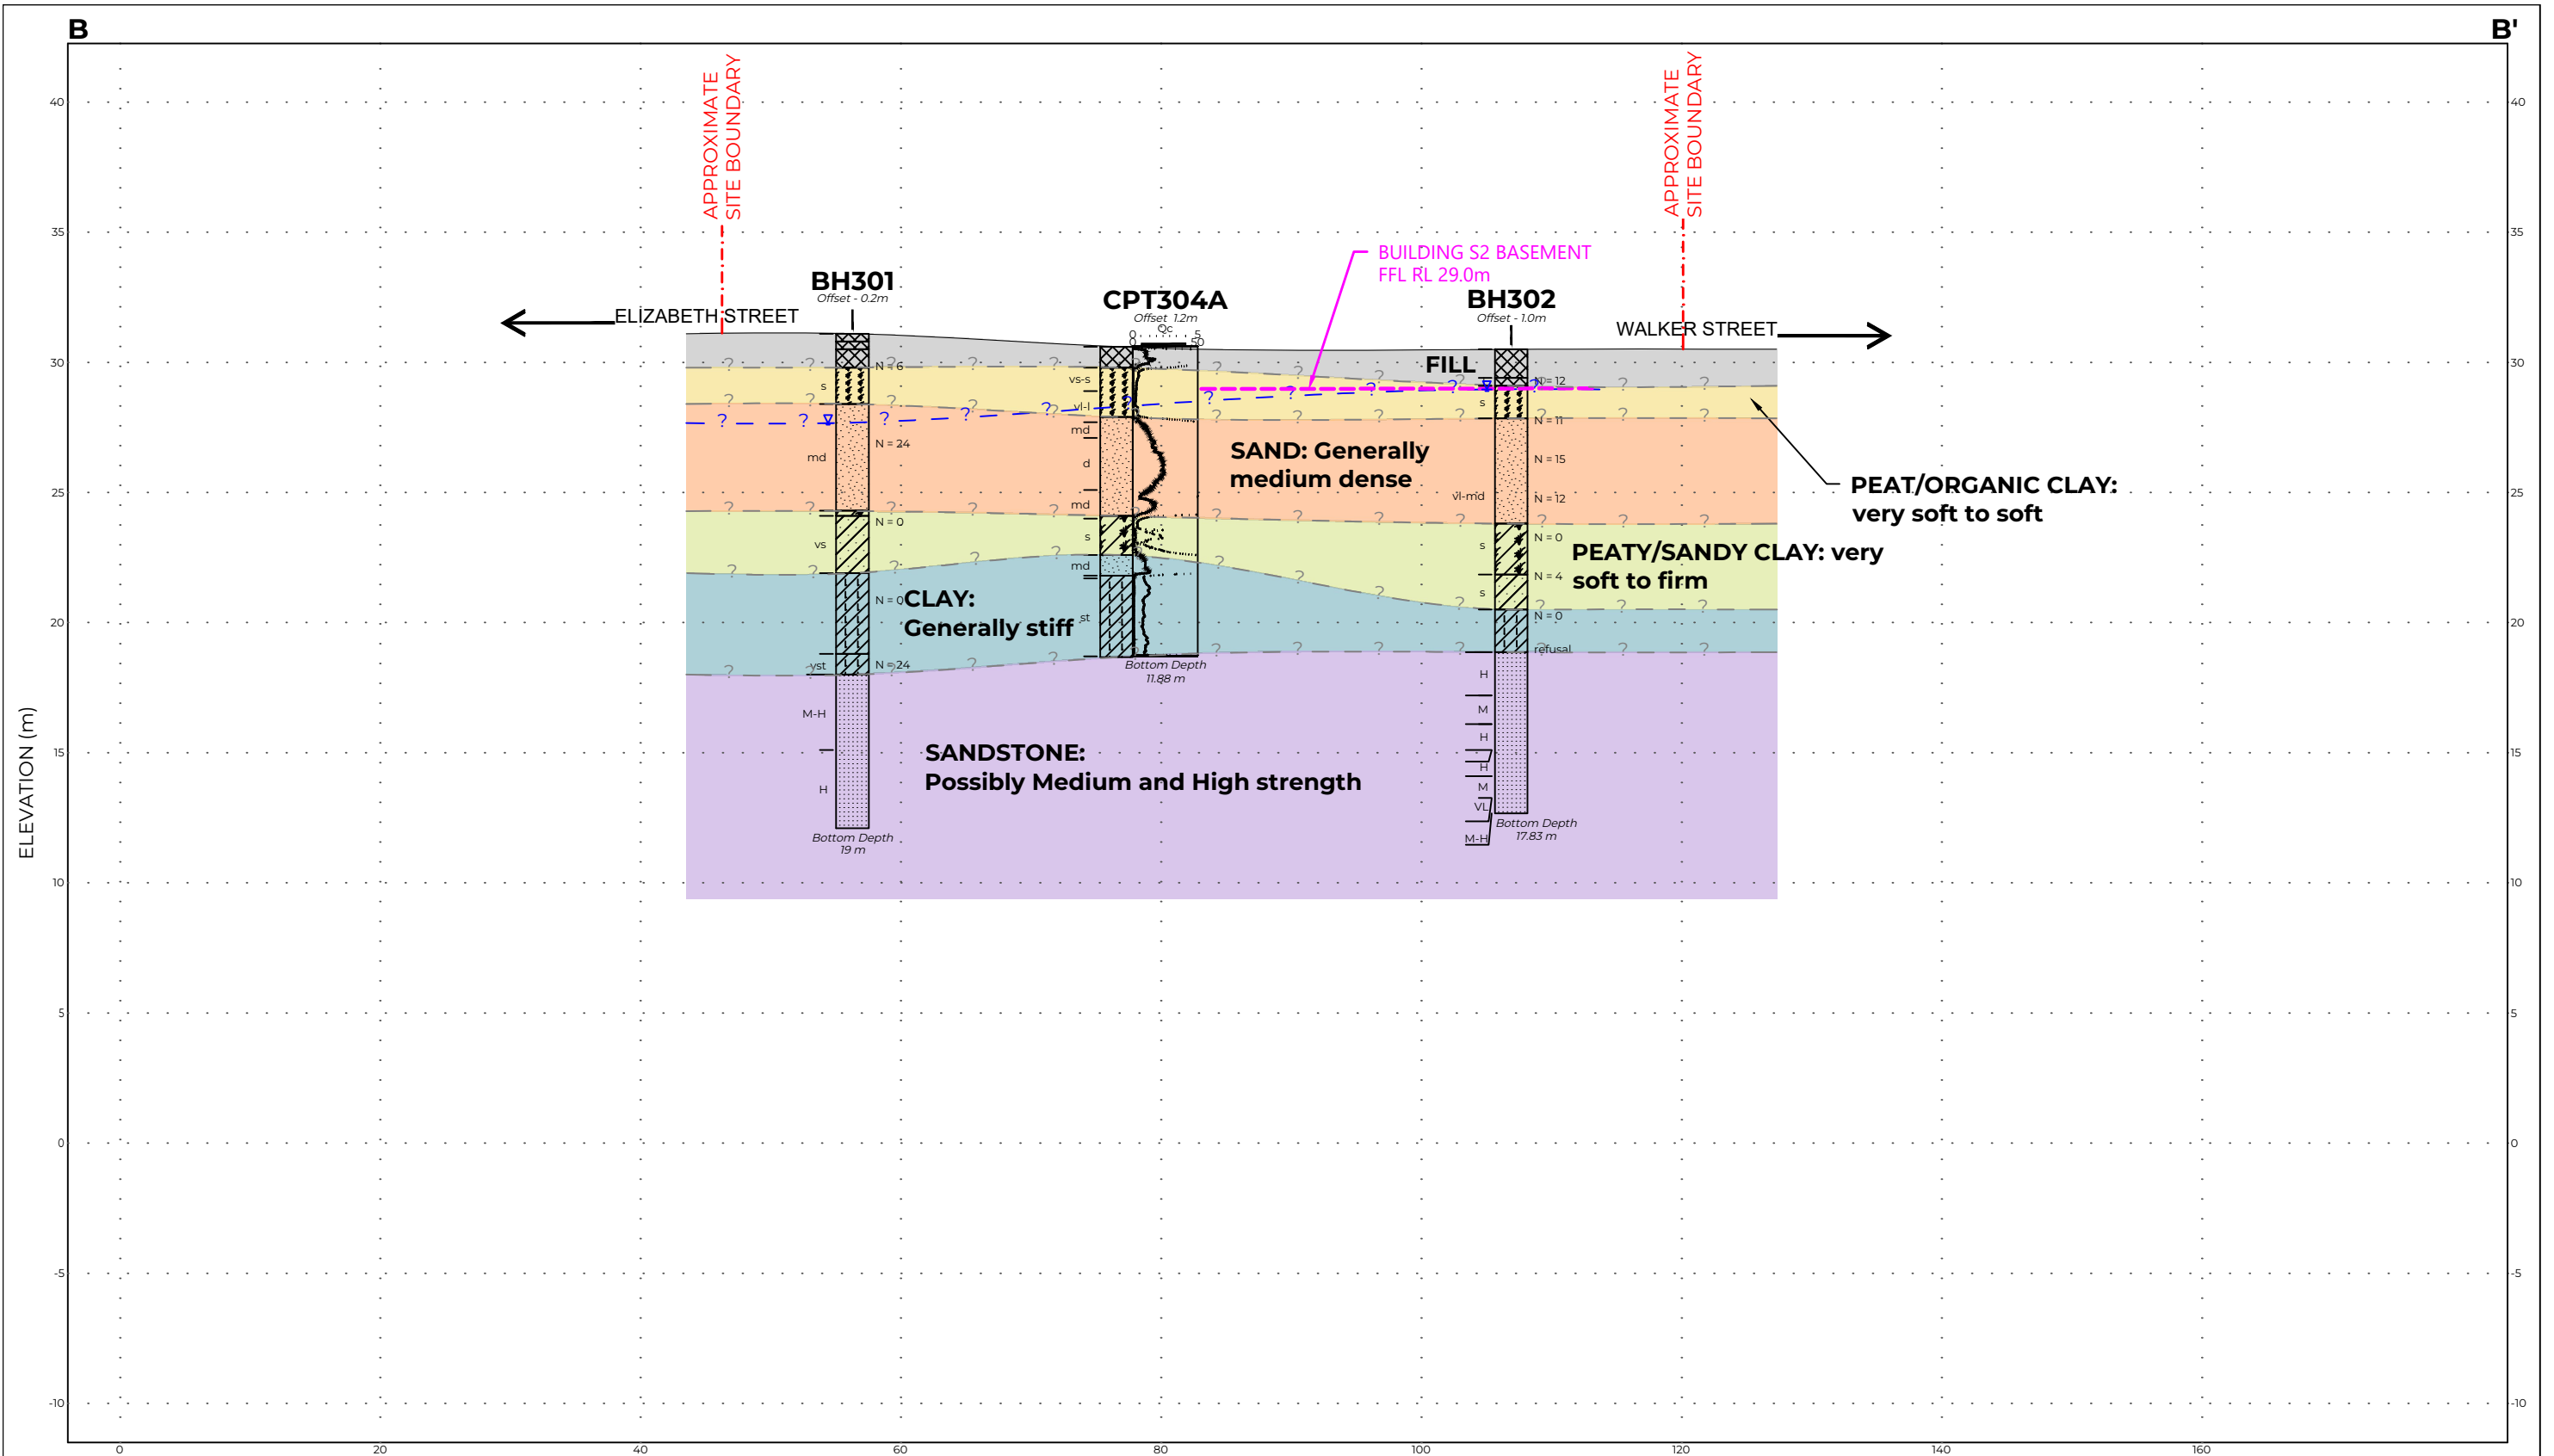
PROJECT No: 99510.02
 DRAWING No: 3
 REVISION: 0

TITLE: Interpreted Geotechnical Cross-Section B-B'
Proposed Redfern Place
600-660 Elizabeth Street, Redfern

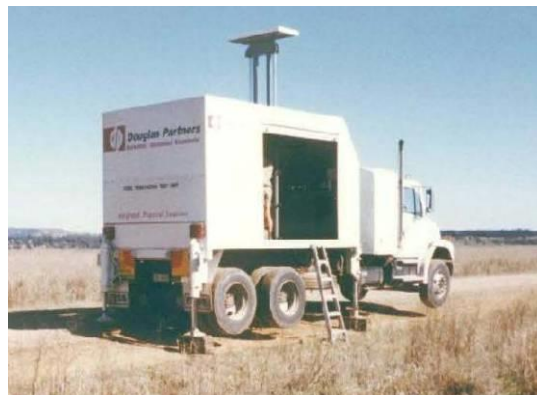
Figure 2: Purpose built CPT rig

The cone is thrust into the ground at a steady rate of about 20 mm/sec, usually using the hydraulic rams of a purpose built CPT rig, or a drilling rig. The testing is carried out in accordance with the Australian Standard AS1289 Test 6.5.1.

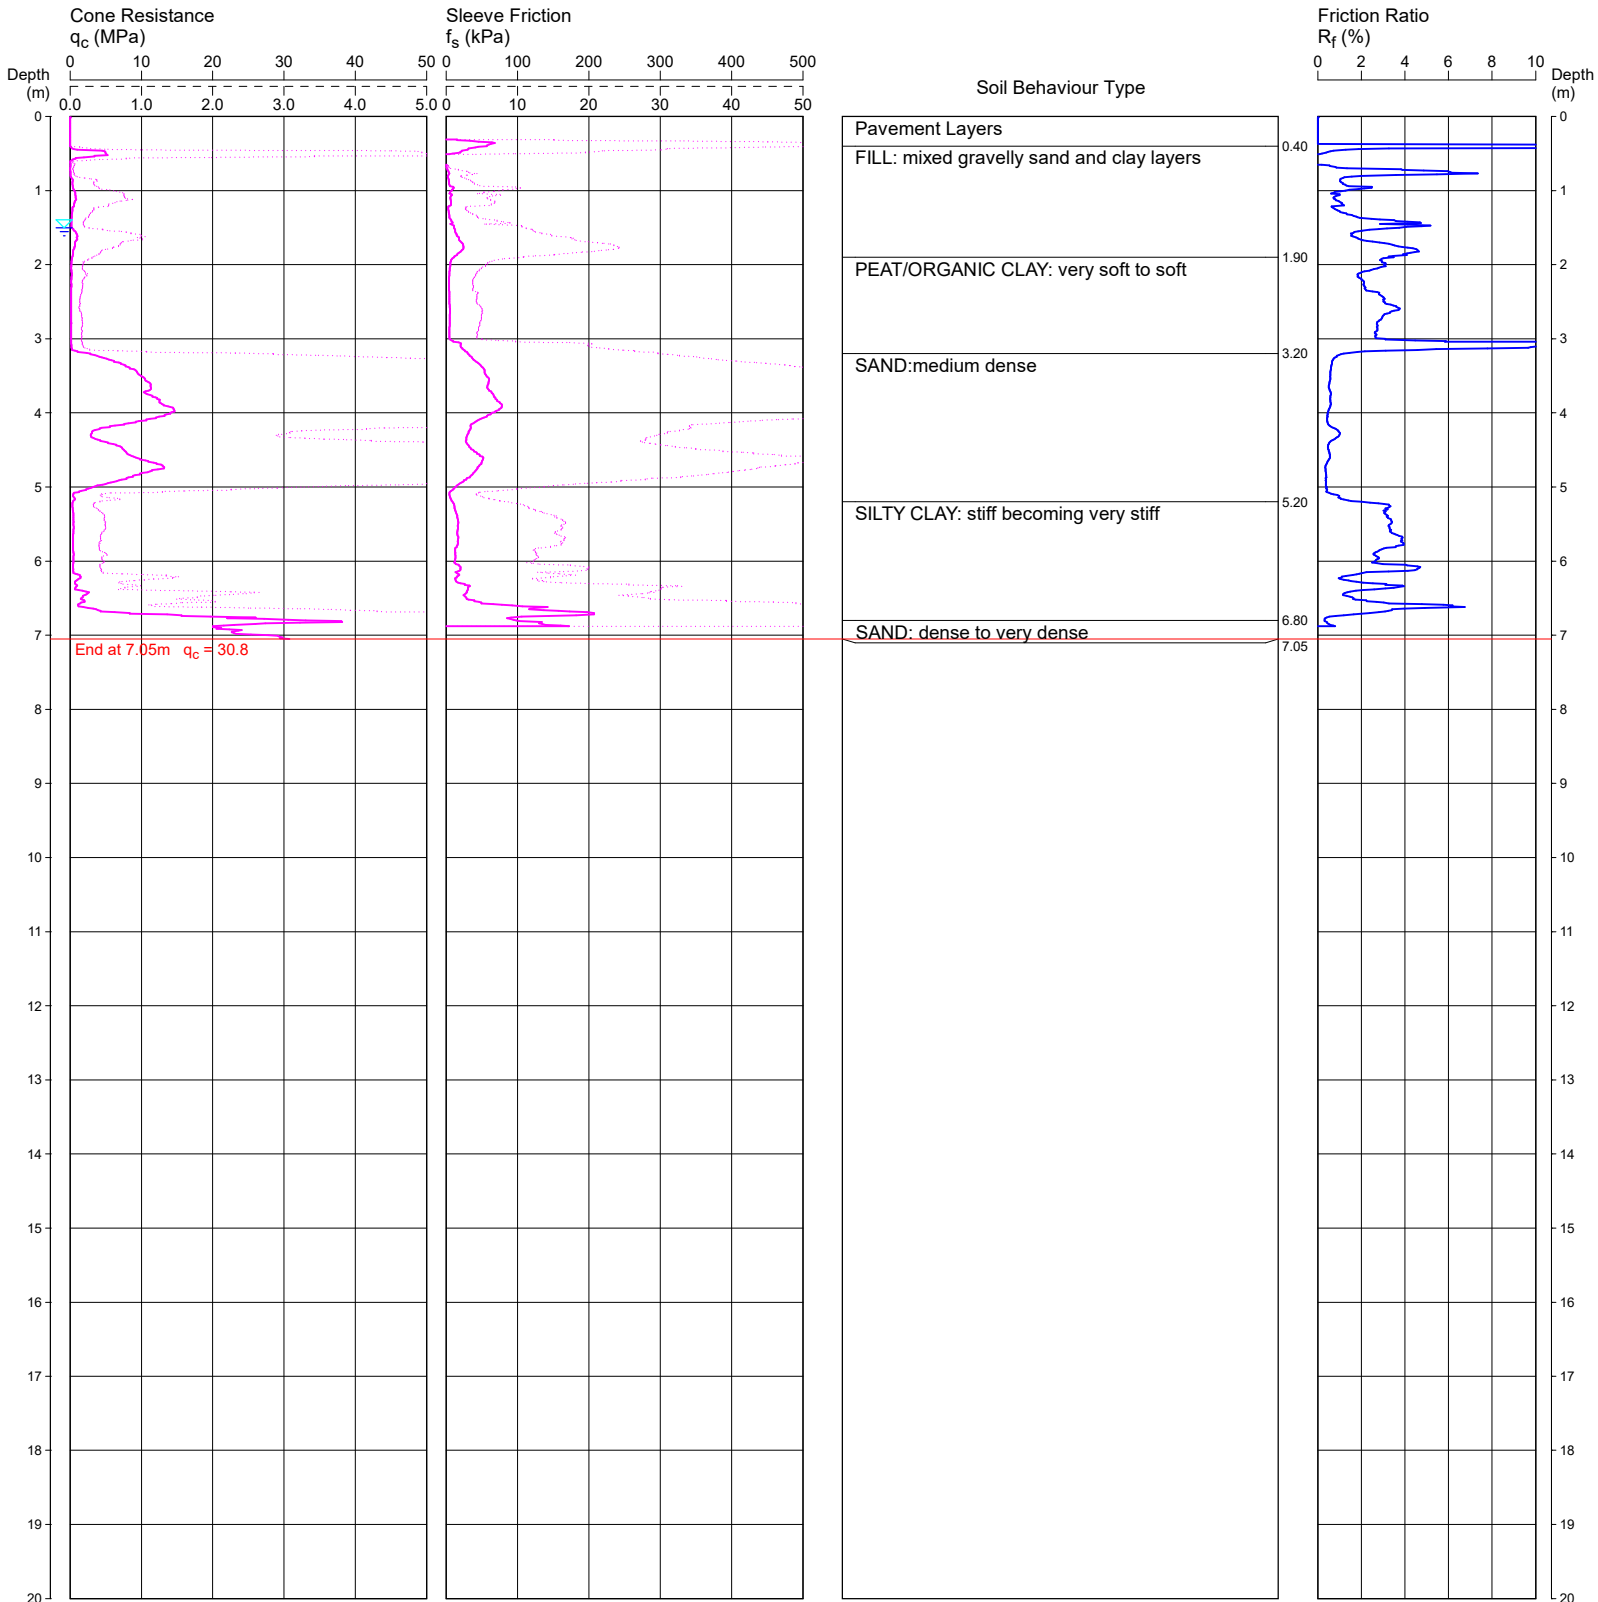
REMARKS: Dummy Cone to 0.4m deep. Test in Asphaltic Concrete Pavement.
Groundwater measured at 1.5m deep

Water depth after test: 1.50m depth (assumed)

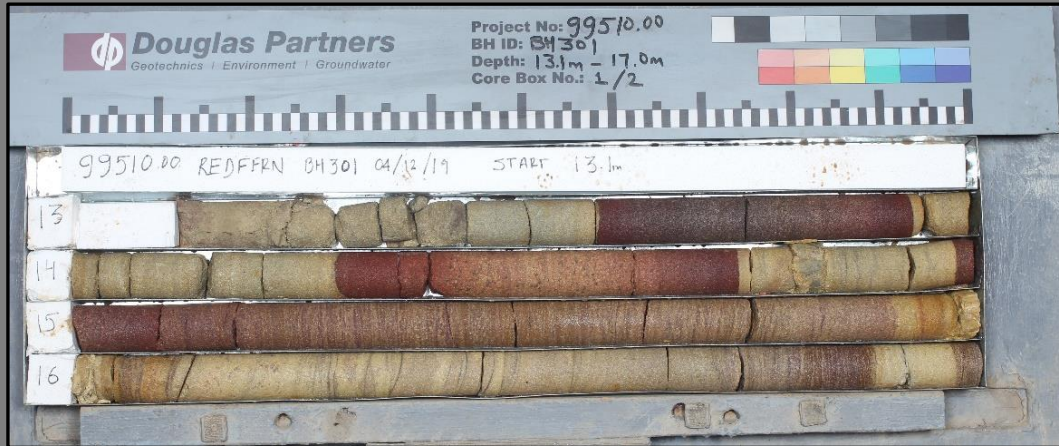
13.1 m – 17.0 m

BORE: 301 PROJECT: REDFERN DECEMBER 2019

The subsurface conditions encountered in the boreholes are described in the logs within Appendix C. Colour photographs of the recovered rock core are also included with the appropriate borehole in Appendix C. Notes defining descriptive terms and classification methods used are also included in Appendix C.

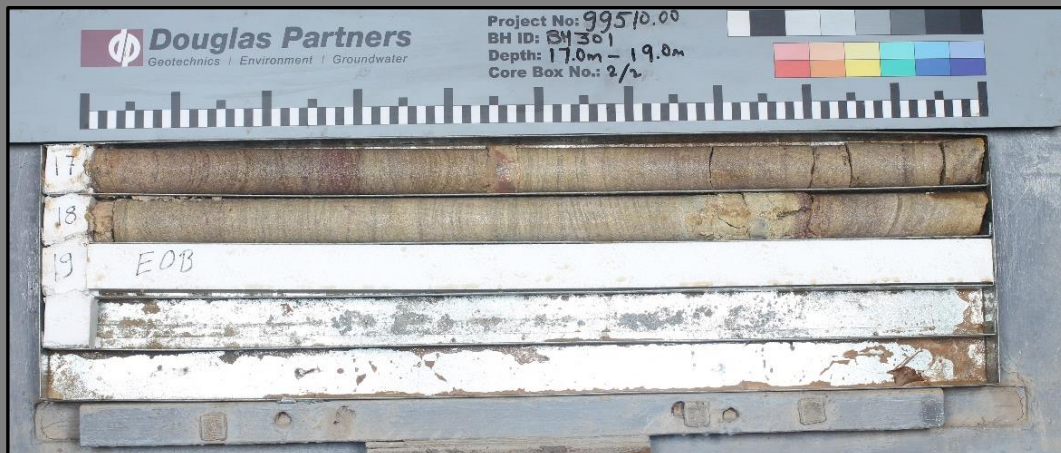
17.0 m – 19.0 m

BORE: 301 PROJECT: REDFERN DECEMBER 2019

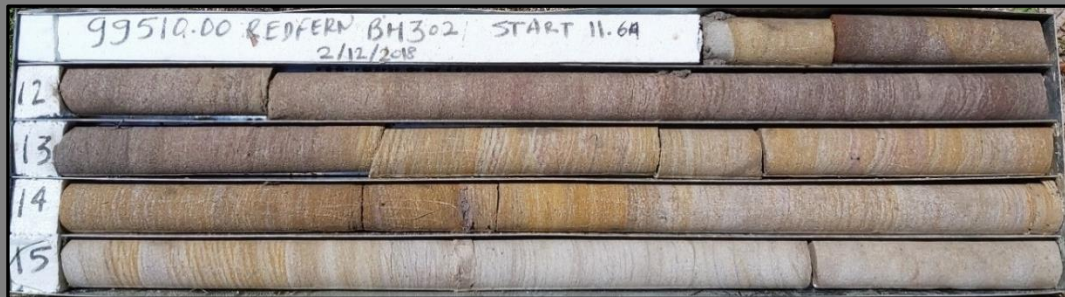
11.6 m – 16.0 m

BORE: 302 PROJECT: REDFERN DECEMBER 2019

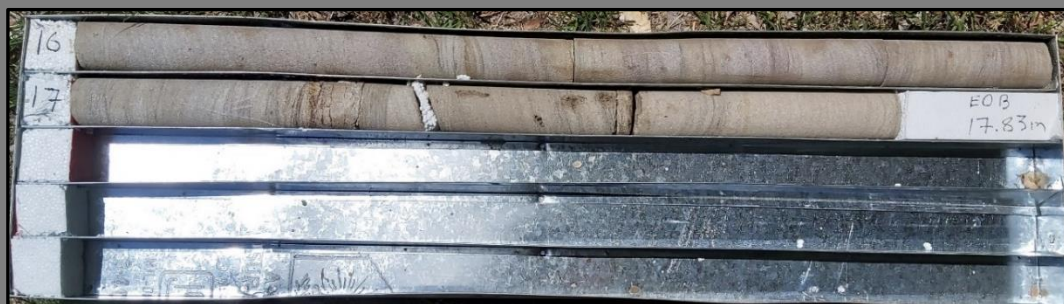
16.0 m – 17.83 m

BORE: 302 PROJECT: REDFERN DECEMBER 2019

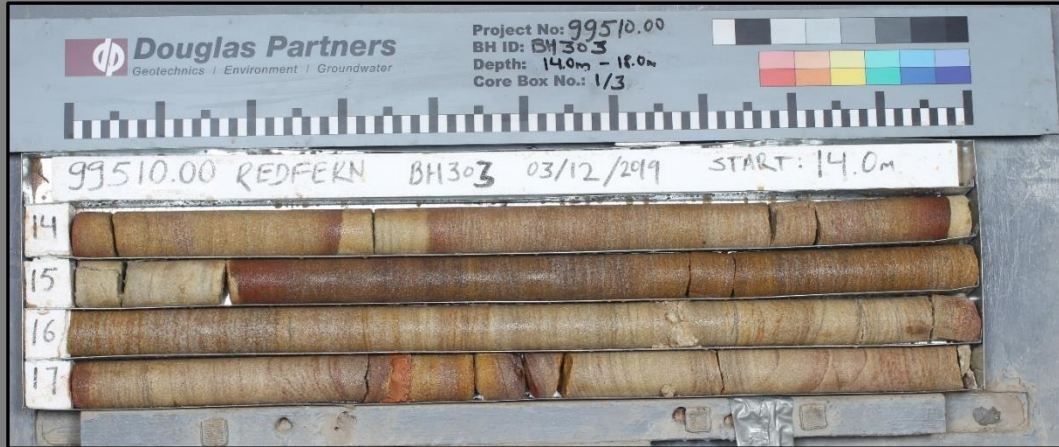
14.0 m – 18.0 m

BORE: 303 PROJECT: REDFERN DECEMBER 2019

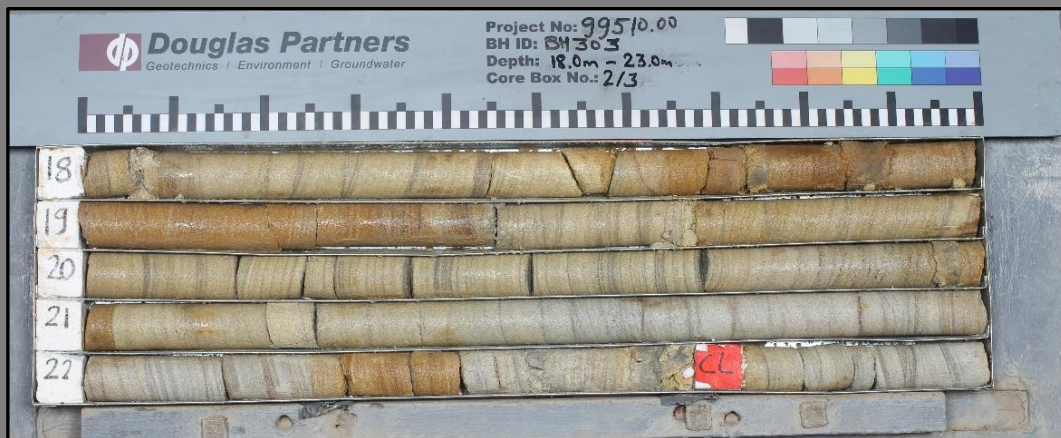
18.0 m – 23.0 m

BORE: 303 PROJECT: REDFERN DECEMBER 2019
