Project 99510.01
2 December 2022
R.006.Rev0
TK / PG:jl

Asbestos Assessment
Police Citizens Youth Club (PCYC), 600-660 Elizabeth Street, Redfern NSW

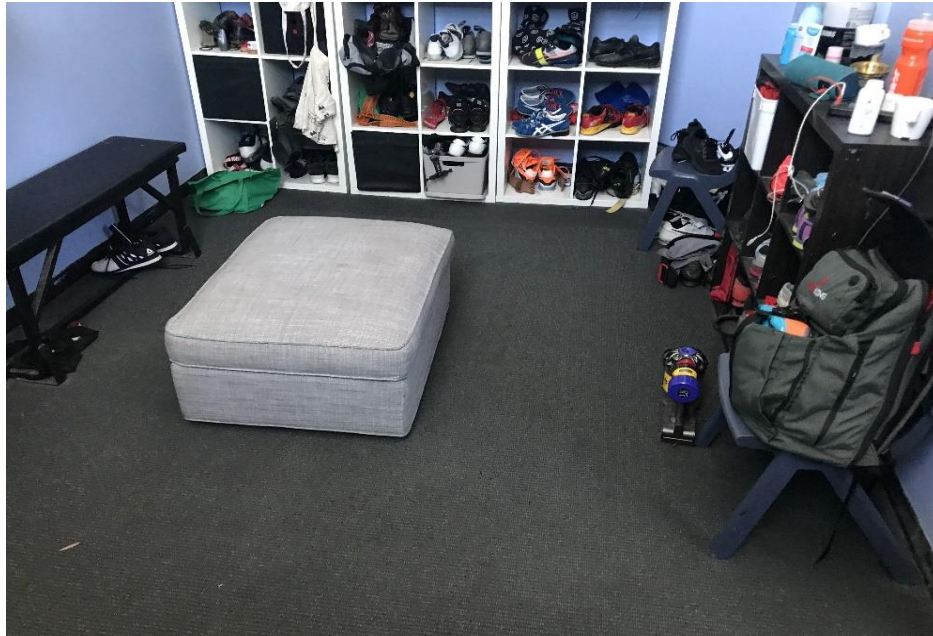
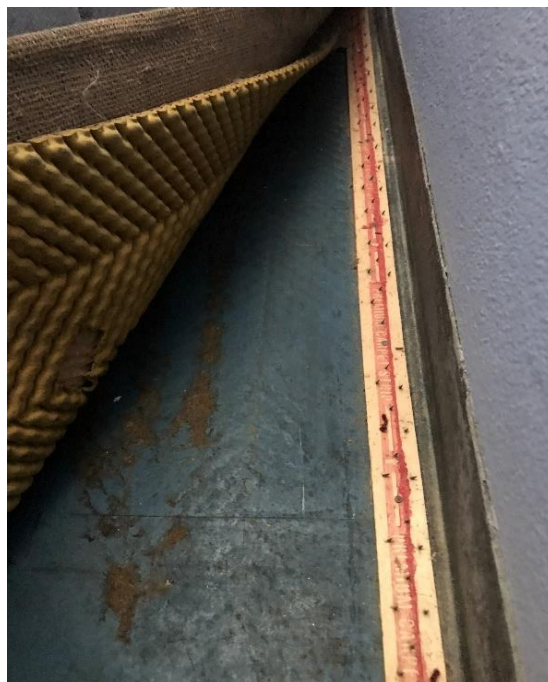
The vinyl floor tiles in Storage 7 were covered by carpet at the time of inspection (refer photograph 1 and 2 in Attachment B). Therefore, the inspection comprised peeling back the carpet in several areas to enable assessment and not all areas of vinyl floor tile could be accessed.

Photograph 1: PCYC, interior, storage 7, floor - blue vinyl floor tiles below carpet.

Photograph 2: PCYC, interior, storage 7, floor - blue vinyl floor tiles below carpet.

| Building | Location (General) | Location (Specific) | Material | Sample No.# | Material Status | Asbestos Risk Assessment | | | | | | | | Photo No.* | Summary Recommendation |
|---|---|---|---|---|---|---|---|---|---|---|---|---|---|---|--|
| PCYC | interior, storage 7 | floor, below carpet | blue vinyl tiles | A16 | asbestos detected by analysis | 0 | 1 | 1 | 1 | 2 | 1 | 6 | Low | 1, 2 | Reinspect hazardous material - Reinspect condition on a regular basis. Remove material prior to any significant disturbance (e.g. renovation, demolition or maintenance work). |

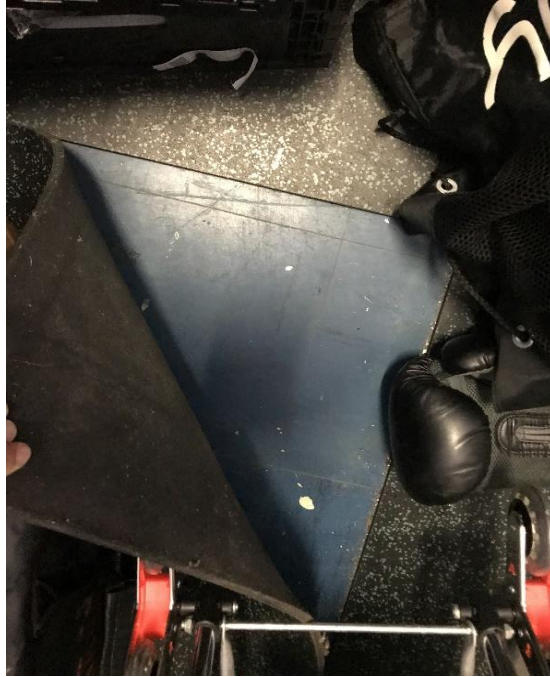
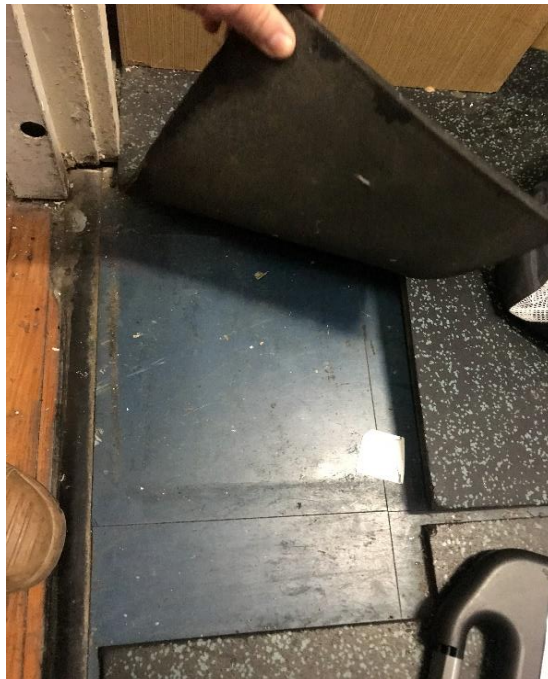
The floor area of Stationary Store was loosely covered by foam matting and access was also limited by stored gym equipment at the time of the inspection (refer photograph 3 and 4 in Attachment B). Therefore, inspection was conducted around and below the matting in several locations and not all areas of vinyl floor tile could be accessed.

Photograph 3: PCYC, interior, stationary store, floor, below matting - blue vinyl floor tiles.

Photograph 4: PCYC, interior, stationary store, floor, below matting - blue vinyl floor tiles.

| Building | Location (General) | Location (Specific) | Material | Sample No.# | Material Status | Asbestos Risk Assessment | | | | | | | | Photo No.* | Summary Recommendation |
|---|---|---|---|---|---|---|---|---|---|---|---|---|---|---|--|
| PCYC | interior, stationary store | floor | blue vinyl tiles | refer A16 | asbestos detected by analysis | 0 | 1 | 1 | 2 | 2 | 1 | 7 | Low | 3,4 | Reinspect hazardous material - Reinspect condition on a regular basis. Remove material prior to any significant disturbance (e.g. renovation, demolition or maintenance work). |
