# EXTENT

## 600–660 ELIZABETH STREET REDFERN

### HISTORICAL ARCHAEOLOGICAL EXCAVATION REPORT

August 2023 — Final

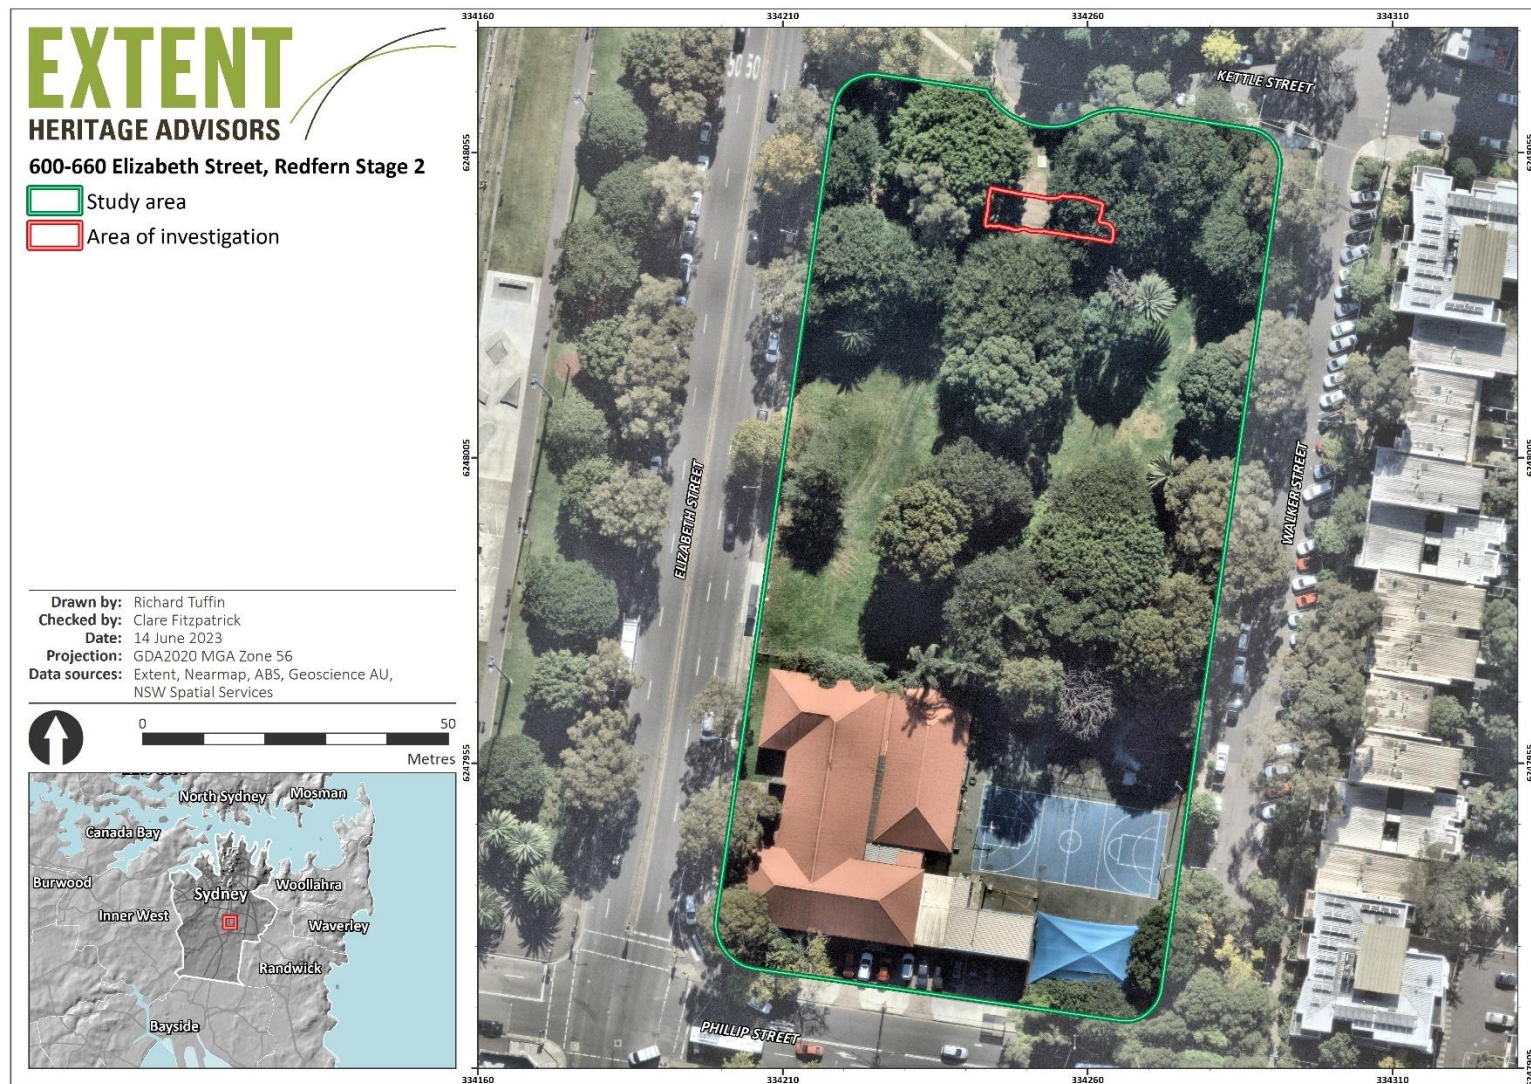
Figure 1. Location of the study area, with the extent of archaeological excavations undertaken within the 11 Alderson Street allotment outlined in red. .

The study area is located at 600–660 Elizabeth Street, Redfern and lies within the City of Sydney local government area (LGA). The study area is an LAHC owned and managed property comprising Lot 1 DP 1249145 and encompassing an area of approximately 1.1 ha. It is located 4 km southwest of the Sydney CBD and is bound to the north by Kettle Street, to the east by Walker Street, to the south by Phillip Street, and to the west by Elizabeth Street (Figure 1). The study area is largely vacant except for a single storey building and outdoor basketball court in the southern portion of the site, currently leased by PCYC South Sydney. Archaeological excavation was limited to the site of the former 11 Alderson Street (also referred to as the ‘area of investigation’), located in the northern portion of the study area.

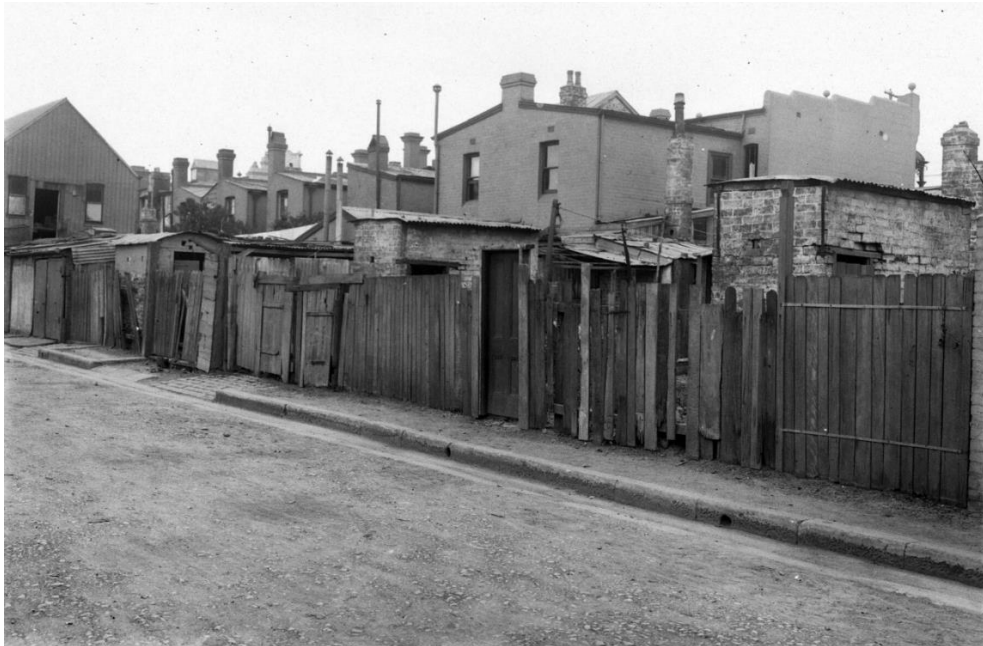
Figure 7. *Alderson Street showing backyards*, 1913 (New South Wales State Archives and Records, Government Printing Office 1 – 31164).

Two photographs capture the streetscape and rear yards of the properties along either side of Alderson Street. A 1913 photograph shows Alderson Street and the rear yards of the Elizabeth Street facing properties and was likely taken standing in front of 3 Alderson Street, facing southwest (Figure 7). A photograph, dating to 1900, was also taken from the northern end of Alderson Street and shows the rear yards of the Alderson Street properties (Figure 8). This photograph was likely taken atop the structure in the rear yard of 9 Alderson Street and although it misses the yard of 11 Alderson Street, the bottom left of the image captures the edge of the corrugated roof of the shared toilet outbuilding.

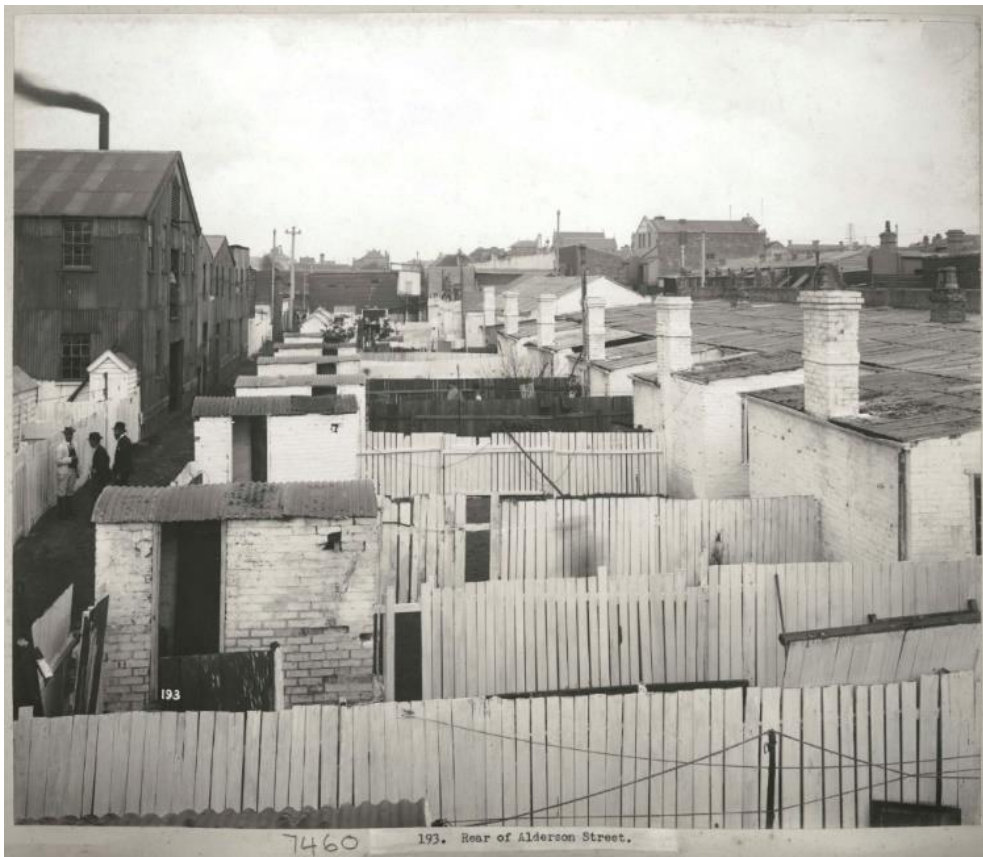
Figure 8. *Rear of Alderson Street*, 1900. Photograph was taken by John Degotardi Jnr, a photographer from the Department of Public Works and comes from a series of images showing the areas in Sydney affected by the outbreak of Bubonic Plague in 1900 (New South Wales State Archives and Records, NRS-12487-1-[5/3260]-Vol III-9).

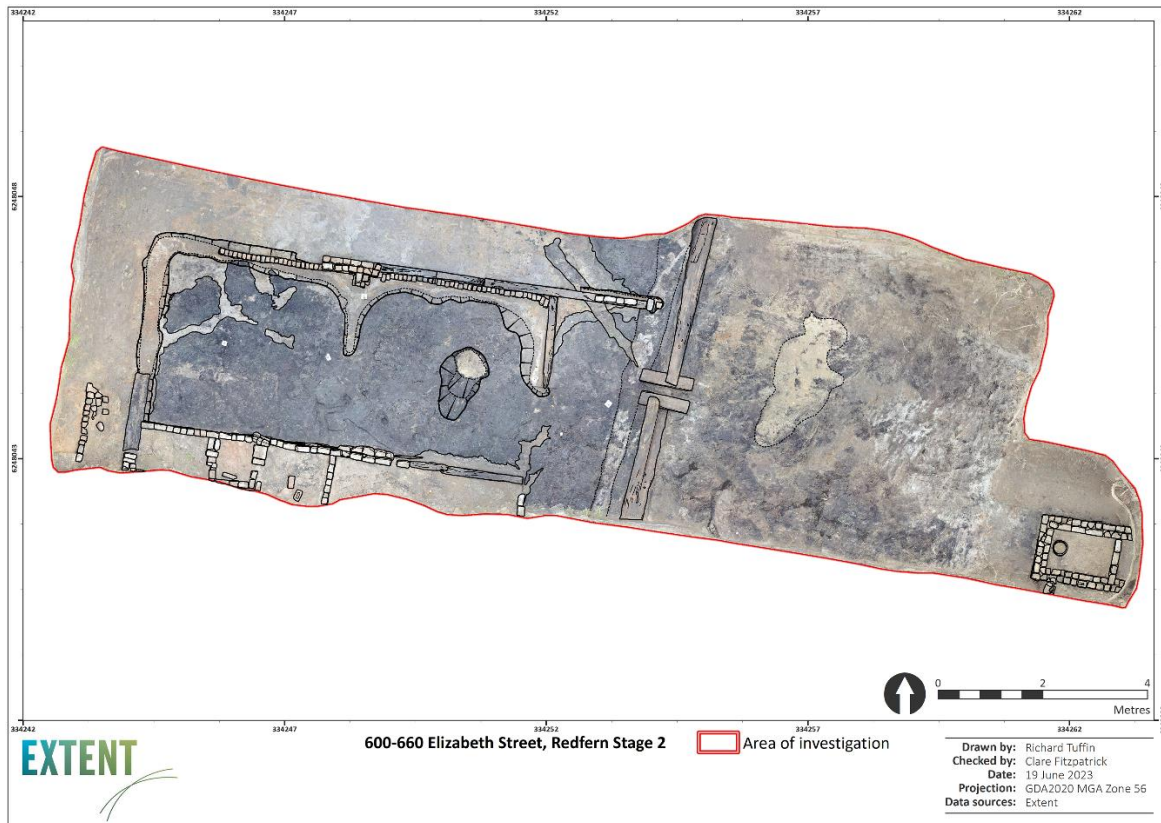
Figure 12. Orthoimage of the area of investigation, overlaid with plan of excavated archaeological features.

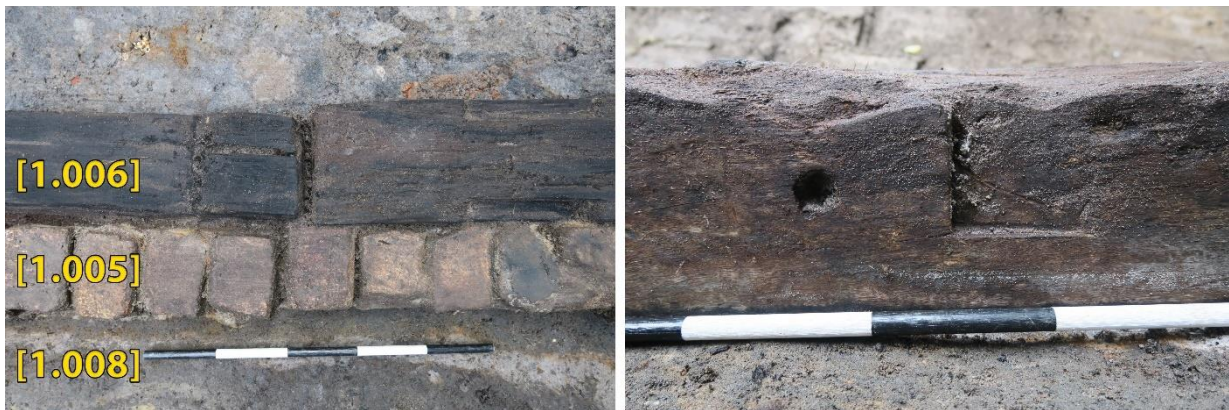
Figure 18. Detail of the timber beams [1.006] showing evidence of reuse in the form of bolt holes, notches, and joins, and the abutting brickbats [1.005], looking north.

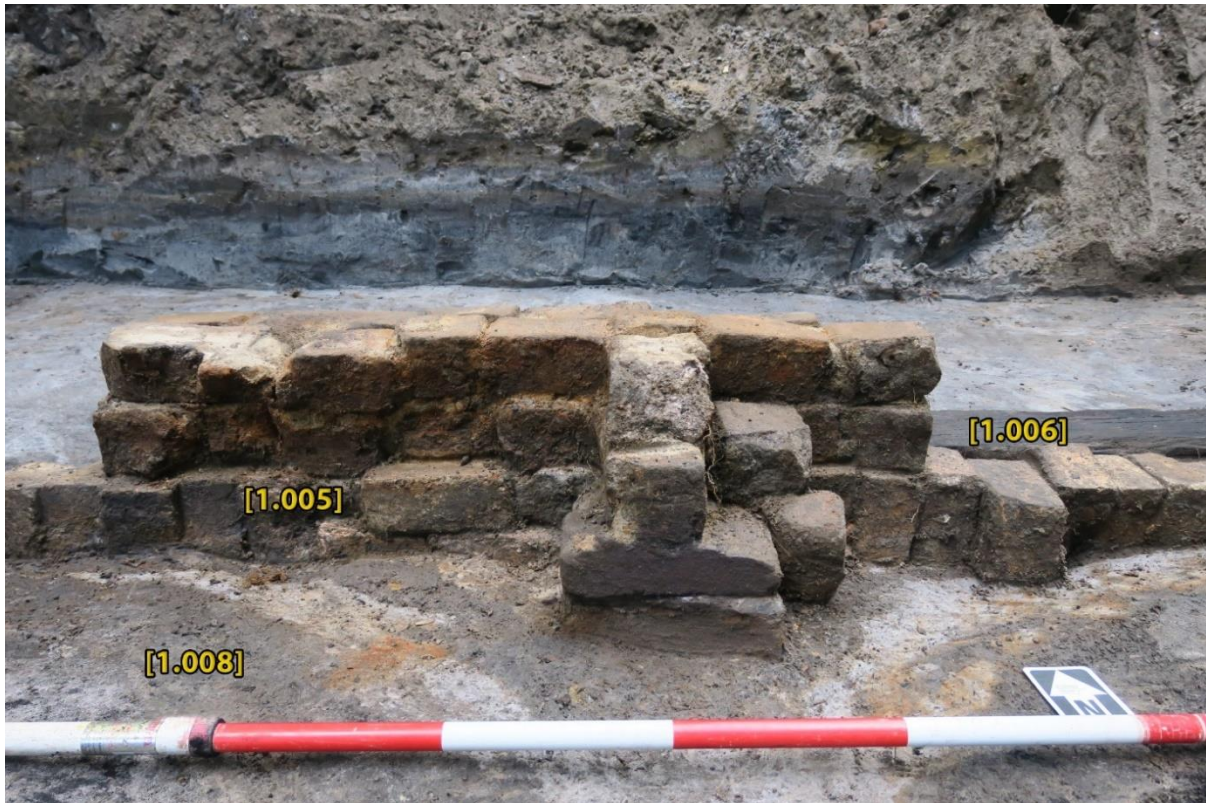
Figure 19. Structural remains of wall foundations and internal wall return along the northern footings between the front and middle rooms, looking north.

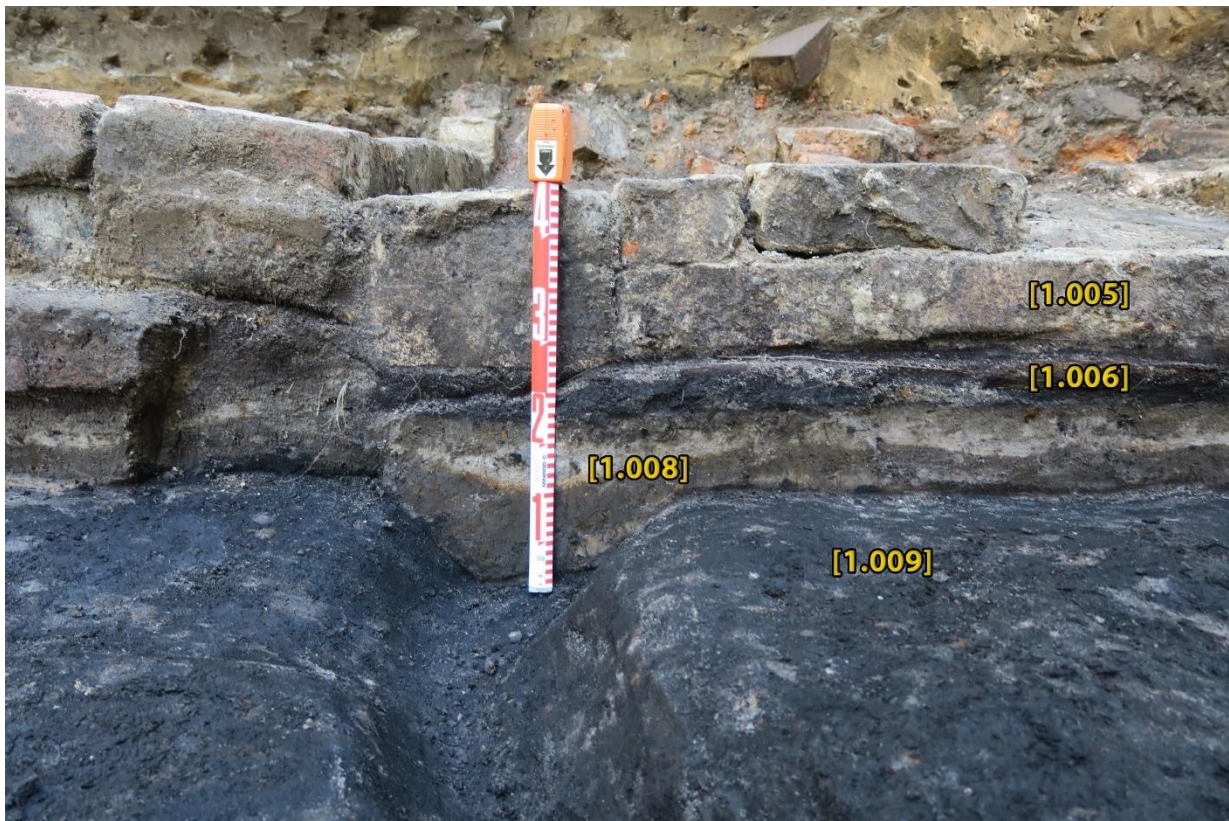
Figure 21. Southern footings, showing the levelling fill [1.008] in section, looking south. The timber and brick footings [1.005 and 1.006] can be seen above the levelling fill [1.008] that is overlying the basal peat.

Unlike the northern footings, the southern footings consisted solely of lengths of adjoining re-used timber beams [1.006] with no abutting course of brickbats. The southern footings were exposed directly under the demolition rubble fill [1.002] at a depth of 650 mm. Wall foundations consisting of two courses of whole and half bricks survived along the top of the timber footings in the front room and partially into the middle room. The southern footings were also cut into a levelling fill [1.008] that had a maximum thickness of 150 mm. As seen in Figure 21, the levelling fill consisted of bands of irregular orange and white sands and greyish brown clay deposited above pockets of light grey sand [1.025] and undulating basal peat [1.009].

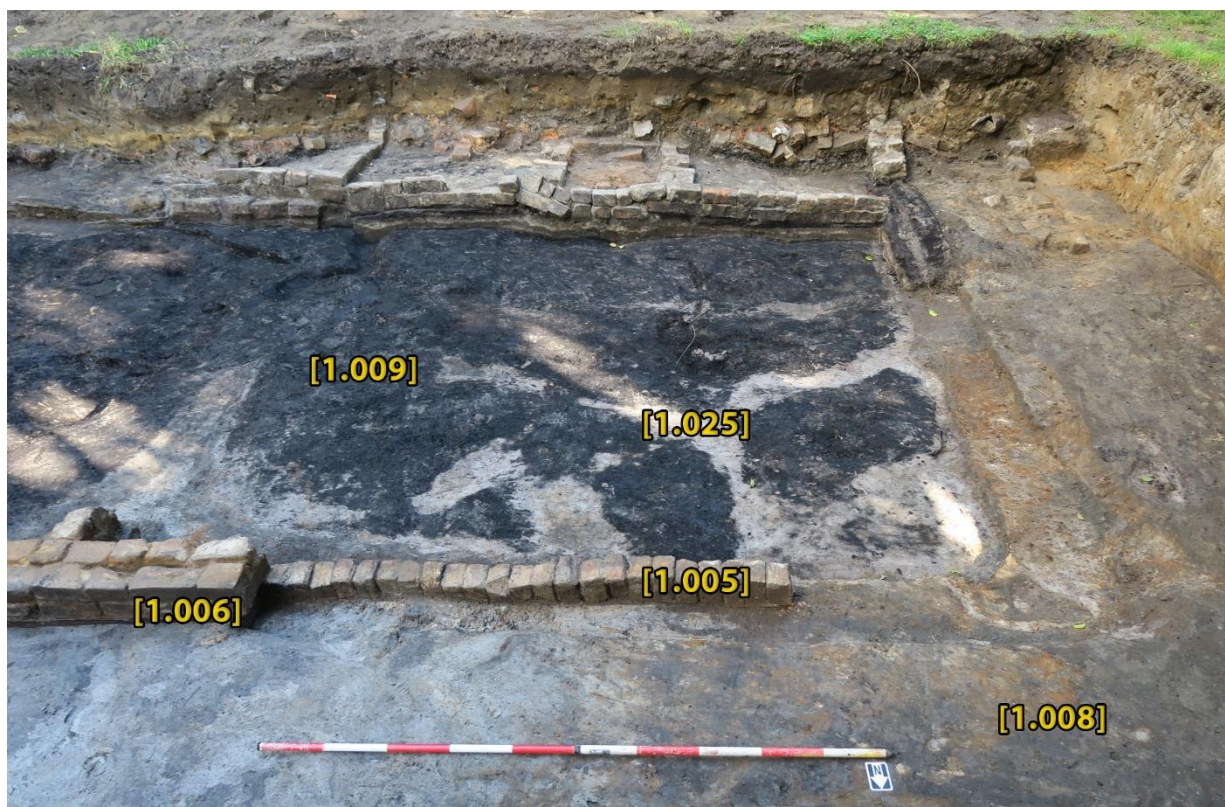
Figure 23. 11 Overview of the front room of the terrace showing the brick [1.005] and timber [1.006] footings, looking south. Light grey sand pockets [1.025] can be seen above the black peat [1.009].

No occupation or underfloor deposits were observed during the excavation of the internal rooms of 11 Alderson Street. The interior space of the front room measured 3,400 mm by 3,300 mm (Figure 23). The levelling fill [1.008] and the light grey sand [1.025] in the southern half of the front room were excavated down to the undulating basal peat [1.009] to confirm the absence of any further deposits overlying the basal peat [1.009]. Three buttons were recovered from the excavation of the internal levelling fill abutting the southern footings. A leather shoe was also found in the internal levelling fill abutting the northern footings. The artefact assemblage is discussed further in Part 4.3.

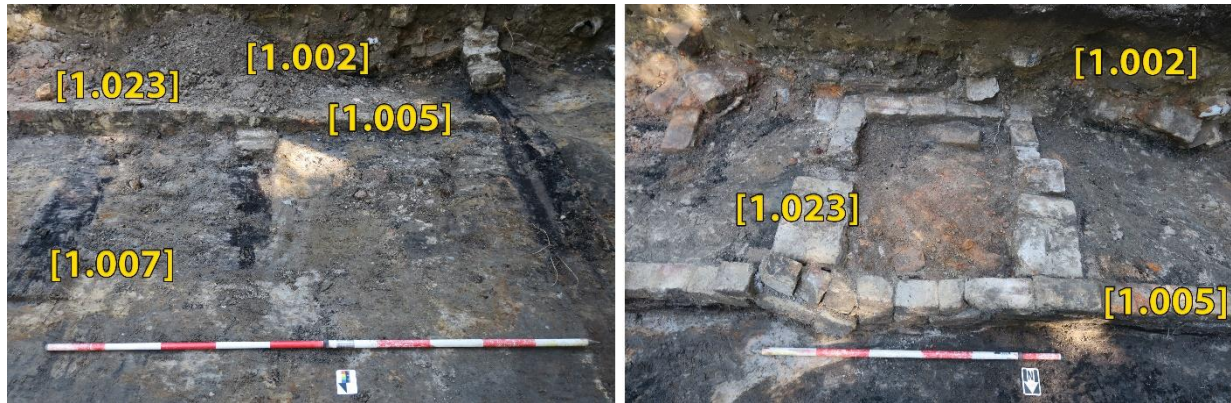
Figure 24. Detail of the remains of the fireplace [1.007] in 11 Alderson Street (*left*), and the more substantial remains of the adjacent fireplace [1.023] in the neighbouring 13 Alderson Street (*right*), looking south.

apart and measured between 1270 mm and 1800 mm in length, and 250 mm in width. Two bricks were located on top of the westernmost timber slab. No further evidence associated with the fireplace such as a hearth were present. The timber fireplace footings were removed during excavation to further reduce the internal level of the terrace and expose the underlying basal peat [1.009]. The intact brick foundations of a fireplace were also exposed in the adjoining terrace 13 Alderson Street, mirroring the location of the timber slab fireplace footings in 11 Alderson Street. Here, the fireplace foundations measured 1,200 mm by 1,000 mm.

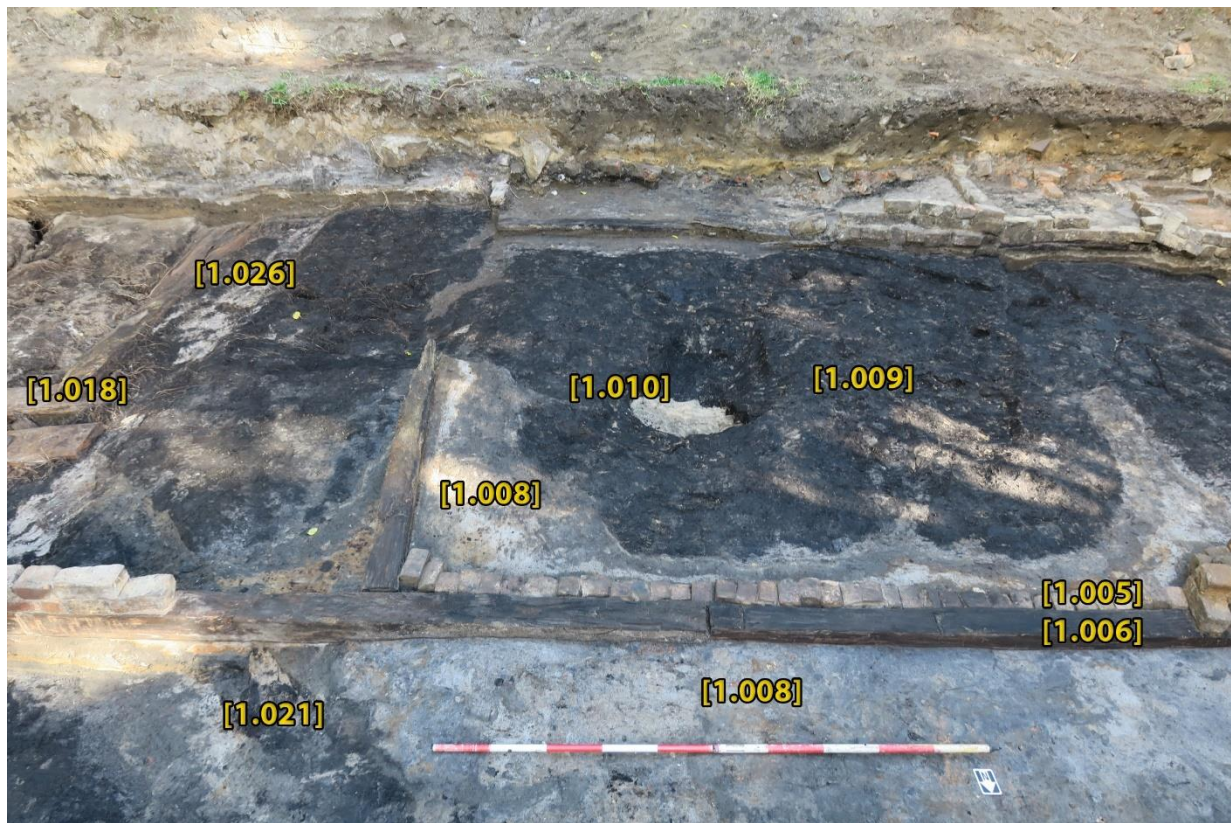
Figure 25. Overview of the middle and rear rooms of the terrace, looking south. The middle room was partially excavated during 2021 test excavations, including the northern footing and the sub-circular feature [1.010]. The levelling fill [1.008] can be observed around the northern footing [1.005 and 1.006].

No features associated with the pre-1883 terraces were exposed in the rear room of the terrace (Figure 25). The rear room was smaller than the two front rooms, extending back only 2,000 mm.

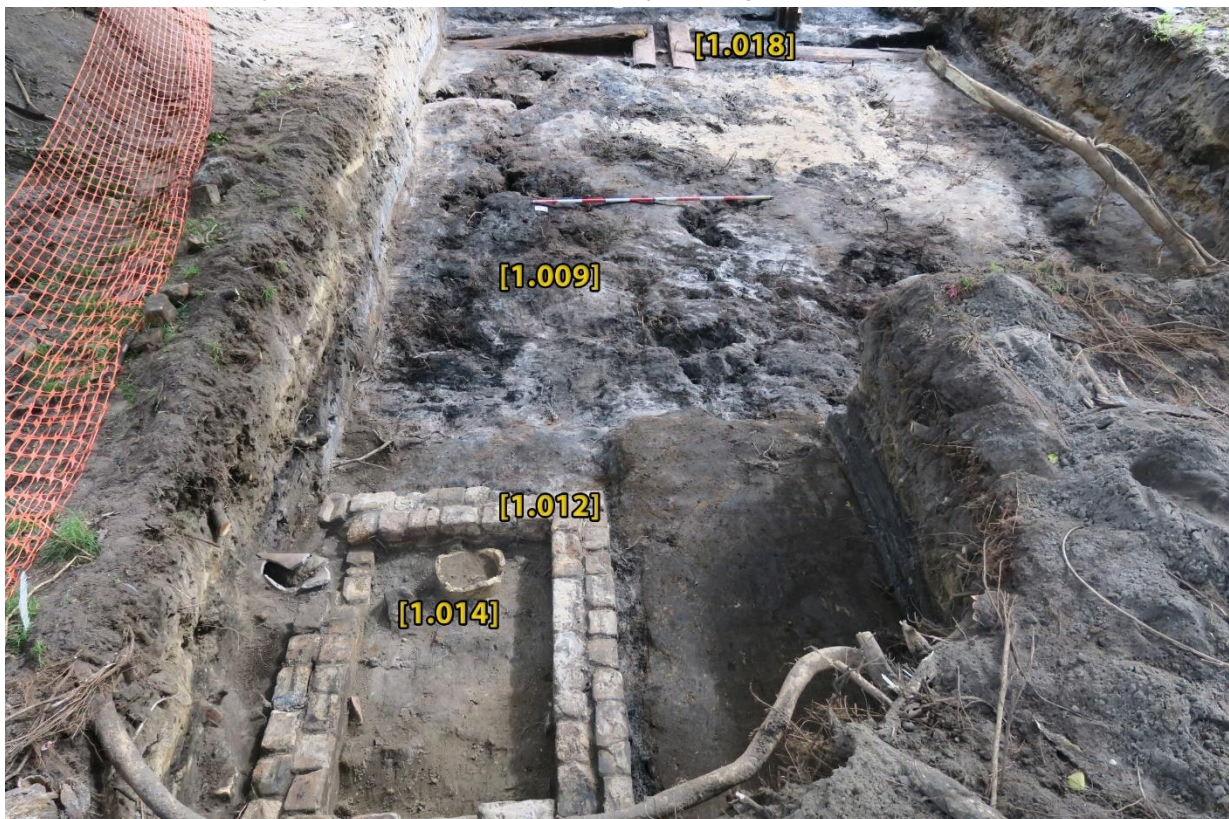
Figure 26. Rear yard of 11 Alderson Street showing the toilet outbuilding [1.012 and 1.014], basal peat [1.009], and the timber beams [1.018], looking west.

No yard surfaces were observed during the excavation of the yard area of 11 Alderson Street (Figure 26 and Figure 27). Beneath the sandy loam topsoil dressing [1.001] and demolition rubble fill [1.002], a sand fill sequence [1.003 and 1.004] approximately 450 mm thick was observed. The sand fills were overlying the basal peat deposit [1.009], with the entire area excavated to a maximum depth of 1,200 mm (Figure 29). Unlike the terrace structure, the yard appears to have been significantly disturbed by later demolition events. Excavation revealed disturbance [1.020] associated with the public housing phase of development not only in the upper fills, but in patches of the peat [1.009] below, consisting of yellow fine-grained sand, bricks, building tiles, and window glass. Additionally, the basal peat [1.009] had been heavily impacted by environmental processes. The compaction and expansion of the peat from moisture fluctuations, as well as the bioturbation from tree root activity created cavities within the deposit (Figure 28).

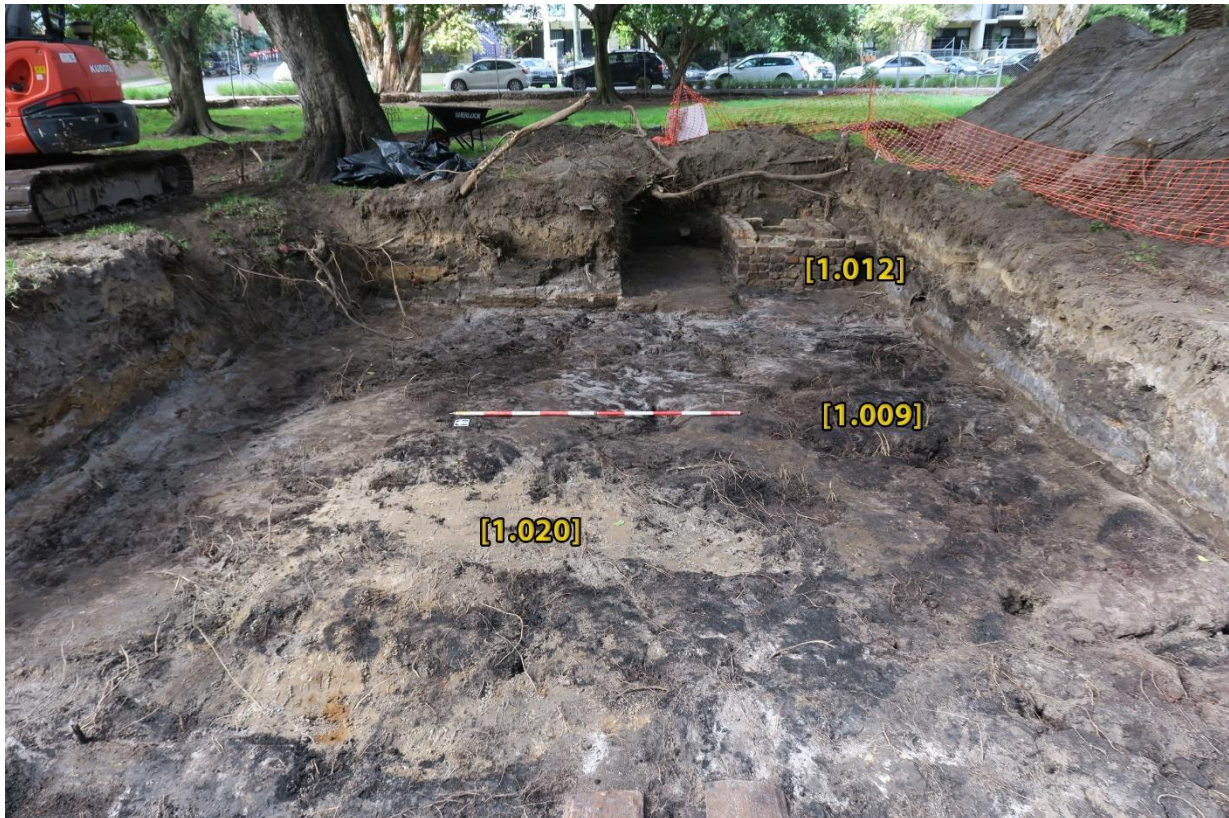
Figure 27. Rear yard of 11 Alderson Street showing the toilet outbuilding [1.012 and 1.014], basal peat [1.009], and public housing demolition disturbance [1.020], looking east.

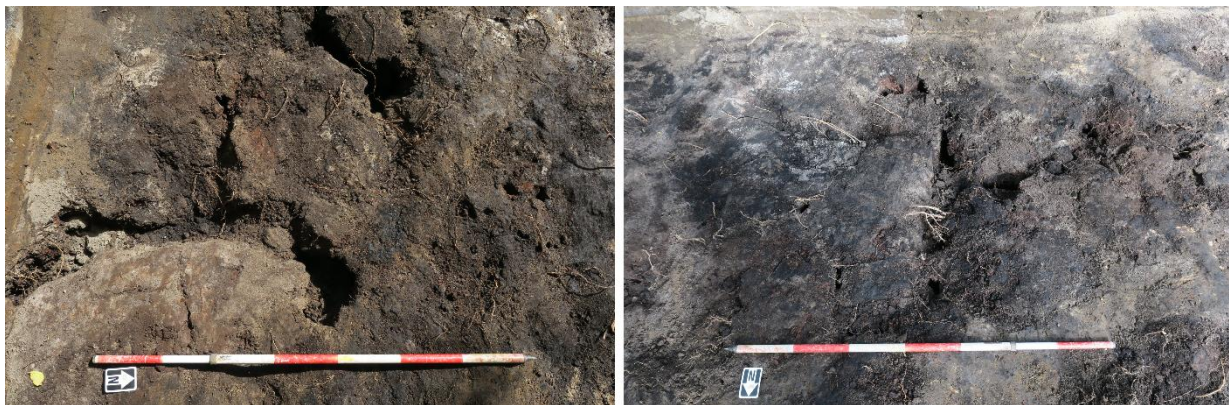
Figure 28. Detail of peat [1.009] in rear yard of 11 Alderson Street showing environmental disturbances to basal peat layer [1.009] caused by moisture processes in the soil and bioturbation from root activity.

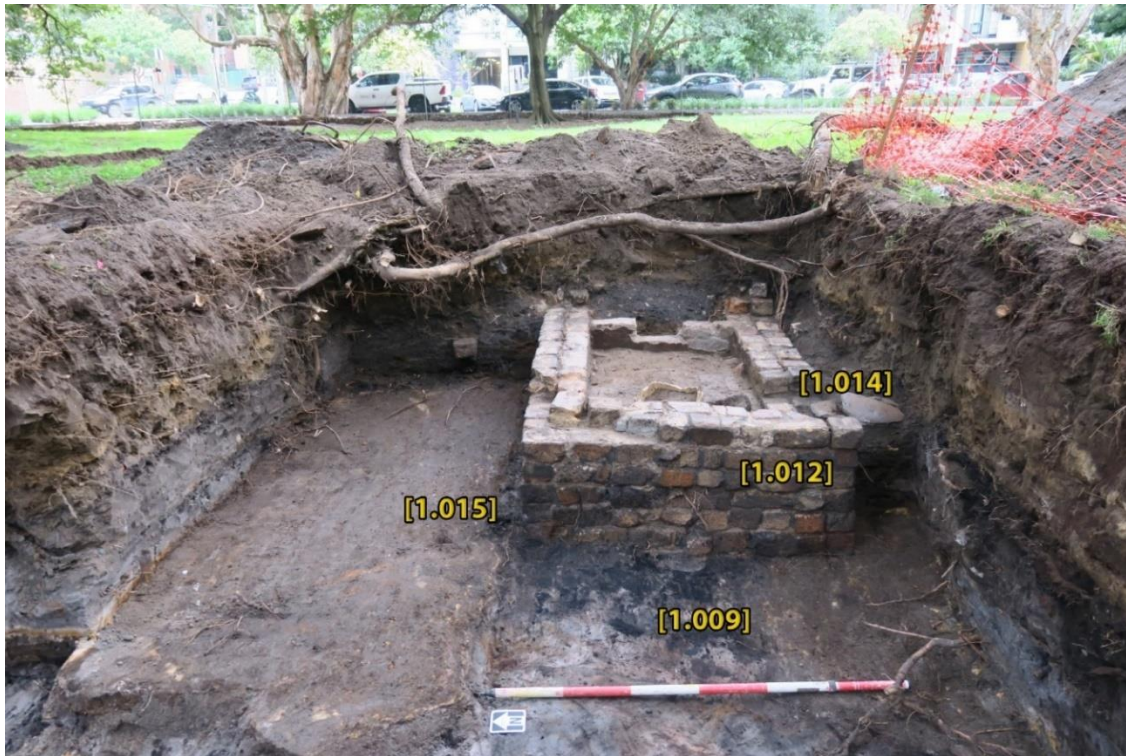
Figure 30. Toilet outbuilding [1.012] in the rear yard with sewer line and closet bend intact [1.014], looking east. A construction cut [1.016] and fill [1.015] for the foundations was identified on the northern side, cut into the levelling fill [1.008]. The internal rooms of the toilet were both lined.

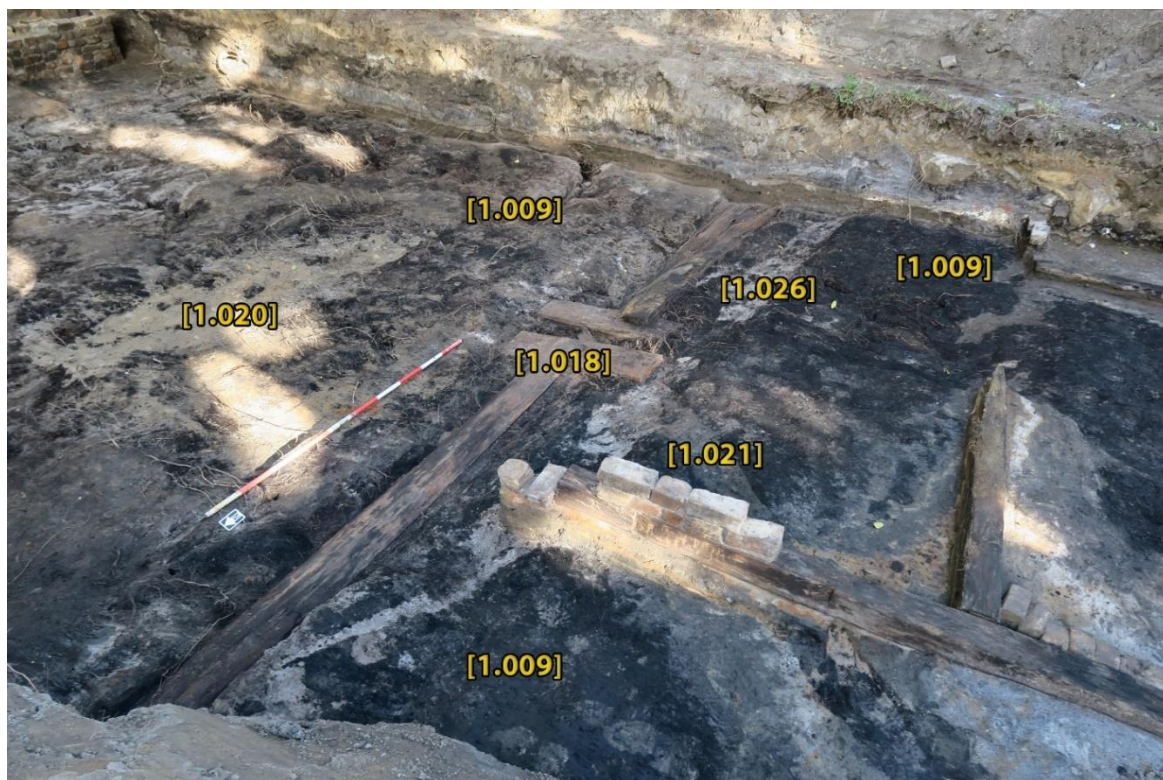
Figure 32. Rear of the terrace and yard, looking southeast, showing timber beams [1.018] and associated parallel drainage cut [1.026] cut into the peat [1.009]. Additional drainage cut associated with Albert Ground phasing [1.021] can be seen running southeast below the timber and brick footings.

In the yard at the rear of the terrace structure, five timber slabs [1.018] were uncovered at a depth of 1,200 mm (Figure 32 to Figure 34). Three of the timber slabs were orientated north to south and had exposed lengths between 2,160 mm and 3,740 mm, continuing into both the south and north trench walls. Two additional slabs orientated east to west were located in the middle, measuring 960 mm in length. The timber slabs were all slightly curved in section and varied in widths from 250 mm to 310 mm. A shallow cut [1.017] for the timber slabs was observed in the basal peat [1.009]. The slabs were not load-bearing and did not form part of the finished structure. They appear to have functioned as barrow-runs or duckboards during construction of the terraces. This may have been a response to weather conditions encountered during construction in which the peat substrate was waterlogged.

A parallel linear feature [1.026] underlying the northern terrace footings was observed west of the timber slabs and interpreted as a construction drainage channel, with a maximum width of 380 mm.

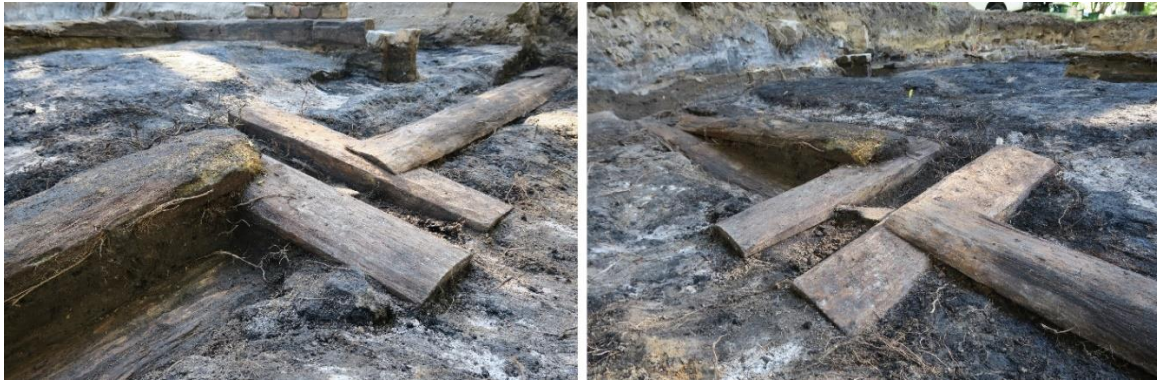
Figure 33. Detail of timber beams [1.018] at the rear of the terrace.

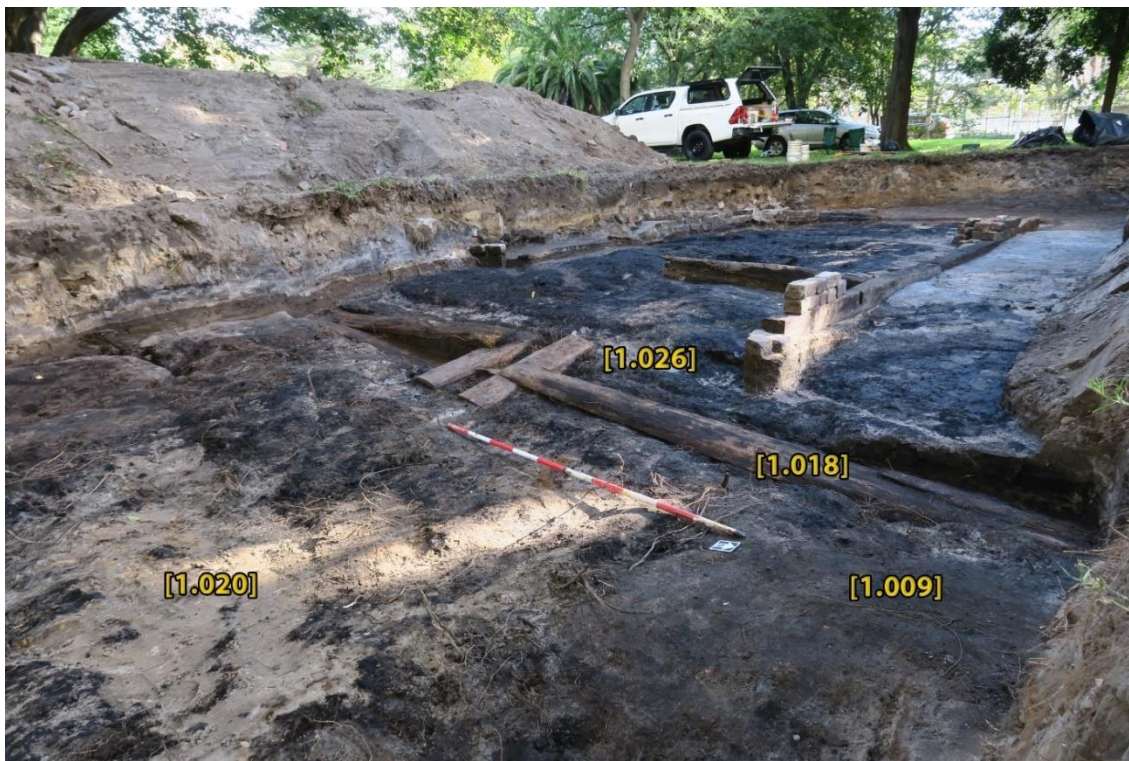
Figure 34. Timber beams [1.018] cut into the peat [1.009] at the rear of the terrace, looking southwest. The timber beams continue into both south and north trench walls.

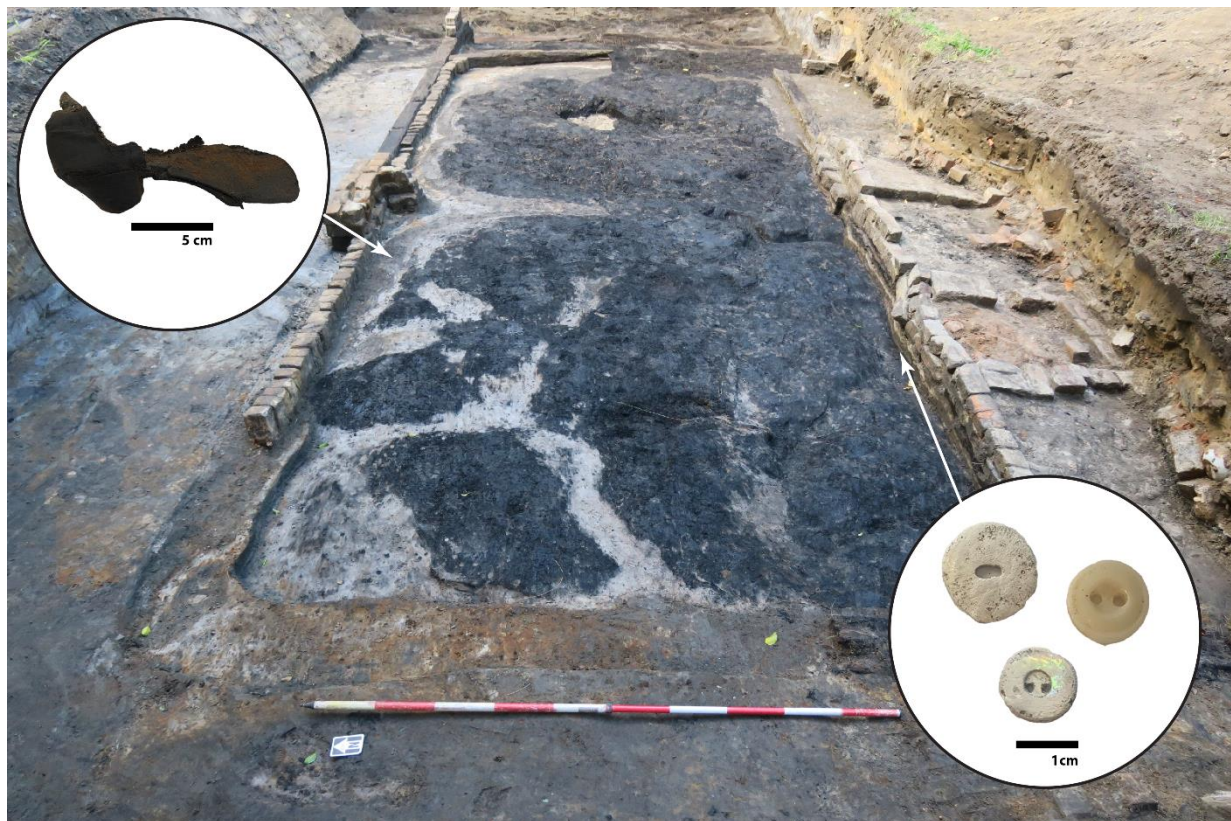
Figure 35. Three buttons and one leather shoe were recovered from the levelling fill [1.008] in the front room of 11 Alderson Street.

A small assemblage of artefacts was unearthed during the excavation of 11 Alderson Street, comprising three buttons and one leather shoe (Figure 35.). Two of the buttons were made of nacre (mother of pearl) and one was made from glass, with all three recovered during the excavation of the internal levelling fill [1.008] abutting the southern footings. The buttons all had two holes within recessed wells, measuring 10 mm, 13 mm, and 15 mm in diameter and were likely used for undergarments or shirts. The leather shoe, with wooden heel and outer sole and midsole intact, was found in the internal levelling fill [1.008] abutting the northern footings. Table 2 presents a summary of the artefact assemblage.

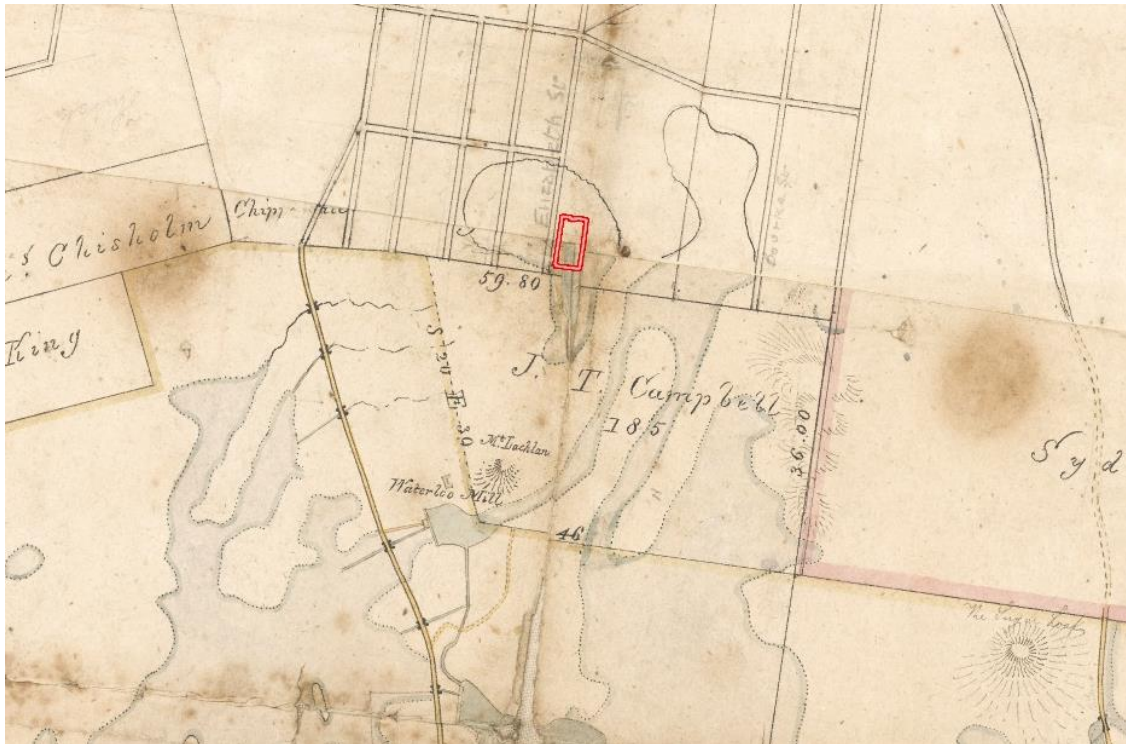
Figure 38. Map dated between 1820 and 1840, showing the study area (outlined in red) located within a swamp (SLNSW Maps/0586).

By the early nineteenth century, land grants were being made throughout the Sydney region. The study area lies within a 185-acre land grant made to Edward Smith Hall in 1822, with development during this period likely limited to land clearing and property fences or survey marker (Jervis and Kelly 1960, 105). After a failed attempt at farming and a turbulent beginning to his career in publishing, Hall was convicted of libel in 1829, and consequently sold his land grant at Redfern to Daniel Cooper and Solomon Levey (Kenny 1966). Flour mills and wool washing industries were established in the swampy areas of neighbouring Waterloo, Randwick, and Moore ~~Park, Park:~~ however, Boxley's Lagoon appears not to have been used for similar industrial pursuits (Figure 38)

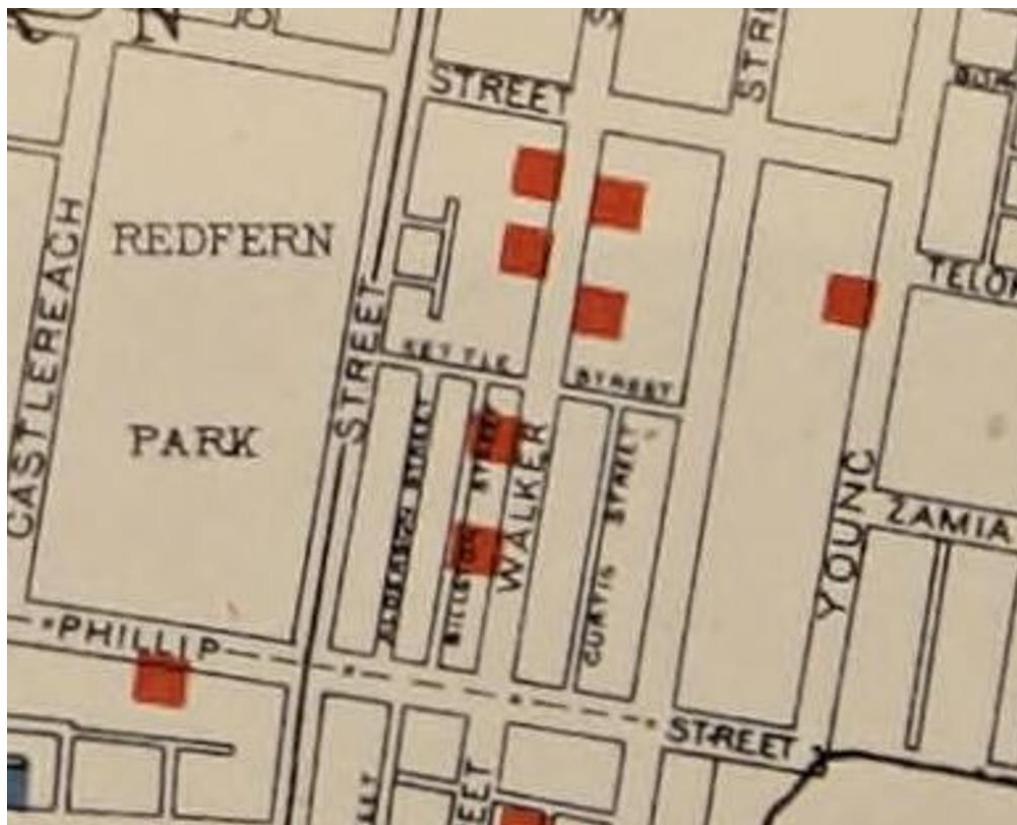
Figure 50. Plague cases recorded in 1900, denoted by red squares. Two cases were recorded within the study area along Walker Street (Department of Public Health – Map of Sydney and Adjacent Municipalities 1903).

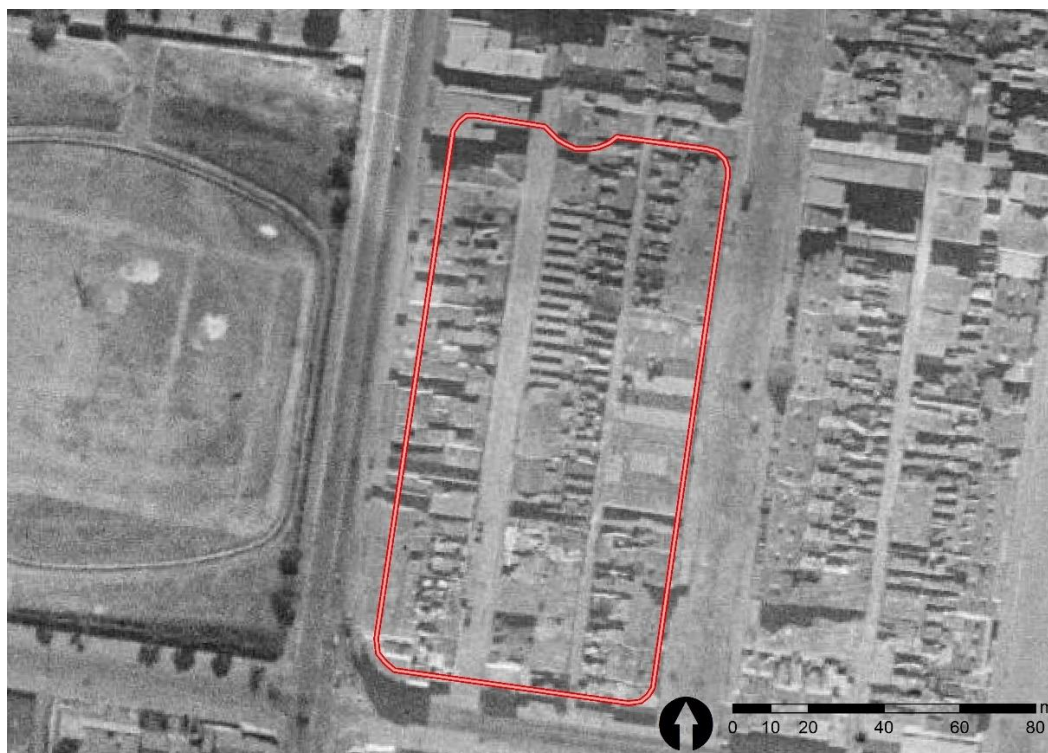
Figure 51. 1943 aerial photograph of the study area (Land and Property Information, Six Maps).

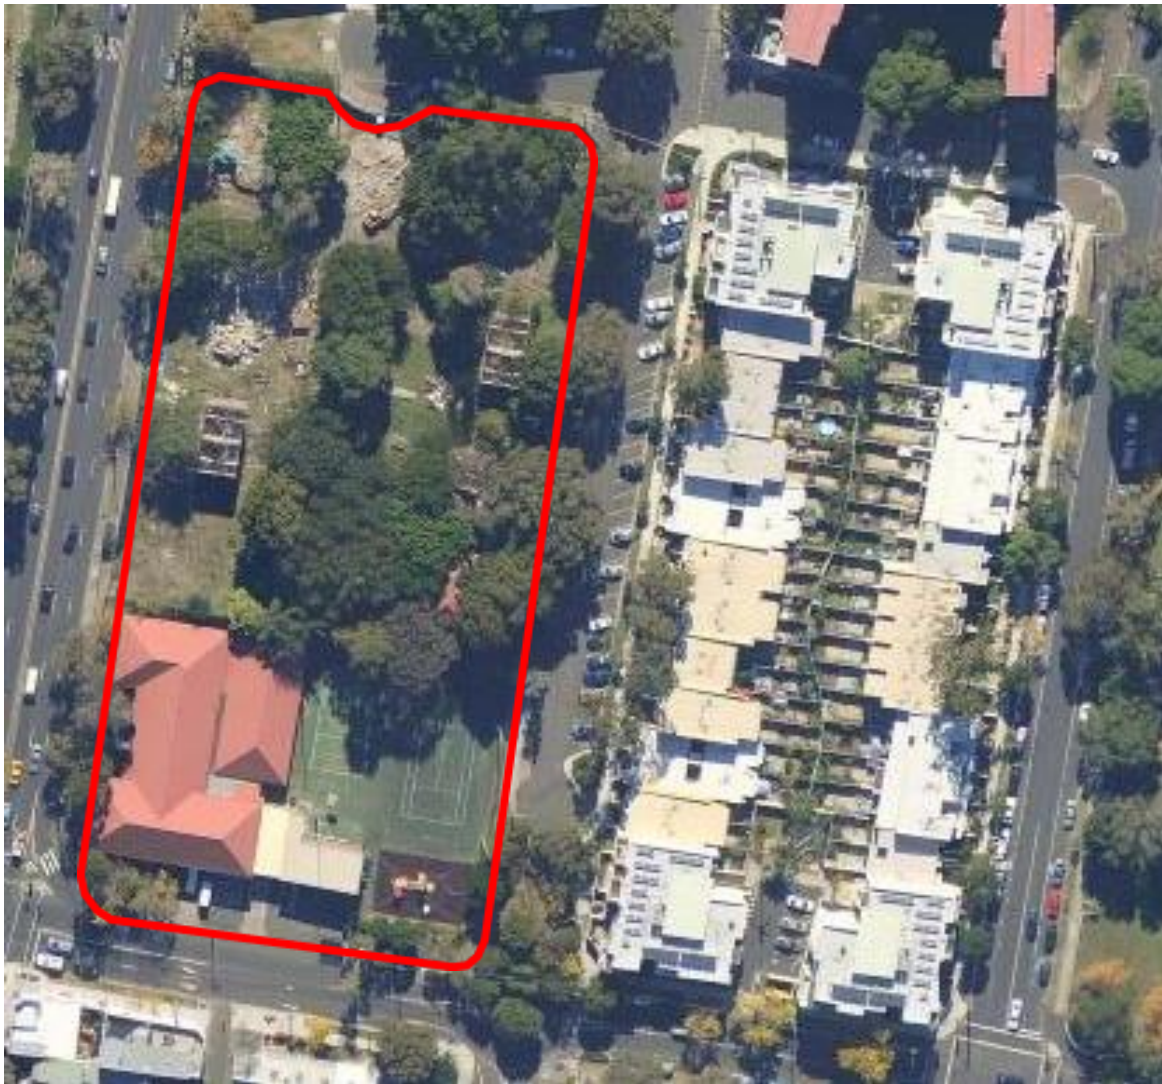
Figure 54. Nearmaps imagery from May 2013, showing structures being demolished. The site is now vacant except for the large mature trees and the remaining PCYC building (Nearmaps, May 2013).

The most recent development on the study area includes the demolition of the nine public housing blocks to ground level by May 2013 (Figure 54). Whilst the NSW Police-Citizens Boys Club is still extant, the northern portion of the site has remained unchanged since this time. Evidence of the demolition of the public housing buildings is still present across the study area, in the form of concrete footings on the surface and landscaping consisting of mature trees and decorative plantings.
