# EXTENT

## 600–660 ELIZABETH STREET REDFERN

### HISTORICAL ARCHAEOLOGICAL EXCAVATION REPORT

August 2023 — Final

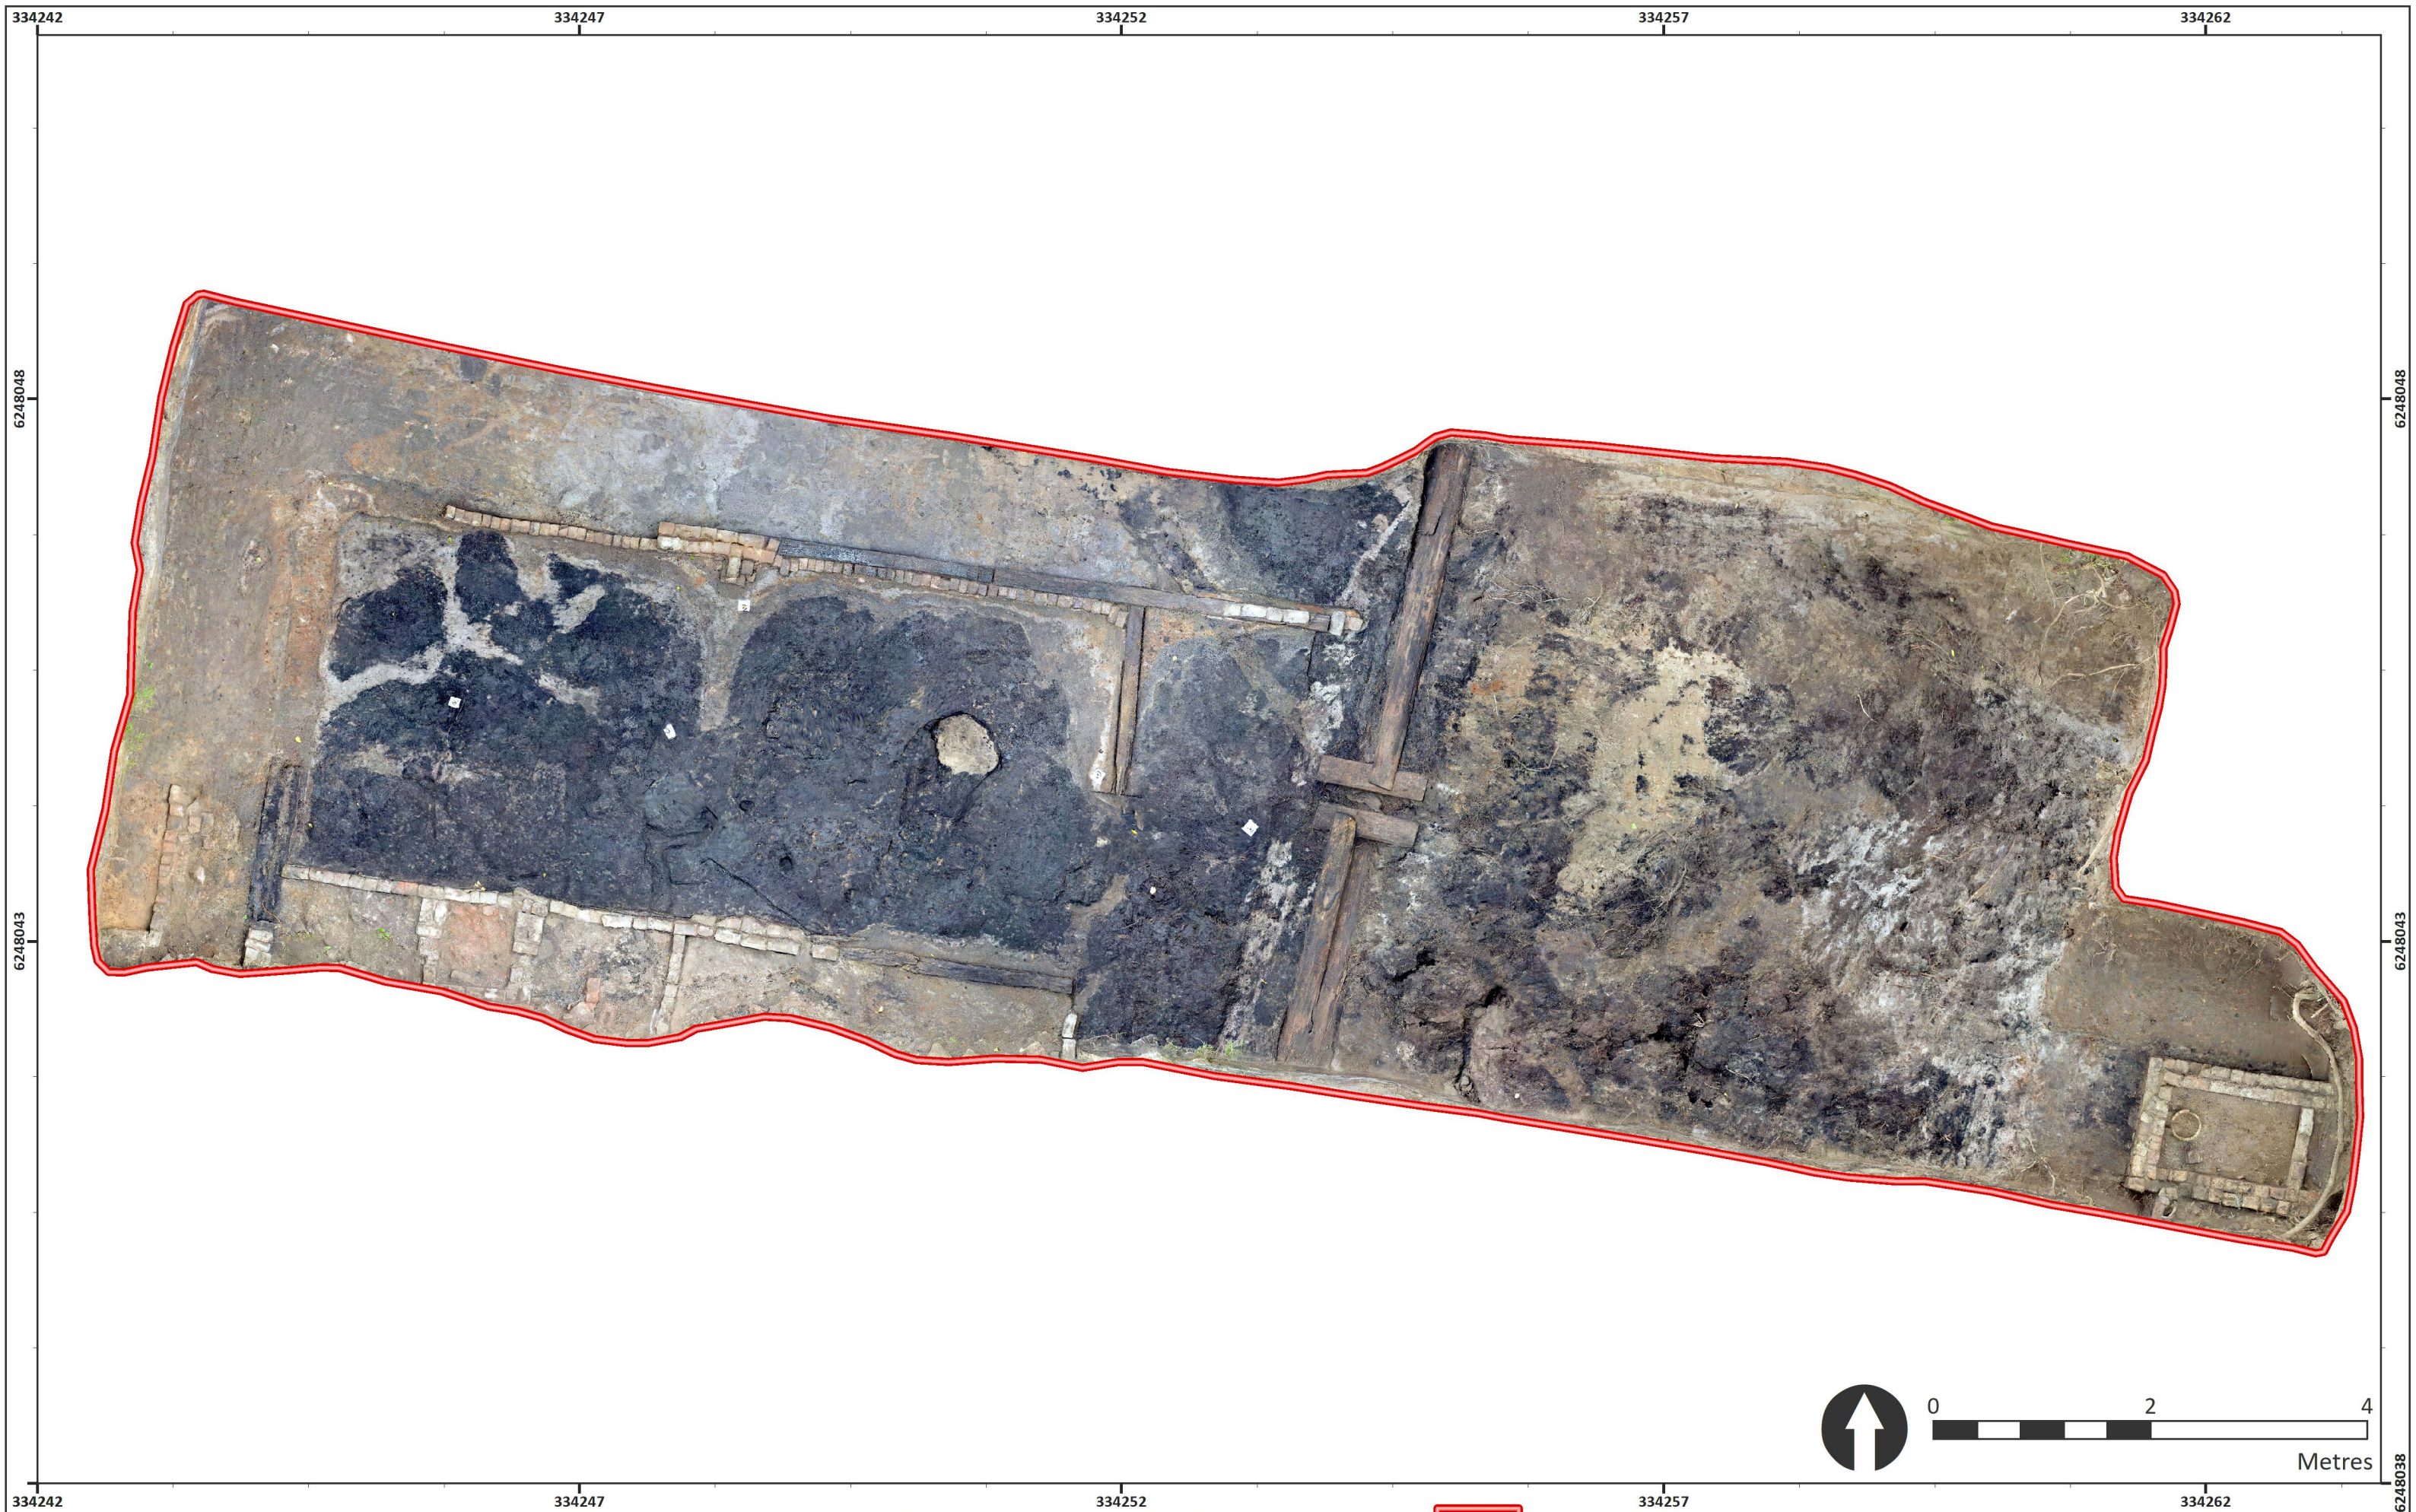
600-660 Elizabeth Street, Redfern Stage 2

Area of investigation
