Remediation Action Plan

600-660 Elizabeth Street, Redfern (Redfern Place), NSW

Report Title: Remediation Action Plan; 600-660 Elizabeth Street, Redfern (Redfern Place), NSW
Report No: E25947.E06_Rev4

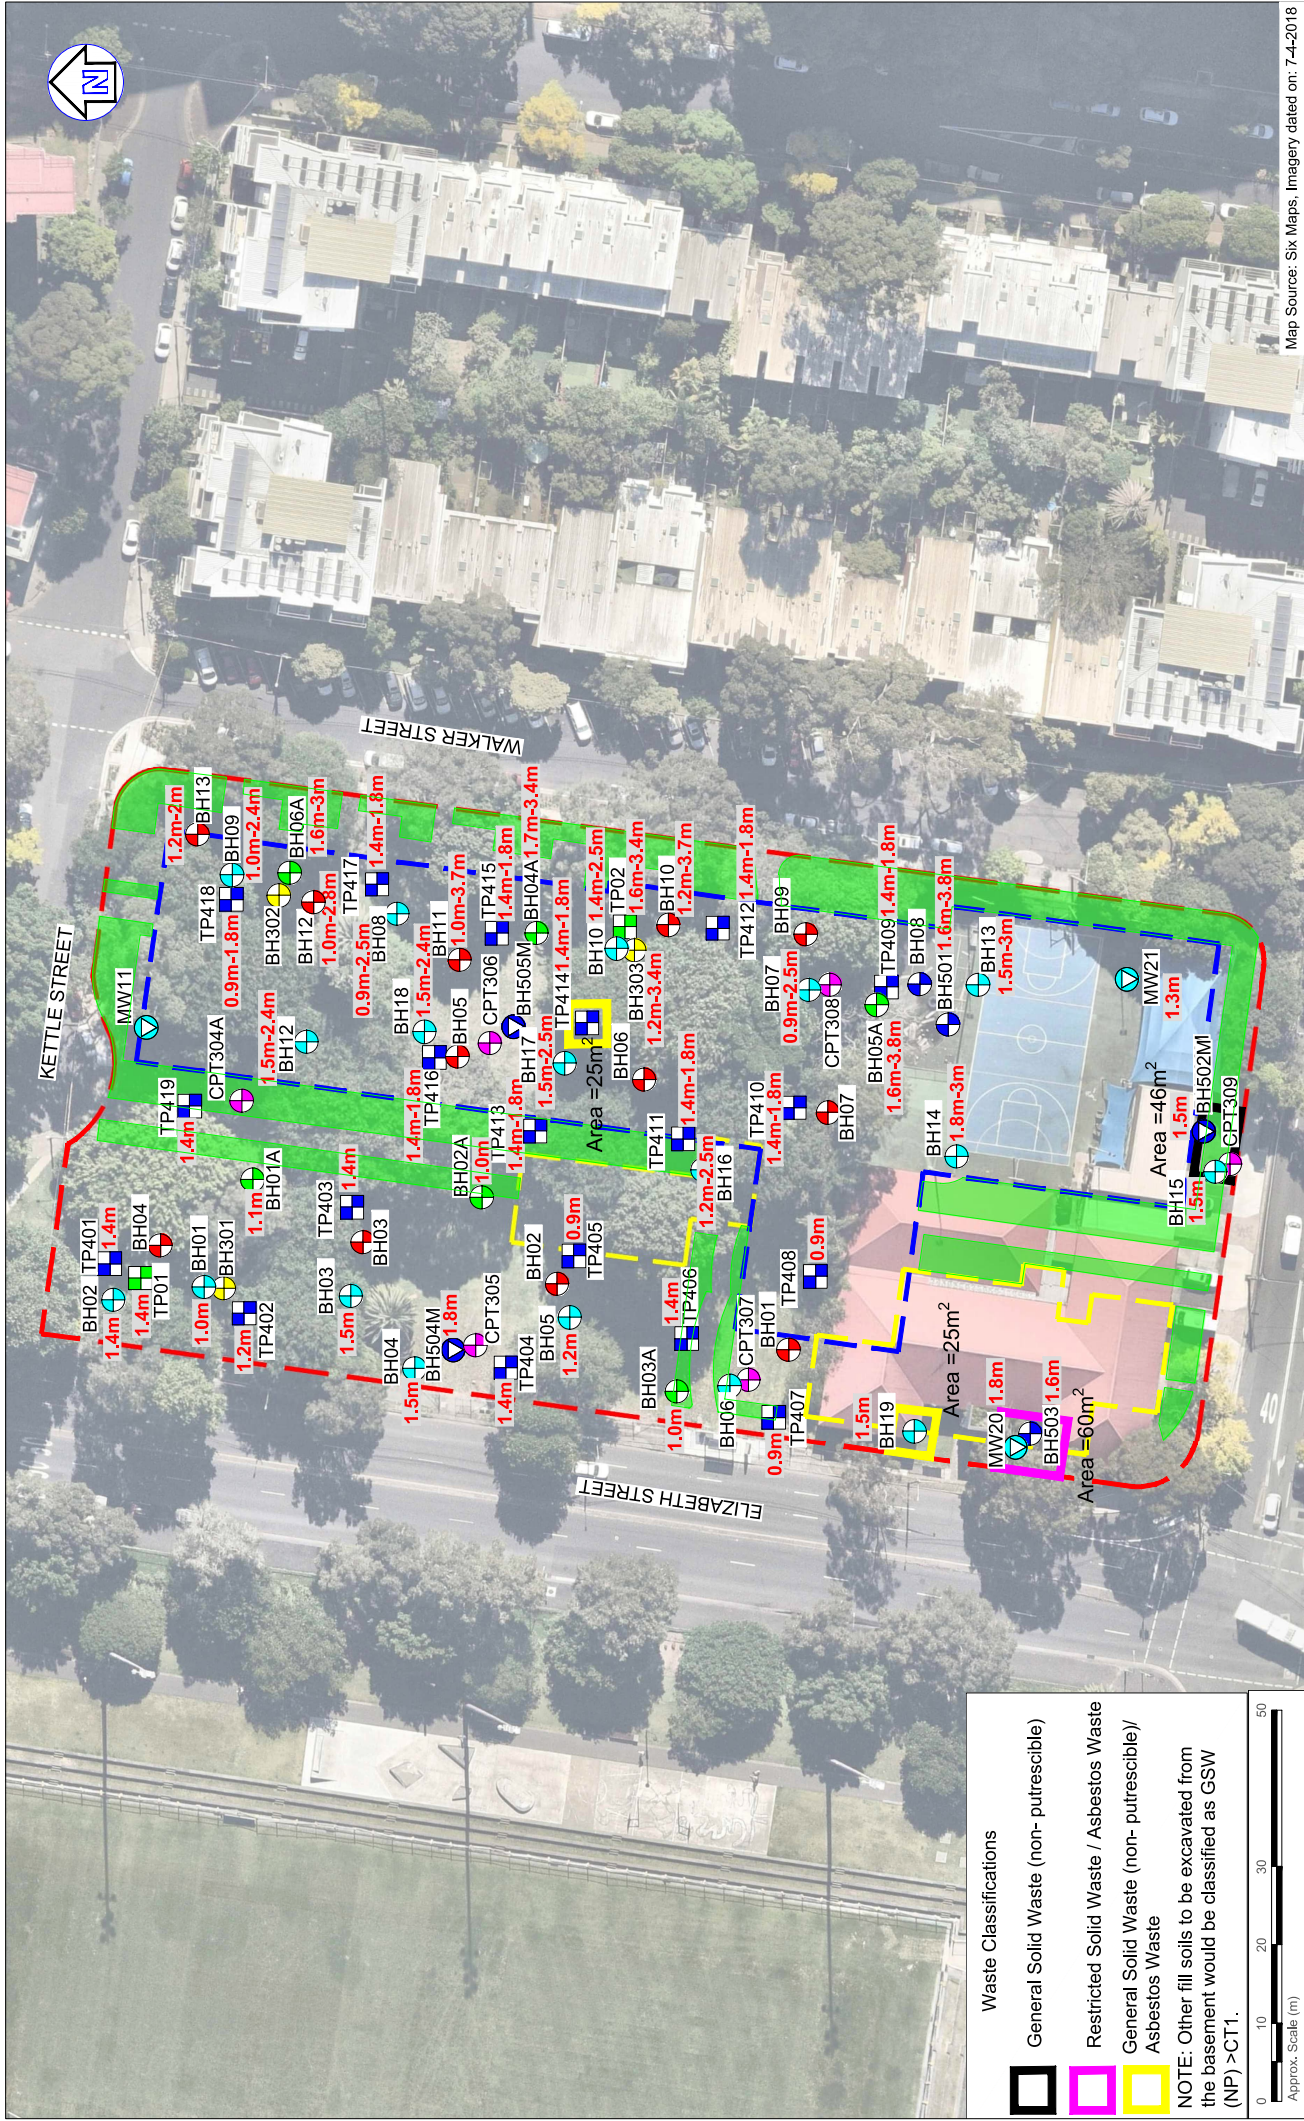
- Waste Classifications**
- General Solid Waste (non-putrescible)
 - Restricted Solid Waste / Asbestos Waste
 - General Solid Waste (non-putrescible) / Asbestos Waste

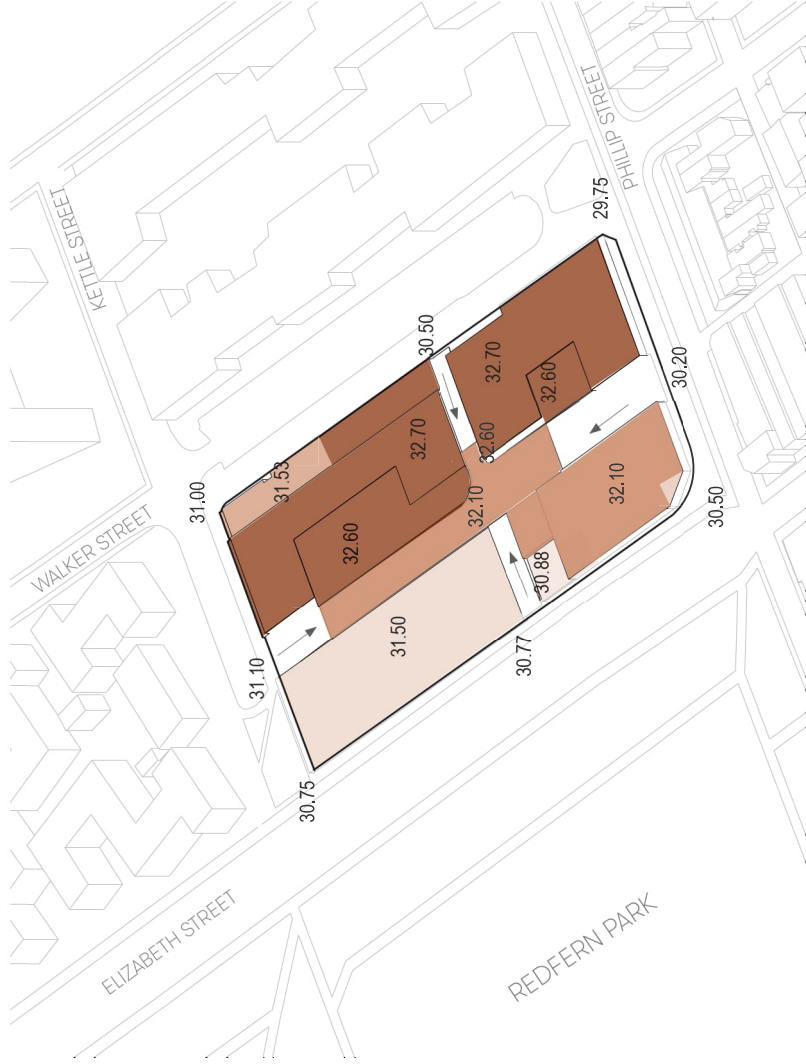
MOVEMENT LEVELS STUDY

- Ground floor residential areas and all connections to the basement set at the 32.70 PMF FPL.
- Commercial and community uses sit between the 1% AEP and PMF as advised by the flooding engineer.
- Central courtyard level set at 32.1 to allow for ease of movement between building levels and the street interfaces.
