Construction Flora and Fauna Management Sub-Plan

Mandalong 33 kV Power Line

MEMS-CEMP-8190-CFFMP-8192

November 2020

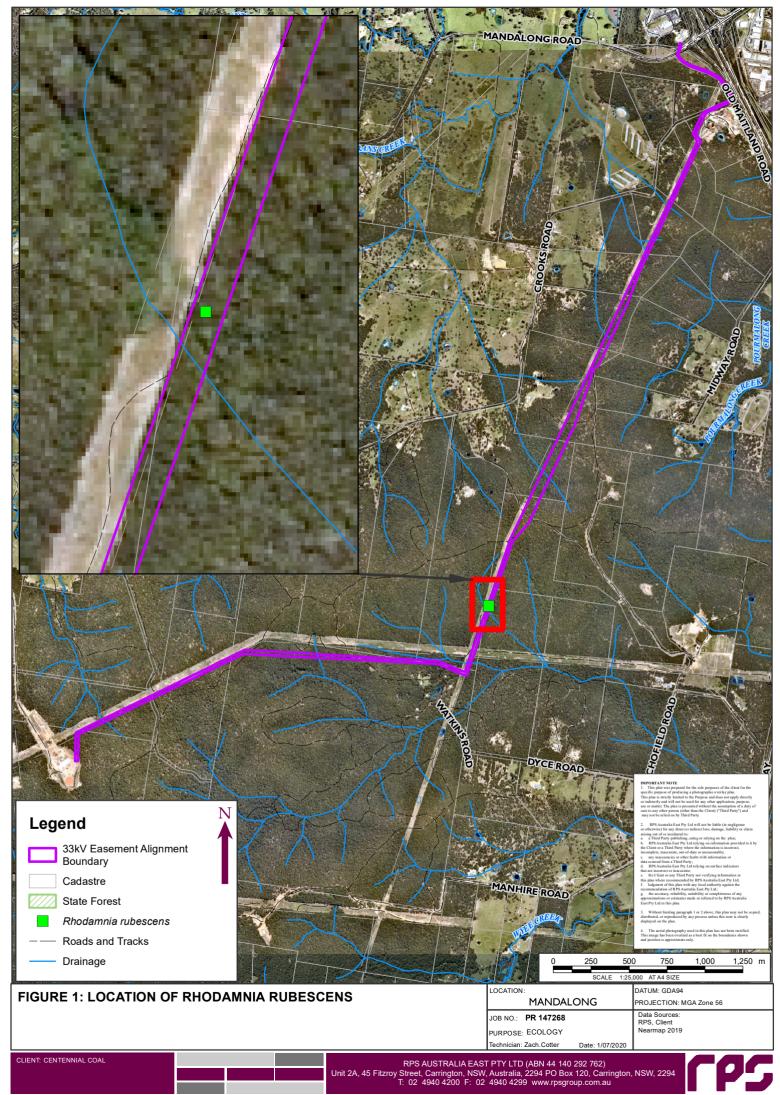
Myrtle Rust was found to have infected individuals of a threatened plant species, *Rhodamnia rubescens* (Scrub Turpentine) (listed as Critically Endangered under the *Biodiversity Conservation Act 2016* [BC Act 2016]) (**Figure 1; Attachment 1**). Myrtle Rust is a Key Threatening Process (KTP) under the BC Act 2016. However, it should be noted that Myrtle Rust is common throughout the Mandalong Valley, as indicated by annual monitoring for Mandalong Mine (which includes nearby State Forest).
