PHASE 2 ENVIRONMENTAL SITE AND GEOTECHNICAL INVESTIGATION

Corner of Horsley Drive and Cowpasture Road, Wetherill Park NSW

7/06/2012

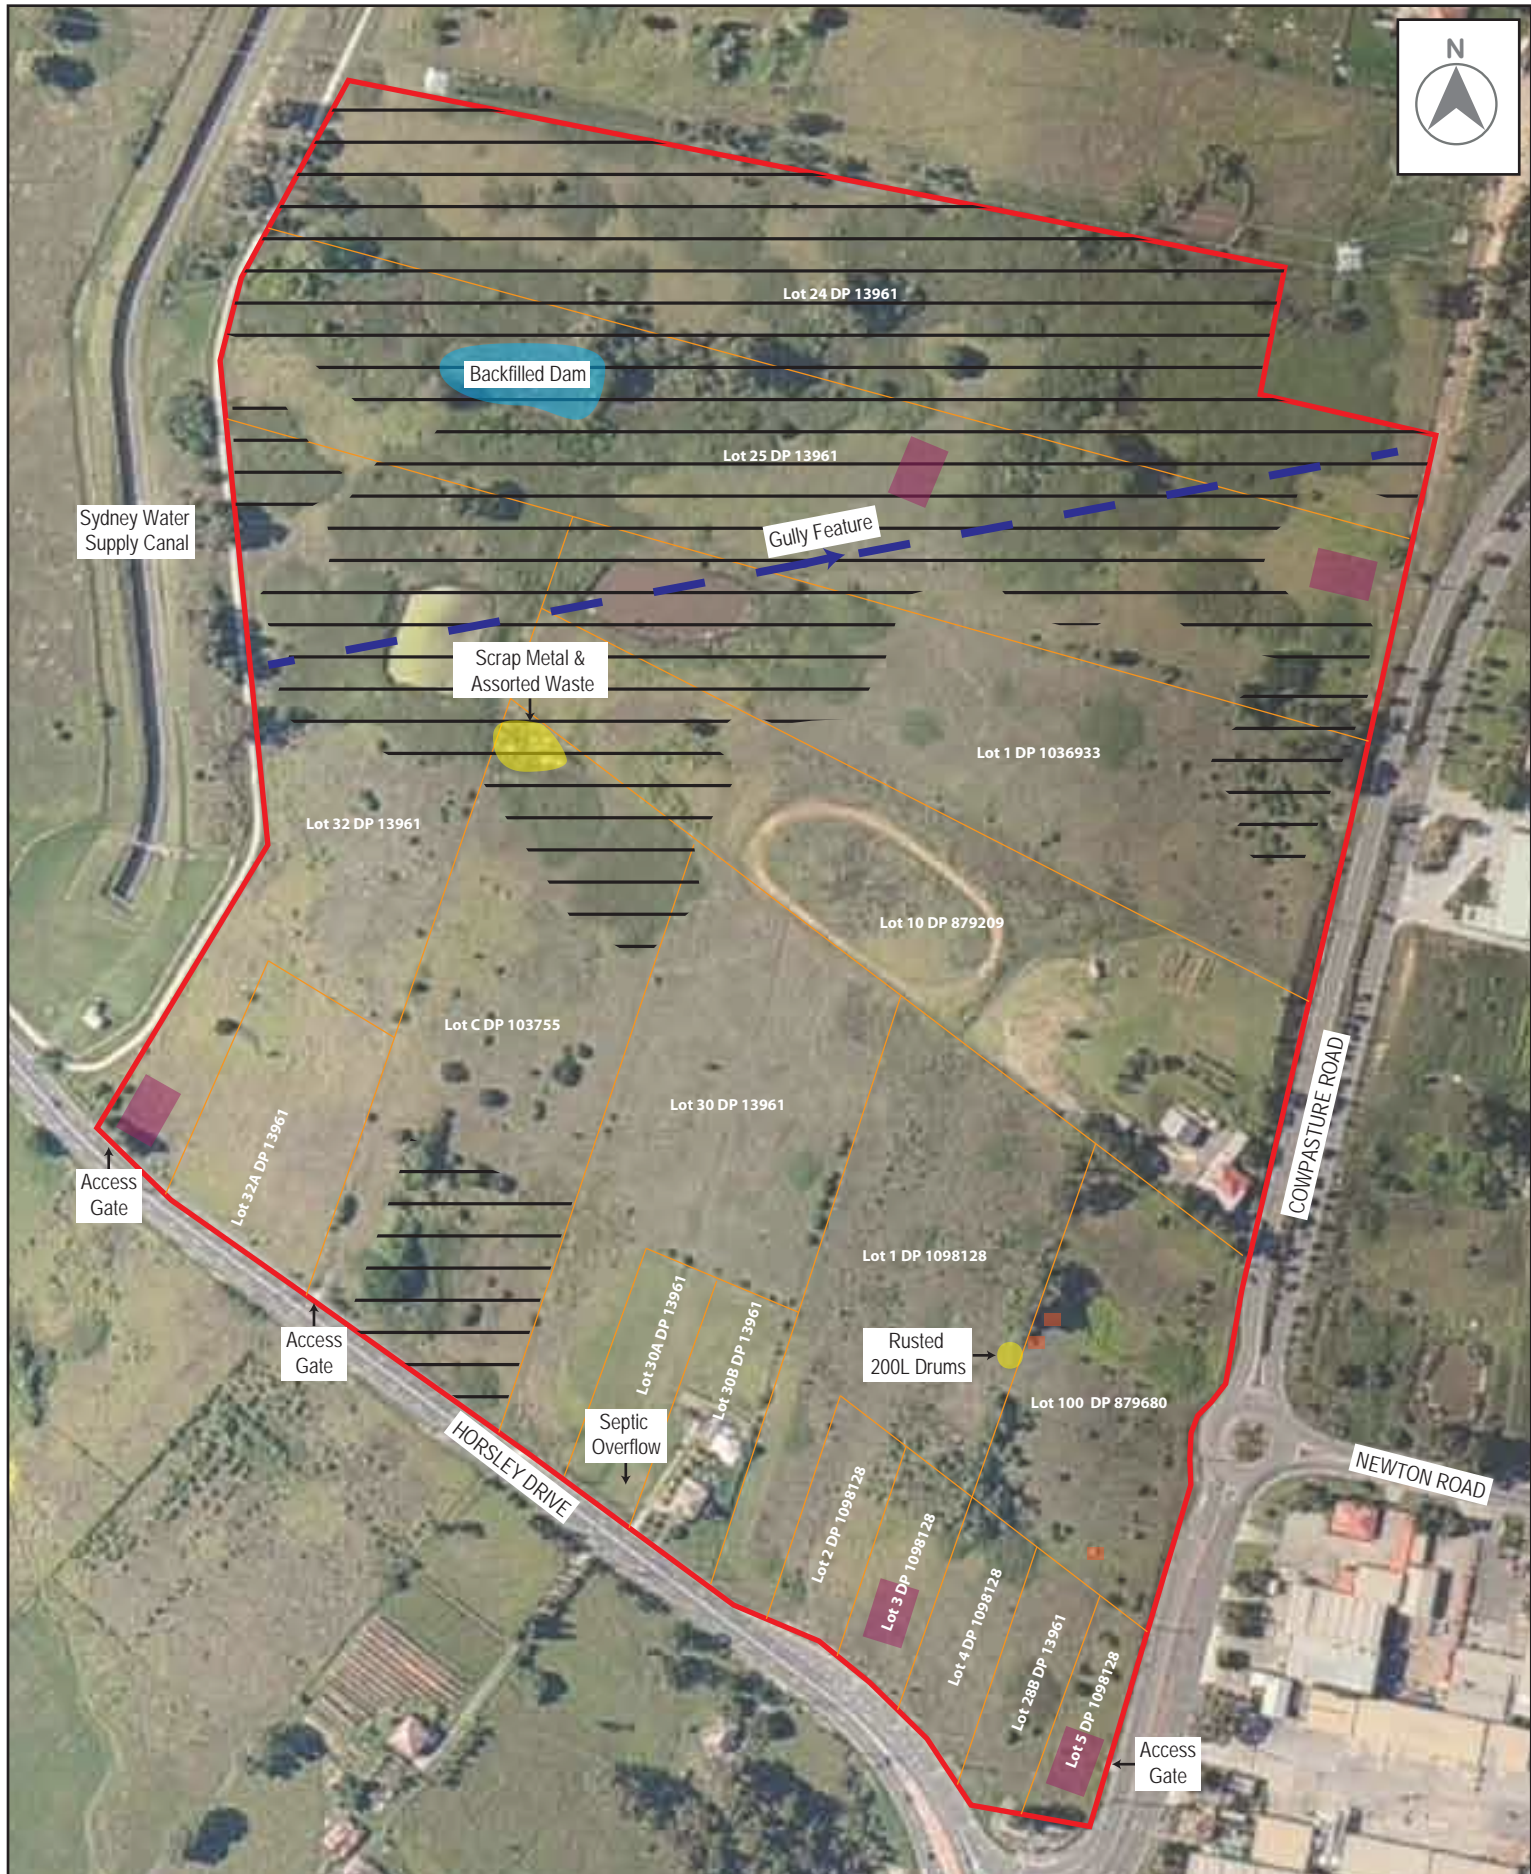
Site Features
 Phase 2 Investigation, Cnr Horsley Drive and Cowpasture Road, Wetherill Park NSW
 00030337
 FIGURE 2

- Site Boundary
- Inaccessible During Initial Investigations
- Former Building Location
- Abandoned Shed

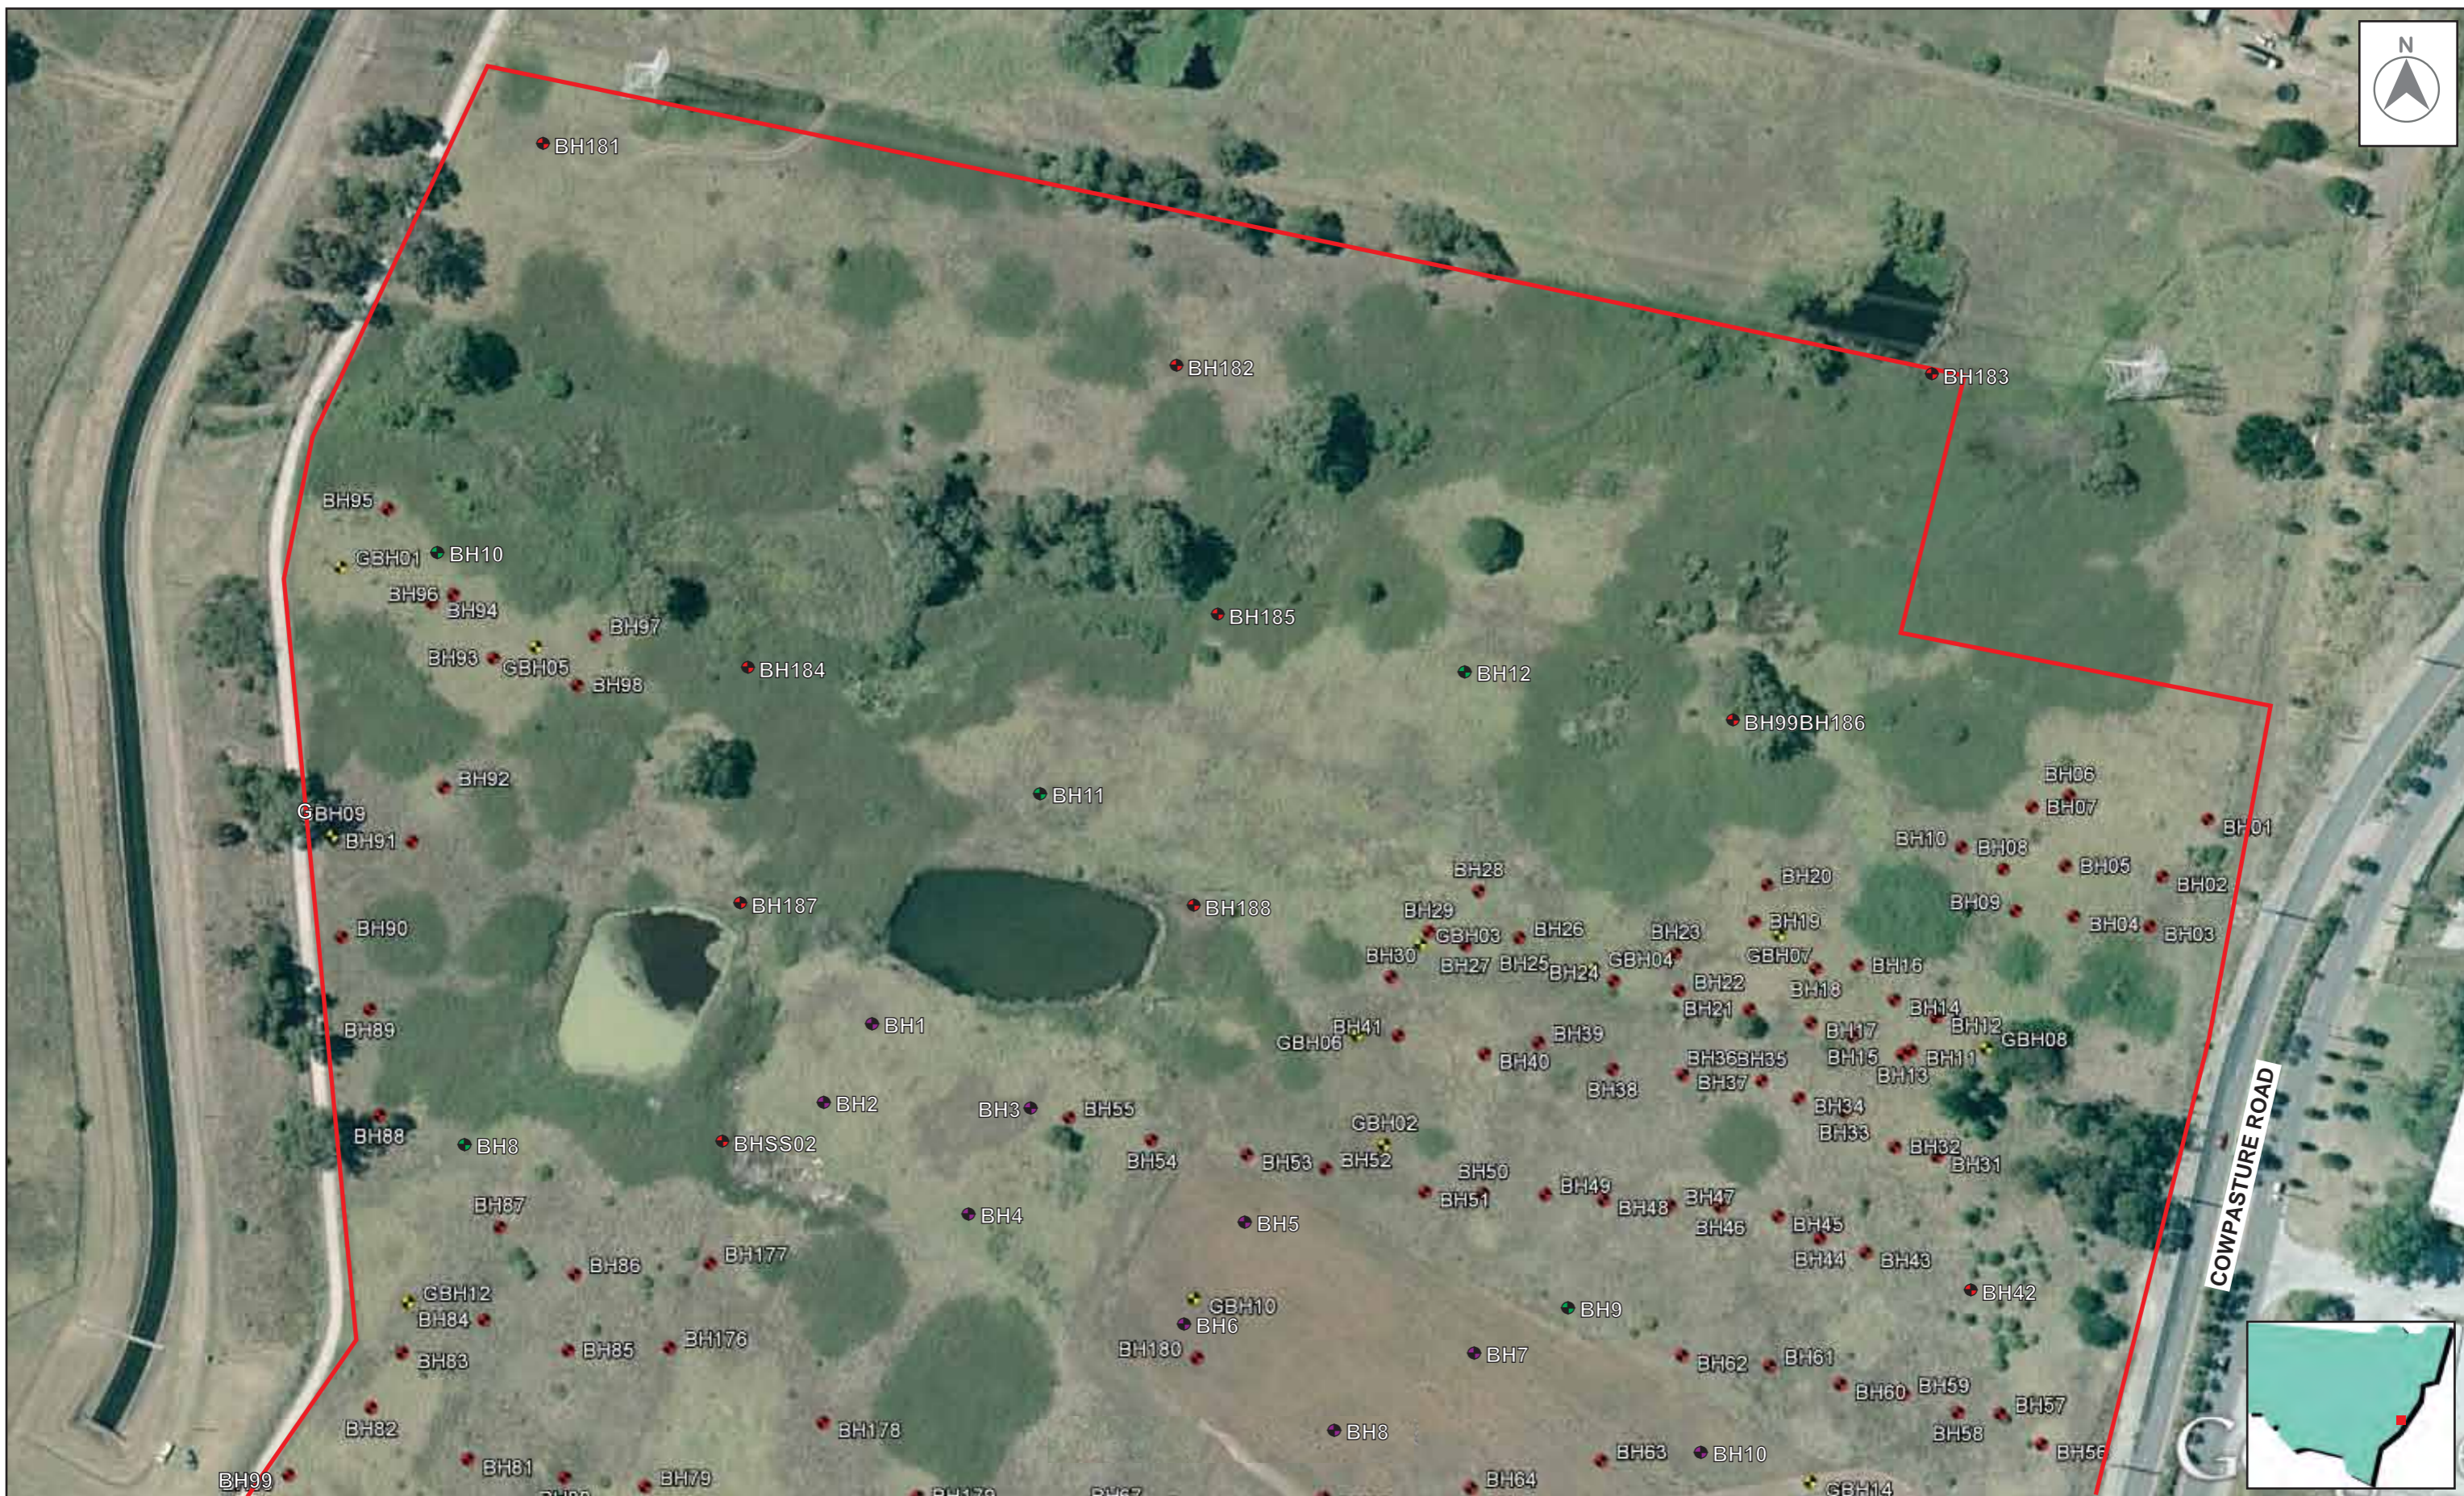
Phase 2 Investigation, Cnr Horsley Drive and Cowpasture Road, Wetherill Park NSW
00030337
FIGURE 3a

- Site Boundary
- BH01 WSP 2012 Soil Bore Location
- GBH01 Geotechnical 2012 Soil Bore Location
- BH1 EIS 2011 Soil Bore Location
- BH1 WSP 2010 Soil Bore Location

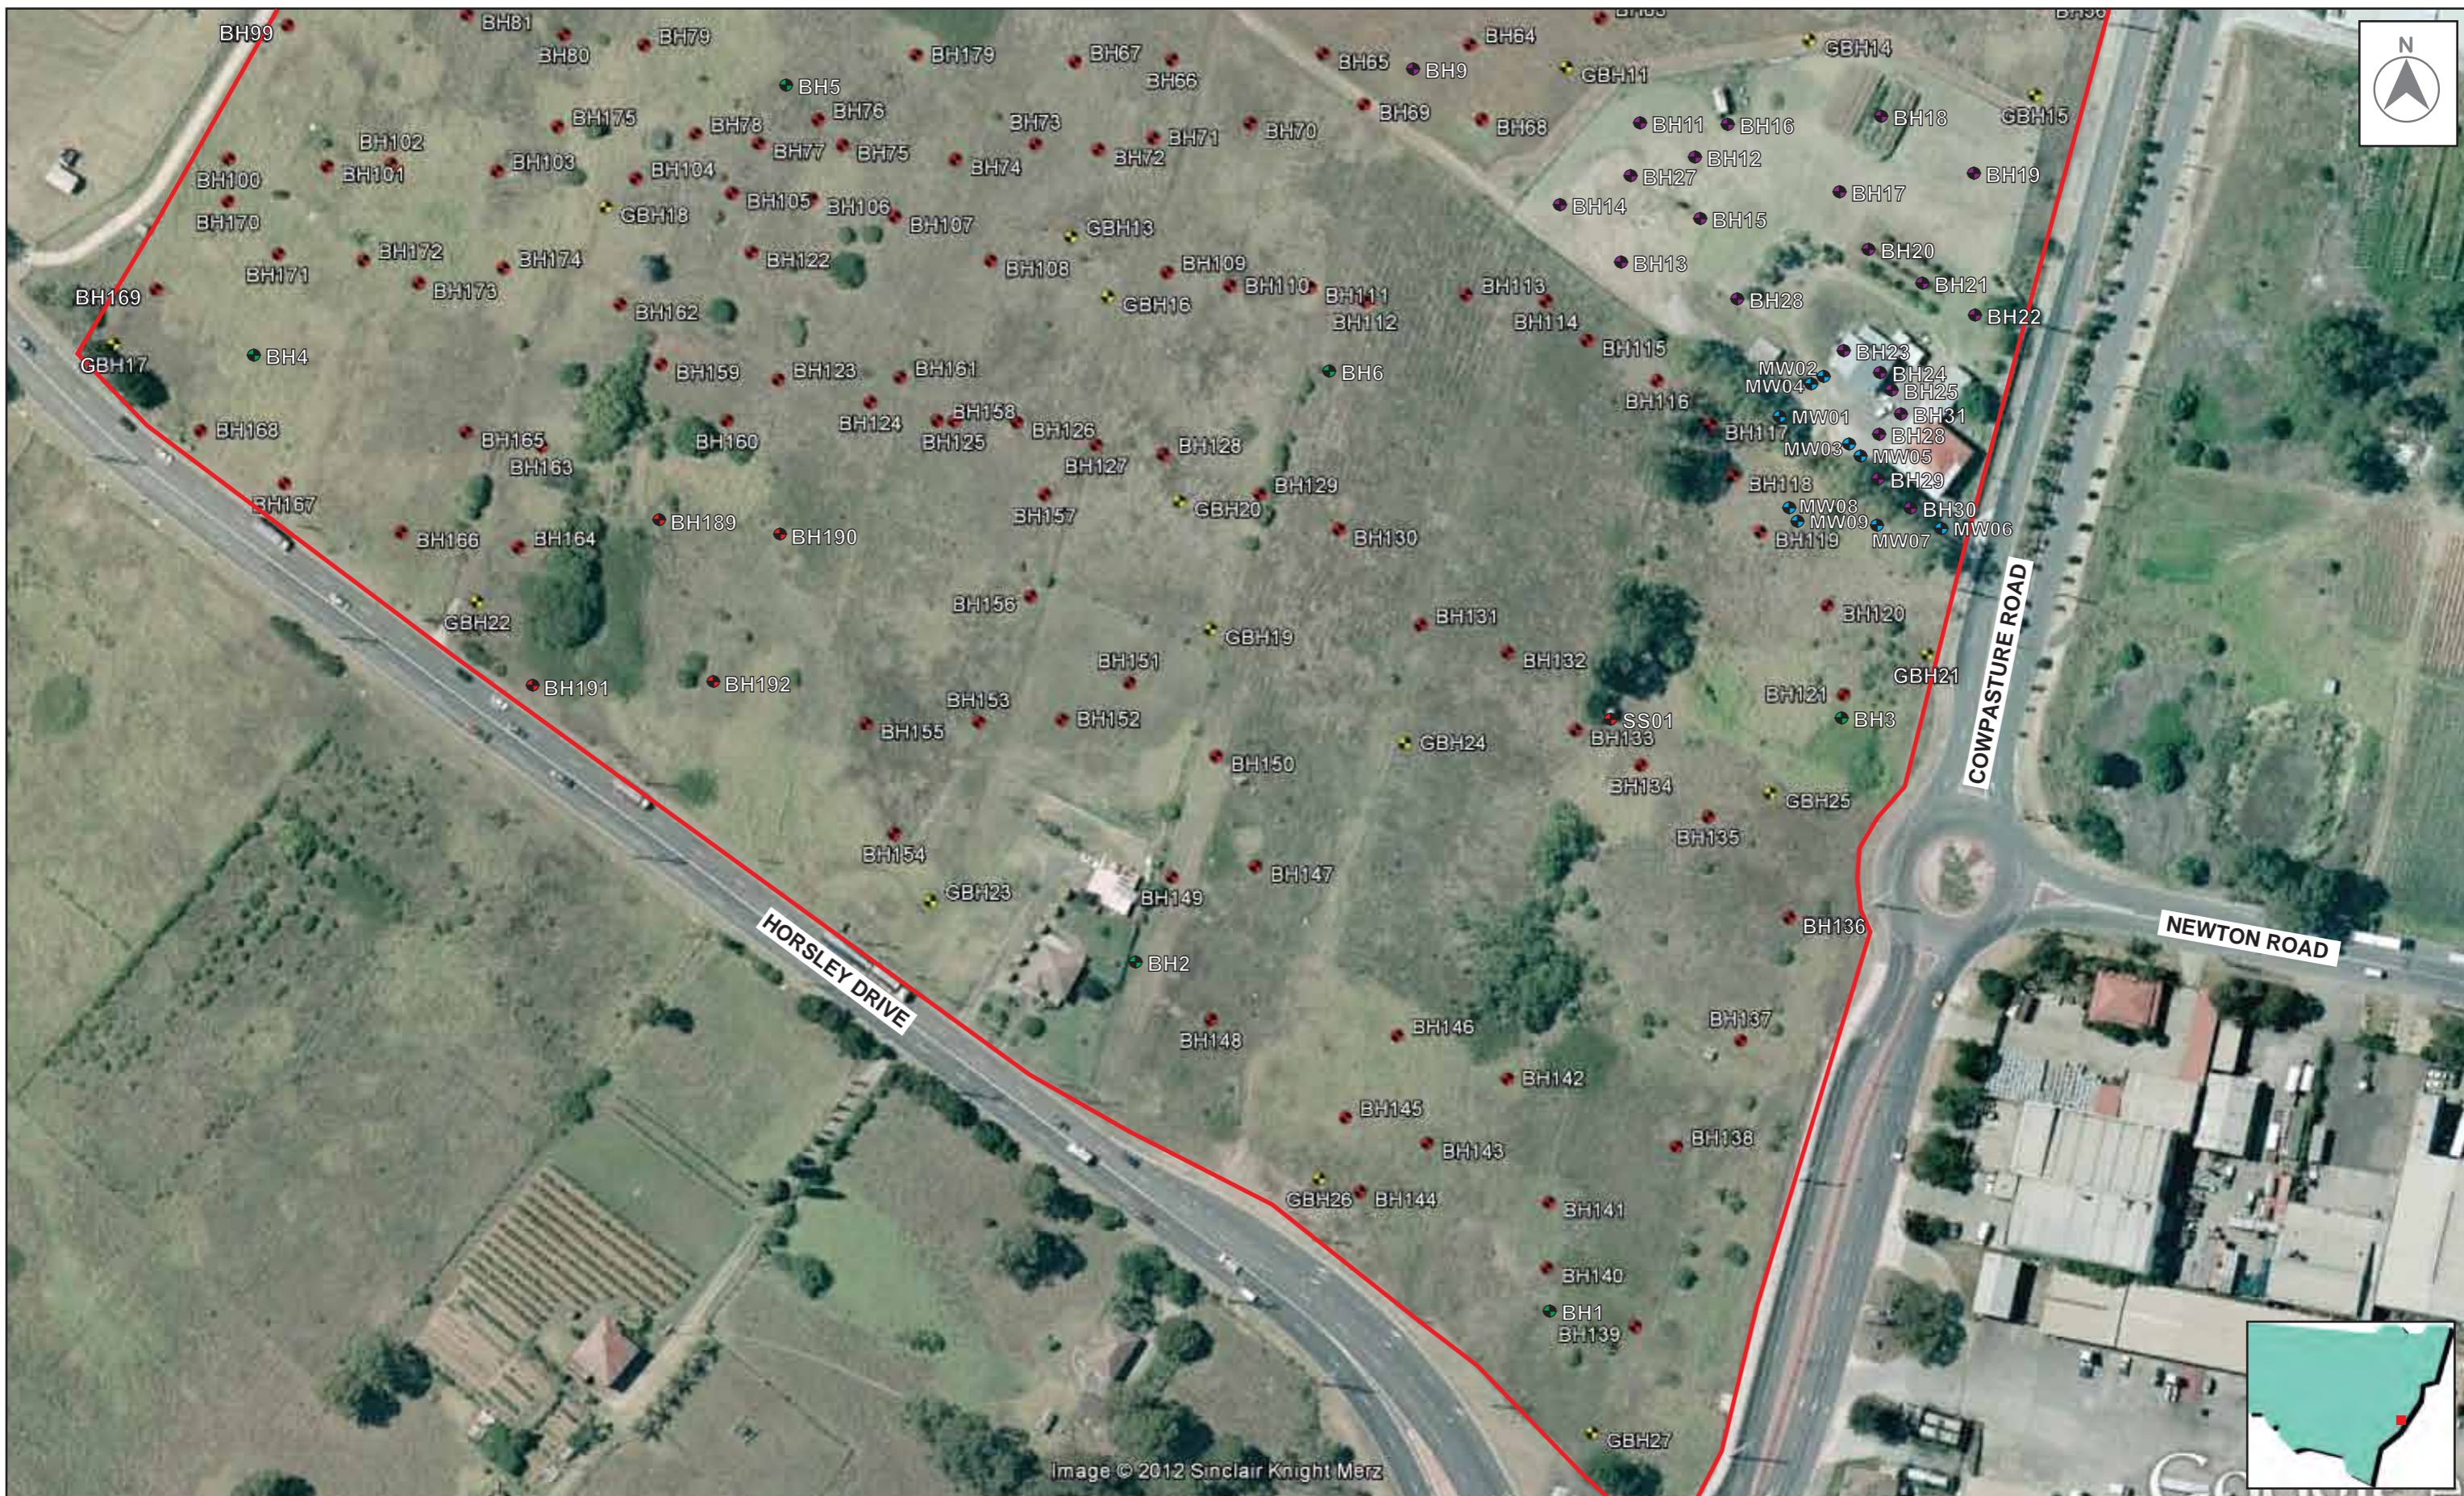
- Site Boundary
- BH01 WSP 2012 Soil Bore Location
- GBH01 Geotechnical 2012 Soil Bore Location
- BH1 EIS 2011 Soil Bore Location
- BH1 WSP 2010 Soil Bore Location
- MW01 WSP 2010 Groundwater Well Location

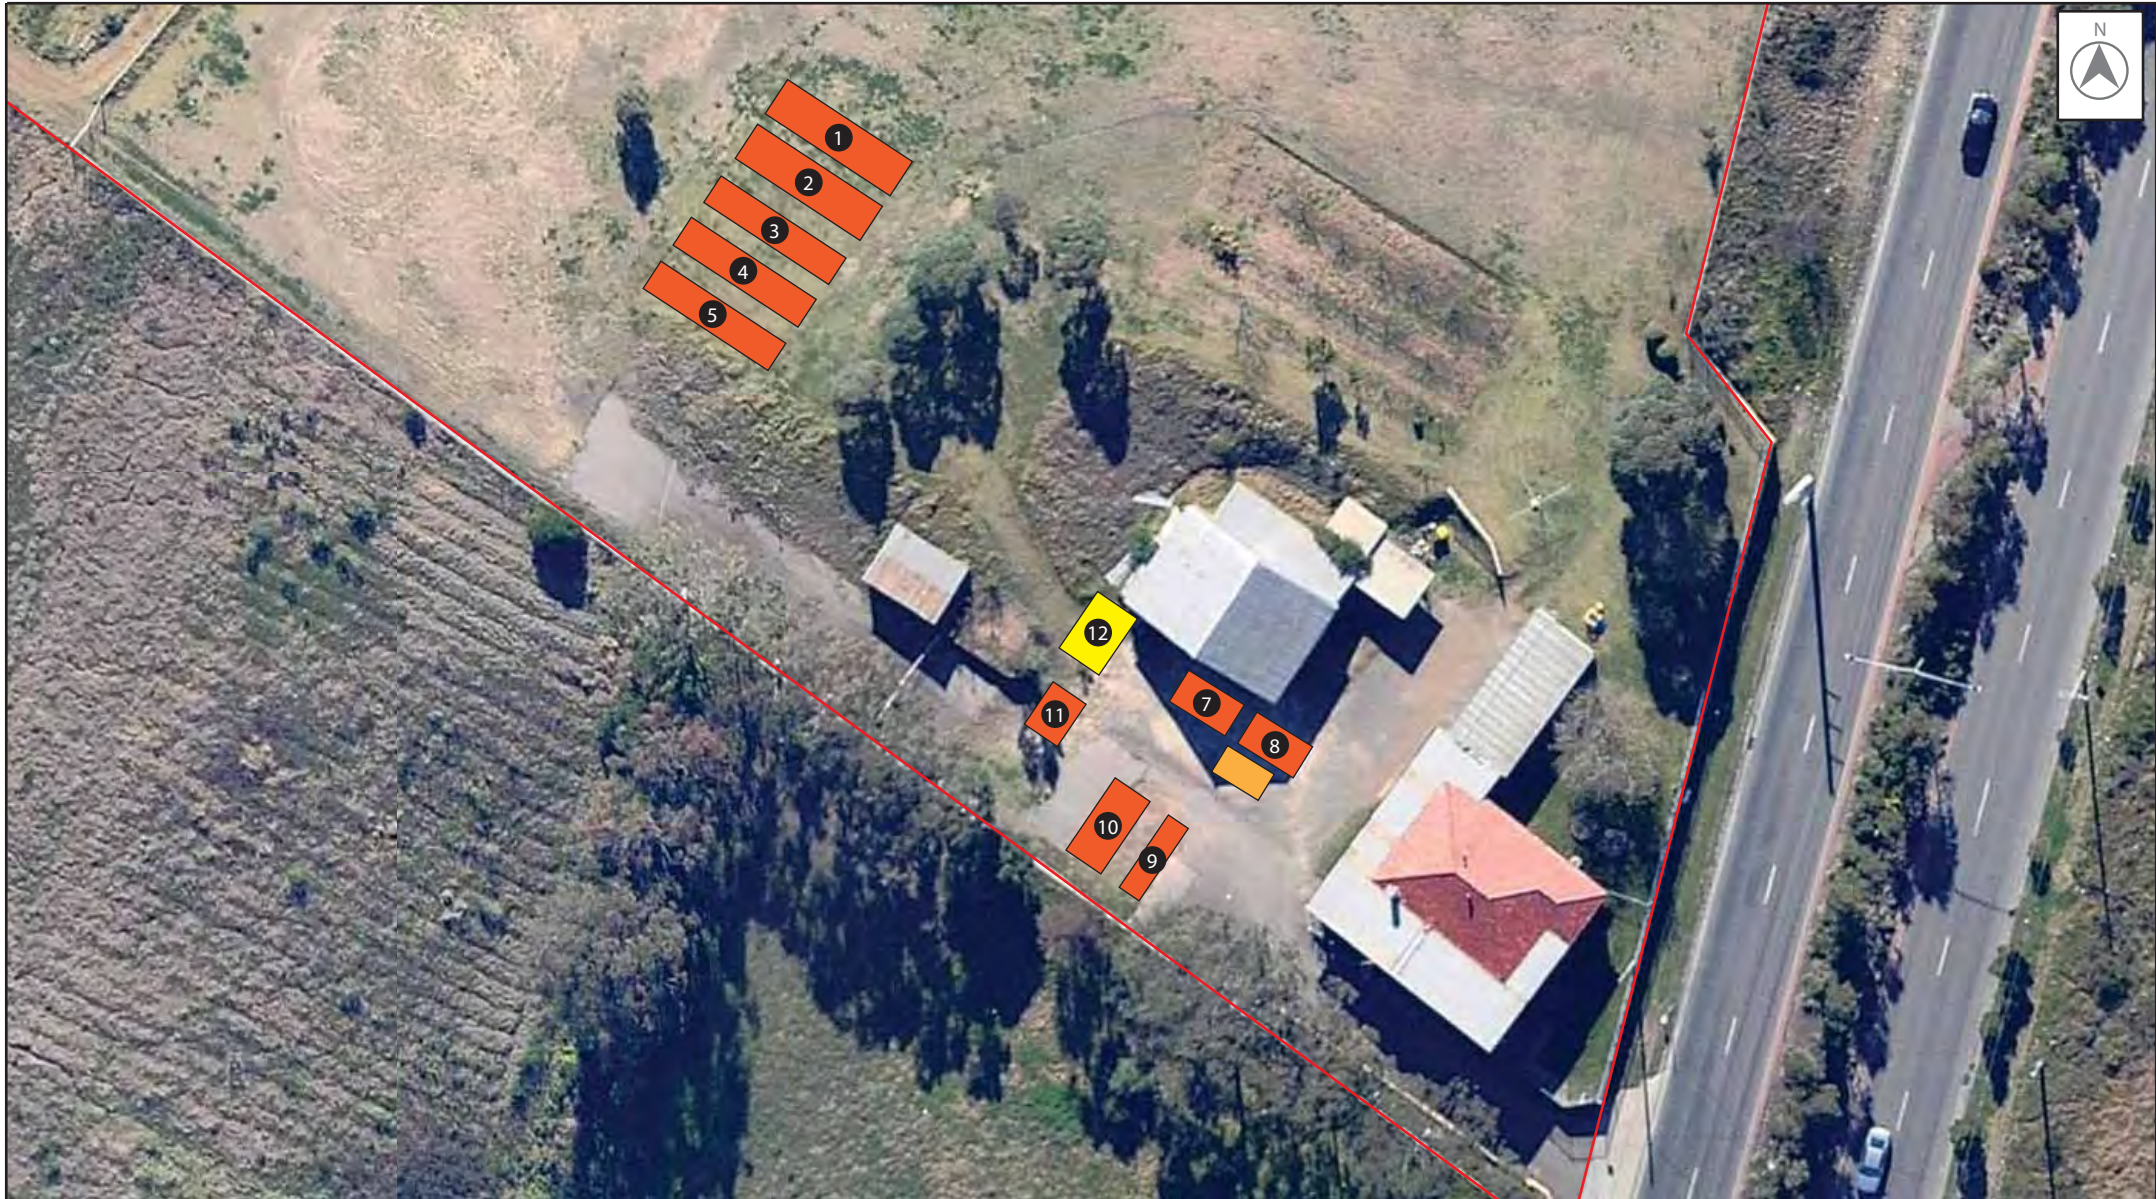
Former Tank Locations
Menolotto, Cowpasture Road, Horsley Park, NSW
FIGURE 1

- Extract 1 Former Tank Locations – Tank Removal Works (2009)
- Extract 2 RES Investigation Areas – Tank Removal Status Report (2006)
- Extract 3 2009 Tank Pull Validation Locations – Tank Removal Works (2009)
- Extract 4 Identified Soil Impact Areas – Phase 2 Draft ESA & Additional Investigation (2010)
- Extract 5 PSH Plume Location – Phase 2 Draft ESA & Additional Investigation (2010)

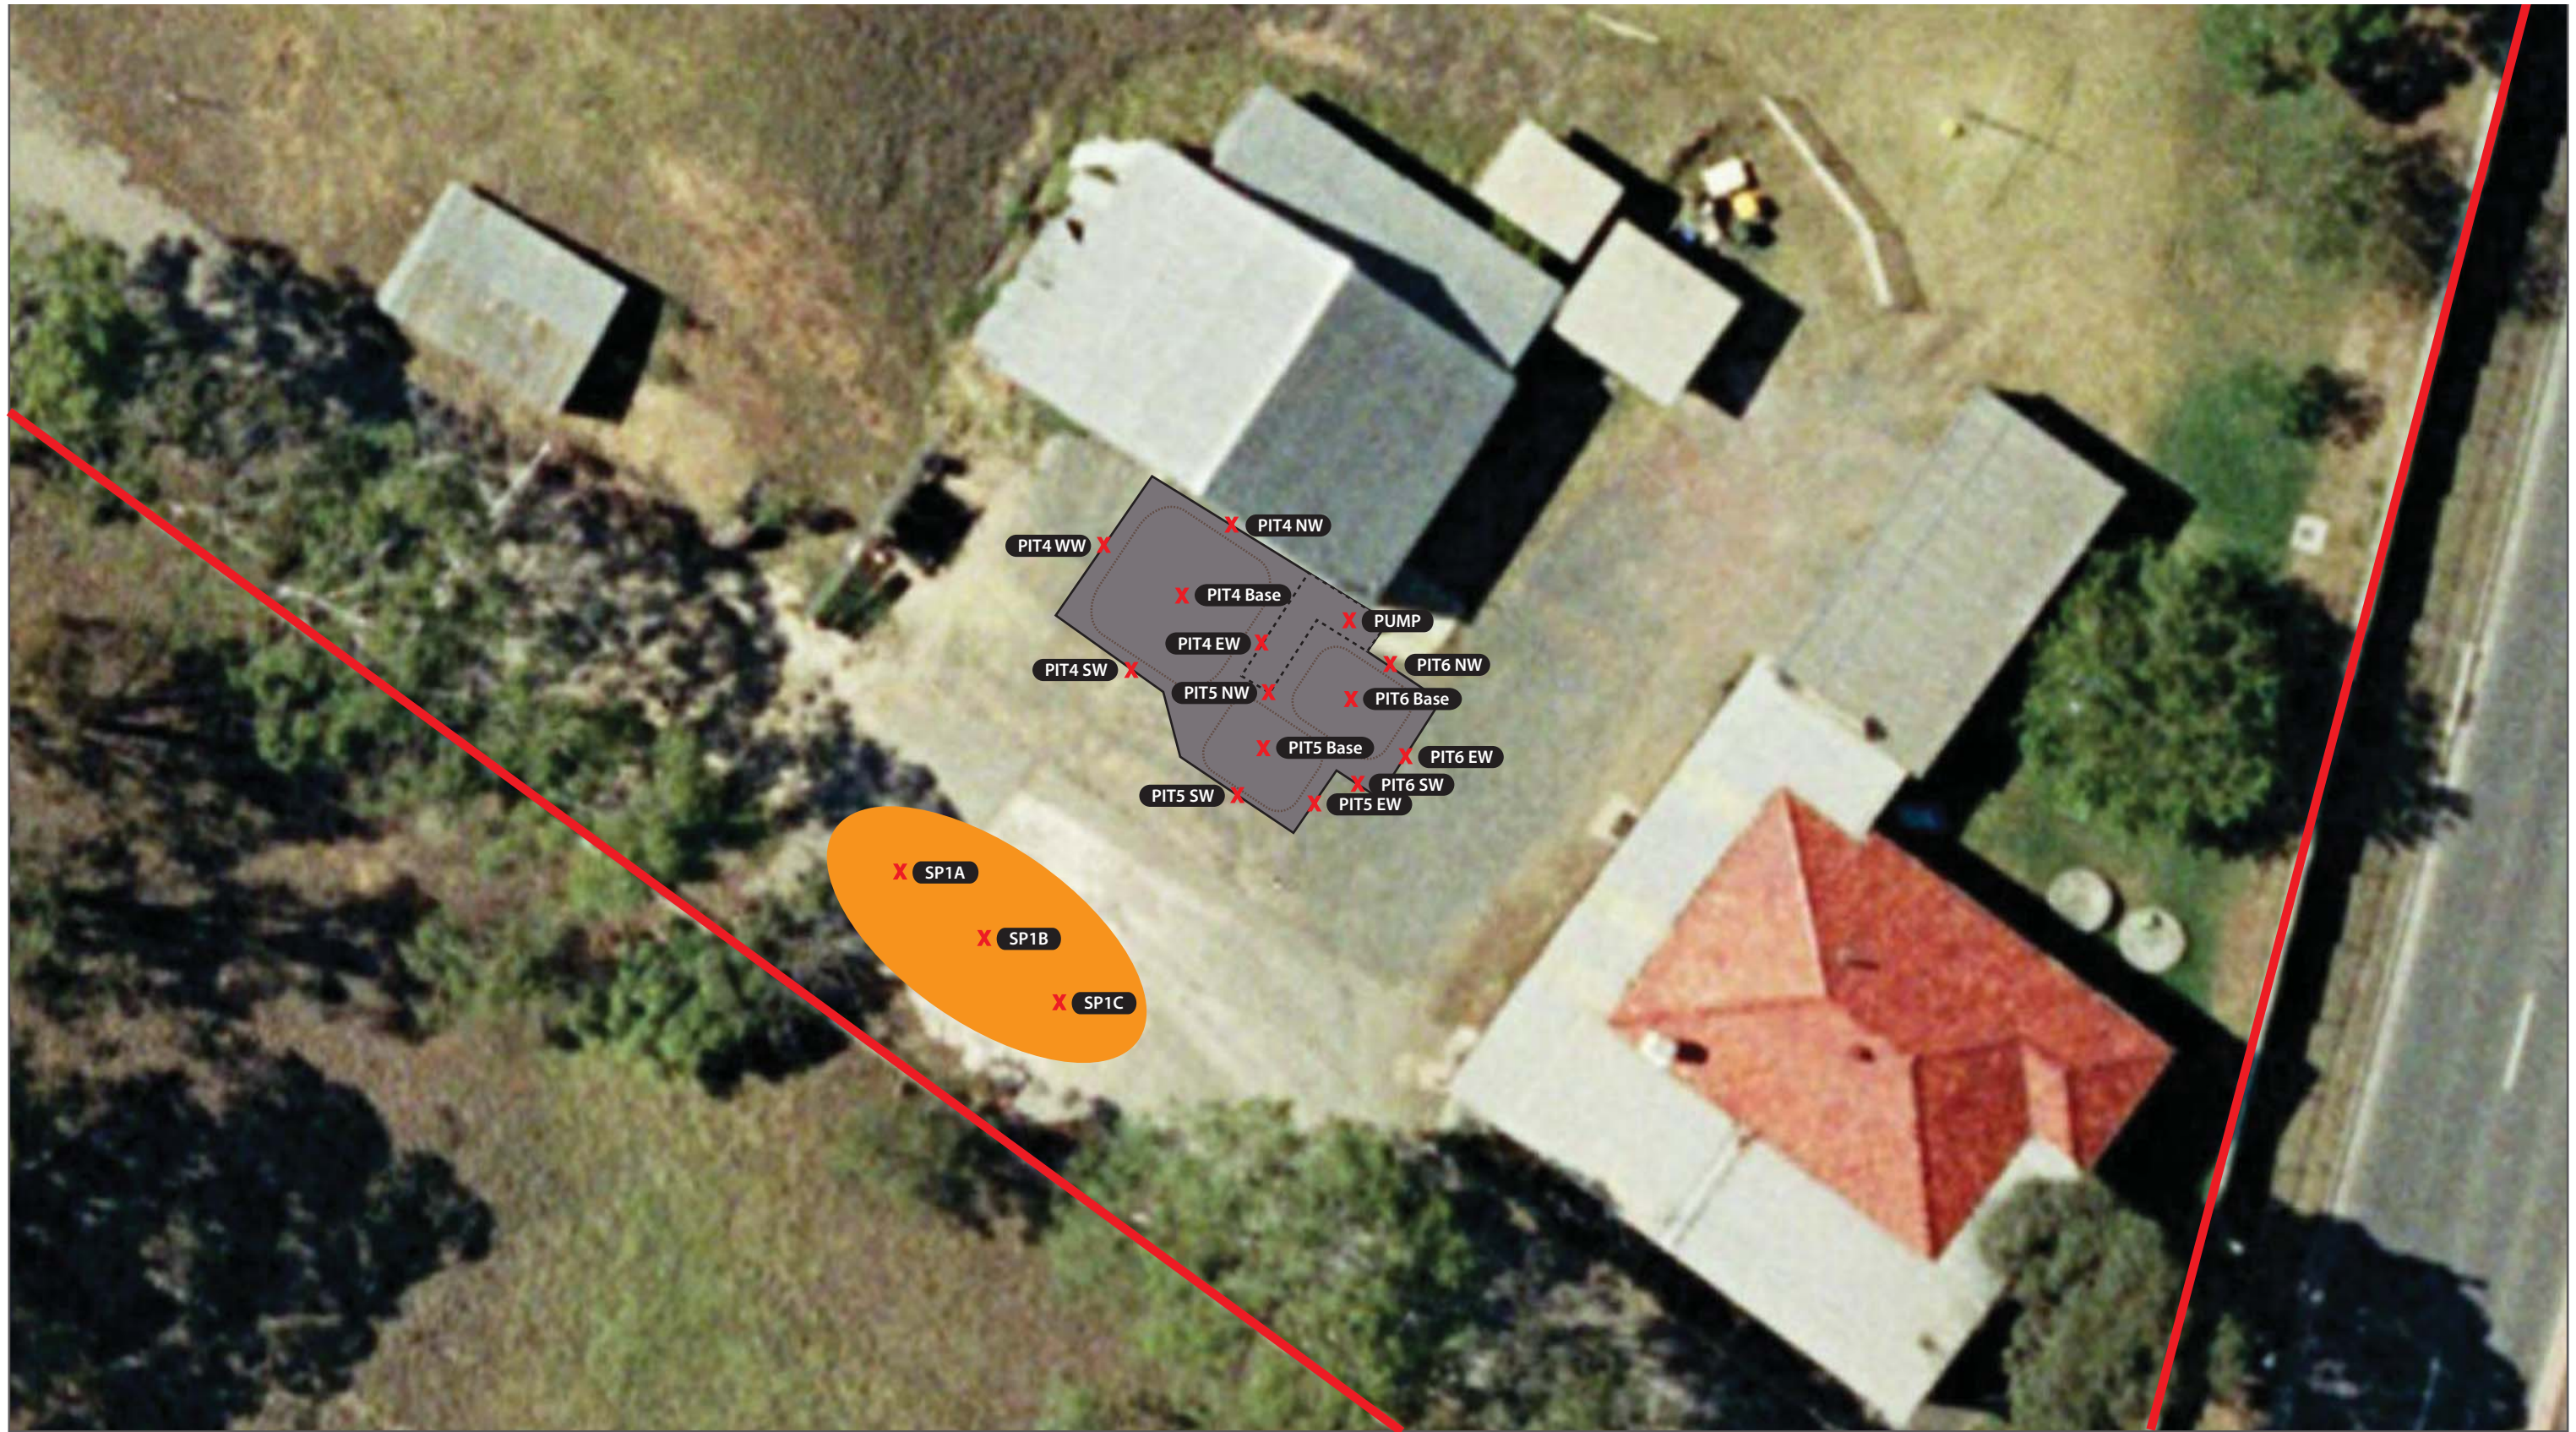
FIGURE 2

- KEY**
- Tank Pit
 - Stockpile
 - Site Boundary
 - X PIT5 EW Sample Location
