## **Appendix G**

### ***Aboriginal Archaeology Assessment***

**RE: Aboriginal Archaeological Due Diligence Assessment for Bengalla Development Consent Modification**

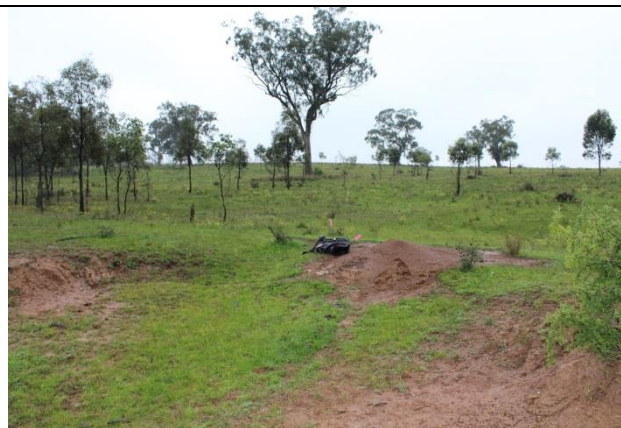
Plate 1: BM-AS27-15 (view north)

**Site Name:** BM-AS27-15

**Site type:** Artefact scatter

**Landform:** Lower slope

**Artefacts:** 1 x silcrete flake shatter, 1 x tuff complete flake

**Disturbance Factors:** Erosion, vegetation clearance

**Significance:** Low (scientific)

- Impacts to previously recorded AHIMS site A7-A8 (#37-2-1468) and newly recorded Aboriginal sites BM-AS27-15 and BM-IA24-15 should be salvaged in accordance with the *Bengalla Mine Aboriginal Cultural Heritage Management Plan* (Bengalla Mine ACHMP) modified as required, once Modification to SSD-5170 has been approved.

- AHIMS site cards should be completed for Aboriginal sites BM-AS27-15 and BM-IA24-15 and submitted to the AHIMS register.
- In the event that Aboriginal objects, including possible human skeletal material (remains), are identified during project related activities all works must cease immediately in the area and the procedures identified in the Bengalla Mine ACHMP are to be followed. This will include contacting BMCs Environment Manager and engaging a qualified archaeologist to assess the site.

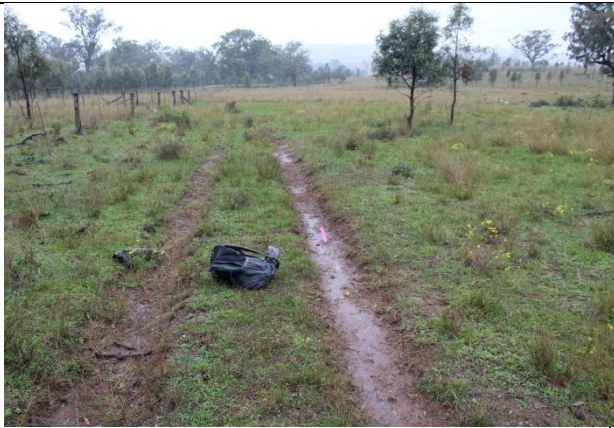
**Plate 3:** BM-IA24-15 (view west)

**Site Name:** BM-IA24-15

**Site type:** Isolated artefact

**Landform:** Lower slope

**Artefacts:** 1 x silcrete complete flake

**Disturbance Factors:** Vehicle track construction, erosion, vegetation clearance

**Significance:** Low (scientific)
