**PHASE 1 PRELIMINARY SITE  
INVESTIGATION  
PROPOSED DEVELOPMENT, NETBALL  
CENTRE OLYMPIC PARK, NSW**

Report Date: 20 January 2012  
Project Ref: GEOTLCOV24420AA-AD

**RE: Phase 1 Preliminary Site Investigation, Proposed Development Netball Centre, Olympic Park, NSW**

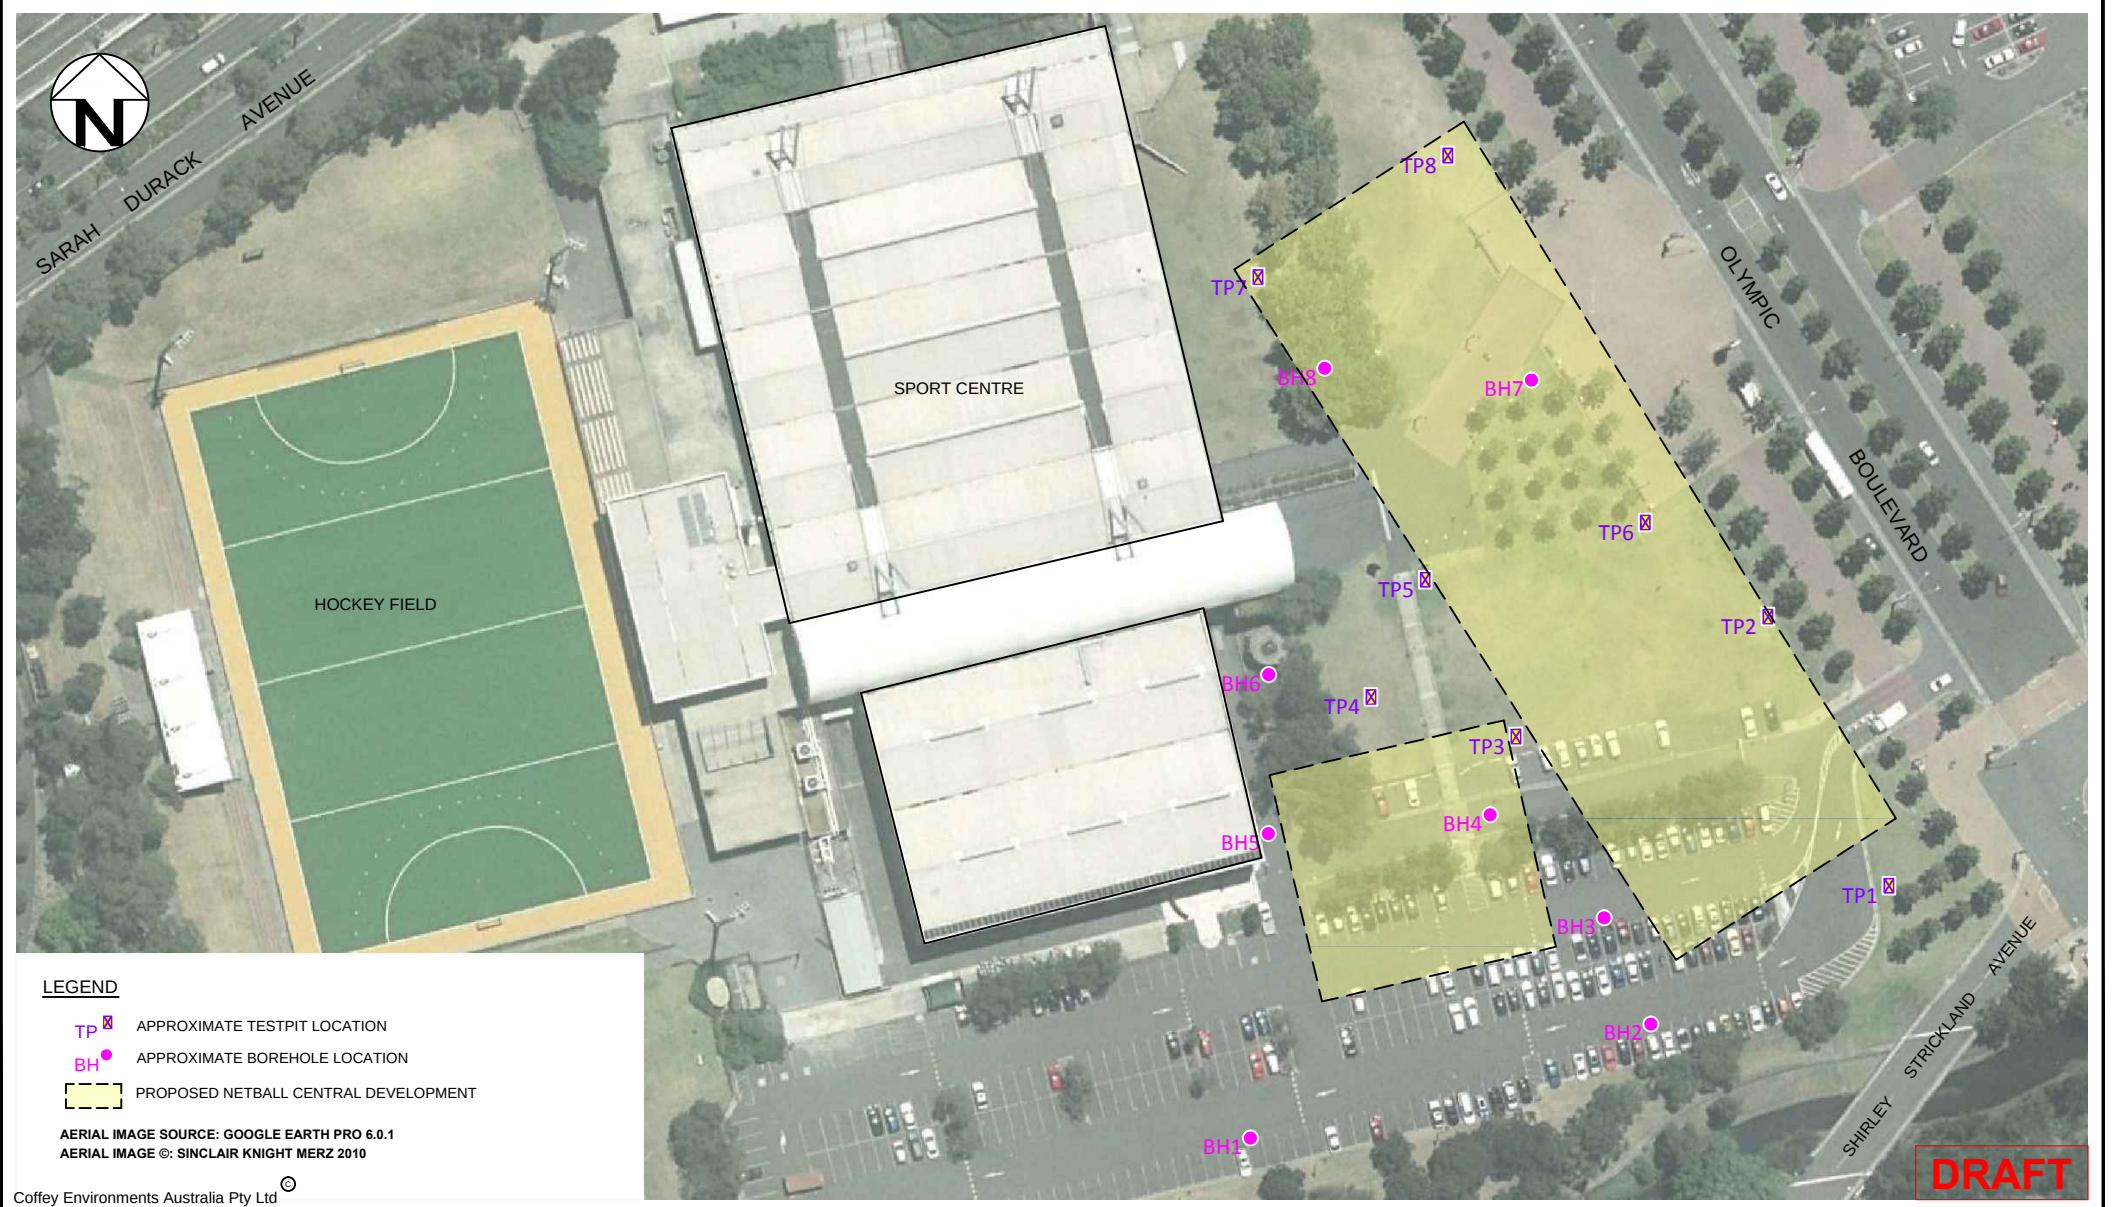
DWG FILE: F:\PROJECTS\OTHER OFFICES\GEOTLCOV24420AA\ENR\HDD0423AAA PHASE 1\DRAWINGS\GEOTLCOV24420AA-D01.DWG

TP APPROXIMATE TESTPIT LOCATION
