Report on
Phase 1 Contamination Assessment

813 - 913 Wallgrove Road
Horsley Park

Prepared for
Gazcorp Pty Ltd

Project 73194 Rev 1
November 2012

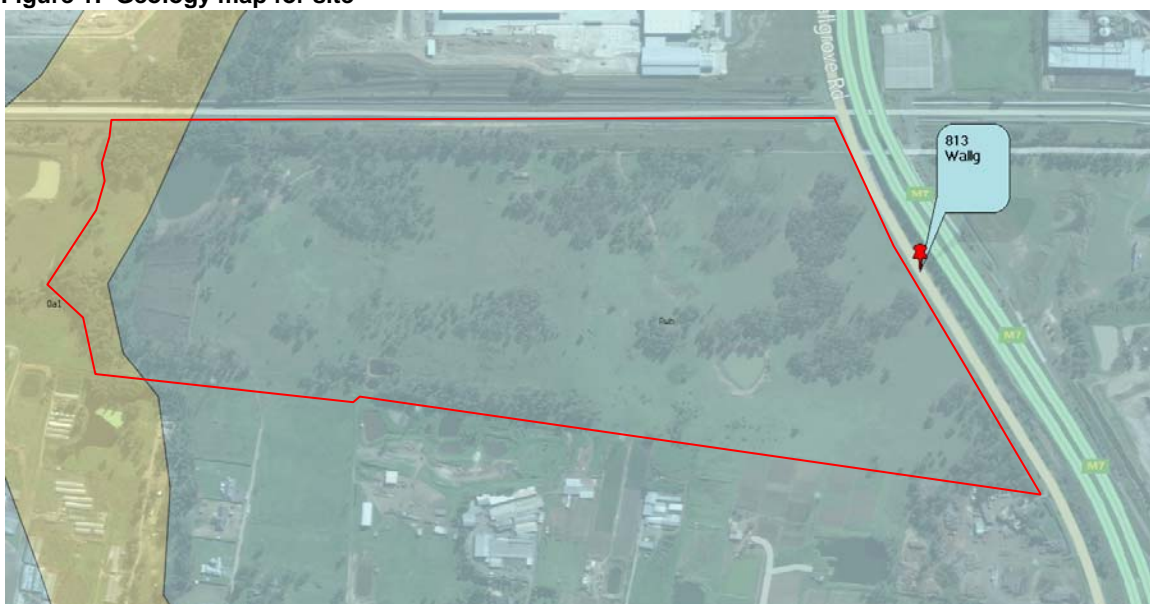
Figure 1: Geology map for site

Reference to the Penrith 1:100,000 Geology sheet indicates that the majority of the site is located on Bringelly Shale which comprises shale, carbonaceous claystone, claystone, laminite, fine to medium-grained lithic sandstone, rare coal and tuff. The western edge of the site is located in an area of fluvial sediments comprising fine-grained sand, silt and clay. Figure 1 shows the geology map overlaying the site.

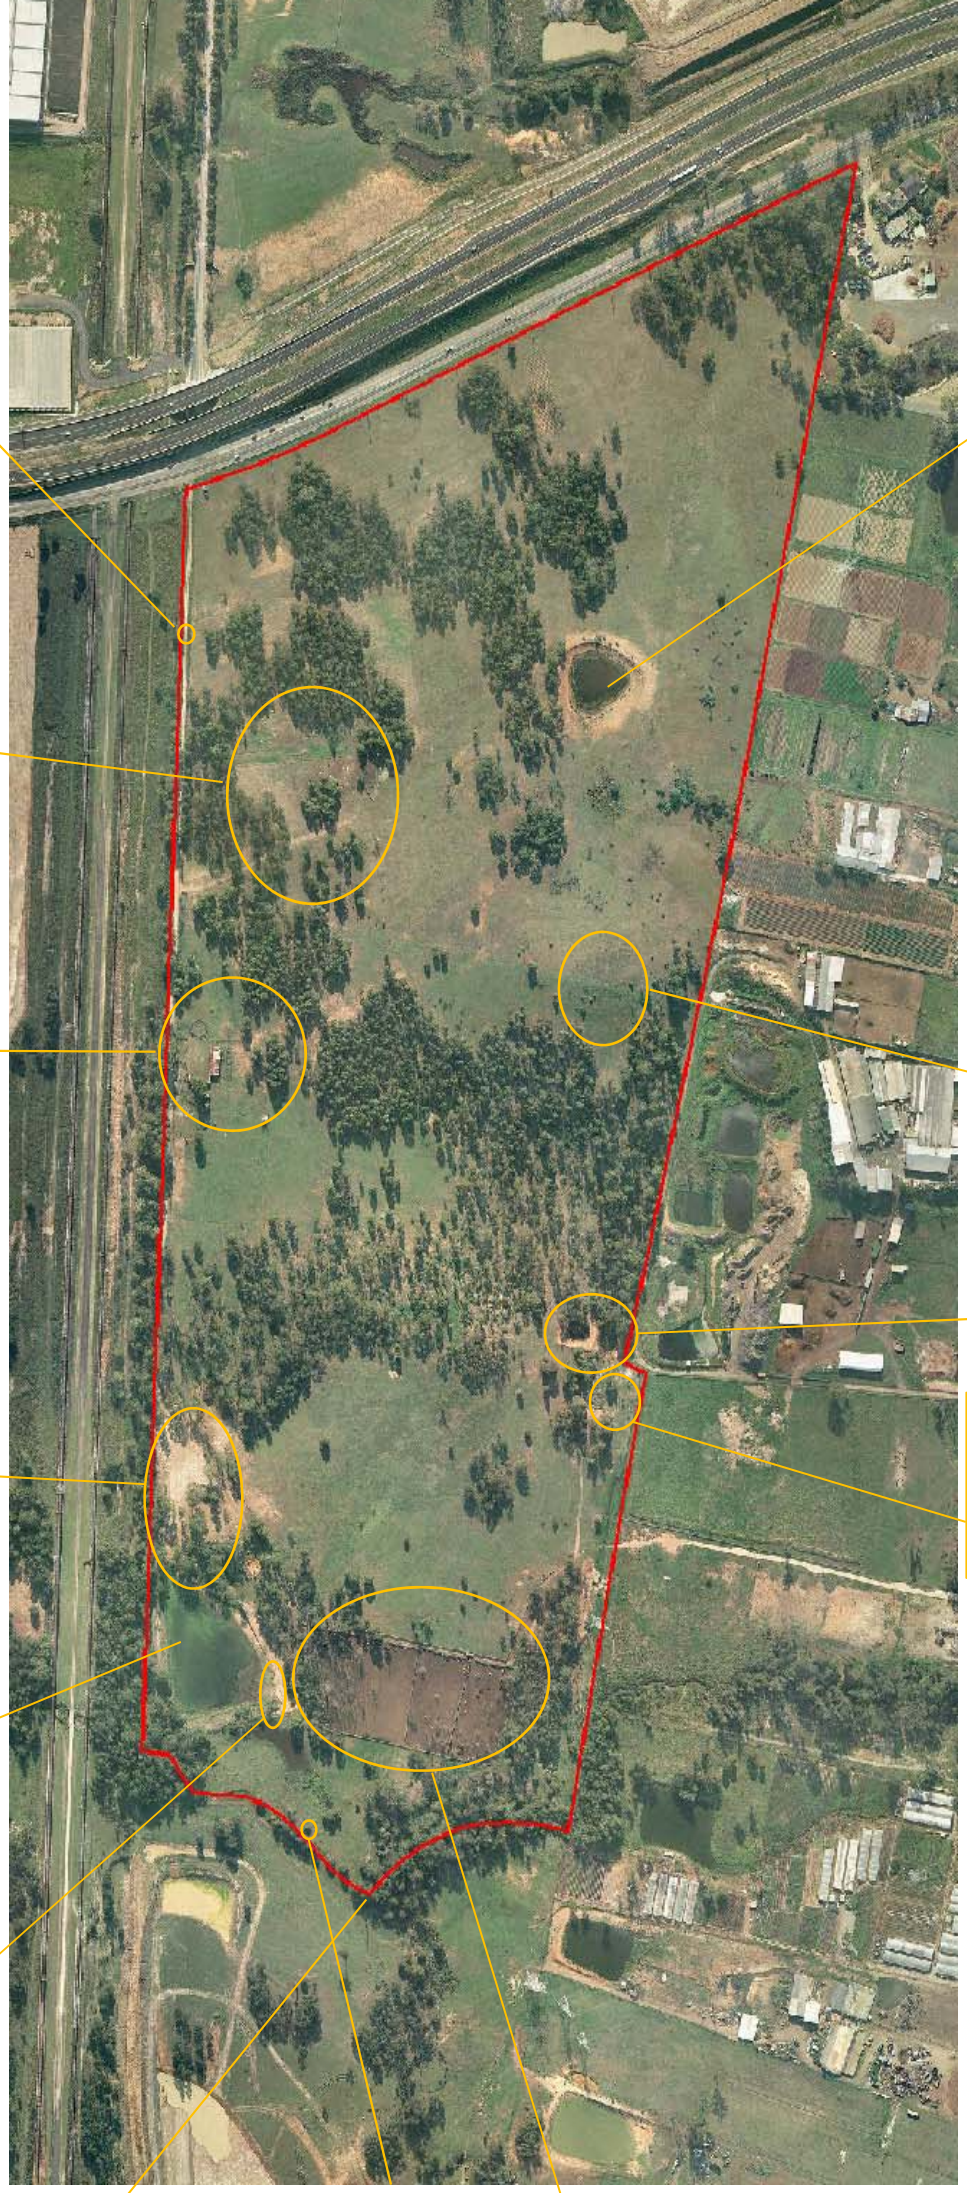
Large dam

Stockpiles of sand & sandstone, and concrete rubble, as well as general waste and possible fill

An inspection of the site was conducted on 30 October 2012 by an environmental engineer from DP. At the time of the inspection, the site was primarily being used for grazing of cattle, sheep and horses. The majority of the site was accessible for the inspection, although access was limited in some parts of the site by fenced or penned areas being used to hold livestock. Site features are shown on Drawing 2, Appendix A.

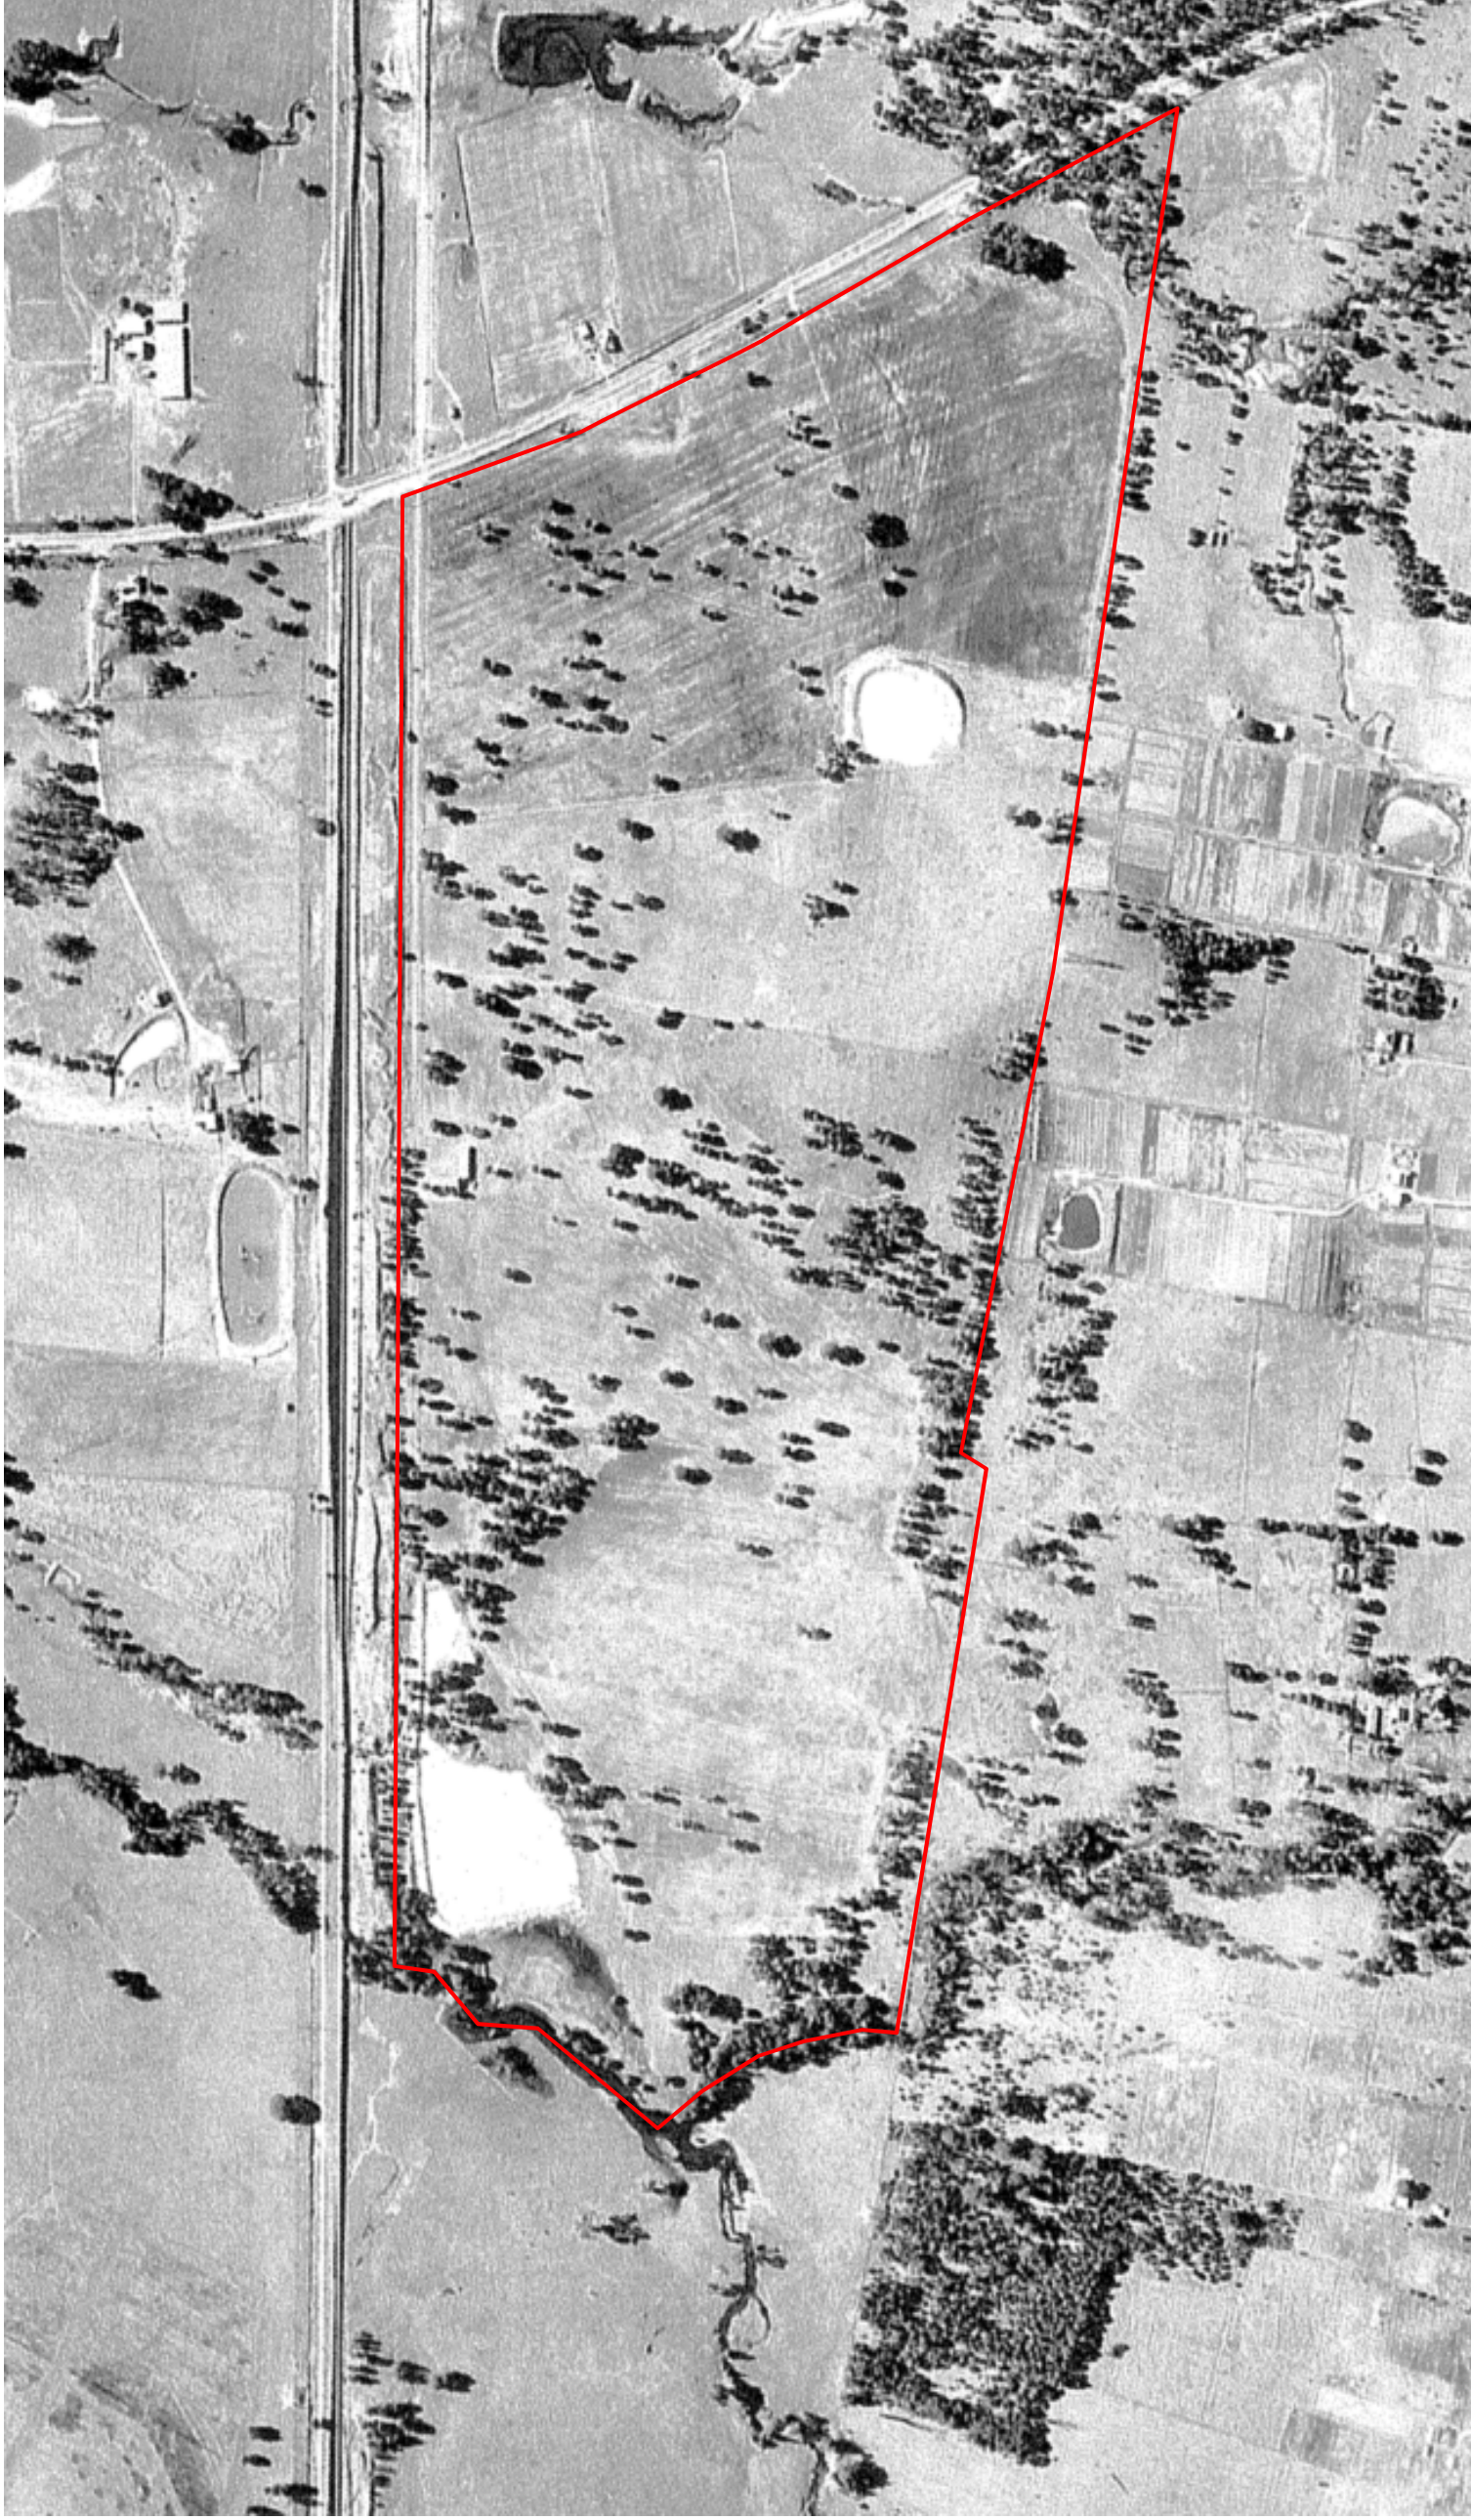
PLATE No: 2

The 1961 image shows that some changes to the site had occurred since 1951. Changes include a reduction of tree cover and the establishment of two large dams. Variations in the shading of the grass suggests that the property had been divided by fences into separate grazing areas. A shed or stable was present near the central part of the northern boundary.

The pipeline that adjoined the north of the site appears to have been completed. The land surrounding the site had been slightly modified for farming (mostly grazing) purposes and included the establishment of dams. Market gardens had been established to the south.

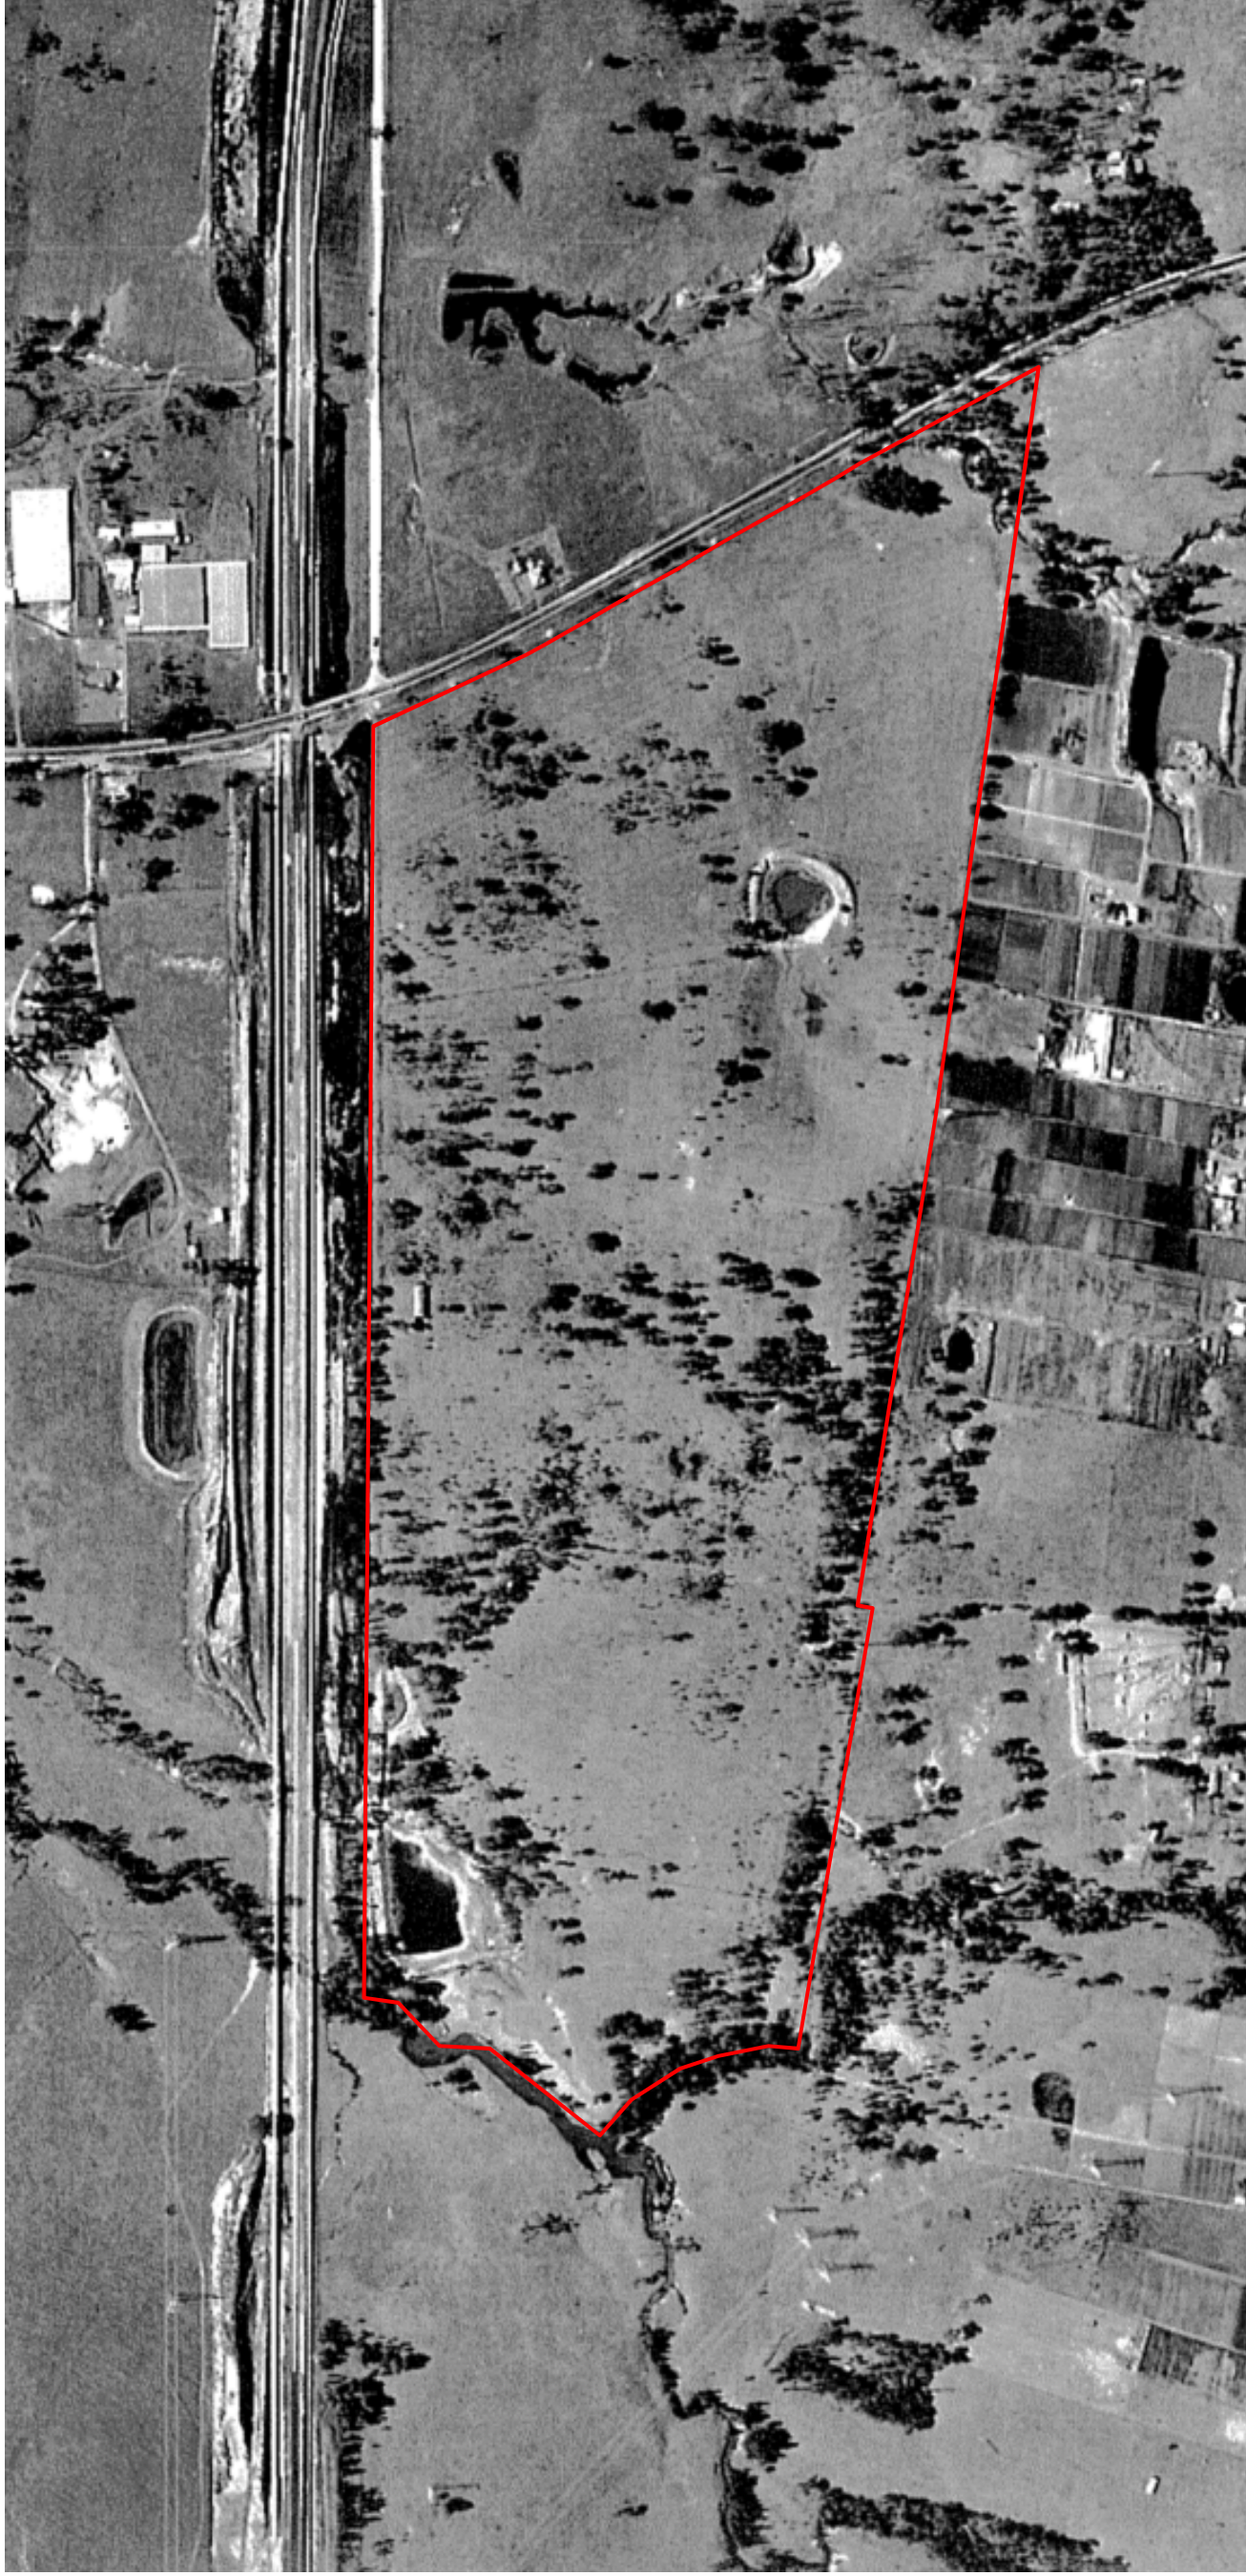
PROJECT No: 73194
PLATE No: 3
REVISION: A

The 1970 image shows that the site appears to have been similar to that shown in the 1961 image. Some small dams may have been established at the southern part of the site but is difficult to determine from the quality of the image.

Another pipeline appears to have been established in the land adjoining the north of the site. The majority of the land surrounding the site continued to be used for farming purposes.

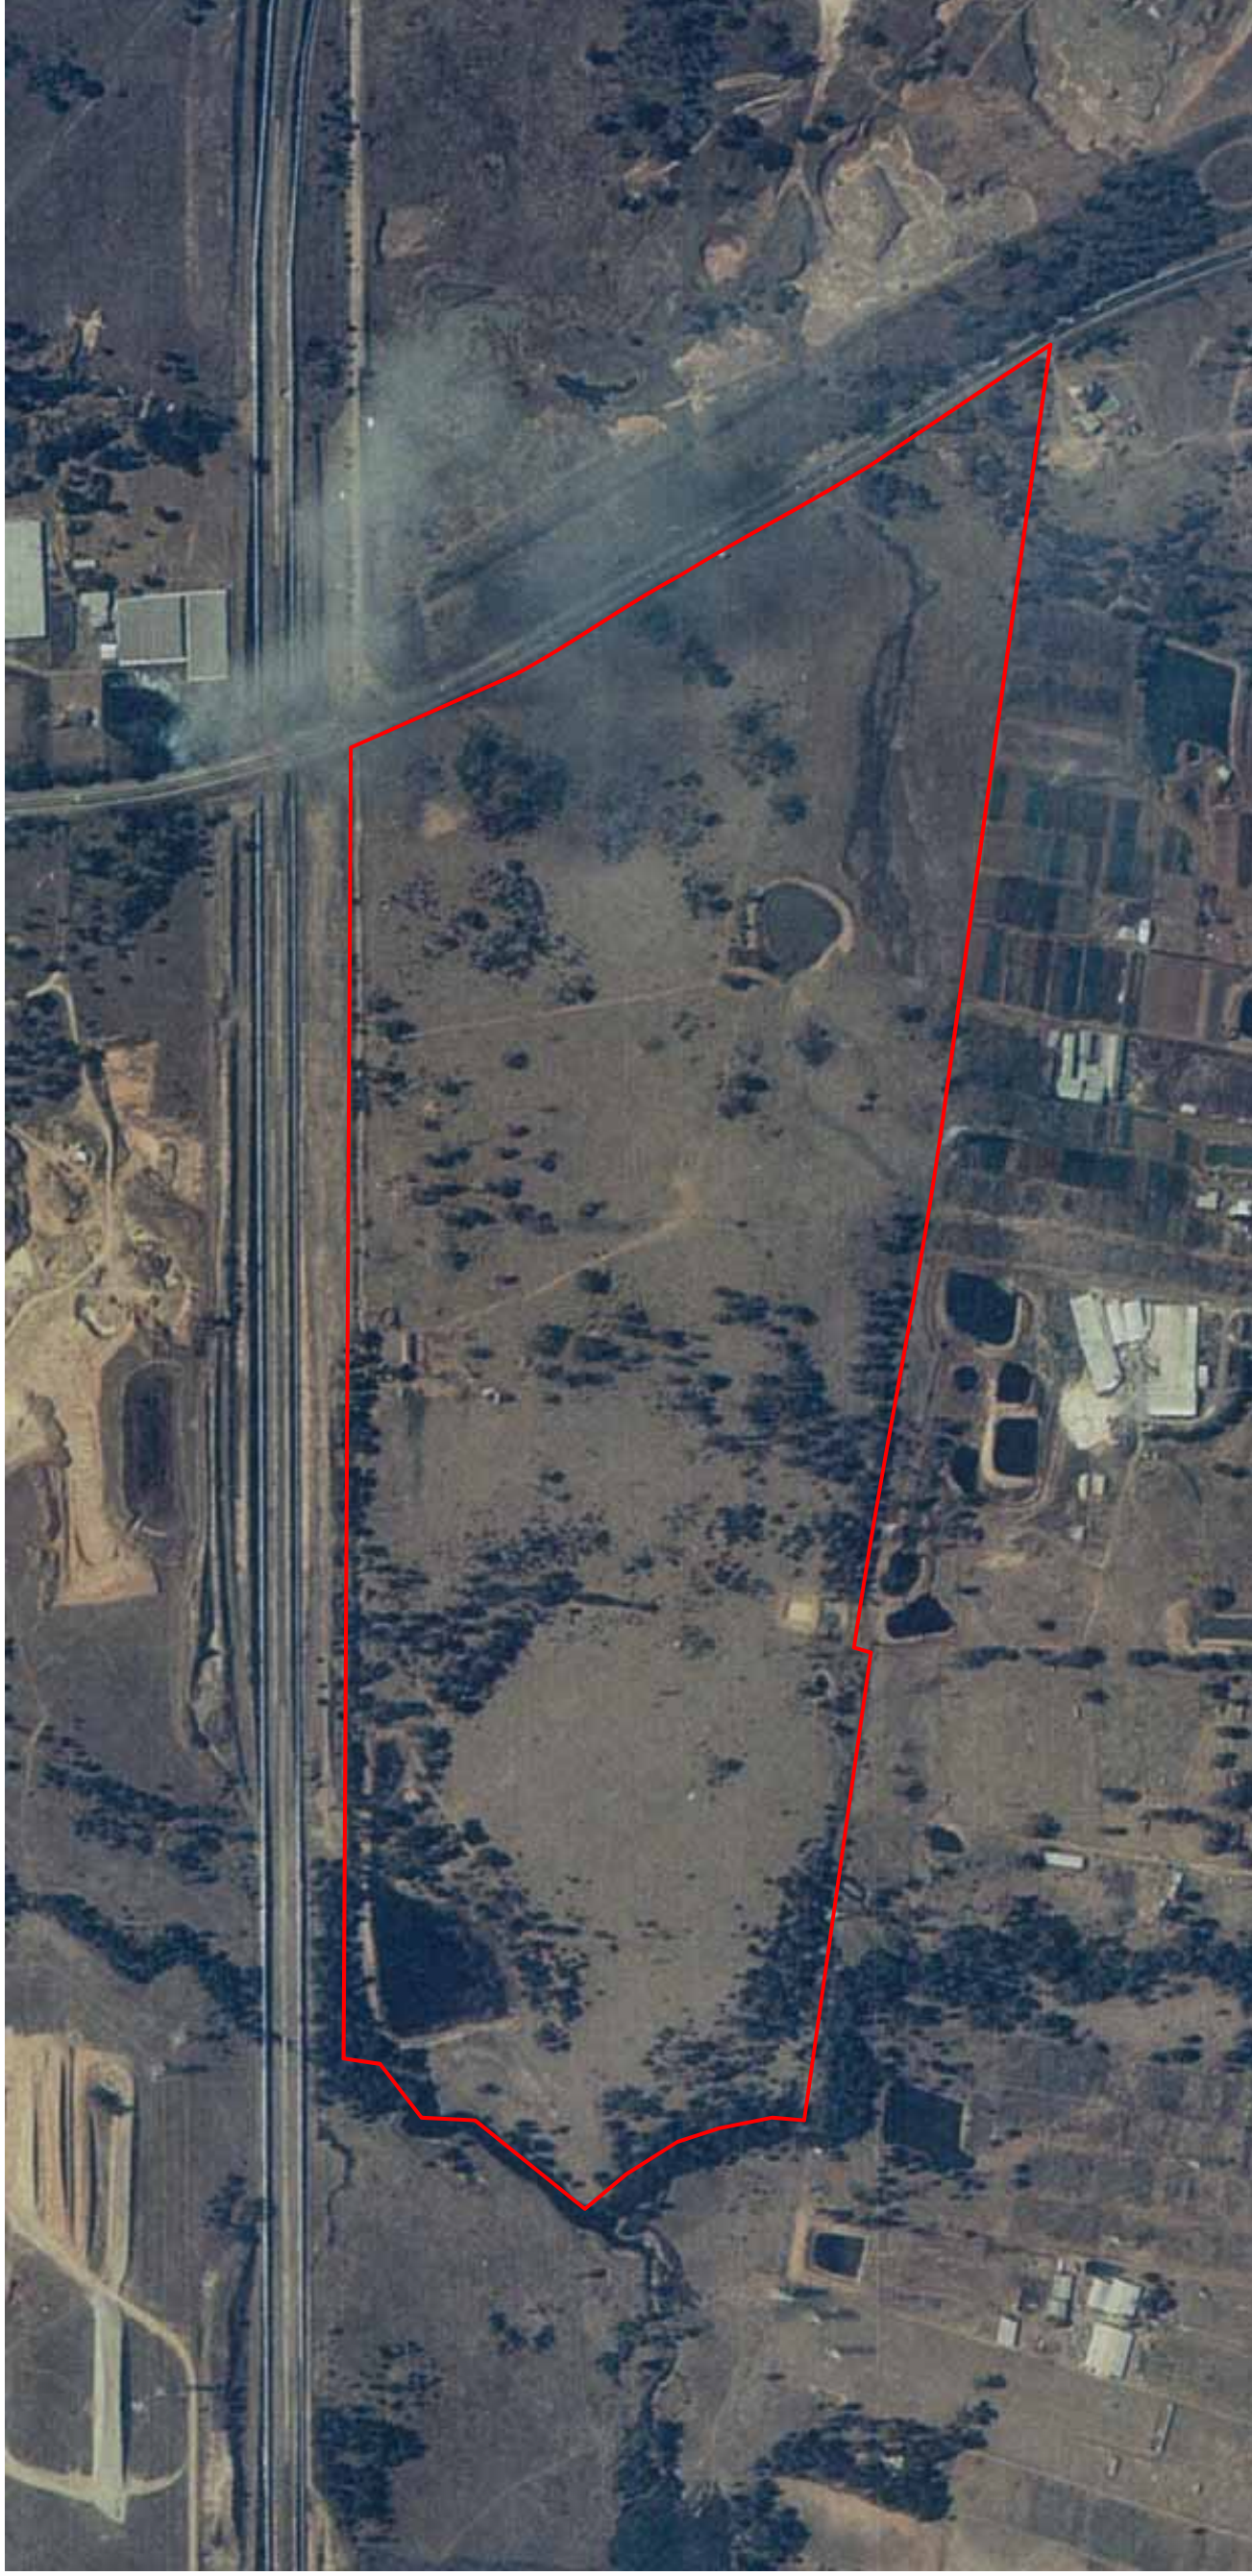
PLATE No: 4

The 1986 image shows that the site appears to have been similar to that shown in the 1970 image. Small dams are shown to have been present near the southern boundary of the site. Small structures were present close to the shed or stable near the northern boundary of the site.

Land surrounding the site had undergone significant change with large areas to the north and east subject to earthworks. Several buildings and dams had been established at the land adjoining the southern boundary of the site. The area to the south of the site also had a significant amount of market gardens.

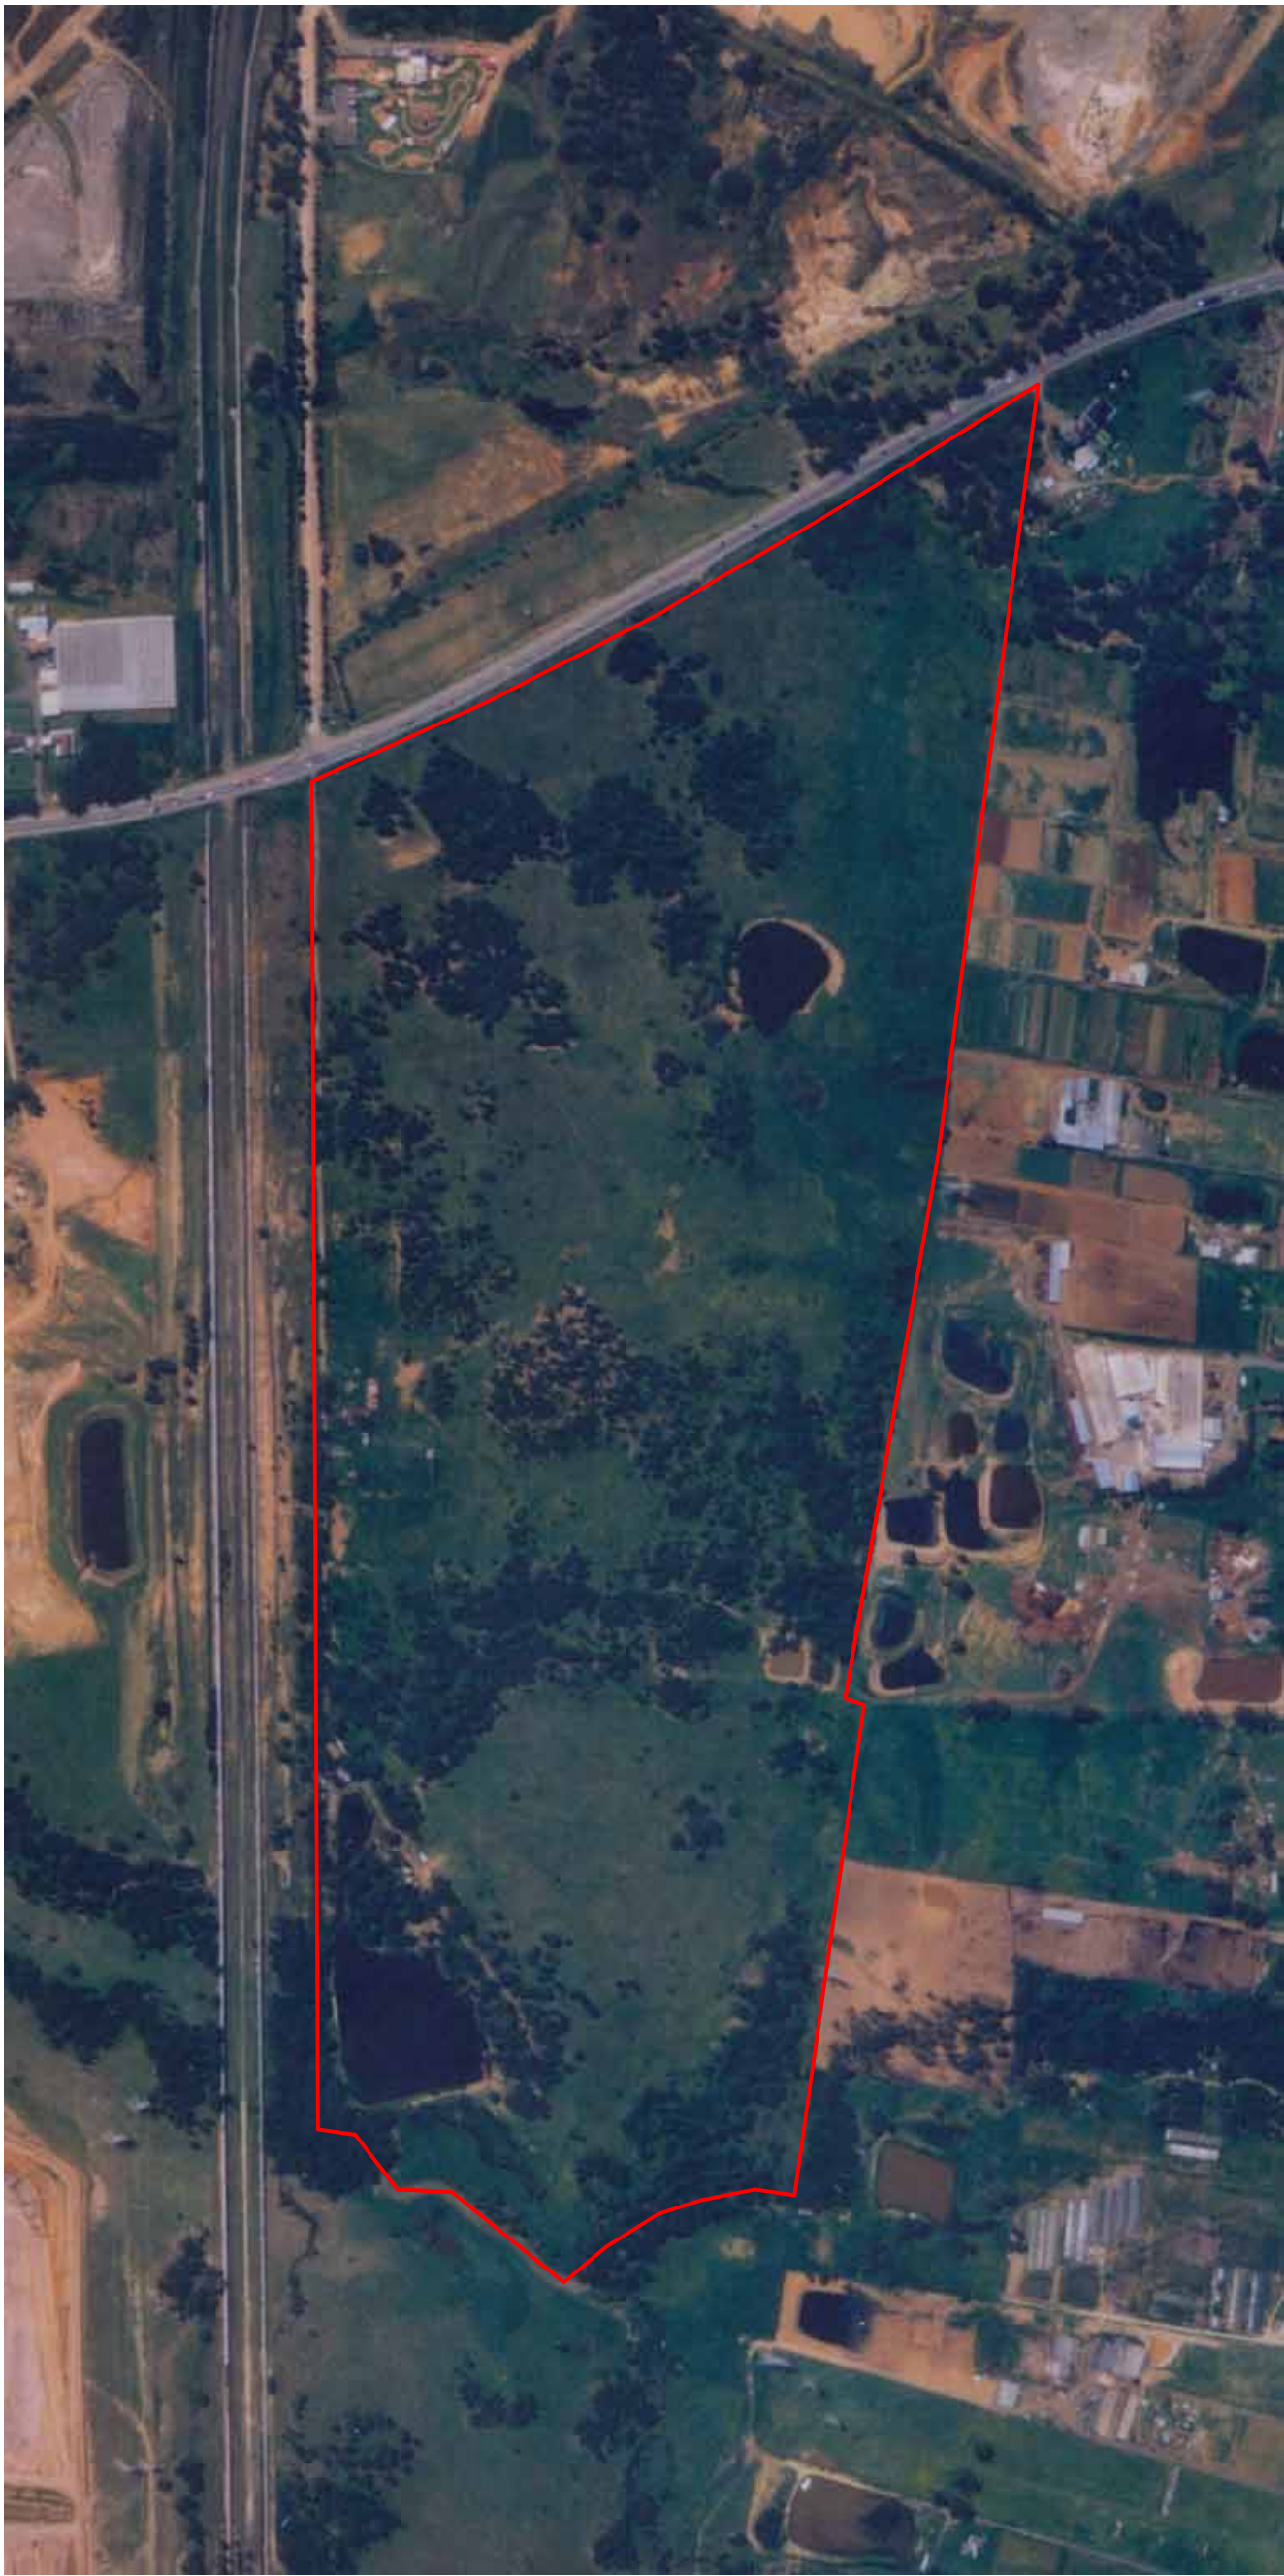
The 1998 image shows that the site appears to have been similar to that shown in the 1986 image. Some additional structures appear to have been present close to the northern boundary of the site. There has been general vegetation growth since 1986.

The land surrounding the site appears to be relatively unchanged since 1986, although several more buildings were present to the south in 1986.
